June 24, 2019

Aercoustics Project #: 15039.00

## **Cedar Point II LP**

Subject: Acoustic I-Audit for the Cedar Point II Wind Power Project  
REA#6914-95L5JBB

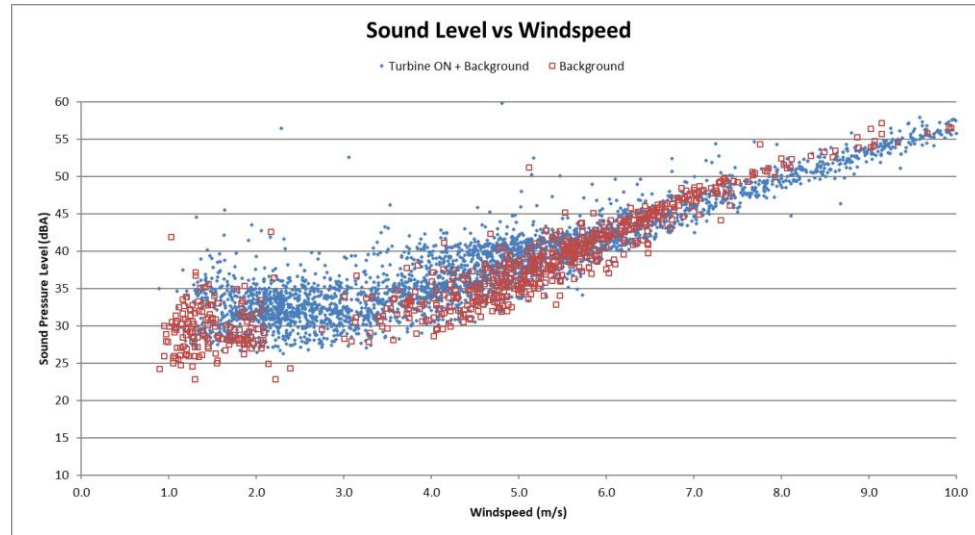
Figure 1 M1414 - 2nd Immission Audit - Turbine ON and Background

It can be seen that although outliers are included in the data, that there is little contamination in the Background data spread. There is one outlier in the background dataset which corresponds to the data point highlighted by the Ministry (M1414 Fall audit, OFF Status, Dec 1, 2016 10:31 pm – 5.1m/s and 51.2 dBA). The inclusion of this contaminated data point is considered negligible and does not affect the assessment of compliance.

It should be noted that the data point excluded in the same night at 5.8 m/s wind speed recorded as 41.9 dBA is the data interval corresponding to Dec 01, 11:52pm. This data point was excluded as not all turbines within proximity of the audit location were parked and therefore this interval is not considered ambient.

The data point for M1414 Fall Audit, OFF status, Dec 20, 2016, 4:19 am is the data point with the highest sound level in the 7m/s Turbine OFF wind bin and has been highlighted by the MECP as a contaminated data point. The source of noise is wind-related noise previously discussed in Section 1.c. It should be noted that wind induced noise is present for both Turbine ON and Turbine OFF at the 7m/s wind bin and the scatter plot confirms that the sound levels are similar in this wind bin. Measures to reduce the impact of wind-related noise were employed at the monitor location, as prescribed in the Protocol; a secondary wind screen was installed to reduce-self noise, and the monitoring equipment was located away from trees as much as practically possible. However, it is not possible to eliminate the affect of wind induced noise at very high wind speeds.

For audit location M1414 Fall the average measured Turbine OFF level in the 7m/s wind bin is greater than or equal to the Turbine ON level, this indicates that the local ambient noise sources, rather than the turbines are driving the overall sound level in this wind bin and as such an assessment of the Turbine ONLY has not been made for this wind bin.

The data point has been removed from the analysis and the results presented in Appendix A. The removal of the contaminated data point resulted in a 0.5 dB reduction to the background sound level in the 5m/s wind bin. Compliance is demonstrated after the removal of the contaminated data point. Furthermore, the maximum Turbine Only level in any wind bin for this monitor has a margin of compliance of 3dBA. It is unlikely that removing additional outliers would change the compliance status at this monitoring location.

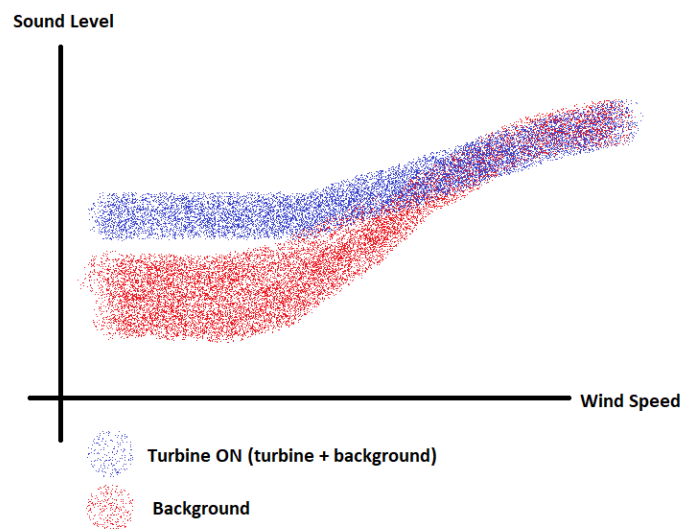
Figure 2: Example of the typical relationship between sound level and wind speed for Turbine ON and Background periods

Trend analysis of wind turbine levels sound levels should be approached with caution because the relationship between ground level winds and wind-induced ambient noise is not linear, it's logarithmic [1] [2] [3]. Further, the trend of the Turbine ON levels vs. ground level wind speed has two distinct sections: at low ground level winds where the turbine noise dominates, and at high ground level

winds where the ambient noise dominates. The typical relationship between wind speed and sound level of both ambient and Turbine ON sound levels is shown in the conceptual drawing in Figure 1. The wind speed at which the ambient noise overtakes Turbine ON noise, the rate of increase of ambient noise, and the minimum sound level of ambient noise all depend on the nature of the surroundings for each monitor.

Trend analysis will also lead to increased error in the estimation of turbine sound levels if the correlation coefficient of the data is low. For example, the IEC 61400-11 (edition 2.1) standard requires a minimum coefficient before trend analysis can be conducted; it also uses a 4<sup>th</sup> order polynomial fit to the data. Further, the subsequent revision of the IEC standard (Edition 3.0) abandoned trend analysis altogether in favour of the binning method (which is the same method used by the Compliance Protocol). Receptor-based field measurements experience more variation in measured sound level compared to IEC 61400-11 measurements, which therefore makes trend analysis even more prone to error.

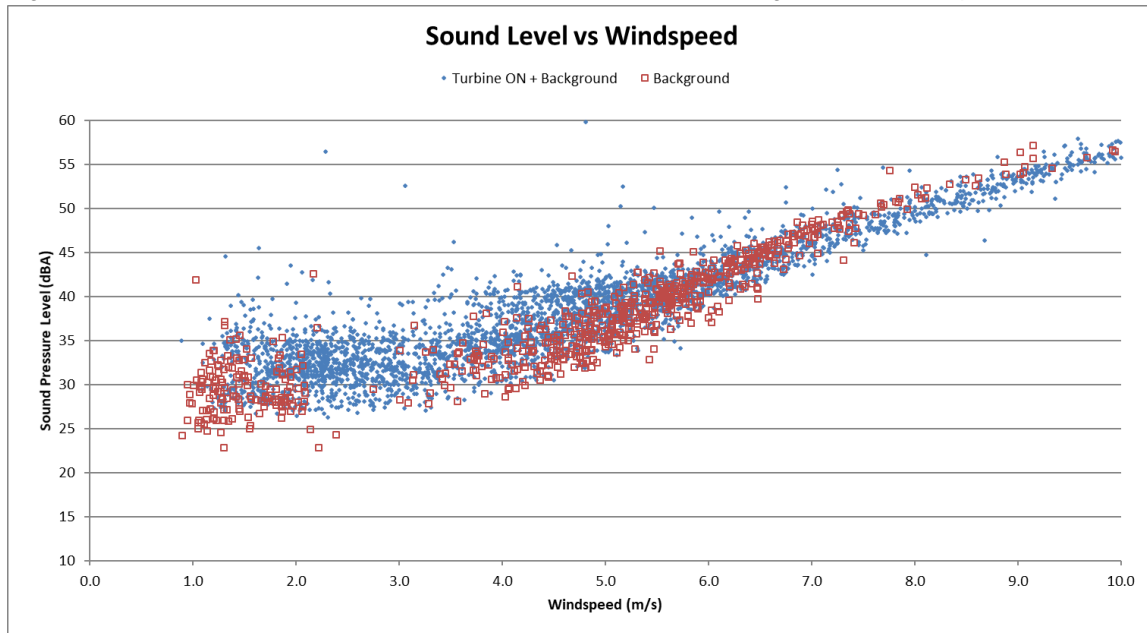
Figure A.01: M1414 - Measured Sound Levels for Turbine ON and Background vs Wind Speed

The following table details the sound levels measured at receptor M1414 during the 2<sup>nd</sup> I-Audit when all the nearby turbines were on (Turbine ON) and when all the nearby turbines were off (Turbine OFF). The Turbine OFF data point corresponding to Dec 1, 2016 10:31 pm – 5.1m/s and 51.2 dBA has been assessed as contaminated and removed from the analysis. Based on the calculated Turbine only component indicated in Table A.01 the Cedar Point Wind Power Project is compliant with the MECP limits at receptor R1414.
