**Stantec Consulting Ltd.**  
1-70 Southgate Drive, Guelph ON N1G 4P5

July 27, 2015  
File: 160960709

**Reference: Status of Immediate Remediation Measures Areas of Vegetation Removal at the Cedar Point Wind Farm**

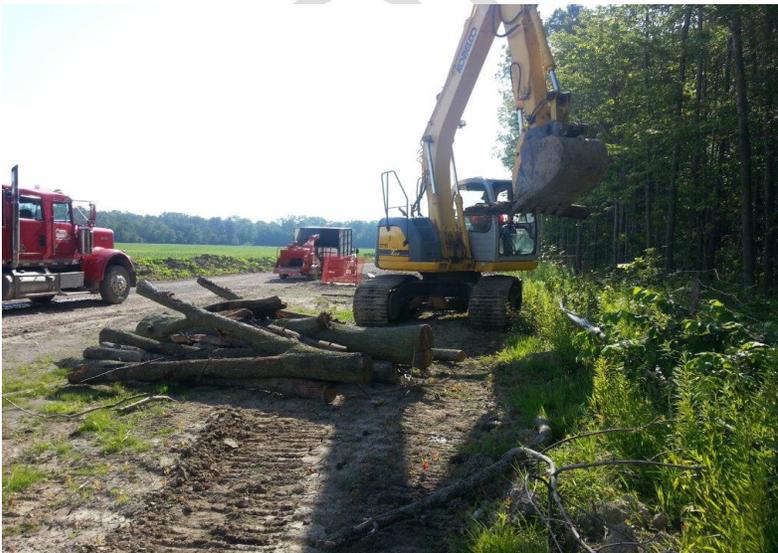
1. The majority of tree trunks and limbs greater than 5 cm in diameter have been removed from the woodlands and stacked on site for appropriate disposal in accordance with landowner requests. Photo 1 shows an example of this measure.

**Photo 1: Trunk and limb removal.**

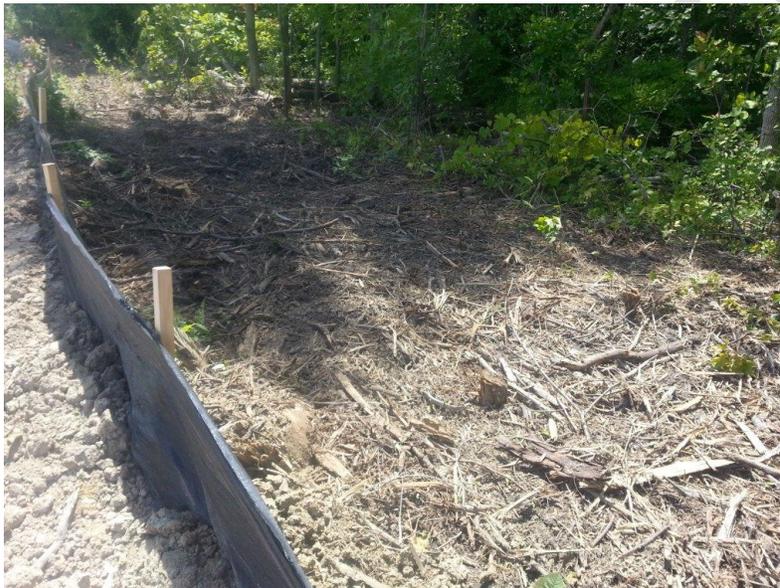
2. Mulch in the disturbed areas has been redistributed to achieve a maximum depth of approximately 5 cm throughout the area of vegetation removal. Existing forest floor conditions, emerging vegetation and naturally occurring large woody litter and deadfall were taken into account in implementing the recommendation to achieve a mix of mulch depth and distribution that fairly represents the litter distribution in the adjacent woodlot. The objective of this recommendation has been achieved.

**Photo 2: Typical Mulch Distribution and Silt Fence**

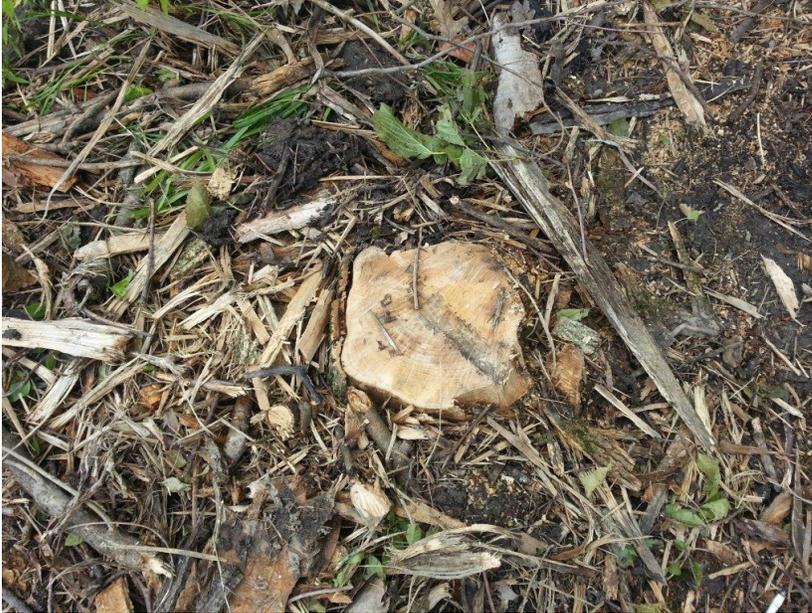
3. The silt fencing adjacent to areas of vegetation removal has been keyed into the ground and maintained as need under the daily supervision of AMEC Foster Wheeler. Photos shows and example of how the fence has been keyed in. No serious sedimentation of woodland habitats was observed during Stantec site visits.
4. Remnant tree stumps or trunks with broken or shredded margins have been cleanly cut close to the ground and evidence of sprouting was observed. Please see Photo 3 as an example.

**Photo 3: Example of flush cutting of stumps**
