AECOM

Study Area: Jericho Goshen Bluewater Land Parcel# GSH 2016 Turbine # C144
 Date: Dec 16, 2011 Start time: 11:15 End Time: 11:45
 Weather Conditions: Cloudy, 1°C Field Notes By: CB

Study Area: Jericho Goshen Bluewater Land Parcel# GSH2016 Turbine # C144

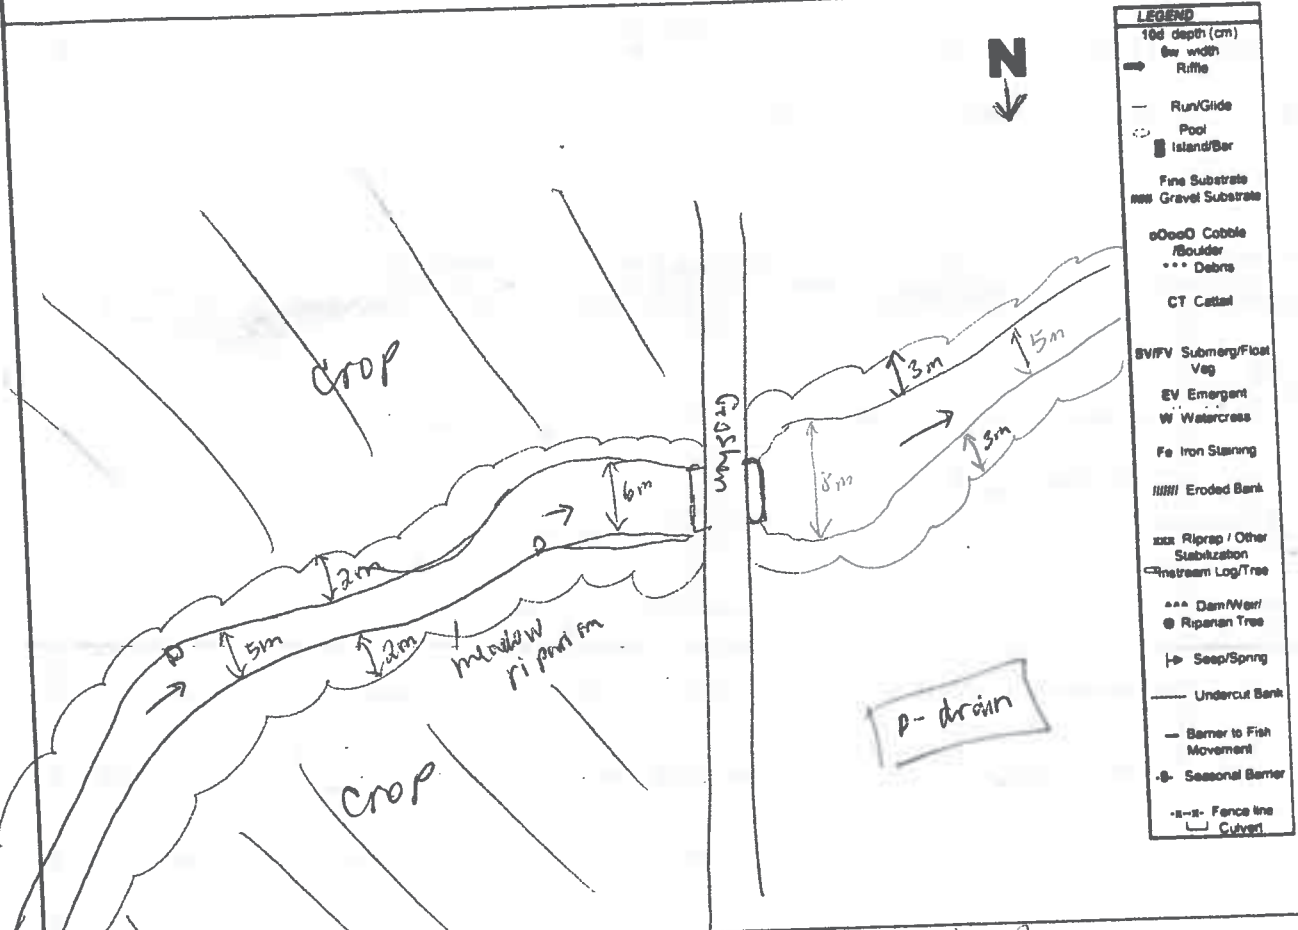
Watercourse Sketch

- stream too deep to wade in
- channelized & uniform throughout site
- debris jams noted throughout - ~~big~~ banks - not blocking flow

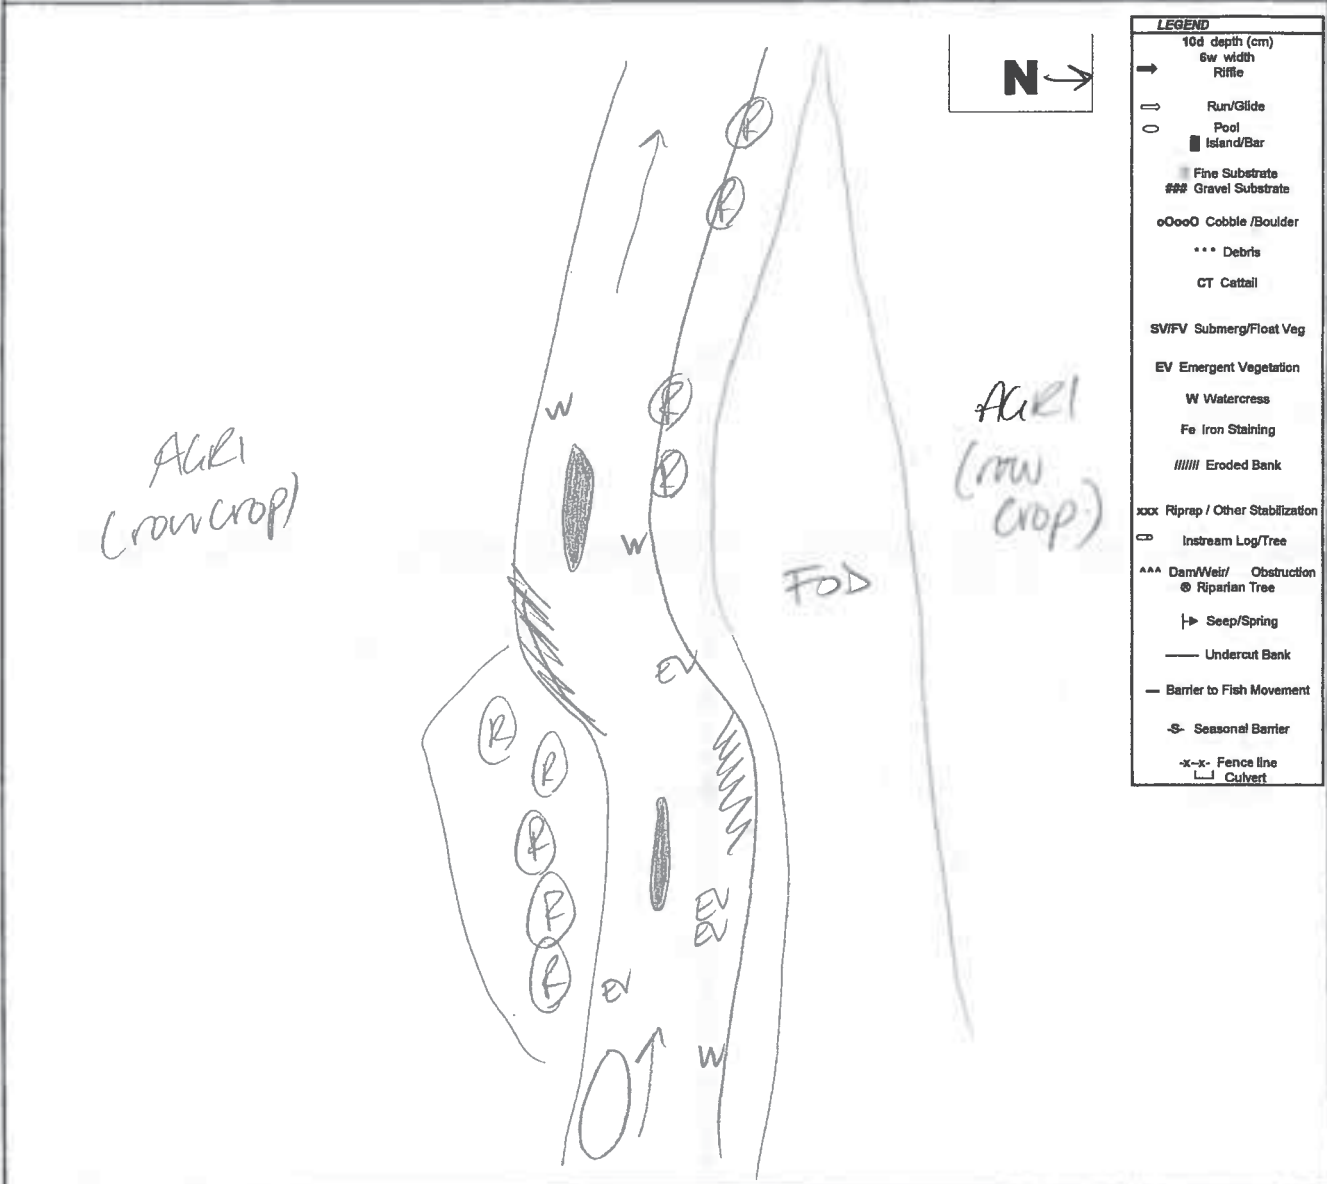
017

Stable	Slightly unstable	Moderately unstable	Unstable														
Left Bank	<input type="checkbox"/>	<input checked="" type="checkbox"/>	<input type="checkbox"/>	<input type="checkbox"/>														
Right Bank	<input type="checkbox"/>	<input checked="" type="checkbox"/>	<input type="checkbox"/>	<input type="checkbox"/>														
Mean Wetted Width (m): <u>1.20m</u>	Mean Wetted Depth (m): <u>0.15m</u>	Description: <u>evidence of past failures, very steep slope, loose soil under top layer of vegetation</u>																
Mean Bankfull Width (m): <u>6.0m</u>	Mean Bankfull Depth (m): <u>1.0m</u>																	
Mean Top of Bank Width (m): <u>8.5m</u>	Mean Top of Bank Depth (m): <u>3.5m</u>																	
Flow Description: (high or low flow conditions, stagnant, etc) <u>low flow, visibly flowing</u>																		
Substrate (<=>)		Morphological Structure (%)																
Bo - Boulder Co - Cobble Gr - Gravel Sa - Sand Si - Silt Cl - Clay MK - Muck DT - Detritus	Description <u>Si >> Gr > Bo</u>	<table border="1" style="width: 100%; text-align: center;"> <tr> <th>Pool</th> <th>Riffle</th> <th>Run</th> <th>Flat</th> </tr> <tr> <td><u>5</u></td> <td><u>5</u></td> <td><u>90</u></td> <td></td> </tr> </table>	Pool	Riffle	Run	Flat	<u>5</u>	<u>5</u>	<u>90</u>		Notes: <u>Pool: 0.50m deep 3m x 1.5m</u>

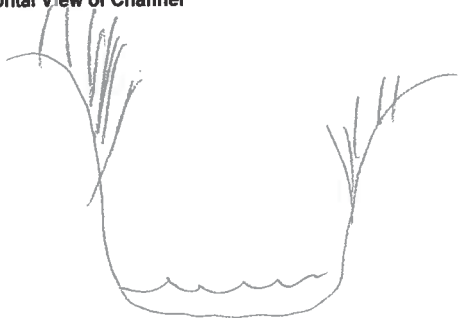
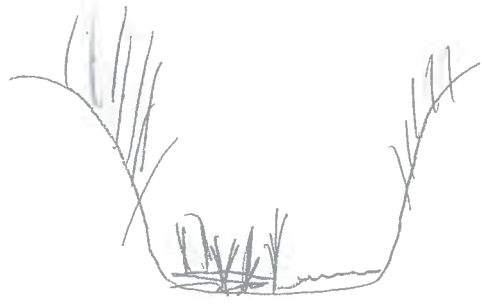
braided on east branch

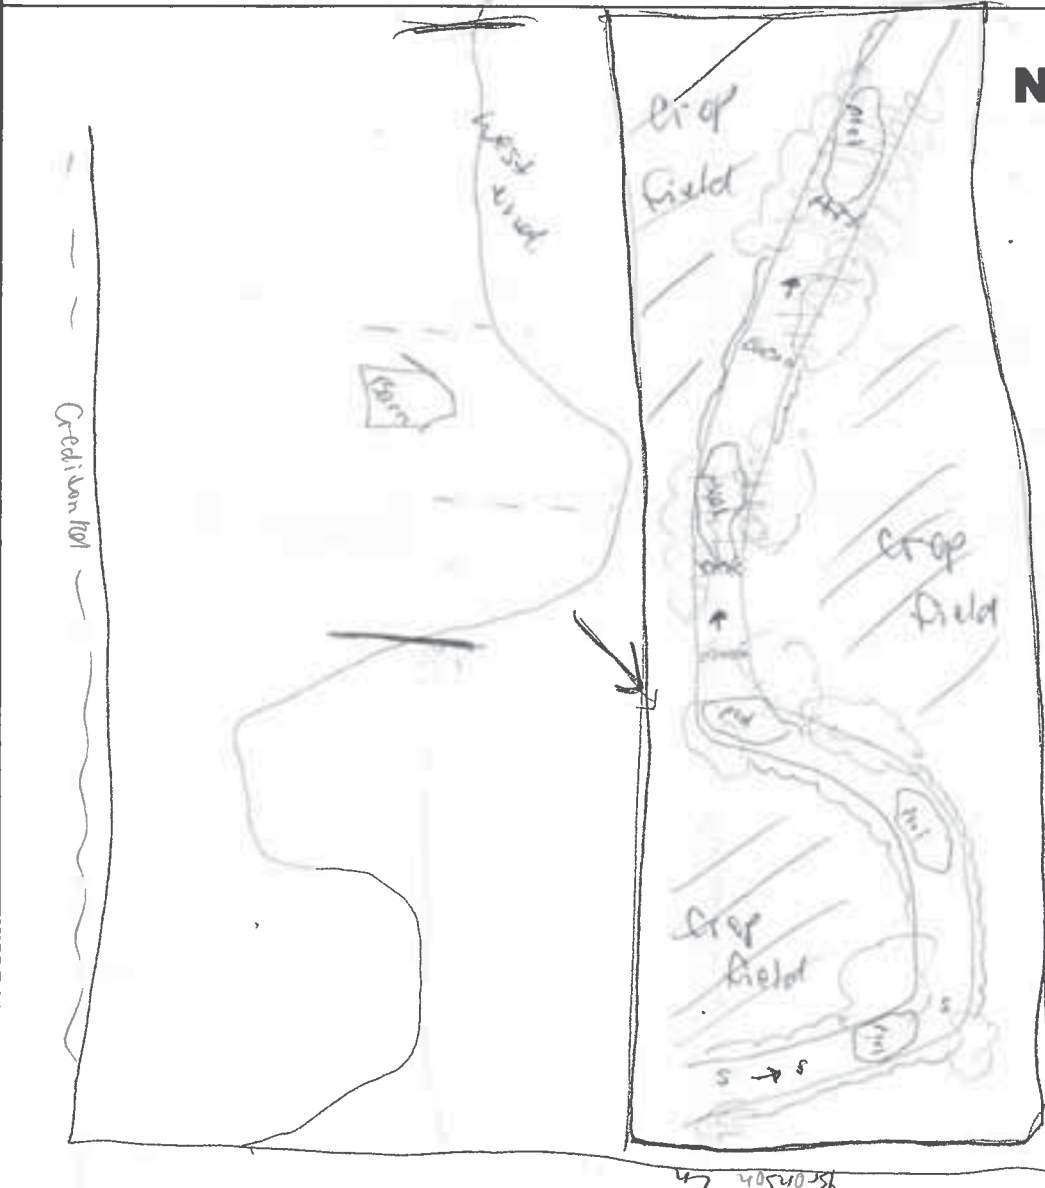
Study Area: Jericho Gospen Bluewater Land Parcel# 1787/1077 Site ID D19

water
 S - speedwell
 X - debris jam
 ooo - riffle

• erosion + shaping found throughout
 • algal coating substrate throughout
