AECOM

Study Area: Jericho Goshen Bluewater Land Parcel# 2236 & 2237 Turbine # GDS ~~C42A~~  
 Date: Sep 28/11 Start time: 8:30 End Time: 9:10 (GE20)

## Site Location

East of Cedar Swamp, North of Kirkton

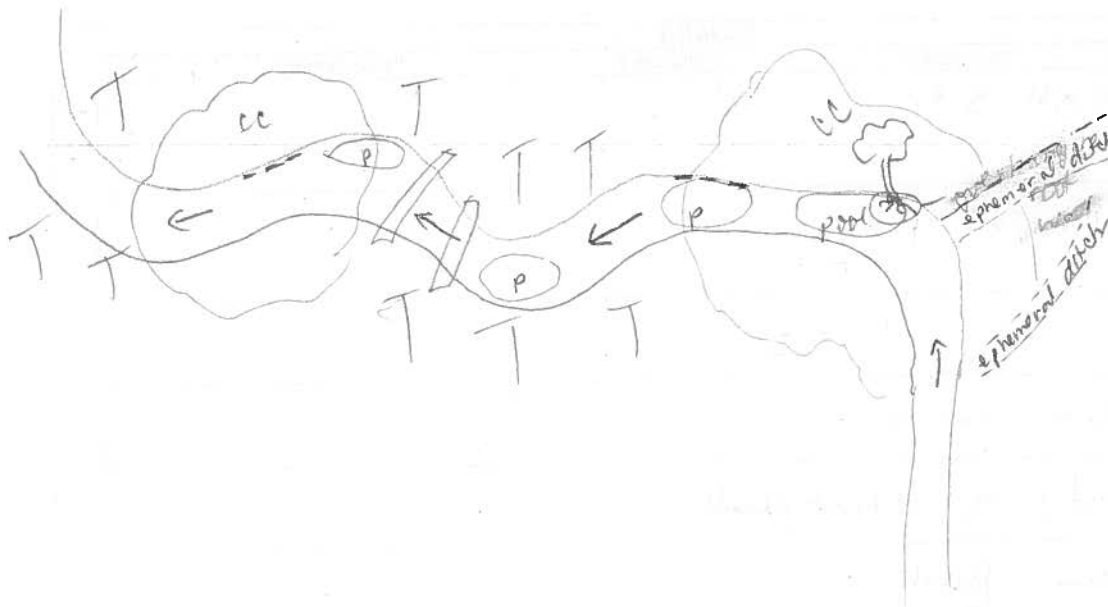
## Watercourse Sketch

Flow Description: - right bank had major erosion on one of the meander bends  
- moderate flow
