# Water Bodies Assessment Field Collection Form

AECOM

Jericho

Goshen

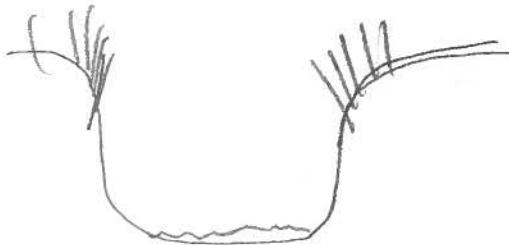
Horizontal View of Channel

- channel appears to be freshly dug out

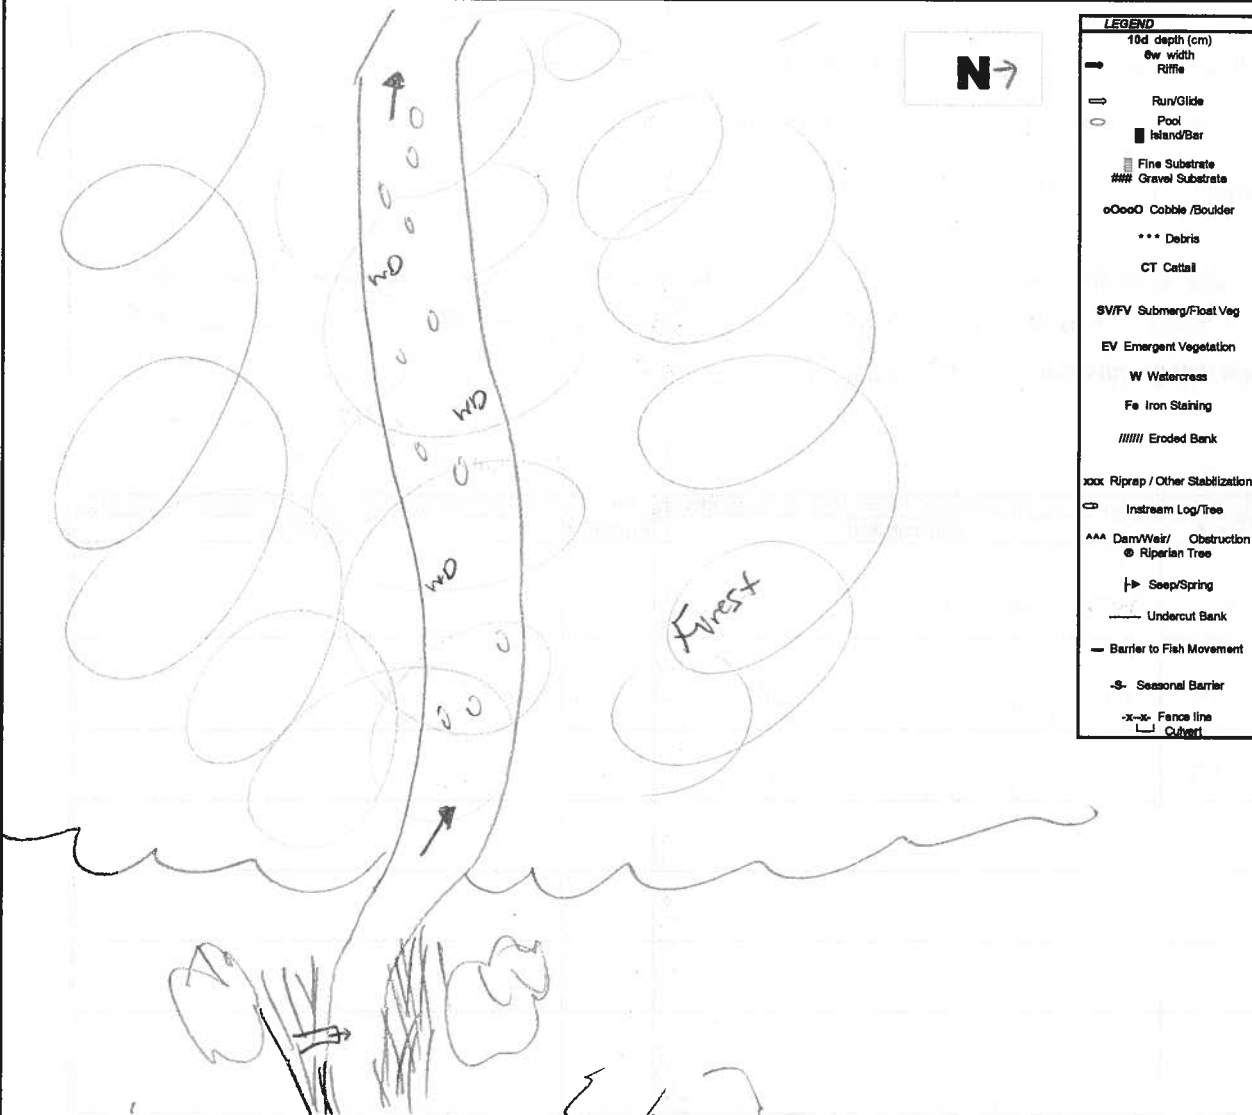
## Watercourse Sketch

Watercourse is channelized and straight, it runs through a forest area that provides dense canopy cover. Instream cover is moderate & dominated by cobble.

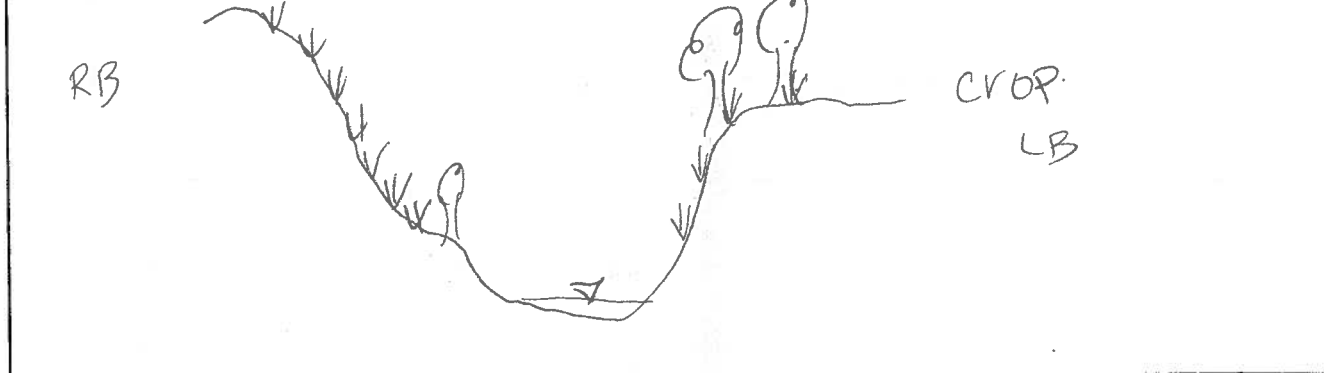
Horizontal View of Channel

- fish observed - cyprinid species
- channelized feature starting to naturalize.
- overhanging vegetation provided by willow shrubs
- Some nice riffle areas
- West of GB line - more natural channel  
good canopy cover
- low riparian cover on LB → crop right to TOR

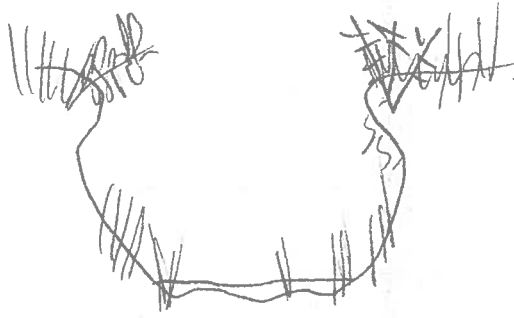
Horizontal View of Channel

| Stream Morphology | | | | | | | | | | | | | | | | | | | | |
|---|---|---|---|---|---|---|---|---|---|---|---|---|---|---|---|---|---|---|---|---|
| Mean Wetted Width (m): <u>1.20m</u> | Mean Wetted Depth (m): <u>0.15m</u> | | Description: <u>evidence of past failures, very steep slope, bare soil under top layer of vegetation</u> | | | | | | | | | | | | | | | | | |
