**Table 9. Water Body Site Investigations Summary for Adelaide Wind Energy Centre Project Area – Sydenham River**

**Table 10. Summary of Water Body Site investigations for the Adelaide Wind Energy Centre**

**Appendix I**  
Site Investigation Field Notes

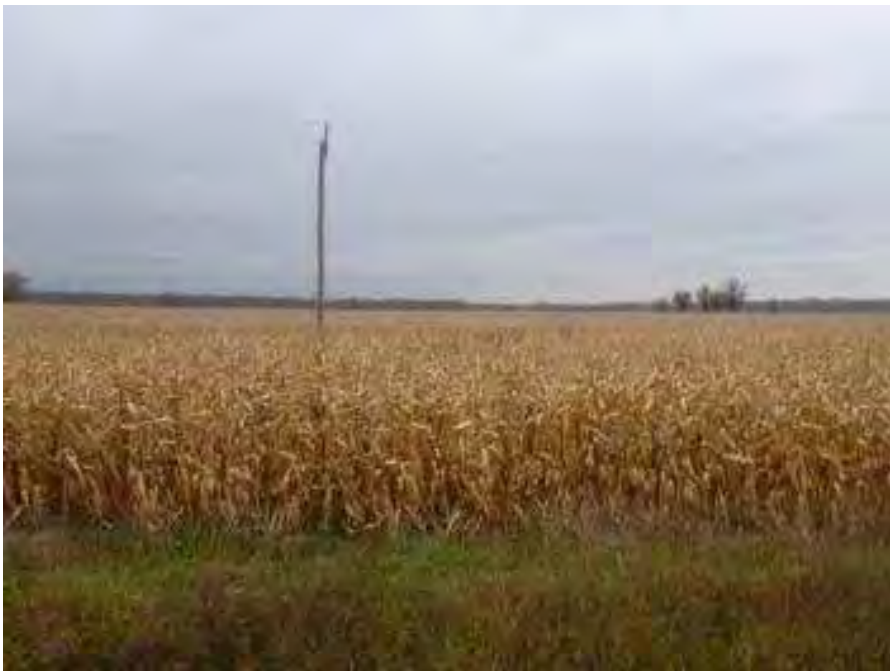
**Figure 8 WB32 (no surface water body)**

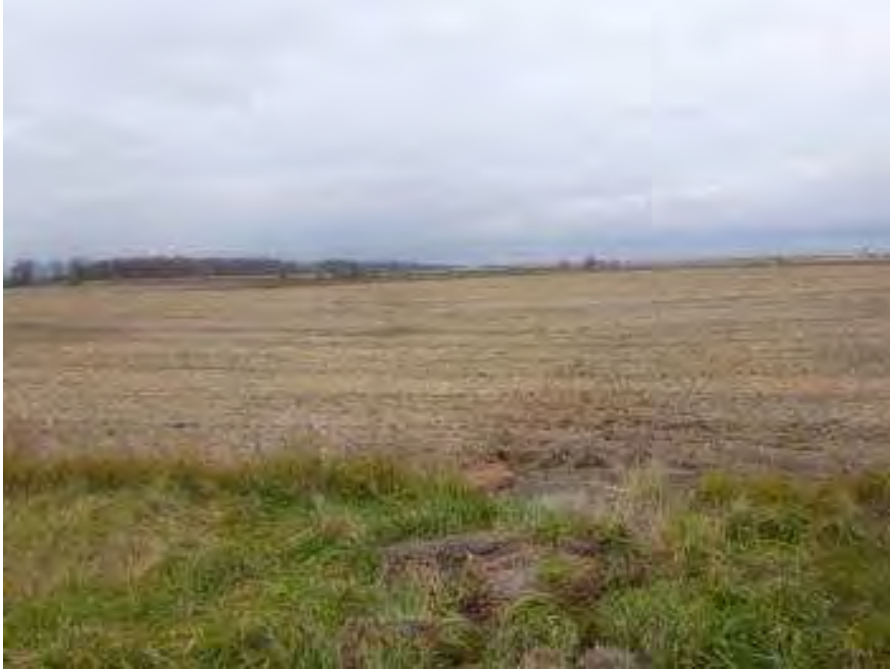
**Figure 23 WB20 (no surface water body)**

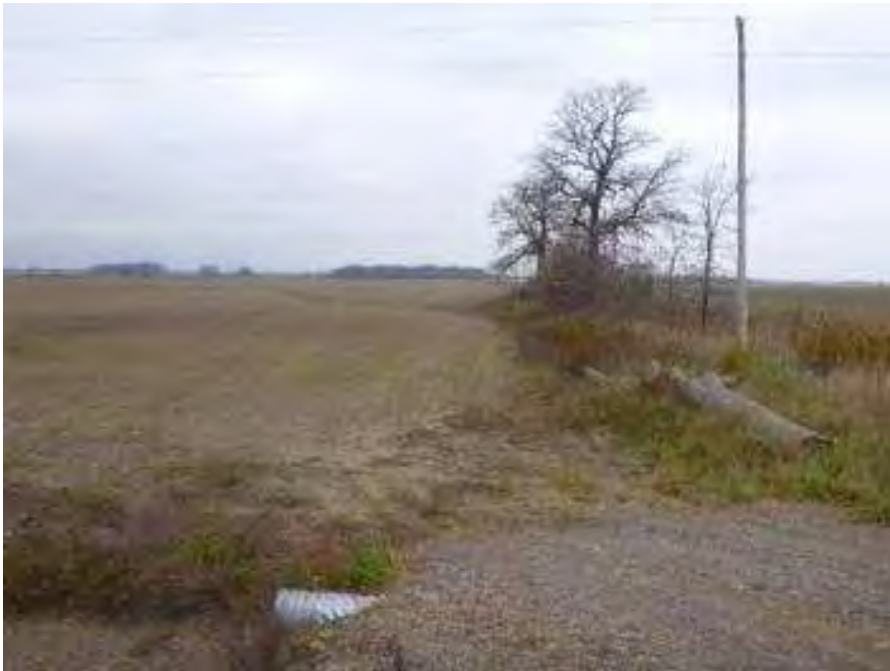
**Figure 24 WB29 (no surface water body)**

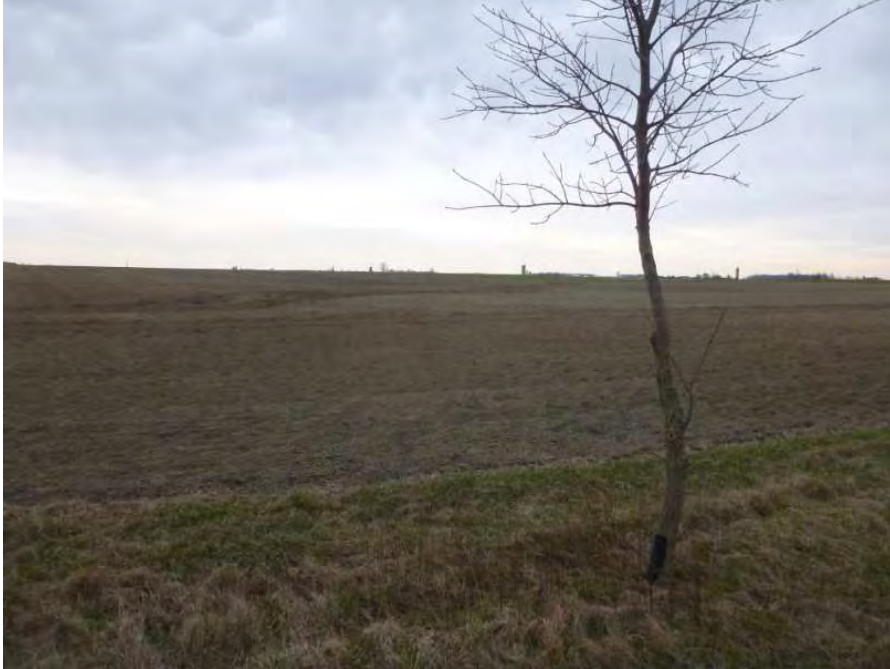
**Figure 27 WB56 (no surface water body)**

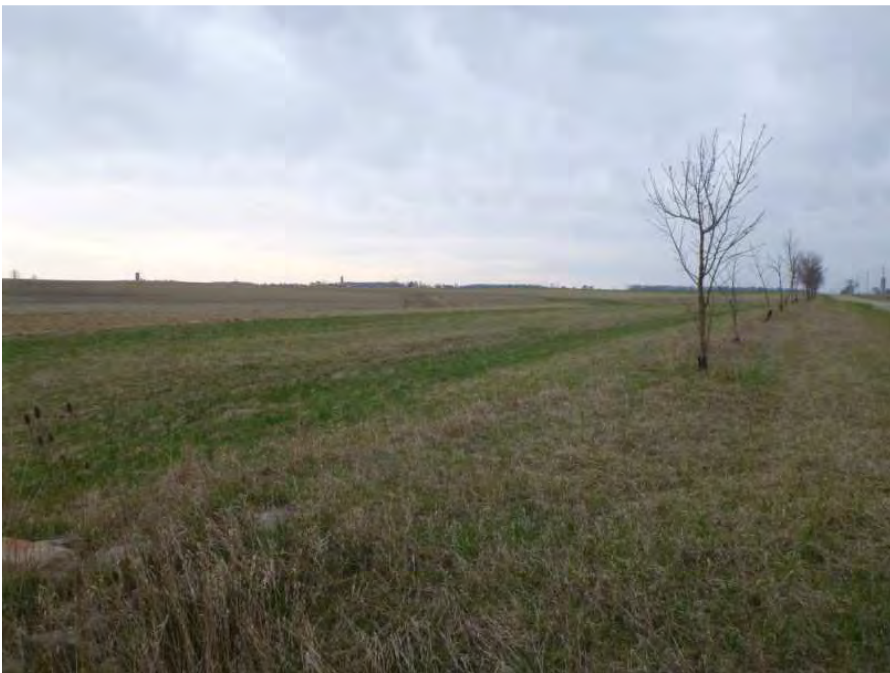
**Figure 28 WB55 (no surface water body)**

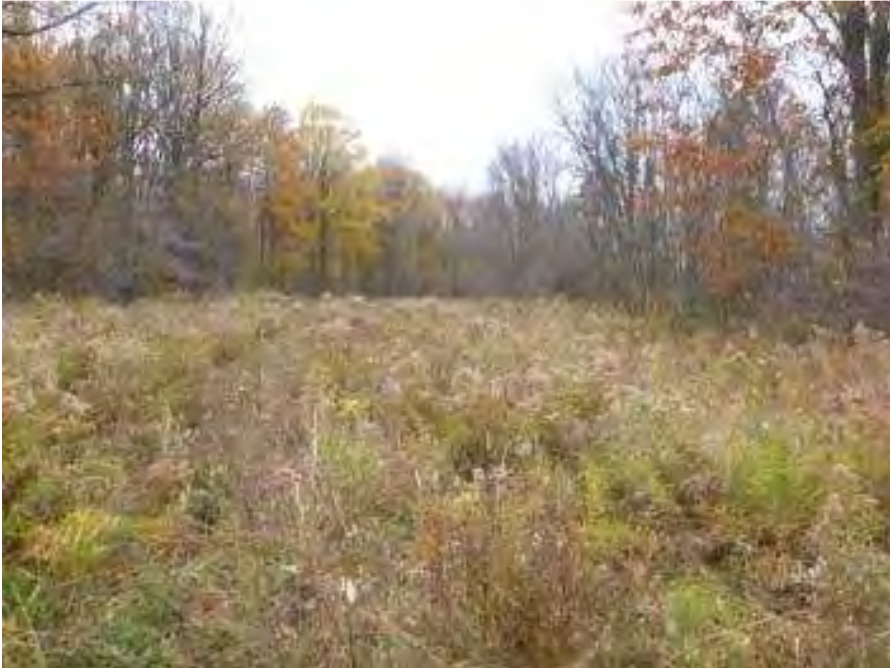
**Figure 35 WB25 (no surface waterbody)**

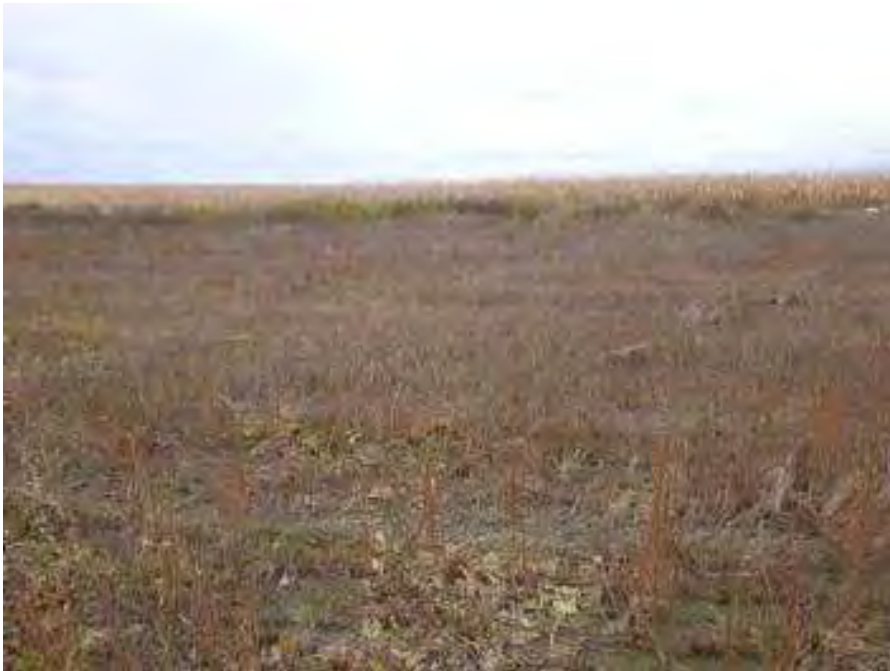
**Figure 36 WB26 (no surface waterbody)**

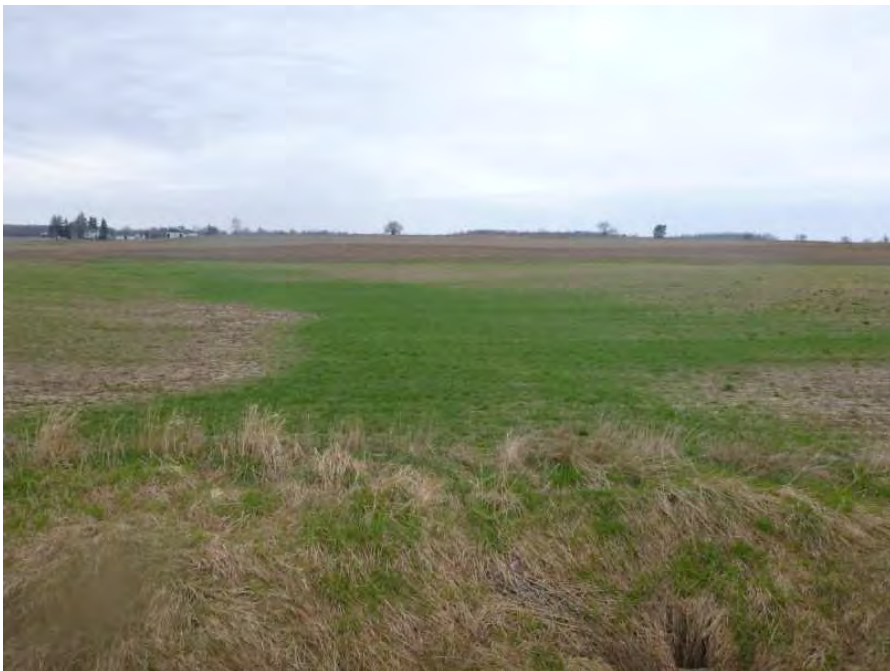
**Figure 38 WB44 (no surface water body)**

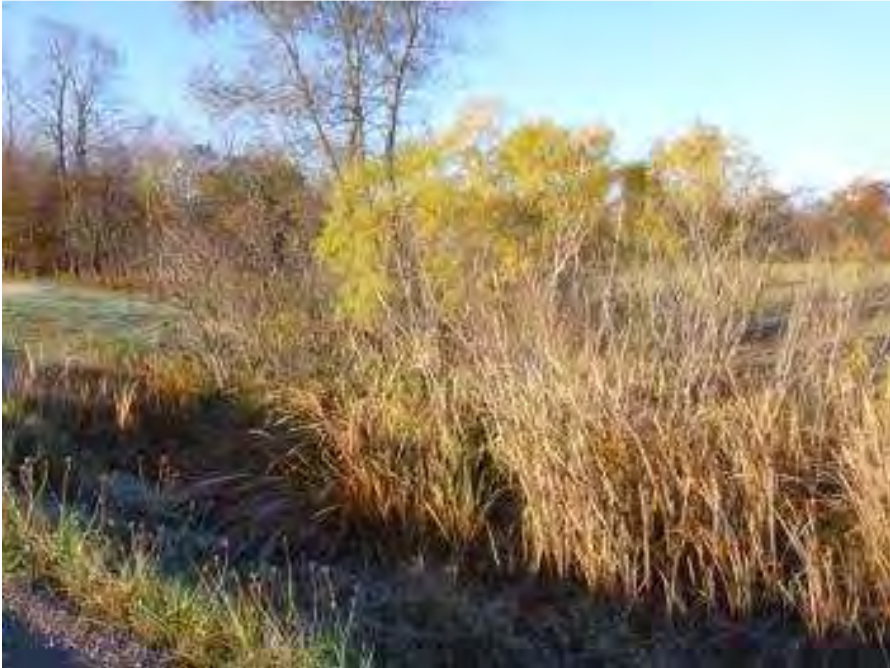
Figure 39 WB40 (no surface water body)
