Reference: Remediation Plan for Areas of Vegetation Removal at the Cedar Point Wind Farm

Cedar Point II Tree Removal Areas

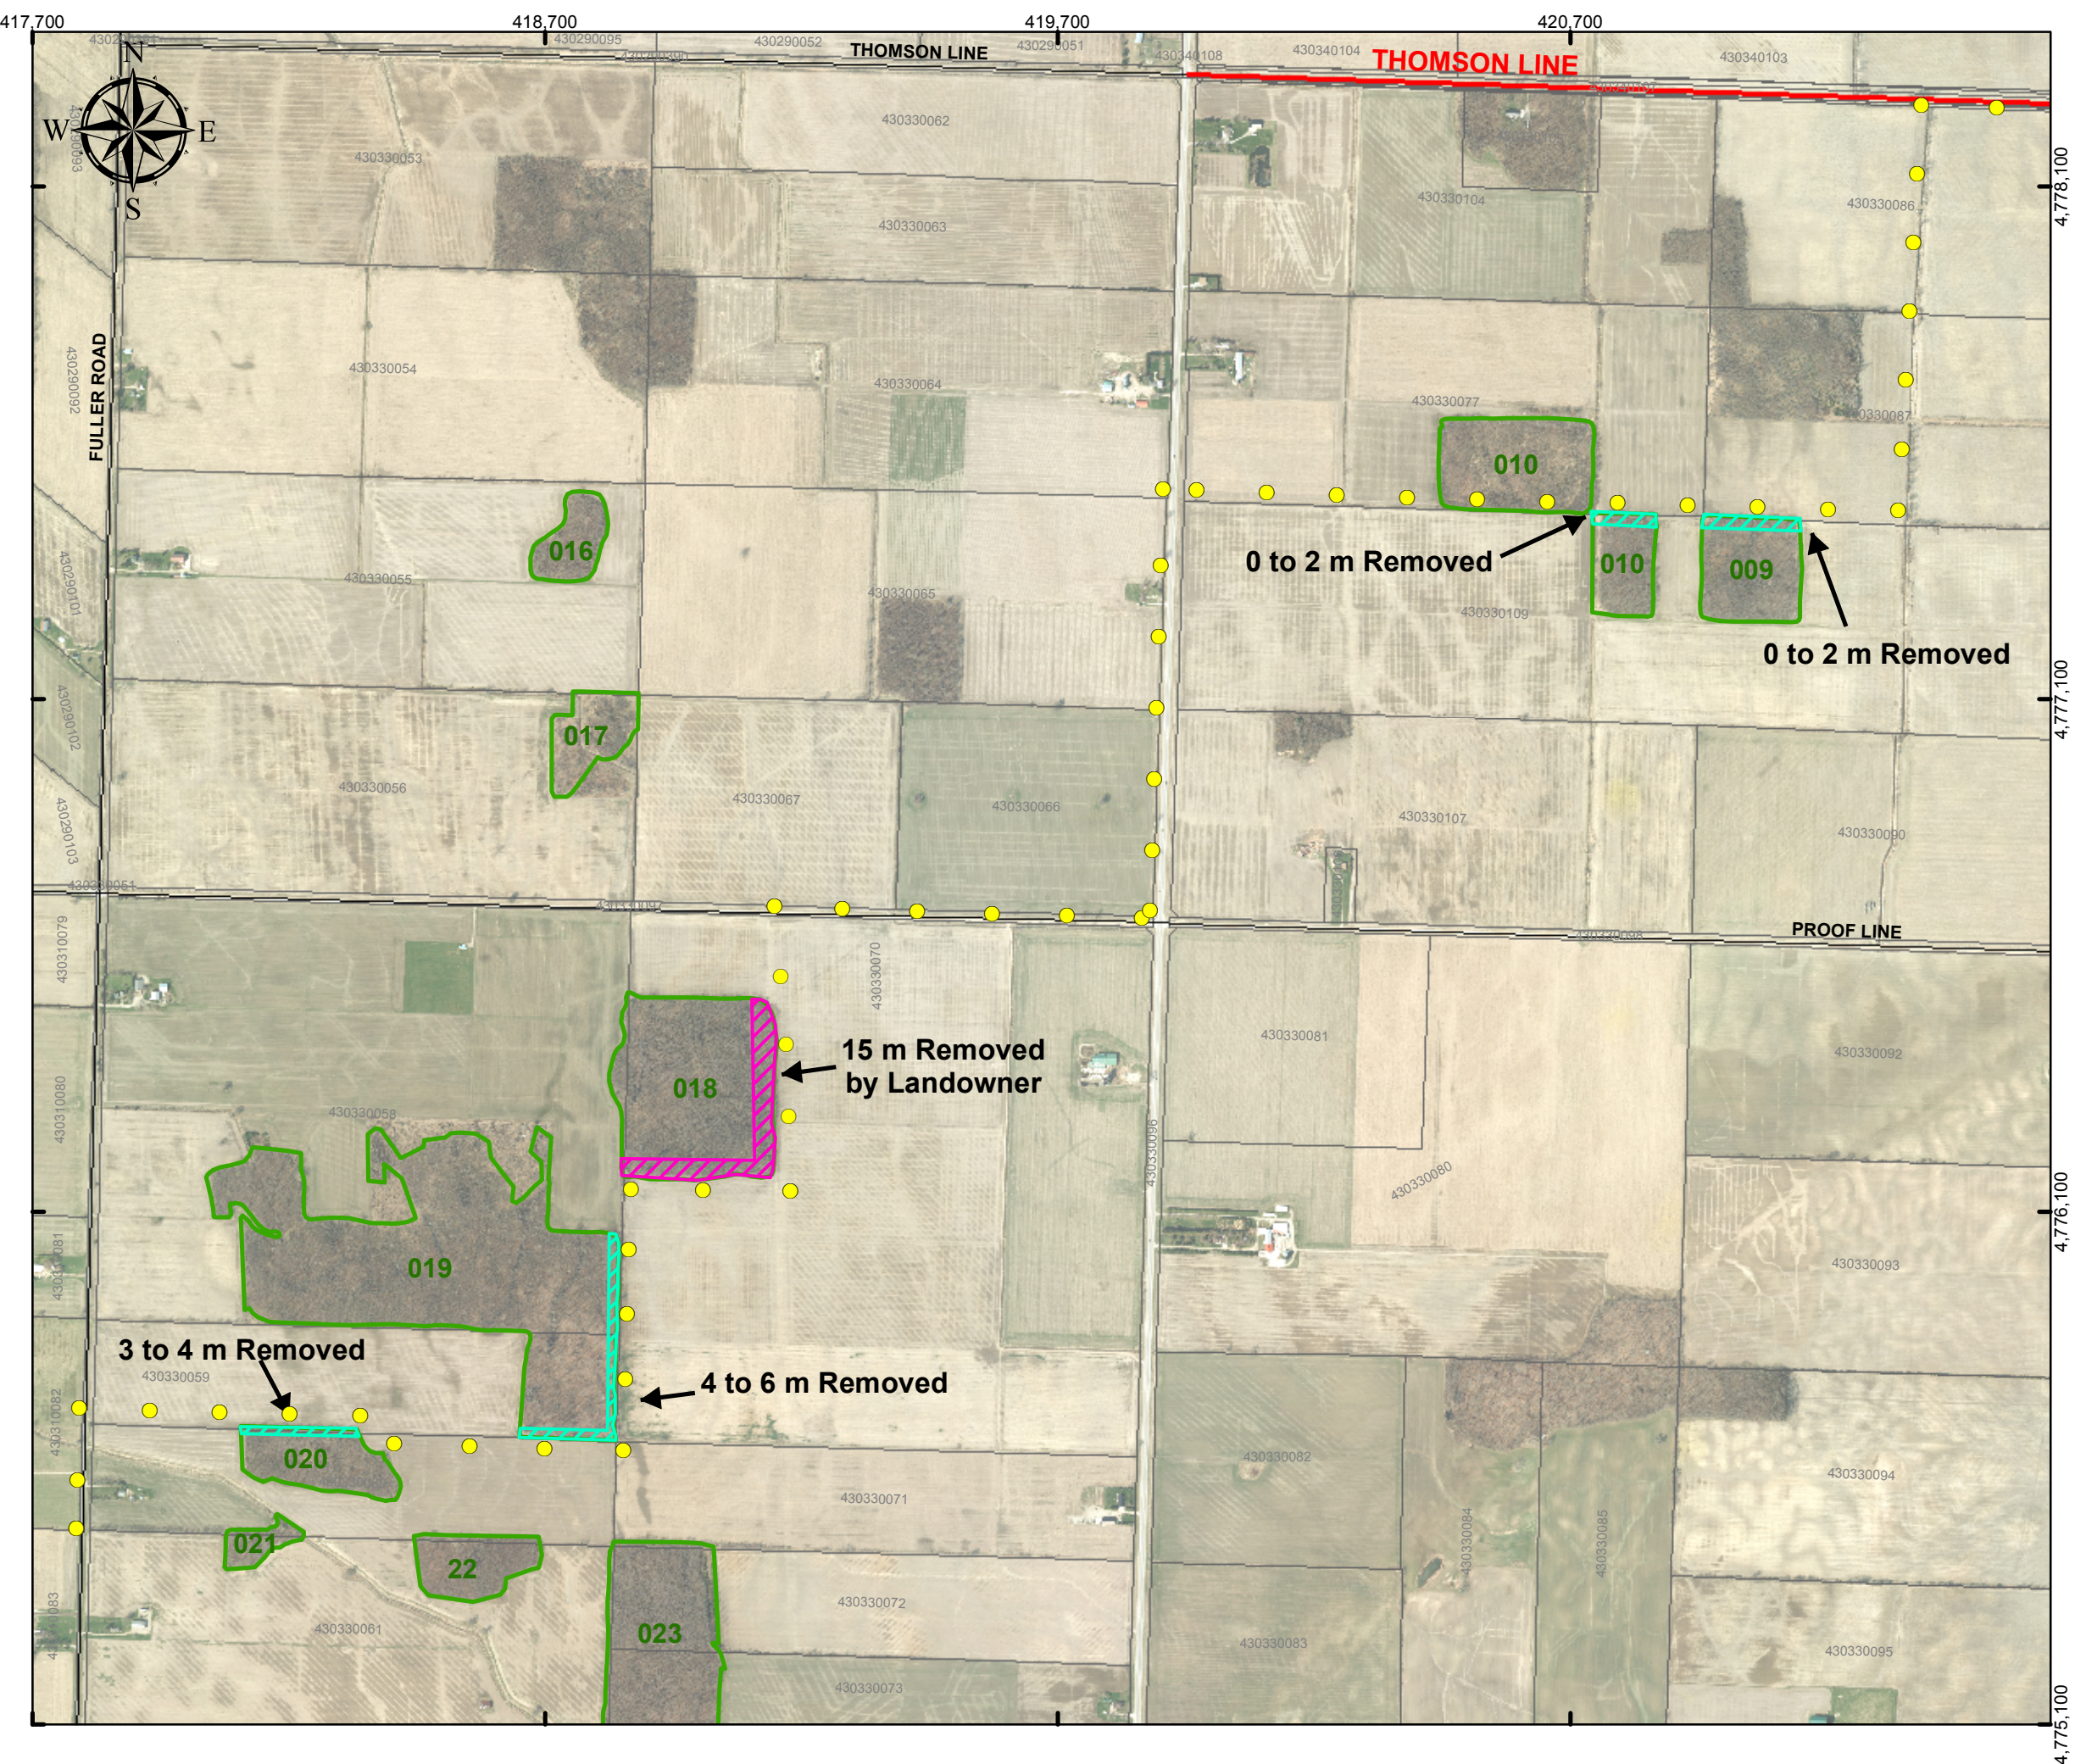
In early 2015, a project-contracted arborist removed small exterior segments of vegetation in significant wetlands and woodlands during site preparation for the installation of the overhead transmission line in the Cedar Point Wind Farm (please see Figure 1, attached). This vegetation removal was not permitted as part of Suncor's Renewable Energy Approval (REA) or St. Clair Region Conservation Authority (SCRCA) permits. On April 24, 2015, the areas of vegetation removal were investigated by the SCRCA, and it was determined that approximately 3166 m² of area had been cleared.

The areas of vegetation removal were observed to have the following estimated widths. Along the eastern edge of Feature 19, the width of disturbance ranged between 4 and 6m, and along Feature 20, the width of disturbance ranged from 3 to 4 m wide. For features 9 and 10, the width of disturbance ranged from 0 to 2 m.
