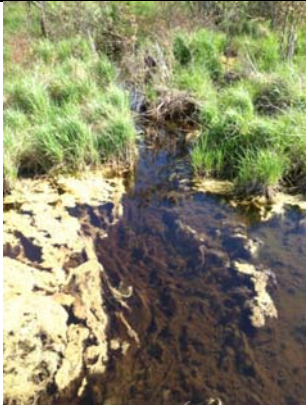
<p>W9- South side of Southline Rd (photo: May 15, 2012)</p>

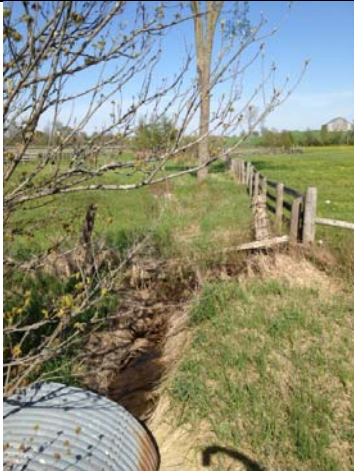
<p>May 15, 2012 - east side of Boot Jack Ranch Road. Conveys water seasonally from agricultural field and dugout pond on east side of the road to wetland on west side of road.</p>

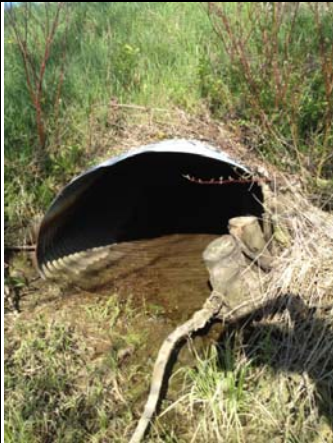
<p>May 15, 2012 - grassy channel downstream of road.</p>	<p>W11 – intermittent stream W45 - not carried forward as a water body W51 - not carried forward as a water body</p>

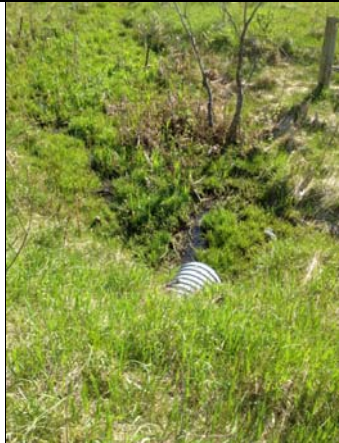
<p>W12 on west side of Boot Jack Ranch Road where vegetation is predominantly hydrophytic in nature (photo: May 15, 2012)</p>	W12 - not carried forward as a water body

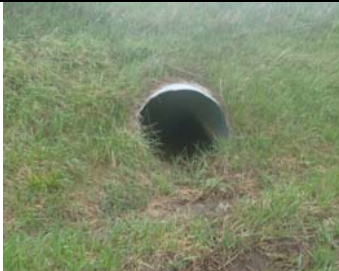
<p>Culvert on south side of County Rd. 4 drains into agricultural field. Standing water in culvert at time of survey – no detectable flow (photo: May 16, 2012).</p>

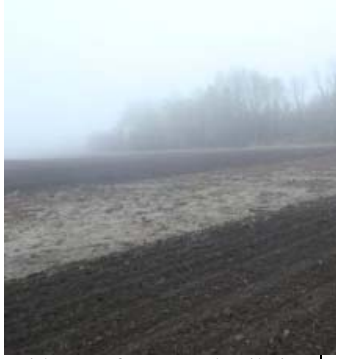
<p>Evidence of saturated soils in field; however, tilled through as part of agricultural field.</p>	<p>W13 - not carried forward as a water body W24 - not carried forward as a water body W40 >120m from project location and not studied further</p>

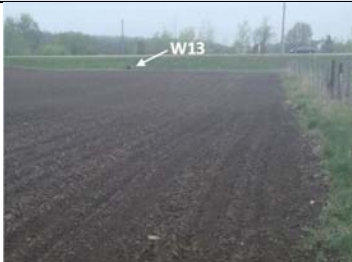
<p>Looking north toward W13 and W24 – no swale evident tilled agricultural field (photo: May 16, 2012)</p>

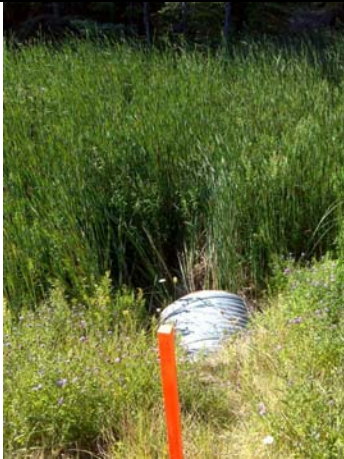
<p>Culvert on south side of County Rd. 4 at ELC unit 85 (photo: August 1, 2012).</p>

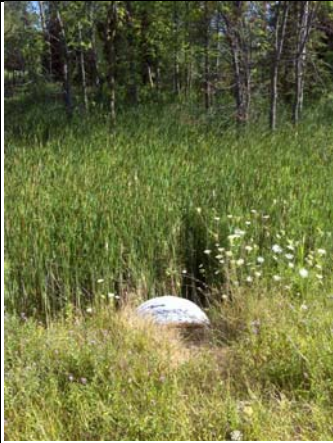
<p>Culvert on north side of County Rd. 4 at ELC unit 62 (photo: August 1, 2012).</p>	W14 - not carried forward as a water body

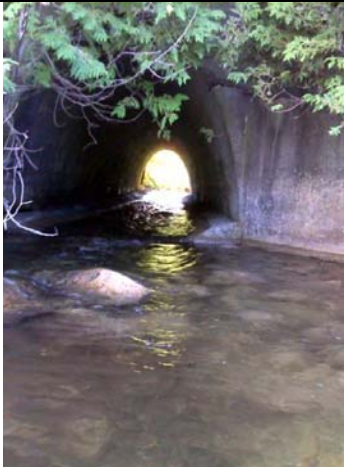
<p>W16 as it passes under old railway line. Large boulder and cobble substrate. (photo: Aug. 1, 2012)</p>

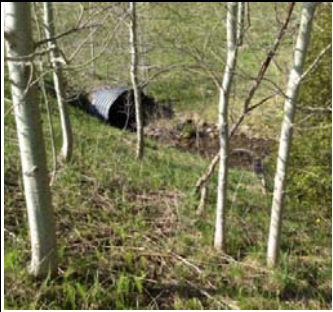
<p>W16 as it approaches culvert at County Rd. 4 (photo: May 15, 2012)</p>	<p>W16 – part of permanent stream</p>

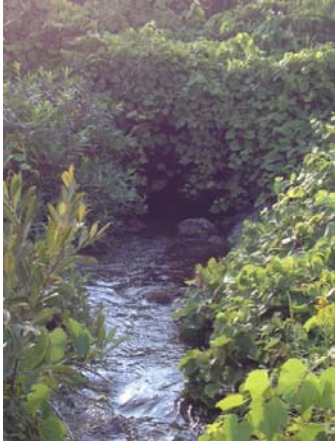
<p>W15 as it begins at the culvert after crossing the road and continues along the north side of County 4Rd. (photo: August 1, 2012)</p>

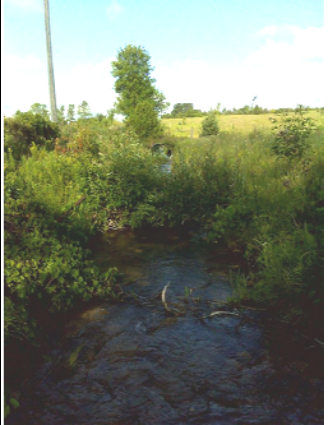
<p>W15 continues through a series of culverts along the roadside until it crosses back over to the south side of County Rd. 4 (photo: August 1, 2012)</p>	<p>W15 – part of permanent stream</p>

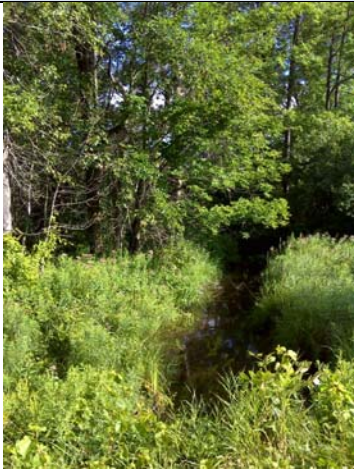
<p>W28 - Channel on upstream side (north) of The Glen Road. With riparian vegetation primarily meadow species at roadside with ash and maple upstream (photo: August 1, 2012)</p>

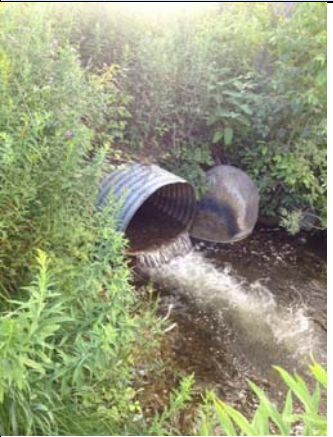
<p>W28 – 0.8m perched culvert has created a plunge pool on south (downstream) side of Glen Road. Channel in this area is 3m wide and 0.5-0.7m deep; beyond plunge pool watercourse becomes shallower and narrower (photo: August 1, 2012).</p>	W28 – part of permanent stream

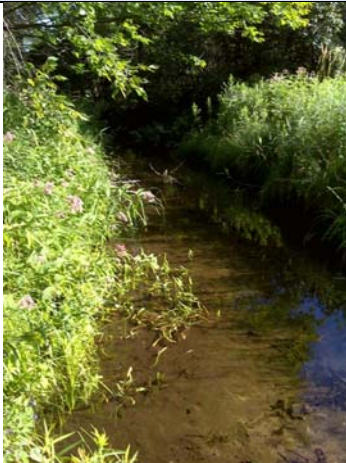
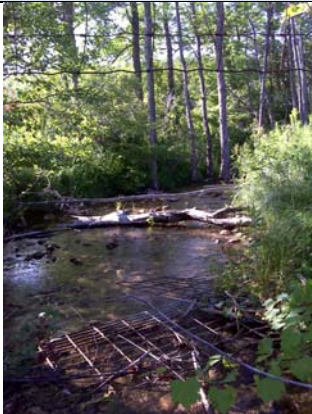
W28 - Channel on upstream side (north) of The Glen Road. (photo: August 1, 2012)	W28 – downstream of The Glen Road, channel wide at roadside and narrow downstream (photo: August 1, 2012)

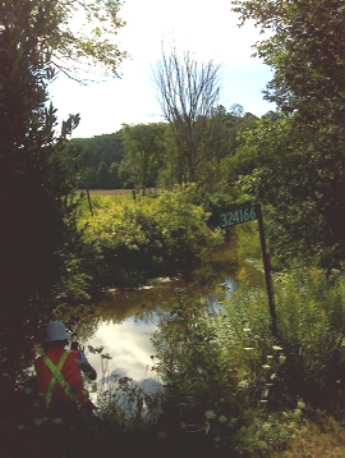
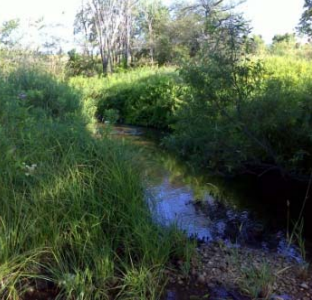
W26 on upstream side (south) of The Glen Road – riparian	W26 – facing downstream (north toward County Rd. 4).

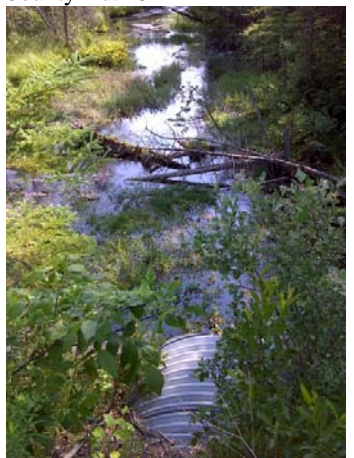
<p>July 5, 2012 – upstream of County Rd. 23</p>

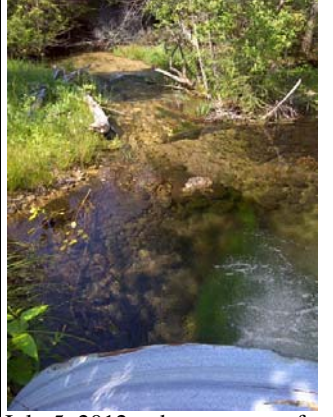
<p>July 5, 2012 – downstream of County Rd. 23, plunge pool at roadside flowing into riffle.</p>	<p>W17 – permanent stream and seepage area</p>

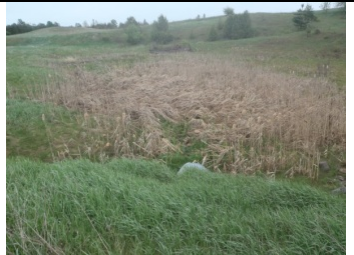
<p>W19 – on south side of road surrounded by cattail vegetation (photo: May 16, 2012).</p>

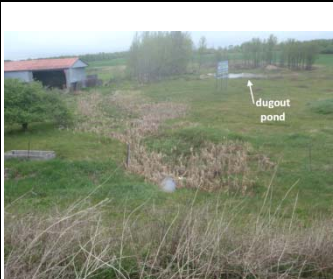
<p>W19 – culvert ends at cattail vegetation on north side of Road with dugout pond beyond in agricultural field (photo: May 16, 2012).</p>

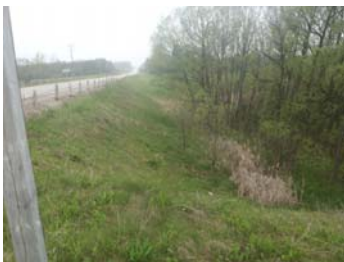
<p>W20 - Cattail feature on north west corner of Boot Jack Rd and County Rd 4 (photo: May 16, 2012).</p>

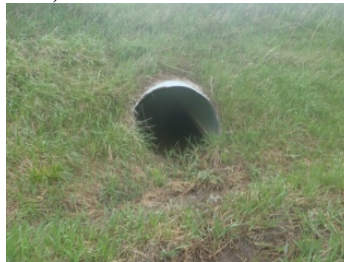
<p>South side of County 4 Rd – Culvert and roadside ditch dry (photo: May 16, 2012)</p>

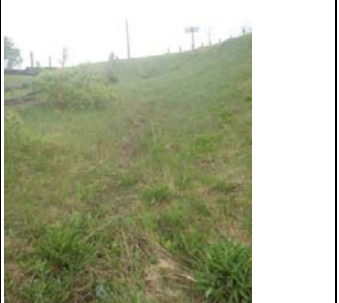
<p>Drainage ditch on north side of County Rd. 4 dry (photo: May 16, 2012).</p>

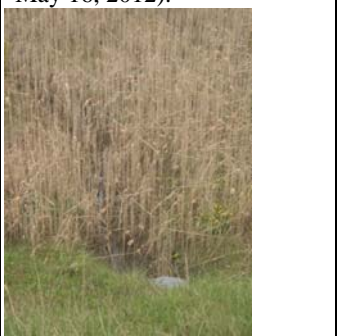
<p>May 16, 2012 southeast corner Boot Jack Ranch and County Rd 4 water in cattail marsh at roadside.</p>	<p>W20 - not carried forward as a water body</p>

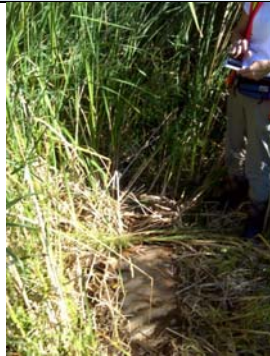
<p>Culvert is buried and ends at cattail marsh. No water evident at time of survey (photo: Aug 1, 2012)</p>

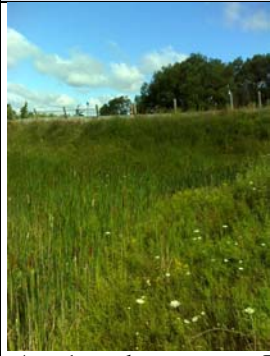
<p>Aug 1 southwest corner Boot Jack Ranch and County Rd 4 – cattails present, no open water.</p>

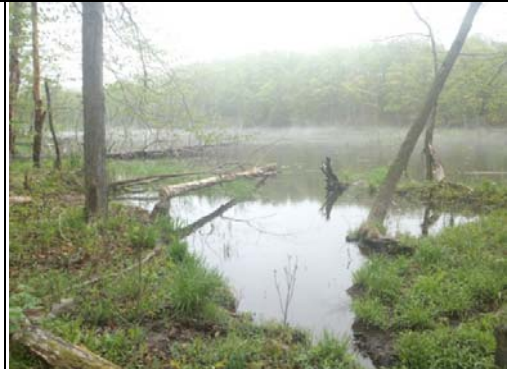
<p>Pond condition on May 16, 2012. Photo taken facing northeast.</p>

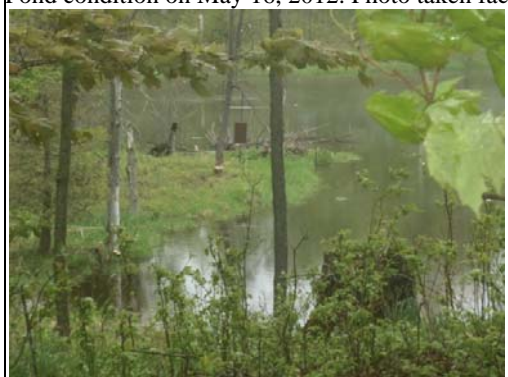
<p>May 16, 2012 – evidence of beaver activity</p>	<p>W25 – pond</p>

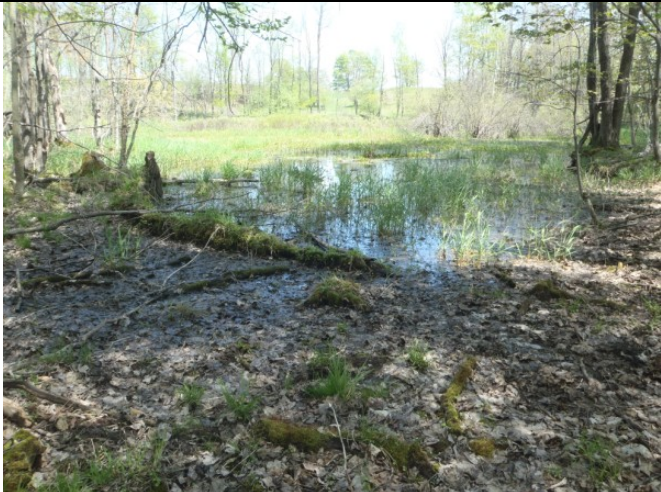
<p>ELC unit 121 (W27) - willow thicket swamp – Connected to deciduous swamp feature (SWD3-1) and surrounding area is primarily deciduous forest (FOD5-7). Cattle have entered the feature and disturbed portions of the wetland.</p>	<p>W27 - not carried forward as a water body</p>

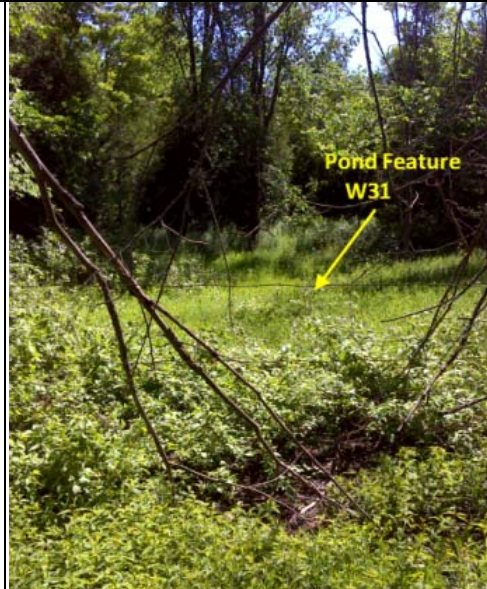
<p>June 14, 2012 – no open water feature found at W31.</p>	<p>W31 - not carried forward as a water body</p>

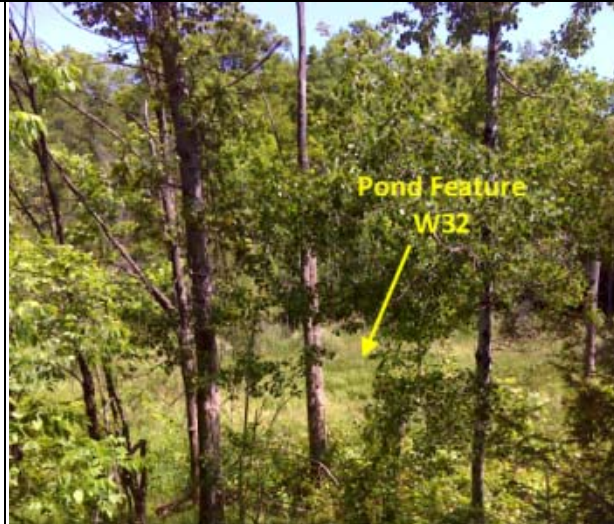
June 14, 2012 – no open water feature found at W32.

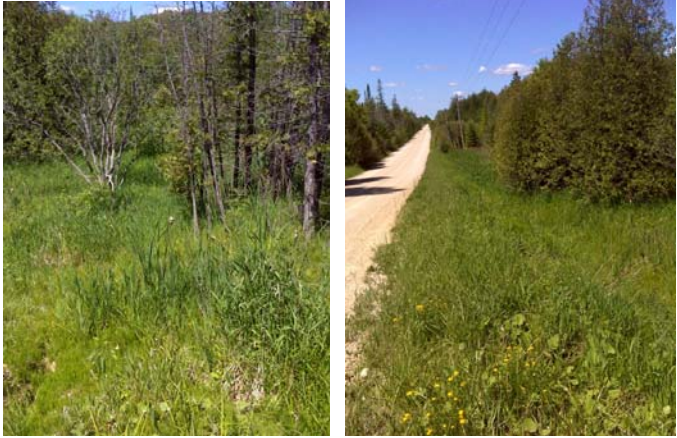
<p>June 14, 2012- no open water feature found at W34</p>	W34- not carried forward as a water body

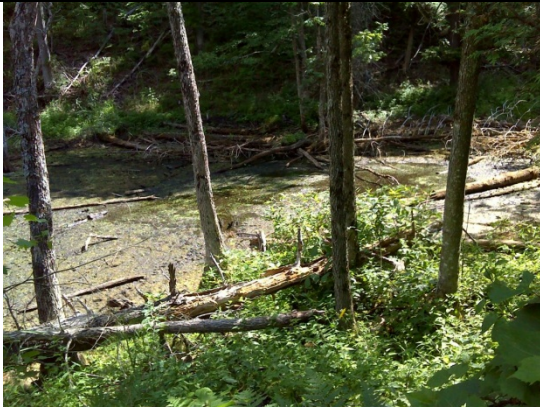
<p>Vernal pool within ELC unit 55 (photo: July 24, 2012)</p>	<p>W48 > 120m from Project Location; not assessed further</p>

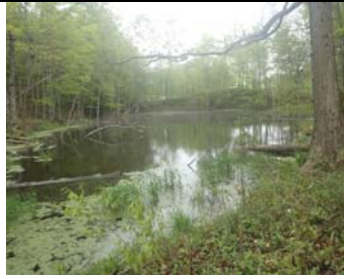
<p>Pond condition on May 16, 2012</p>

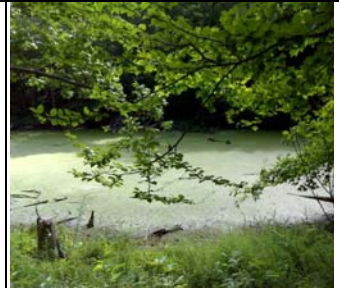
<p>Pond condition on July 24, 2012</p>	W36 - pond

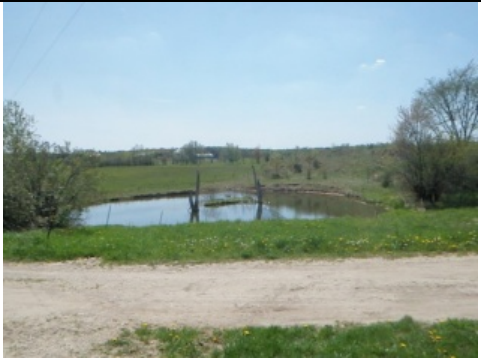
<p>W37 – dugout pond adjacent to laneway (photo: May 15, 2012).</p>	<p>W37 - not carried forward as a water body</p>

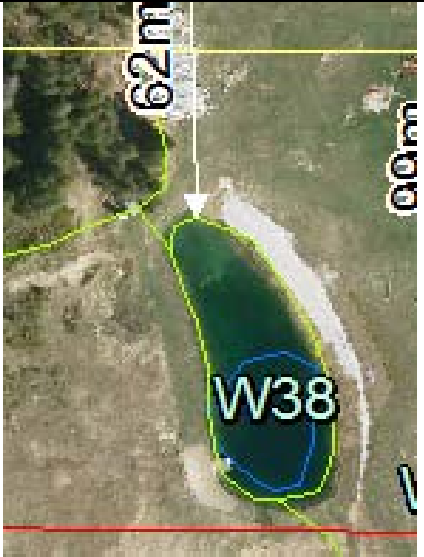
<p>Dugout pond used for recreational activity by landowner.</p>	<p>W38 - not carried forward as a water body</p>

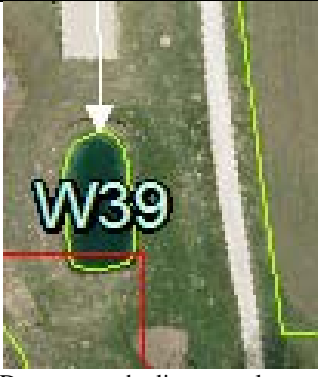
<p>Dugout pond adjacent to laneway to landowner's house.</p>	<p>W39 - not carried forward as a water body</p>
