PROJECT (Number & Name): 1231 Bornish wf

Appendix II
Site Investigation Photographs

1231 Bornish Wind Energy Centre Water Body Photographs

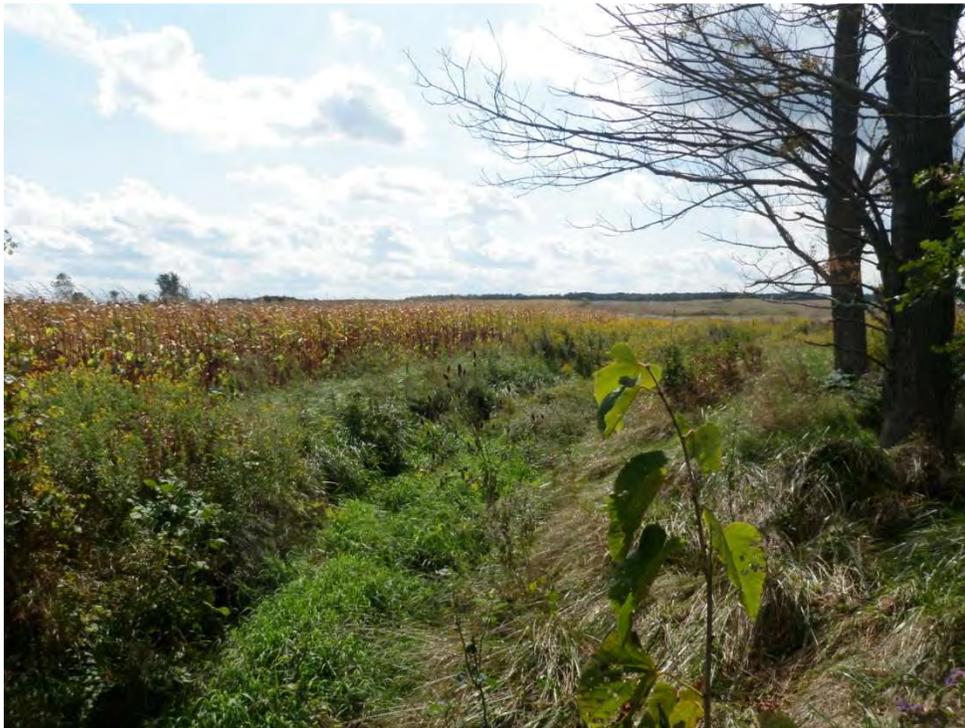
Figure 1 WB16/TribC facing upstream to the southwest.

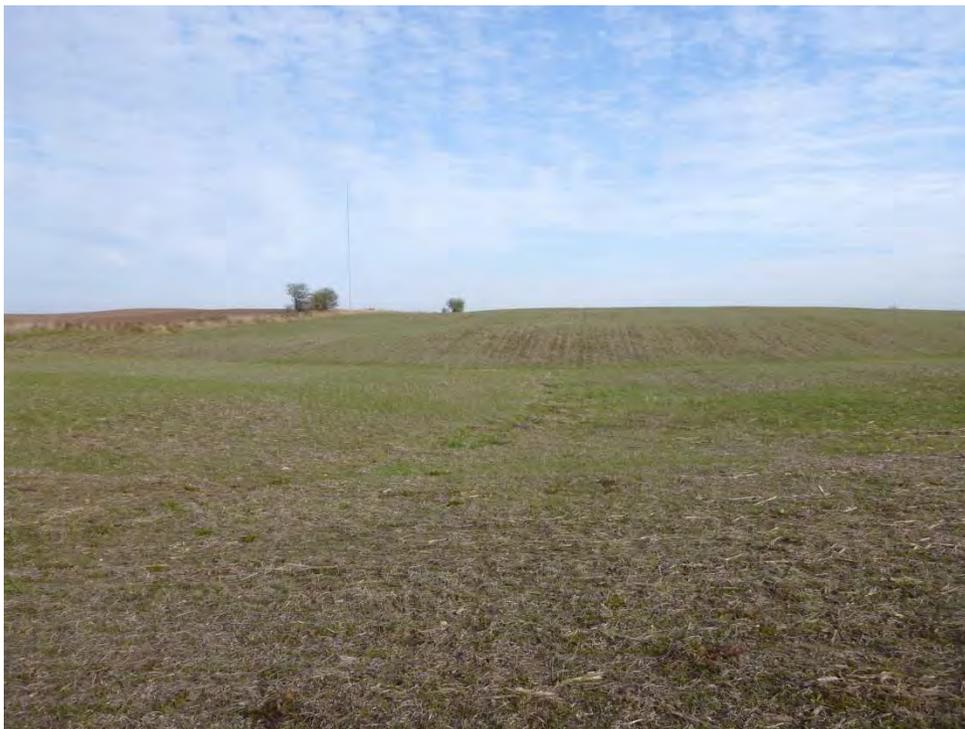
Figure 2 WB4/TribD facing downstream and north.

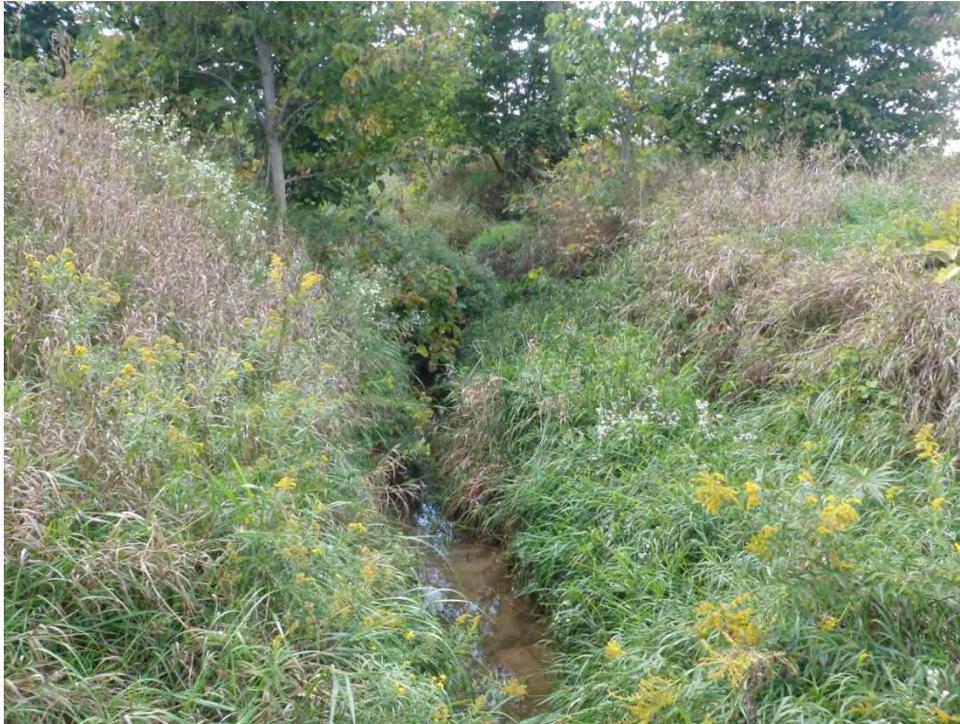
Figure 3 WB17/TribD facing downstream and north.

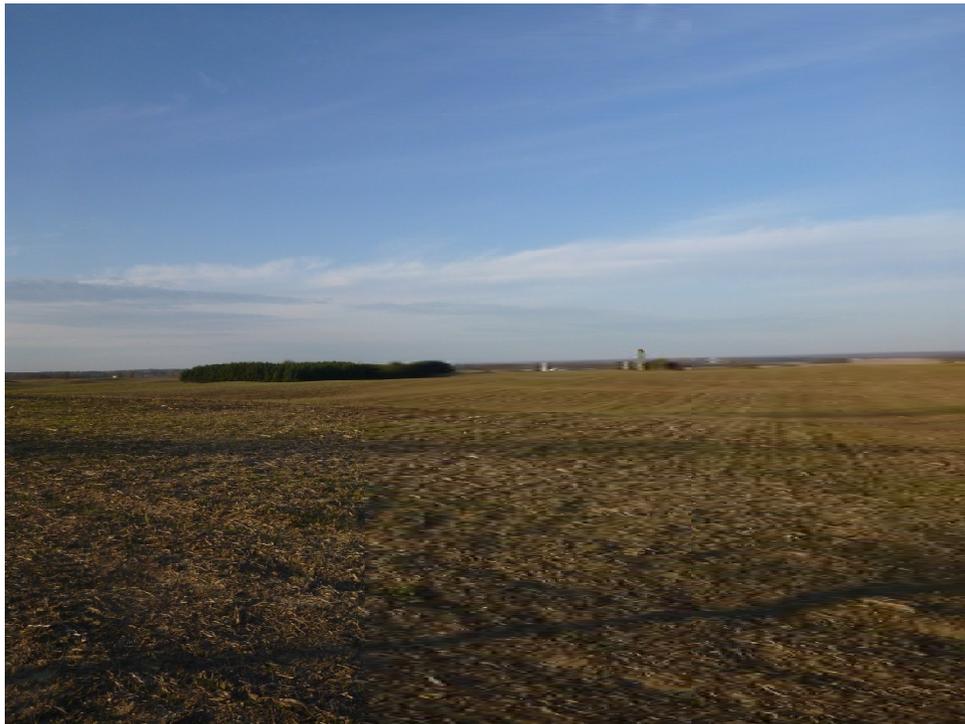
Figure 4 WB3/TribE facing north.
