Goshen Wind Energy Centre
Water Assessment and Water Body Report

Project Location
December 2012
Project 60155032

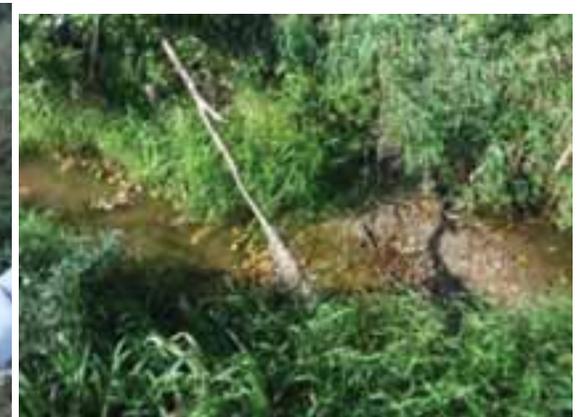
C6		C6
MWW(m):	1.5	MWD(m):	0.12
MBW(m):	3.0	MBD(m):	0.7

Photograph 3. Bank erosion ↑

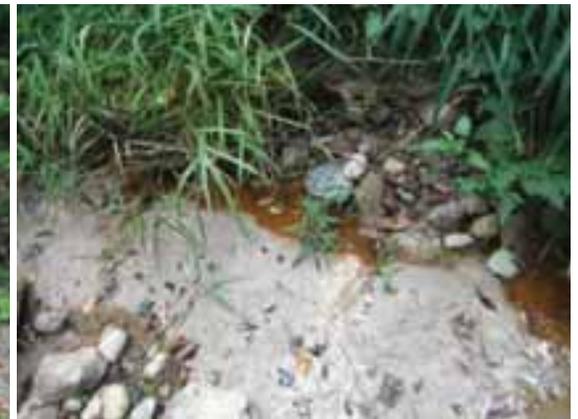
C7		C7
MWW(m):	2.0	MWD(m):	0.2
MBW(m):	6.2	MBD(m):	1.5

Photograph 3. Iron staining ↑

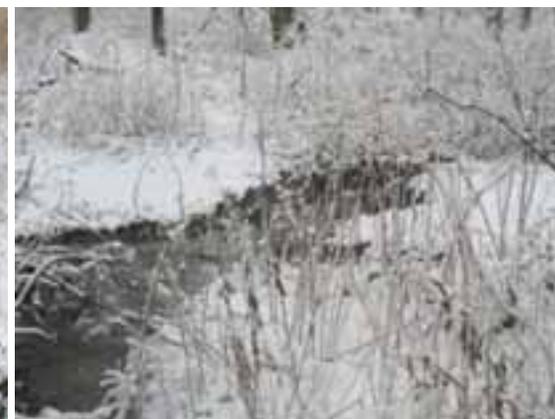
C33		C33
MWW(m):	2.0	MWD(m):	0.23
MBW(m):	3.5	MBD(m):	0.75

Photograph 3. Tile drain fed watercourse feeding into C33 ↑

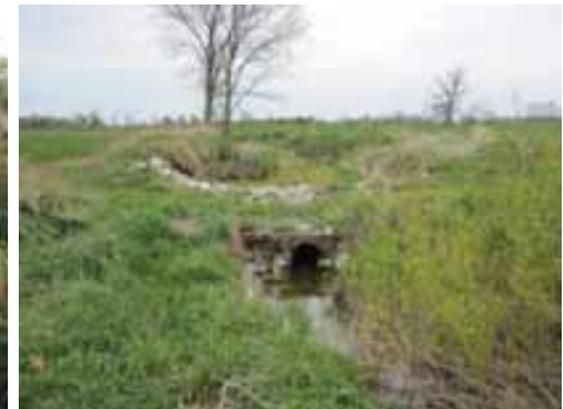
Photograph 3. Potential barrier ↑

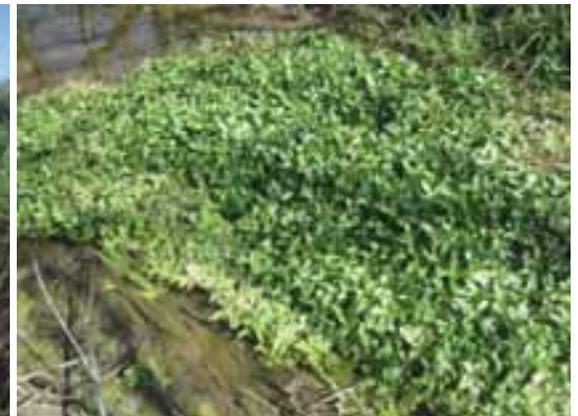
D11		D11
MWW(m):	1.3	MWD(m):	0.2
MBW(m):	3.0	MBD(m):	0.7

Photograph 3. Water speedwell ↑

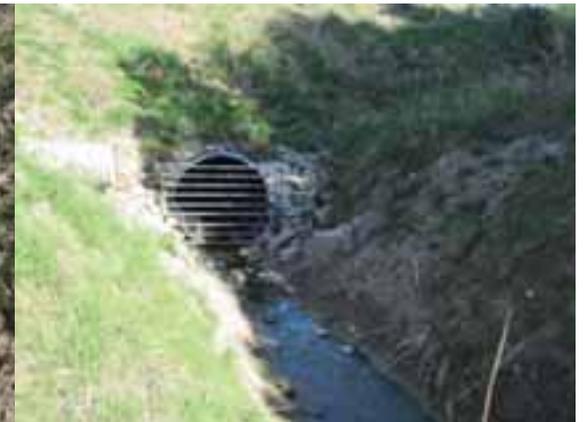
D01		D01
MWW(m):	0.75	MWD(m):	0.05
MBW(m):	1.5	MBD(m):	0.6

Photograph 3. Outlet pipe at Grand Bend Line ↑

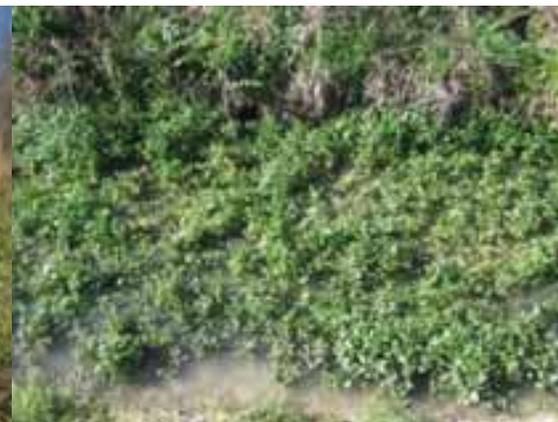
C75		C75
MWW(m):	1.5	MWD(m):	0.2
MBW(m):	2.2	MBD(m):	0.6

Photograph 3. Watercress ↑

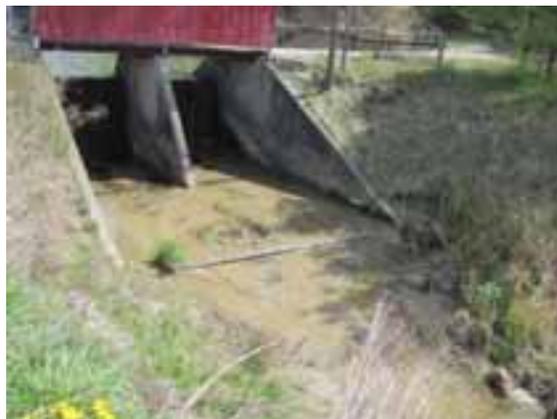
P8		P8
MWW(m):	n/a	MWD(m):	n/a
MBW(m):	n/a	MBD(m):	n/a

Photograph 1. Dam ↑

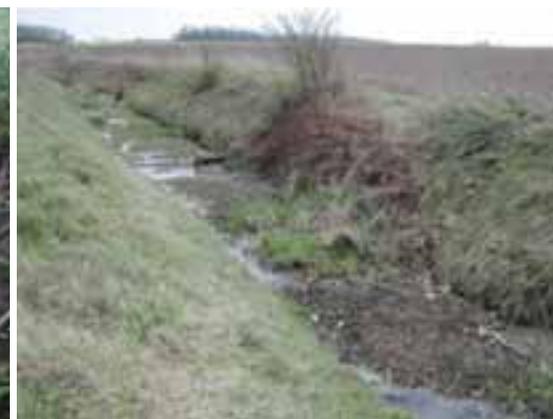
D14		D14
MWW(m):	1.0	MWD(m):	0.1
MBW(m):	3.0	MBD(m):	0.7

Photograph 3. Low flow barrier ↑

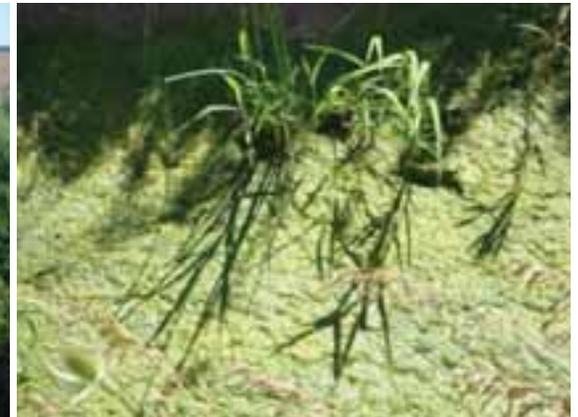
C62
MWD(m):	0.1
MBD(m):	2.0

Photograph 3. Algae growth ↑

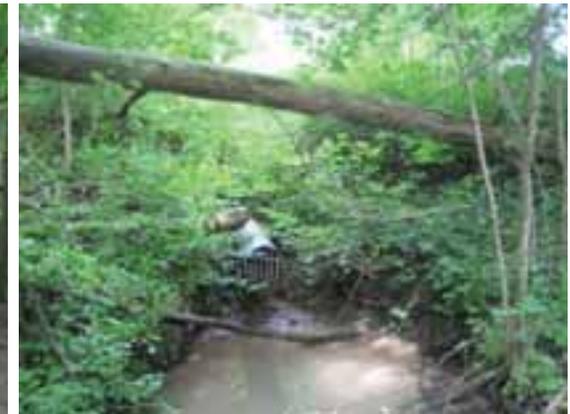
Photograph 3. Tile drain ↑
