Stream Morphology (continued)

Study Area: Jericho Goshen Bluewater Land Parcel# G541079 Turbine # C63

Water Bodies Assessment Field Collection Form

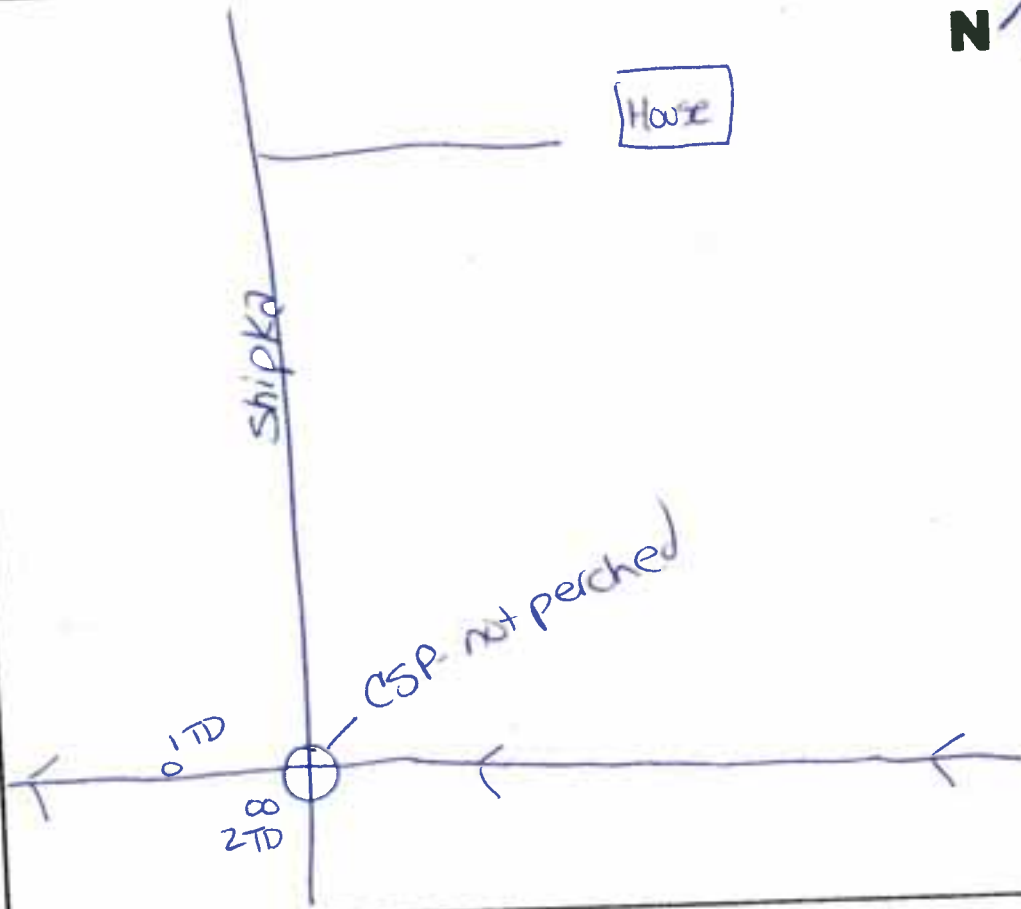
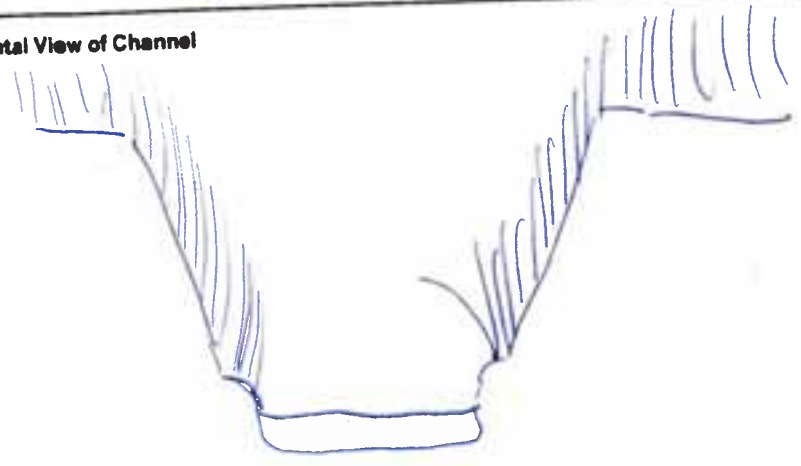
west side channel becomes more narrow + shallow with increased vegetation (cattails) in stream

Downstream more veg in water

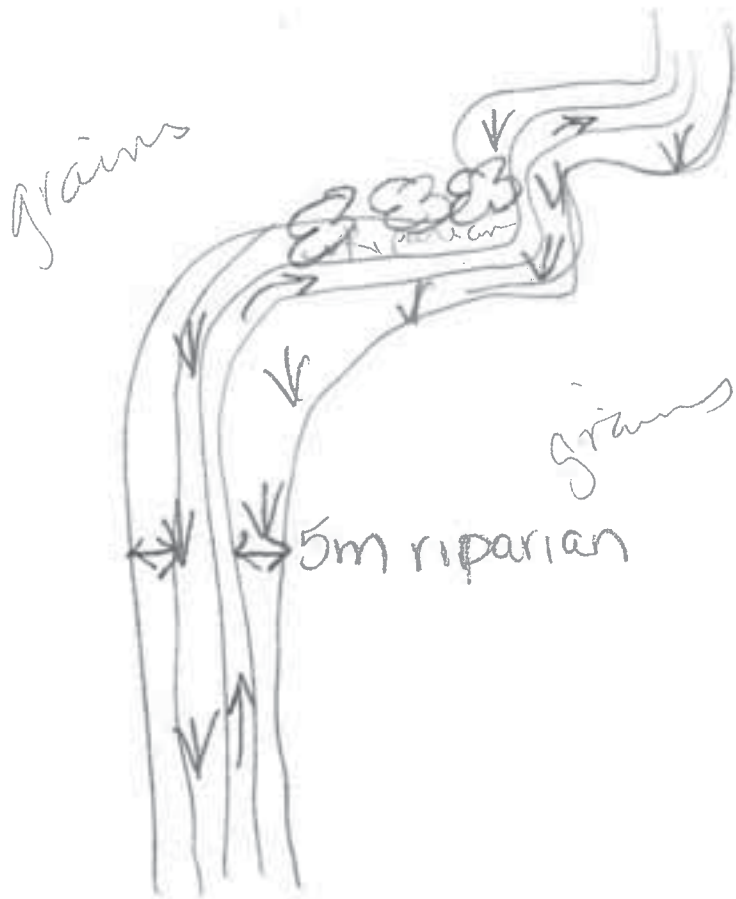
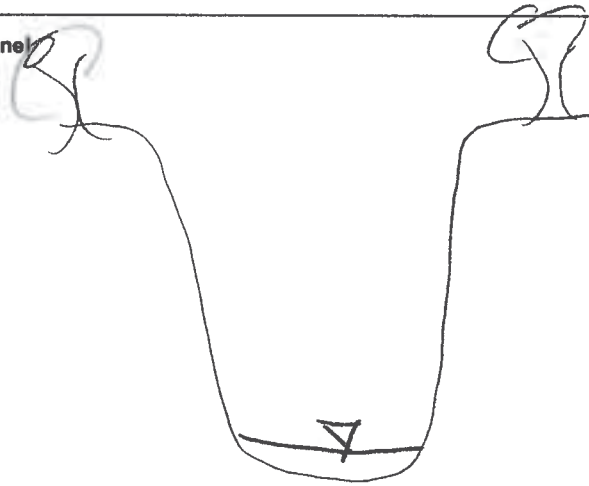
C68

- fish observed - cyprinids
- intermittent channel - choked w/ cattail in reaches closest to the road.
- mats of emergent vegetation
- appears to be tile drain fed, no connectivity to other channels

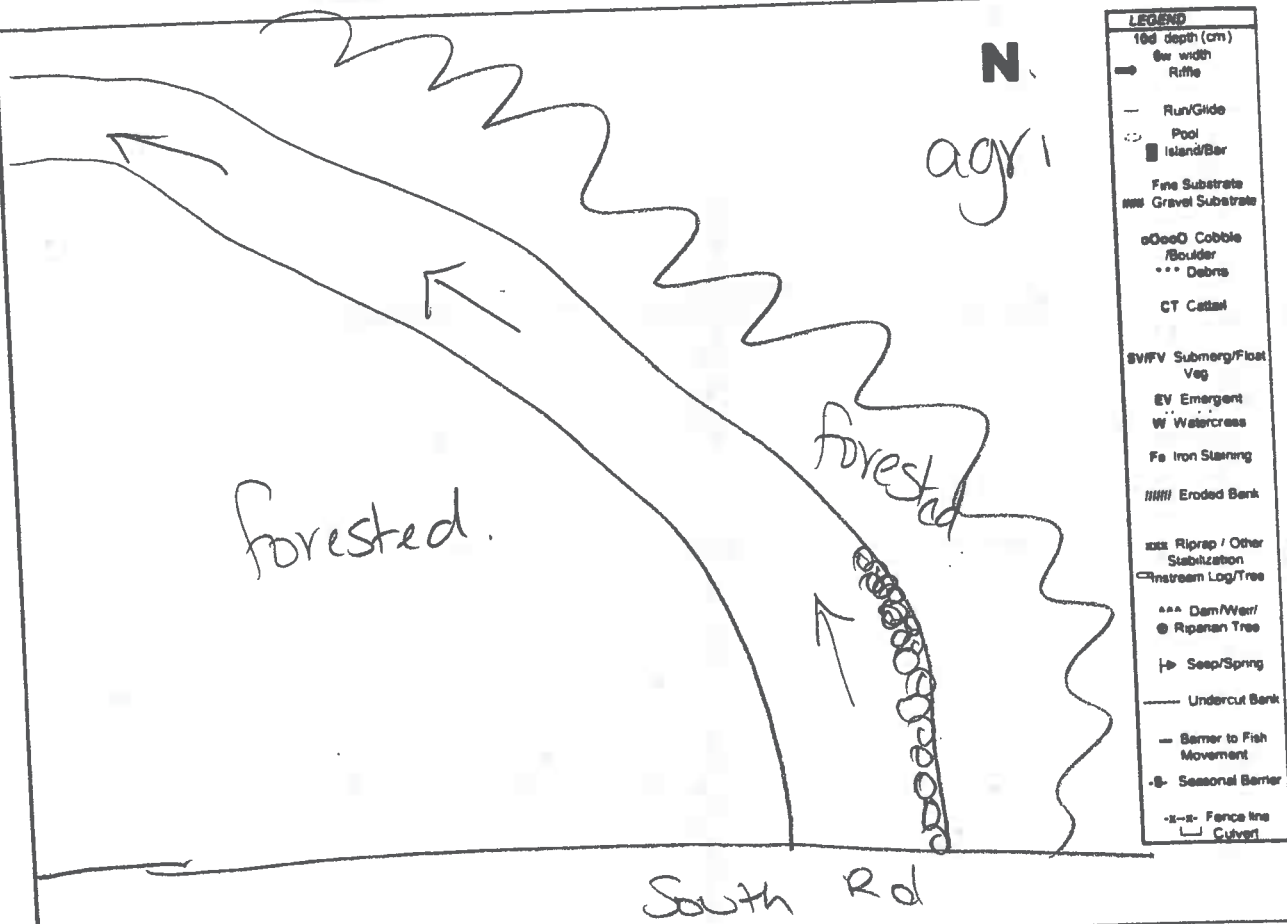
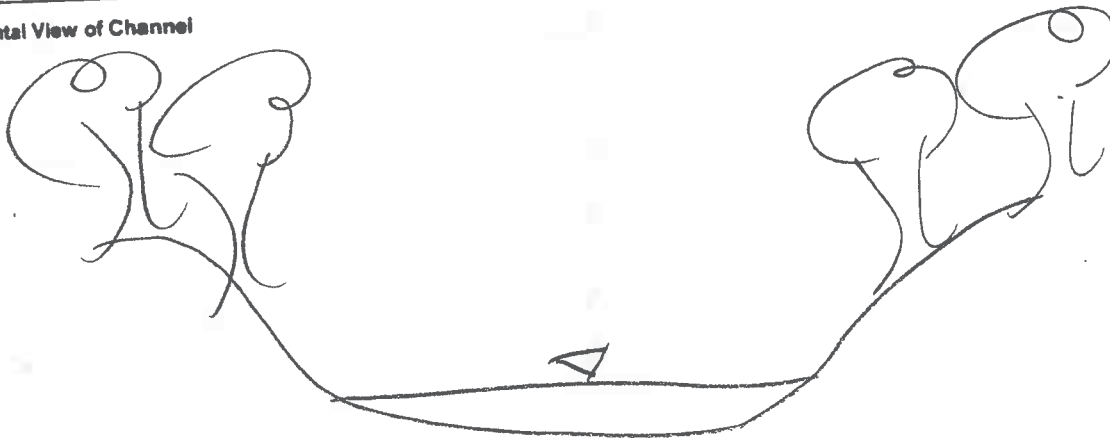
C82

- area near culvert where bank have been reinforced w/ cobble
- severe erosion located near culvert
- failed reinforcements
- up side is green colour & very slow moving due to stream modifications made d/s
