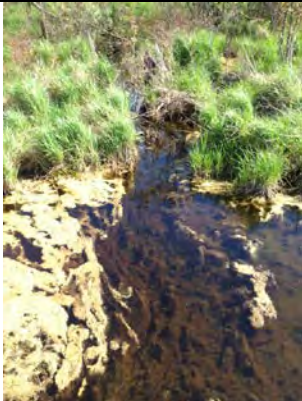
<p>W9- South side of Southline Rd (photo: May 15, 2012)</p>

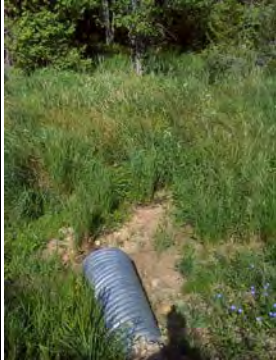
<p>W10 on west side of Boot Jack Ranch Road (photo: August 1, 2012)</p>	<p>W10 - not carried forward as a water body</p>

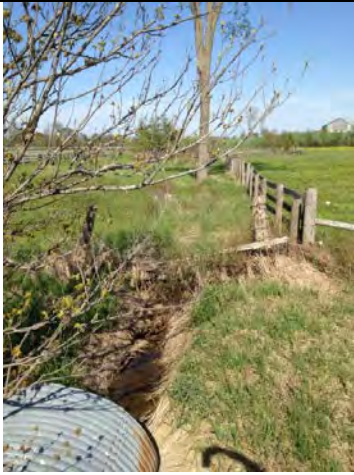
<p>May 15, 2012 – east side of Boot Jack Ranch Road. Conveys water seasonally from agricultural field and dugout pond on east side of the road to wetland on west side of road.</p>

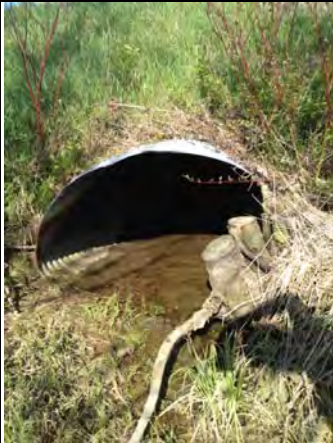
<p>May 15, 2012 – grassy channel downstream of road.</p>	<p>W11 – intermittent stream W45 - not carried forward as a water body W51 - not carried forward as a water body</p>

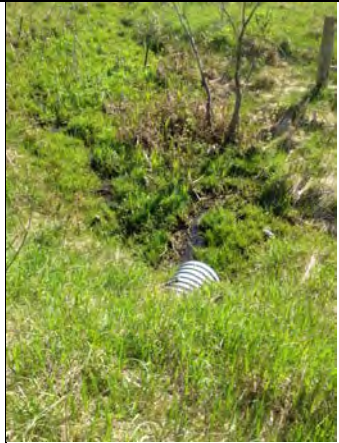
<p>W12 on west side of Boot Jack Ranch Road where vegetation is predominantly hydrophytic in nature (photo: May 15, 2012)</p>	W12 - not carried forward as a water body

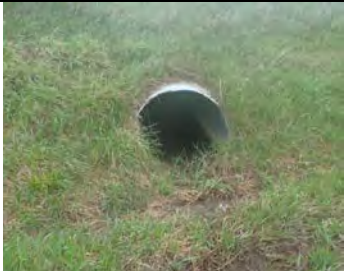
<p>Culvert on south side of County Rd. 4 drains into agricultural field. Standing water in culvert at time of survey – no detectable flow (photo: May 16, 2012).</p>

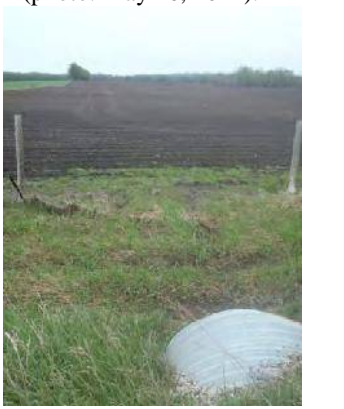
<p>Looking south from County 4 Rd to W24 May 16, 2012 – no agricultural swale/drainage evident.</p>

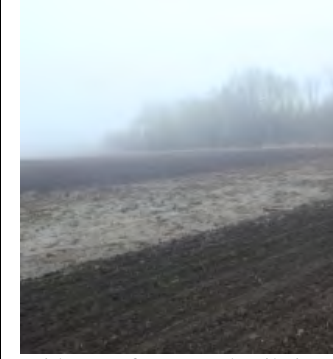
<p>Evidence of saturated soils in field; however, tilled through as part of agricultural field.</p>	<p>W13 - not carried forward as a water body W24 - not carried forward as a water body W40 >120m from project location and not studied further</p>

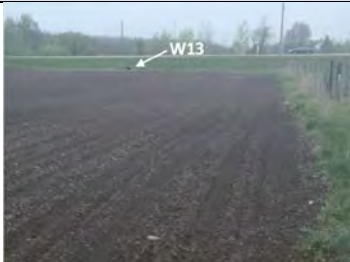
<p>Looking north toward W13 and W24 – no swale evident tilled agricultural field (photo: May 16, 2012)</p>

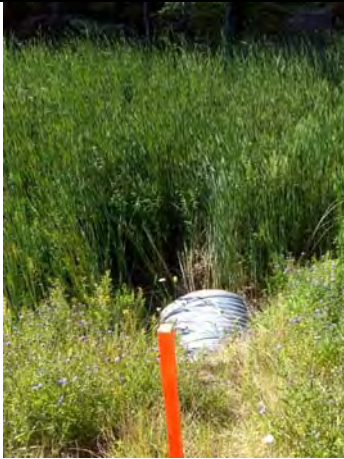
<p>Culvert on south side of County Rd. 4 at ELC unit 85 (photo: August 1, 2012).</p>

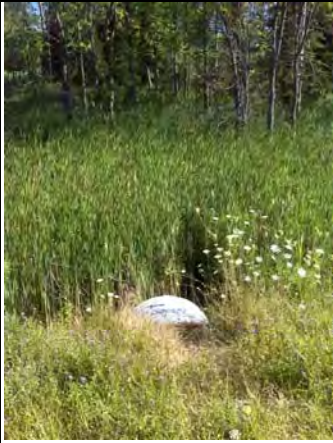
<p>Culvert on north side of County Rd. 4 at ELC unit 62 (photo: August 1, 2012).</p>	W14 - not carried forward as a water body

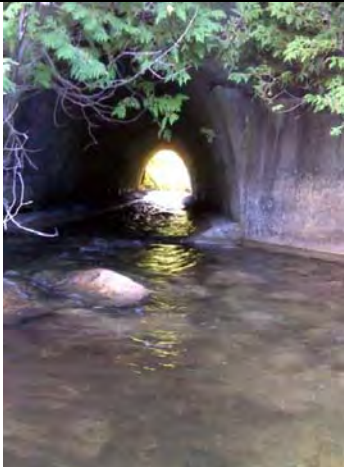
<p>W16 as it passes under old railway line. Large boulder and cobble substrate. (photo: Aug. 1, 2012)</p>

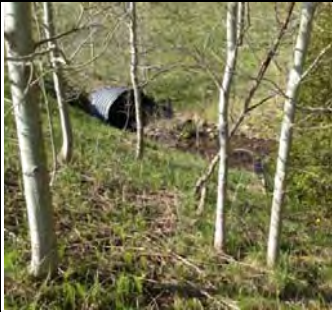
<p>W16 as it approaches culvert at County Rd. 4 (photo: May 15, 2012)</p>	<p>W16 – part of permanent stream</p>

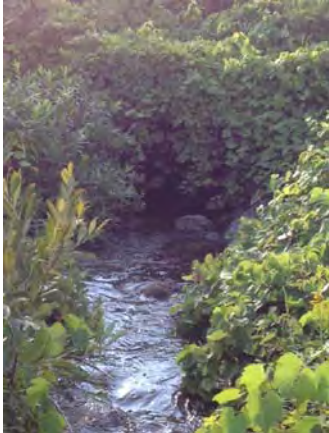
<p>W15 as it begins at the culvert after crossing the road and continues along the north side of County 4Rd. (photo: August 1, 2012)</p>

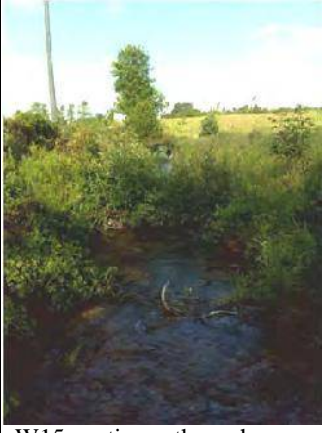
<p>W15 continues through a series of culverts along the roadside until it crosses back over to the south side of County Rd. 4 (photo: August 1, 2012)</p>	<p>W15 – part of permanent stream</p>

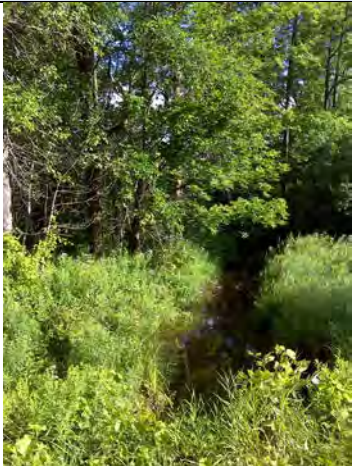
<p>W28 - Channel on upstream side (north) of The Glen Road. With riparian vegetation primarily meadow species at roadside with ash and maple upstream (photo: August 1, 2012)</p>

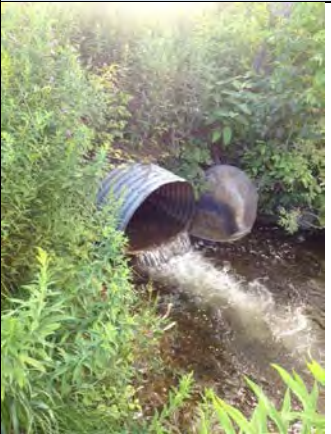
<p>W28 – 0.8m perched culvert has created a plunge pool on south (downstream) side of Glen Road. Channel in this area is 3m wide and 0.5-0.7m deep; beyond plunge pool watercourse becomes shallower and narrower (photo: August 1, 2012).</p>	W28 – part of permanent stream

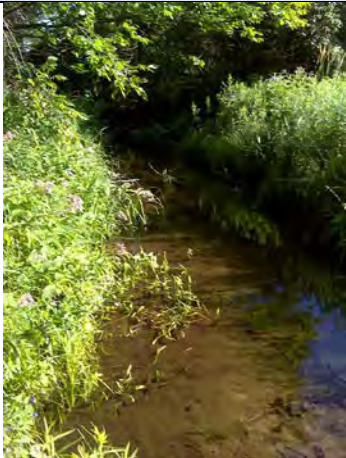
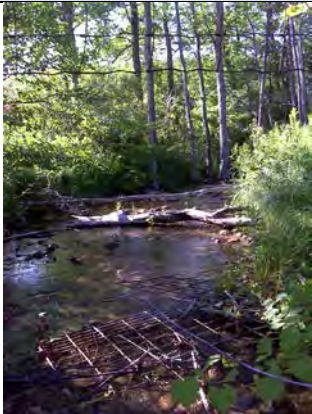
W28 - Channel on upstream side (north) of The Glen Road. (photo: August 1, 2012)	W28 – downstream of The Glen Road, channel wide at roadside and narrow downstream (photo: August 1, 2012)

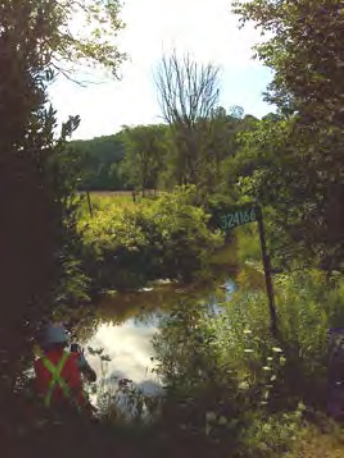
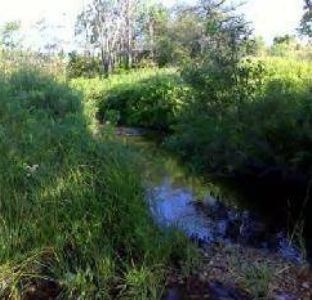
W26 on upstream side (south) of The Glen Road – riparian	W26 – facing downstream (north toward County Rd. 4).

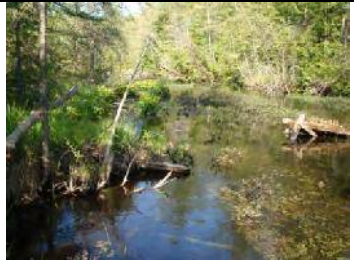
<p>May 15, 2012 – upstream of County Rd. 23</p>

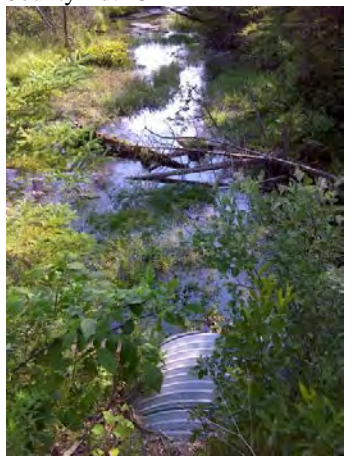
<p>July 5, 2012 – upstream of County Rd. 23</p>

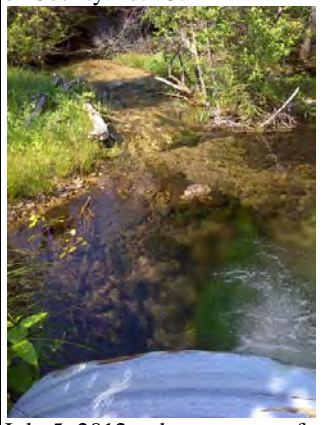
<p>July 5, 2012 – downstream of County Rd. 23, plunge pool at roadside flowing into riffle.</p>	<p>W17 – permanent stream and seepage area</p>

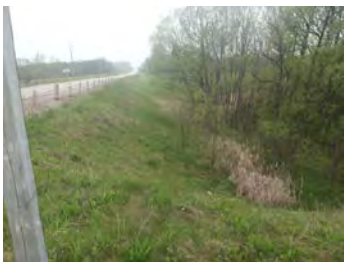
<p>W20 - Cattail feature on north west corner of Boot Jack Rd and County Rd 4 (photo: May 16, 2012).</p>

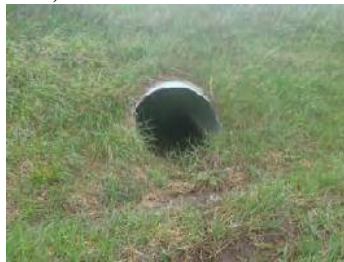
<p>South side of County 4 Rd – Culvert and roadside ditch dry (photo: May 16, 2012)</p>

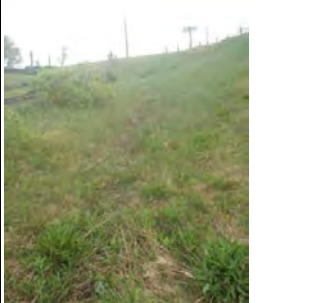
<p>Drainage ditch on north side of County Rd. 4 dry (photo: May 16, 2012).</p>

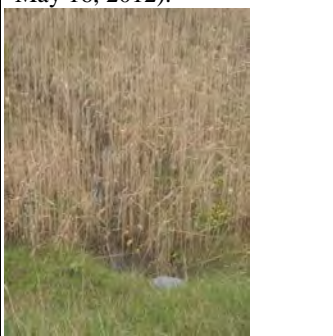
<p>May 16, 2012 southeast corner Boot Jack Ranch and County Rd 4 water in cattail marsh at roadside.</p>	<p>W20 - not carried forward as a water body</p>

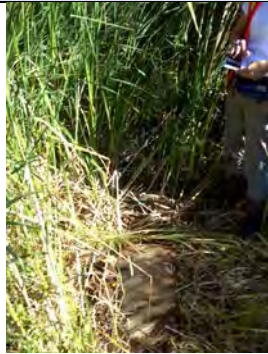
<p>Culvert is buried and ends at cattail marsh. No water evident at time of survey (photo: Aug 1, 2012)</p>

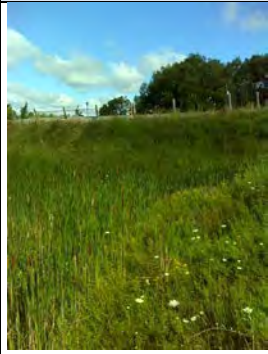
<p>Aug 1 southwest corner Boot Jack Ranch and County Rd 4 – cattails present, no open water.</p>

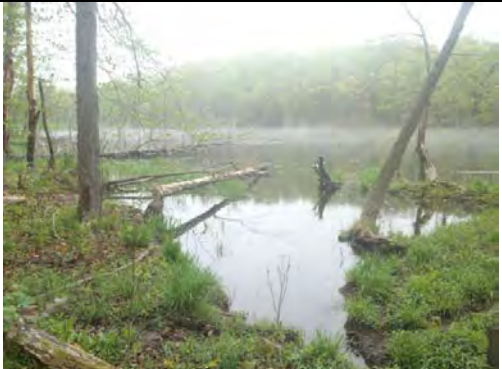
<p>Pond condition on May 16, 2012. Photo taken facing northeast.</p>

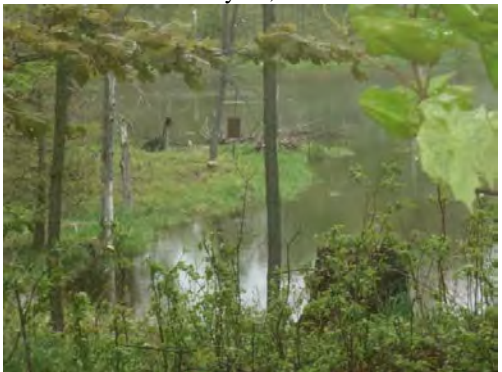
<p>May 16, 2012 – evidence of beaver activity</p>	<p>W25 – pond</p>

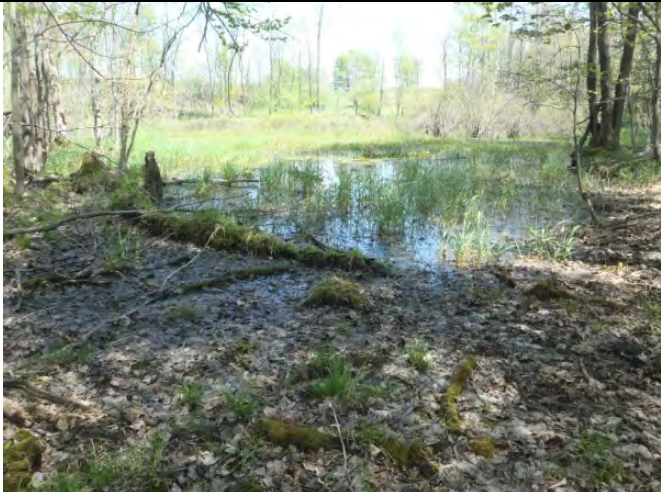
<p>ELC unit 121 (W27) - willow thicket swamp – Connected to deciduous swamp feature (SWD3-1) and surrounding area is primarily deciduous forest (FOD5-7). Cattle have entered the feature and disturbed portions of the wetland.</p>	<p>W27 - not carried forward as a water body</p>

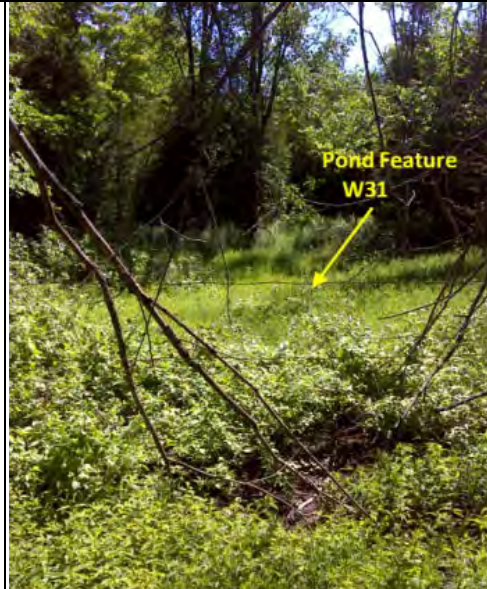
<p>June 14, 2012 – no open water feature found at W31.</p>	<p>W31 - not carried forward as a water body</p>

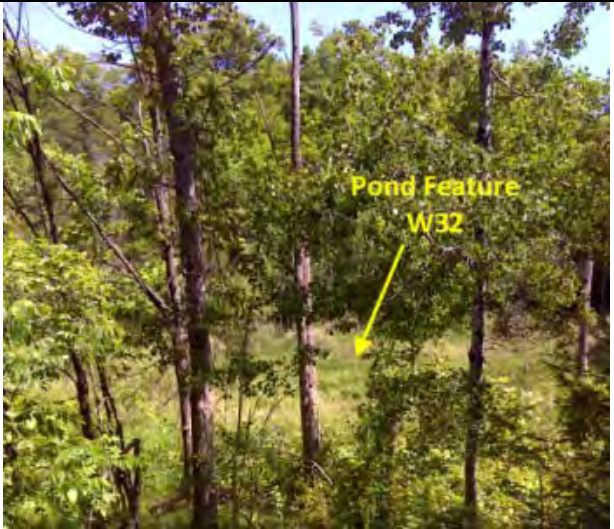
W32 - not carried forward as a water body

<p>June 14, 2012 – no open water feature found at W32.</p>

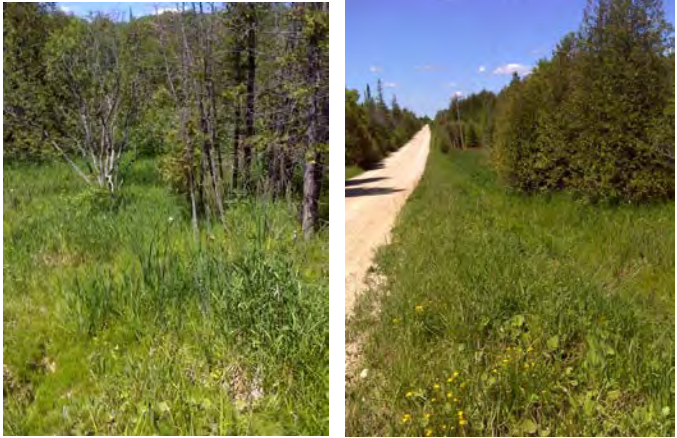
<p>June 14, 2012- no open water feature found at W34</p>	W34- not carried forward as a water body

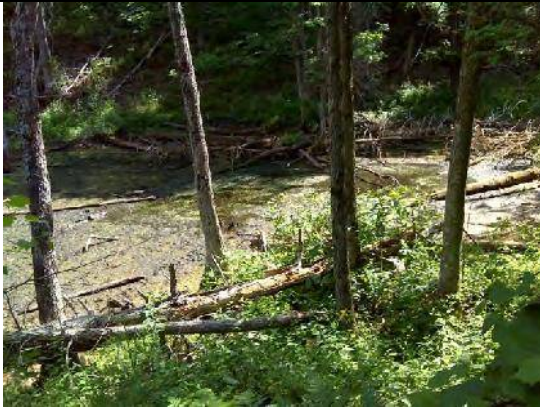
<p>Vernal pool within ELC unit 55 (photo: July 24, 2012)</p>	<p>W48 > 120m from Project Location; not assessed further</p>

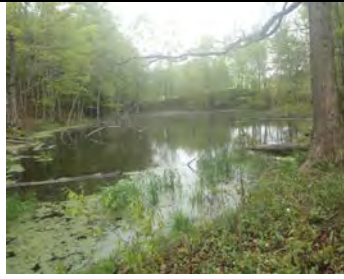
<p>Pond condition on May 16, 2012</p>

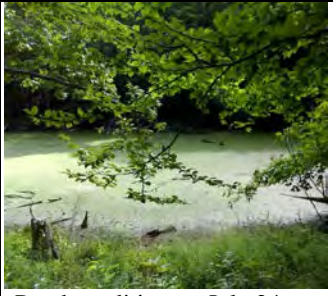
<p>Pond condition on July 24, 2012</p>	W36 - pond

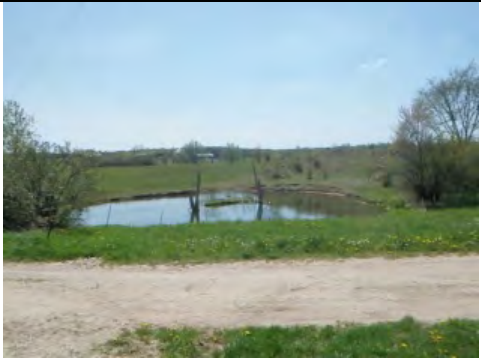
<p>W37 – dugout pond adjacent to laneway (photo: May 15, 2012).</p>	<p>W37 - not carried forward as a water body</p>

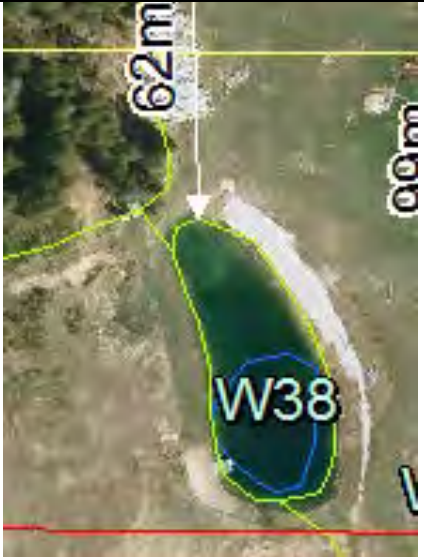
<p>Dugout pond used for recreational activity by landowner.</p>	<p>W38 - not carried forward as a water body</p>

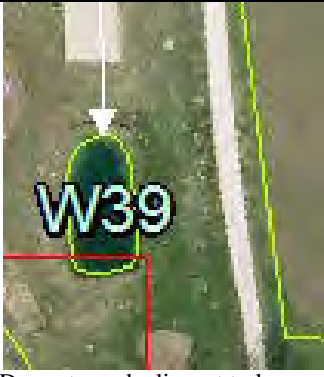
<p>Dugout pond adjacent to laneway to landowner's house.</p>	<p>W39 - not carried forward as a water body</p>
