Study Area: Jericho Goshen Bluewater Land Parcel# 1635, 1636 Turbine# EC63 C201  
 Date: Dec 16/11 Start time: 14:45 End Time: 15:20

Watercourse Sketch

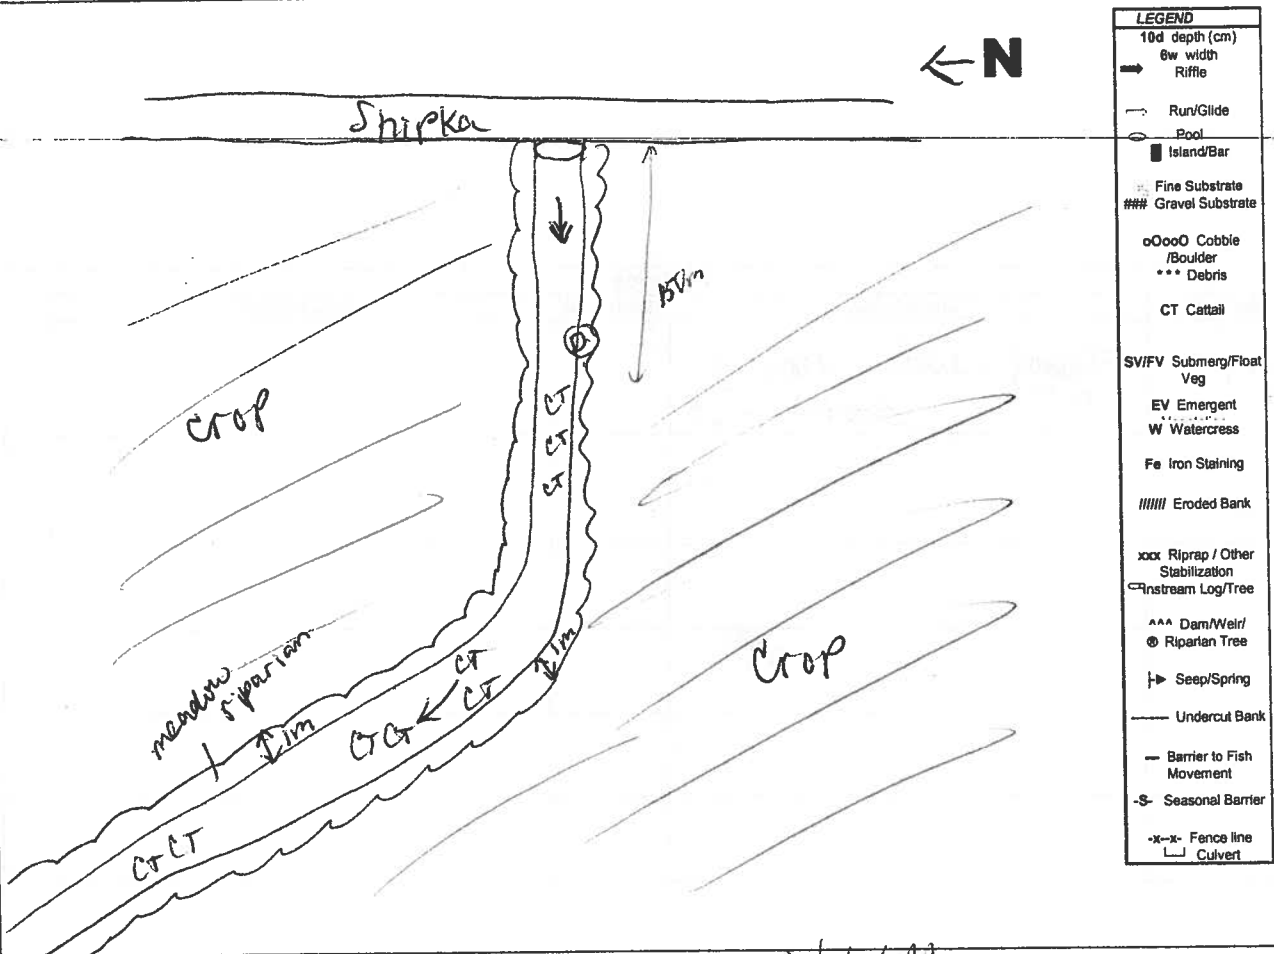
- Channelized + uniform throughout

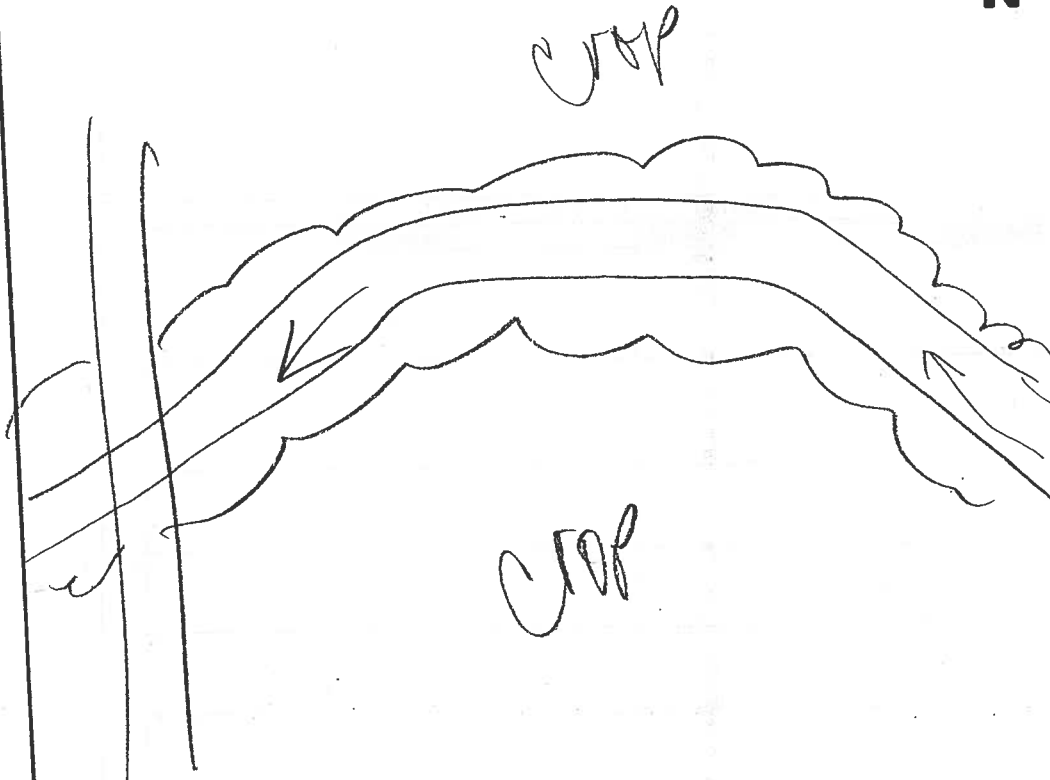
Watercourse Sketch

exposed soils, some slumping, exposed roots  
TOBW - 5.0m  
TOBH - 3.0m

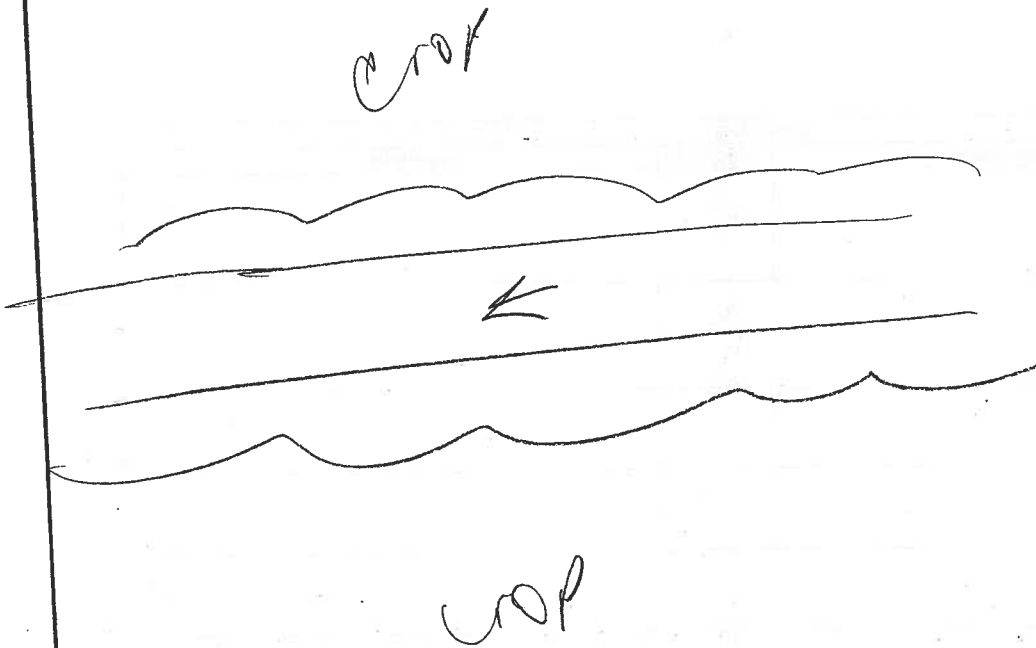
bank scouring observed, exposed tree roots  
TOBH - 2.5 m  
TOBW - 7.0 m
