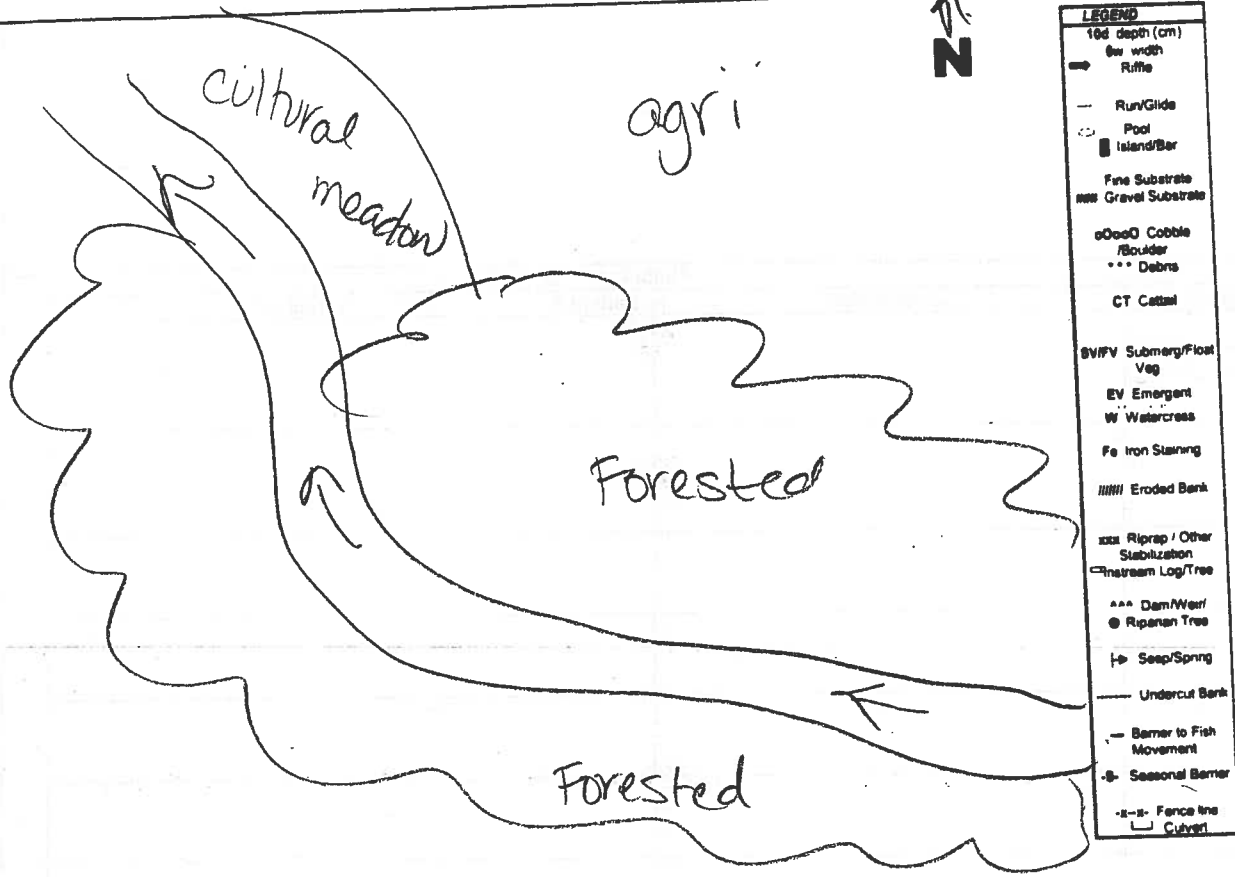
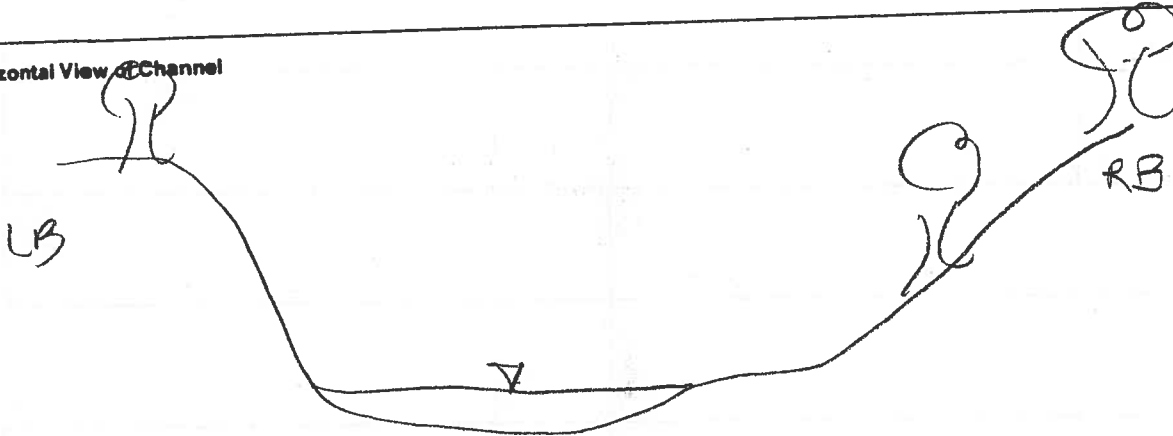
Study Area: Jericho Goshen Bluewater Land Parcel# 1090 Turbine # C81

Notes: signs of erosion along RB & LB - exposed soils + tree roots

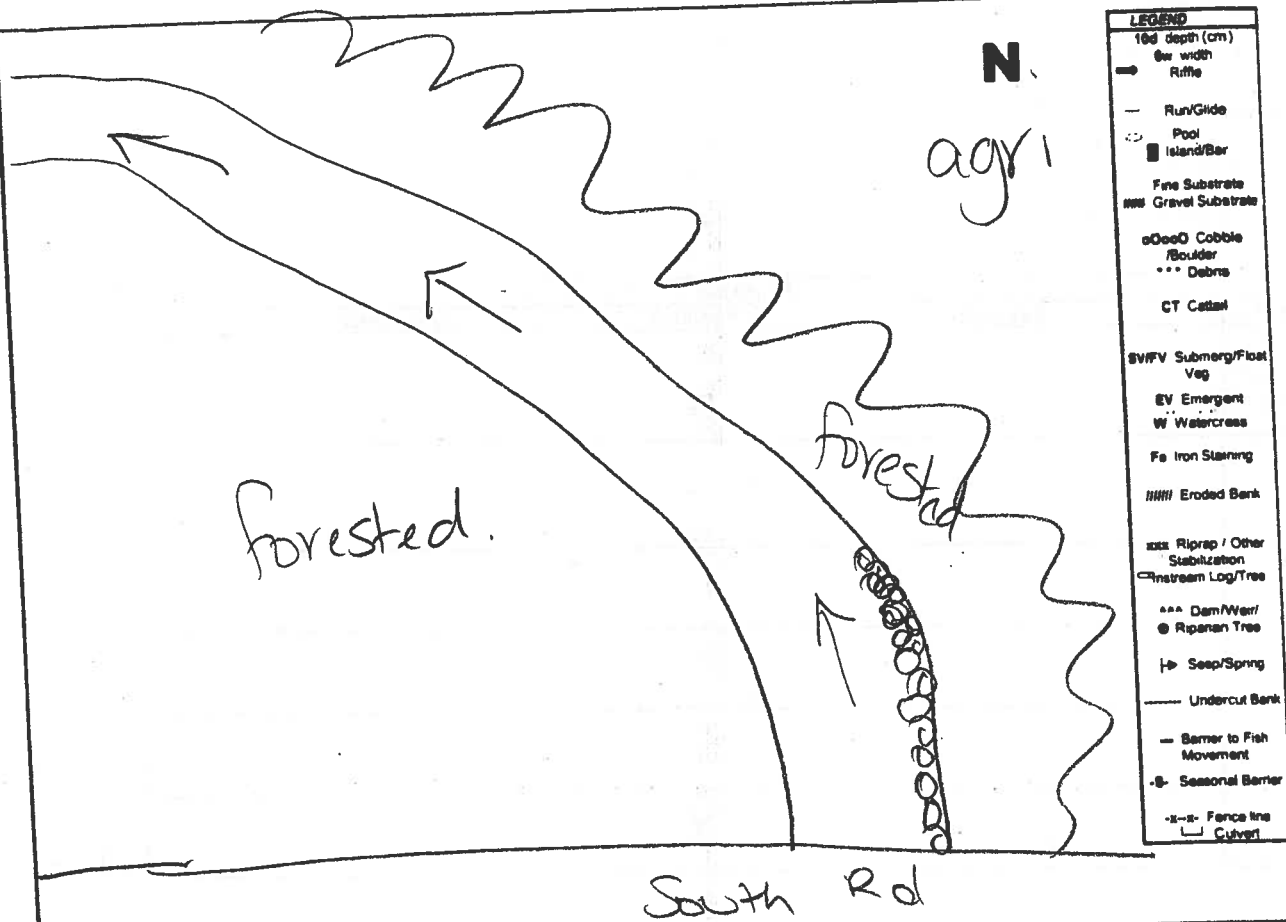
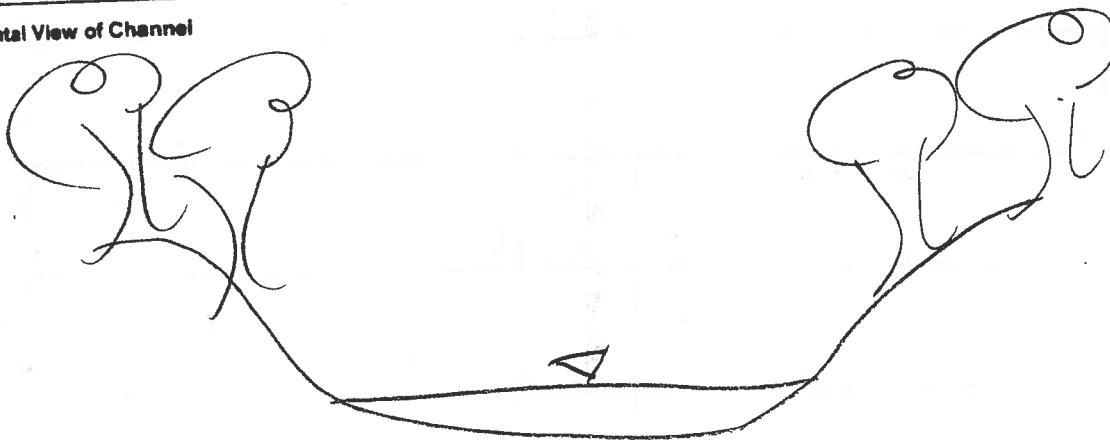
Study Area: Jericho Goshen Bluewater Land Parcel# 1075 Turbine # C82

large meander where bank is eroding away

- area near culvert where bank have been reinforced w/ cobble
- severe erosion located near culvert
- failed reinforcements
- u/s side is green colour & very slow moving due to stream modifications made d/s
