Watercourse Sketch

Study Area: Jericho Goshen Bluewater Land Parcel# GSH2016 Turbine # C144

Study Area: Jericho Goshen Bluewater Land Parcel# GSM 2016 Turbine # C144  
 Date: Nov 18, 2011 Start time: 9:30 End Time: 9:40

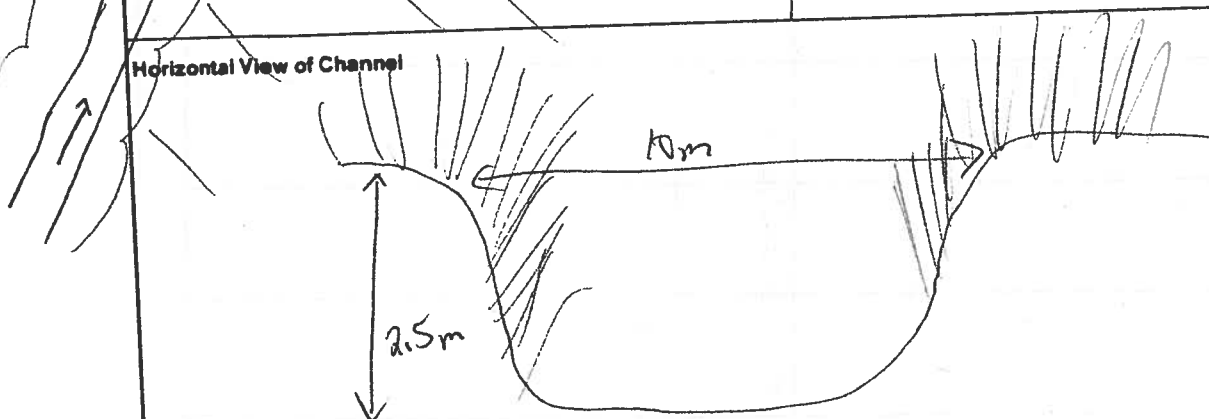
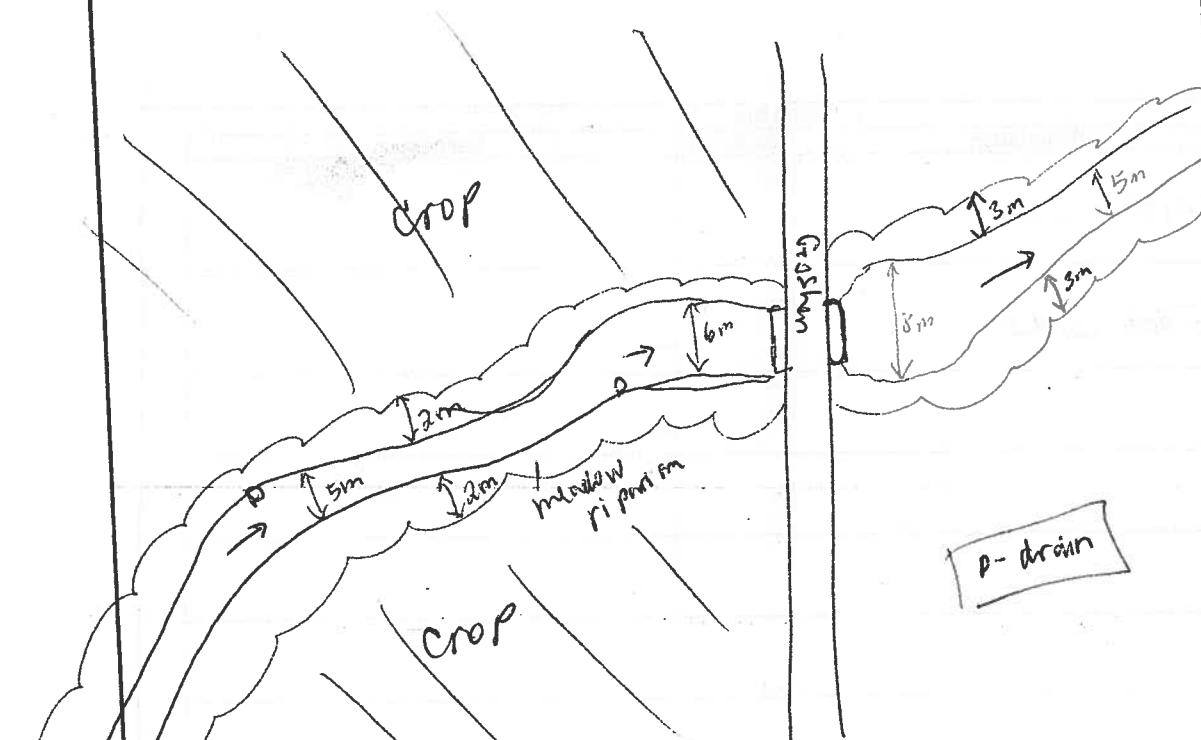
- stream too deep to wade in
- channelized & uniform throughout site
- debris jams noted throughout - ~~big~~ banks - not blocking flow

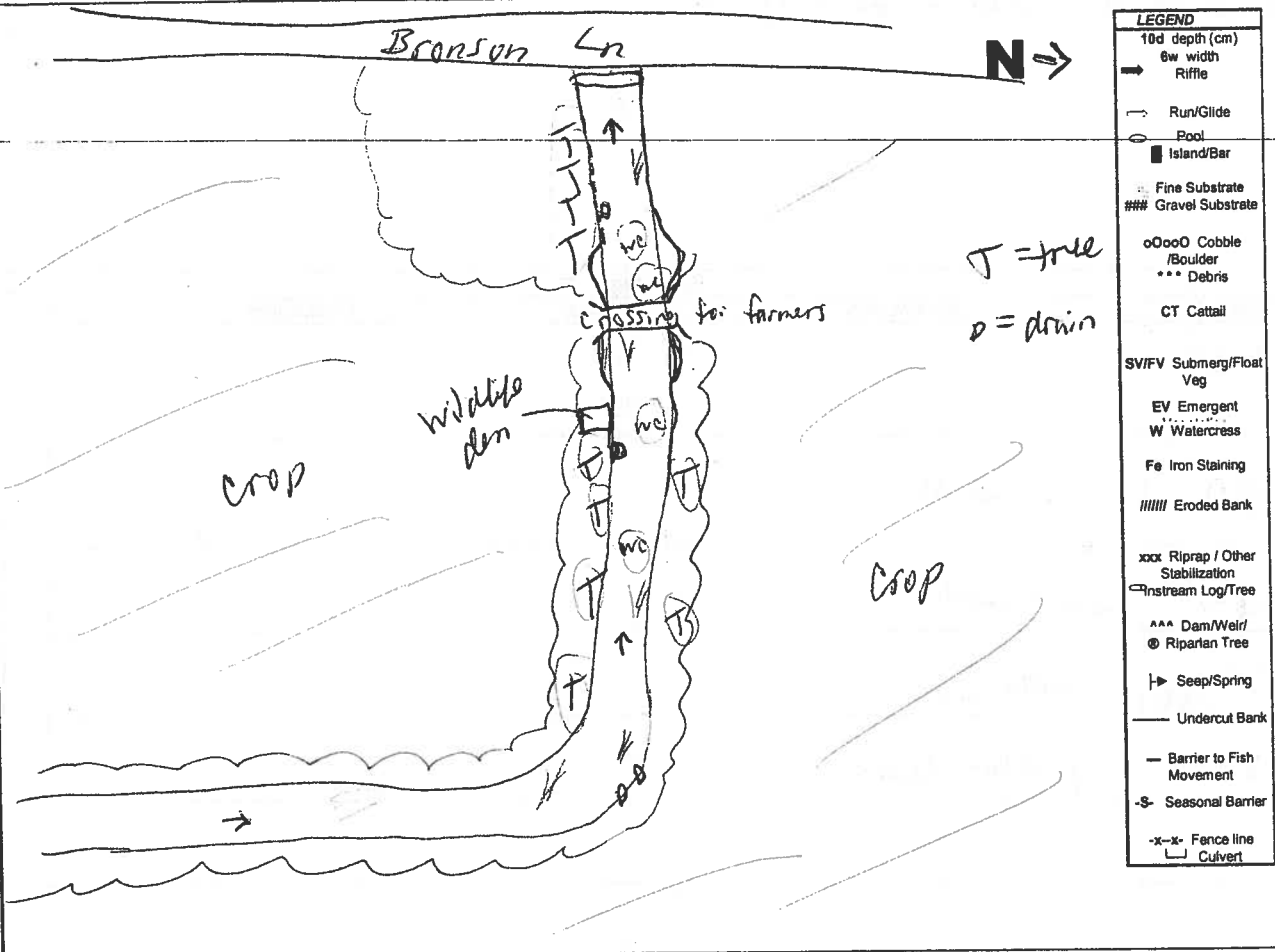
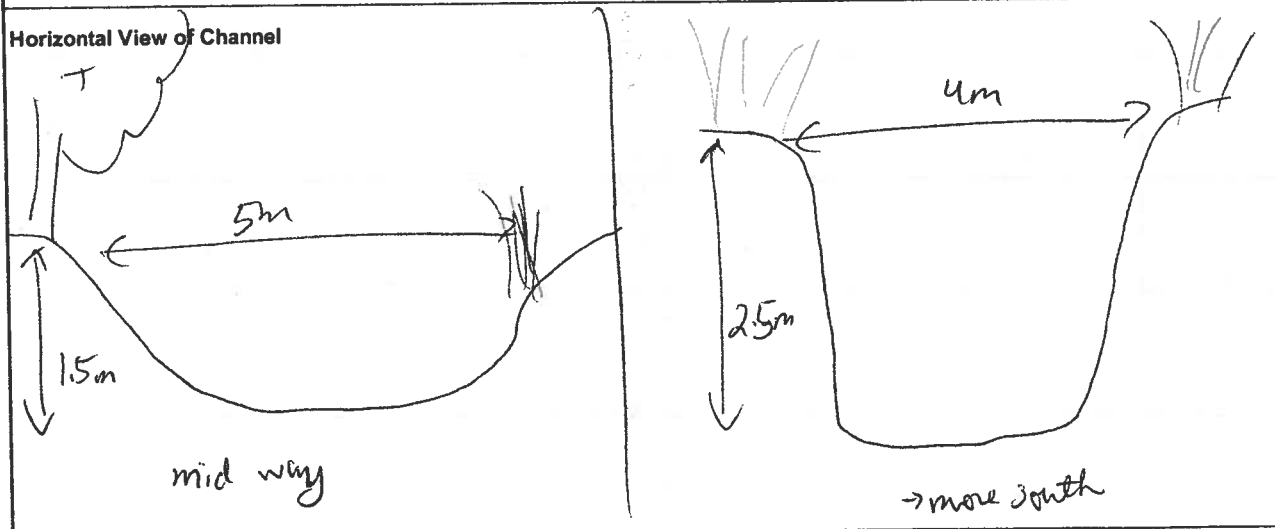
Watercourse Sketch

perched culvert at property line (south side)

- wildlife den observed east of crossing
- multiple tile drains flowing into channel - appears to be agri drain
