# Water Bodies Assessment Field Collection Form

| AECOM | | | | Page 1 of 4 | |
|---|---|---|---|---|--|
| Study Area: Jericho <u>Goshen</u> Bluewater | | Land Parcel# <u>2114</u> | | Site ID: <u>D20-u/s</u> | |

Study Area: Jericho Goshen Bluewater Land Parcel# ASH2124 Site ID: D20 D/S

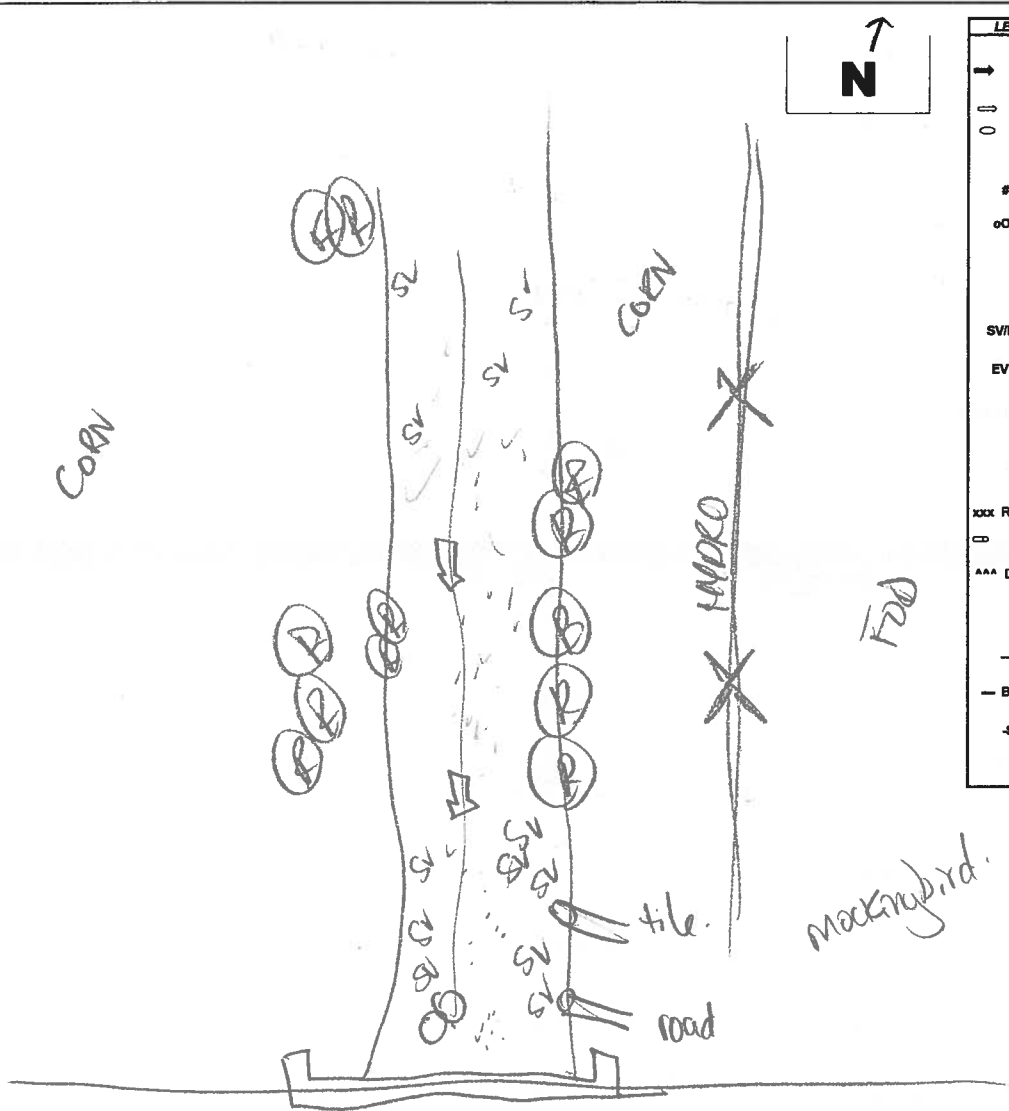
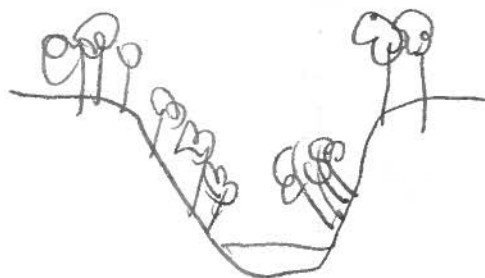
Watercourse Sketch

Channel moving slowly ~ well vegetated w/sub. veg + floating algae. Relatively good bank + riparian cover ups and very little d/s.

Downstream reach seems managed for veg. growth (cut grass laneway + hay field). no

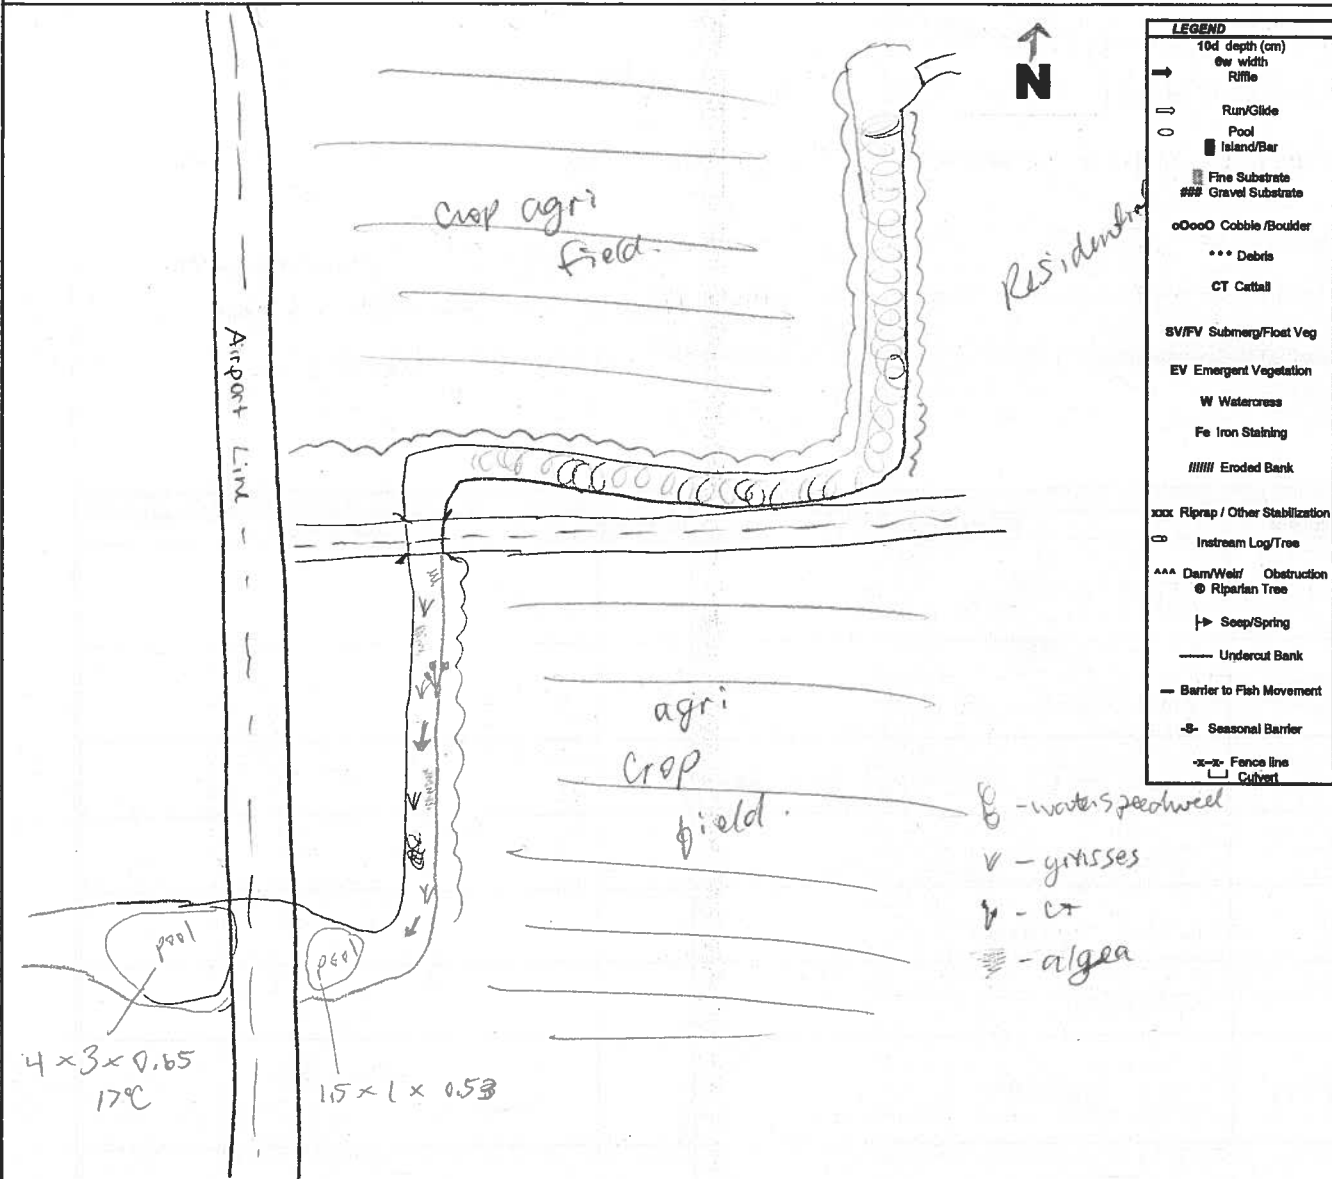
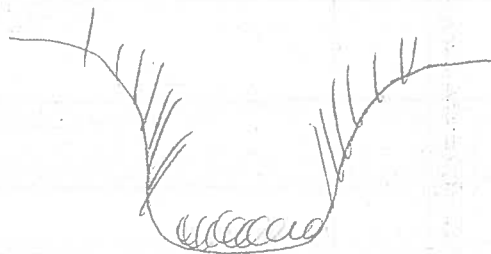
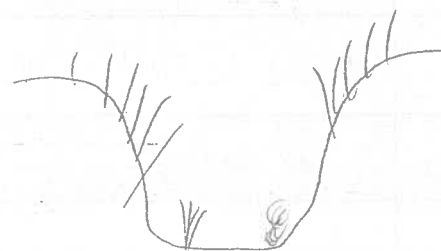
Study Area: Jericho Goshen Bluewater Land Parcel# 2480/2867 Site ID D23 North

- watercourse is most likely buried and then pops out north of house  
Mapping is accurate
- Chimney crayfish homes noted at start of watercourse
- schools of cyprinids observed along road side and pool at culvert
- Watercourse straight channelized - water speedwell mats entire watercourse  
until it reaches the road. It starts flowing and has high instream  
cover from algae, grasses, speedwell. Substrate silt/mk.

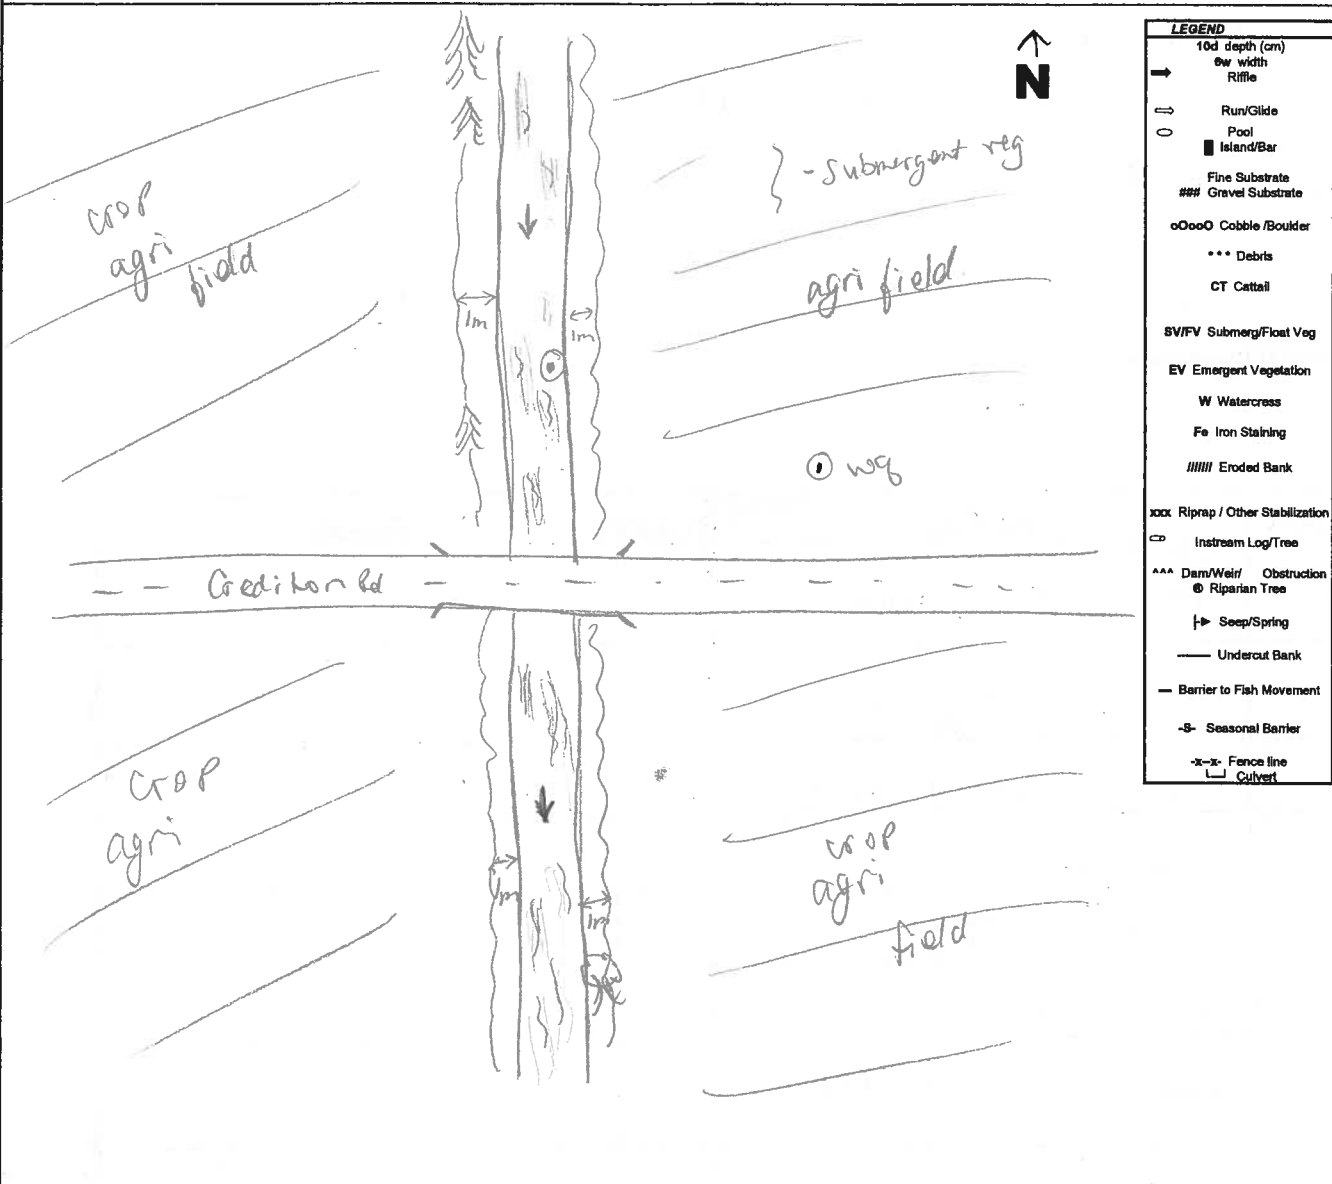
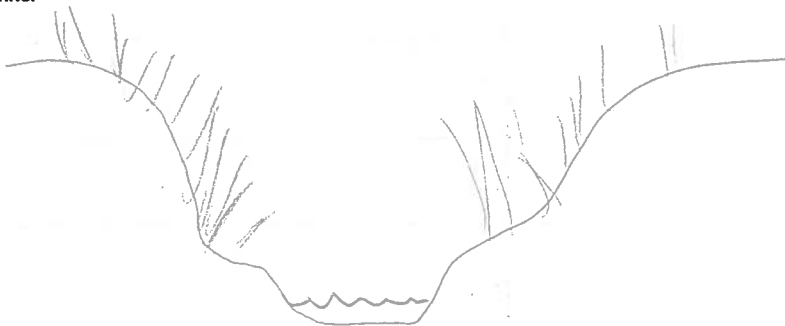
Study Area: Jericho Goshen Bluewater Land Parcel# 2770/3130 Site ID D26

- no bird nests observed under bridge
- red winged blackbird + robin observed

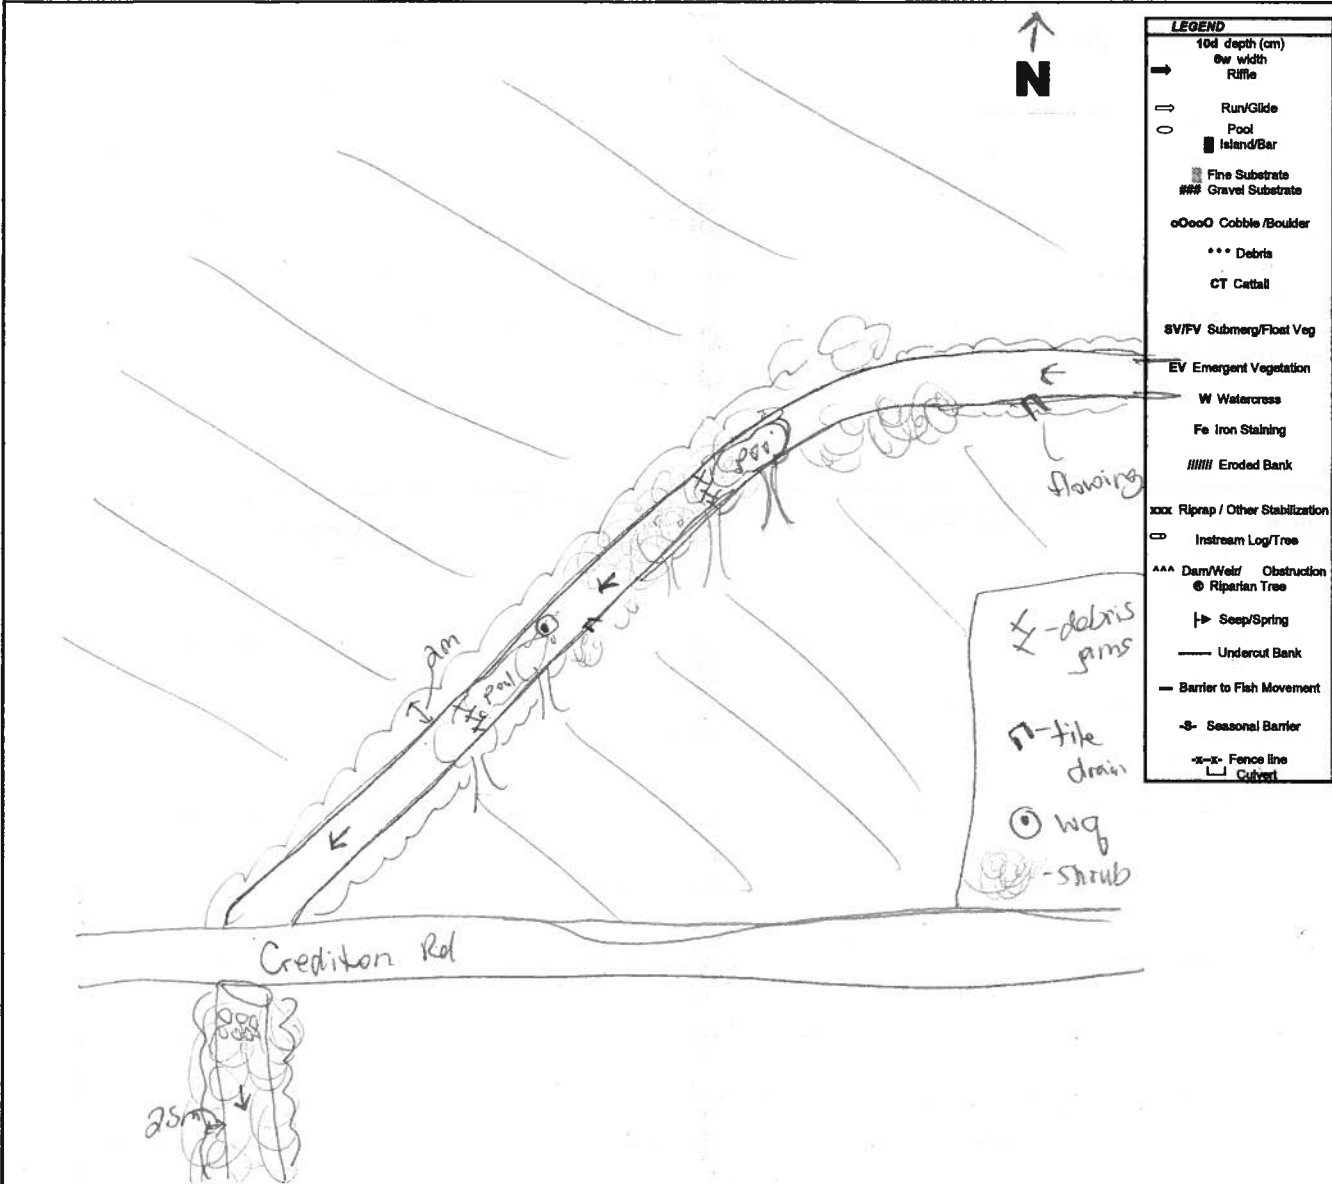
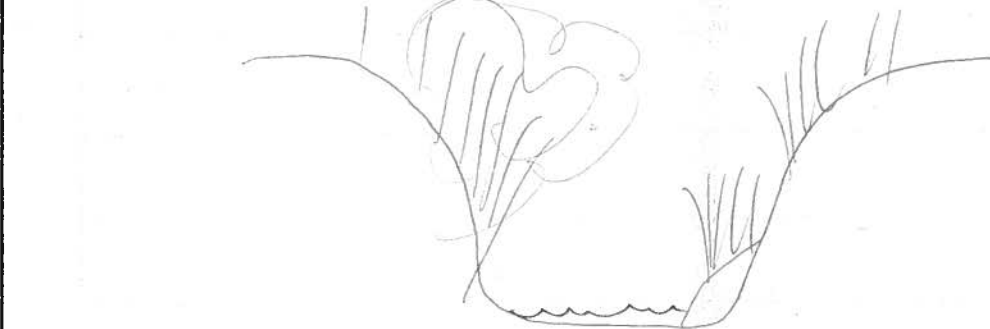
Study Area: Jericho Goshen Bluewater Land Parcel# 2769 / 2768 Site ID D27

- schools of minnow observed
- muskrat observed at wg station
- onsite survey for north side of watercourse, roadside south
- watercourse straight channelized with high instream cover (algae) and mud canopy cover (grass, trees, shrubs). Substrate cobbly, gravelly sand. It starts to flow and meander more naturally as it enters and goes through the forest area - assessment not completed in forest

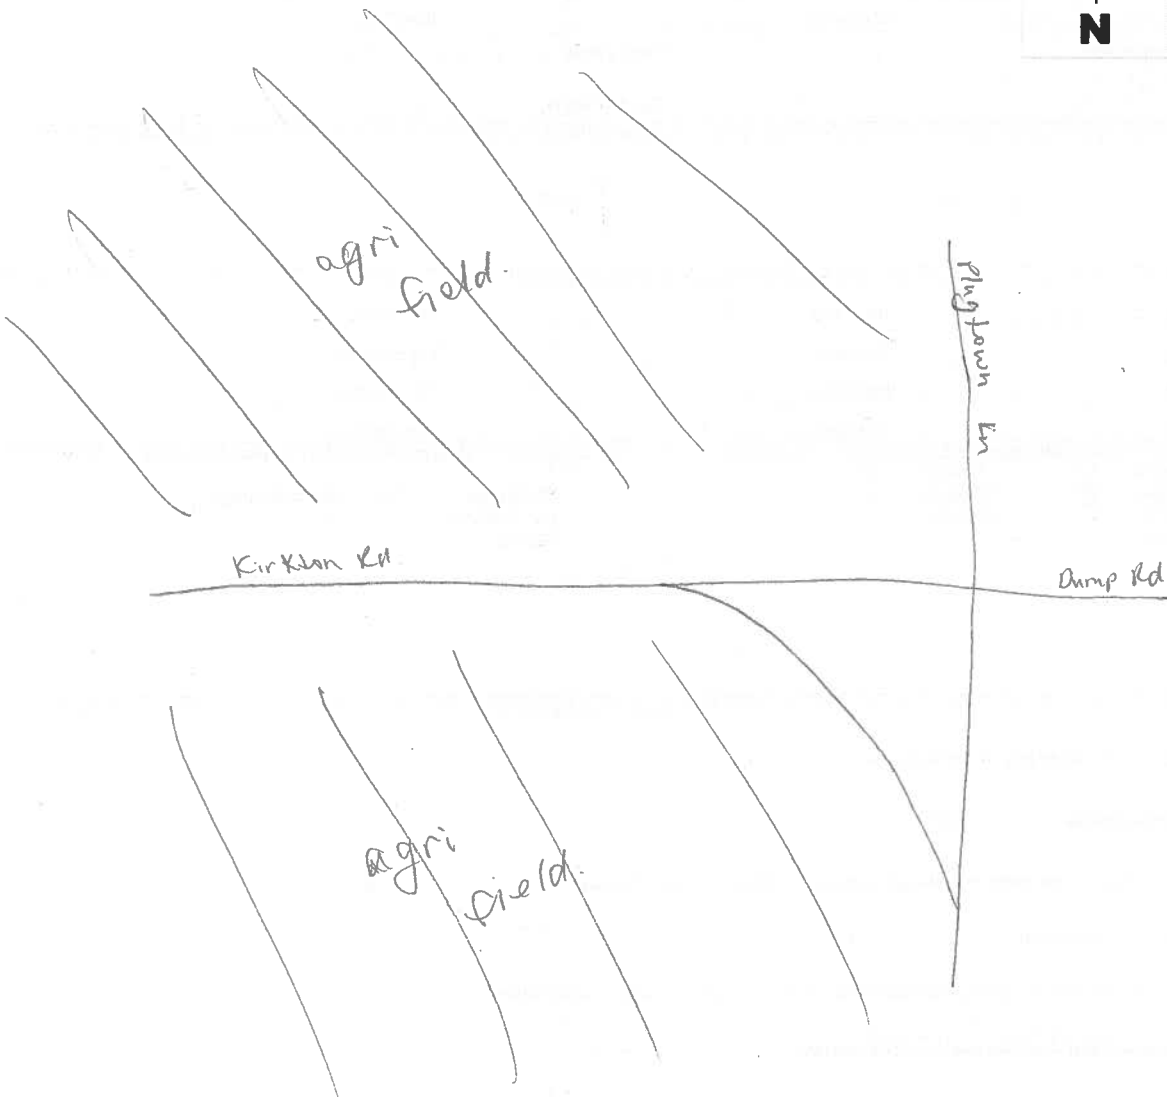
Site Sketch

- no watercourse observed.
