# Water Bodies Assessment Field Collection Form

Land Parcel/Site ID: GSH2717

| AECOM | | Page 1 of 4 | |
|---|---|---|---|
| Study Area: Jericho <u>Goshen</u> | Bluewater | Land Parcel# <u>2370</u><br><u>23609</u><br><u>2371</u> | Site ID: <u>037</u> |

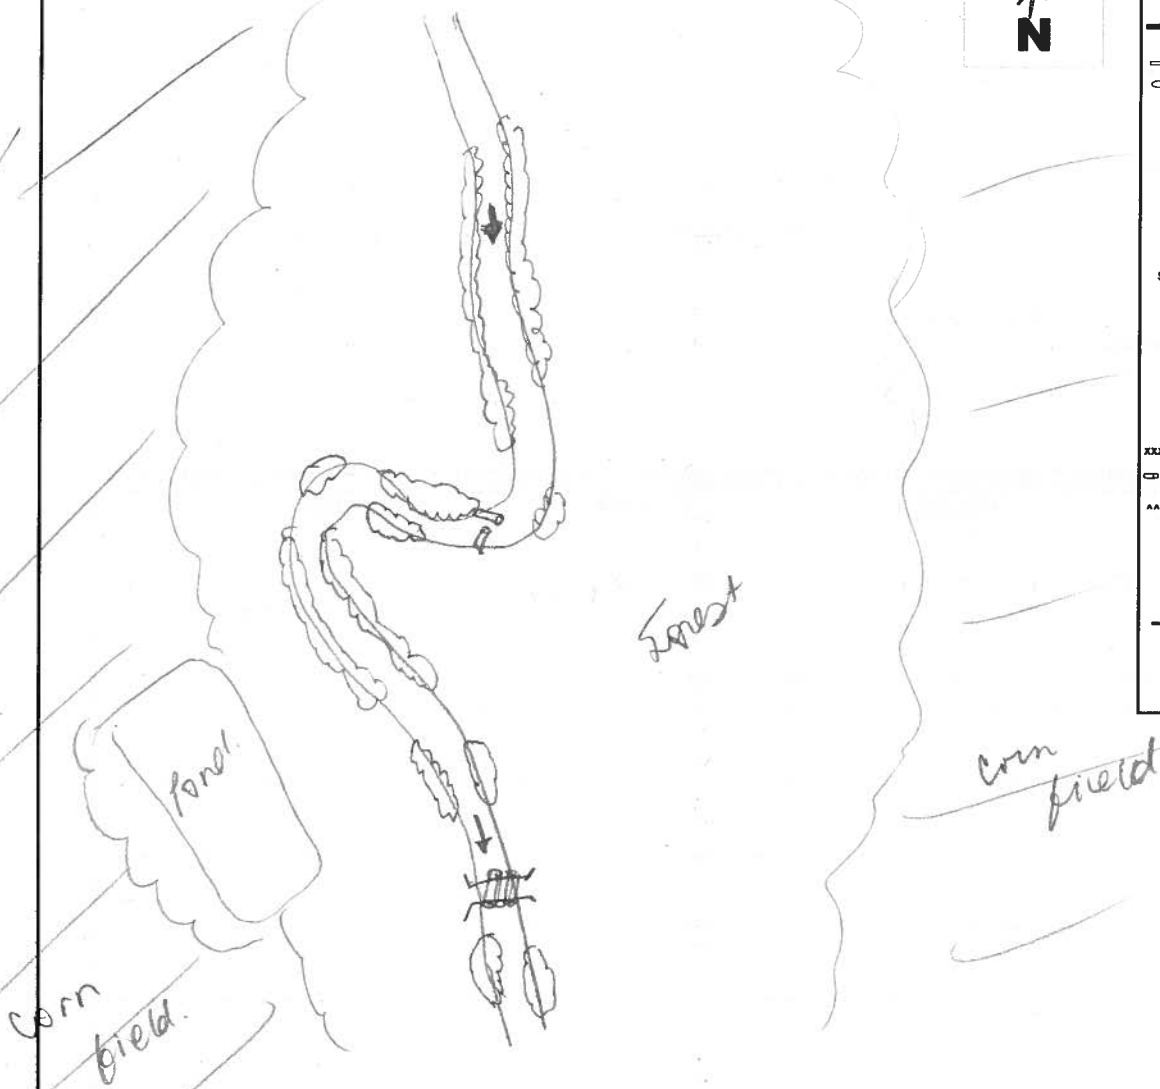
P36

Watercourse is a wide slow moving system that has turbid water. There is overhanging shrubs lining the banks and then forest area behind. Watercourse was too deep to wade however at edge substrate was silty, sandy + clayey. It has a natural meander.

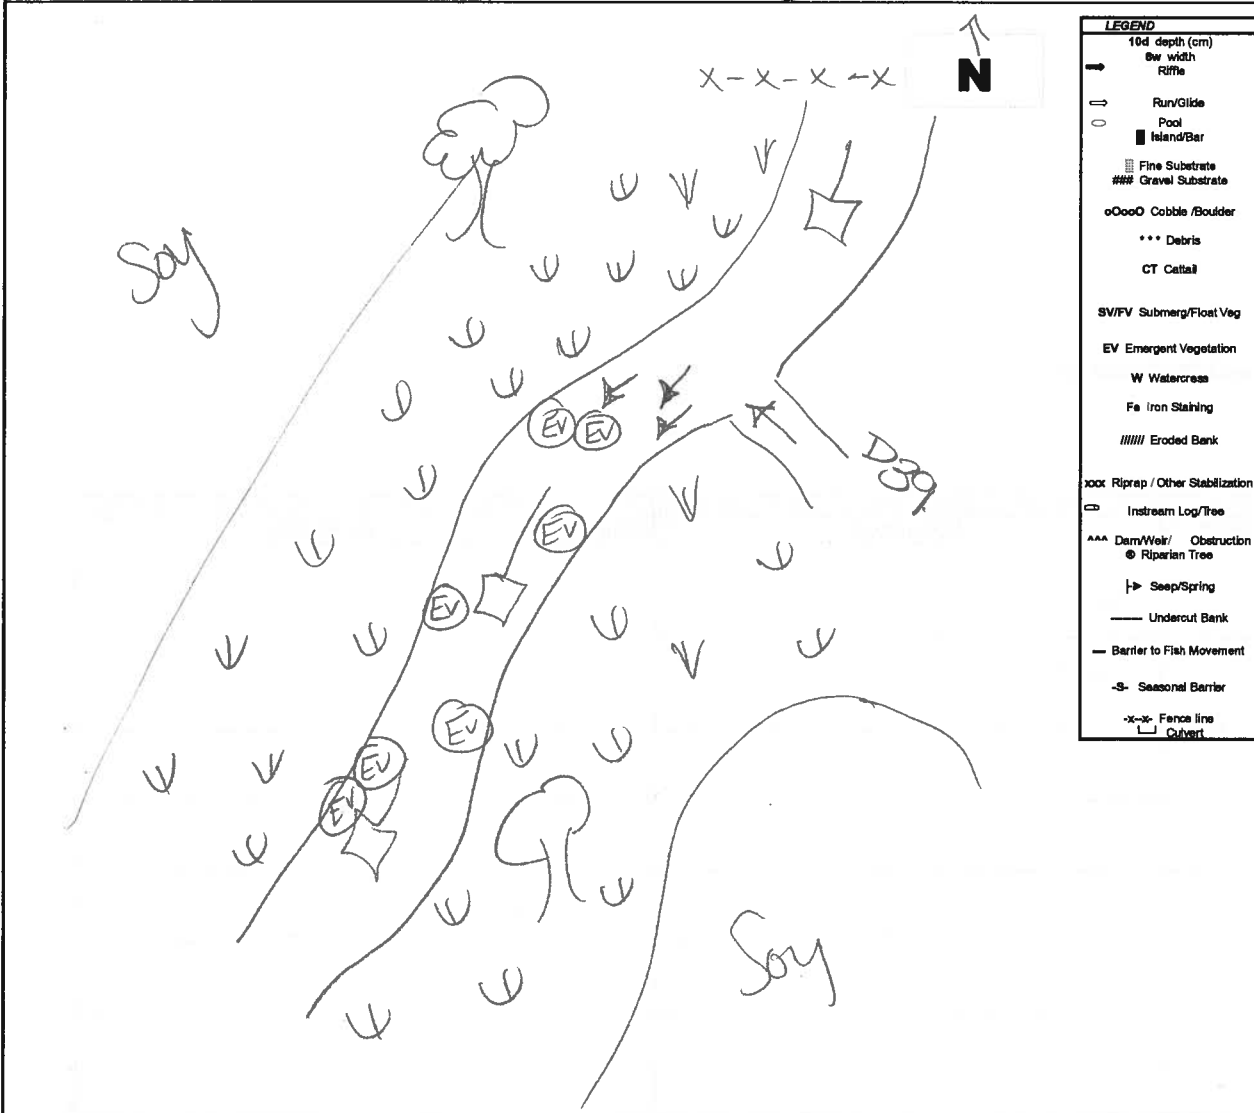
D38

| Stream Morphology | | | | | | | | | | | | | | | | | | | | |
|---|---|---|---|---|---|---|---|---|---|---|---|---|---|---|---|---|---|---|---|---|
| Mean Wetted Width (m): <u>1.5</u> | Mean Wetted Depth (m): <u>0.08</u> | Description: <u>signs of erosion &amp; undercut banks</u> | | | | | | | | | | | | | | | | | | |
