NextEra Energy Canada, ULC
Goshen Wind Energy Centre

DRAFT Water Assessment and Water Body Report

60155032

September, 2012

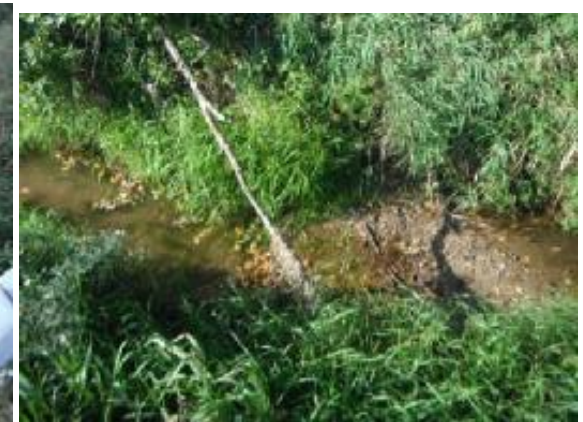
Photograph 3. Bank erosion ↑

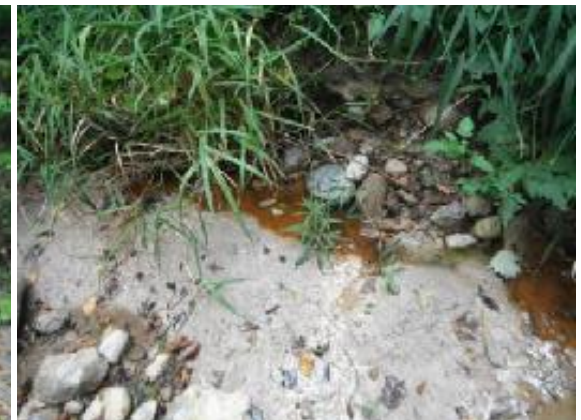
Photograph 3. Iron staining ↑

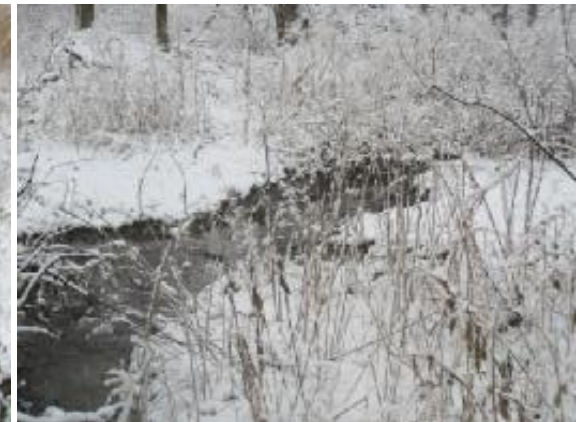
Photograph 3. Tile drain fed watercourse feeding into C33 ↑

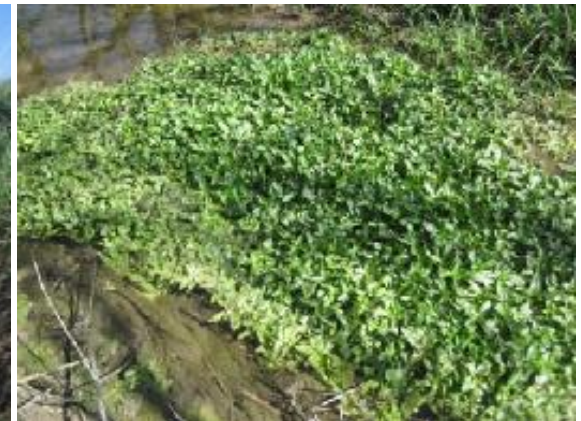
Photograph 3. Water speedwell ↑

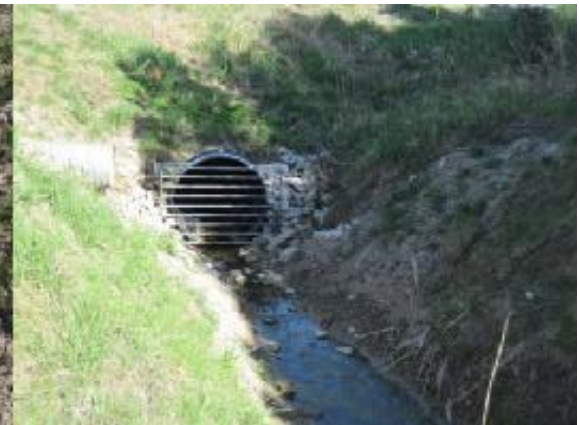
Photograph 3. Outlet pipe at Grand Bend Line ↑

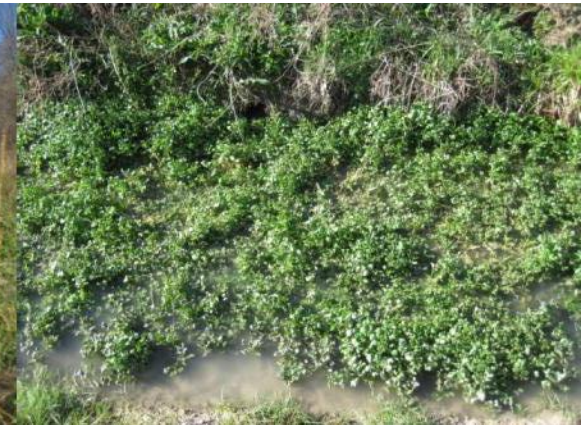
Photograph 3. Watercress ↑

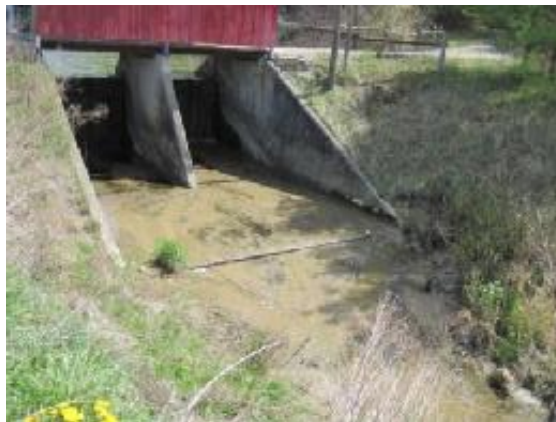
Photograph 1. Dam ↑

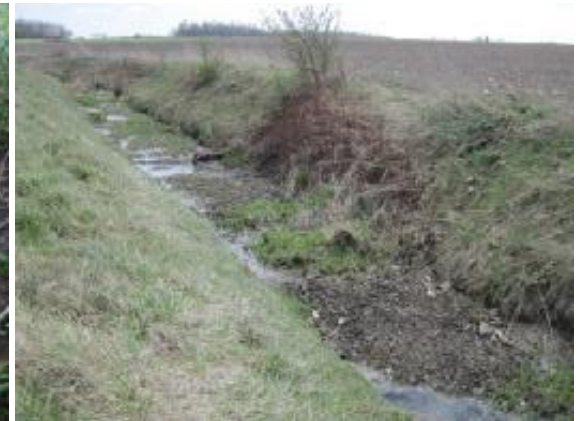
Photograph 3. Low flow barrier ↑

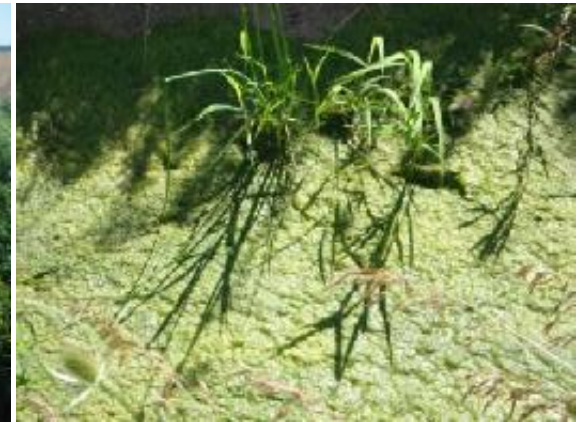
Photograph 3. Algae growth ↑

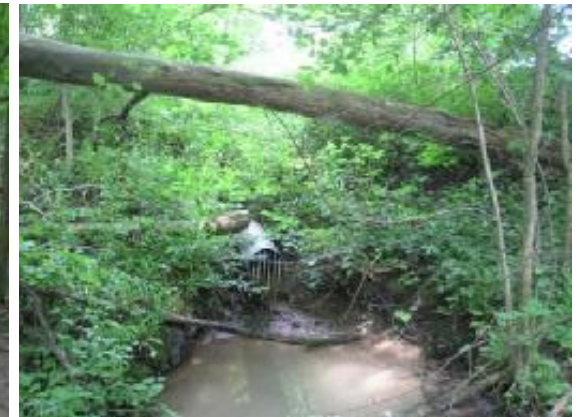
Photograph 3. Tile drain ↑
