PROJECT: ADELAIDE WIND FARM PROJECT

HERITAGE RESOURCE ASSESSMENT AIR ENERGY TCI ADELAIDE WIND FARM

APPENDIX A

Cultural Structures located on Participating Parcels with Proposed Turbine Related Activities

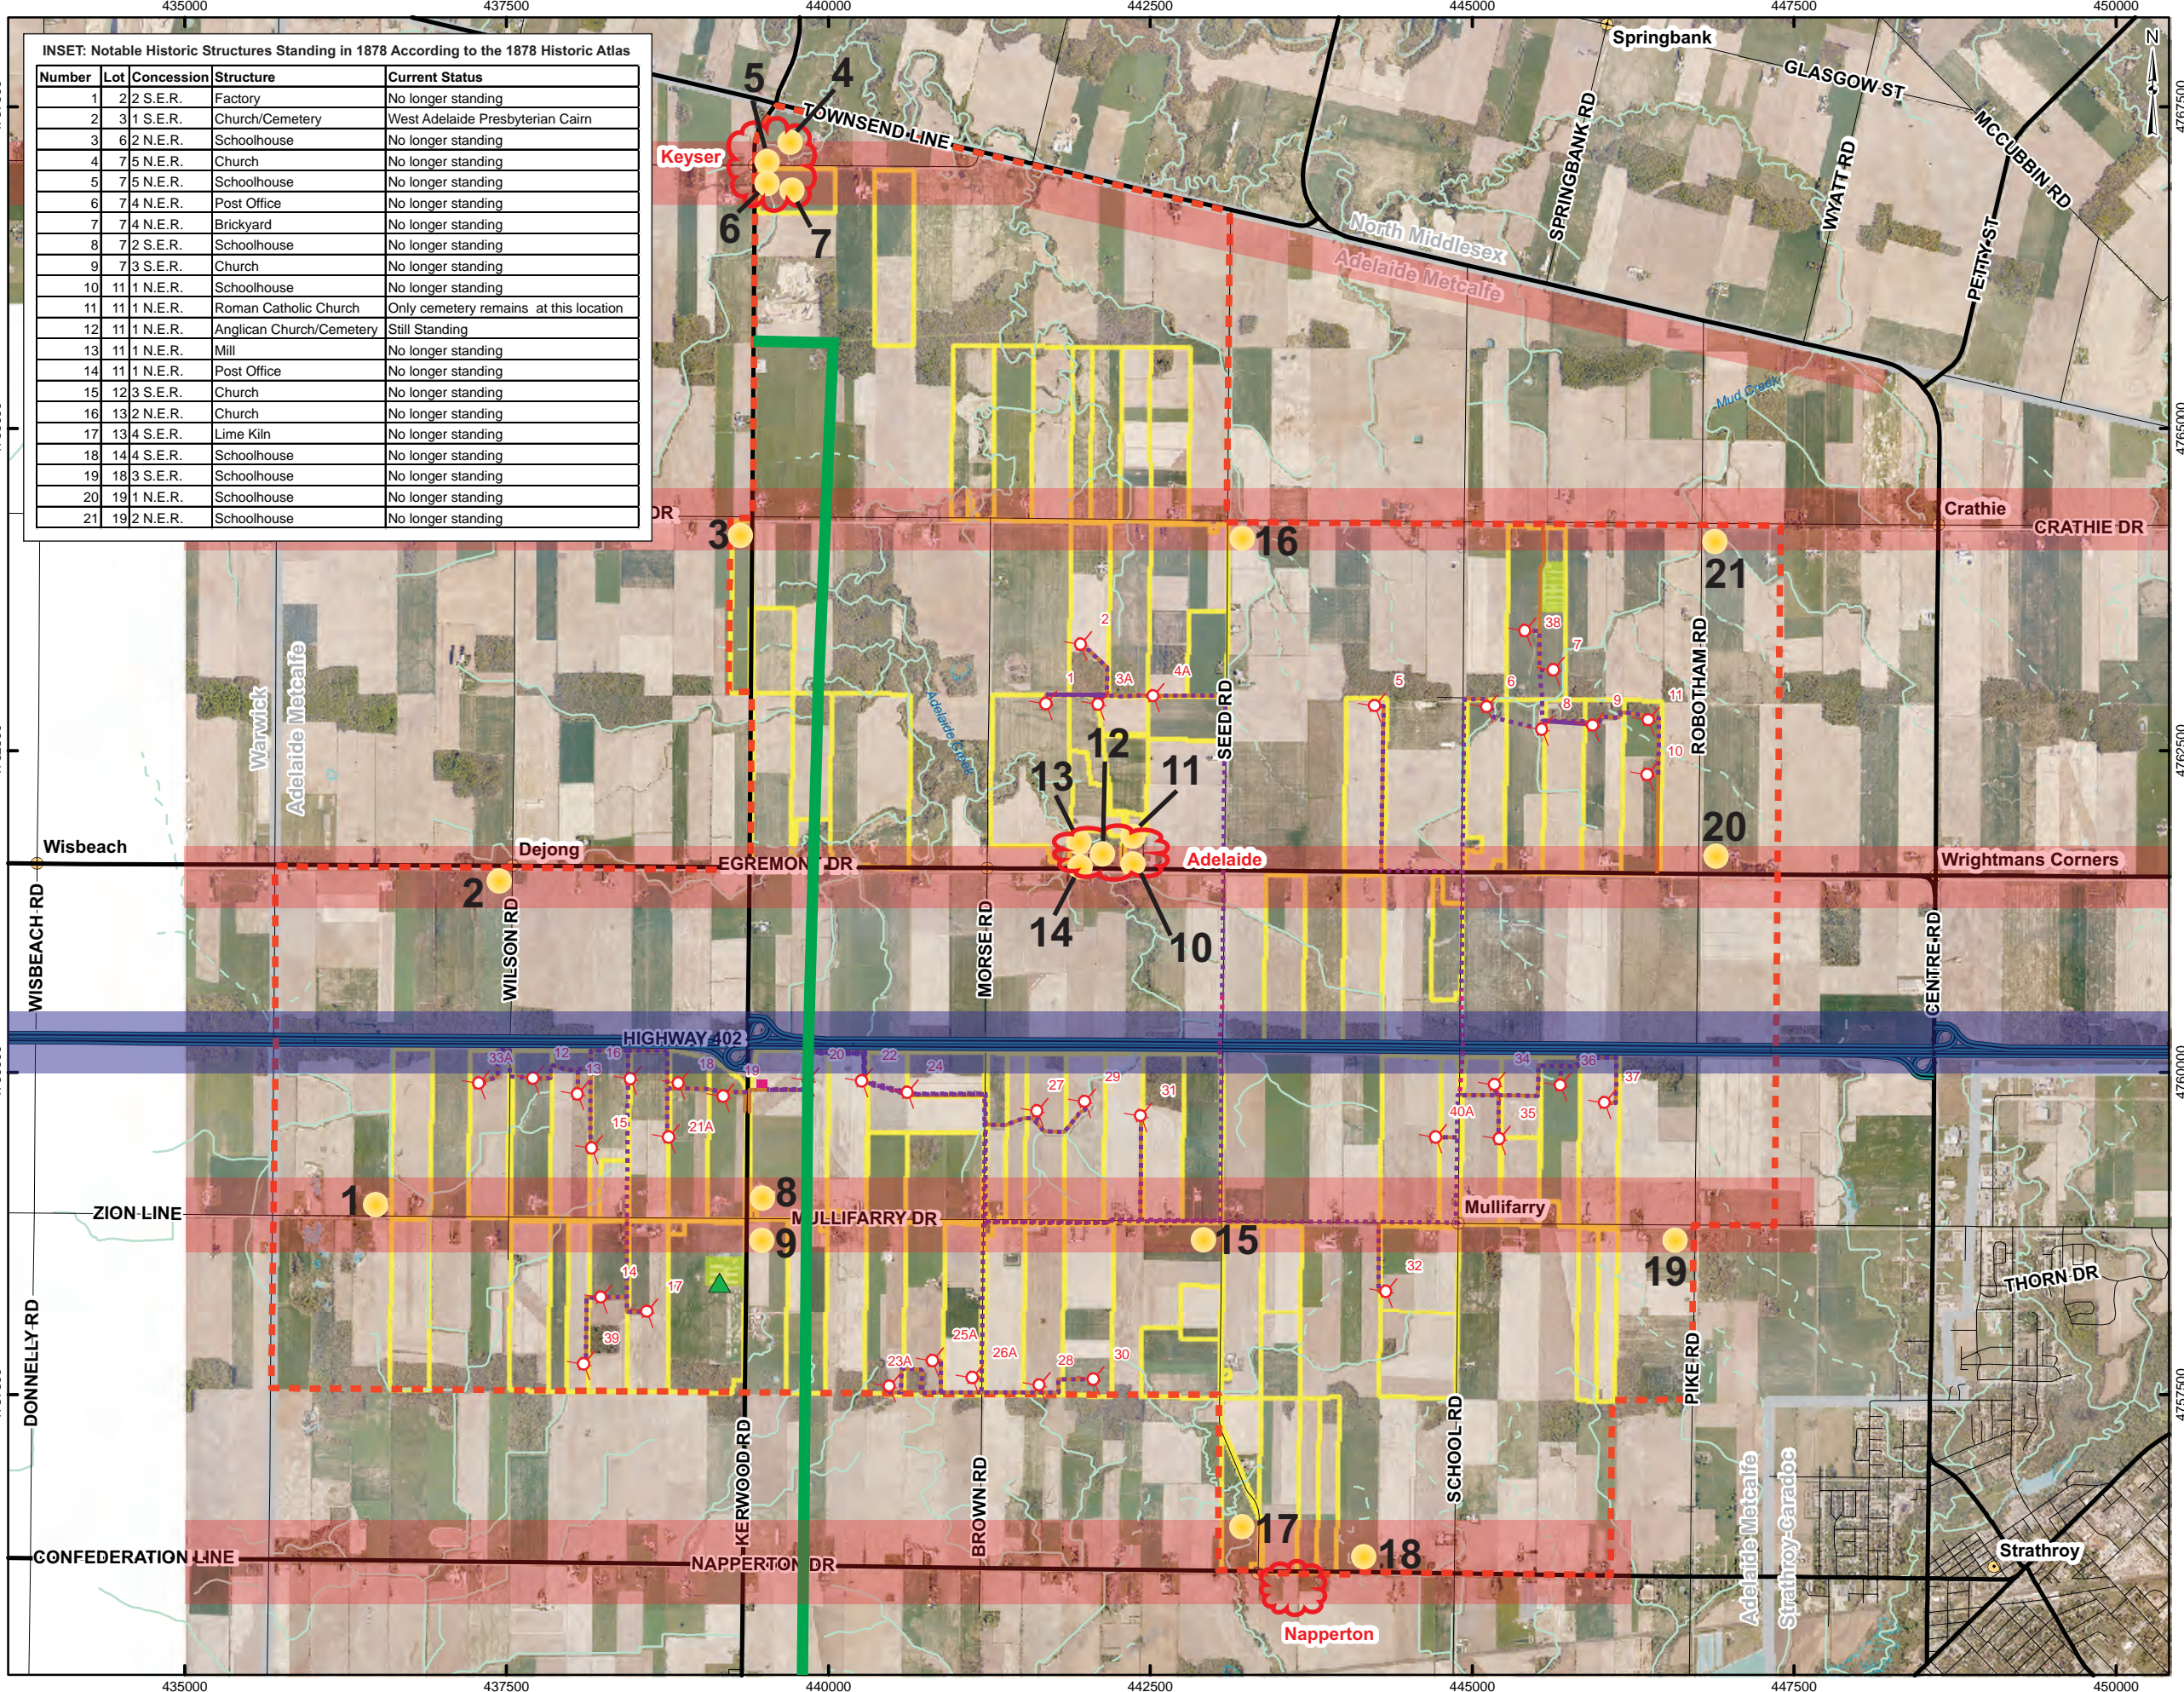
FIGURE: 11

INSET: Notable Historic Structures Standing in 1878 According to the 1878 Historic Atlas

TITLE: General Historical Thematic Map of the Study Area

A hydro corridor transects the study area running north to south along the east side of Kerwood Road (Figure 1 and Figure 11).

The study area is defined as a rural cultural landscape consisting of a homogeneous land use pattern of agricultural fields, pastures, woodlots and associated farmsteads, with no separate or highly sensitive cultural landscapes identified. One small urbanized area, the village of Adelaide, is located in the central portion of the study area and blends in as part of the surrounding rural landscape. The study area is located very close to Strathroy, which is a major urbanized settlement for the general vicinity. The initial survey of Adelaide Township had profound effects on the modern cultural heritage landscape. The grid from the survey ultimately established the road and settlement patterns. The farmsteads are primarily clustered along the concession roads and in most cases the structures that exist along the side roads were built long after the initial phase of settlement (Figure 8 and Figure 11).

Highway 402 and its associated underpasses is the most prominent transportation related cultural feature in the study area landscape (Figure 11). All other roads within the study area outside of the village of Adelaide are based on the original transportation grid established in the early 19th century, with Egremont Road (now Egremont Drive) being the most prominent and historically significant.

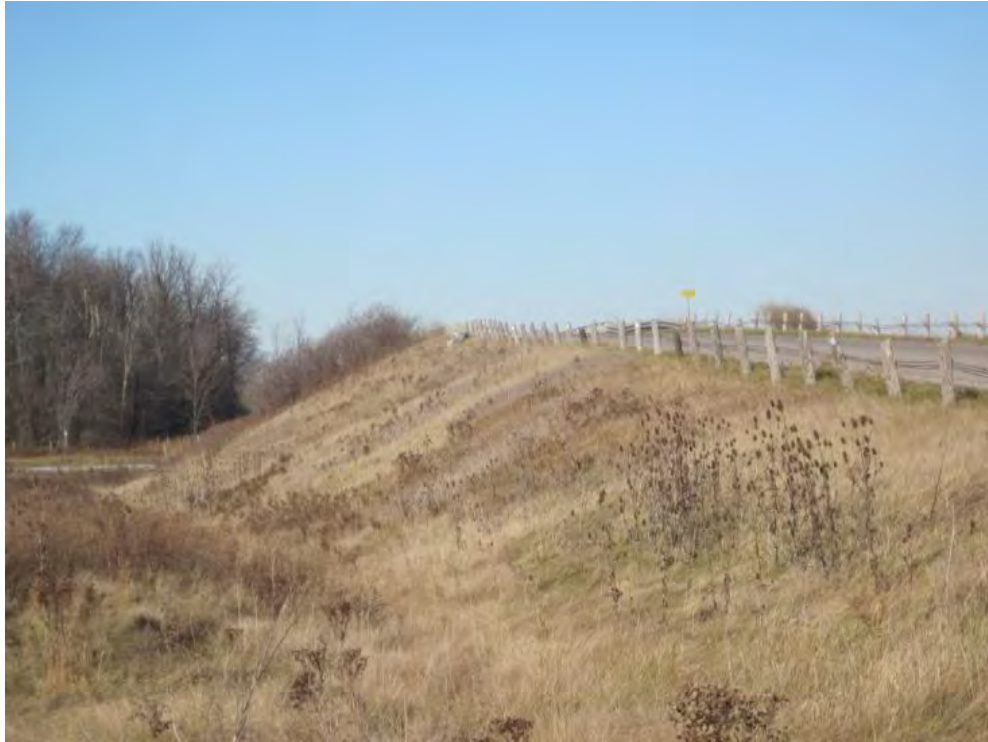
Plate 10: Earth Work Approach of Highway 402 Underpass, Looking North on School Road

Egremont Drive and Highway 402 provide the main east-west access to the region. Highway 402 from London to Sarnia was constructed in stages between 1975 and 1982. The location of Highway 402 was chosen in order to minimize as much as possible the disruption to the local farmers and as such it follows the blind line between Concessions 1 and 2 S.E.R. along the backs of the farms (Figure 11). Kerwood Road provides a highway interchange at Highway 402. In addition to the interchange, both School Road and Seed Road extend over Highway 402, connecting the areas north and south of the highway. The highway underpasses that are located on these roads have substantial earth work approaches helping them to blend in with the rural nature of the side roads (Plate 10).

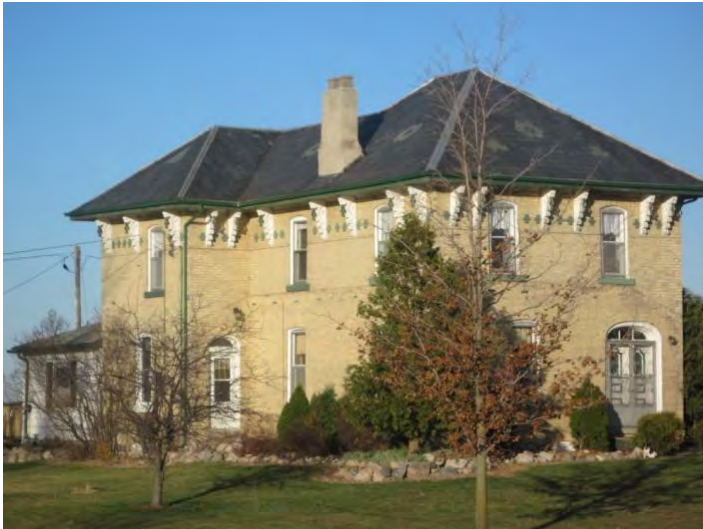
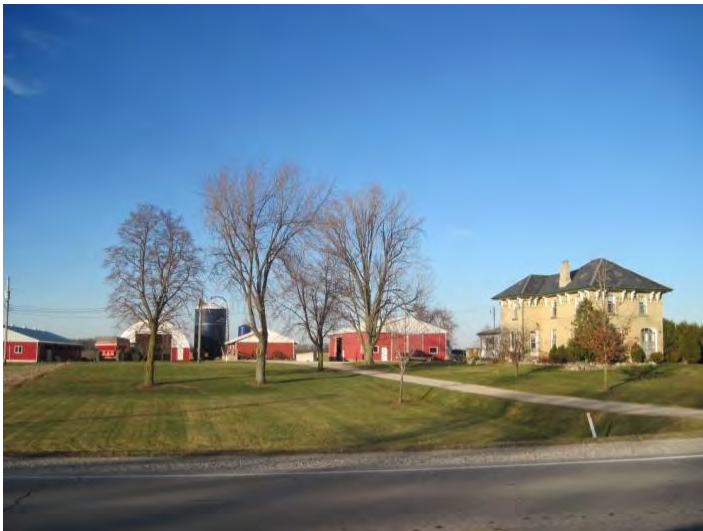
Location: 3018 Egremont Drive

Date: c. 1870's-1880's

Description: Two storey, low pitch roof, fanlight transom over main door, brick, vernacular design with Italianate brackets; porches removed; slate roof

1. Design/Physical Value: Large house, in good condition; brackets are prominent; exterior largely unaltered except for removal of porches.
2. Historical Value: Indicative that original owner had been prosperous
3. Contextual Value: All farm buildings new

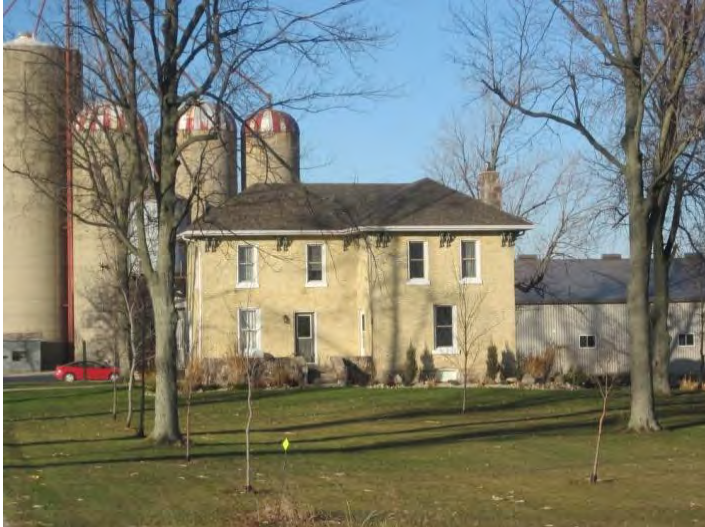
Location: 2888 Egremont Drive

Date: c. 1870's-1880's

Description: Similar to Site #1; paired brackets modern roof

1. Design/Physical Value: Large house, in good condition; brackets are prominent; exterior largely unaltered except for removal of porches.
2. Historical Value: Indicative that original owner had been prosperous
3. Contextual Value: All farm buildings new

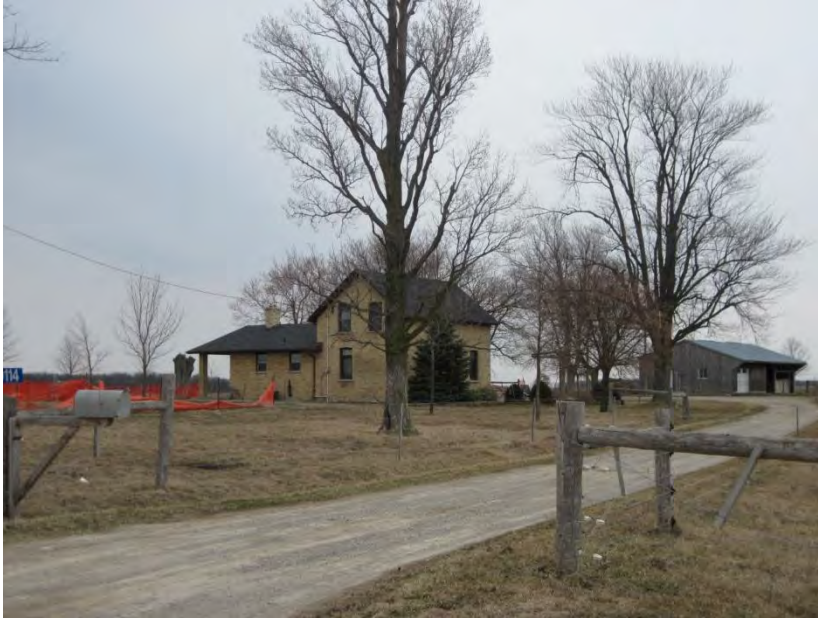
Site #3

Date: mid-late 19th century

Description: One and a half storey brick with one storey rear addition; medium pitch gable end roof

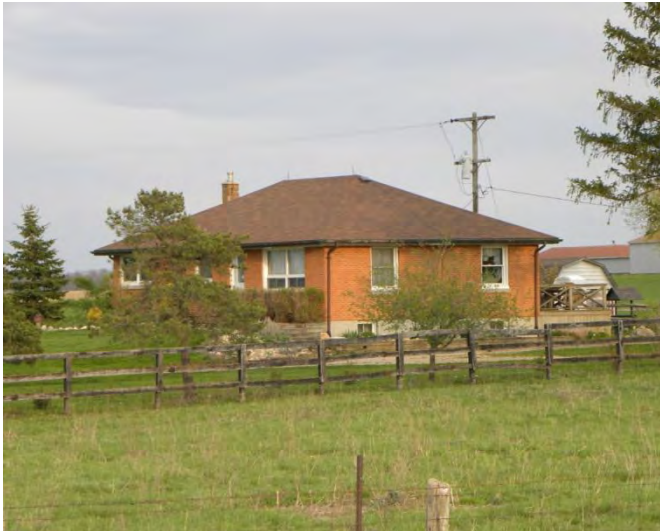
Site #4

HOUSE

Date: c. 1960s

1. Design/Physical Value: typical design of 1950s/60s.
2. Historical Value: None noted
3. Contextual Value: None noted

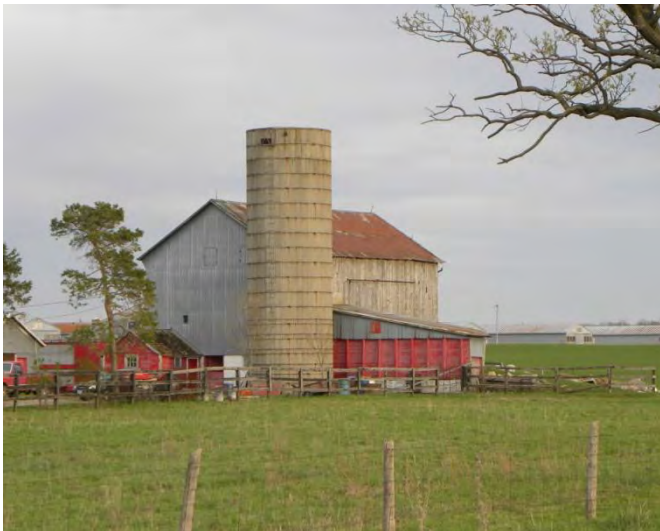
BARN

Date: late 19th /early 20th century

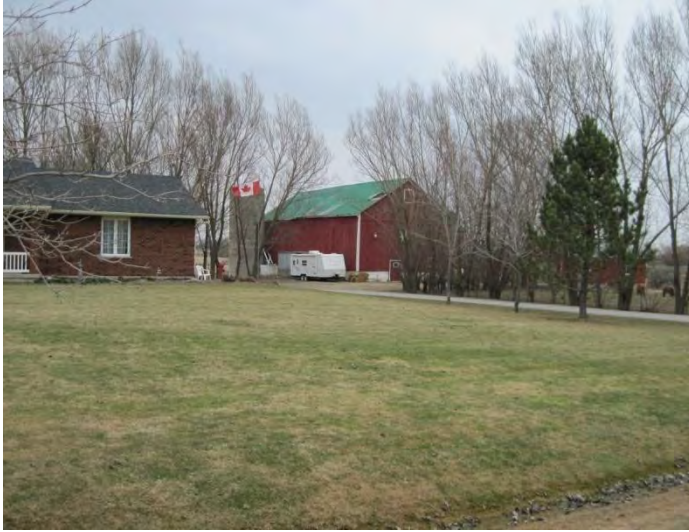
Location: 2180 Egremont Drive

BARN

Date: c. 1890's-1920's

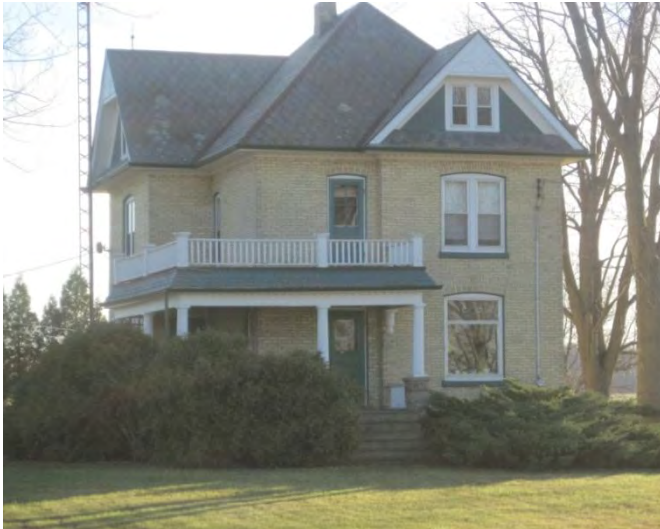
Location: 2305 Cuddy Road

HOUSE

Date: c. 1890-1910

1. Design/Physical Value: Large house. Good condition.
2. Historical Value: None identified
3. Contextual Value: Contributes to early 20th century agricultural activity of study area

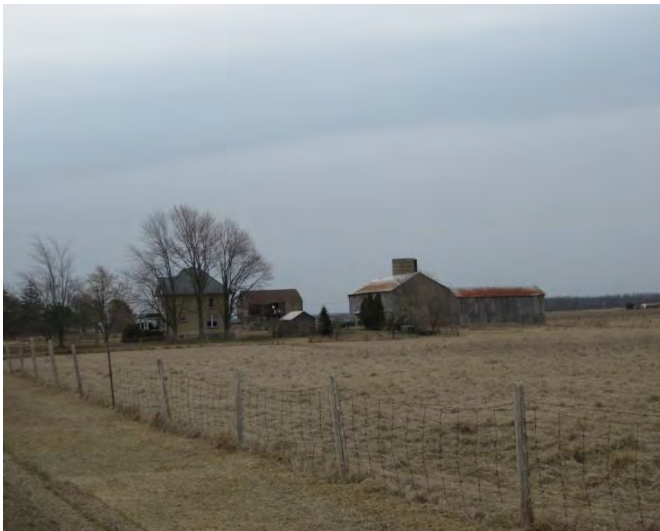
BARN

Date: c. 1890-1910

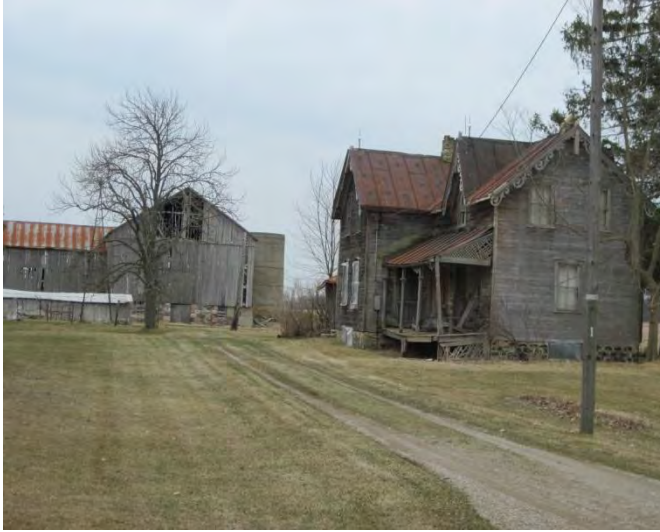
Site #7

HOUSE

Date: Late 19th century

1. Design/Physical Value: Exterior appears to be largely unaltered. House is abandoned and in poor condition.
2. Historical Value: None identified
3. Contextual Value: Contributes to early 19th century agricultural activity of study area.

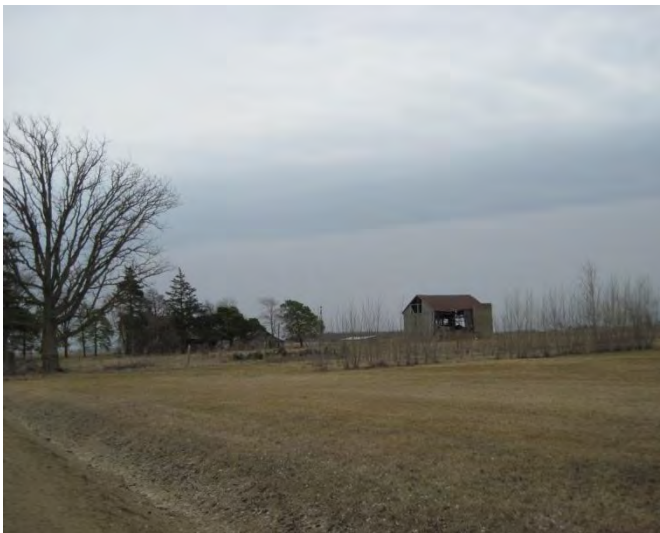
BARN

Date: Late 19th century

Description: medium pitch roof, timber frame, concrete silo; in poor condition

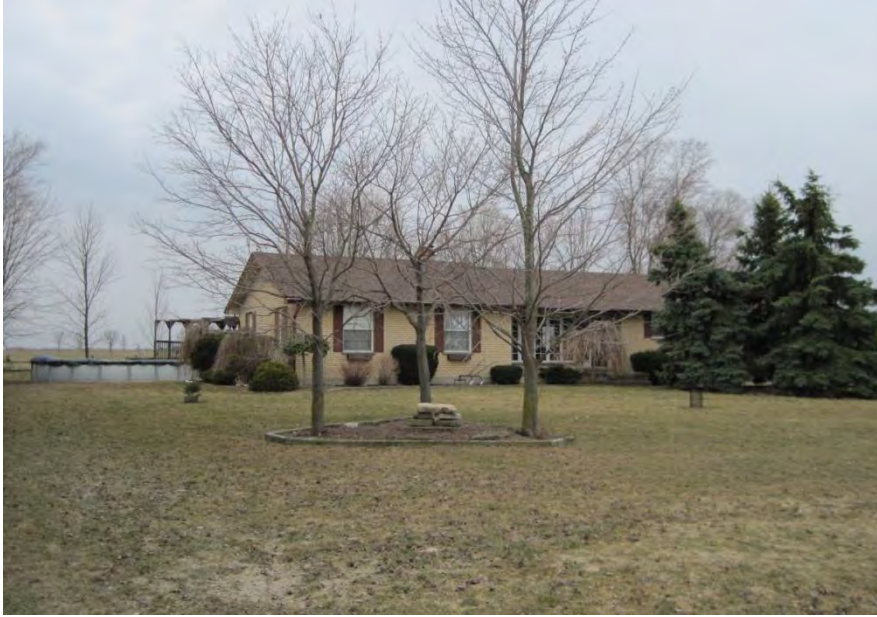
Site #8

Date: 1960s

Description: one storey Ranch style, gable-roof, brick-siding

- 1. Design/Physical Value: Typical design of 1960s**
- 2. Historical Value: None noted**
- 3. Contextual Value: None noted**

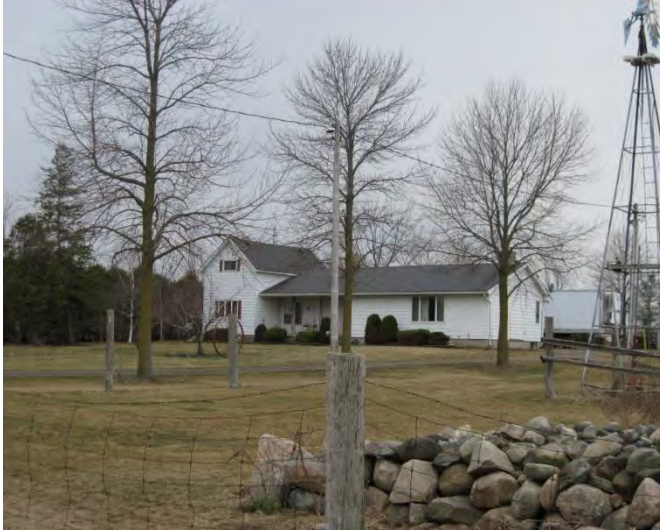
Location: 29391 Seed Road

HOUSE

Date: c. 1900 ?

1. Design/Physical Value: Heavily modified
2. Historical Value: None identified
3. Contextual Value: Contributes to early 20th century agricultural activity of study area

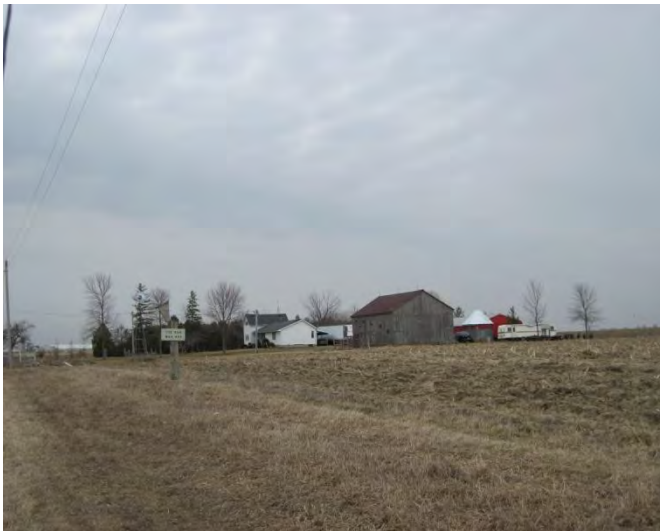
BARN

Date: late 19th century/ early 20th century

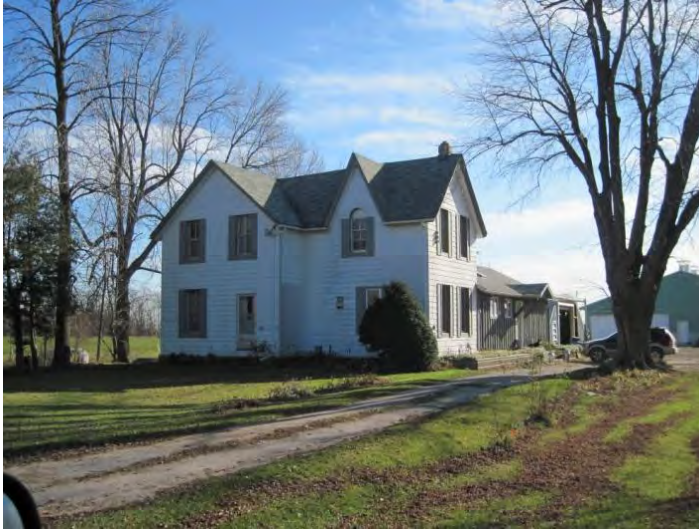
Site #10

Date: c. 1890-1900?

Description: One and a half storey, "L" plan frame; medium pitch roof; steep pitch dormer possibly modern

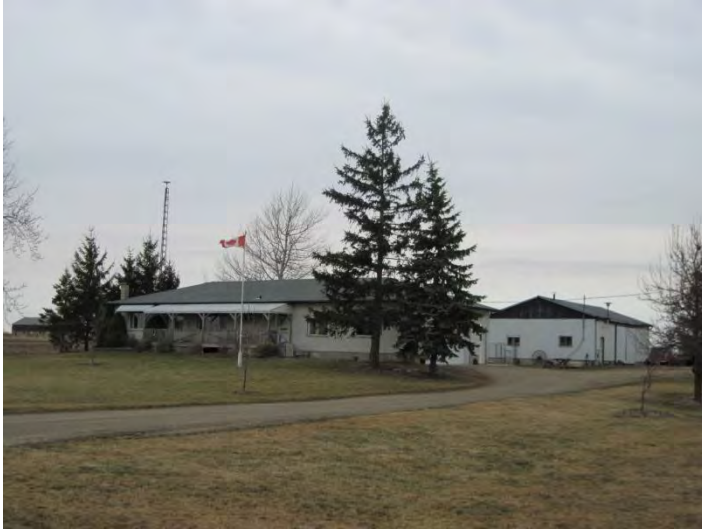
Location: 2988 Mullifarry Drive

Date: c. 1960s

Description: One and storey Ranch style, hip-roof, brick-siding

1. Design/Physical Value: Typical design of 1960s
2. Historical Value: None noted
3. Contextual Value: None noted

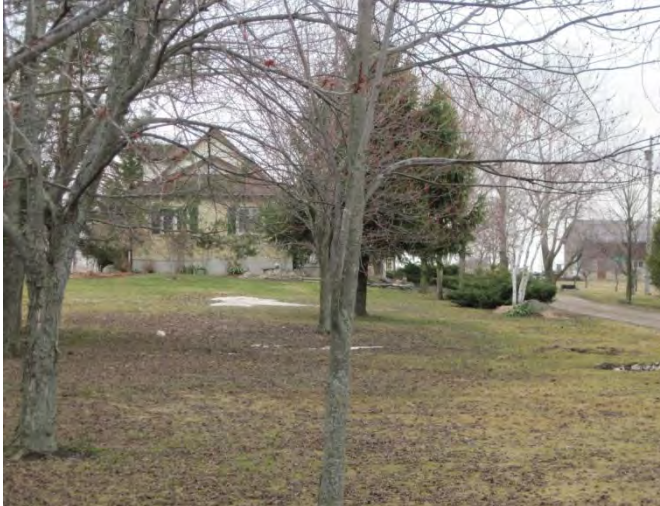
Site #12

HOUSE

Date: Mid 20th century

1. Design/Physical Value: Not visible
2. Historical Value: None identified
3. Contextual Value: Contributes to early 20th century agricultural activity of study area.

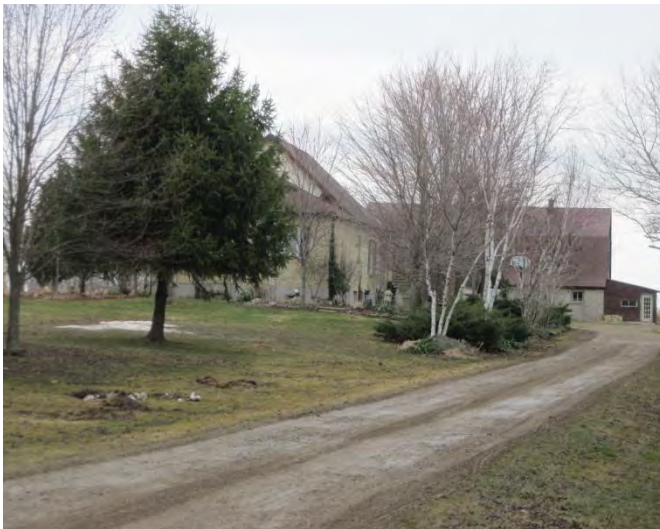
BARN

Date: Mid 20th century

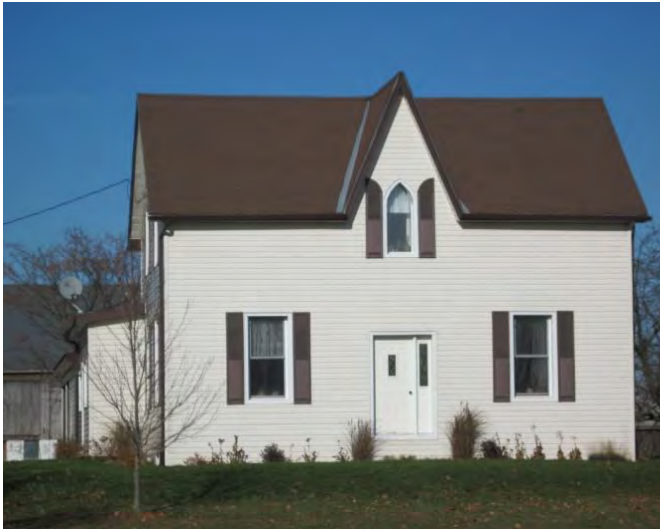
Site #13

HOUSE

Date: Late 19th century

1. Design/Physical Value: Well maintained house despite modifications.
2. Historical Value: None identified
3. Contextual Value: Contributes to early 20th century agricultural activity of study area.

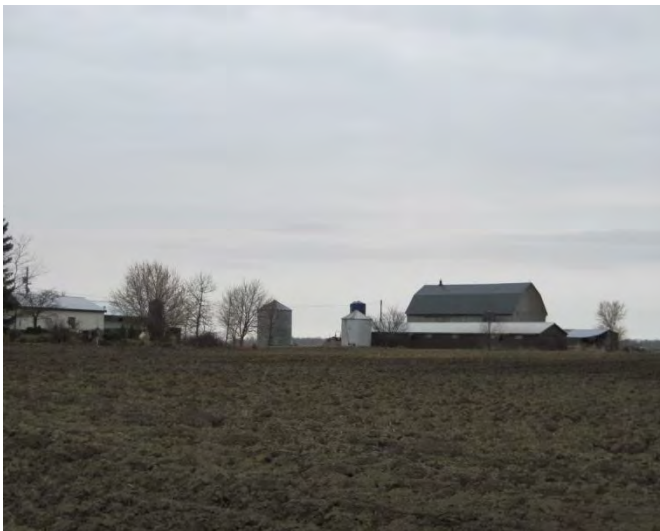
BARN

Date: Late 19th century early 20th century
Description: Gambrel roof
