4.0 Amendments to the Records Review

Table 1. Updated Distances between Project Components and Significant Natural Features in the Parkhill Interconnect

Parkhill Interconnect

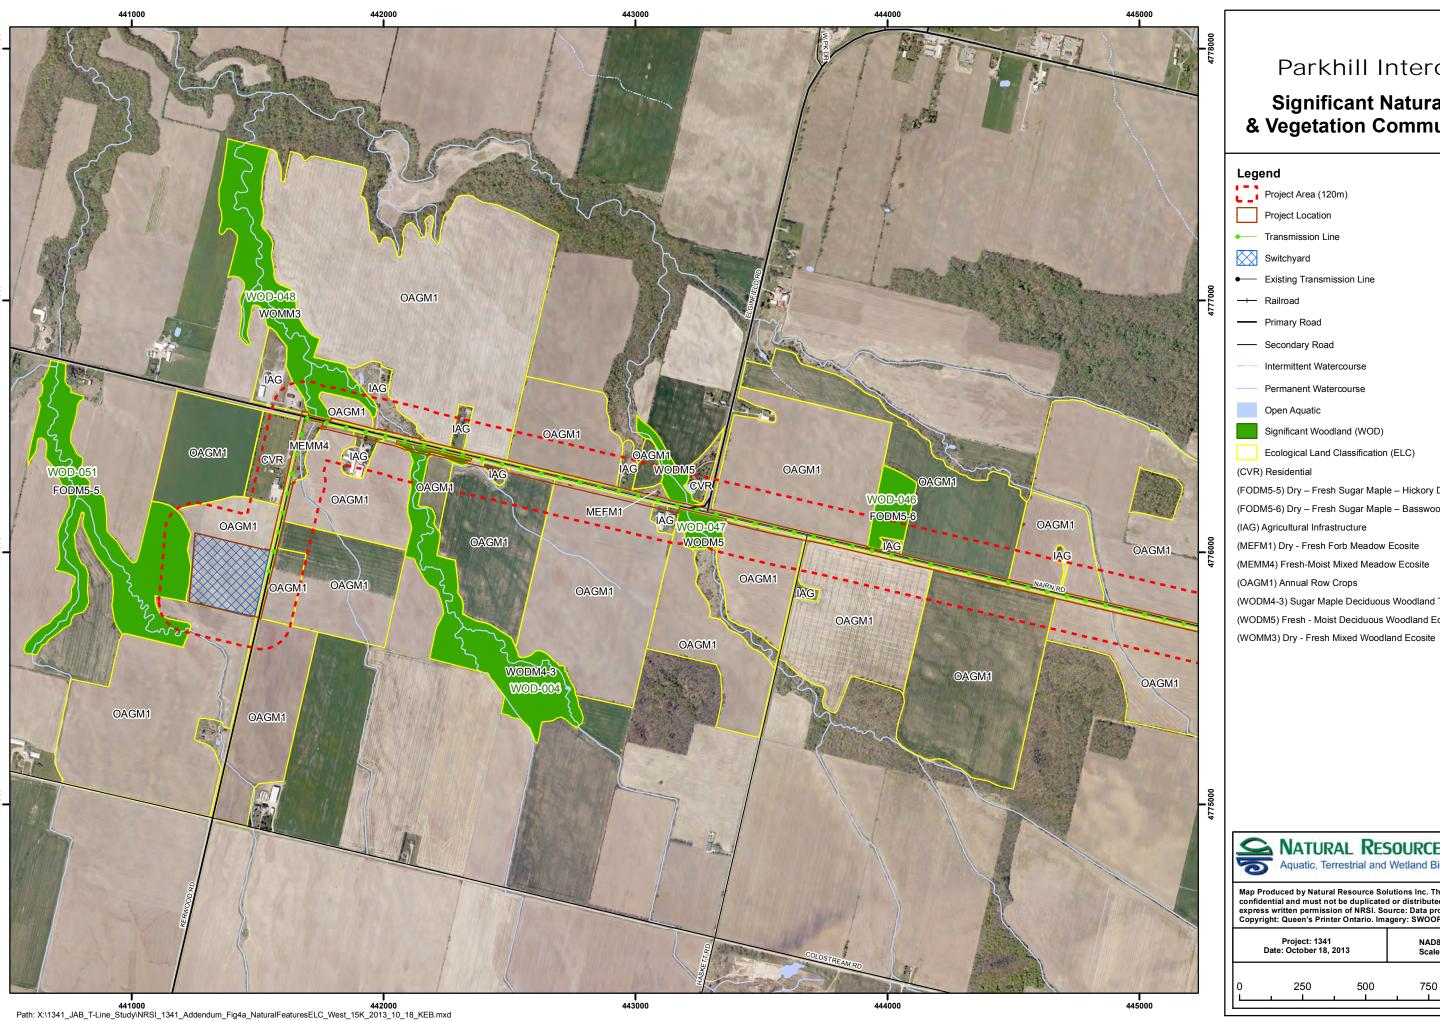
Figure 4a

Significant Natural Features & Vegetation Communities - West

Survey methodology and significant natural feature delineations for woodlands followed the same methods as outlined in the *Parkhill Interconnect Natural Heritage Assessment Report* (NRSI 2013). The woodland boundaries of WOD-048 have been amended based on additional areas examined for this Addendum Report, which previously had restricted site access. The area south of Elginfield Road was previously delineated as part of the woodland and has been removed from the WOD-048 boundaries. This area has been delineated as meadow habitat, MEMM4. See Figures 4a-4c for updated vegetation community mapping and Appendix I for photos of the meadow habitat.
