Ministry of Tourism Culture and Sport  
Comments and Recommendations  
October 5, 2012

**RE: Suncor Energy Cedar Point Wind Energy Facility**  
**Location: Multiple lots, Municipality of Lambton Shores, Township of Warwick, and Town of Plympton-Wyoming, Lambton County**  
**OPA Reference Number: FIT-F80K1QB**  
**MTC DPR File No.: PLAN-38EA051**

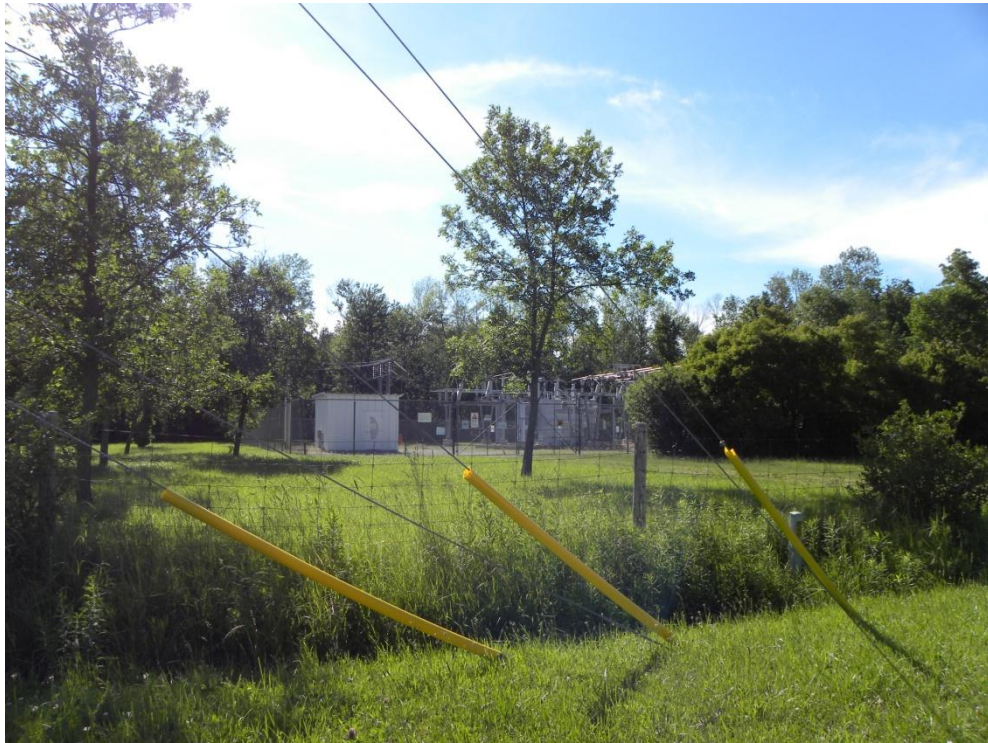
Today, transmission lines traverse the Study Area at various locations. A transformer station is located on Elarton Road between Townsend Line and Hickory Creek Line (Plate 4).

*Plate 4: Transformer Station, south of Townsend Line on Elarton Road, looking west.*

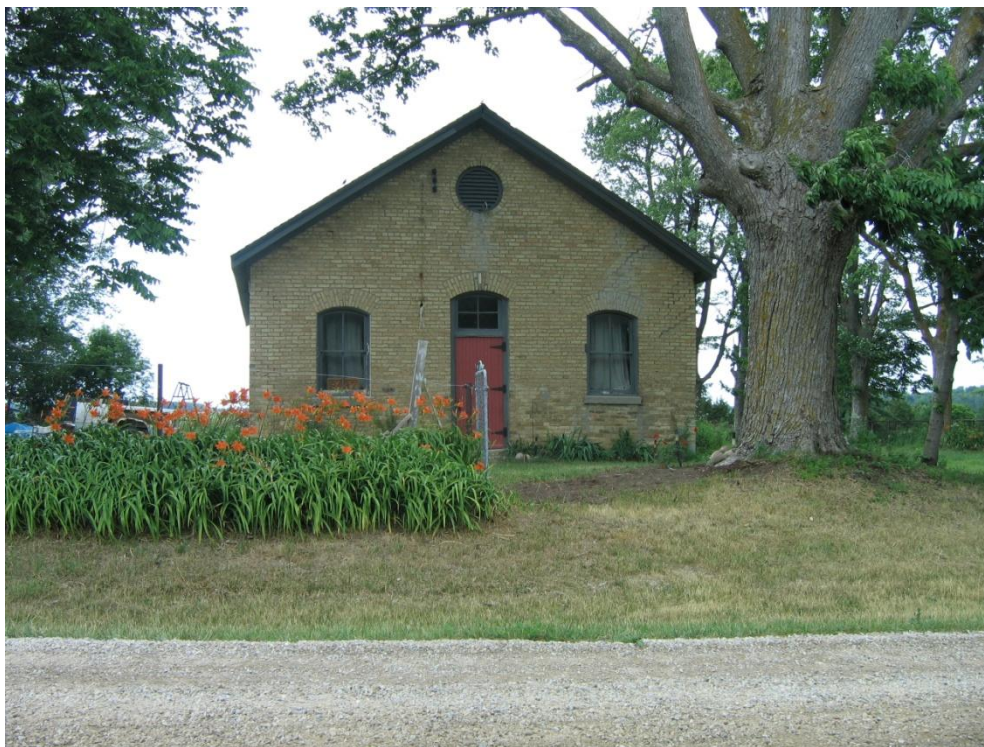
*Plate 7: Former S.S. No. 9 Bosanquet (Kinnaird), located on the corner of Proof Line and Kinnaird Road, today a private residence.*

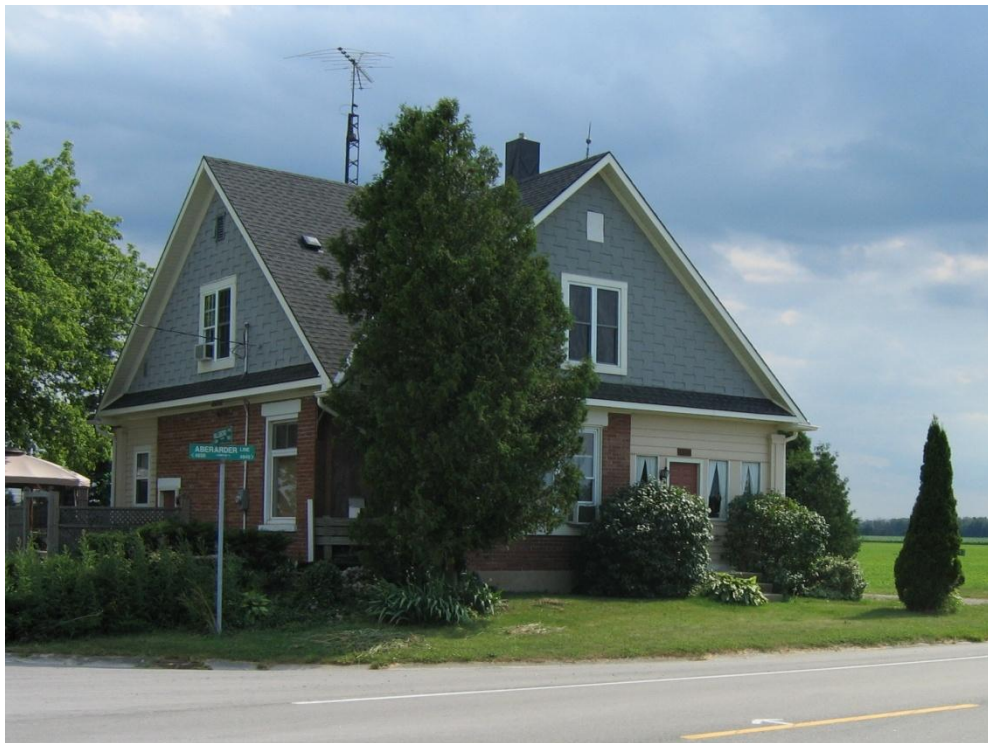
*Plate 11: Private residence located on the southwest corner of Hillsboro Road and Aberarder Line.*

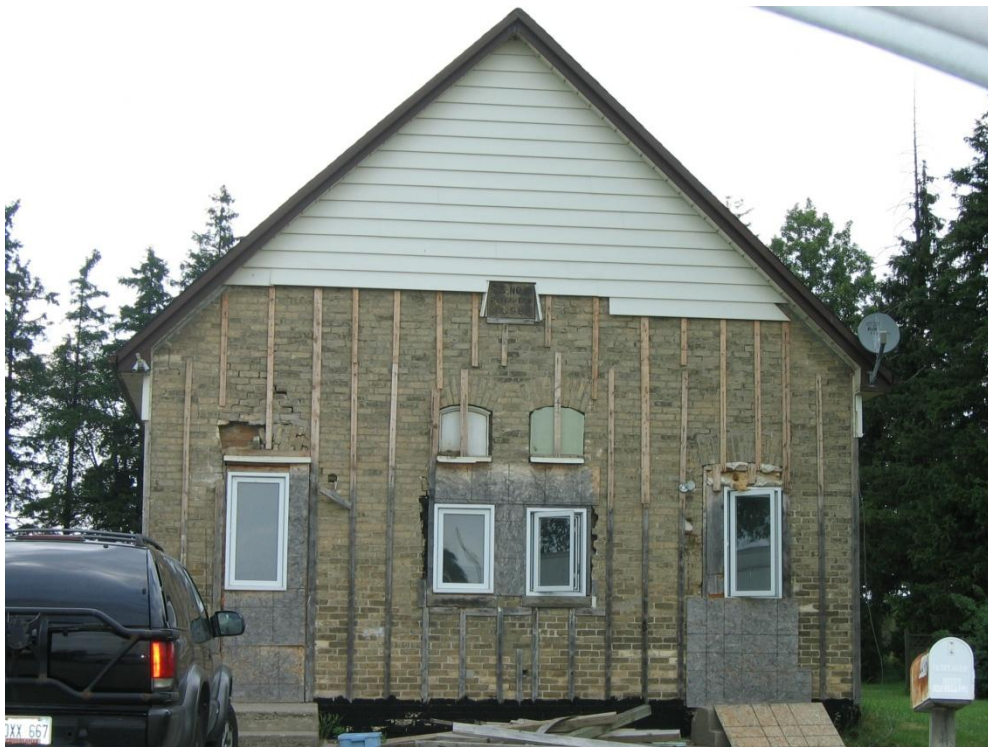
Today, the school house remains, although it is extensively modified and used as a private residence (Plate 15). No evidence of the church is visible from the road.

*Plate 14: S. S. No. 10 Plympton, located at northwest corner of the intersection of Michigan Line and Oil Heritage Road. Currently in use as a residence.*

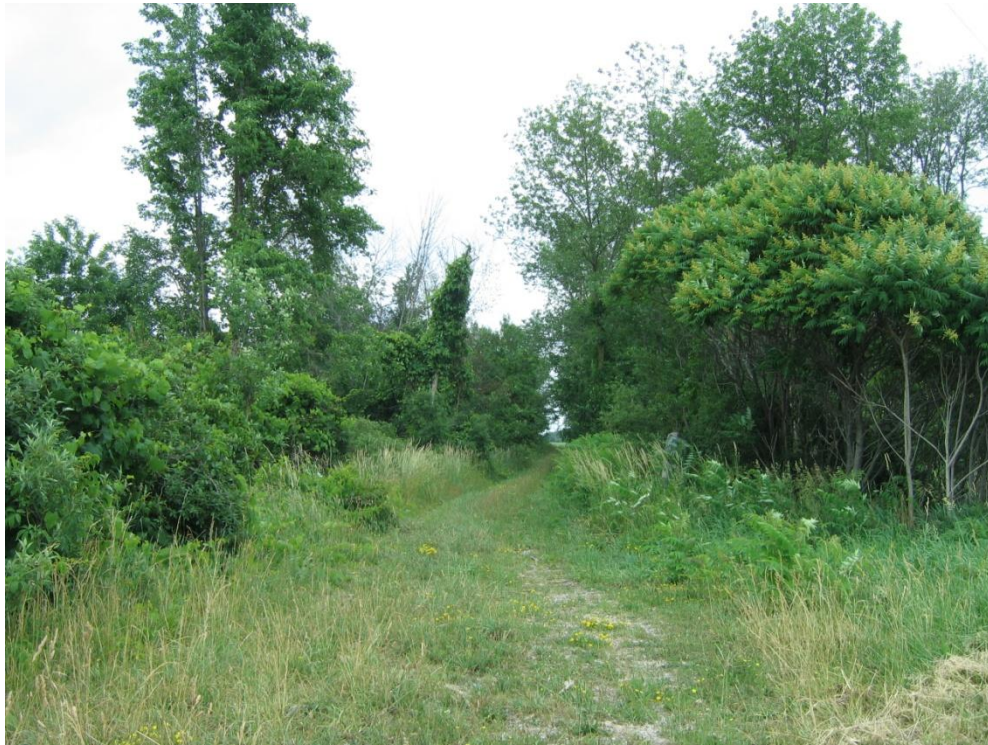
Today, the abandoned railway is partially visible in the landscape, largely through the division of woodlots. Portions of the former railway are currently used as unsanctioned trails (Plate 20). Although the majority of the line is overgrown, in some cases, it acts as a property line.

*Plate 19: Abandoned railway line, looking northeast from Cedar Point Line, between Army Camp and Kinnaird Roads.*

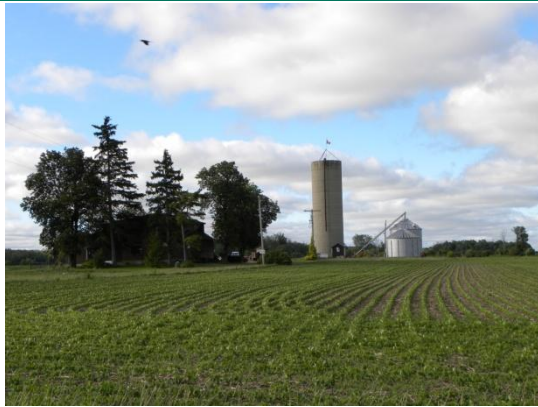
**Site #1 – 3525 Michigan Line (Town of Plympton-Wyoming)**

**Date:** 20<sup>th</sup> century

**Description:** Concrete silo with two modern metal bins.

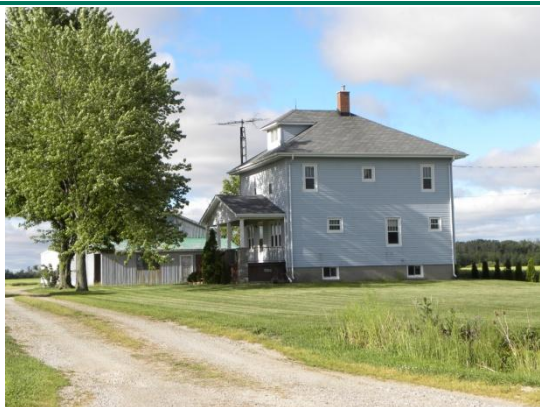
**Site #2 – 3729 Michigan Line (Town of Plympton-Wyoming)**

**Date:** 1890 – 1910s

**Description:** Two storey house clad in modern siding, with pyramidal hipped roof, central hipped dormer and covered concrete foundation. Appears symmetrical in design with full central front porch.

**Mitigation of Negative Impacts:** No negative impacts identified, therefore no further mitigation recommended.

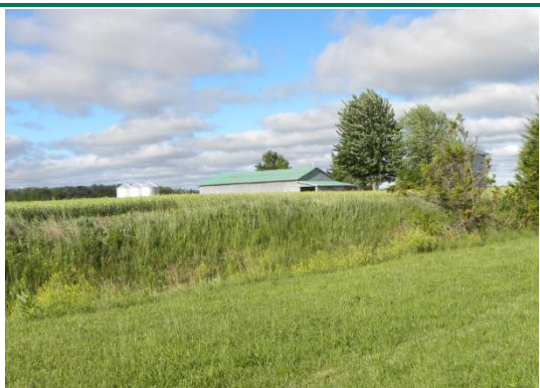
**Date:** 20<sup>th</sup> century

**Description:** Single storey metal clad shed. Three metal bins.

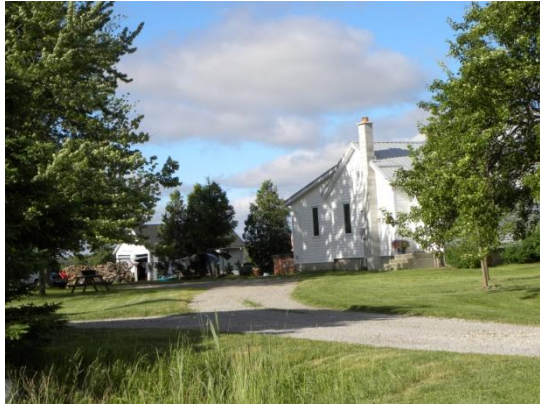
**Site #3 – 3769 Michigan Line (Town of Plympton-Wyoming)**

**Date:** Late 19<sup>th</sup> – early 20<sup>th</sup> century

**Description:** One and one half storey L-shaped house with shed addition; medium pitched cross-gabled roof; clad in modern siding; and concrete foundation.

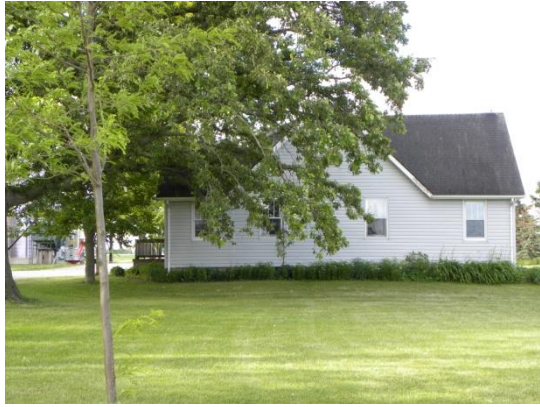
**Site #4- 3827 Michigan Line (Town of Plympton-Wyoming)**

**Date:** Undetermined

**Description:** One and one half storey house; side gabled roof and prominent cross gable dormer; clad in modern siding; and undetermined foundation.

**Mitigation of Negative Impacts:** Impacts were not identified, therefore mitigation is not recommended or necessary.

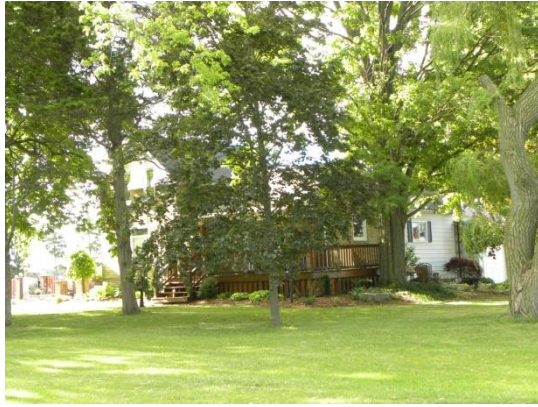
**Site #5 – 3829 Michigan Line (Town of Plympton-Wyoming)**

**Date:** Late 19<sup>th</sup> century

**Description:** One and one half storey L-shaped house with rear addition, medium pitched cross-gabled roof; brick exterior and modern siding on addition; concrete foundation. Design details include rounded brick lintels.

**Potential Direct and Indirect Impacts to the Identified Heritage Attributes:** None anticipated.

**Mitigation of Negative Impacts:** No negative impacts identified, therefore no further mitigation recommended.

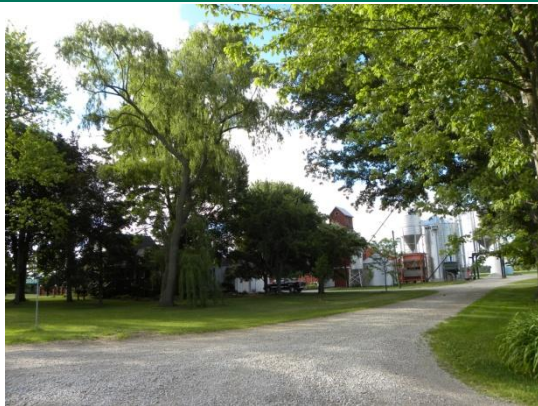
**Date:** Various (19<sup>th</sup> and 20<sup>th</sup> century)

**Description:** Two frame barns with metal roofs and undetermined foundation. Timber silo has metal roof and undetermined foundation. Numerous metal silos and modern grain feed equipment onsite.

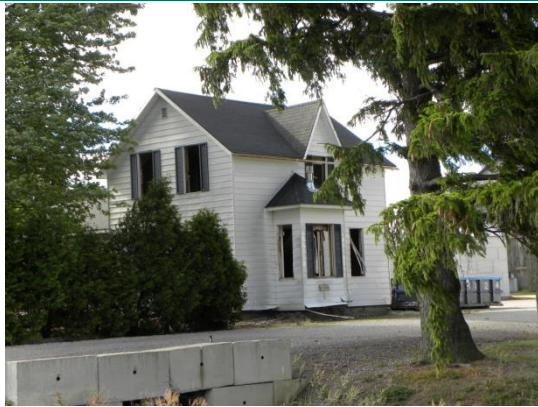
**Site #6 – 3979 Michigan Line (Town of Plympton-Wyoming)**

**Date:** Late 19<sup>th</sup> – early 20<sup>th</sup> century

**Description:** One and one half storey L-shaped house; cross gabled roof with medium pitch, small cross gable dormer at side and bay window projection; clad in modern siding; concrete foundation.

**Potential Direct and Indirect Impacts to the Identified Heritage Attributes:** None anticipated.

**Mitigation of Negative Impacts:** No negative impacts identified, therefore no further mitigation recommended.

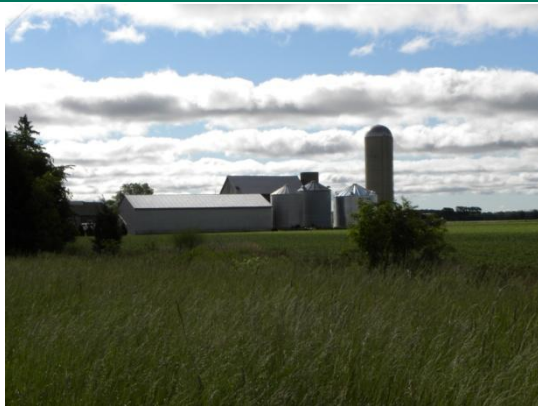
**Date:** Various (19<sup>th</sup> and 20<sup>th</sup> century)

**Description:** One frame barn with attached side gabled timber shed; metal roof and concrete block foundation. Two concrete silos. Three metal bins.

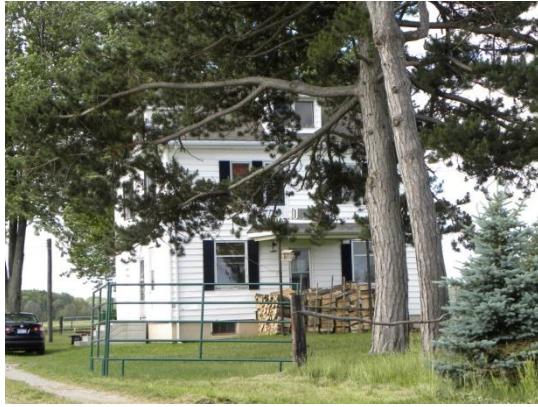
**Site #7 – 4041 Michigan Line (Town of Plympton-Wyoming)**

**Date:** 1890s – 1920s

**Description:** Two storey vernacular foursquare house with central covered entry porch; pyramidal hipped roof with medium pitch and two hipped dormers; modern siding; concrete covered foundation.

**Potential Direct and Indirect Impacts to the Identified Heritage Attributes:** None anticipated.

**Mitigation of Negative Impacts:** No negative impacts identified, therefore no further mitigation recommended.

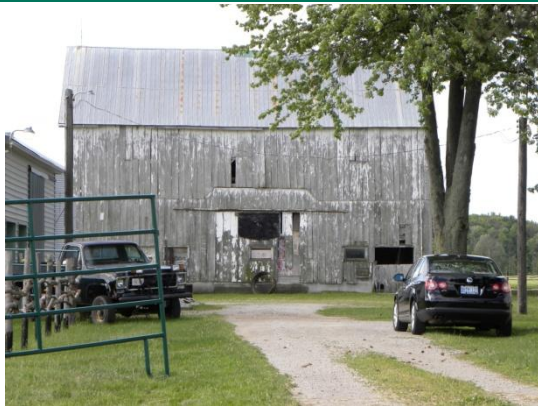
**Date:** 19<sup>th</sup> – early 20<sup>th</sup> century

**Description:** Raised, side gabled, frame barn with rear shed addition; metal roof; undetermined foundation.

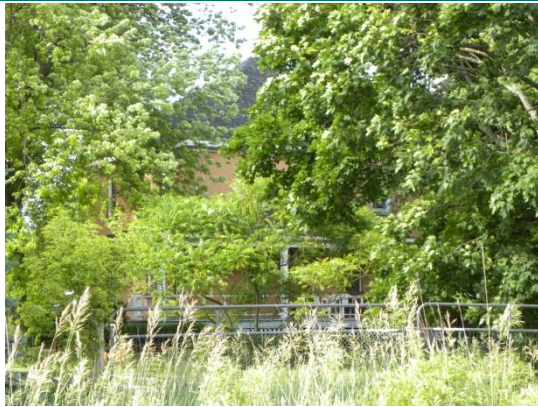
**Site #8 – 4133 Michigan Line (Town of Plympton-Wyoming)**

**Date:** 1880s – 1900s

**Description:** Two storey vernacular foursquare with house; pyramidal hipped roof with medium pitch and cross dormers; brick exterior; and undetermined foundation.

**Mitigation of Negative Impacts:** No negative impacts identified, therefore no further mitigation recommended.

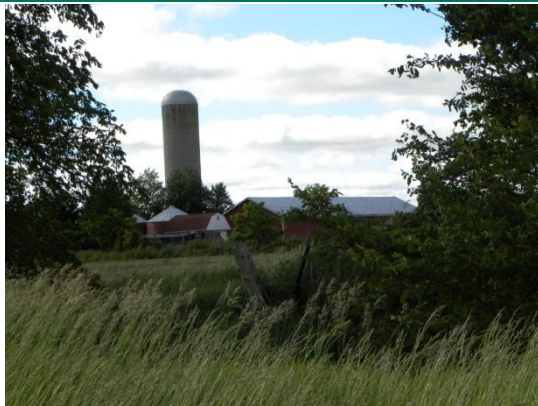
**Date:** 20<sup>th</sup> century

**Description:** Single storey metal clad shed. Two metal bins. One concrete silo.

**Mitigation of Negative Impacts:** Impacts were not identified, therefore mitigation is not recommended or necessary.

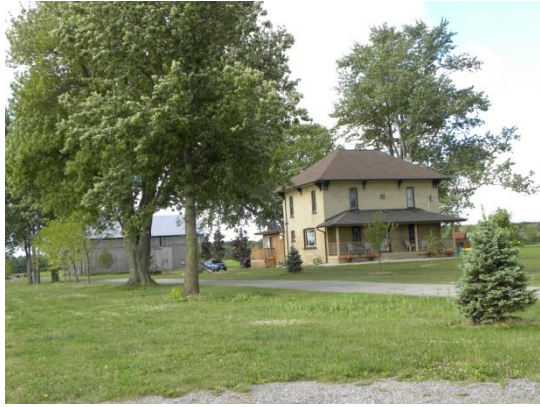
**Site #9 – 4429 Michigan Line (Town of Plympton-Wyoming)**

**Date:** c.1900

**Description:** Two storey brick house with rear addition; hipped roof with medium pitch and eave brackets; yellow brick; undetermined foundation. Centre of front facade contains date stone of 1900.

**Mitigation of Negative Impacts:** No negative impacts identified, therefore no further mitigation recommended.

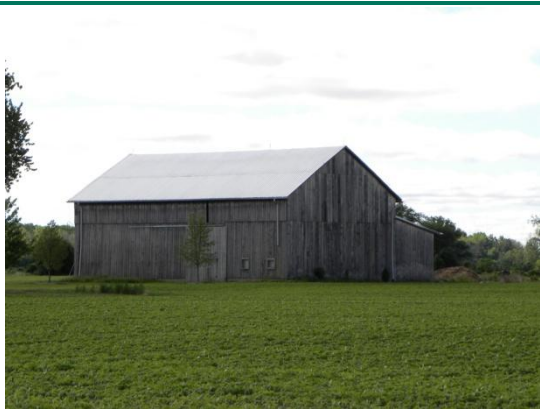
**Date:** 19<sup>th</sup> – early 20<sup>th</sup> century

**Description:** Side gabled, frame barn with rear shed addition; metal roof; undetermined foundation.

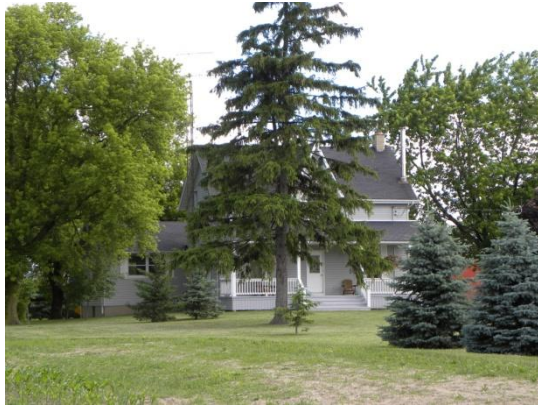
**Site #10 – 4136 Michigan Line (Town of Plympton-Wyoming)**

**Date:** 1860s – 1900

**Description:** One and one half storey house with full front porch and rear addition; side gabled roof with steep pitch and central dormer with steep pitch; modern siding, and undetermined foundation. Vernacular Gothic Revival design details include symmetrical design with full front porch, steep pitched roof with central gable containing window extending into gable.

**Mitigation of Negative Impacts:** No negative impacts identified, therefore no further mitigation recommended.

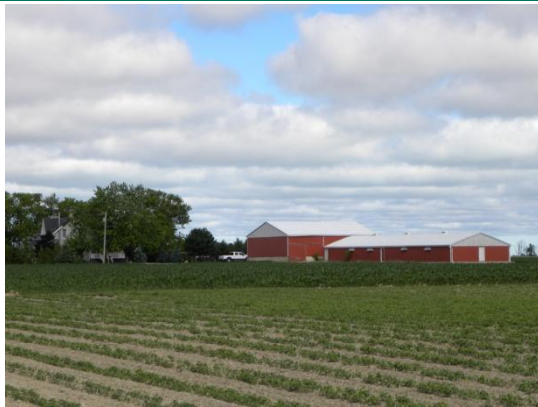
**Date:** Post 1950

**Description:** Two barns with metal roofs; metal siding; concrete foundations. Two metal bins.

**Mitigation of Negative Impacts:** Impacts were not identified, therefore mitigation is not recommended or necessary.

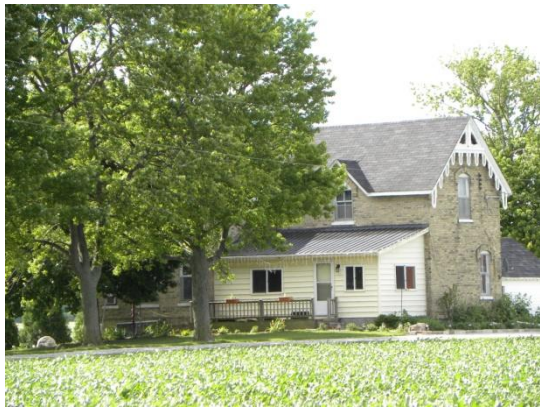
**Site #11 – 4077 Hyslop Line (Town of Plympton-Wyoming)**

**Date:** 1850s – 1890s

**Description:** One and one half storey T-shaped house with covered inset front porch; cross gabled roof with moderate pitch and small cross gable on front facade; yellow brick exterior with front porch clad in modern siding; undetermined foundation. Decorative vergeboard with crossbracing, brick drip moulds above windows. Modern shed on same lot adjacent.

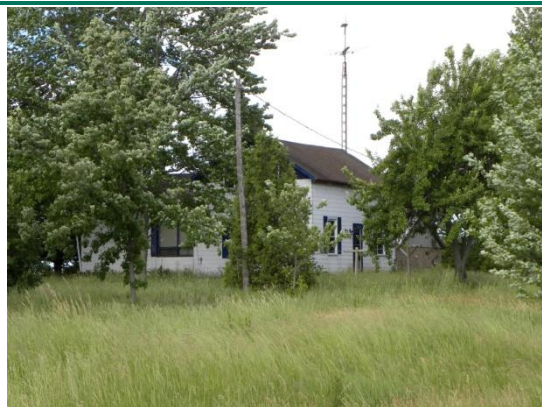
**Site #12 – 6559 MacFarlene Road (Town of Plympton-Wyoming)**

**Date:** 1880s – 1900s

**Description:** One and one half storey T-shaped house with covered front porch; cross gabled roof with medium pitch; clad in modern siding; undetermined foundation. Decorative vargeboard and remnants of roof brackets.

**Mitigation of Negative Impacts:** Impacts were not identified, therefore mitigation is not recommended or necessary.

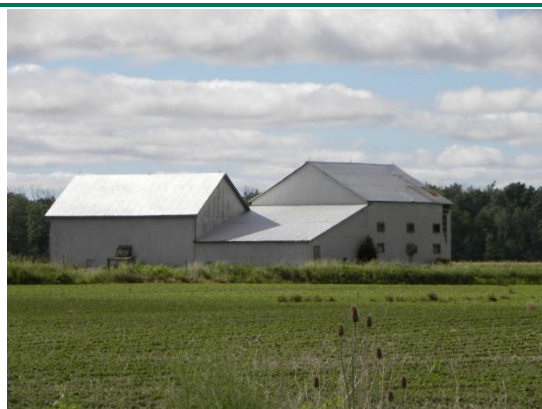
**Date:** Late 19<sup>th</sup> – 20<sup>th</sup> century

**Description:** Three interconnected barns; two side-gabled and one shed connection. All have metal roofs, timber clad in metal siding, and undetermined foundation. Modern metal drive shed on property.

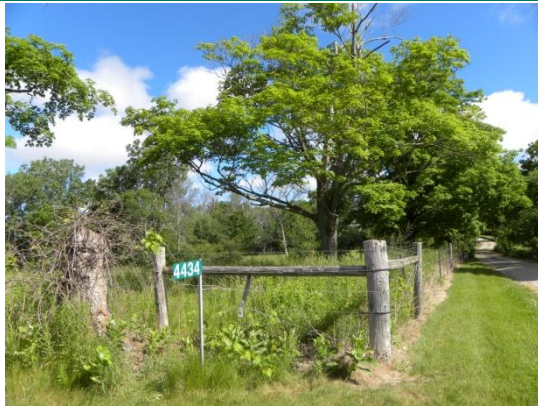
**Site #13 – 4433 Fisher Line (Town of Plympton-Wyoming)**

**Date:** Undetermined

**Description:** House entirely obstructed by foliage.

**Mitigation of Negative Impacts:** No negative impacts identified, therefore no further mitigation recommended.

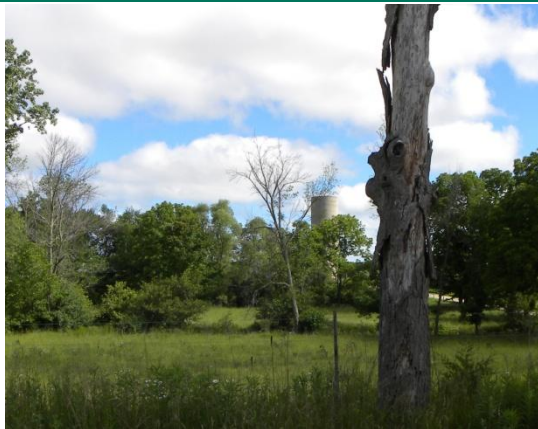
**Date:** Undetermined

**Description:** Barn entirely obstructed by foliage. Two concrete silos visible.

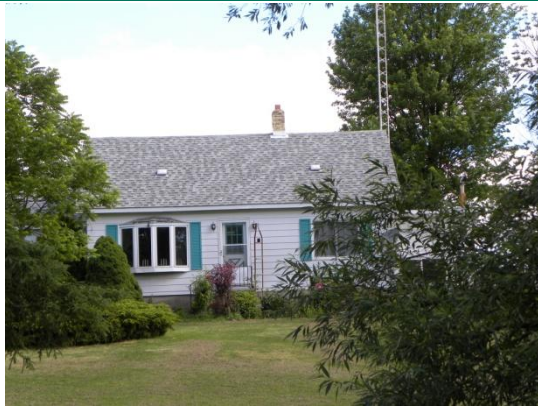
**Site #14 – 4358 Fisher Line (Town of Plympton-Wyoming)**

**Date:** Early 20<sup>th</sup> century

**Description:** One and one half storey house; side gabled roof with medium pitch; clad in modern siding; concrete covered foundation.

**Mitigation of Negative Impacts:** Impacts were not identified, therefore mitigation is not recommended or necessary.

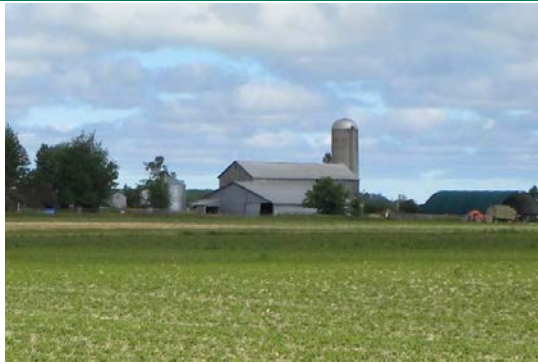
**Site #15 –4282 Fisher Line (Town of Plympton-Wyoming)**

**Date:** Various (19<sup>th</sup> and 20<sup>th</sup> century)

**Description:** Barn, concrete silo, metal drive shed and multiple metal bins. Front gabled, raised frame barn with front single storey barn addition; metal roof; undetermined foundation. Modern house onsite.

**Mitigation of Negative Impacts:** No negative impacts identified, therefore no further mitigation recommended.

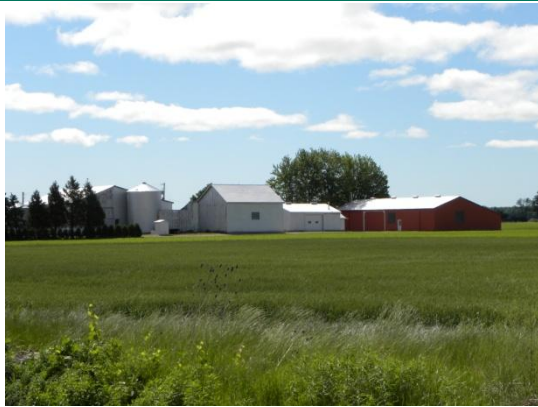
**Site #16 – 4589 Aberader Line (Town of Plympton-Wyoming)**

**Date:** Various (19<sup>th</sup> and 20<sup>th</sup> century)

**Description:** Two timber frame single storey barns with metal roofs clad in metal siding and with concrete block foundation. Two metal sheds. Three modern metal grain bins.

**Mitigation of Negative Impacts:** No negative impacts identified, therefore no further mitigation recommended.

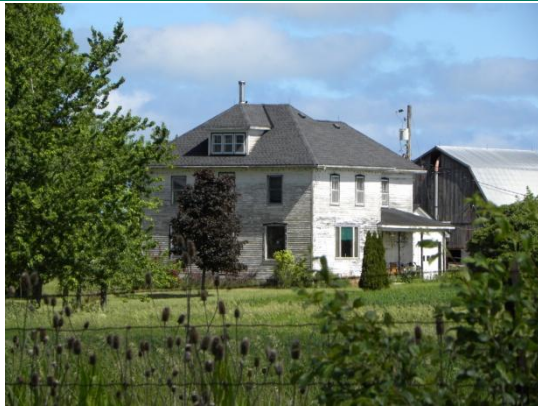
**Site #17 – 4808 Egermont Road (Town of Plympton-Wyoming)**

**Date:** 1870s – 1910s

**Description:** Two storey house T-shaped house with inset side porch; hipped roof with hipped gable containing three, six-over-one windows; clapboard siding; undetermined foundation. Window casings appear original.

**Mitigation of Negative Impacts:** No negative impacts identified, therefore no further mitigation recommended.

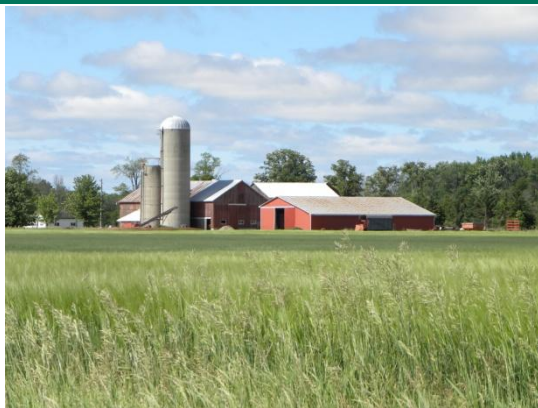
**Date:** Various (19<sup>th</sup> and 20<sup>th</sup> century)

**Description:** Two raised, side gable barns with metal roofs, metal clad exteriors, and undetermined foundations. One barn has gambrel roof, metal clad exterior, and undetermined foundation. Two concrete silos. One metal shed.

**Mitigation of Negative Impacts:** No negative impacts identified, therefore no further mitigation recommended.

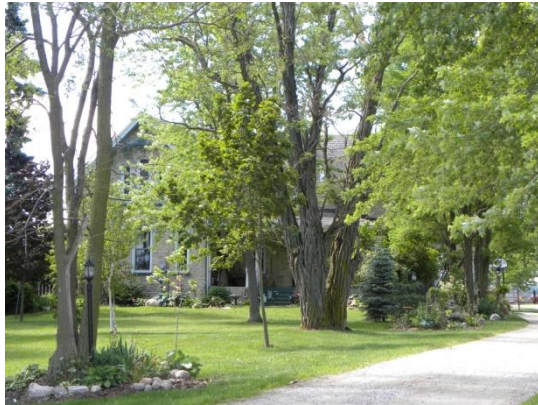
**Site #18 – 4837 Egermont Road (Town of Plympton-Wyoming)**

**Date:** 1870s – 1910s

**Description:** One and one half storey L-shaped house with front inset porch and rear addition; cross gabled roof with medium pitch, central gable and side dormer; yellow brick exterior; rusticated concrete block foundation. Decorative details include: vergeboard with crossbracing; brick drip moulds with keystone above windows; side bay window with brick detailing. Rear addition used for dog kennel.

**Mitigation of Negative Impacts:** No negative impacts identified, therefore no further mitigation recommended.

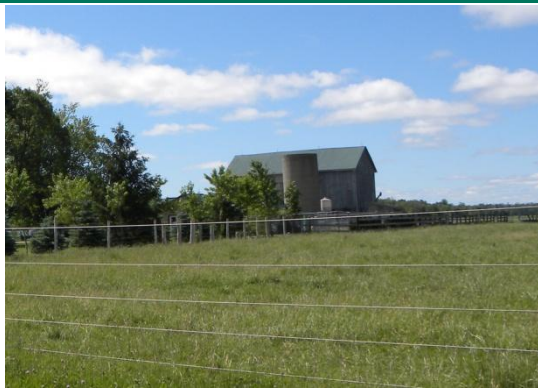
**Date:** Various (19<sup>th</sup> and 20<sup>th</sup> century)

**Description:** Side gabled, raised frame barn; metal roof; rusticated concrete block foundation. Concrete silo.

**Mitigation of Negative Impacts:** No negative impacts identified, therefore no further mitigation recommended.

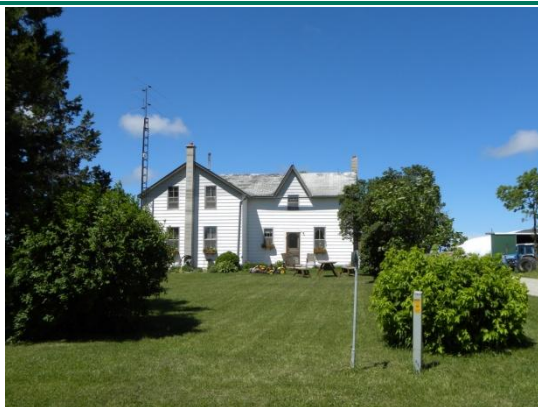
**Site #19 –7849 Uttoxeter Road (Town of Plympton-Wyoming)**

**Date:** 1880s – 1920s

**Description:** One and half storey L-shaped house; cross gabled roof with medium pitch and central gable with window and steep pitch; clad in modern siding; undetermined foundation.

**Mitigation of Negative Impacts:** No negative impacts identified, therefore no further mitigation recommended.

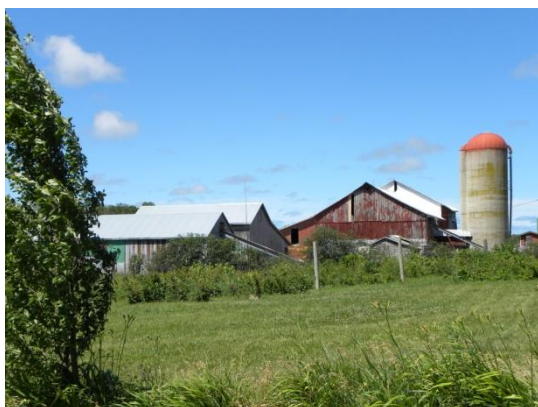
**Date:** Various (19<sup>th</sup> and 20<sup>th</sup> century)

**Description:** Two raised frame barns appear attached, with rear shed addition, and undetermined foundation. Two additional barns also with metal roofs, clad in metal siding with undetermined foundation. One metal drive shed. Two concrete silos. One metal bin.

**Mitigation of Negative Impacts:** No negative impacts identified, therefore no further mitigation recommended.

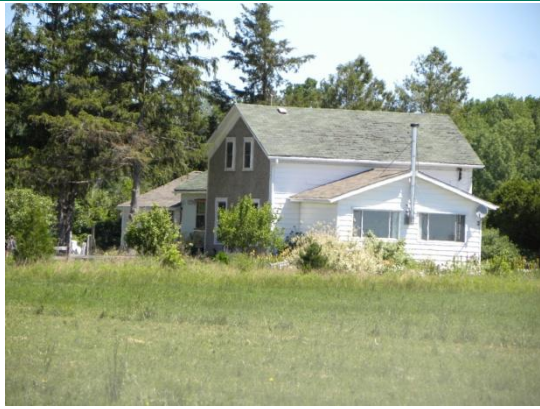
**Site #20 – 5222 Hubbard Line (Town of Plympton-Wyoming)**

**Date:** 1850s – 1890s

**Description:** One and one half storey house with rear and front addition; side gabled roof with front gabled along front facade; clad in modern siding; undetermined foundation.

**Mitigation of Negative Impacts:** Impacts were not identified, therefore mitigation is not recommended or necessary.

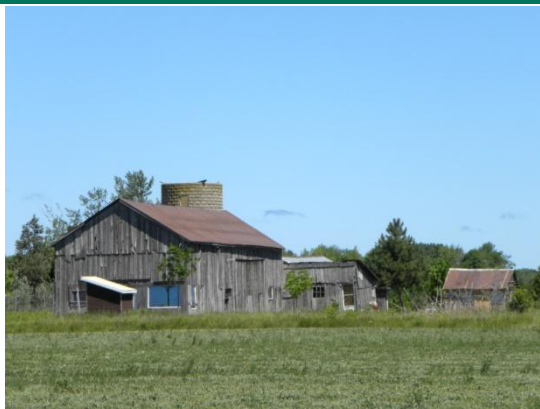
**Date:** Various (19<sup>th</sup> and 20<sup>th</sup> century)

**Description:** Front gabled frame barn with metal roof and rusticated concrete block foundation. Rusticated concrete block silo.

**Mitigation of Negative Impacts:** No negative impacts identified, therefore no further mitigation recommended.

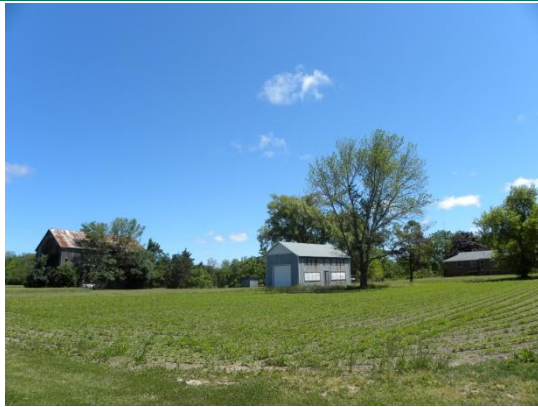
**Site #21 – 7870 Elmsley Road (Town of Plympton-Wyoming)**

**Date:** Various (19<sup>th</sup> and 20<sup>th</sup> century)

**Description:** Front gabled shed with metal roof, metal siding, and undetermined foundation. Front gabled frame barn with metal roof, partial metal siding, and rusticated concrete block foundation.

**Mitigation of Negative Impacts:** No negative impacts identified, therefore no further mitigation recommended.

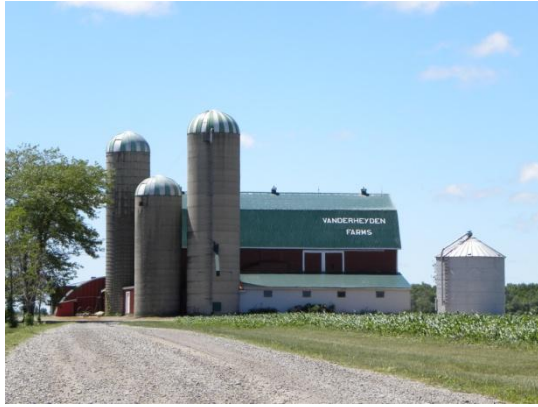
### Site #22 – 5121 Hubbard Line (Town of Plympton-Wyoming)

**Date:** Various (19<sup>th</sup> and 20<sup>th</sup> century)

**Description:** Frame barn with gambrel roof and undetermined siding and foundation. Three concrete silos. One modern metal bin. Two metal drive sheds.

**Mitigation of Negative Impacts:** No negative impacts identified, therefore no further mitigation recommended.

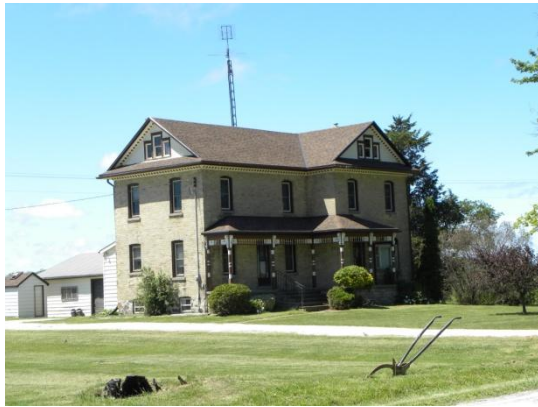
**Site #23– 5019 Hubbord Line (Town of Plympton-Wyoming)**

**Date:** 1880s – 1920s

**Description:** Two storey L-shaped house with rear addition and partial inset front porch; cross gabled roof with medium pitch; yellow brick exterior; stone foundation. Decorative details throughout include: gable end fishscale wood shingles, cornice detailing, porch spindles.

**Mitigation of Negative Impacts:** No negative impacts identified, therefore no further mitigation recommended.

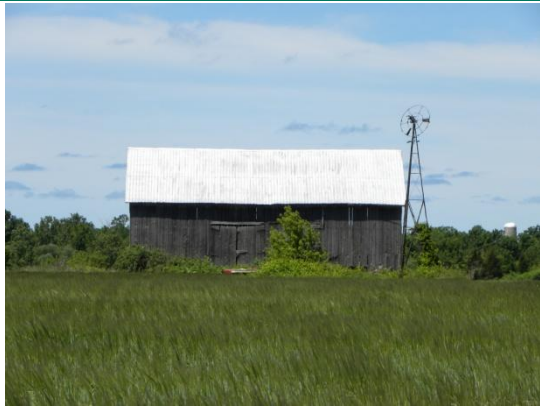
**Site #24 – Hillsboro Road (Town of Plympton-Wyoming)**

**Date:** 19<sup>th</sup> – early 20<sup>th</sup> century

**Description:** Front gabled frame barn; metal roof; undetermined foundation.

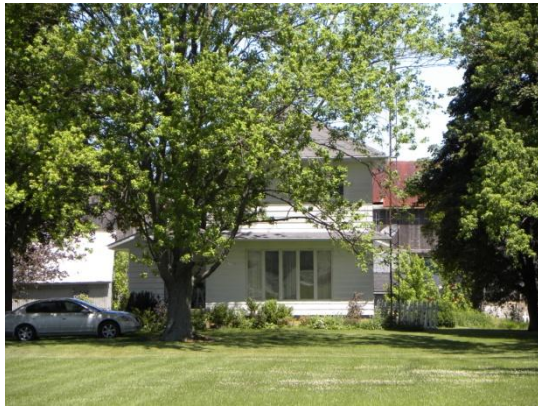
**Site #25 –4788 and 4790 Douglas Line (Town of Plympton-Wyoming)**

**Date:** 1870s – 1900s

**Description:** Two storey foursquare house; hipped roof with medium pitch; clad in modern siding; and undetermined foundation.

**Mitigation of Negative Impacts:** No negative impacts identified, therefore no further mitigation recommended.

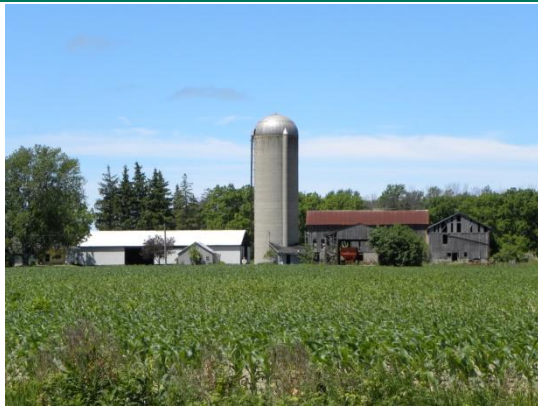
**Date:** Various (19<sup>th</sup> – 20<sup>th</sup> century)

**Description:** Two frame barns, both with metal roofs and concrete block foundations. One concrete silo. Single metal storage shed.

**Mitigation of Negative Impacts:** No negative impacts identified, therefore no further mitigation recommended.

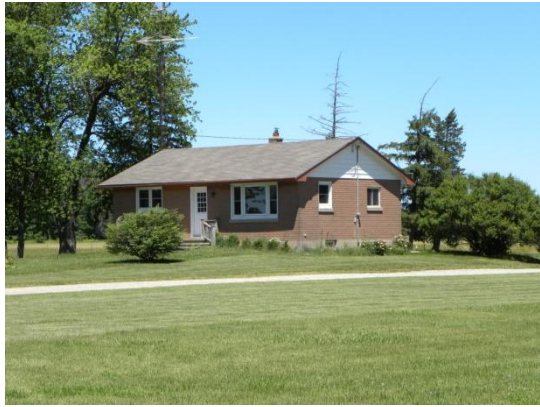
**Date:** Post 1950

**Description:** Single storey rectangular; side gabled roof with low pitch; brick exterior; concrete foundation.

**Mitigation of Negative Impacts:** Impacts were not identified, therefore mitigation is not recommended or necessary.

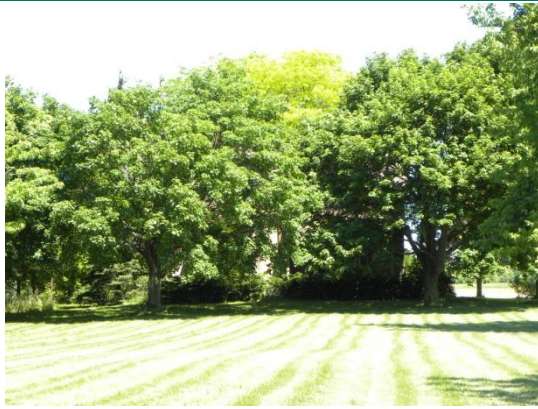
**Site #26 –4420 Douglas Line (Town of Plympton-Wyoming)**

**Date:** Undetermined

**Description:** Two storey T-shaped yellow brick house with rear addition; cross gabled roof with medium pitch; undetermined foundation. Foliage coverage restricted design and age identification.

**Mitigation of Negative Impacts:** No negative impacts identified, therefore no further mitigation recommended.

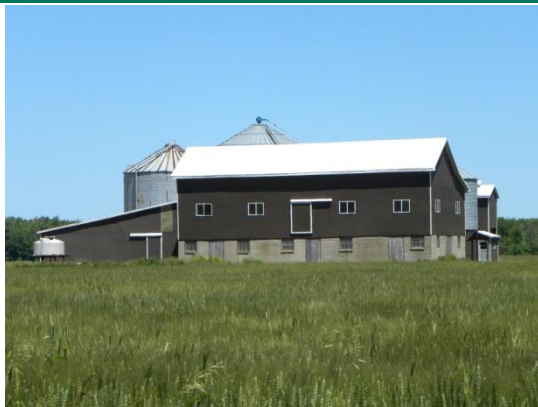
**Date:** Late 19<sup>th</sup> – 20<sup>th</sup> century

**Description:** Two raised barns with metal roofs, clad in modern siding, with concrete block foundations. Two metal bins.

**Mitigation of Negative Impacts:** No negative impacts identified, therefore no further mitigation recommended.

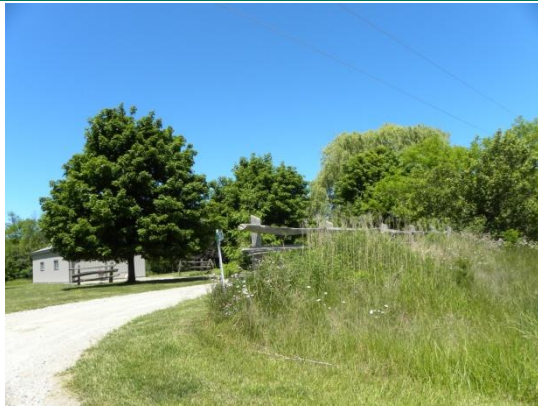
**Site #27 – 7363 Oil Heritage Road (Town of Plympton-Wyoming)**

**Date:** Undetermined

**Description:** Undetermined.

**Mitigation of Negative Impacts:** No negative impacts identified, therefore no further mitigation recommended.

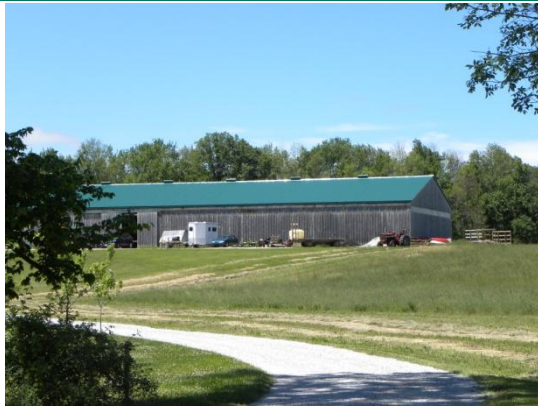
**Site #28 – 7363 Oil Heritage Road (Town of Plympton-Wyoming)**

**Date:** 20<sup>th</sup> century

**Description:** Long, side gabled frame barn; modern metal roof; undetermined foundation.

**Mitigation of Negative Impacts:** Impacts were not identified, therefore mitigation is not recommended or necessary.

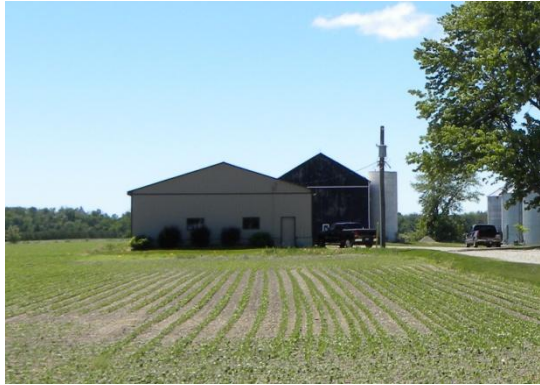
**Site #29 – Douglas Line (Town of Plympton-Wyoming)**

**Date:** 20<sup>th</sup> century

**Description:** Side gabled frame barn with metal roof, undetermined foundation. One metal shed. One concrete silo. Three metal bins.

**Mitigation of Negative Impacts:** Impacts were not identified, therefore mitigation is not recommended or necessary.

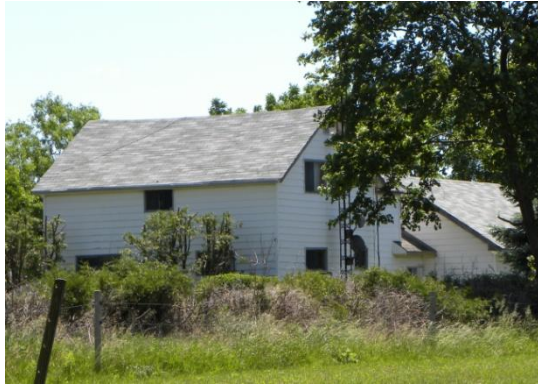
**Site #30 – 4695 Douglas Line (Town of Plympton-Wyoming)**

**Date:** 1850s – 1890s

**Description:** One and one half storey house with rear addition; side gabled roof with medium pitch; clad in modern siding; and undetermined foundation.

**Mitigation of Negative Impacts:** Impacts were not identified, therefore mitigation is not recommended or necessary.

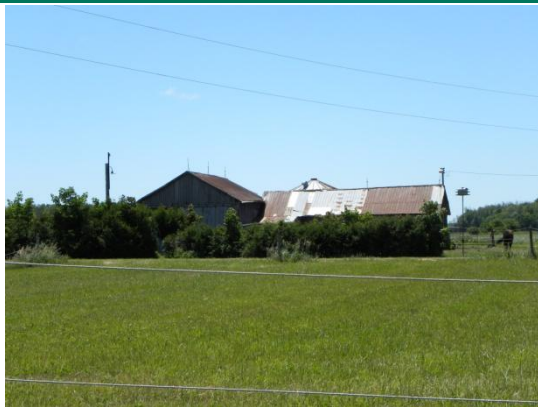
**Date:** Various (19<sup>th</sup> and 20<sup>th</sup> century)

**Description:** Two frame barns with metal roofs and undetermined foundations. One metal bin.

**Mitigation of Negative Impacts:** No negative impacts identified, therefore no further mitigation recommended.

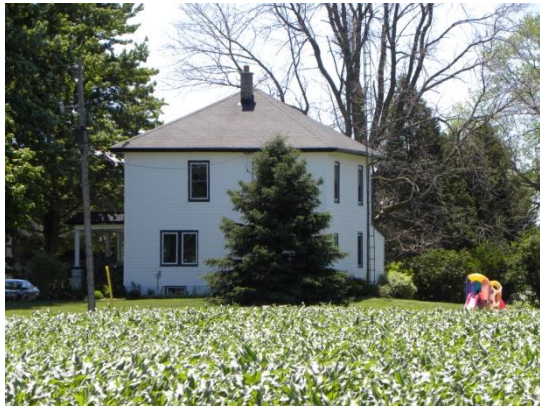
**Site #31 – 4823 Douglas Line (Town of Plympton-Wyoming)**

**Date:** 1870s – 1900s

**Description:** Two storey foursquare house with partial front porch and side addition; pyramidal roof with medium pitch; clad in modern siding; concrete covered stone foundation (stone partially visible).

**Mitigation of Negative Impacts:** No negative impacts identified, therefore no further mitigation recommended.

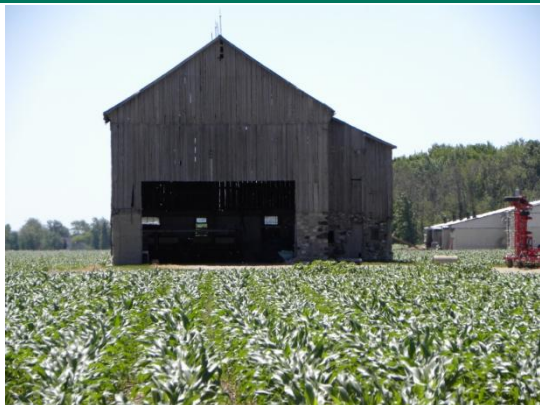
**Date:** Various (19<sup>th</sup> and 20<sup>th</sup> century)

**Description:** Front gabled frame barn, undetermined roof and stone foundation. Two modern metal bins.

**Identified Heritage Attributes:** Timber frame construction and stone foundation. Relationship of structure to residence and road.

**Mitigation of Negative Impacts:** No negative impacts identified, therefore no further mitigation recommended.

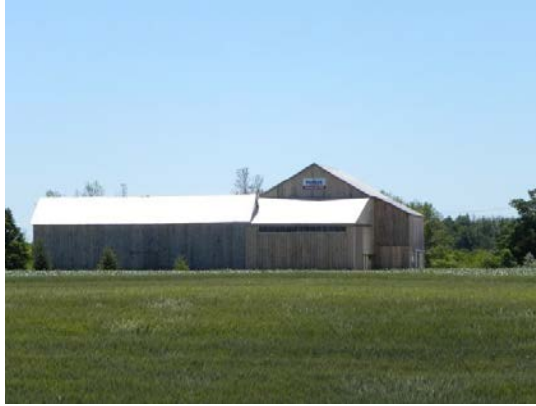
**Site #32 –5023 Douglas Line (Town of Plympton-Wyoming)**

**Date:** Various (19<sup>th</sup> – 20<sup>th</sup> century)

**Description:** Two frame barns and two metal barns. One frame barn is raised with a front gabled metal roof (possibly new timber used). Second frame barn is side gabled, also with metal roof. One metal barn has a gambrel metal roof and is clad in metal siding. Second metal barn has front gabled metal roof and also clad in metal. All foundations were undetermined.

**Mitigation of Negative Impacts:** No negative impacts identified, therefore no further mitigation recommended.

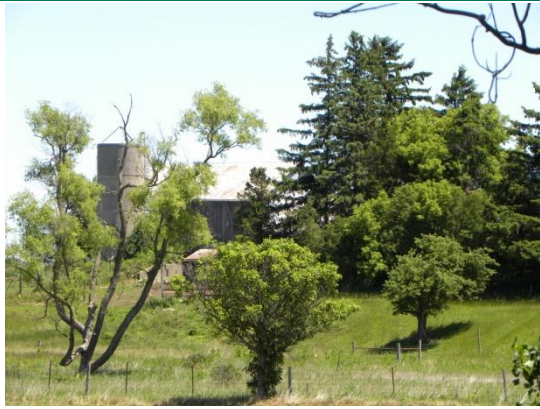
**Site #33 –4976 Douglas Line (Town of Plympton-Wyoming)**

**Date:** Various (19<sup>th</sup> – 20<sup>th</sup> century).

**Description:** Side gabled raised frame barn with a metal roof and concrete block foundation. Concrete silo.

**Mitigation of Negative Impacts:** No negative impacts identified, therefore no further mitigation recommended.

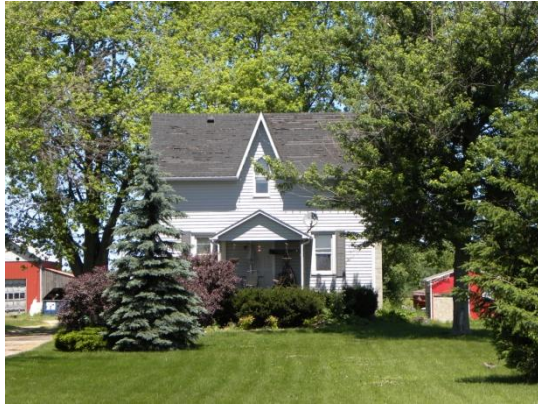
**Site #34 – 4534 Douglas Line (Town of Plympton-Wyoming)**

**Date:** 1890 – 1920s

**Description:** One and one half story house with central entry porch; side gabled roof with steep pitch and central dormer with steep pitch; clad in modern siding; rusticated concrete block foundation. Vernacular Gothic Revival characteristics include: symmetrical design; steep pitched side gabled roof; steep pitched central gable containing a pointed window extending into the gable.

**Mitigation of Negative Impacts:** No negative impacts identified, therefore no further mitigation recommended.

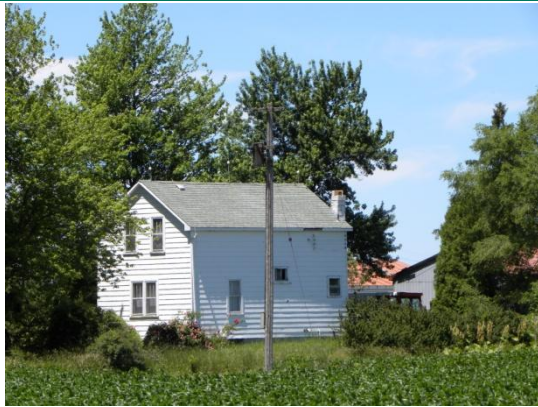
**Site #35 –4474 Aberarder Line (Town of Plympton-Wyoming)**

**Date:** 1850s – 1890s

**Description:** One and one half storey house with single storey addition; front gabled roof with medium pitch and side gabled addition with medium pitch; clad in modern siding; undetermined foundation.

**Mitigation of Negative Impacts:** Impacts were not identified, therefore mitigation is not recommended or necessary.

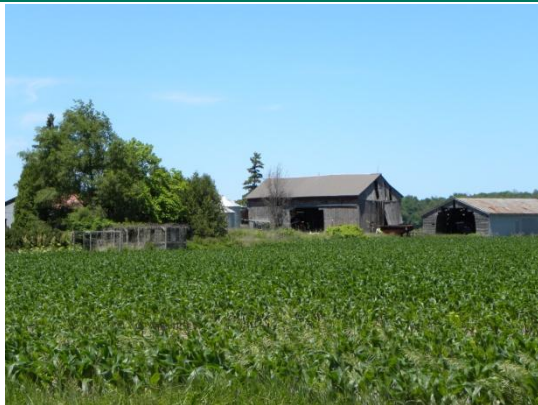
**Date:** 20<sup>th</sup> century

**Description:** Side gabled frame barn with metal roof and undetermined foundation. Three timber sheds, and three modern metal bins.

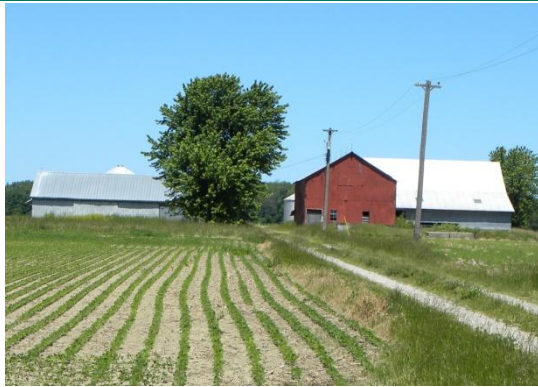
**Site #36 –4334 Aberarder Line (Town of Plympton-Wyoming)**

**Date:** Various (19<sup>th</sup> – 20<sup>th</sup> century)

**Description:** Two attached frame barns both with metal siding and undetermined foundation. One metal barn. Two metal bins.

**Mitigation of Negative Impacts:** No negative impacts identified, therefore no further mitigation recommended.

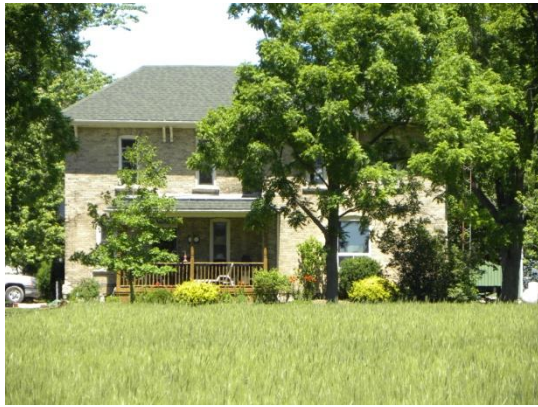
**Site #37 –4334 Aberarder Line (Town of Plympton-Wyoming)**

**Date:** 1870s – 1900s

**Description:** Two storey T-shaped house with rear addition and partial inset porch; cross-hipped roof with medium pitch brick house; hipped roof; undetermined foundation. Decorative brackets.

**Mitigation of Negative Impacts:** No negative impacts identified, therefore no further mitigation recommended.

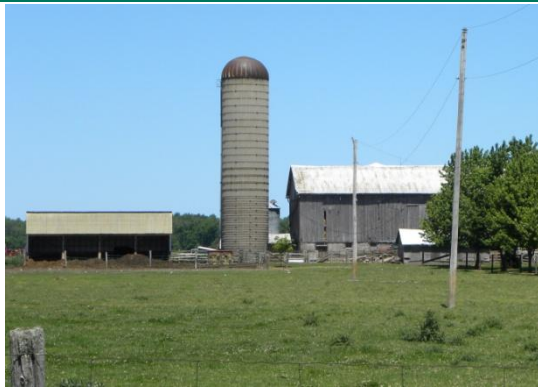
**Date:** Various (19<sup>th</sup> and 20<sup>th</sup> century)

**Description:** Timber framed barn; concrete foundation; concrete silo. Two modern silos. Modern metal shed.

**Mitigation of Negative Impacts:** No negative impacts identified, therefore no further mitigation recommended.

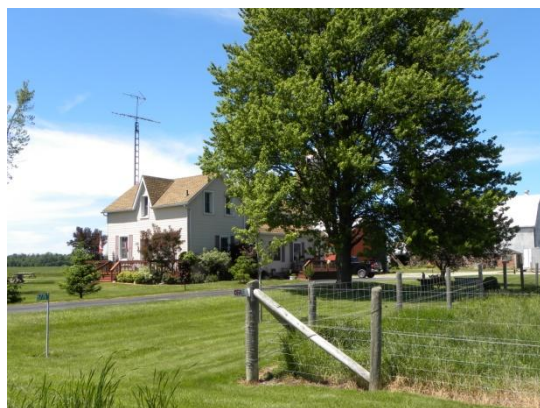
**Site #38 –5776 Townsend Line (Municipality of Lambton Shores)**

**Date:** 1850s – 1890s

**Description:** One and one half storey T-shaped house with full front porch and rear additions; side gabled roof with medium pitch, steep pitched central gable containing a window extending into gable, and side shed addition; clad in modern siding; undetermined foundation.

**Mitigation of Negative Impacts:** No negative impacts identified, therefore no further mitigation recommended.
