Ministry of Tourism Culture and Sport  
Comments and Recommendations  
October 5, 2012

**RE: Suncor Energy Cedar Point Wind Energy Facility**  
**Location: Multiple lots, Municipality of Lambton Shores, Township of Warwick, and Town of Plympton-Wyoming, Lambton County**  
**OPA Reference Number: FIT-F80K1QB**  
**MTC DPR File No.: PLAN-38EA051**

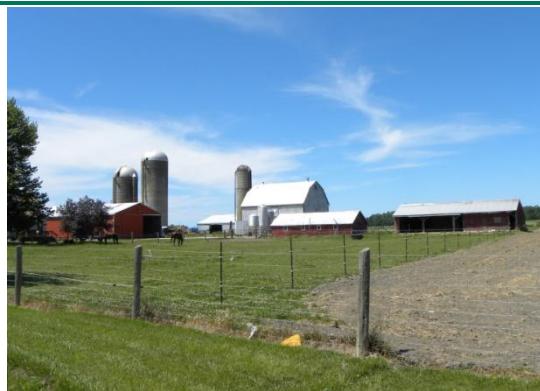
**Date:** Various (19<sup>th</sup> – 20<sup>th</sup> century)

**Description:** Raised frame barn with metal roof, metal siding, and undetermined foundation. Two timber sheds. Two metal sheds. Three concrete silos.

**Mitigation of Negative Impacts:** No negative impacts identified, therefore no further mitigation recommended.

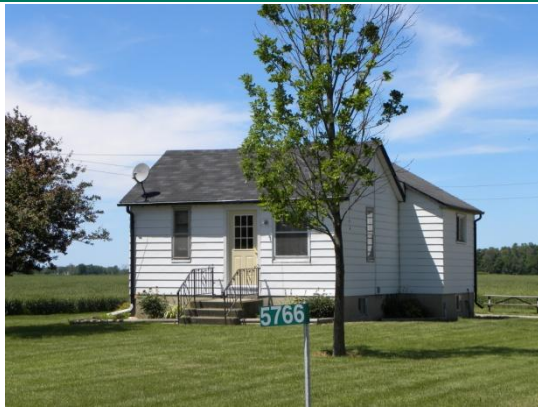
**Date:** 20<sup>th</sup> century

**Description:** Single story L-shaped house; side gabled roof with medium pitch; clad in modern siding; concrete foundation.

**Mitigation of Negative Impacts:** Impacts were not identified, therefore mitigation is not recommended or necessary.

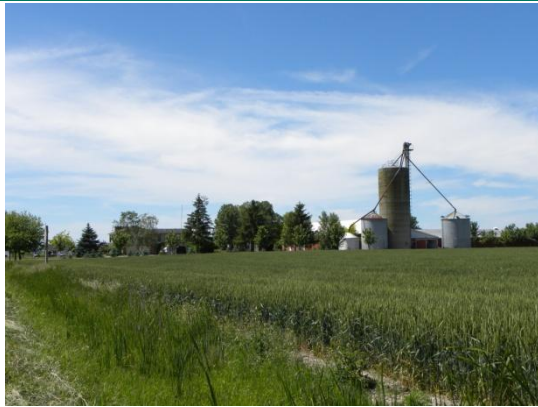
**Site #39 –5720 Townsend Line (Municipality of Lambton Shores)**

**Date:** Post 1950s

**Description:** Livestock barn with metal roof, metal siding, undetermined foundation. One concrete silo and three metal bins.

**Mitigation of Negative Impacts:** Impacts were not identified, therefore mitigation is not recommended or necessary.

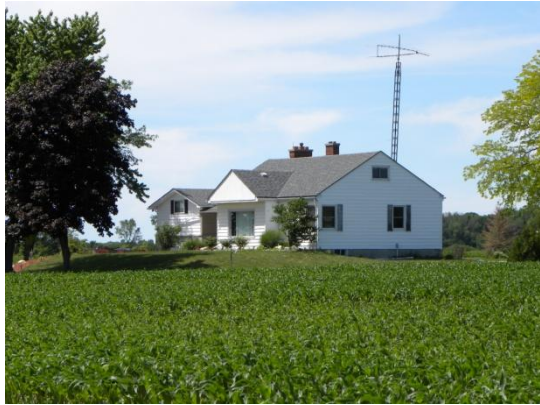
**Site #40 –5622 Townsend Line (Municipality of Lambton Shores)**

**Date:** Post 1950

**Description:** One and one half storey side-split house; side gabled roof with low pitch, cross gable at front, and side dormer with garage; clad in modern siding; concrete foundation.

**Mitigation of Negative Impacts:** Impacts were not identified, therefore mitigation is not recommended or necessary.

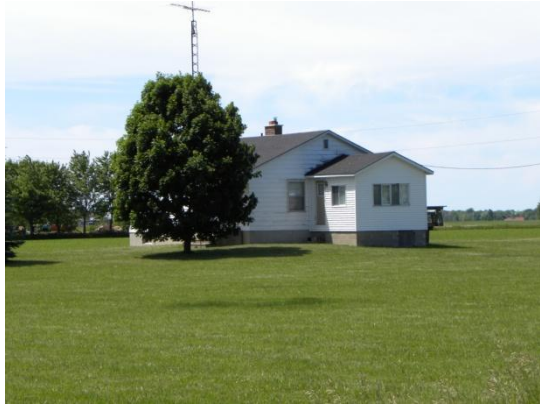
**Site #41 –5512 Townsend Line (Municipality of Lambton Shores)**

**Date:** Post 1950

**Description:** Single storey house with small side addition; side gabled roof with low pitch; clad in modern siding; concrete block foundation.

**Mitigation of Negative Impacts:** Impacts were not identified, therefore mitigation is not recommended or necessary.

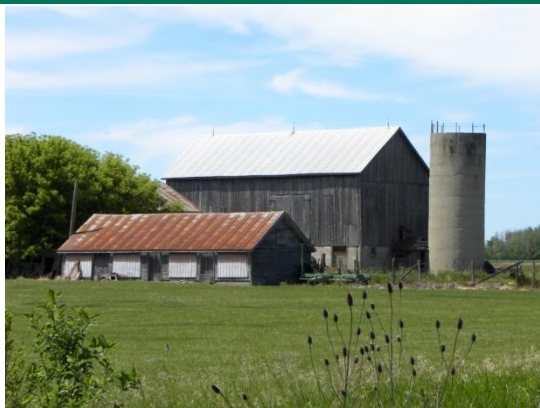
**Date:** Various (19<sup>th</sup> and 20<sup>th</sup> century)

**Description:** Raised frame barn with metal roof, timber siding and concrete block foundation. Two smaller timber sheds with metal roof, timber siding, and concrete foundation. One concrete silo.

**Mitigation of Negative Impacts:** No negative impacts identified, therefore no further mitigation recommended.

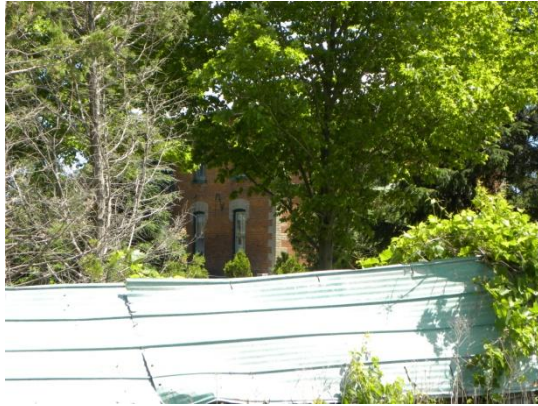
**Site #42 –6019 Lakeshore Road (Municipality of Lambton Shores)**

**Date:** Undetermined

**Description:** Two storey house with rear addition; hipped roof with medium pitch; red brick exterior with yellow brick details including quoins and window/door crowns; undetermined foundation Foliage coverage restricted design and age identification.

**Mitigation of Negative Impacts:** No negative impacts identified, therefore no further mitigation recommended.

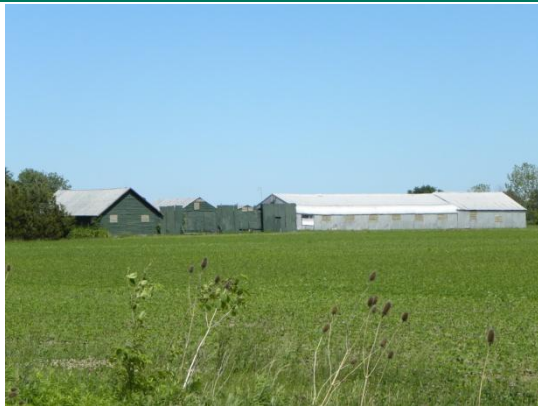
**Date:** 20<sup>th</sup> century

**Description:** Three sheds and one barn. All appear to have metal roofs, metal siding and undetermined foundations.

**Mitigation of Negative Impacts:** No negative impacts identified, therefore no further mitigation recommended.

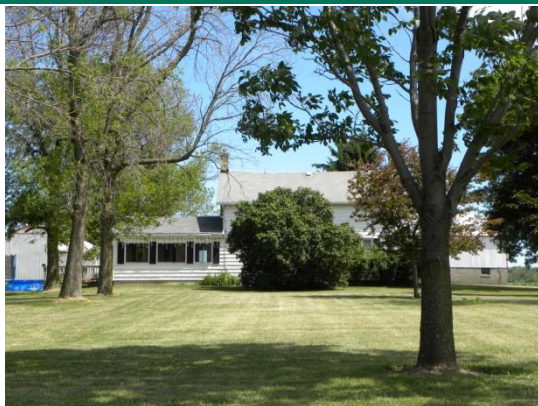
**Site #43 – Unidentified Address, Lakeshore Road (Municipality of Lambton Shores)**

**Date:** 1850s – 1900

**Description:** One and one half storey L-shaped house with single storey side addition; side gabled roof with medium pitch; clad in modern siding, undetermined foundation.

**Mitigation of Negative Impacts:** Impacts were not identified, therefore mitigation is not recommended or necessary.

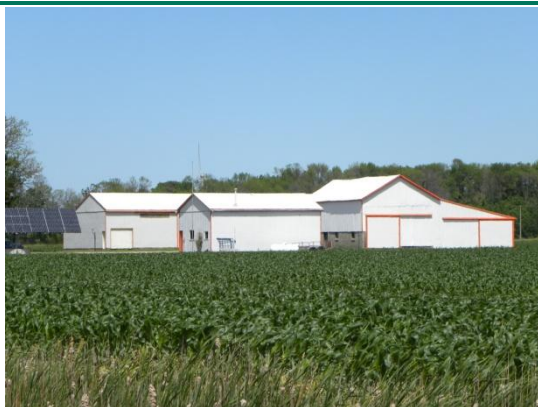
**Date:** Late 19<sup>th</sup> – 20<sup>th</sup> century

**Description:** One raised frame barn with rear shed addition, metal roof, metal siding and concrete block foundation. Two sheds with metal roofs, metal siding and undetermined foundations.

**Mitigation of Negative Impacts:** No negative impacts identified, therefore no further mitigation recommended.

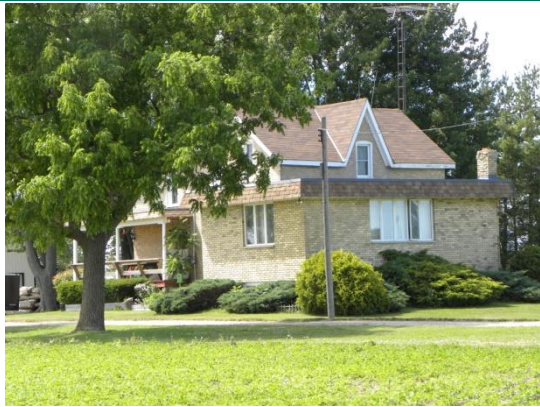
**Site #44 –8337 Fuller Road (Municipality of Lambton Shores)**

**Date:** 1880s – 1920s

**Description:** One and one half storey T-shaped house with modern front and side additions and inset side porch; side gabled roof with medium roof pitch and central gable with steep pitch; yellow brick exterior; undetermined foundation.

**Mitigation of Negative Impacts:** No negative impacts identified, therefore no further mitigation recommended.

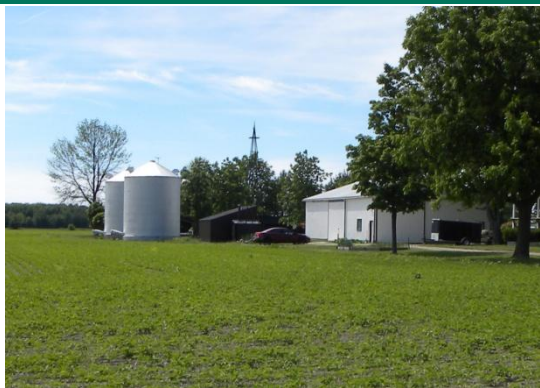
**Date:** Post 1950

**Description:** Metal shed and two metal bins.

**Mitigation of Negative Impacts:** Impacts were not identified, therefore mitigation is not recommended or necessary.

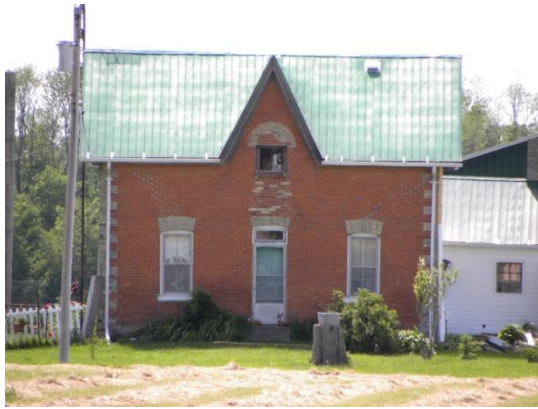
**Site #45 – 8279 Fuller Road (Municipality of Lambton Shores)**

**Date:** 1870s – 1890s

**Description:** One and one half storey red brick house with single storey addition; side gabled roof with medium roof pitch and central gable with steep pitch; red brick exterior with yellow brick detailing including quoins and rounded window crowns; undetermined foundation. Vernacular Gothic Revival characteristics include symmetrical design and steep pitched central gable containing window extending into gable.

**Mitigation of Negative Impacts:** No negative impacts identified, therefore no further mitigation recommended.

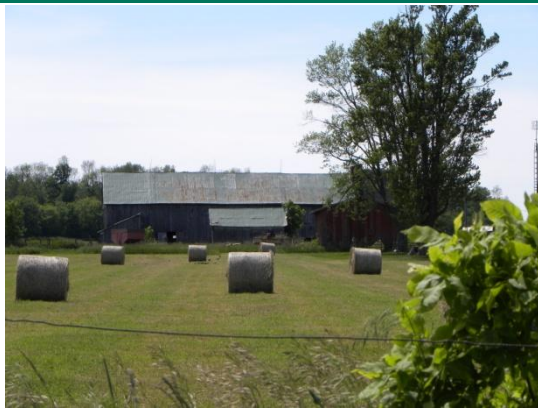
**Date:** Late 19<sup>th</sup> – 20<sup>th</sup> century

**Description:** Frame barn with metal roof, timber siding and undetermined foundation. Two sheds, both with metal roofs, one with timber siding and one with metal, both have undetermined foundations. Concrete silo.

**Mitigation of Negative Impacts:** No negative impacts identified, therefore no further mitigation recommended.

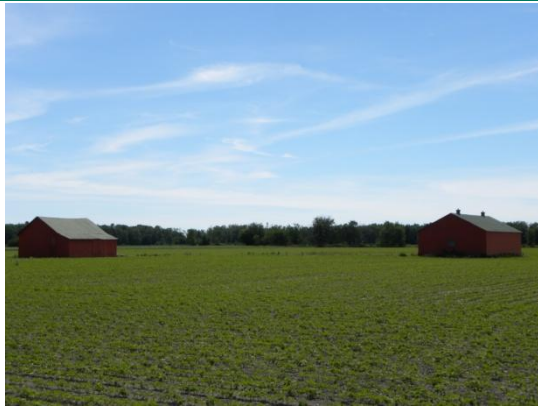
**Site #46 – 8183 Fuller Road (Municipality of Lambton Shores)**

**Date:** 20<sup>th</sup> century

**Description:** Two sheds both with metal roofs, metal siding and undetermined foundation.

**Mitigation of Negative Impacts:** No negative impacts identified, therefore no further mitigation recommended.

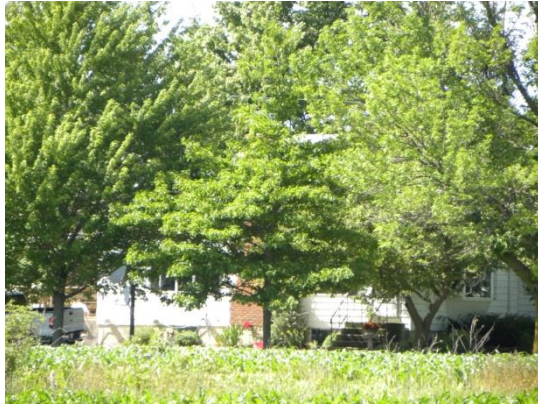
**Site #47 – 8133 Fuller Road (Municipality of Lambton Shores)**

**Date:** 1890s – 1920s

**Description:** One and one half storey; undetermined roof; clad in modern siding; rusticated concrete block foundation. Foliage coverage restricted design and age identification.

**Mitigation of Negative Impacts:** No negative impacts identified, therefore no further mitigation recommended.

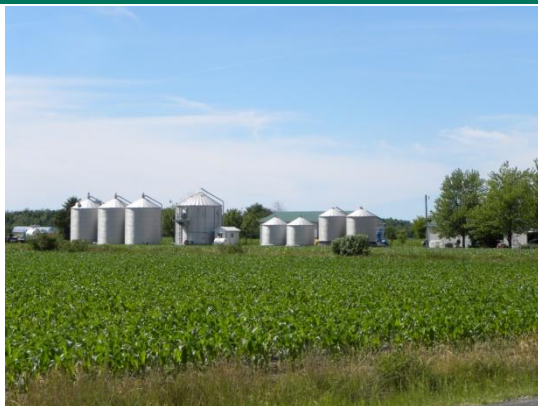
**Date:** Post 1950

**Description:** Three sheds with metal roofs, metal siding and undetermined foundations. Eight metal bins.

**Mitigation of Negative Impacts:** Impacts were not identified, therefore mitigation is not recommended or necessary.

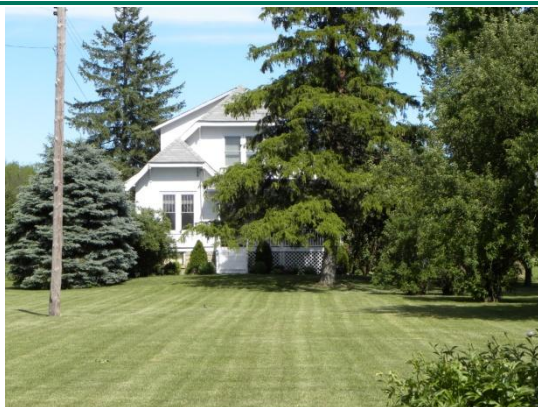
**Site #48 – 8274 Fuller Road (Municipality of Lambton Shores)**

**Date:** 1890s – 1920s

**Description:** One and one half storey house with inset front porch; hip-on-gable roof with medium pitch and side shed dormer and cross gable; modern siding; rusticated concrete block foundation.

**Mitigation of Negative Impacts:** Impacts were not identified, therefore mitigation is not recommended or necessary.

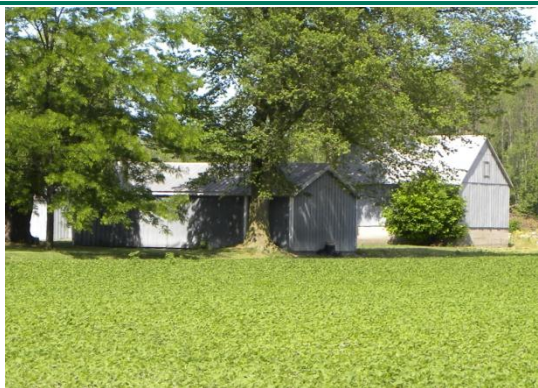
**Date:** 20<sup>th</sup> century

**Description:** Two sheds with metal roofs, metal siding and concrete block foundation and one with undetermined foundation.

**Mitigation of Negative Impacts:** Impacts were not identified, therefore mitigation is not recommended or necessary.

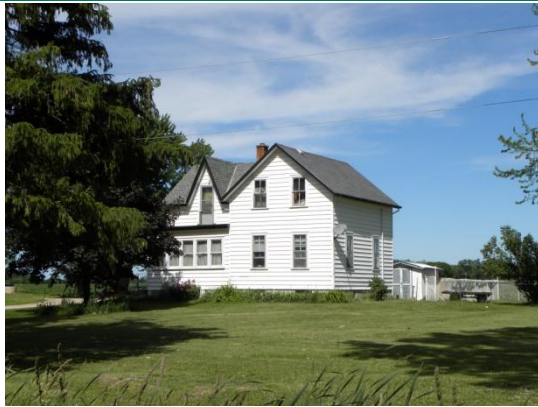
**Site #49 – 8596 Fuller Road (Municipality of Lambton Shores)**

**Date:** 1880s – 1920s

**Description:** One and one half storey L-shaped house with covered inset porch; cross gabled roof with medium pitch and dormer with doorway and steep roof pitch; clad in modern siding; concrete block foundation.

**Mitigation of Negative Impacts:** No negative impacts identified, therefore no further mitigation recommended.

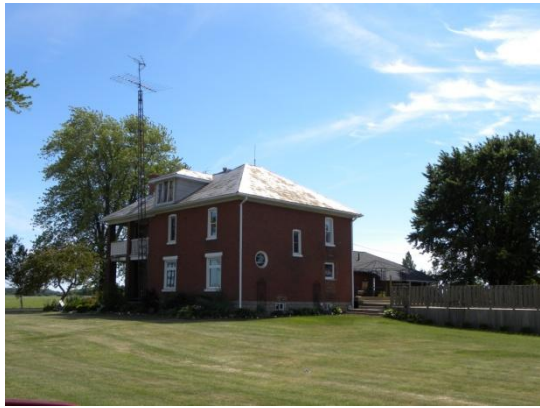
**Site #50 – 8603 Rawlings Road (Municipality of Lambton Shores)**

**Date:** 1890s – 1920s

**Description:** Two storey L-shaped house with single storey rear addition and inset two storey porch; hipped roof with medium pitch and central hipped gable; red brick exterior; rusticated concrete block foundation.

**Mitigation of Negative Impacts:** No negative impacts identified, therefore no further mitigation recommended.

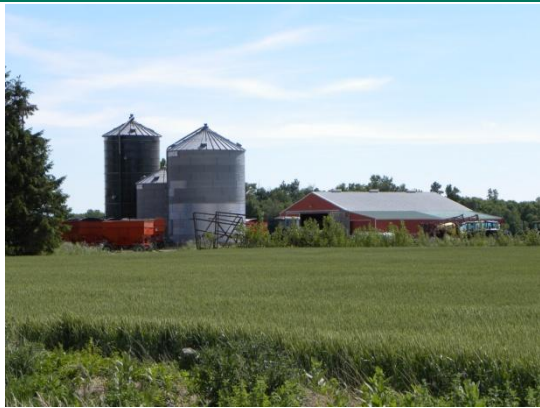
**Date:** 20<sup>th</sup> century

**Description:** Shed with metal roof, metal exterior and undetermined foundation. Three metal bins.

**Mitigation of Negative Impacts:** No negative impacts identified, therefore no further mitigation recommended.

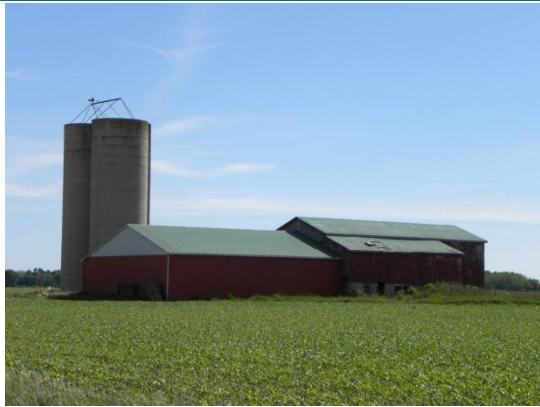
**Site #51 – 8405 Rawlings Road (Municipality of Lambton Shores)**

**Date:** Various (19<sup>th</sup> and 20<sup>th</sup> century)

**Description:** Raised frame barn with side shed and modern front addition. Frame barn has metal roof, metal siding and concrete block foundation. Modern addition has metal roof, metal siding and undetermined foundation. Two concrete silos.

**Mitigation of Negative Impacts:** No negative impacts identified, therefore no further mitigation recommended.

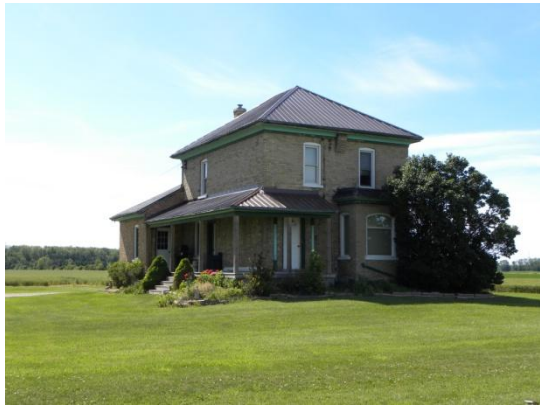
**Site #52 – 8219 Rawlings Road (Municipality of Lambton Shores)**

**Date:** 1870s – 1900s

**Description:** Two storey house with rear addition, partial wrap-around porch and mansard roof bay window; pyramidal hipped roof with medium pitch and decorative wood cornice and frieze; yellow brick exterior; stone foundation.

**Mitigation of Negative Impacts:** No negative impacts identified, therefore no further mitigation recommended.

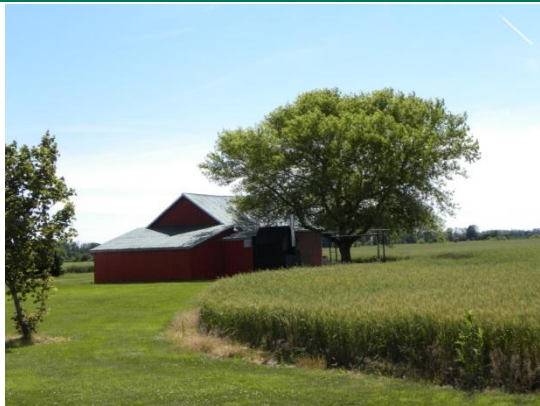
**Date:** 20<sup>th</sup> century

**Description:** Front gabled shed with shed addition, metal roof, metal siding and undetermined foundation.

**Mitigation of Negative Impacts:** Impacts were not identified, therefore mitigation is not recommended or necessary.

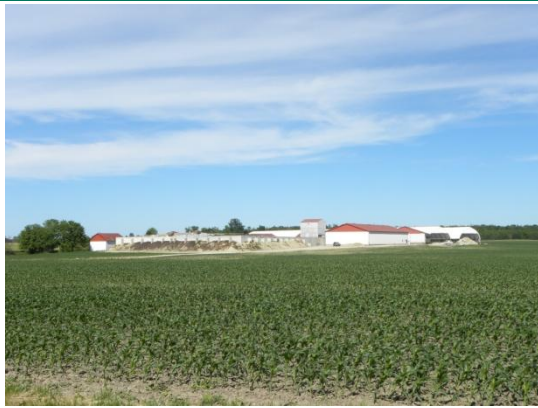
**Site #53 – 8070 Rawlings Road (Municipality of Lambton Shores)**

**Date:** 20<sup>th</sup> century

**Description:** Five metal livestock barns with metal roofs, metal siding and concrete foundations. Two plastic drive sheds. Three storey structure with metal roof, metal siding and undetermined foundation.

**Mitigation of Negative Impacts:** Impacts were not identified, therefore mitigation is not recommended or necessary.

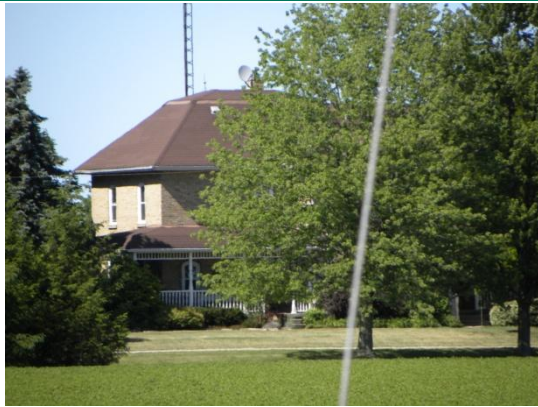
**Site #54 – 8354 Rawlings Road (Municipality of Lambton Shores)**

**Date:** 1870s – 1900s

**Description:** Two storey vernacular foursquare house with wrap-around porch, rear garage and side addition; yellow brick exterior; undetermined foundation. Foliage coverage restricted design and age identification.

**Mitigation of Negative Impacts:** No negative impacts identified, therefore no further mitigation recommended.

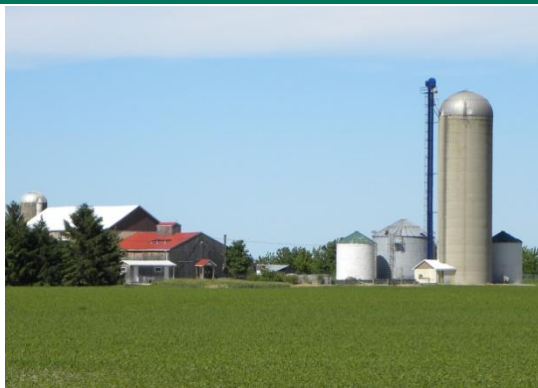
**Date:** Various (19<sup>th</sup> and 20<sup>th</sup> century)

**Description:** Raised frame barn with metal roof, timber siding and undetermined foundation. Frame barn with a single roof ventilator, metal roof, timber siding and undetermined foundation. Both frame barns linked together. Two additional sheds not visible. Two concrete silos and three metal bins.

**Mitigation of Negative Impacts:** No negative impacts identified, therefore no further mitigation recommended.

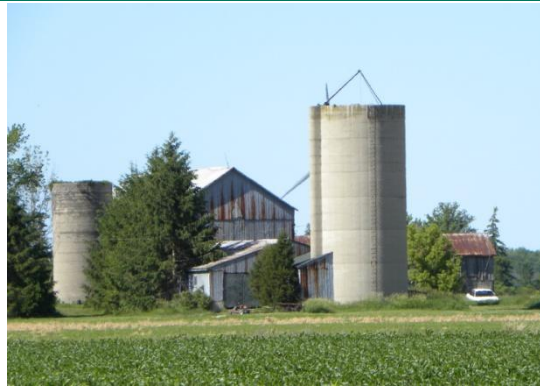
**Site #55 – No municipal address, Rawlings Road (Municipality of Lambton Shores)**

**Date:** Various (19<sup>th</sup> and 20<sup>th</sup> century)

**Description:** One raised frame barn with metal roof, both timber and metal siding and undetermined foundation. Second barn obstructed by foliage. Two concrete silos. Foliage coverage restricted design and age identification.

**Mitigation of Negative Impacts:** No negative impacts identified, therefore no further mitigation recommended.

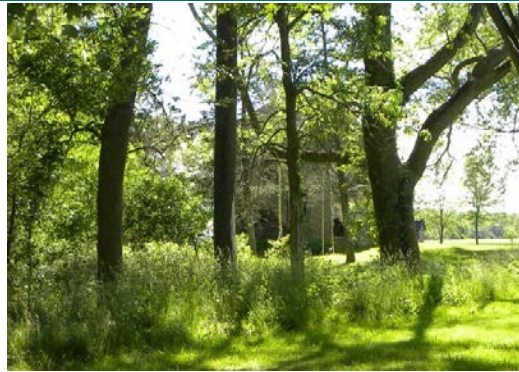
**Site #56 – 8605 Kinnaird Road (Municipality of Lambton Shores)**

**Date:** 1870s – 1900s

**Description:** Two storey L-shaped timber framed house; hipped roof with medium pitch; timber clad in brick laid on edge, frog-side out; stone foundation. Foliage coverage restricted design and age identification.

**Mitigation of Negative Impacts:** No negative impacts identified, therefore no further mitigation recommended.

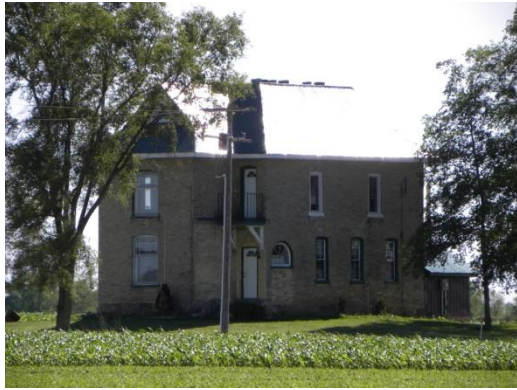
**Site #57 – 8135 Kinnaird Road (Municipality of Lambton Shores)**

**Date:** 1880s – 1920s

**Description:** Two storey house with small rear addition; flat-top hipped roof with cross gable; yellow brick exterior; undetermined foundation. Possibly some original windows remain including six over six windows throughout main floor and stained glass in gable windows.

**Mitigation of Negative Impacts:** No negative impacts identified, therefore no further mitigation recommended.

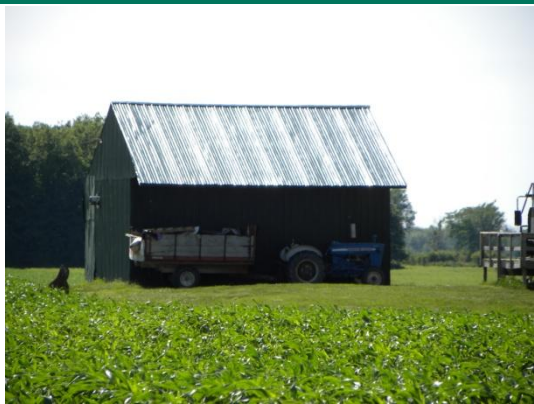
**Date:** 20<sup>th</sup> century

**Description:** Metal shed with metal roof, metal siding and undetermined foundation.

**Mitigation of Negative Impacts:** Impacts were not identified, therefore mitigation is not recommended or necessary.

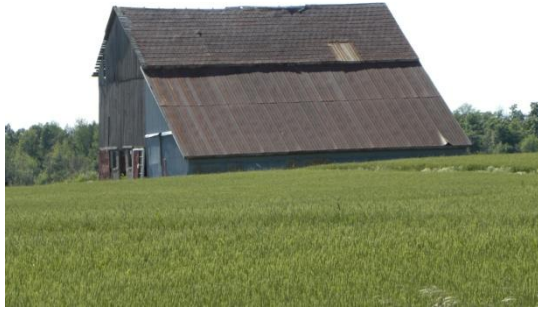
**Site #58 – Undetermined address, Kinnaird Road (Municipality of Lambton Shores)**

**Date:** 19<sup>th</sup> – early 20<sup>th</sup> century

**Description:** Frame barn with side shed addition, asphalt and metal roof, timber and metal siding and concrete block foundation.

**Mitigation of Negative Impacts:** No negative impacts identified, therefore no further mitigation recommended.

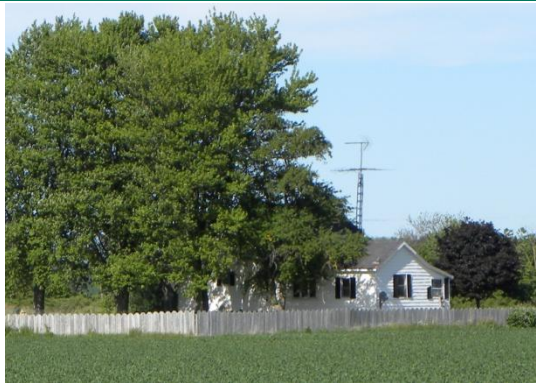
**Site #59 – 6672 Townsend Line (Municipality of Lambton Shores)**

**Date:** Post 1950

**Description:** Single storey house; side gabled roof with low pitch; undetermined foundation.

**Mitigation of Negative Impacts:** Impacts were not identified, therefore mitigation is not recommended or necessary.

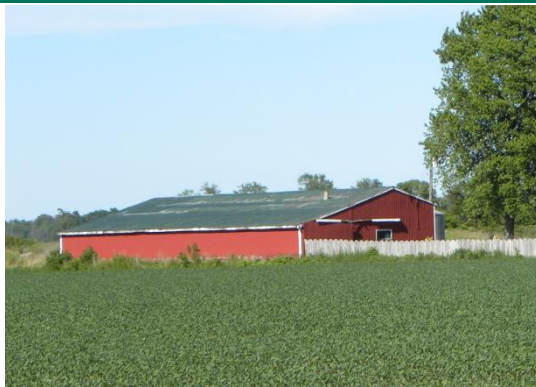
**Date:** 20<sup>th</sup> century

**Description:** Metal shed with low pitched front gable roof, metal siding and undetermined foundation.

**Mitigation of Negative Impacts:** Impacts were not identified, therefore mitigation is not recommended or necessary.

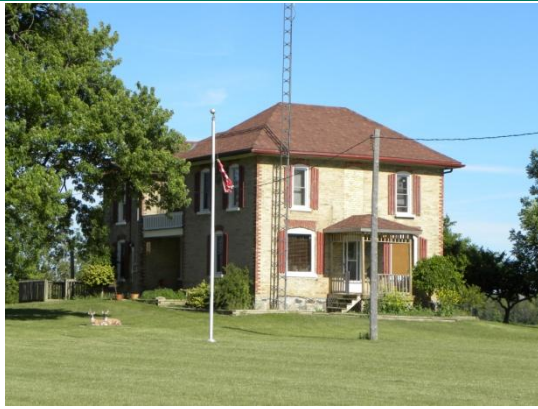
**Site #60 – 8228 Kinnard Road(Municipality of Lambton Shores)**

**Date:** 1880s – 1920s

**Description:** Two storey I-shaped house with central entry porch and inset two-storey side porch; hipped roof throughout with medium pitch; yellow brick exterior with red brick detailing including quoins and window surrounds; stone foundation.

**Mitigation of Negative Impacts:** No negative impacts identified, therefore no further mitigation recommended.

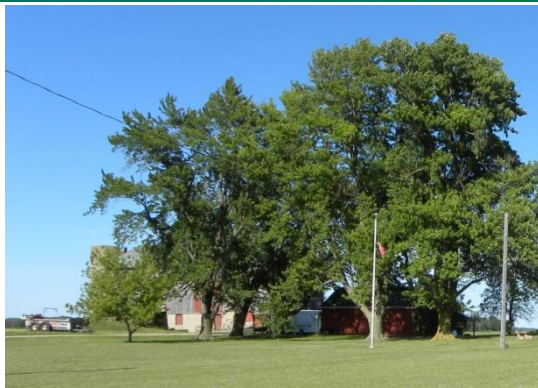
**Date:** Various (19<sup>th</sup> and 20<sup>th</sup> century)

**Description:** Frame barn with metal roof, timber siding and concrete covered, stone foundation. Shed with metal roof, metal siding and undetermined foundation. Concrete silo.

**Identified Heritage Attributes:** Timber frame construction and stone foundation. Relationship of structure to residence and road.

**Mitigation of Negative Impacts:** No negative impacts identified, therefore no further mitigation recommended.

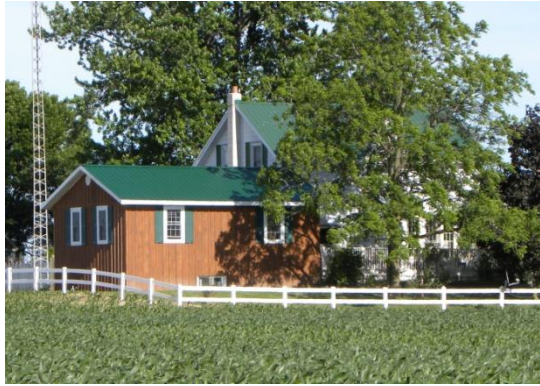
**Site #61 – 8294 Kinnard Road (Municipality of Lambton Shores)**

**Date:** 1850s – 1890s

**Description:** One and one half storey house with single storey side and rear additions; side gabled roof with medium pitch and central dormer with steep pitch; clad in variety of modern siding and undetermined foundation. Foliage coverage restricted design and age identification.

**Mitigation of Negative Impacts:** Impacts were not identified, therefore mitigation is not recommended or necessary.

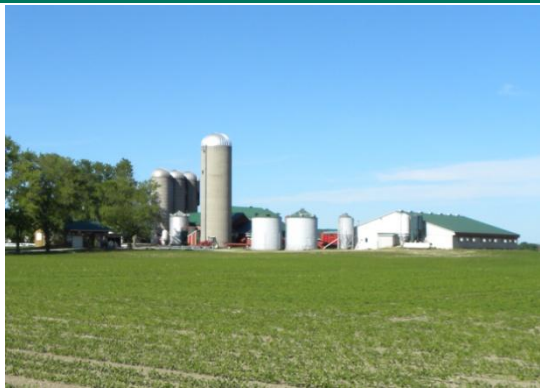
**Date:** Various (20<sup>th</sup> century)

**Description:** At least two barns with metal roofs, metal siding and undetermined foundations. One modern livestock barn with metal roof, metal siding and undetermined foundation. Four metal bins. Four concrete silos. Two plastic drive sheds. Small modern store onsite. Foliage coverage restricted design and age identification.

**Mitigation of Negative Impacts:** Impacts were not identified, therefore mitigation is not recommended or necessary.

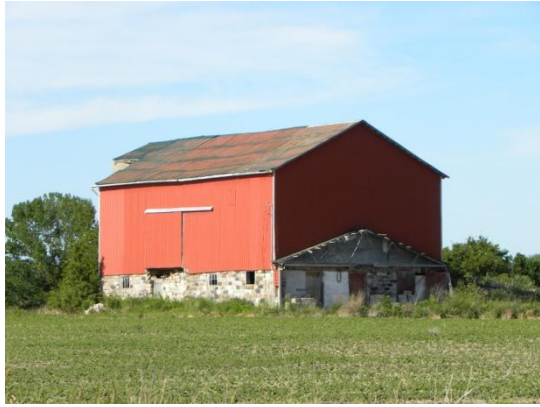
**Site #62 – 8538 Kinnard Road (Municipality of Lambton Shores)**

**Date:** 19<sup>th</sup> – early 20<sup>th</sup> century

**Description:** Raised frame barn with metal roof, metal siding and stone foundation. Former side addition has been removed.

**Identified Heritage Attributes:** Timber frame construction and stone foundation. Relationship of structure to road.

**Mitigation of Negative Impacts:** No negative impacts identified, therefore no further mitigation recommended.

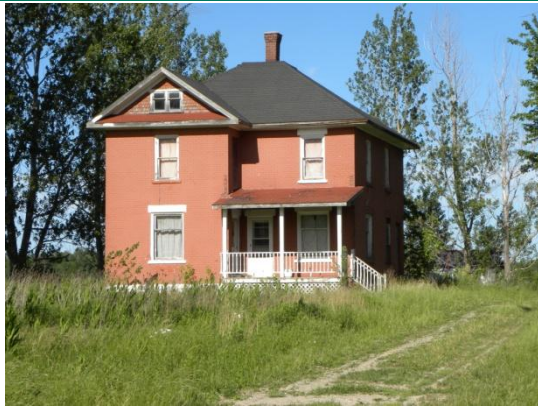
**Site #63 – 8780 Kinnard Road (Municipality of Lambton Shores)**

**Date:** 1880s – 1920s

**Description:** Two storey house with lower front cross gable and partial front porch; pyramidal hipped roof with medium pitch; red brick exterior painted red; undetermined foundation. Design details include fishscale shingles in gable and wide eaves. House appears abandoned.

**Mitigation of Negative Impacts:** No negative impacts identified, therefore no further mitigation recommended.

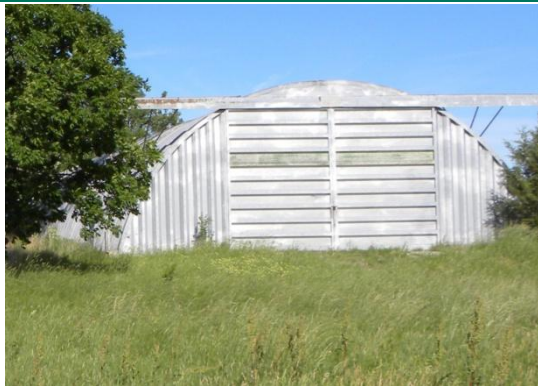
**Date:** Post 1950

**Description:** Metal drive shed.

**Mitigation of Negative Impacts:** Impacts were not identified, therefore mitigation is not recommended or necessary.

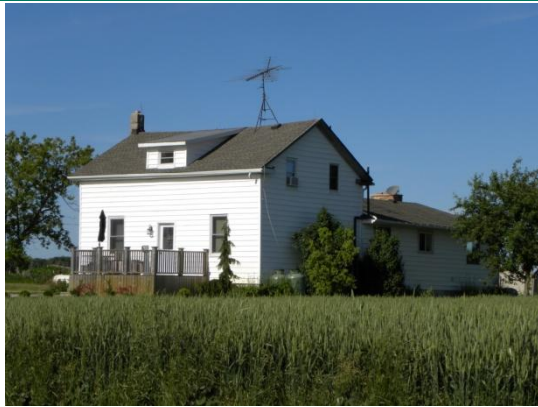
**Site #64 – 8954 Kinnard Road (Municipality of Lambton Shores)**

**Date:** 1850s – 1890s

**Description:** One and half storey house with rear addition; side gabled roof with low pitch and central hood dormer; clad in modern siding; concrete foundation.

**Mitigation of Negative Impacts:** Impacts were not identified, therefore mitigation is not recommended or necessary.

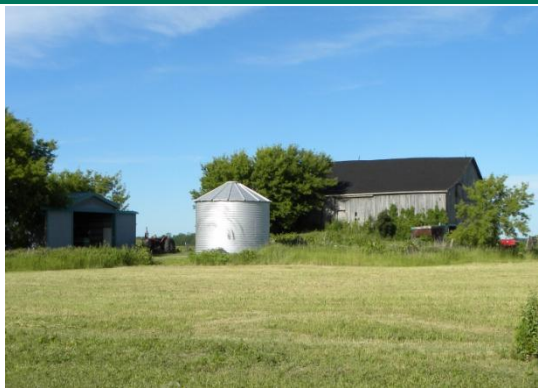
**Date:** Various (19<sup>th</sup> and 20<sup>th</sup> century)

**Description:** Raised frame barn with asphalt shingle roof, timber siding and concrete block foundation. One concrete silo. One metal bin.

**Mitigation of Negative Impacts:** No negative impacts identified, therefore no further mitigation recommended.

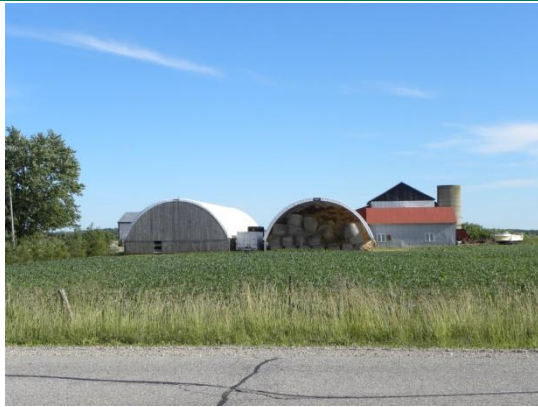
**Site #65 – 8977 and 8981 Army Camp Road (Municipality of Lambton Shores)**

**Date:** Various (19<sup>th</sup> and 20<sup>th</sup> century)

**Description:** One raised frame barn with rear shed addition, metal roof, metal siding and undetermined foundation. Two sheds with metal roofs, metal siding and undetermined foundation. Two modern drive sheds. One concrete silo.

**Mitigation of Negative Impacts:** No negative impacts identified, therefore no further mitigation recommended.

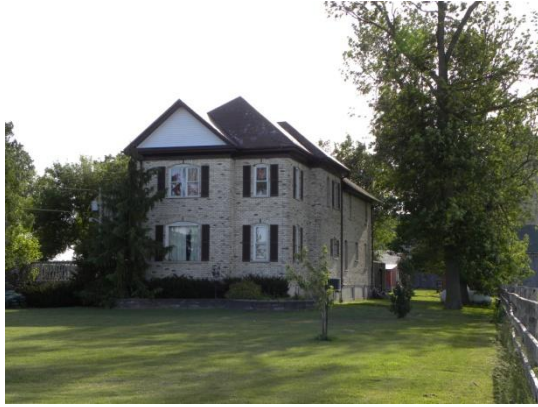
**Site #66 –8851 Army Camp Road (Municipality of Lambton Shores)**

**Date:** 1880s – 1920s

**Description:** Two storey cross-gabled house with projecting front gable and two storey side porch; hipped roof with irregular cross gables and modern design and materials; mixed yellow brick exterior; concrete foundation.

**Mitigation of Negative Impacts:** No negative impacts identified, therefore no further mitigation recommended.

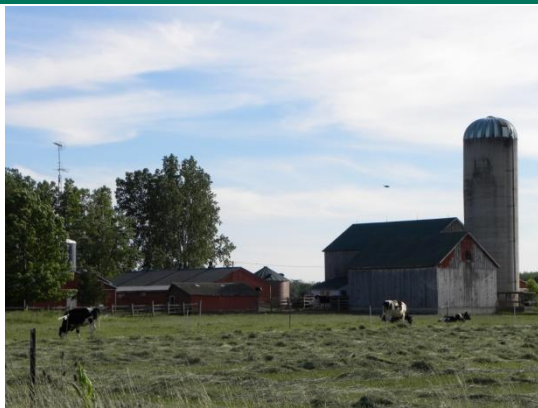
**Date:** Various (19<sup>th</sup> and 20<sup>th</sup> century)

**Description:** One raised frame barn with small shed addition, metal roof, timber siding, and undetermined foundation. One timber shed with metal roof, timber siding and concrete foundation. Livestock barns with metal roof, metal siding and undetermined foundation. Two metal bins. One concrete silo.

**Mitigation of Negative Impacts:** No negative impacts identified, therefore no further mitigation recommended.

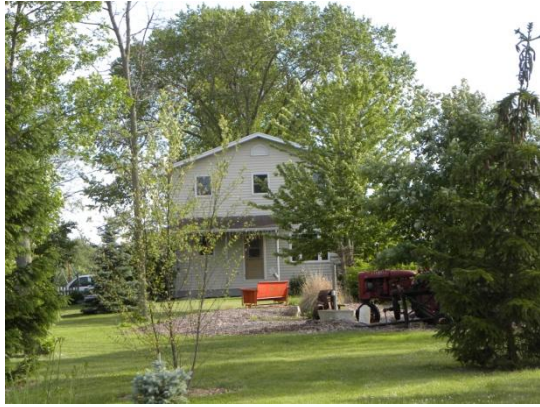
**Site #67 –5407 Cedar Point Line (Municipality of Lambton Shores)**

**Date:** Late 19<sup>th</sup> – early 20<sup>th</sup> century

**Description:** Two storey house; front gabled roof with low pitch; clad in modern siding; concrete foundation.

**Mitigation of Negative Impacts:** Impacts were not identified, therefore mitigation is not recommended or necessary.

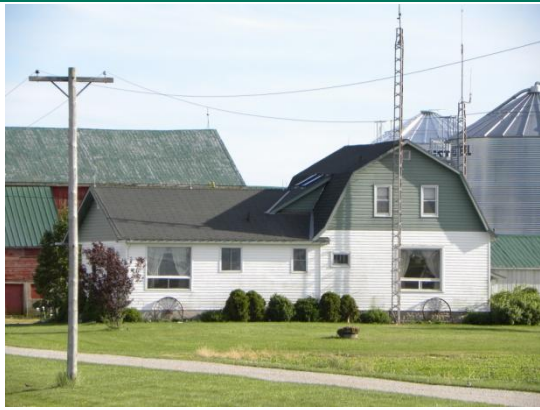
**Site #68 –5323 Aberarder Line (Town of Plympton-Wyoming)**

**Date:** Early 20<sup>th</sup> century

**Description:** One and one half storey house with rear and single storey side addition; side gabled and gambrel roof with medium pitch; clad in modern siding; concrete block foundation.

**Mitigation of Negative Impacts:** Impacts were not identified, therefore mitigation is not recommended or necessary.

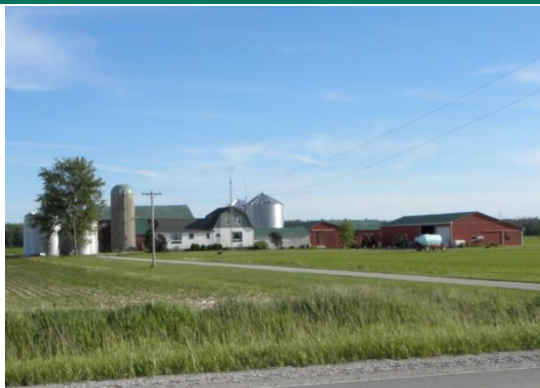
**Date:** Various (19<sup>th</sup> and 20<sup>th</sup> century)

**Description:** One raised frame barn with metal roof, timber siding and concrete foundation. One concrete silo. Two timber sheds with metal roofs, timber siding and undetermined foundation. One metal shed with metal siding, and undetermined foundation. Six modern metal bins.

**Mitigation of Negative Impacts:** No negative impacts identified, therefore no further mitigation recommended.

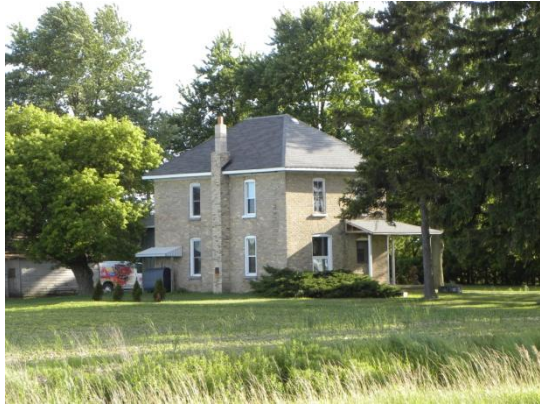
**Site #69 –5273 Aberarder Line (Town of Plympton-Wyoming)**

**Date:** 1870s – 1900s

**Description:** Two storey L-shaped house with rear addition and side wrap-around porch; hipped roof with medium pitch; yellow brick exterior; undetermined foundation.

**Mitigation of Negative Impacts:** No negative impacts identified, therefore no further mitigation recommended.

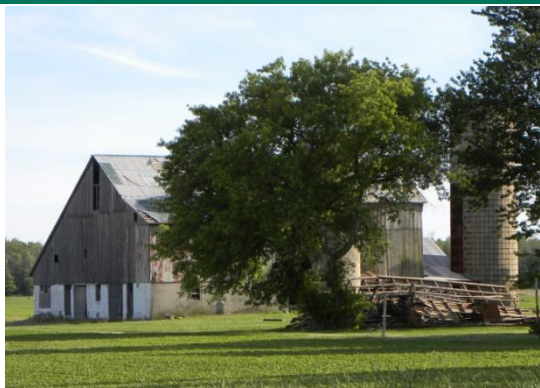
**Date:** Various (19<sup>th</sup> and 20<sup>th</sup> century)

**Description:** Raised frame barn with rear shed addition, metal roof, timber frame siding, and concrete foundation. One concrete silo.

**Mitigation of Negative Impacts:** No negative impacts identified, therefore no further mitigation recommended.

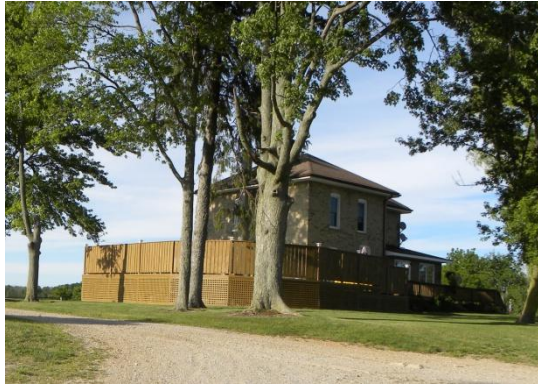
**Site #70 –5334 Fisher Line (Town of Plympton-Wyoming)**

**Date:** 1870s – 1900s

**Description:** Two storey L-shaped house with covered inset porch; pyramidal hipped roof with low pitch; yellow brick exterior; covered concrete foundation.

**Mitigation of Negative Impacts:** No negative impacts identified, therefore no further mitigation recommended.

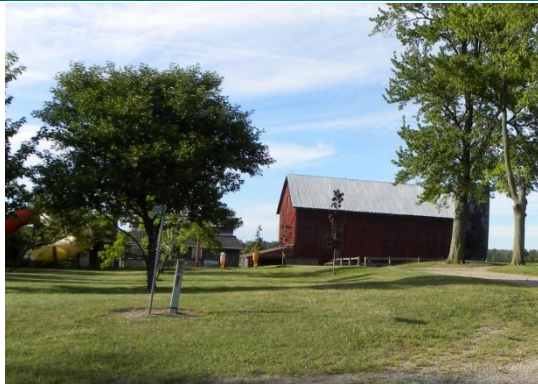
**Date:** 19<sup>th</sup> – early 20<sup>th</sup> century

**Description:** Raised frame barn with side addition, metal roof, metal siding and stone foundation.

**Mitigation of Negative Impacts:** No negative impacts identified, therefore no further mitigation recommended.

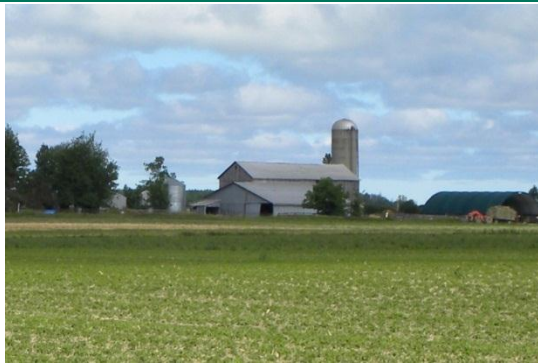
#### Site #1 –4282 Fisher Line (Town of Plympton-Wyoming)

**Date:** Various (19<sup>th</sup> and 20<sup>th</sup> century)

**Description:** Barn, concrete silo, metal drive shed and multiple metal bins. Front gabled, raised frame barn with front single storey barn addition; metal roof; undetermined foundation. Modern house onsite.

**Mitigation of Negative Impacts:** No negative impacts identified, therefore no further mitigation recommended.

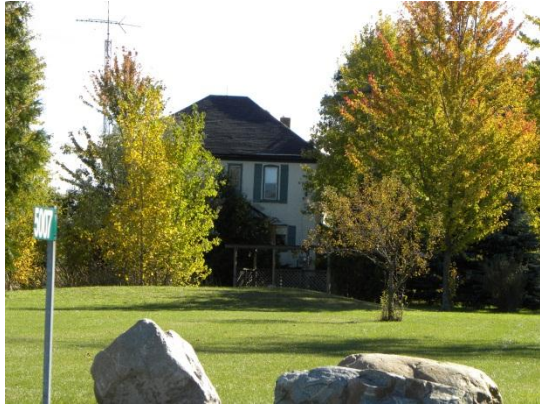
**Site #2 – 5007 Wright Line (Town of Plympton-Wyoming)**

**Date:** 1870s – 1900s

**Description:** Two storey house with covered entry porch and rear addition; hipped roof with medium pitch; painted brick exterior; undetermined foundation. Design details include dentils and possible symmetrical design.

**Mitigation of Negative Impacts:** No negative impacts identified, therefore no further mitigation recommended.

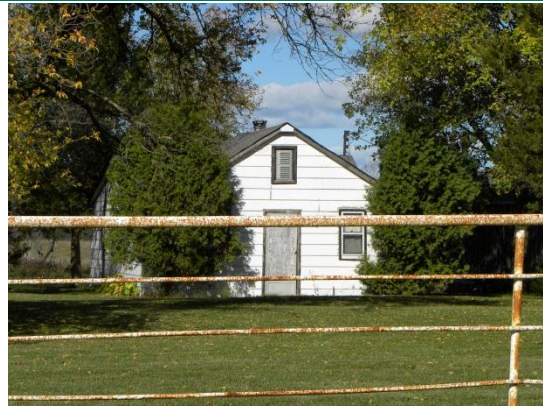
**Site #3 – 5490 Fisher Line (Town of Plympton-Wyoming)**

**Date:** 20<sup>th</sup> century

**Description:** Single storey structure appears to be a cabin; front gabled roof with medium pitch and possible side dormer; appears to be clad in white clapboard siding; undetermined foundation.

**Mitigation of Negative Impacts:** No negative impacts identified, therefore no further mitigation recommended.

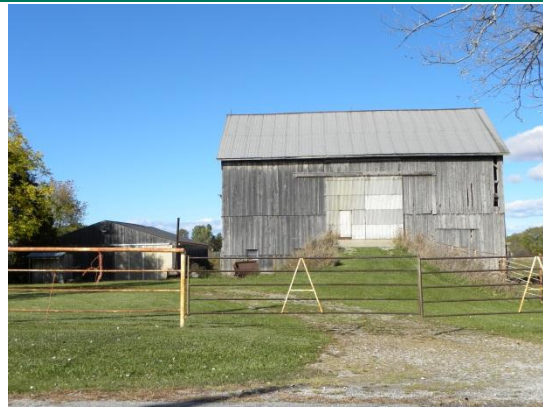
**Date:** 19<sup>th</sup> – early 20<sup>th</sup> century

**Description:** Raised frame barn with metal roof, timber siding and concrete foundation. Timber shed adjacent

**Mitigation of Negative Impacts:** No negative impacts identified, therefore no further mitigation recommended.

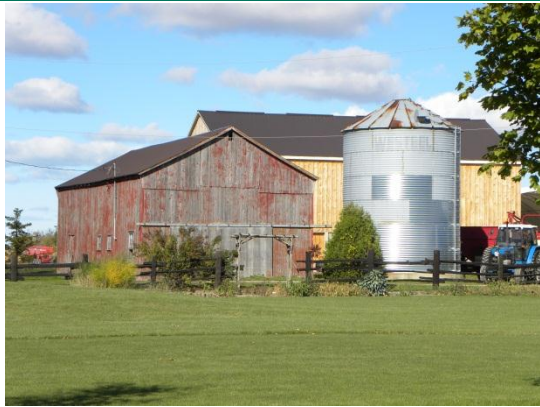
**Site #4 – 5608 Fisher Line (Town of Plympton-Wyoming)**

**Date:** 19<sup>th</sup> – early 20<sup>th</sup> century

**Description:** Frame barn with metal roof, timber siding and undetermined foundation. One metal bin and modern timber barn adjacent.

**Mitigation of Negative Impacts:** No negative impacts identified, therefore no further mitigation recommended.

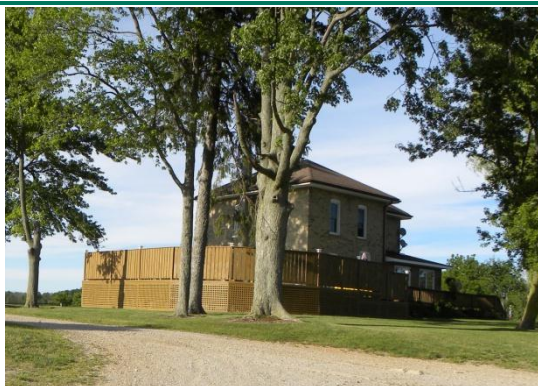
**Site #5 –5334 Fisher Line (Town of Plympton-Wyoming)**

**Date:** 1870s – 1900s

**Description:** Two storey L-shaped house with covered inset porch; pyramidal hipped roof with low pitch; yellow brick exterior; covered concrete foundation.

**Mitigation of Negative Impacts:** No negative impacts identified, therefore no further mitigation recommended.

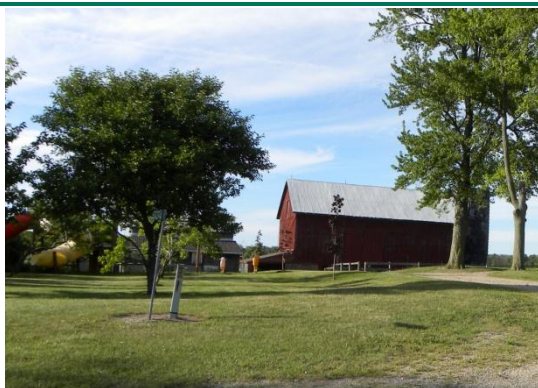
**Date:** 19<sup>th</sup> – early 20<sup>th</sup> century

**Description:** Raised frame barn with side addition, metal roof, metal siding and stone foundation.

**Mitigation of Negative Impacts:** No negative impacts identified, therefore no further mitigation recommended.

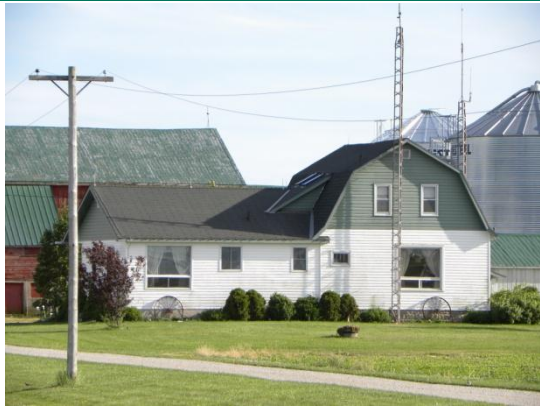
**Site #6 –5323 Aberarder Line (Town of Plympton-Wyoming)**

**Date:** Early 20<sup>th</sup> century

**Description:** One and one half storey house with rear and single storey side addition; side gabled and gambrel roof with medium pitch; clad in modern siding; concrete block foundation.

**Mitigation of Negative Impacts:** Impacts were not identified, therefore mitigation is not recommended or necessary.

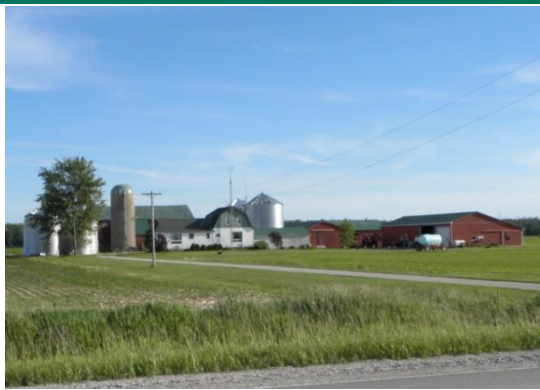
**Date:** Various (19<sup>th</sup> and 20<sup>th</sup> century)

**Description:** One raised frame barn with metal roof, timber siding and concrete foundation. One concrete silo. Two timber sheds with metal roofs, timber siding and undetermined foundation. One metal shed with metal siding, and undetermined foundation. Six modern metal bins.

**Mitigation of Negative Impacts:** No negative impacts identified, therefore no further mitigation recommended.

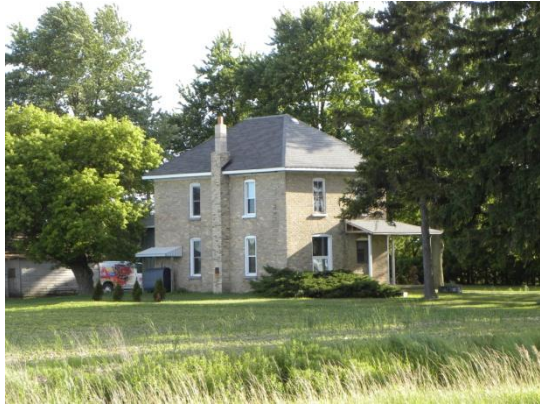
**Site #7 –5273 Aberarder Line (Town of Plympton-Wyoming)**

**Date:** 1870s – 1900s

**Description:** Two storey L-shaped house with rear addition and side wrap-around porch; hipped roof with medium pitch; yellow brick exterior; undetermined foundation.

**Potential Direct and Indirect Impacts to the Identified Heritage Attributes:** None anticipated.

**Mitigation of Negative Impacts:** No negative impacts identified, therefore no further mitigation recommended.

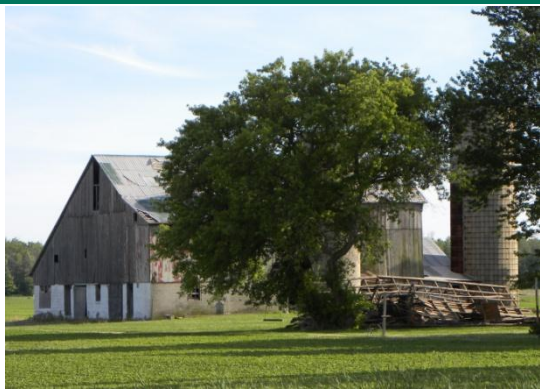
**Date:** Various (19<sup>th</sup> and 20<sup>th</sup> century)

**Description:** Raised frame barn with rear shed addition, metal roof, timber frame siding, and concrete foundation. One concrete silo.

**Mitigation of Negative Impacts:** No negative impacts identified, therefore no further mitigation recommended.

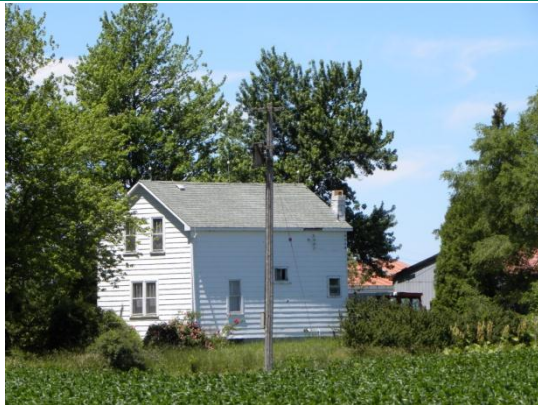
**Site #8 –4474 Aberarder Line (Town of Plympton-Wyoming)**

**Date:** 1850s – 1890s

**Description:** One and one half storey house with single storey addition; front gabled roof with medium pitch and side gabled addition with medium pitch; clad in modern siding; undetermined foundation.

**Potential Direct and Indirect Impacts to the Identified Heritage Attributes:** CHVI was not identified, therefore impacts were not assessed.

**Mitigation of Negative Impacts:** Impacts were not identified, therefore mitigation is not recommended or necessary.

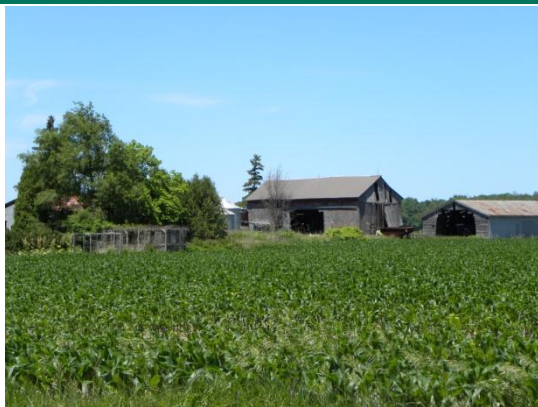
**Date:** 20<sup>th</sup> century

**Description:** Side gabled frame barn with metal roof and undetermined foundation. Three timber sheds, and three modern metal bins.

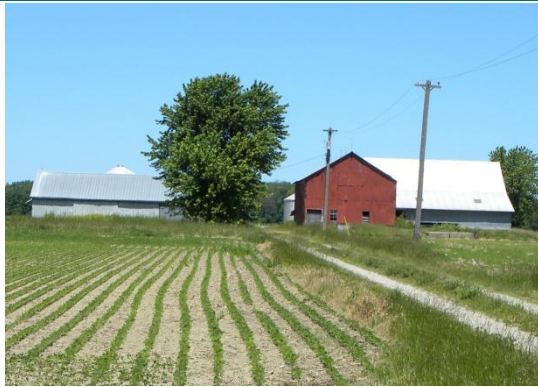
**Site #9 –4334 Aberarder Line (Town of Plympton-Wyoming)**

**Date:** Various (19<sup>th</sup> – 20<sup>th</sup> century)

**Description:** Two attached frame barns both with metal siding and undetermined foundation. One metal barn. Two metal bins.

**Mitigation of Negative Impacts:** No negative impacts identified, therefore no further mitigation recommended.

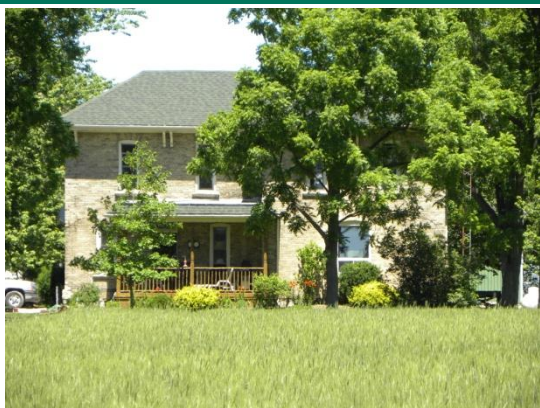
**Site #10 –4334 Aberarder Line (Town of Plympton-Wyoming)**

**Date:** 1870s – 1900s

**Description:** Two storey T-shaped house with rear addition and partial inset porch; cross-hipped roof with medium pitch brick house; hipped roof; undetermined foundation. Decorative brackets.

**Potential Direct and Indirect Impacts to the Identified Heritage Attributes:** None anticipated.

**Mitigation of Negative Impacts:** No negative impacts identified, therefore no further mitigation recommended.

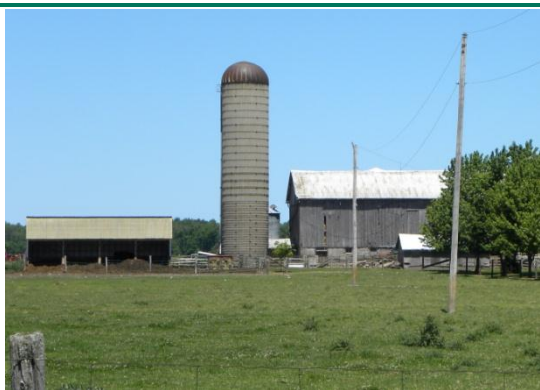
**Date:** Various (19<sup>th</sup> and 20<sup>th</sup> century)

**Description:** Timber framed barn; concrete foundation; concrete silo. Two modern silos. Modern metal shed.

**Mitigation of Negative Impacts:** No negative impacts identified, therefore no further mitigation recommended.
