Ministry of Tourism Culture and Sport  
Comments and Recommendations  
October 5, 2012

**RE: Suncor Energy Cedar Point Wind Energy Facility**  
**Location: Multiple lots, Municipality of Lambton Shores, Township of Warwick, and Town of Plympton-Wyoming, Lambton County**  
**OPA Reference Number: FIT-F80K1QB**  
**MTC DPR File No.: PLAN-38EA051**

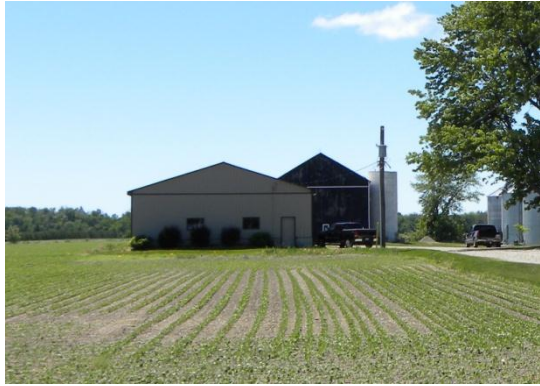
**Site #11 – Douglas Line (Town of Plympton-Wyoming)**

**Date:** 20<sup>th</sup> century

**Description:** Side gabled frame barn with metal roof, undetermined foundation. One metal shed. One concrete silo. Three metal bins.

**Mitigation of Negative Impacts:** Impacts were not identified, therefore mitigation is not recommended or necessary.

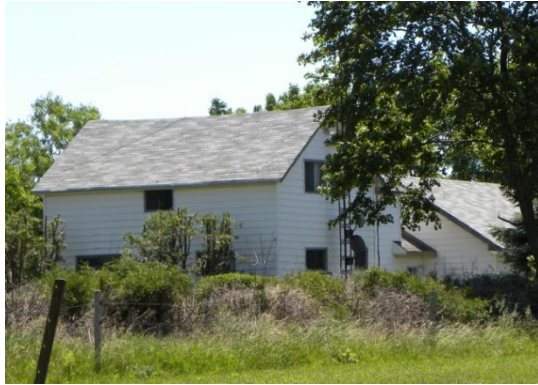
**Site #12 – 4695 Douglas Line (Town of Plympton-Wyoming)**

**Date:** 1850s – 1890s

**Description:** One and one half storey house with rear addition; side gabled roof with medium pitch; clad in modern siding; and undetermined foundation.

**Potential Direct and Indirect Impacts to the Identified Heritage Attributes:** CHVI was not identified, therefore impacts were not assessed.

**Mitigation of Negative Impacts:** Impacts were not identified, therefore mitigation is not recommended or necessary.

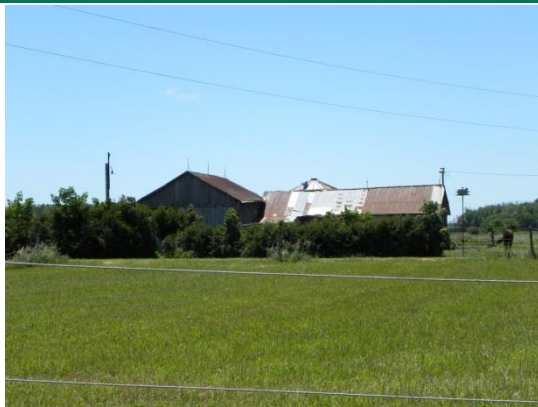
**Date:** Various (19<sup>th</sup> and 20<sup>th</sup> century)

**Description:** Two frame barns with metal roofs and undetermined foundations. One metal bin.

**Mitigation of Negative Impacts:** No negative impacts identified, therefore no further mitigation recommended.

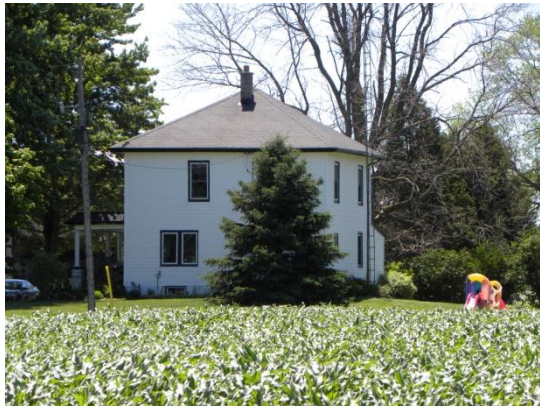
**Site #13 – 4823 Douglas Line (Town of Plympton-Wyoming)**

**Date:** 1870s – 1900s

**Description:** Two storey foursquare house with partial front porch and side addition; pyramidal roof with medium pitch; clad in modern siding; concrete covered stone foundation (stone partially visible).

**Potential Direct and Indirect Impacts to the Identified Heritage Attributes:** None anticipated.

**Mitigation of Negative Impacts:** No negative impacts identified, therefore no further mitigation recommended.

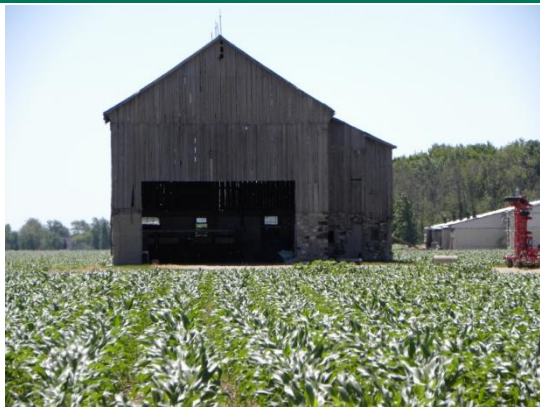
**Date:** Various (19<sup>th</sup> and 20<sup>th</sup> century)

**Description:** Front gabled frame barn, undetermined roof and stone foundation. Two modern metal bins.

**Identified Heritage Attributes:** Timber frame construction and stone foundation. Relationship of structure to residence and road.

**Mitigation of Negative Impacts:** No negative impacts identified, therefore no further mitigation recommended.

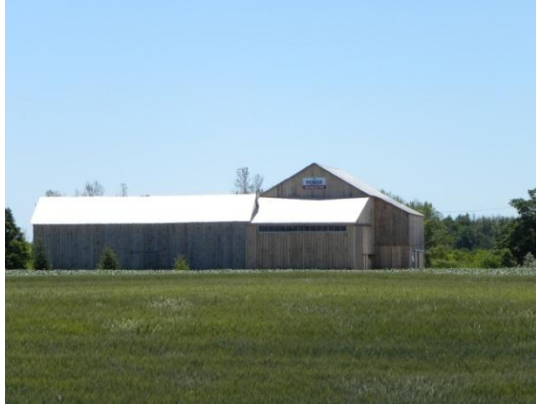
**Site #14 –5023 Douglas Line (Town of Plympton-Wyoming)**

**Date:** Various (19<sup>th</sup> – 20<sup>th</sup> century)

**Description:** Two frame barns and two metal barns. One frame barn is raised with a front gabled metal roof (possibly new timber used). Second frame barn is side gabled, also with metal roof. One metal barn has a gambrel metal roof and is clad in metal siding. Second metal barn has front gabled metal roof and also clad in metal. All foundations were undetermined.

**Mitigation of Negative Impacts:** No negative impacts identified, therefore no further mitigation recommended.

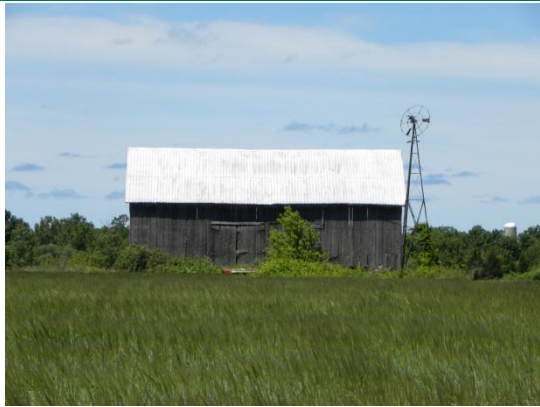
**Site #15 – Hillsboro Road (Town of Plympton-Wyoming)**

**Date:** 19<sup>th</sup> – early 20<sup>th</sup> century

**Description:** Front gabled frame barn; metal roof; undetermined foundation.

**Mitigation of Negative Impacts:** No negative impacts identified, therefore no further mitigation recommended.

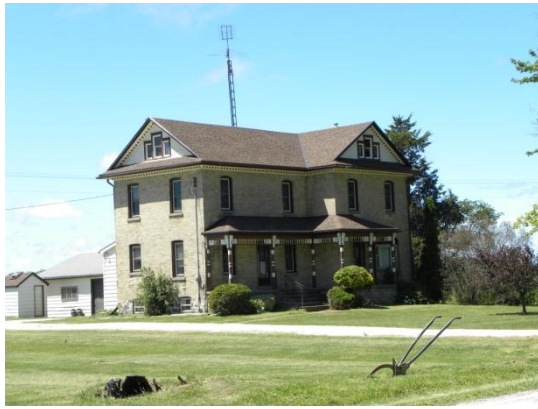
**Site #16– 5019 Hubbard Line (Town of Plympton-Wyoming)**

**Date:** 1880s – 1920s

**Description:** Two storey L-shaped house with rear addition and partial inset front porch; cross gabled roof with medium pitch; yellow brick exterior; stone foundation. Decorative details throughout include: gable end fishscale wood shingles, cornice detailing, porch spindles.

**Mitigation of Negative Impacts:** No negative impacts identified, therefore no further mitigation recommended.

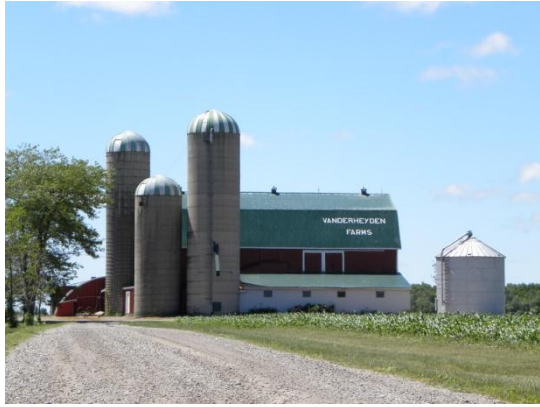
**Site #17 – 5121 Hubbard Line (Town of Plympton-Wyoming)**

**Date:** Various (19<sup>th</sup> and 20<sup>th</sup> century)

**Description:** Frame barn with gambrel roof and undetermined siding and foundation. Three concrete silos. One modern metal bin. Two metal drive sheds.

**Mitigation of Negative Impacts:** No negative impacts identified, therefore no further mitigation recommended.

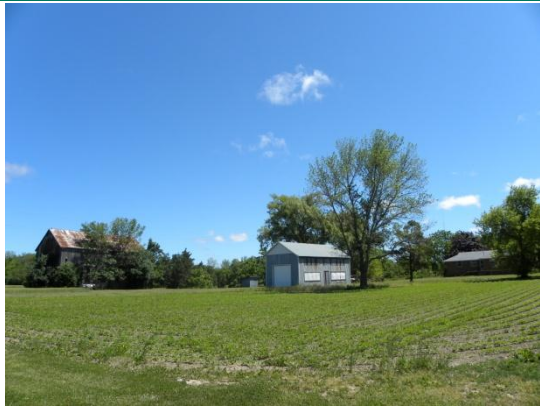
**Site #18 – 7870 Elmsley Road (Town of Plympton-Wyoming)**

**Date:** Various (19<sup>th</sup> and 20<sup>th</sup> century)

**Description:** Front gabled shed with metal roof, metal siding, and undetermined foundation. Front gabled frame barn with metal roof, partial metal siding, and rusticated concrete block foundation.

**Mitigation of Negative Impacts:** No negative impacts identified, therefore no further mitigation recommended.

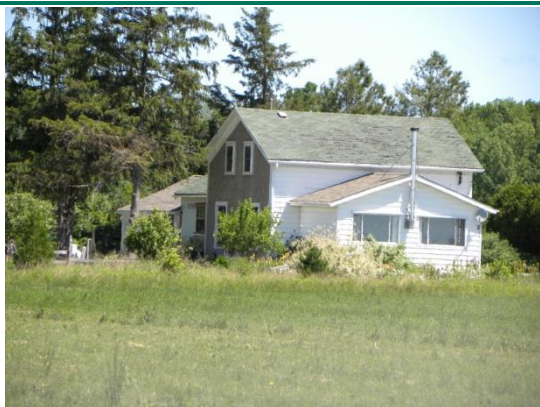
**Site #19 – 5222 Hubbard Line (Town of Plympton-Wyoming)**

**Date:** 1850s – 1890s

**Description:** One and one half storey house with rear and front addition; side gabled roof with front gabled along front facade; clad in modern siding; undetermined foundation.

**Potential Direct and Indirect Impacts to the Identified Heritage Attributes:** CHVI was not identified, therefore impacts were not assessed.

**Mitigation of Negative Impacts:** Impacts were not identified, therefore mitigation is not recommended or necessary.

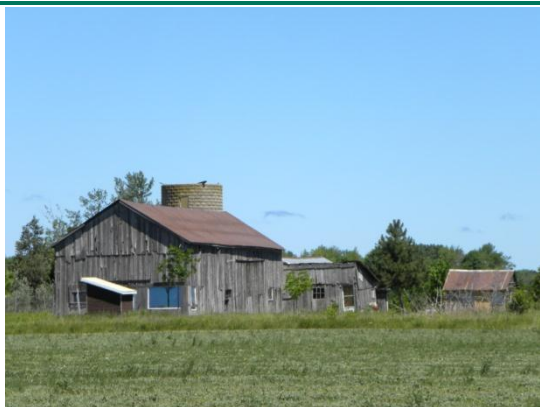
**Date:** Various (19<sup>th</sup> and 20<sup>th</sup> century)

**Description:** Front gabled frame barn with metal roof and rusticated concrete block foundation. Rusticated concrete block silo.

**Mitigation of Negative Impacts:** No negative impacts identified, therefore no further mitigation recommended.

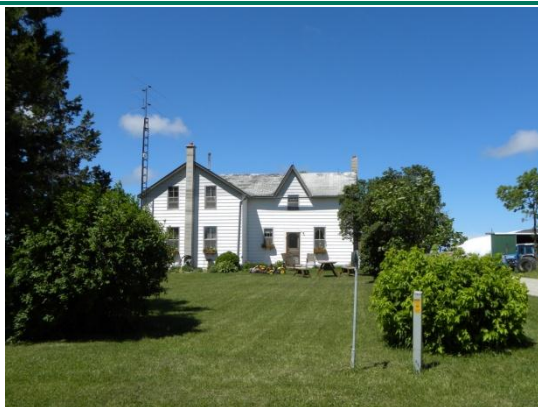
**Site #20 –7849 Uttoxeter Road (Town of Plympton-Wyoming)**

**Date:** 1880s – 1920s

**Description:** One and half storey L-shaped house; cross gabled roof with medium pitch and central gable with window and steep pitch; clad in modern siding; undetermined foundation.

**Potential Direct and Indirect Impacts to the Identified Heritage Attributes:** None anticipated.

**Mitigation of Negative Impacts:** No negative impacts identified, therefore no further mitigation recommended.

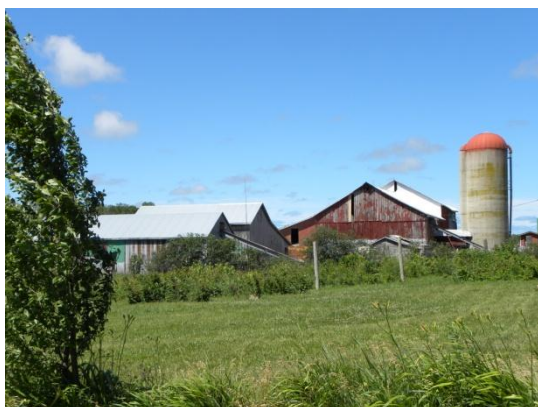
**Date:** Various (19<sup>th</sup> and 20<sup>th</sup> century)

**Description:** Two raised frame barns appear attached, with rear shed addition, and undetermined foundation. Two additional barns also with metal roofs, clad in metal siding with undetermined foundation. One metal drive shed. Two concrete silos. One metal bin.

**Mitigation of Negative Impacts:** No negative impacts identified, therefore no further mitigation recommended.

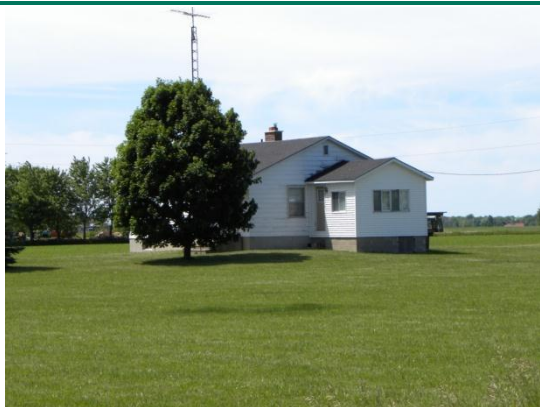
**Site #21 –5512 Townsend Line (Municipality of Lambton Shores)**

**Date:** Post 1950

**Description:** Single storey house with small side addition; side gabled roof with low pitch; clad in modern siding; concrete block foundation.

**Potential Direct and Indirect Impacts to the Identified Heritage Attributes:** CHVI was not identified, therefore impacts were not assessed.

**Mitigation of Negative Impacts:** Impacts were not identified, therefore mitigation is not recommended or necessary.

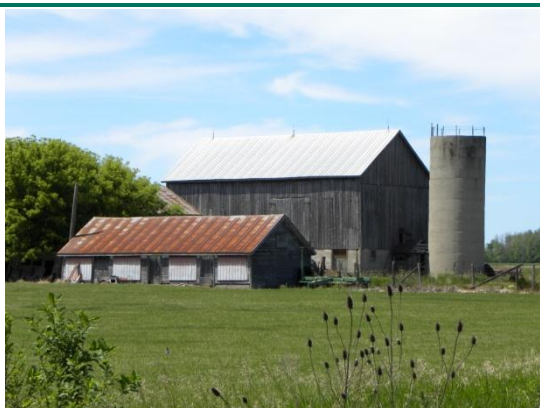
**Date:** Various (19<sup>th</sup> and 20<sup>th</sup> century)

**Description:** Raised frame barn with metal roof, timber siding and concrete block foundation. Two smaller timber sheds with metal roof, timber siding, and concrete foundation. One concrete silo.

**Mitigation of Negative Impacts:** No negative impacts identified, therefore no further mitigation recommended.

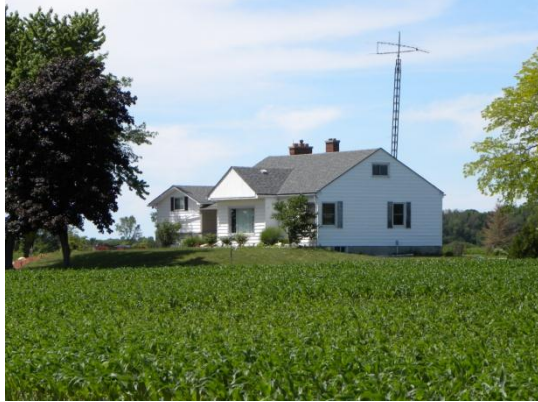
**Site #22 –5622 Townsend Line (Municipality of Lambton Shores)**

**Date:** Post 1950

**Description:** One and one half storey side-split house; side gabled roof with low pitch, cross gable at front, and side dormer with garage; clad in modern siding; concrete foundation.

**Mitigation of Negative Impacts:** Impacts were not identified, therefore mitigation is not recommended or necessary.

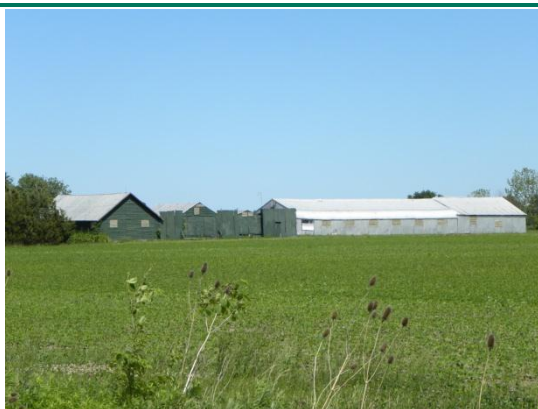
**Date:** 20<sup>th</sup> century

**Description:** Three sheds and one barn. All appear to have metal roofs, metal siding and undetermined foundations.

**Mitigation of Negative Impacts:** No negative impacts identified, therefore no further mitigation recommended.

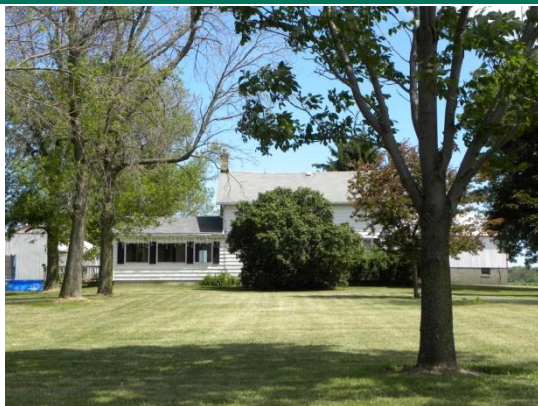
**Site #24 – Unidentified Address, Lakeshore Road (Municipality of Lambton Shores)**

**Date:** 1850s – 1900

**Description:** One and one half storey L-shaped house with single storey side addition; side gabled roof with medium pitch; clad in modern siding, undetermined foundation.

**Potential Direct and Indirect Impacts to the Identified Heritage Attributes:** CHVI was not identified, therefore impacts were not assessed.

**Mitigation of Negative Impacts:** Impacts were not identified, therefore mitigation is not recommended or necessary.

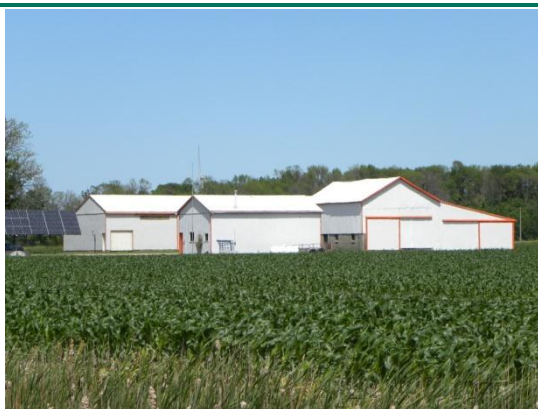
**Date:** Late 19<sup>th</sup> – 20<sup>th</sup> century

**Description:** One raised frame barn with rear shed addition, metal roof, metal siding and concrete block foundation. Two sheds with metal roofs, metal siding and undetermined foundations.

**Mitigation of Negative Impacts:** No negative impacts identified, therefore no further mitigation recommended.

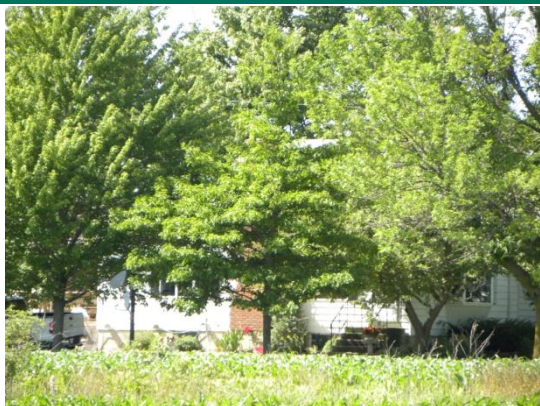
**Site #25 – 8133 Fuller Road (Municipality of Lambton Shores)**

**Date:** 1890s – 1920s

**Description:** One and one half storey; undetermined roof; clad in modern siding; rusticated concrete block foundation. Foliage coverage restricted design and age identification.

**Potential Direct and Indirect Impacts to the Identified Heritage Attributes:** None anticipated.

**Mitigation of Negative Impacts:** No negative impacts identified, therefore no further mitigation recommended.

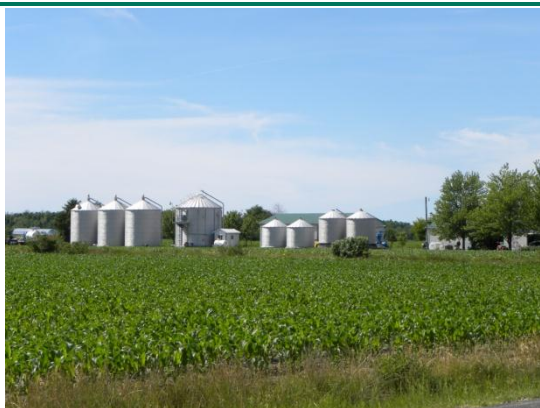
**Date:** Post 1950

**Description:** Three sheds with metal roofs, metal siding and undetermined foundations. Eight metal bins.

**Mitigation of Negative Impacts:** Impacts were not identified, therefore mitigation is not recommended or necessary.

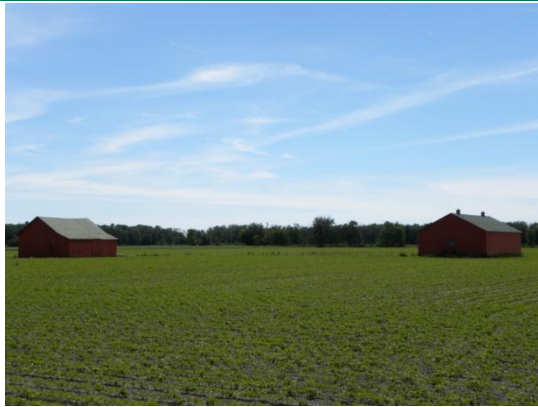
**Site #26 – 8183 Fuller Road (Municipality of Lambton Shores)**

**Date:** 20<sup>th</sup> century

**Description:** Two sheds both with metal roofs, metal siding and undetermined foundation.

**Mitigation of Negative Impacts:** No negative impacts identified, therefore no further mitigation recommended.

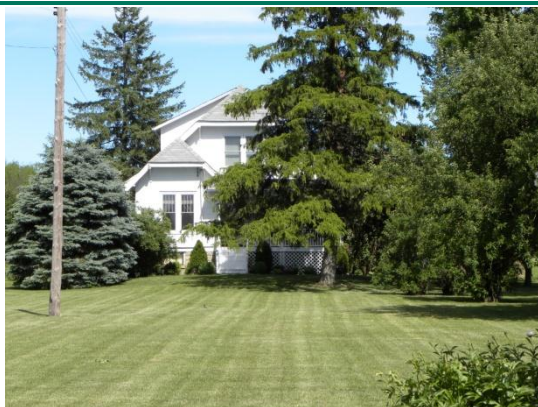
**Site #27 – 8274 Fuller Road (Municipality of Lambton Shores)**

**Date:** 1890s – 1920s

**Description:** One and one half storey house with inset front porch; hip-on-gable roof with medium pitch and side shed dormer and cross gable; modern siding; rusticated concrete block foundation.

**Mitigation of Negative Impacts:** Impacts were not identified, therefore mitigation is not recommended or necessary.

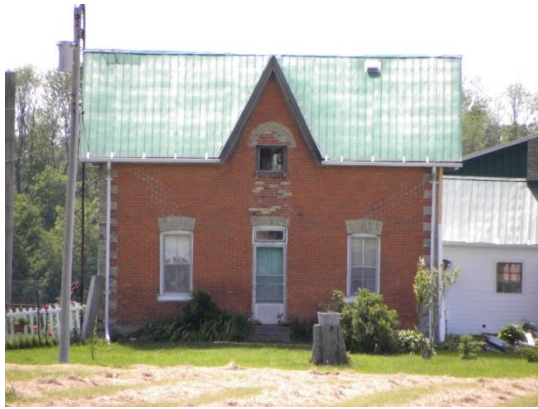
**Site #28 – 8279 Fuller Road (Municipality of Lambton Shores)**

**Date:** 1870s – 1890s

**Description:** One and one half storey red brick house with single storey addition; side gabled roof with medium roof pitch and central gable with steep pitch; red brick exterior with yellow brick detailing including quoins and rounded window crowns; undetermined foundation. Vernacular Gothic Revival characteristics include symmetrical design and steep pitched central gable containing window extending into gable.

**Mitigation of Negative Impacts:** No negative impacts identified, therefore no further mitigation recommended.

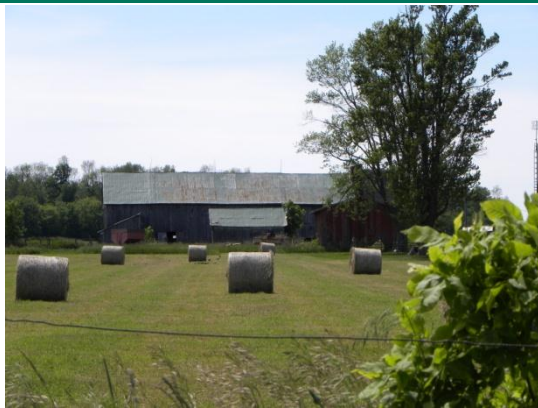
**Date:** Late 19<sup>th</sup> – 20<sup>th</sup> century

**Description:** Frame barn with metal roof, timber siding and undetermined foundation. Two sheds, both with metal roofs, one with timber siding and one with metal, both have undetermined foundations. Concrete silo.

**Mitigation of Negative Impacts:** No negative impacts identified, therefore no further mitigation recommended.

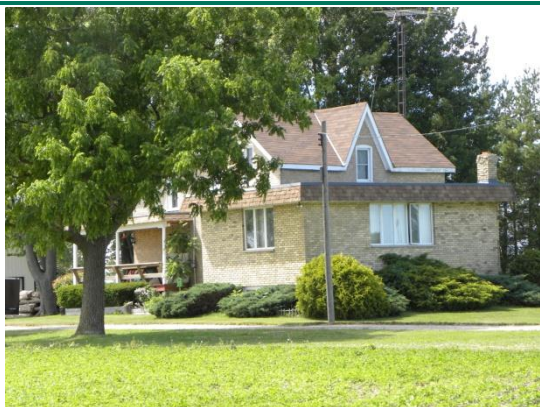
**Site #29 –8337 Fuller Road (Municipality of Lambton Shores)**

**Date:** 1880s – 1920s

**Description:** One and one half storey T-shaped house with modern front and side additions and inset side porch; side gabled roof with medium roof pitch and central gable with steep pitch; yellow brick exterior; undetermined foundation.

**Potential Direct and Indirect Impacts to the Identified Heritage Attributes:** None anticipated.

**Mitigation of Negative Impacts:** No negative impacts identified, therefore no further mitigation recommended.

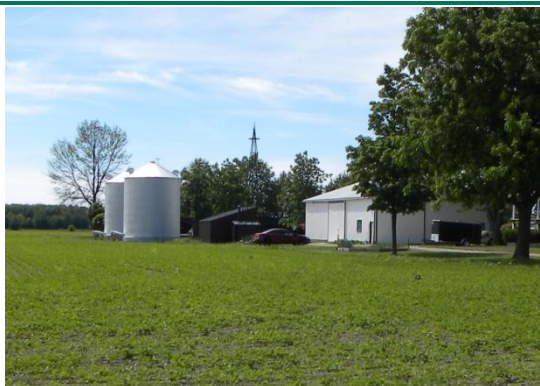
**Date:** Post 1950

**Description:** Metal shed and two metal bins.

**Mitigation of Negative Impacts:** Impacts were not identified, therefore mitigation is not recommended or necessary.

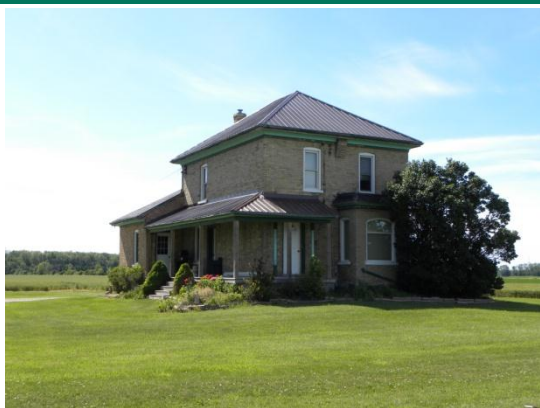
**Site #30 – 8219 Rawlings Road (Municipality of Lambton Shores)**

**Date:** 1870s – 1900s

**Description:** Two storey house with rear addition, partial wrap-around porch and mansard roof bay window; pyramidal hipped roof with medium pitch and decorative wood cornice and frieze; yellow brick exterior; stone foundation.

**Potential Direct and Indirect Impacts to the Identified Heritage Attributes:** None anticipated.

**Mitigation of Negative Impacts:** No negative impacts identified, therefore no further mitigation recommended.

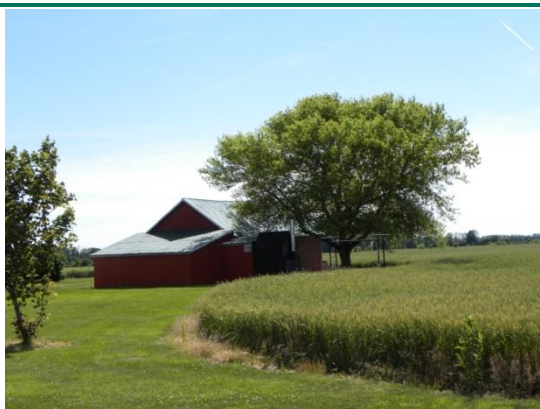
**Date:** 20<sup>th</sup> century

**Description:** Front gabled shed with shed addition, metal roof, metal siding and undetermined foundation.

**Mitigation of Negative Impacts:** Impacts were not identified, therefore mitigation is not recommended or necessary.

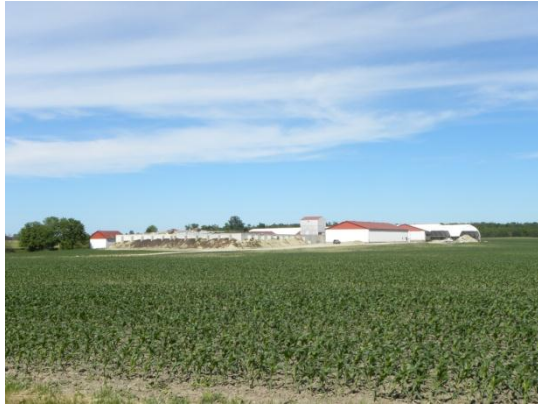
**Site #31 – 8070 Rawlings Road (Municipality of Lambton Shores)**

**Date:** 20<sup>th</sup> century

**Description:** Five metal livestock barns with metal roofs, metal siding and concrete foundations. Two plastic drive sheds. Three storey structure with metal roof, metal siding and undetermined foundation.

**Mitigation of Negative Impacts:** Impacts were not identified, therefore mitigation is not recommended or necessary.

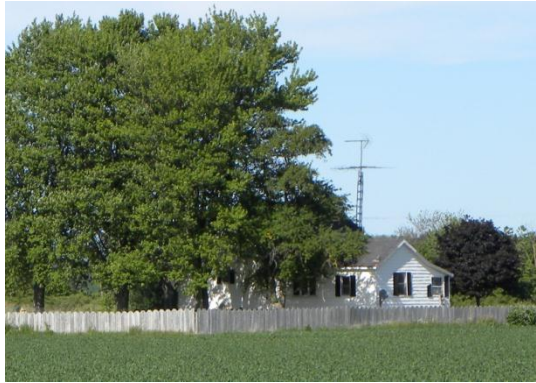
**Site #32 – 6672 Townsend Line (Municipality of Lambton Shores)**

**Date:** Post 1950

**Description:** Single storey house; side gabled roof with low pitch; undetermined foundation.

**Potential Direct and Indirect Impacts to the Identified Heritage Attributes:** CHVI was not identified, therefore impacts were not assessed.

**Mitigation of Negative Impacts:** Impacts were not identified, therefore mitigation is not recommended or necessary.

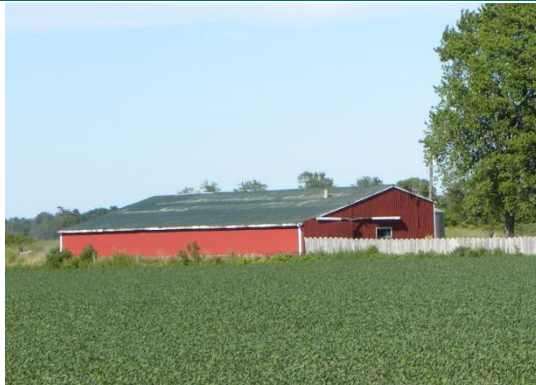
**Date:** 20<sup>th</sup> century

**Description:** Metal shed with low pitched front gable roof, metal siding and undetermined foundation.

**Mitigation of Negative Impacts:** Impacts were not identified, therefore mitigation is not recommended or necessary.

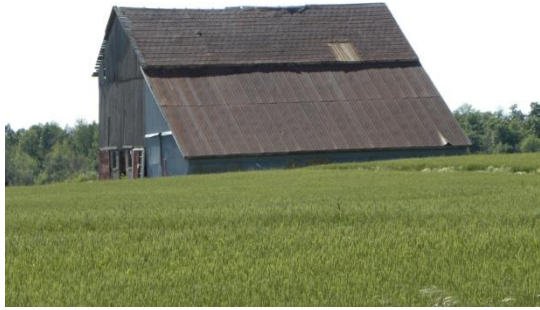
**Site #33 – Undetermined address, Kinnaird Road (Municipality of Lambton Shores)**

**Date:** 19<sup>th</sup> – early 20<sup>th</sup> century

**Description:** Frame barn with side shed addition, asphalt and metal roof, timber and metal siding and concrete block foundation.

**Mitigation of Negative Impacts:** No negative impacts identified, therefore no further mitigation recommended.

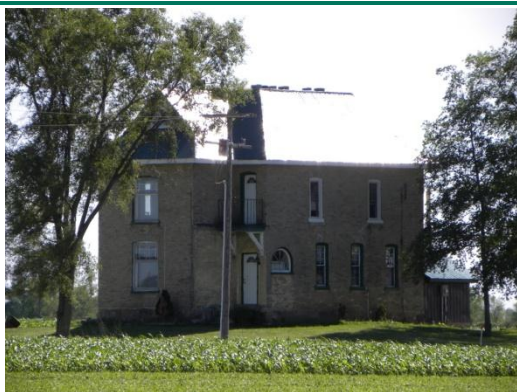
**Site #34 – 8135 Kinnaird Road (Municipality of Lambton Shores)**

**Date:** 1880s – 1920s

**Description:** Two storey house with small rear addition; flat-top hipped roof with cross gable; yellow brick exterior; undetermined foundation. Possibly some original windows remain including six over six windows throughout main floor and stained glass in gable windows.

**Potential Direct and Indirect Impacts to the Identified Heritage Attributes:** None anticipated.

**Mitigation of Negative Impacts:** No negative impacts identified, therefore no further mitigation recommended.

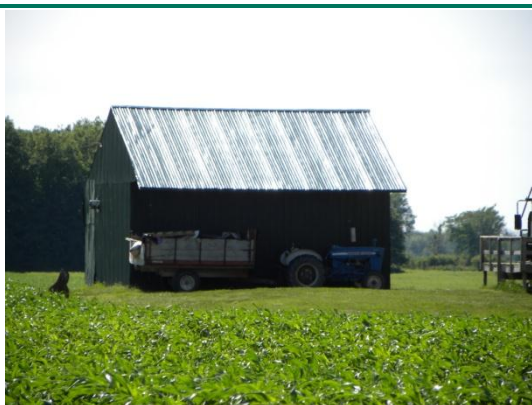
**Date:** 20<sup>th</sup> century

**Description:** Metal shed with metal roof, metal siding and undetermined foundation.

**Mitigation of Negative Impacts:** Impacts were not identified, therefore mitigation is not recommended or necessary.

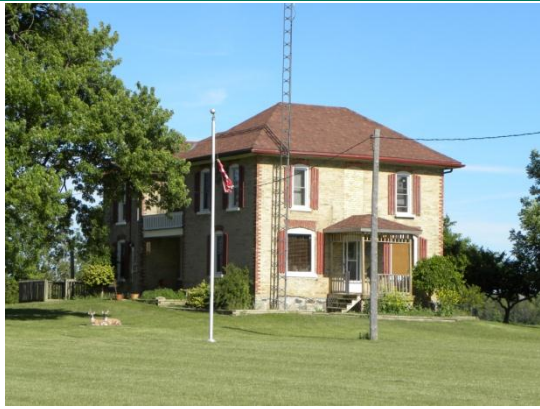
**Site# 35 – 8228 Kinnard Road(Municipality of Lambton Shores)**

**Date:** 1880s – 1920s

**Description:** Two storey I-shaped house with central entry porch and inset two-storey side porch; hipped roof throughout with medium pitch; yellow brick exterior with red brick detailing including quoins and window surrounds; stone foundation.

**Potential Direct and Indirect Impacts to the Identified Heritage Attributes:** None anticipated.

**Mitigation of Negative Impacts:** No negative impacts identified, therefore no further mitigation recommended.

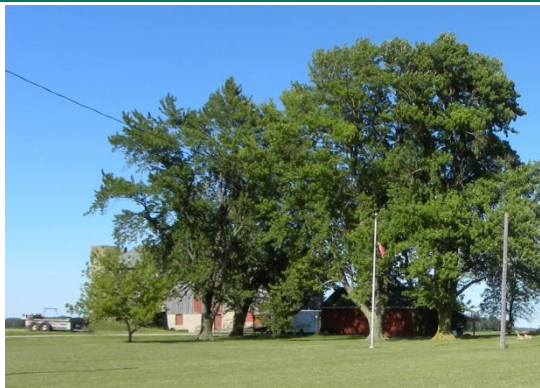
**Date:** Various (19<sup>th</sup> and 20<sup>th</sup> century)

**Description:** Frame barn with metal roof, timber siding and concrete covered, stone foundation. Shed with metal roof, metal siding and undetermined foundation. Concrete silo.

**Identified Heritage Attributes:** Timber frame construction and stone foundation. Relationship of structure to residence and road.

**Mitigation of Negative Impacts:** No negative impacts identified, therefore no further mitigation recommended.

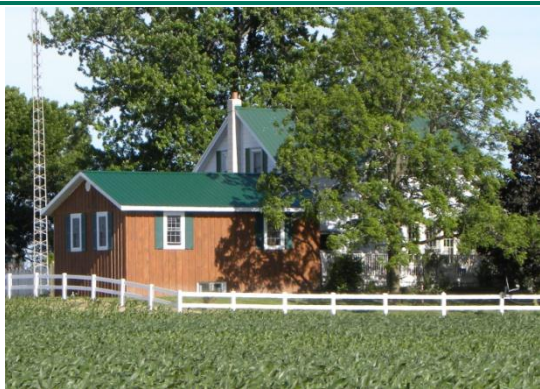
**Site #36 – 8294 Kinnard Road (Municipality of Lambton Shores)**

**Date:** 1850s – 1890s

**Description:** One and one half storey house with single storey side and rear additions; side gabled roof with medium pitch and central dormer with steep pitch; clad in variety of modern siding and undetermined foundation. Foliage coverage restricted design and age identification.

**Potential Direct and Indirect Impacts to the Identified Heritage Attributes:** CHVI was not identified, therefore impacts were not assessed.

**Mitigation of Negative Impacts:** Impacts were not identified, therefore mitigation is not recommended or necessary.

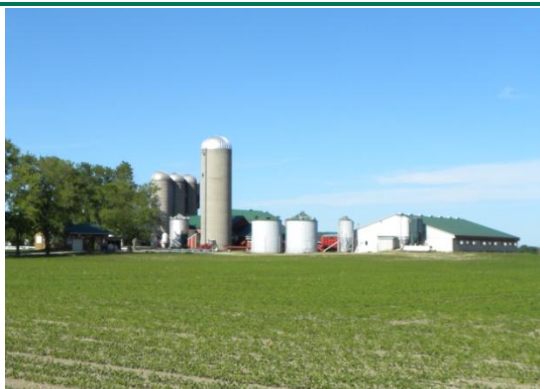
**Date:** Various (20<sup>th</sup> century)

**Description:** At least two barns with metal roofs, metal siding and undetermined foundations. One modern livestock barn with metal roof, metal siding and undetermined foundation. Four metal bins. Four concrete silos. Two plastic drive sheds. Small modern store onsite. Foliage coverage restricted design and age identification.

**Mitigation of Negative Impacts:** Impacts were not identified, therefore mitigation is not recommended or necessary.

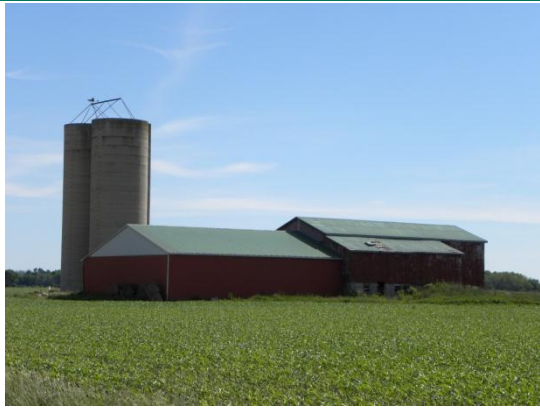
**Site #37 – 8405 Rawlings Road (Municipality of Lambton Shores)**

**Date:** Various (19<sup>th</sup> and 20<sup>th</sup> century)

**Description:** Raised frame barn with side shed and modern front addition. Frame barn has metal roof, metal siding and concrete block foundation. Modern addition has metal roof, metal siding and undetermined foundation. Two concrete silos.

**Mitigation of Negative Impacts:** No negative impacts identified, therefore no further mitigation recommended.

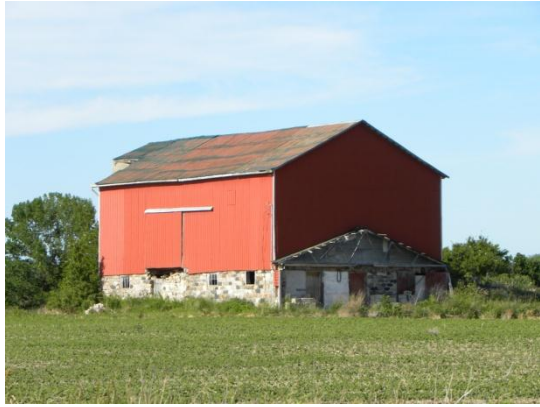
**Site #38 – 8538 Kinnard Road (Municipality of Lambton Shores)**

**Date:** 19<sup>th</sup> – early 20<sup>th</sup> century

**Description:** Raised frame barn with metal roof, metal siding and stone foundation. Former side addition has been removed.

**Identified Heritage Attributes:** Timber frame construction and stone foundation. Relationship of structure to road.

**Mitigation of Negative Impacts:** No negative impacts identified, therefore no further mitigation recommended.

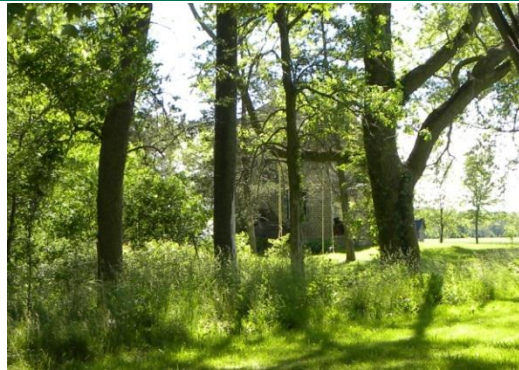
**Site #39 – 8605 Kinnaird Road (Municipality of Lambton Shores)**

**Date:** 1870s – 1900s

**Description:** Two storey L-shaped timber framed house; hipped roof with medium pitch; timber clad in brick laid on edge, frog-side out; stone foundation. Foliage coverage restricted design and age identification.

**Mitigation of Negative Impacts:** No negative impacts identified, therefore no further mitigation recommended.

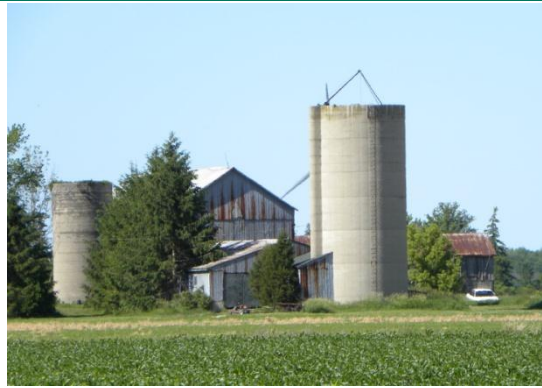
**Site #40 – No municipal address, Rawlings Road (Municipality of Lambton Shores)**

**Date:** Various (19<sup>th</sup> and 20<sup>th</sup> century)

**Description:** One raised frame barn with metal roof, both timber and metal siding and undetermined foundation. Second barn obstructed by foliage. Two concrete silos. Foliage coverage restricted design and age identification.

**Mitigation of Negative Impacts:** No negative impacts identified, therefore no further mitigation recommended.

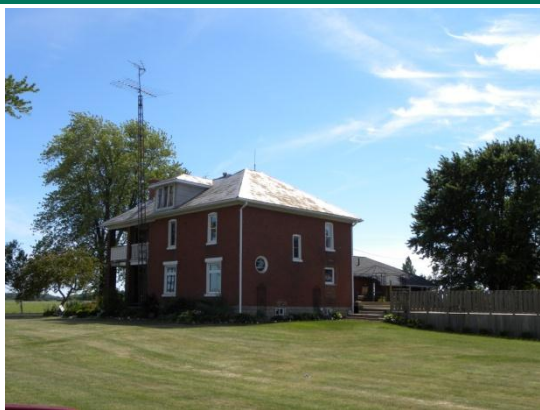
**Site #41 – 8603 Rawlings Road (Municipality of Lambton Shores)**

**Date:** 1890s – 1920s

**Description:** Two storey L-shaped house with single storey rear addition and inset two storey porch; hipped roof with medium pitch and central hipped gable; red brick exterior; rusticated concrete block foundation.

**Potential Direct and Indirect Impacts to the Identified Heritage Attributes:** None anticipated.

**Mitigation of Negative Impacts:** No negative impacts identified, therefore no further mitigation recommended.

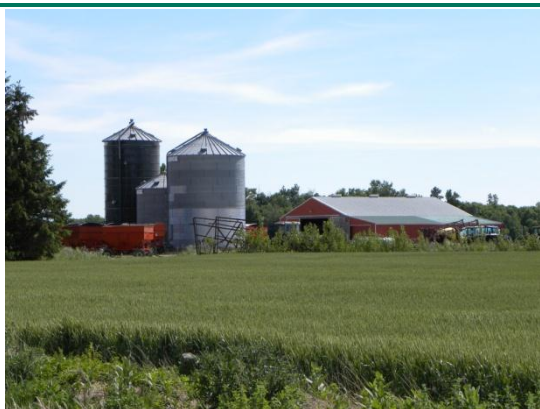
**Date:** 20<sup>th</sup> century

**Description:** Shed with metal roof, metal exterior and undetermined foundation. Three metal bins.

**Mitigation of Negative Impacts:** No negative impacts identified, therefore no further mitigation recommended.

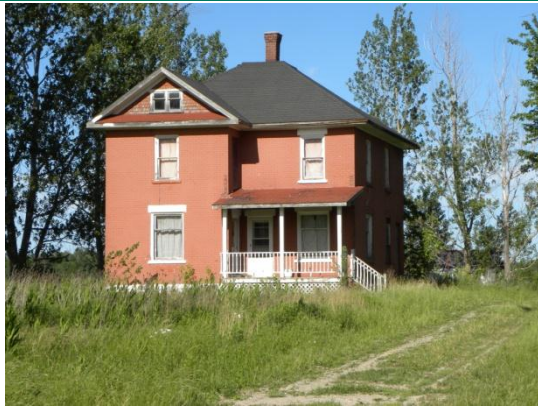
**Site #42 – 8780 Kinnard Road (Municipality of Lambton Shores)**

**Date:** 1880s – 1920s

**Description:** Two storey house with lower front cross gable and partial front porch; pyramidal hipped roof with medium pitch; red brick exterior painted red; undetermined foundation. Design details include fishscale shingles in gable and wide eaves. House appears abandoned.

**Potential Direct and Indirect Impacts to the Identified Heritage Attributes:** None anticipated.

**Mitigation of Negative Impacts:** No negative impacts identified, therefore no further mitigation recommended.

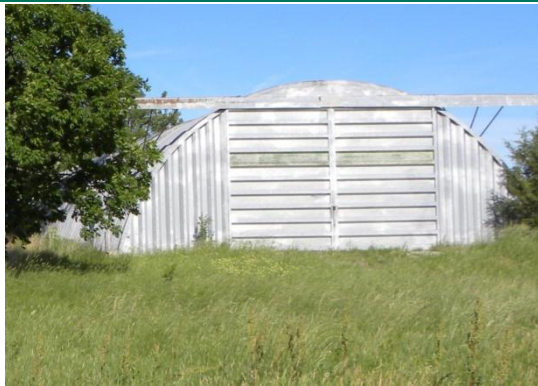
**Date:** Post 1950

**Description:** Metal drive shed.

**Mitigation of Negative Impacts:** Impacts were not identified, therefore mitigation is not recommended or necessary.

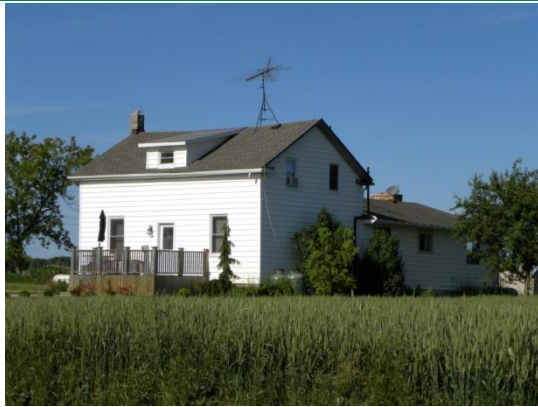
**Site #43 – 8954 Kinnard Road (Municipality of Lambton Shores)**

**Date:** 1850s – 1890s

**Description:** One and half storey house with rear addition; side gabled roof with low pitch and central hood dormer; clad in modern siding; concrete foundation.

**Potential Direct and Indirect Impacts to the Identified Heritage Attributes:** CHVI was not identified, therefore impacts were not assessed.

**Mitigation of Negative Impacts:** Impacts were not identified, therefore mitigation is not recommended or necessary.

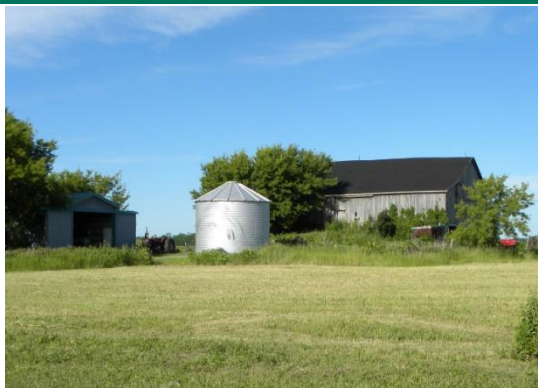
**Date:** Various (19<sup>th</sup> and 20<sup>th</sup> century)

**Description:** Raised frame barn with asphalt shingle roof, timber siding and concrete block foundation. One concrete silo. One metal bin.

**Mitigation of Negative Impacts:** No negative impacts identified, therefore no further mitigation recommended.

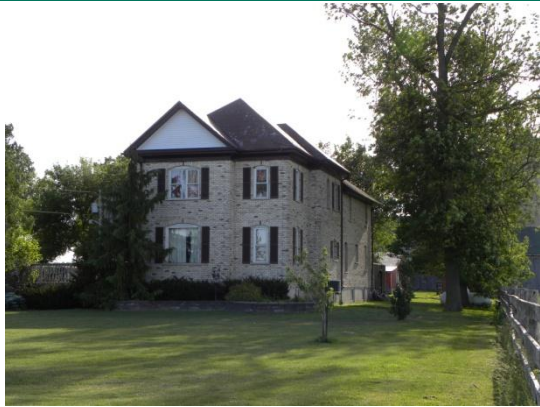
**Site #44 –8851 Army Camp Road (Municipality of Lambton Shores)**

**Date:** 1880s – 1920s

**Description:** Two storey cross-gabled house with projecting front gable and two storey side porch; hipped roof with irregular cross gables and modern design and materials; mixed yellow brick exterior; concrete foundation.

**Potential Direct and Indirect Impacts to the Identified Heritage Attributes:** None anticipated.

**Mitigation of Negative Impacts:** No negative impacts identified, therefore no further mitigation recommended.

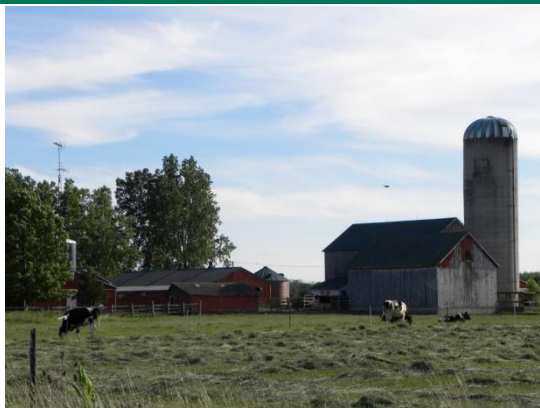
**Date:** Various (19<sup>th</sup> and 20<sup>th</sup> century)

**Description:** One raised frame barn with small shed addition, metal roof, timber siding, and undetermined foundation. One timber shed with metal roof, timber siding and concrete foundation. Livestock barns with metal roof, metal siding and undetermined foundation. Two metal bins. One concrete silo.

**Mitigation of Negative Impacts:** No negative impacts identified, therefore no further mitigation recommended.

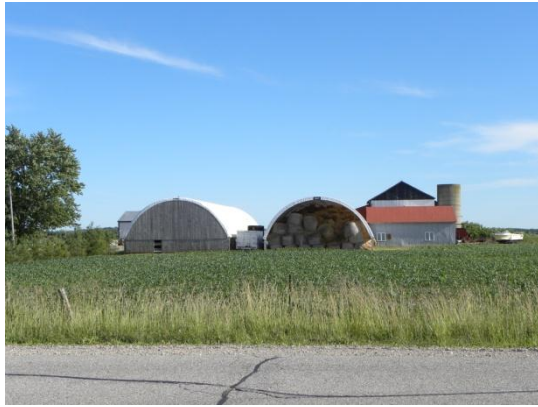
**Site #45 – 8977 and 8981 Army Camp Road (Municipality of Lambton Shores)**

**Date:** Various (19<sup>th</sup> and 20<sup>th</sup> century)

**Description:** One raised frame barn with rear shed addition, metal roof, metal siding and undetermined foundation. Two sheds with metal roofs, metal siding and undetermined foundation. Two modern drive sheds. One concrete silo.

**Mitigation of Negative Impacts:** No negative impacts identified, therefore no further mitigation recommended.

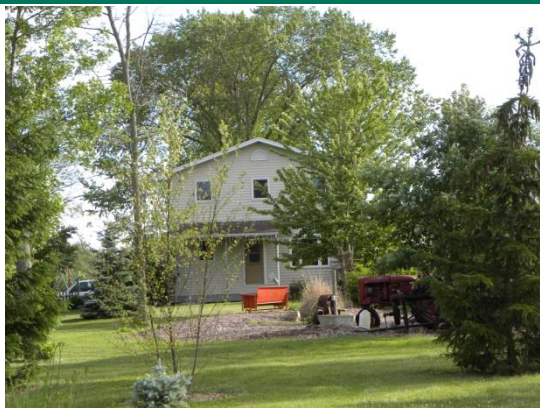
**Site #46 –5407 Cedar Point Line (Municipality of Lambton Shores)**

**Date:** Late 19<sup>th</sup> – early 20<sup>th</sup> century

**Description:** Two storey house; front gabled roof with low pitch; clad in modern siding; concrete foundation.

**Mitigation of Negative Impacts:** Impacts were not identified, therefore mitigation is not recommended or necessary.
