APPENDIX A

CULTURAL STRUCTURES LOCATED ON OPTIONAL PROPERTIES WITH PROPOSED TURBINE RELATED ACTIVITIES

PROJECT			
ADELAIDE WIND FARM PROJECT			
TITLE			
LOCATION OF STRUCTURES FOR BUILT HERITAGE AND CULTURAL LANDSCAPE APPENDIX B			
PROJECT NO. 07-1112-0151		SCALE AS SHOWN	
DESIGN	PP	05 Mar 2008	Tile: 1
GIS	PP	26 Mar 2010	
CHECK	TCJR	26 Mar 2010	
REVIEW	JW	26 Mar 2010

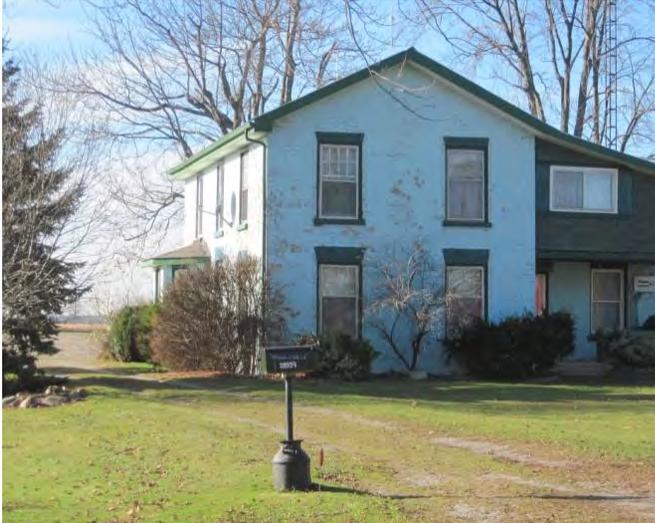
Site #14

HOUSE

Date: mid-late 19th century

Description: Two storey painted brick; low pitch gable end roof, modern addition at rear

1. Design/Physical Value: Possibly an early house; heavily modified.
2. Historical Value: None identified
3. Contextual Value: Contributes to early 20th century agricultural activity of study area.

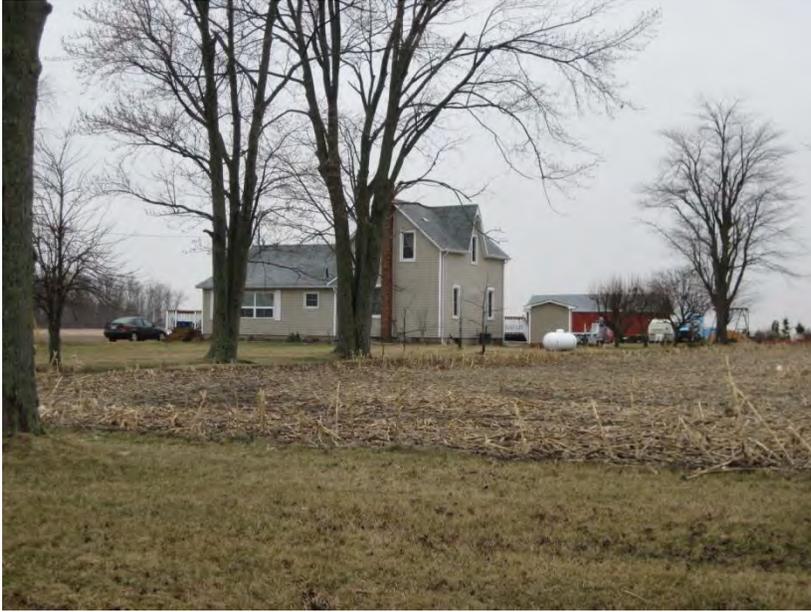
Site #17

Date: c. 1900 ? ; modern addition

Description: Possible one and a half storey, medium pitch gable end roof; frame house, modern one storey addition

1. Design/Physical Value: Heavily modified
2. Historical Value: None identified
3. Contextual Value: Contributes to early 20th century agricultural activity of study area.

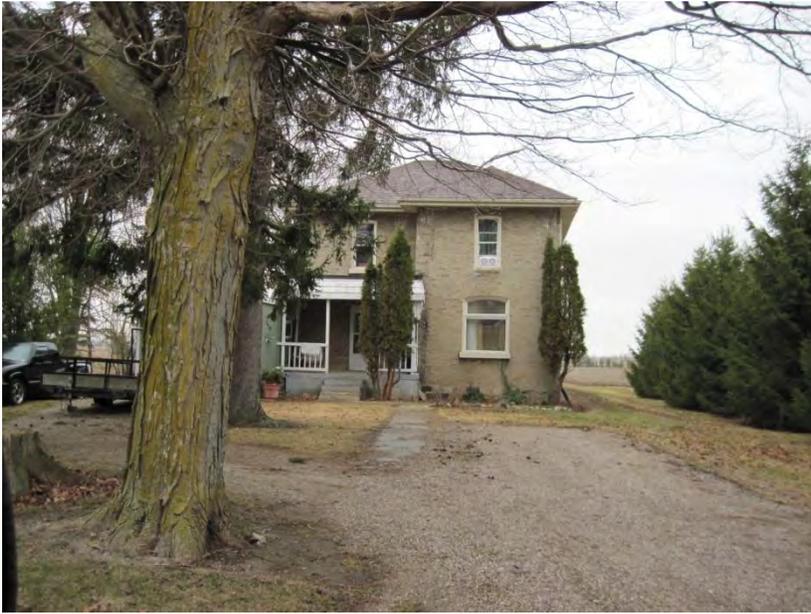
Site #19

Date: c. 1880's-1900

Description: Two storey brick; "L" plan; shallow pitch hipped roof porch on main façade

1. Design/Physical Value: Large house; good condition
2. Historical Value: None identified
3. Contextual Value: Contributes to early 20th century agricultural activity of study area

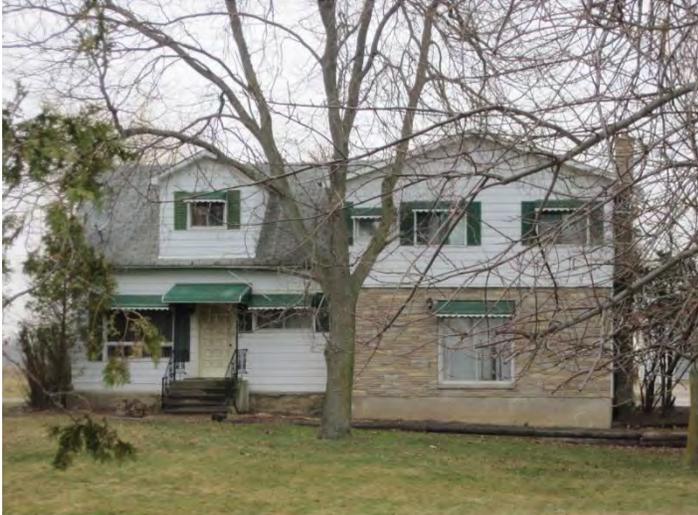
Site #22

Date: c. 1920's ? modern addition

Description: One and a half storey house, steep pitch roof; modern two storey addition

1. Design/Physical Value: Heavily modified
2. Historical Value: None identified
3. Contextual Value: Contributes to early 20th century agricultural activity of study area

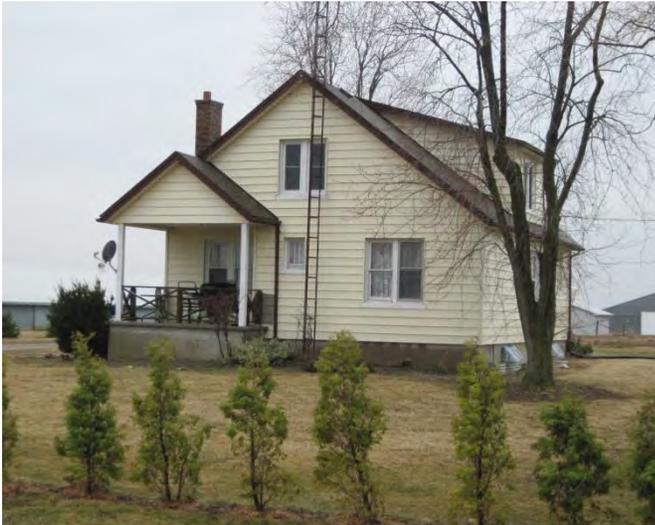
Site #25

HOUSE

Date: c. 1920-1930

Description: One and a half storey; modern vinyl siding; medium pitch roof

1. Design/Physical Value: Heavily modified
2. Historical Value: None identified
3. Contextual Value: Contributes to early 20th century agricultural activity of study area

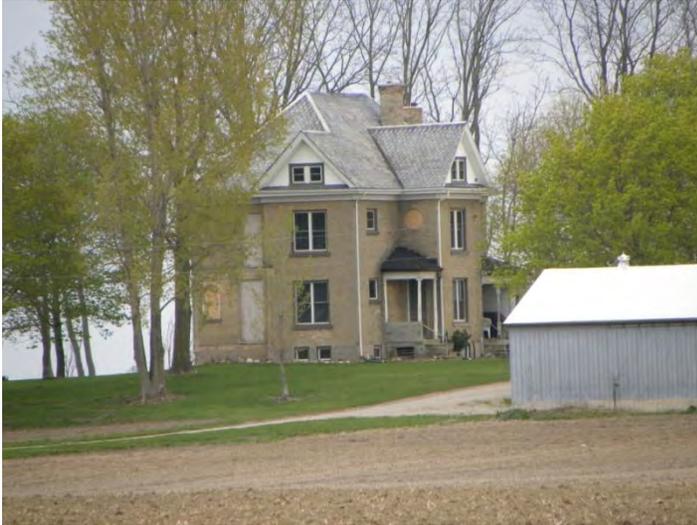
Site #27

Date: 1890s-1910

Description: Two and a half storey, brick, steeply pitched slate roof

1. Design/Physical Value: Large house
2. Historical Value: None identified
3. Contextual Value: Contributes to early 20th century agricultural activity of study area

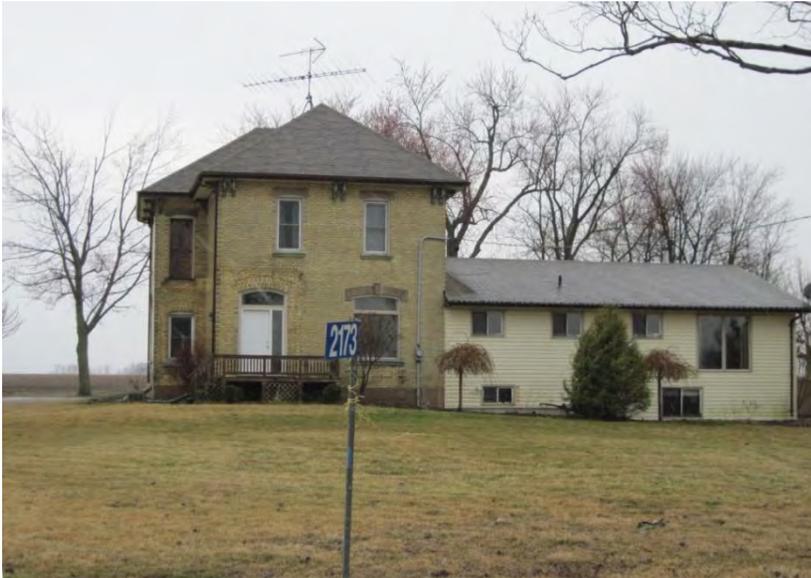
Site #28

Date: c. 1870's-1880's

Description: Similar to Site #1; paired brackets modern roof; large modern addition at rear

1. Design/Physical Value: Large house, in good condition; brackets are prominent; exterior largely unaltered except for removal of porches.
2. Historical Value: Indicative that original owner had been prosperous
3. Contextual Value: All farm buildings new

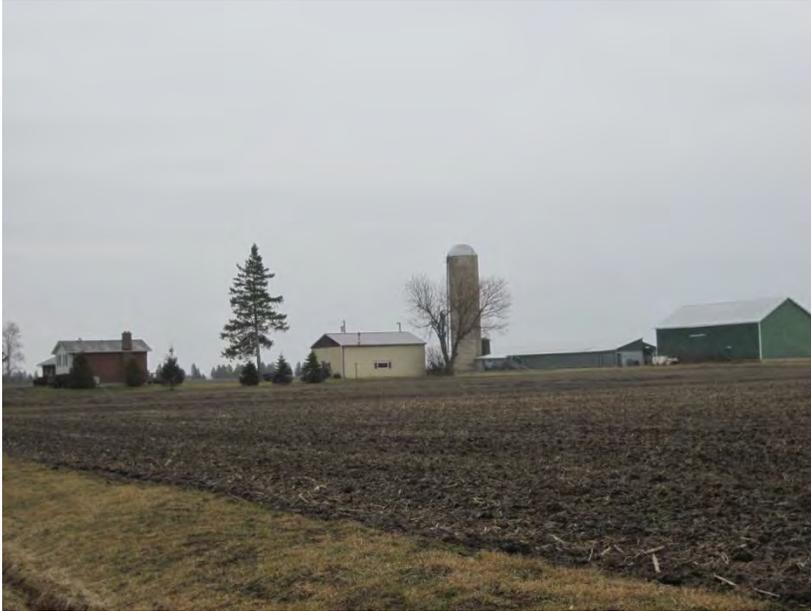
Site #29

BARN (right side of photo)

Date: 1960's-1970's

Description: Similar gable roof, medium pitch

1. **Design/Physical Value:** Once popular style of barn. Many still standing in the area
2. **Historical Value:** None identified
3. **Contextual Value:** Contribute to early 20th century agriculture activity of study area

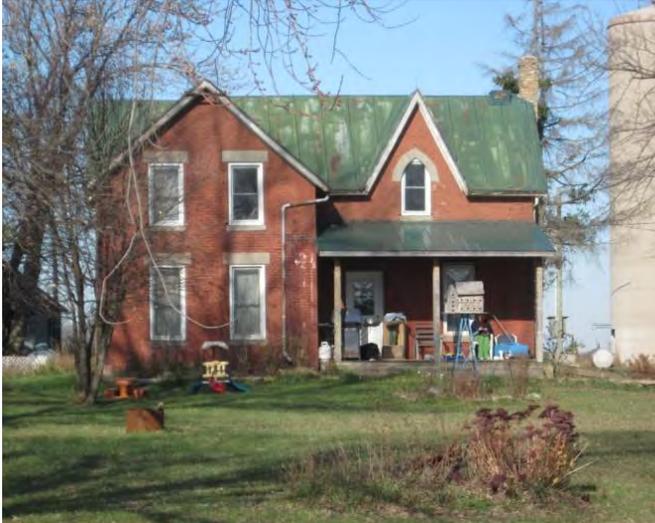
Site #30

HOUSE

Date: c. 1860-1880's

Description: One and a half storey brick, "L" plan; medium pitch roof, gable end, porch on main

1. Design/Physical Value: Early use of red brick
2. Historical Value: None identified
3. Contextual Value: Contributes to early 20th century agricultural activity of study area

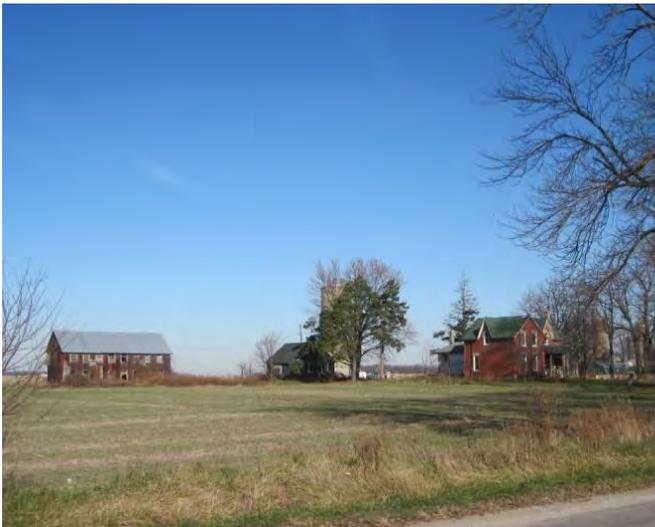
BARN

Date: early 20th century

Description: Small, two storey timber barn with multiple windows; possibly former poultry/pig barn

1. Design/Physical Value: Once popular style of barn. Many still standing in the area
2. Historical Value: Example of non-cattle barn noted in study area
3. Contextual Value: Contributes to early 20th century agricultural activity of study area

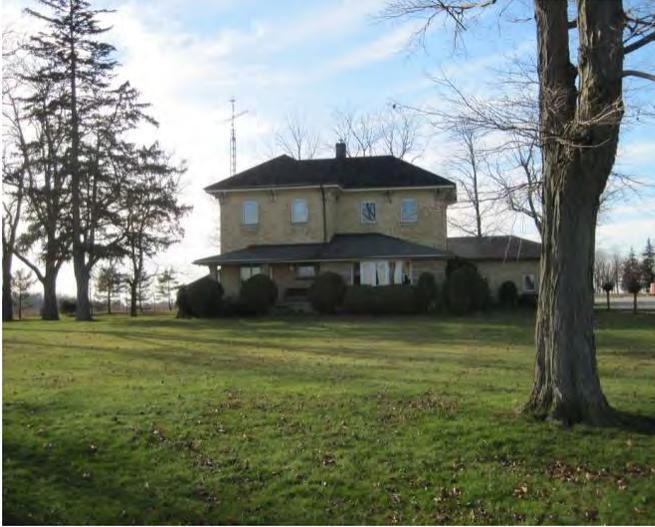
Site #31

HOUSE

Date: c. 1870's-1880's

Description: Similar to Site #1; paired brackets modern roof; new porch

1. Design/Physical Value: Large house; good condition; brackets are prominent; exterior largely unaltered except for removal of porches
2. Historical Value: Indicative that original owner had been prosperous
3. Contextual Value: Contributes to early 20th century agricultural activity of study area

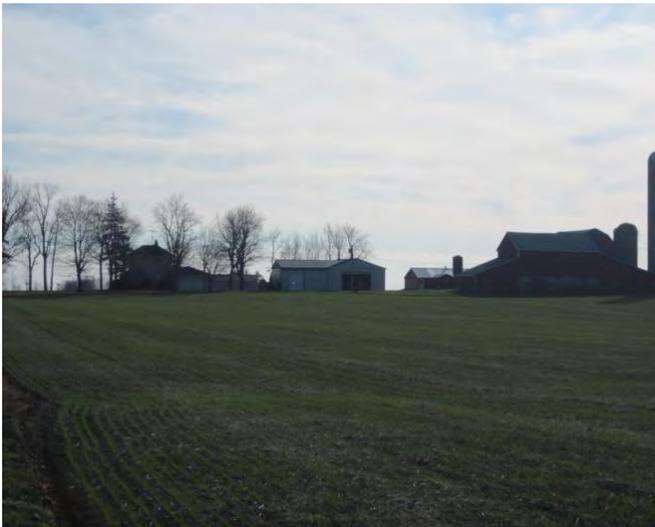
BARN

Date: late 19th /early 20th century

Description: Gambrel roof, frame barn with smaller gable roof barn

1. Design/Physical Value: Once popular style of barn. Many still standing in the area
2. Historical Value: None identified
3. Contextual Value: Contributes to early 20th century agricultural activity of study area

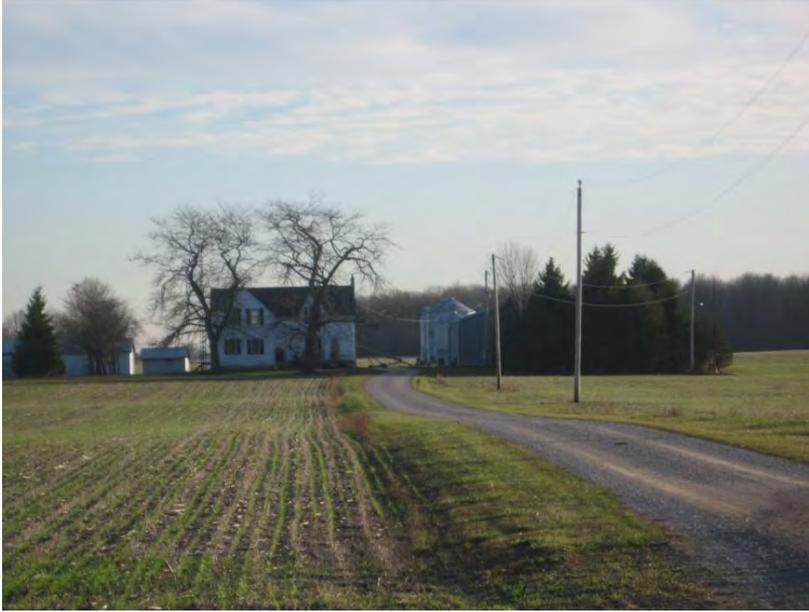
Site #32

Date: late 19th century

Description: One and a half storey “L” plan; medium pitch roof; too far from road to evaluate

1. Design/Physical Value: Unknown
2. Historical Value: None identified
3. Contextual Value: Contributes to early 20th century agricultural activity of study area

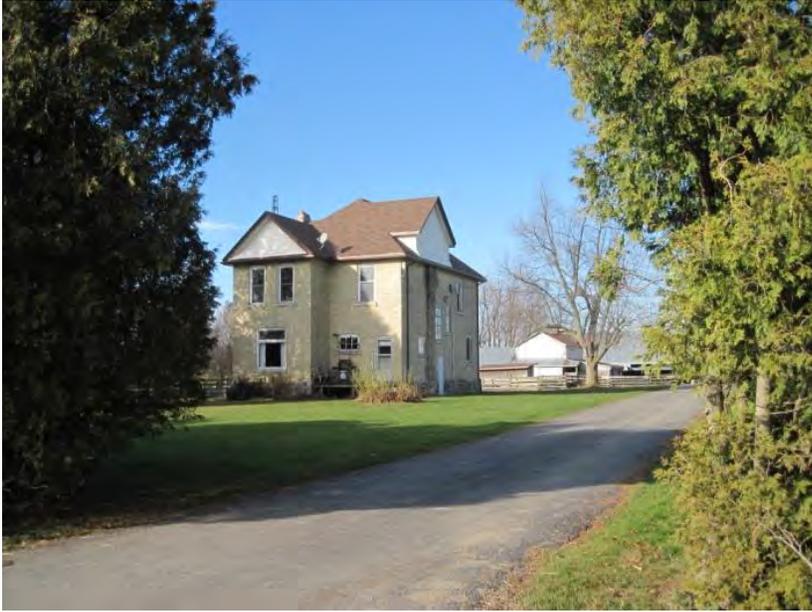
Site 33

Date: c. 1890-1910

Description: Two storey brick, steep pitch hip roof; gable end on front projection

1. Design/Physical Value: Large house; good condition
2. Historical Value: None identified
3. Contextual Value: Contributes to early 20th century agricultural activity of study area

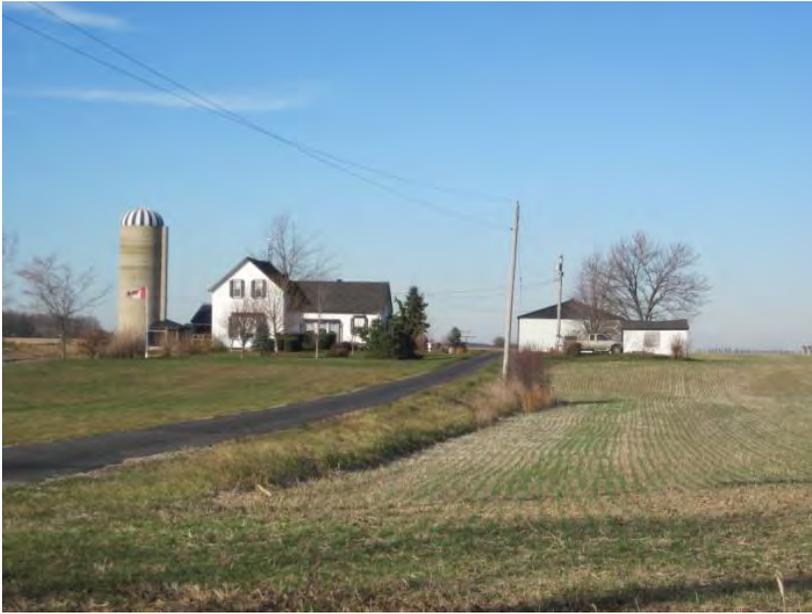
Site #34

Date: c. 1900

Description: Possible one and a half storey, medium pitch gable end roof; frame house, modern one storey addition

1. Design/Physical Value: Heavily modified
2. Historical Value: None identified
3. Contextual Value: Contributes to early 20th century agricultural activity of study area

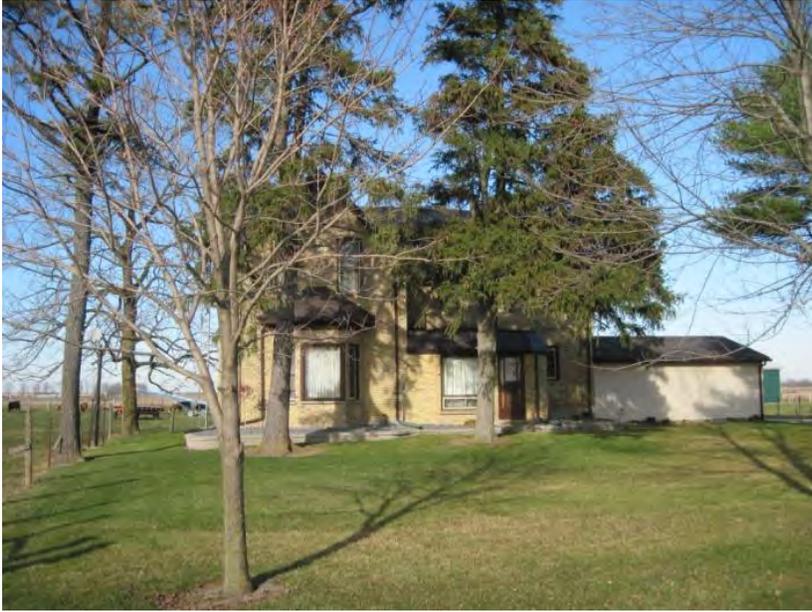
Site #35

Date: late 19th century

Description: Brick one and a half storey

1. Design/Physical Value: Not identified from road
2. Historical Value: None identified
3. Contextual Value: Contributes to early 20th century agricultural activity of study area
