PROJECT		ADELAIDE WIND FARM PROJECT			
TITLE		LOCATION OF STRUCTURES FOR BUILT HERITAGE AND CULTURAL LANDSCAPE			
		APPENDIX A			
PROJECT NO.		07-1112-0151		SCALE AS SHOWN	
DESIGN	PP	05 Mar 2008	REV. 0		
GIS	PP	26 Mar 2010			
CHECK	TCJR	26 Mar 2010			
REVIEW	JW	26 Mar 2010

APPENDIX A

CULTURAL STRUCTURES LOCATED ON OPTIONAL PROPERTIES WITH PROPOSED TURBINE RELATED ACTIVITIES

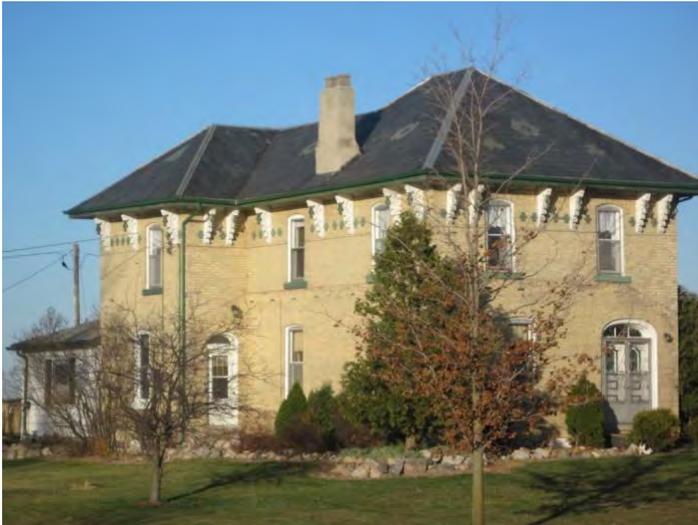
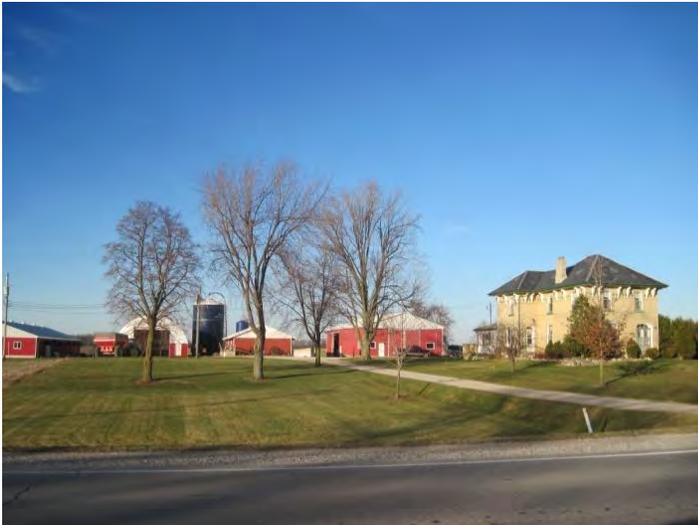
Site #1

Description: Two storey, low pitch roof, fanlight transom over main door, brick, vernacular design with Italianate brackets; porches removed; slate roof

1. Design/Physical Value: Large house, in good condition; brackets are prominent; exterior largely unaltered except for removal of porches.
2. Historical Value: Indicative that original owner had been prosperous
3. Contextual Value: All farm buildings new

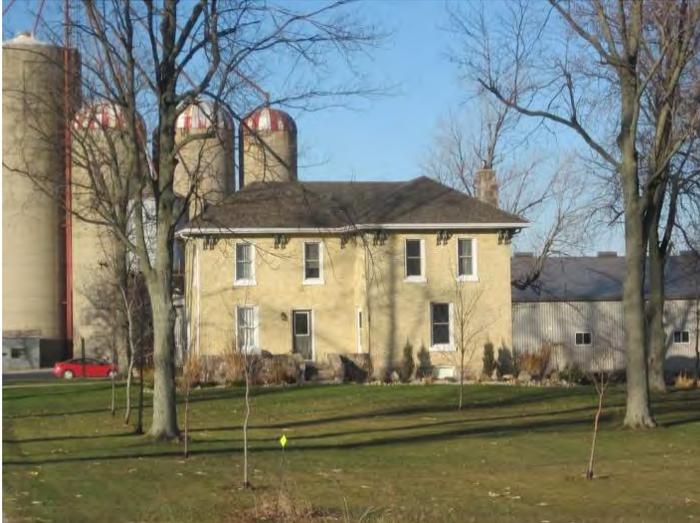
Site #2

Description: Similar to Site #1; paired brackets modern roof

1. Design/Physical Value: Large house, in good condition; brackets are prominent; exterior largely unaltered except for removal of porches.
2. Historical Value: Indicative that original owner had been prosperous
3. Contextual Value: All farm buildings new

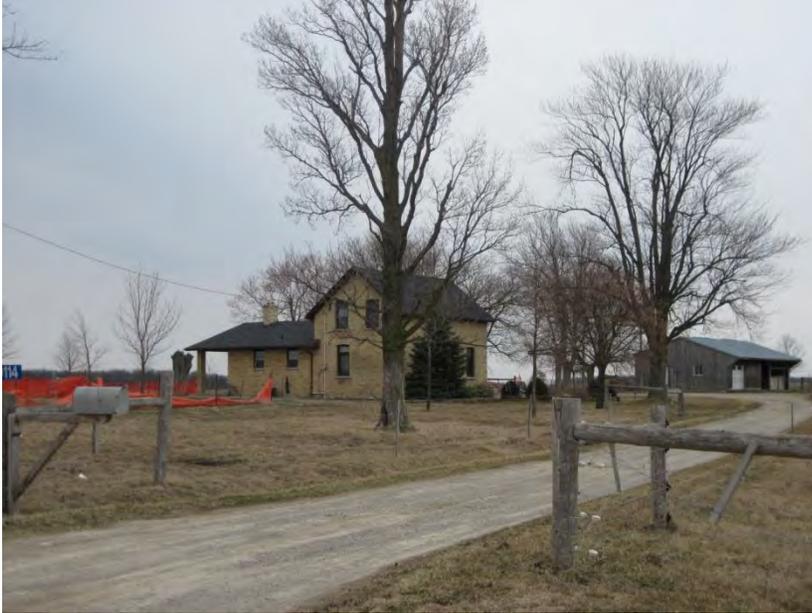
Site #3

Description: One and a half storey brick with one storey rear addition; medium pitch gable end roof

1. Design/Physical Value: Typical 19th century farm house
2. Historical Value: None identified
3. Contextual Value: Contributes to 19th century agricultural landscape of study area

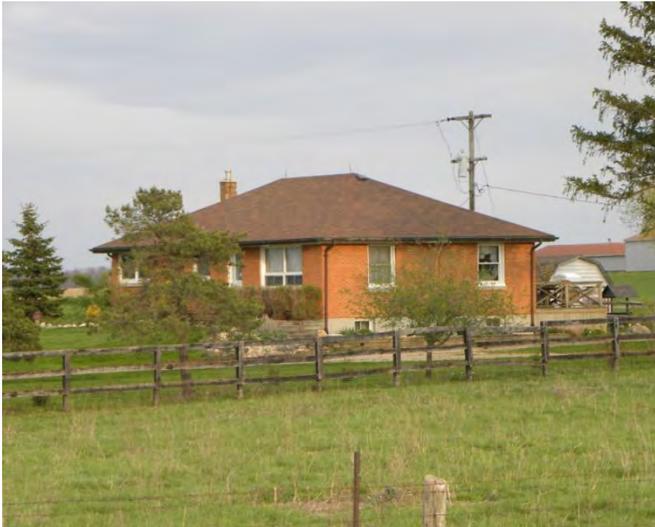
HOUSE

Description: one storey, hip roof, brick siding bungalow

1. Design/Physical Value: typical design of 1950s/60s.
2. Historical Value: None noted
3. Contextual Value: None noted

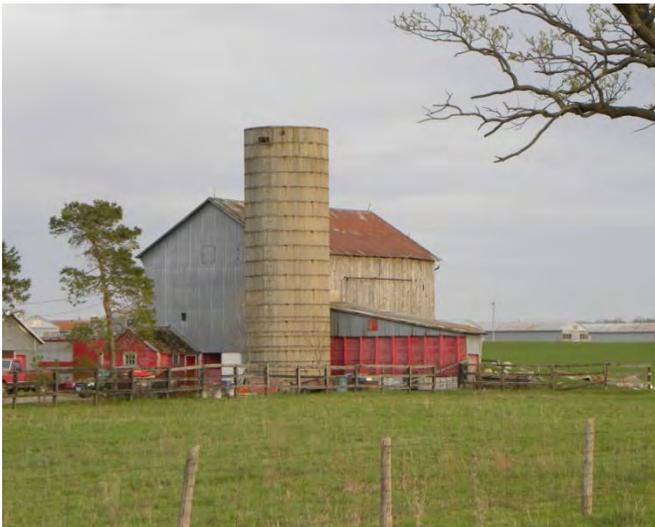
BARN

Description: metal, gable roof, wood siding

1. Design/Physical Value: Once popular style of barn. Many still standing in the area
2. Historical Value: Indicative 19th century agriculture
3. Contextual Value: Contributes to early 20th century agricultural activity of study area

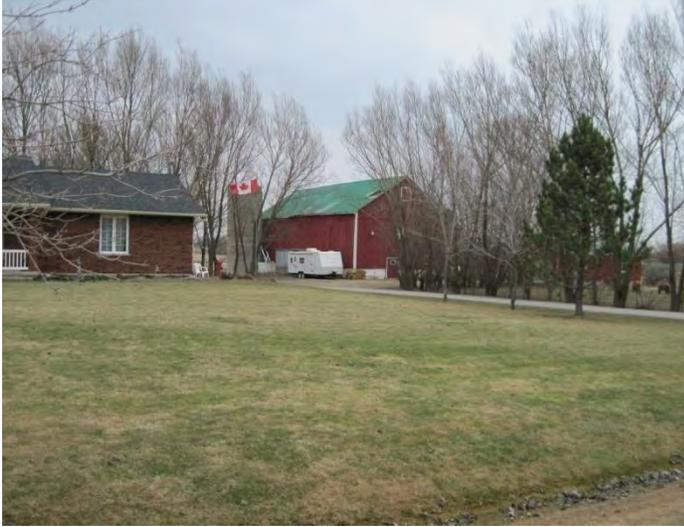
Site #5

Description: low pitch gable end roof; sheet metal rectangular, timber frame and cladding cement silo

1. Design/Physical Value: Once popular style of barn. Many still standing in the area
2. Historical Value: Indicative 19th century agriculture
3. Contextual Value: Contributes to early 20th century agricultural activity of study area

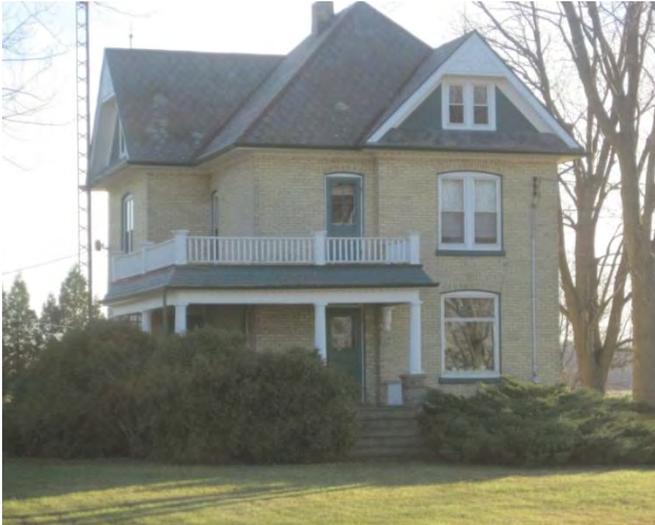
HOUSE

Description: Two storey; brick; "L" plan; steep pitch hip roof, with gable end roof on rear projection, Queen Anne style dormer on main façade; possibly original two storey porches; slate roof

1. Design/Physical Value: Large house. Good condition.
2. Historical Value: None identified
3. Contextual Value: Contributes to early 20th century agricultural activity of study area

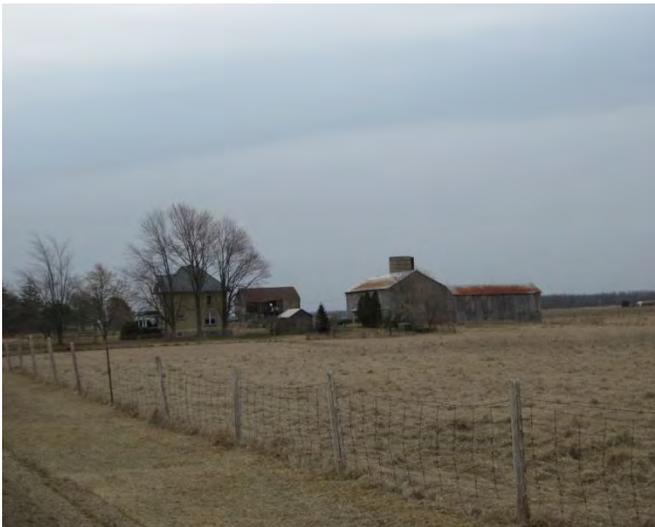
BARN

Description: three timber barns c. 1900 low pitch gable roof

1. Design/Physical Value: Once popular style of barn. Many still standing in the area
2. Historical Value: None identified
3. Contextual Value: Contributes to late 19th century agricultural activity of study area

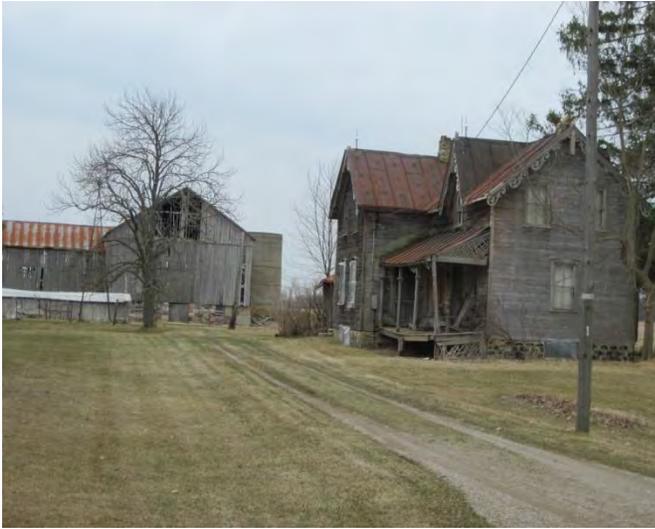
HOUSE

Description: One and a half storey “L” plan; medium pitch roof, metal clad, frame building, with possible original porch, remnant of gingerbread trim in gable end; abandoned

1. Design/Physical Value: Exterior appears to be largely unaltered. House is abandoned and in poor condition.
2. Historical Value: None identified
3. Contextual Value: Contributes to early 19th century agricultural activity of study area.

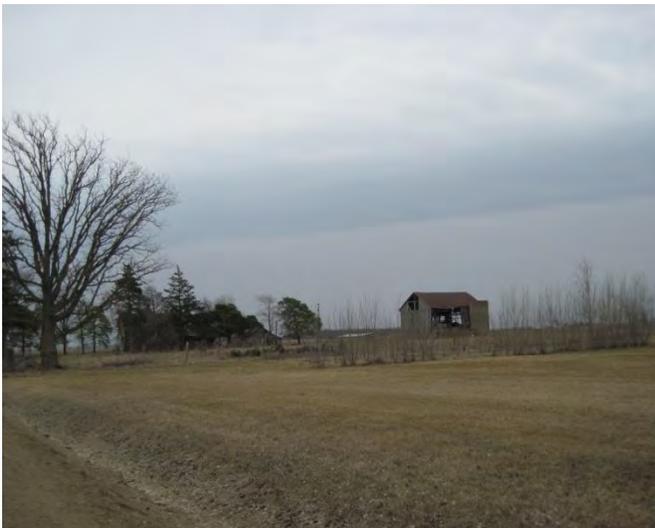
BARN

Description: medium pitch roof, timber frame, concrete silo; in poor condition

1. Design/Physical Value: Once popular style of barn. Many still standing in the area.
2. Historical Value: None identified
3. Contextual Value: Contributes to late 19th century agricultural activity of study area

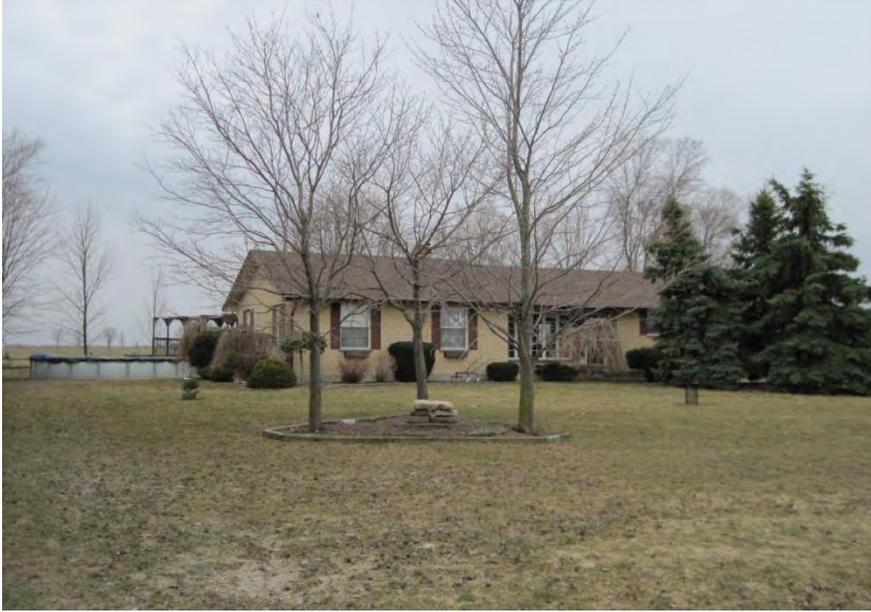
Site #8

Description: one storey Ranch style, gable-roof, brick-siding

- 1. Design/Physical Value: Typical design of 1960s**
- 2. Historical Value: None noted**
- 3. Contextual Value: None noted**

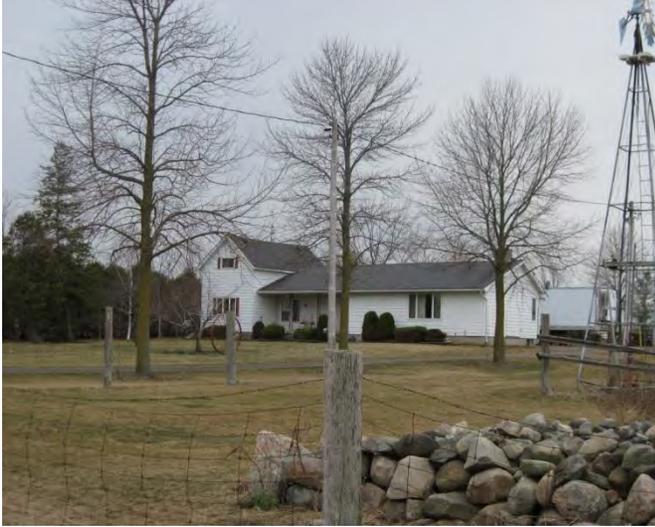
HOUSE

Description: Possible one and a half storey, medium pitch gable end roof; frame house, modern one storey addition

1. Design/Physical Value: Heavily modified
2. Historical Value: None identified
3. Contextual Value: Contributes to early 20th century agricultural activity of study area

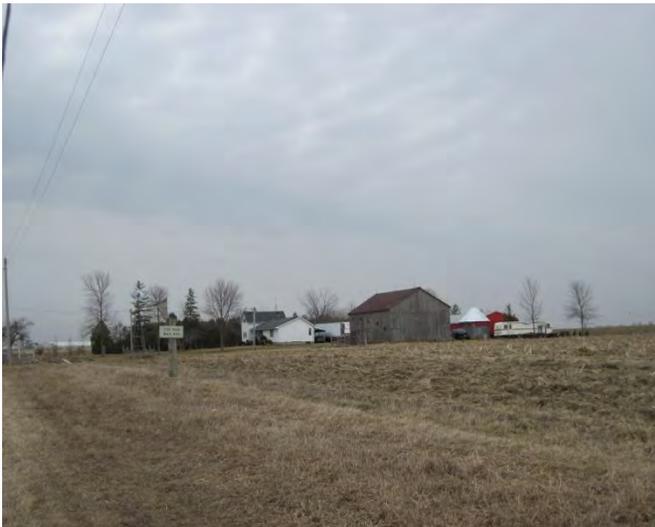
BARN

Description: medium pitch roof; timber frame

1. Design/Physical Value: Once popular style of barn. Many still standing in the area.
2. Historical Value: None identified
3. Contextual Value: Contributes to early 20th century agricultural activity of study area

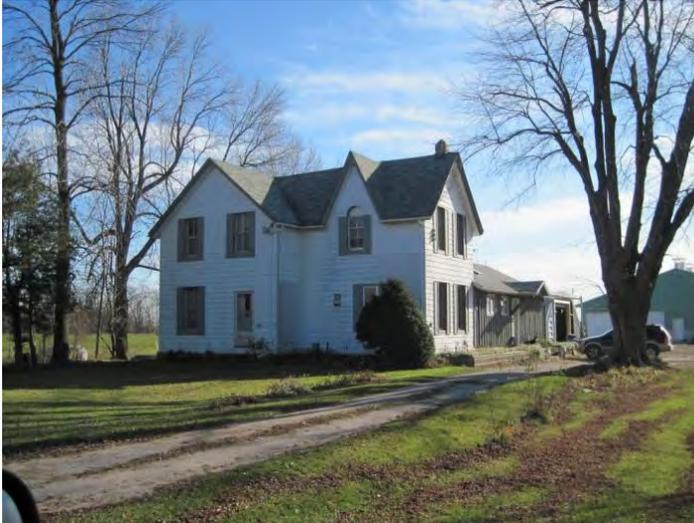
Site #10

Description: One and a half storey, "L" plan frame; medium pitch roof; steep pitch dormer possibly modern

1. Design/Physical Value: Large example of farm house
2. Historical Value: None identified
3. Contextual Value: Modern farm buildings

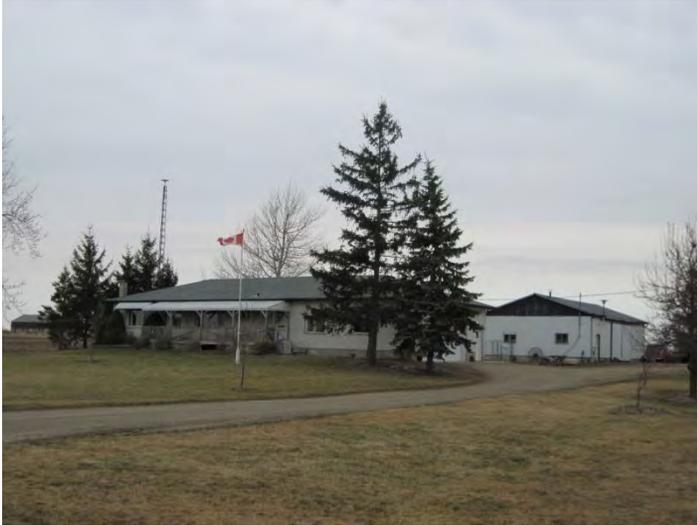
Site #11

Description: One and storey Ranch style, hip-roof, brick-siding

1. Design/Physical Value: Typical design of 1960s
2. Historical Value: None noted
3. Contextual Value: None noted

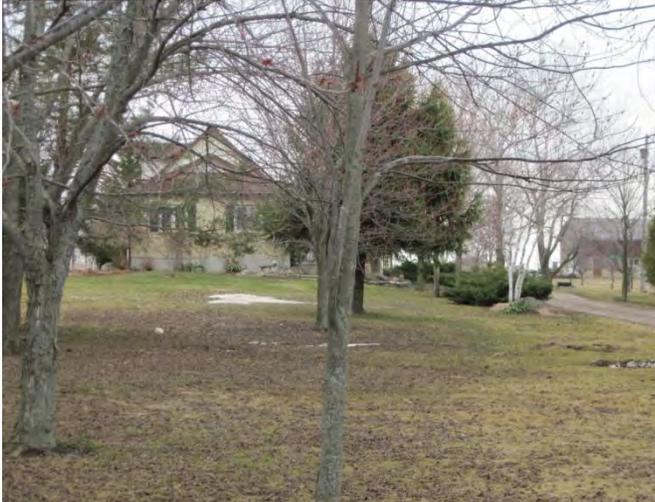
HOUSE

Description: Possible one storey brick, steep pitch roof with one storey brick hip roof addition on front.

1. Design/Physical Value: Not visible
2. Historical Value: None identified
3. Contextual Value: Contributes to early 20th century agricultural activity of study area.

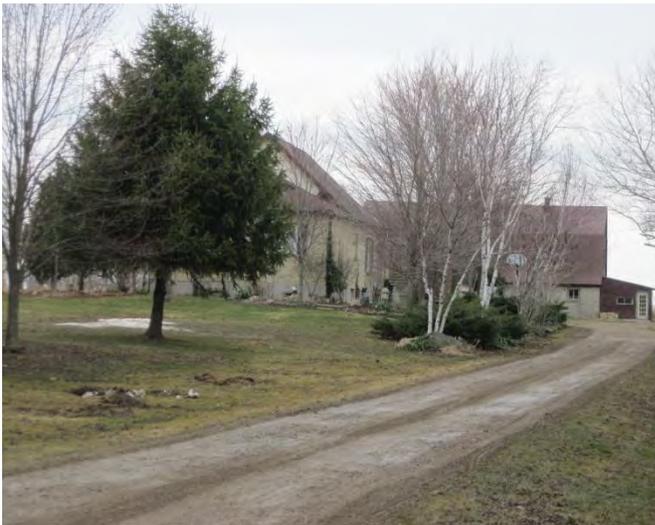
BARN

Description: Gambrel roof, concrete walls

1. Design/Physical Value: Once popular style of barn. Many still standing in the area.
2. Historical Value: None identified
3. Contextual Value: Contributes to early 20th century agricultural activity of study area.

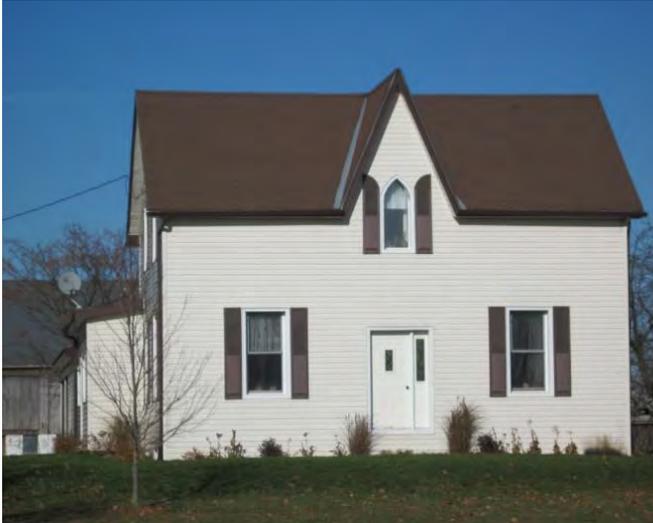
HOUSE

Description: Vernacular, one and a half storey frame with elements of Gothic revival style; steep pitch gable end roof; symmetrical main façade but original porch probably removed

1. Design/Physical Value: Well maintained house despite modifications.
2. Historical Value: None identified
3. Contextual Value: Contributes to early 20th century agricultural activity of study area.

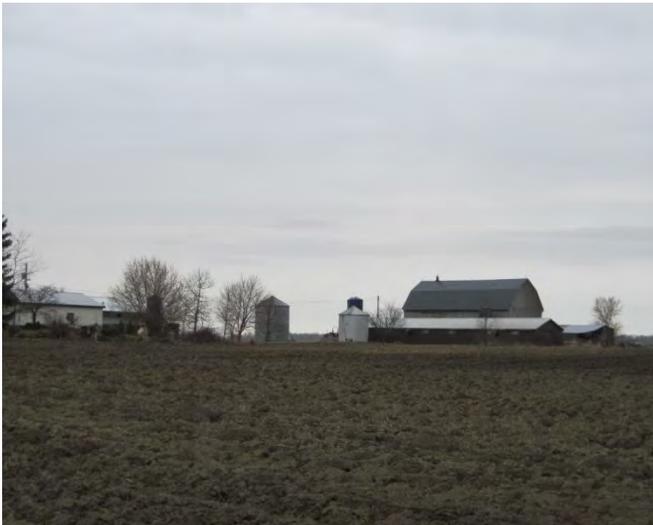
BARN

Date: Late 19th century early 20th century
Description: Gambrel roof

1. Design/Physical Value: Once popular style of barn. Many still standing in the area.
2. Historical Value: None identified
3. Contextual Value: Contributes to early 20th century agricultural activity of study area.

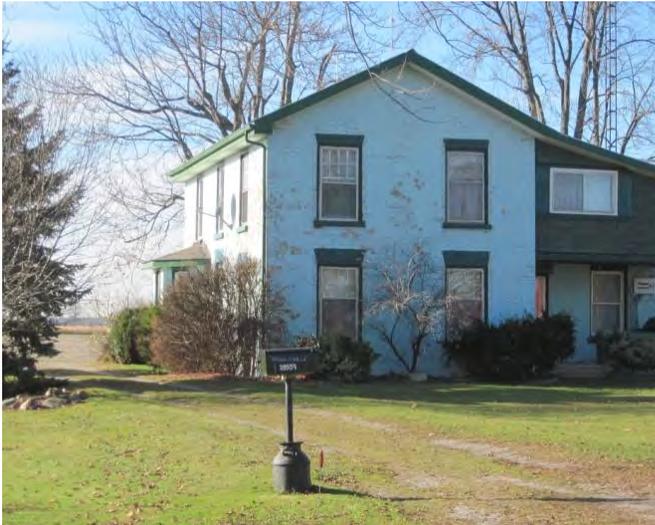
HOUSE

Description: Two storey painted brick; low pitch gable end roof, modern addition at rear

1. Design/Physical Value: Possibly an early house; heavily modified.
2. Historical Value: None identified
3. Contextual Value: Contributes to early 20th century agricultural activity of study area.

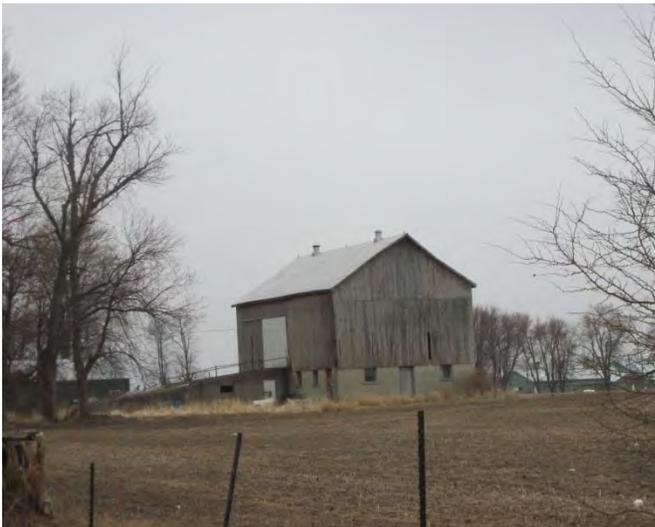
BARN

Description: Timber frame, rectangular, medium pitch metal clad roof

1. Design/Physical Value: Once popular style of barn. Many still standing in the area.
2. Historical Value: None identified
3. Contextual Value: Contributes to early 20th century agricultural activity of study area.

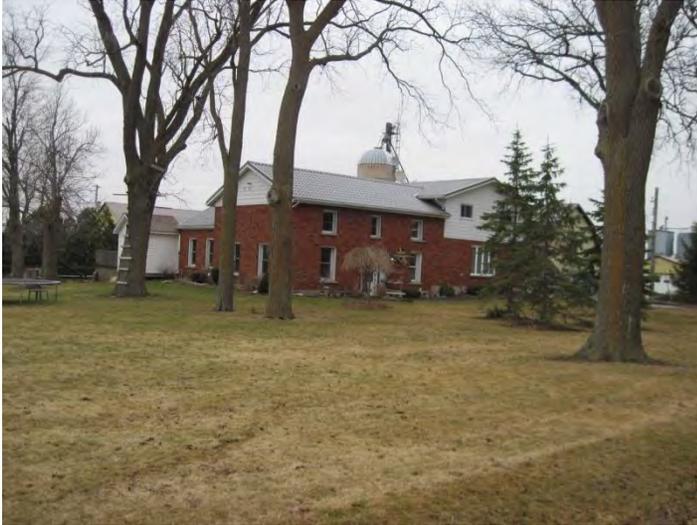
Site #15

Description: Split level, hip roof Ranch style, brick siding

1. Design/Physical Value: Typical design of 1960s
2. Historical Value: None noted
3. Contextual Value: None noted

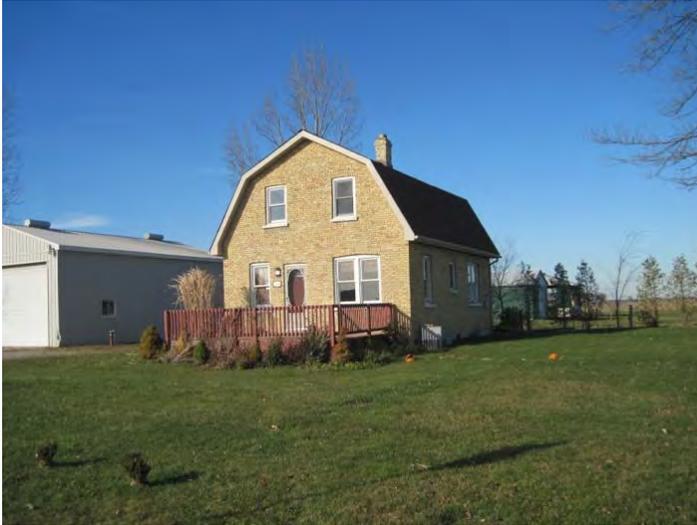
Site #16

Description: One and a half storey brick, gambrel roof

1. Design/Physical Value: Relatively uncommon style in the area.
2. Historical Value: None identified
3. Contextual Value: Contributes to early 20th century agricultural activity of study area.

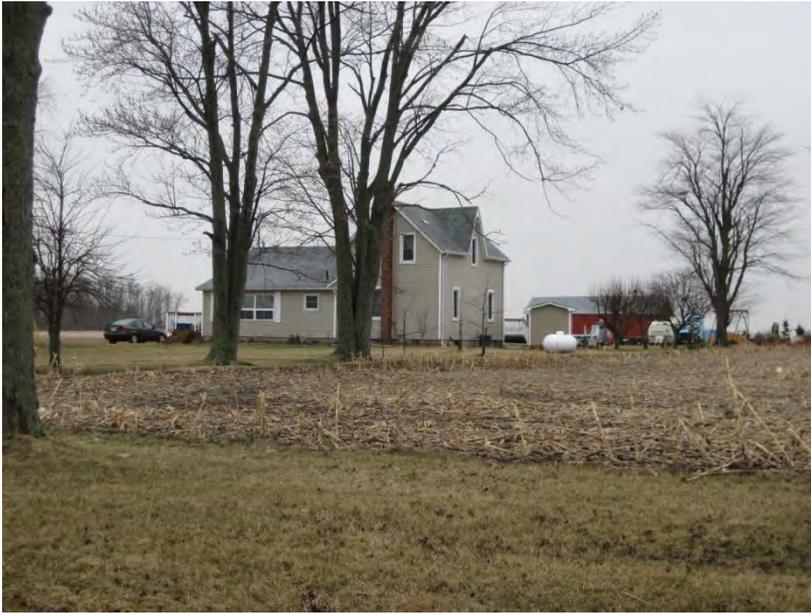
Site #17

Description: Possible one and a half storey, medium pitch gable end roof; frame house, modern one storey addition

1. Design/Physical Value: Heavily modified
2. Historical Value: None identified
3. Contextual Value: Contributes to early 20th century agricultural activity of study area.

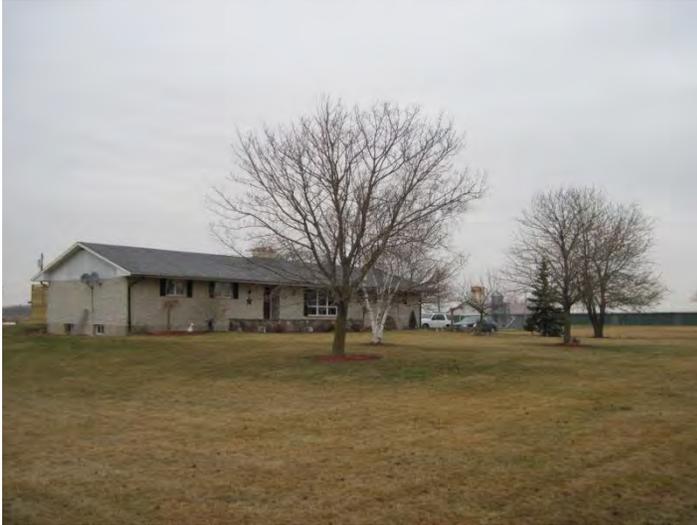
Site #18

Description: One storey Ranch style, gable-roof, brick-siding

1. Design/Physical Value: Typical design of the 1960's
2. Historical Value: None noted
3. Contextual Value: None noted

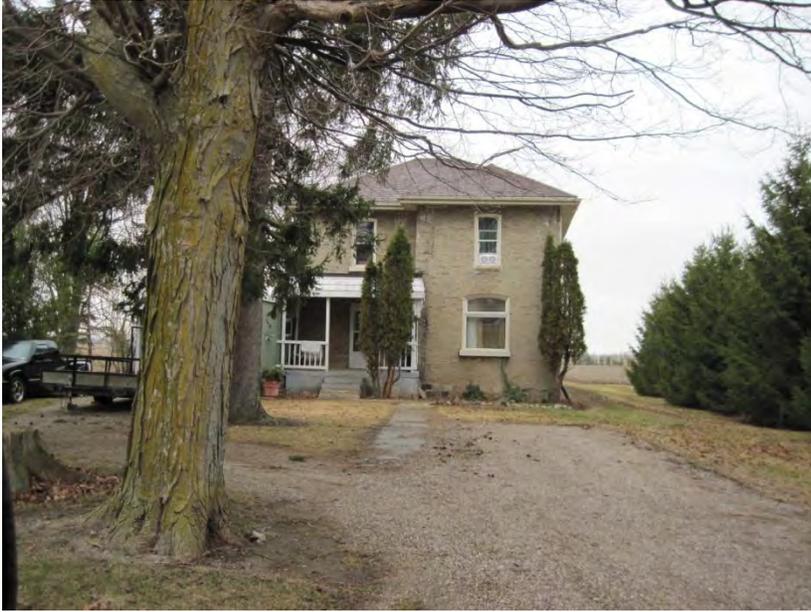
Site #19

Description: Two storey brick; "L" plan; shallow pitch hipped roof porch on main façade

1. Design/Physical Value: Large house; good condition
2. Historical Value: None identified
3. Contextual Value: Contributes to early 20th century agricultural activity of study area

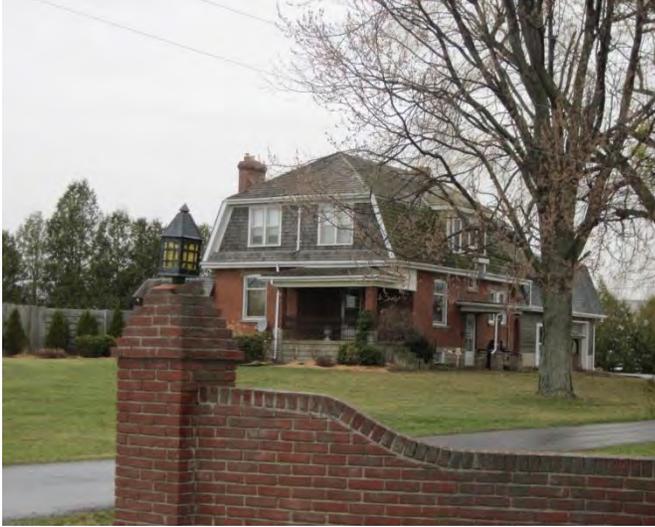
HOUSE

Description: red brick, one and a half storey, hipped gambrel roof with side dormer, porch on end wall

1. Design/Physical Value: Unusual roof design
2. Historical Value: None identified
3. Contextual Value: Contributes to early 20th century agricultural activity of study area

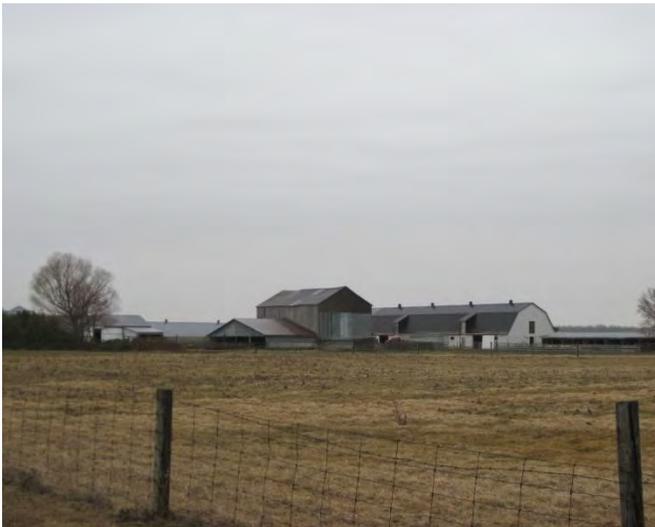
BARN

Description: timber frame; medium pitch metal clad roof

4. Design/Physical Value: Once popular style of barn. Many still standing in the area
5. Historical Value: None identified
6. Contextual Value: Contributes to early 20th century agricultural activity of study area

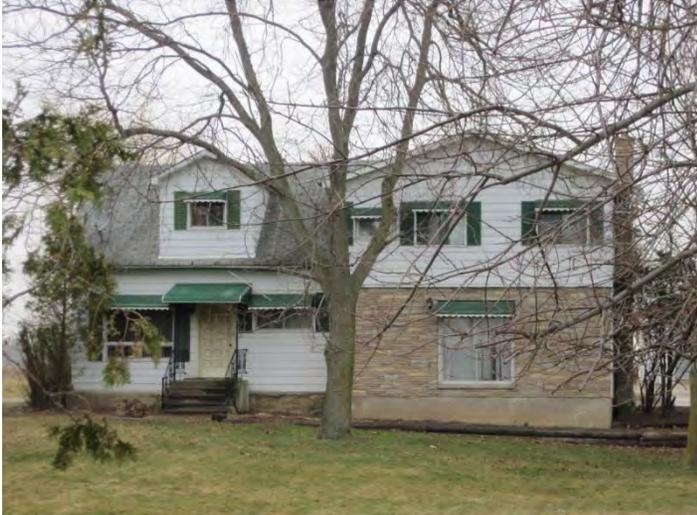
Site #22

Description: One and a half storey house, steep pitch roof; modern two storey addition

1. Design/Physical Value: Heavily modified
2. Historical Value: None identified
3. Contextual Value: Contributes to early 20th century agricultural activity of study area

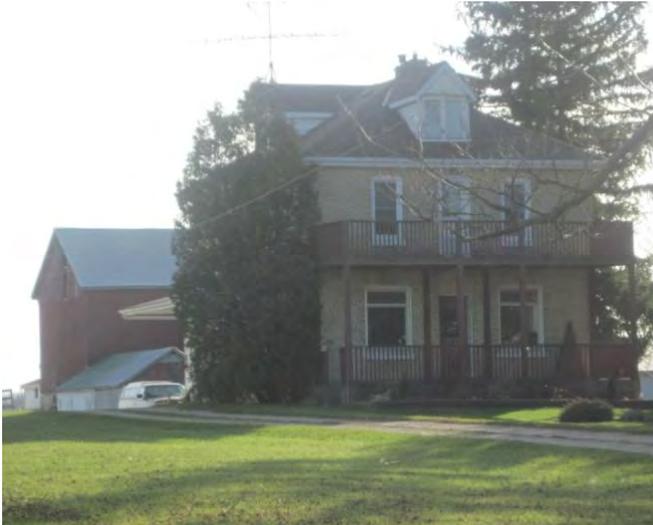
HOUSE

Description: Two storey brick; low pitch hip gable roof, modern two storey porch

1. Design/Physical Value: Large house; good condition
2. Historical Value: None identified
3. Contextual Value: Contributes to early 20th century agricultural activity of study area

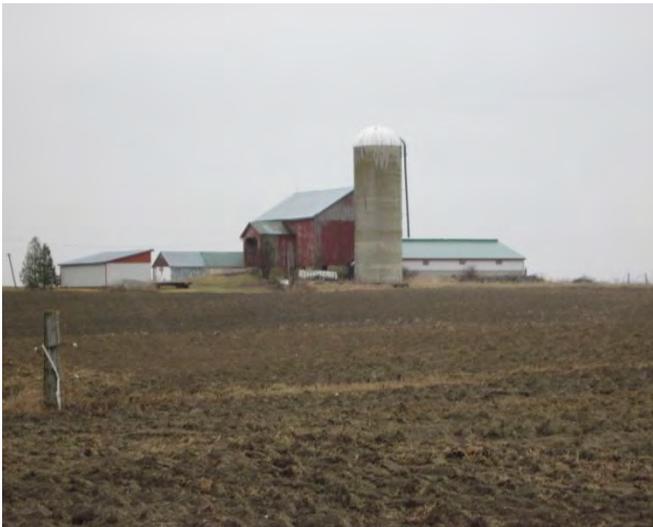
BARN

Description: Timber frame, medium pitch gable end roof; concrete silo

4. Design/Physical Value: Once popular style of barn. Many still standing in the area
5. Historical Value: None identified
6. Contextual Value: Contributes to early 20th century agricultural activity of study area

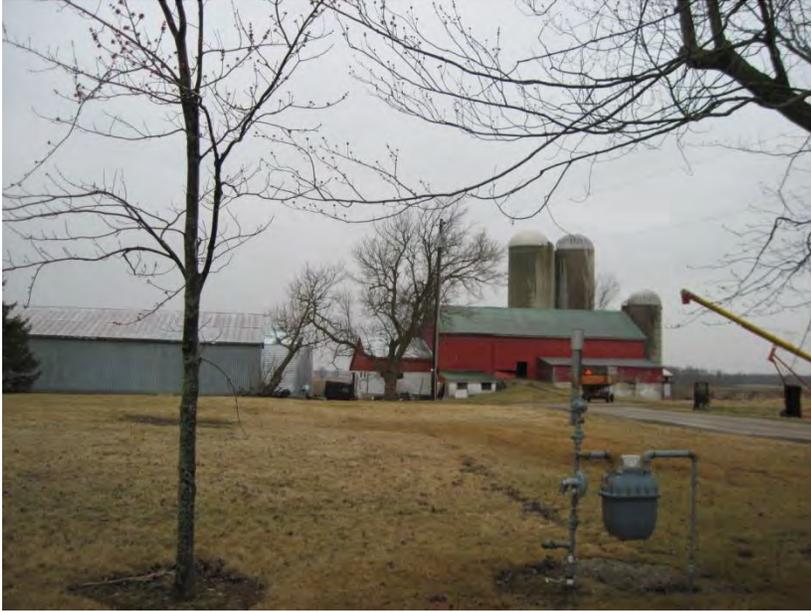
Site #24

Description: Timber frame, medium pitch gable end roof, concrete silos.

1. Design/Physical Value: Once popular style of barn. Many still standing in the area
2. Historical Value: None identified
3. Contextual Value: Contributes to early 20th century agricultural activity of study area

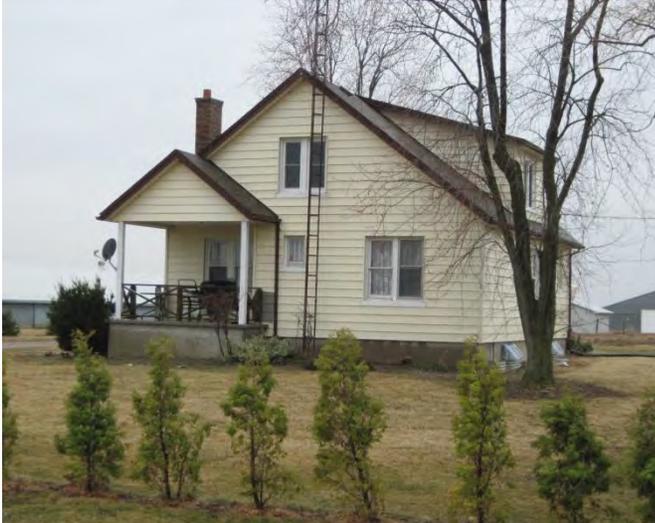
HOUSE

Description: One and a half storey; modern vinyl siding; medium pitch roof

1. Design/Physical Value: Heavily modified
2. Historical Value: None identified
3. Contextual Value: Contributes to early 20th century agricultural activity of study area

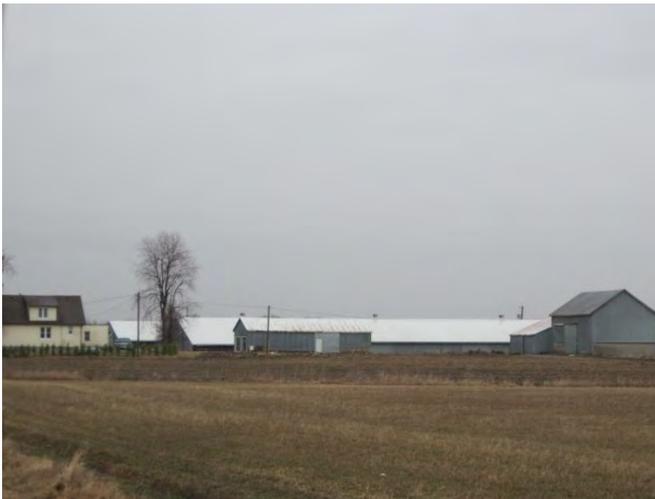
BARN

Description: Timber frame, medium pitch gable end roof

4. Design/Physical Value: Once popular style of barn. Many still standing in the area.
5. Historical Value: None identified
6. Contextual Value: Contributes to early 20th century agricultural activity of study area

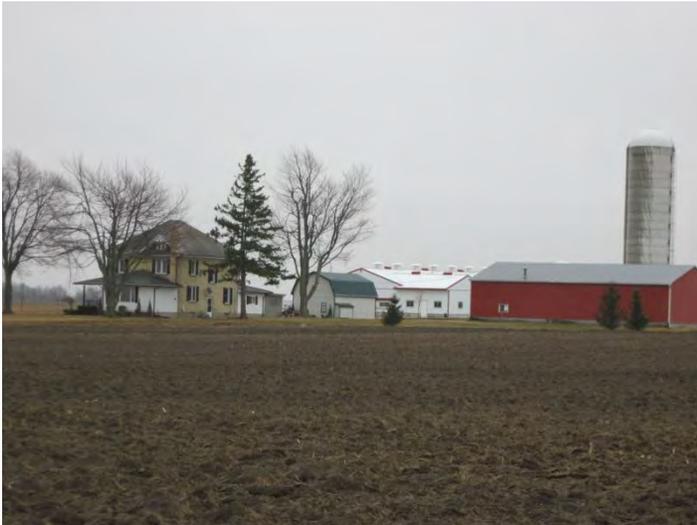
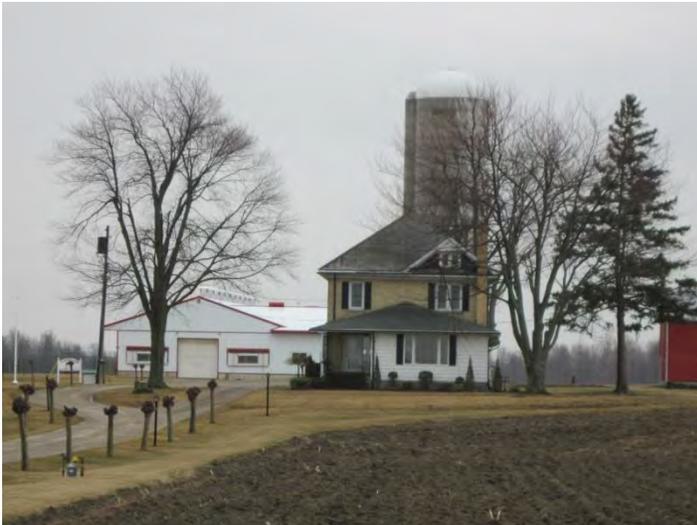
Site #26

Description: Two storey brick, steep pitch hip roof with Queen Anne style dormer on main façade; modern addition to ground floor main façade

1. Design/Physical Value: Large house; good condition
2. Historical Value: None identified
3. Contextual Value: Contributes to early 20th century agricultural activity of study area
