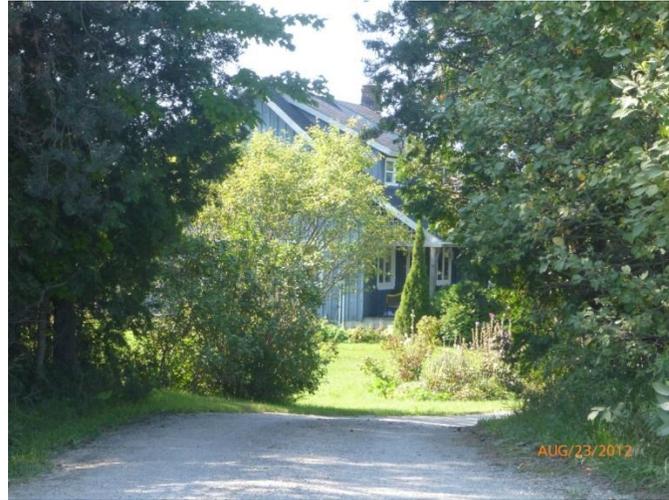
BF#50 – 384642 Concession Road 4, Map #50

Description - The house has board and batten siding but is largely obscured by vegetation.

Although not visible enough to determine whether there is potential cultural heritage value or interest, the cladding could indicate an earlier house.

Heritage Attributes – not visible enough to determine.

Potential Impacts – turbine #14 on adjacent lot is located more than 500 metres away; no impact

Mitigation Recommended – none required

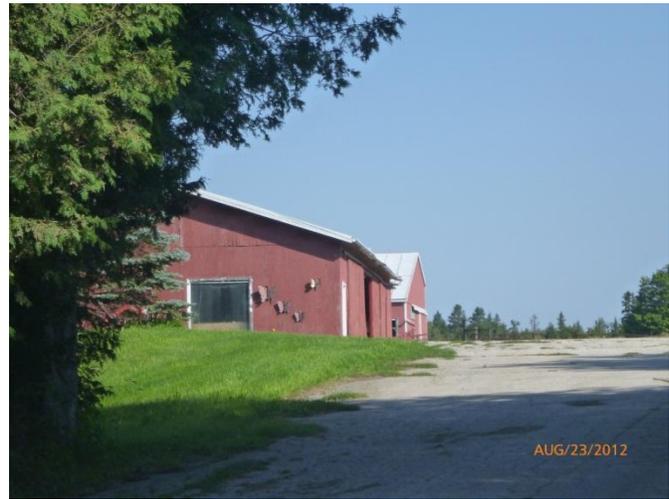
BF#51 – 384643 Concession Road 4, Map #51

Description - The red steel sided bank barn is newer, dating to the late 20th century. There is a wooden shed located behind the barn. The house is a modern, red brick construction with poured concrete foundation dating to the late 20th century.

Date Range – post 1972

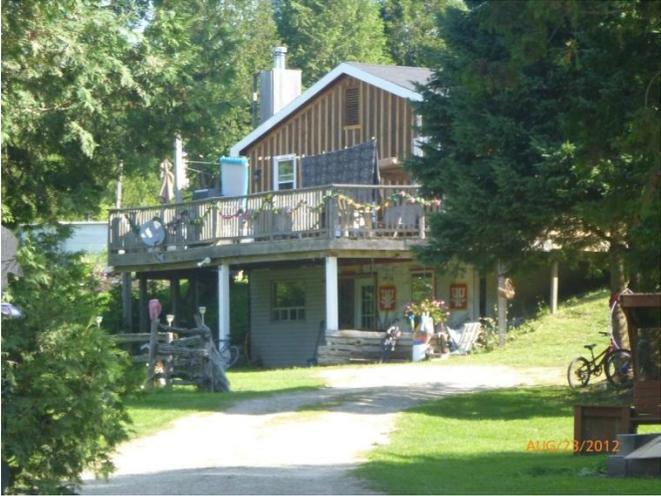
BF#53 – 384701 Concession Road 4, Map #53

<p>Description - This is a 2 storey chalet style house built into the hillside, with board and batten cladding. The single door garage has vinyl siding.</p>	<p>X</p>
	<p>Date Range – c1960-1980</p>	<p>Further Evaluation for Potential Cultural Heritage Value or Interest</p>
	<p>Status – non-participating</p>

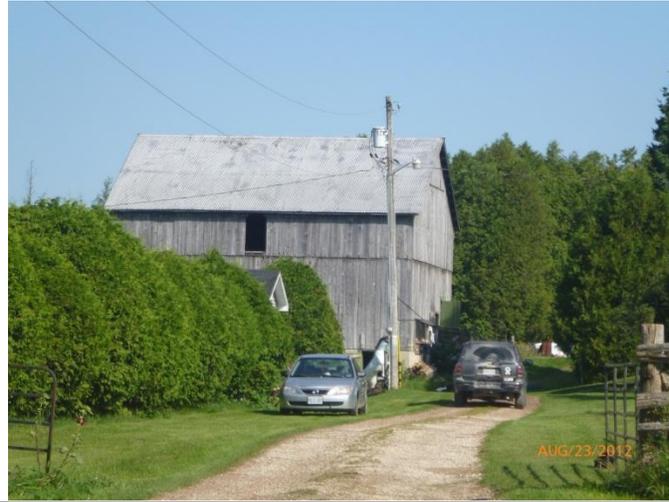
BF#54 – 384721 Concession Road 4, Map #54

Description - This is a bank barn with concrete or parged foundation and vertical barn board. There is a stone monument on the property, with a lion's head on top. The house appears to have vinyl siding, but is barely visible from the roadway.

Date Range – c1900

Design Value or Physical Value – Barn is representative of mid-19th to early 20th century timber-frame structures that are found in the study area.

Contextual Value – Contributes to the later 19th to mid-20th century agricultural landscape of the Municipality of West Grey

Heritage Attributes – timber-frame structure on a concrete or parged foundation, vertical planking, location relative to the agricultural fields and the house

Potential Impacts – none

Mitigation Recommended – none required

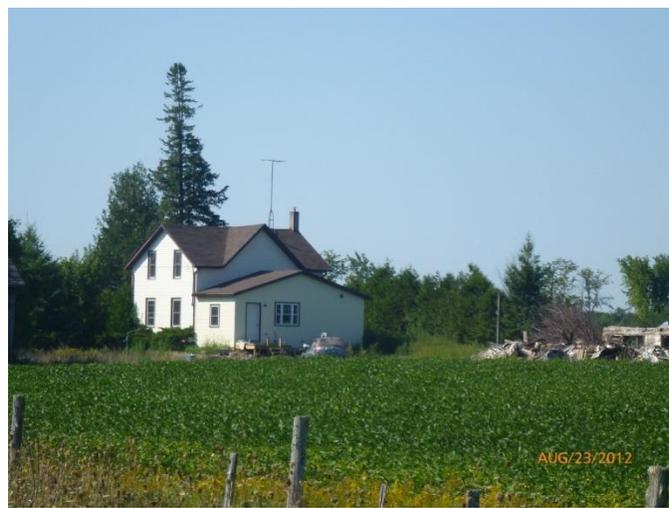
BF#55 – 634016 Artemesia-Glenelg Townline, Map #55

Description - There are the ruins of a barn, and an adjacent concrete and rebar silo. There are two metal clad sheds and an old wooden clad garage. The 2 storey farmhouse in Gothic Revival form with an addition is clad in vinyl.

Date Range – c1900

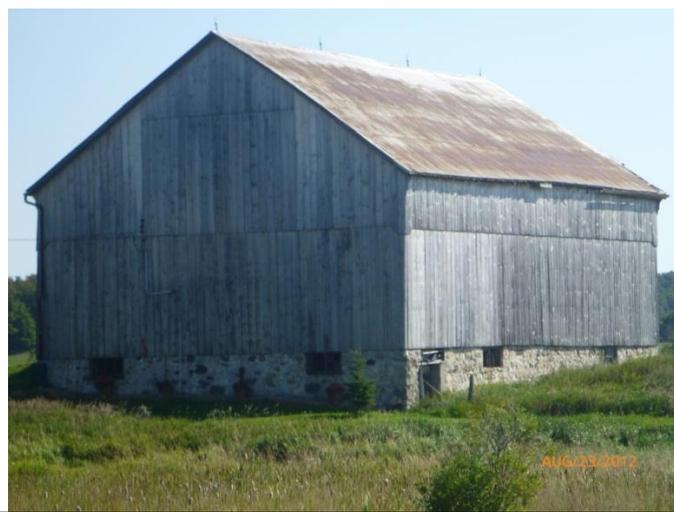
BF#56 – 634043 Artemesia-Glenelg Townline, Map #56

Description - This is a bank barn in good shape, with fieldstone foundation and vertical barn board. The house has a fieldstone foundation and board and batten addition, but is not visible from the roadway.

Date Range – c1920

Design Value or Physical Value – Barn is representative of mid-19th to early 20th century timber-frame structures that are found in the study area.

Contextual Value – Contributes to the later 19th to mid-20th century agricultural landscape of the Municipality of West Grey

Heritage Attributes – timber-frame structure on a fieldstone foundation, vertical planking, location relative to the agricultural fields and the house

Potential Impacts – none

Mitigation Recommended – none required

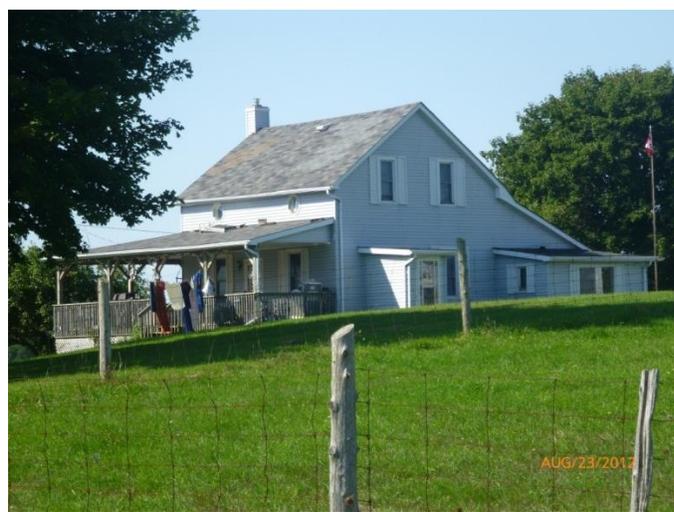
BF#57 – 633888 Artemesia-Glenelg Townline, Map #57

Description - 2 storey house with vinyl cladding, addition at rear and verandah.

Date Range – 1860-1900

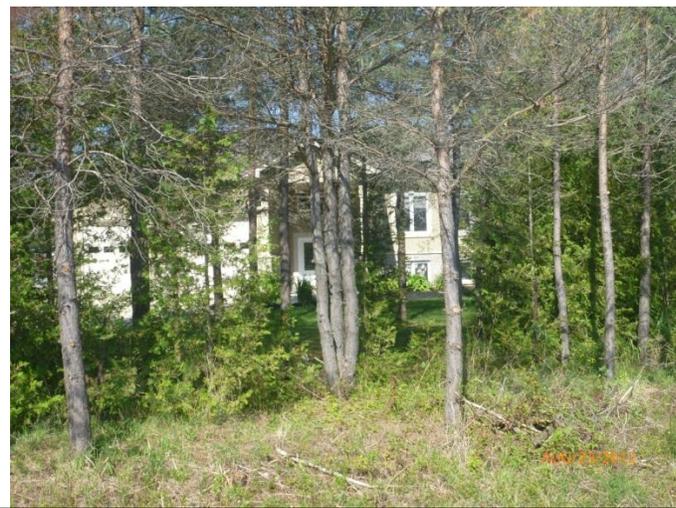
BF#61 – 633740 Artemesia-Glenelg Townline, Map #61

Description - Not fully visible from roadway but appears to be a modern residence with an attached 2 door garage.

Date Range – post 1972

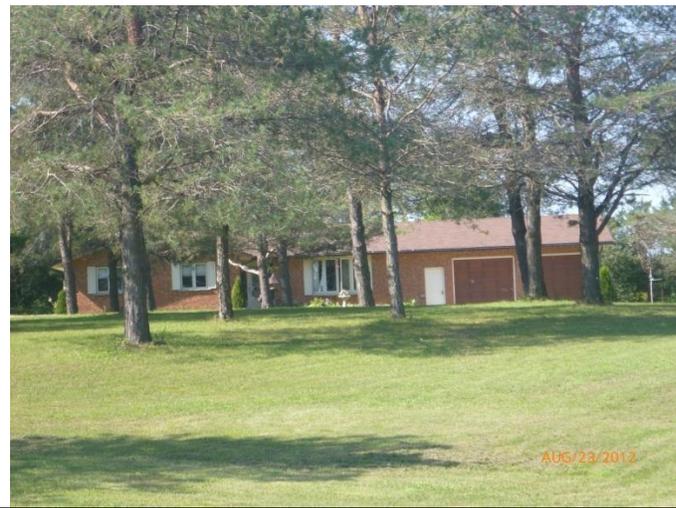
BF#62 – 633722 Artemesia-Glenelg Townline, Map #62

Description - modern red brick ranch style house, with attached 2 door garage and a detached vinyl clad 2 door garage/shed.

Date Range – post 1972

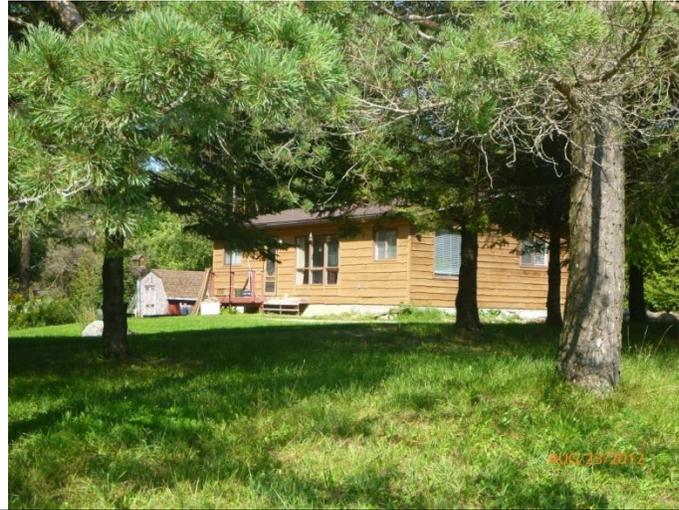
BF#63 – 633710 Artemesia-Glenelg Townline, Map #63

Description - modern wood siding single storey house, that is classic 1970s vintage style. There is an attached garage/shed.

Date Range – 1970s

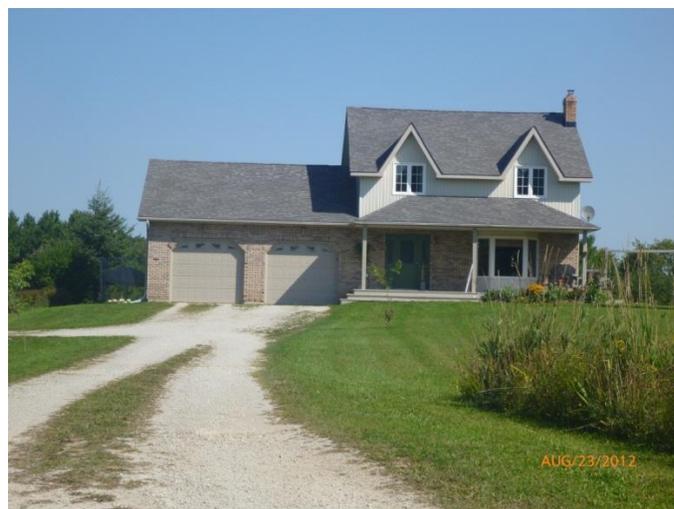
BF#65 – 344683 North Line, Map #65

Description - modern 2 storey house with 2 door attached garage, clad in brick façade and vinyl.

Date Range – post 1972

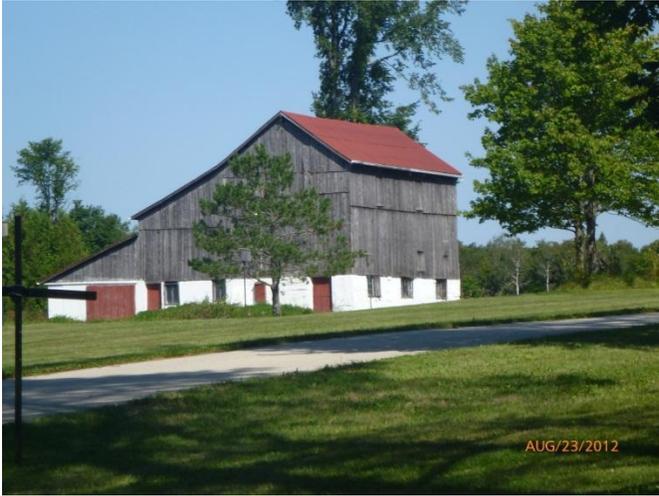
Description - Well-maintained barn, vertical wood board, addition to barn. House is modern 2½ storey split level, vinyl siding.	V
	Date Range – c1920	Further Evaluation for Potential Cultural Heritage Value or Interest
	Status – non-participating	
Potential Cultural Heritage Value or Interest (O.Reg 9/06) Design Value or Physical Value – Barn is representative of mid-19 th to early 20 th century timber-frame structures that are found in the study area. Historical Value or Associative Value - none Contextual Value – Contributes to the later 19 th to mid-20 th century agricultural landscape of the Municipality of West Grey	Heritage Attributes – timber-frame structure with two additions on a painted fieldstone foundation, vertical planking, location relative to the agricultural fields Potential Impacts – none Mitigation Recommended – none required

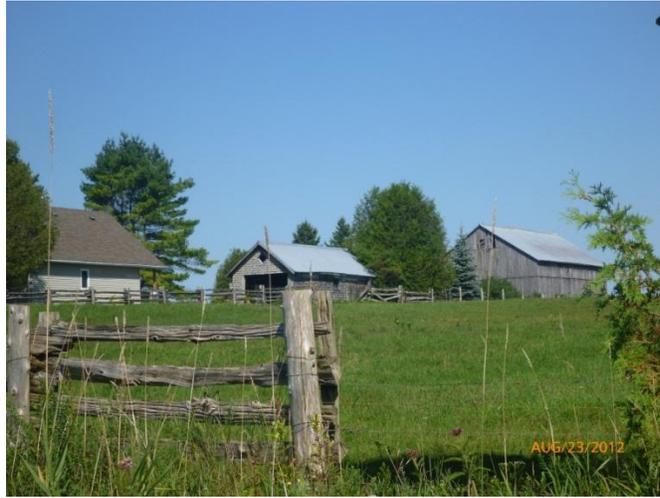
BF#68 – 344617 North Line, Map #68

Description - bank barn with addition, 2 sheds, house not fully visible from roadway, but appears modern.

Date Range – c1920

Design Value or Physical Value – Barn is representative of mid-19th to early 20th century timber-frame structures that are found in the study area.

Contextual Value – Contributes to the later 19th to mid-20th century agricultural landscape of the Municipality of West Grey

Heritage Attributes – timber-frame structure with addition, vertical planking, location relative to the agricultural fields

Potential Impacts – turbine #14 located on adjacent lot more than 1 km away; no impact

Mitigation Recommended – none required

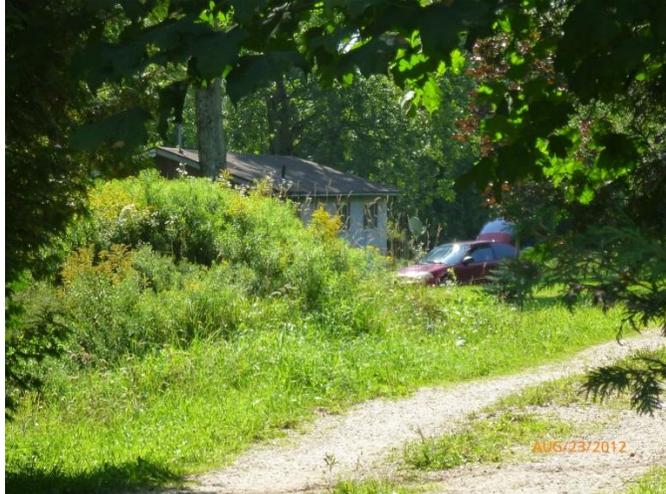
Description - Corrugated metal Quonset hut/garage, single storey house not visible from roadway, with vinyl siding	X
	Date Range – post 1972	Further Evaluation for Potential Cultural Heritage Value or Interest
	Status – non-participating	
BF#72 – 344517 North Line, Map #72		
No photo available	Description - not visible from roadway	X
	Date Range	Further Evaluation for Potential Cultural Heritage Value or Interest
	Status – non-participating
