HERITAGE ASSESSMENT REPORT

**NextEra Energy Canada, ULC
Goshen Wind Energy Centre
Municipalities of Bluewater
and South Huron
Huron County, Ontario**

Report Number: 10-1151-0201-3000-3200-R01

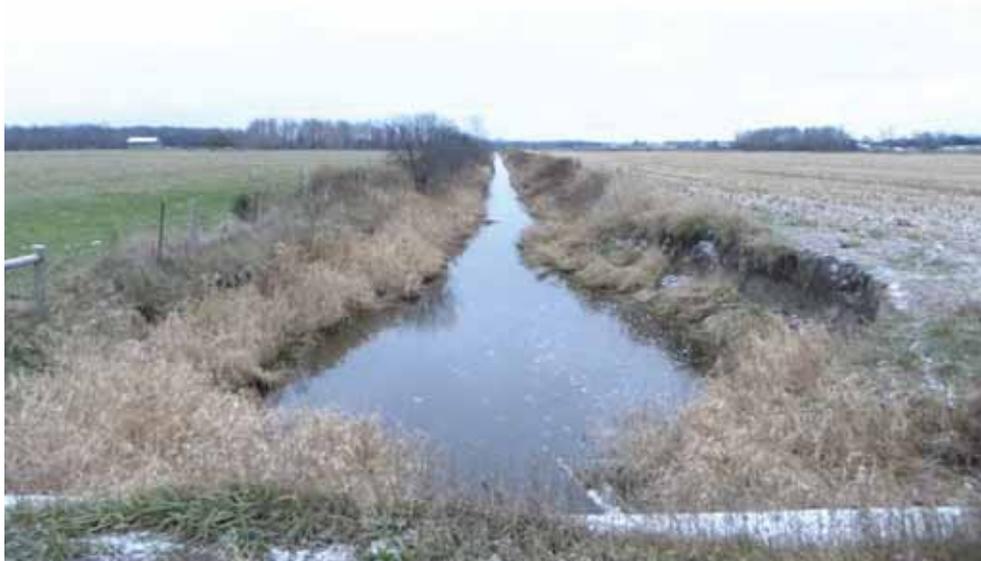
Plate 9: Drainage ditch crossing beneath the Zurich Hensall Road between Parr Line and Babylon Line, looking south.

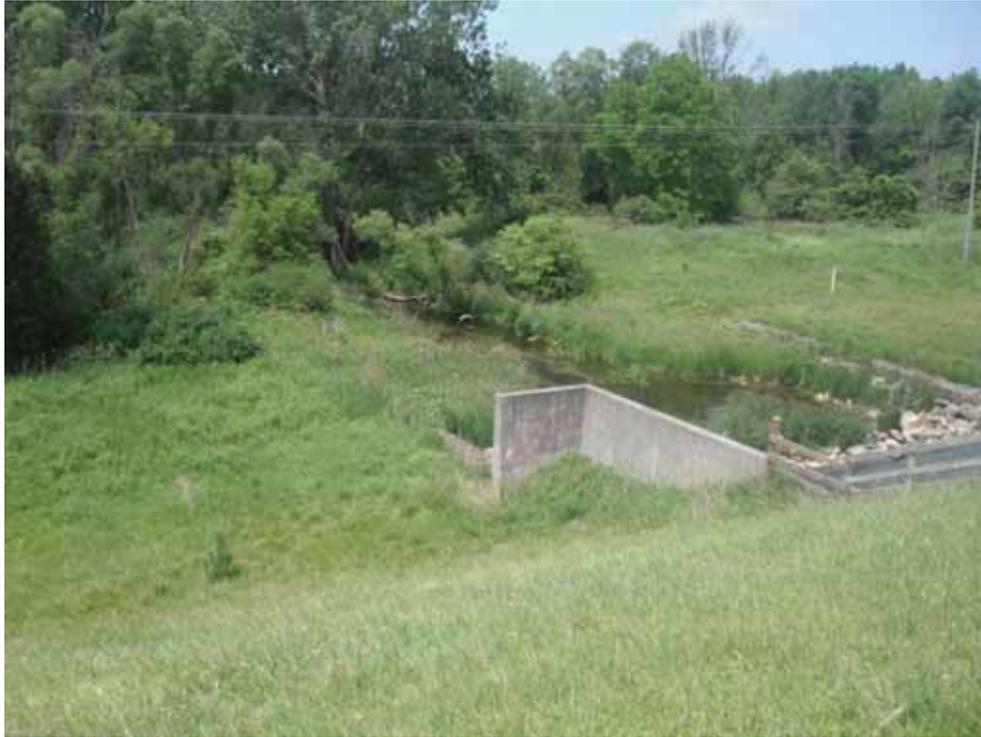
The second cultural heritage landscape identified within the Study Area relates to water management. This is seen in the wetlands formed by the Hay Swamp and in the Morrison Dam and reservoir. Only a small portion of the Hay Swamp is located in the northeast corner of the Study Area (Plate 10). The landscape is characterized by densely forests containing flat and low marshlands. The wet lands appear to be typical of those found throughout the region. The man-made Morrison Dam and reservoir is located within the Study Area, east of Exeter and maintained by the Ausable Bayfield Conservation Authority (ABCA) (Plates 11 and 12).

Plate 12: Morrison Dam, east of Exeter, looking downstream from Morrison Line.

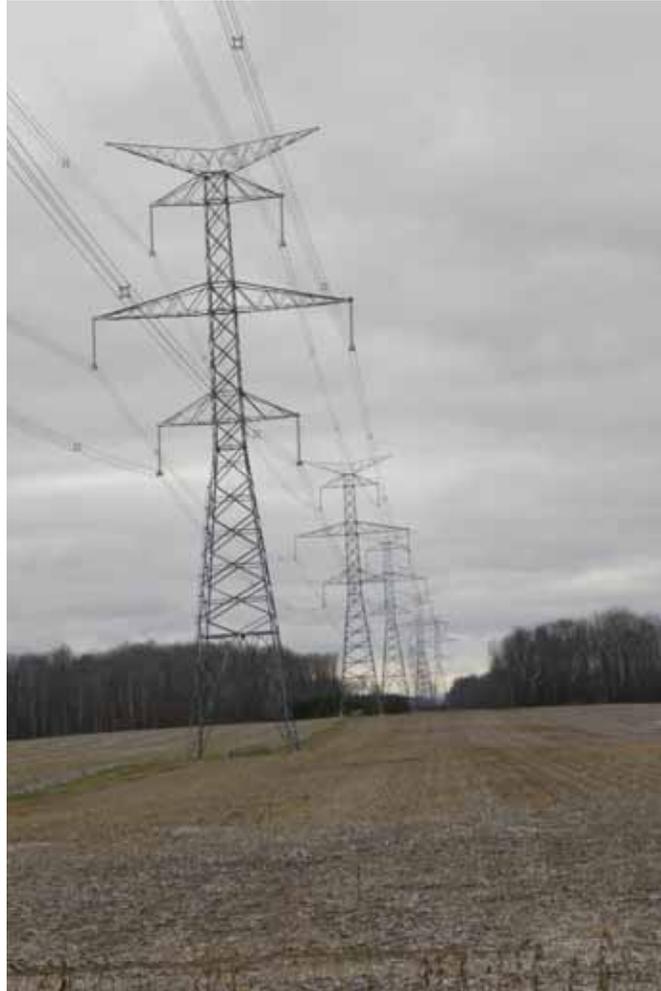
The third landscape identified within the Study Area is a hydro transmission corridor. The corridor is defined by a row of tall steel hydro towers (Plate 13). Where it passes through woodlots, the trees have been removed to create an unobstructed right-of-way. The size and spacing of the towers create a prominent landscape feature particularly given the flat landscape of the Study Area. The corridor crosses the Study Area from north to south between Goshen and Babylon Lines.

Plate 13: Hydro corridor, looking south from Dashwood Road, between Goshen Line and Babylon Line.

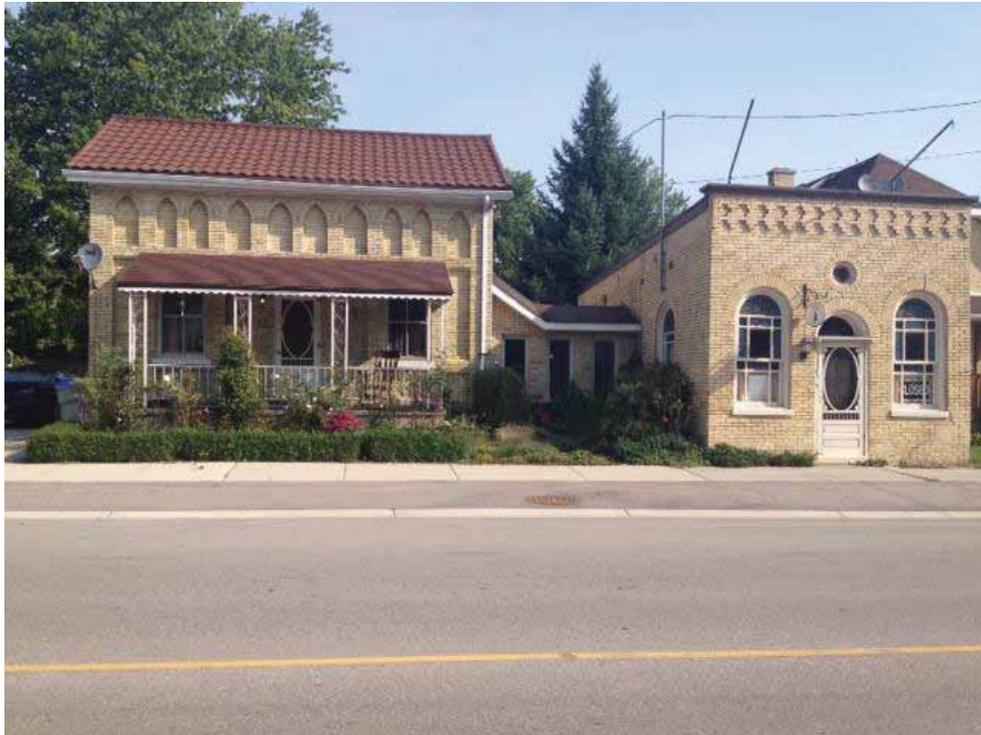
The house and adjacent office were built by Henry Eilber in 1888. Local construction materials were used in addition to the German-imported stain glass windows (Plate 16). Eilber was a prominent businessman and the proprietor of a very successful local insurance company. He played an important role in 19th century politics as the Clerk for Stephen Township and was later elected a Member of Provincial Parliament.

Plate 14: The Henry Eilber House, 12 Victoria Street East, Crediton

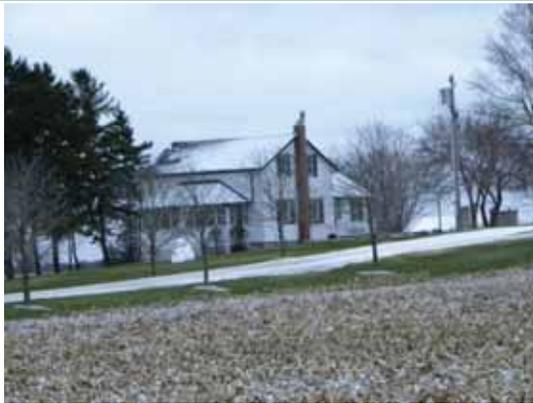
Site #1 – 38309 Rogerville Road (Municipality of Bluewater)

Date: Late 19th century

Description: One and one half storey side gabled house with medium roof pitch, modern siding and undetermined foundation. Symmetrical in design. Rear addition, red brick chimney with modern elements, and covered porch on the front facade.

Mitigation of Negative Impacts: Impacts were not identified, therefore mitigation is not recommended or necessary.

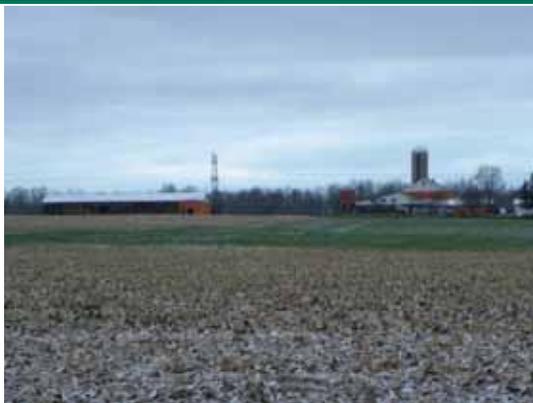
Date: Various (20th century)

Description: Frame barn with a stone foundation and rear shed addition. One concrete silo and two metal bins onsite with various outbuildings. Additional buildings onsite.

Mitigation of Negative Impacts: Impacts were not identified, therefore mitigation is not recommended or necessary.

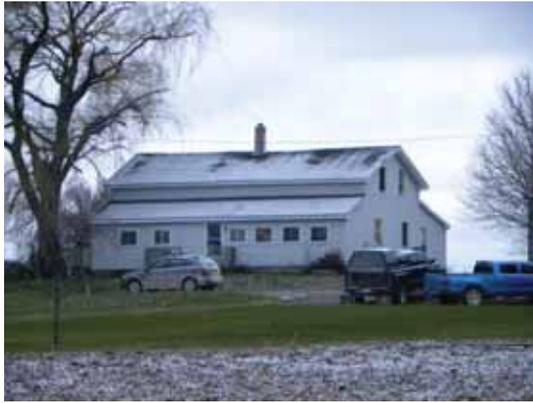
Site #2 – 72167 Babylon Line (Municipality of Bluewater)

Date: 20th century

Description: One and one half storey side gabled house with medium roof pitch, modern siding and concrete covered foundation. Full width covered front porch and apparent rear addition. Modern outbuildings onsite.

Mitigation of Negative Impacts: Impacts were not identified, therefore mitigation is not recommended or necessary.

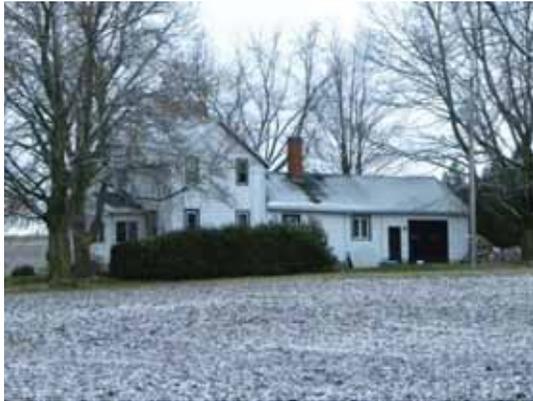
Site #3 – 72039 Babylon Line (Municipality of Bluewater)

Date: Late 19th century

Description: One and one half storey side gabled house with medium roof pitch, modern siding and concrete foundation. Symmetrical in design with a central double hung paired window. Addition at rear and covered central entryway with front gable.

Potential Direct and Indirect Impacts to the Heritage Attributes: None anticipated; see *Heritage Assessment Report* Section 6.1 for more information.

Mitigation of Negative Impacts: No negative impacts identified, therefore no further mitigation recommended.

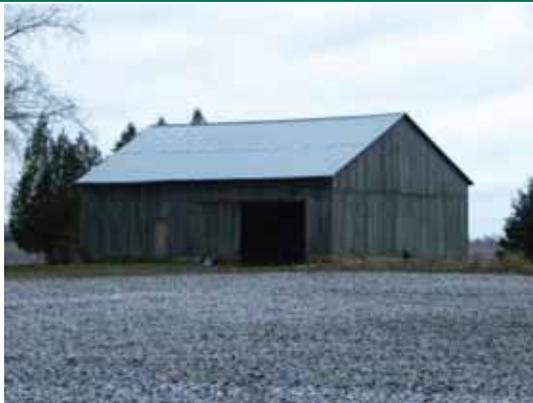
Date: 20th century

Description: Timber barn with metal roof, timber frame and concrete foundation.

Mitigation of Negative Impacts: Impacts were not identified, therefore mitigation is not recommended or necessary.

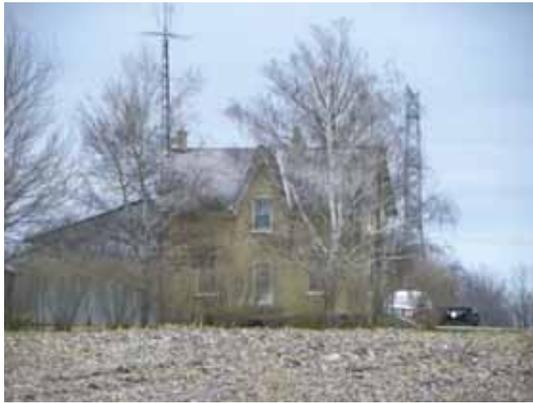
Site #4 – 72048 Goshen Line (Municipality of Bluewater)

Date: 1860s – 1890s

Description: One and one half storey side gabled house with a medium roof pitch and prominent central gable, yellow brick exterior and stone foundation. Vernacular Gothic Revival design elements include symmetrical design, central door, steeply pitched central gable with a decorative rounded window arch and bargeboard with cross-bracing and open rake. Timber addition at rear.

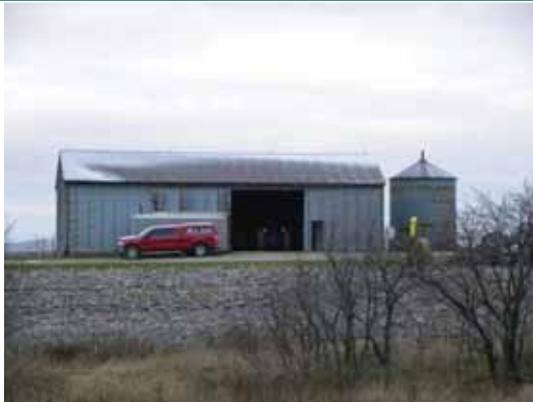
Date: 20th century

Description: Storage shed with metal roof, metal exterior on an undetermined foundation. Metal bin located at the rear.

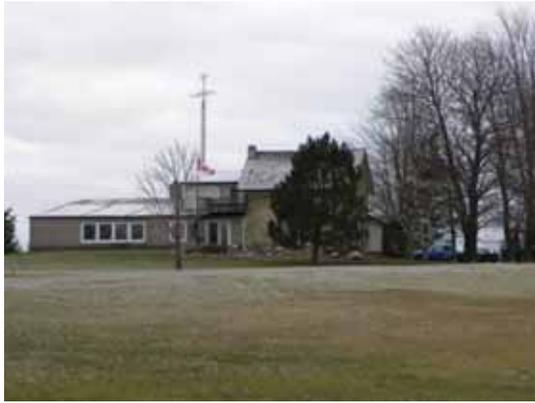
Site #5 – 71416 Bronson Line (Municipality of Bluewater)

Date: Late 19th century

Description: One and one half storey, side gabled, yellow brick house on an undetermined foundation. House has long, multi room/garage, single-storey metal-roofed gabled addition with a second storey addition attached to the house.

Mitigation of Negative Impacts: Impacts were not identified, therefore mitigation is not recommended or necessary.

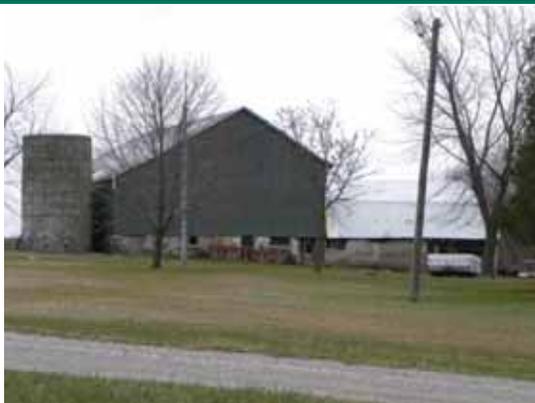
Date: Various (19th and 20th century)

Description: Frame barn with side shed addition, metal roof, timber frame and stone foundation. Silo attached to the shed addition. Side addition with metal gambrel roof and concrete foundation.

Mitigation of Negative Impacts: No negative impacts identified, therefore no further mitigation recommended.

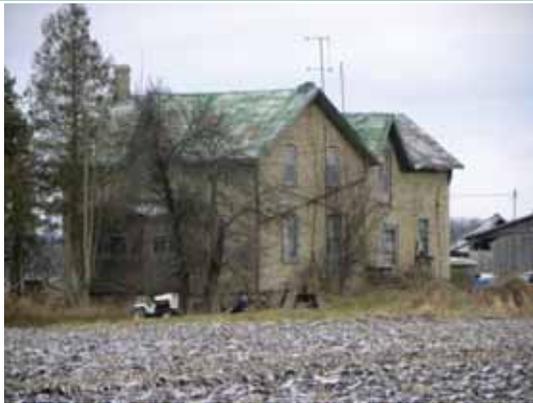
Site #6 – 71778 Blackbush Line (Municipality of Bluewater)

Date: 1860s – 1890s

Description: One and one half storey side gabled t-shaped house with a medium roof pitch and steeply pitched gables throughout, yellow brick exterior, and stone foundation. Vernacular Gothic Revival design elements include symmetrical design, central (covered) door, central gable, extensive brick detailing along cornice and rounded window arch, and remnants of decorative brackets. Possibly abandoned.

Mitigation of Negative Impacts: No negative impacts identified, therefore no further mitigation recommended.

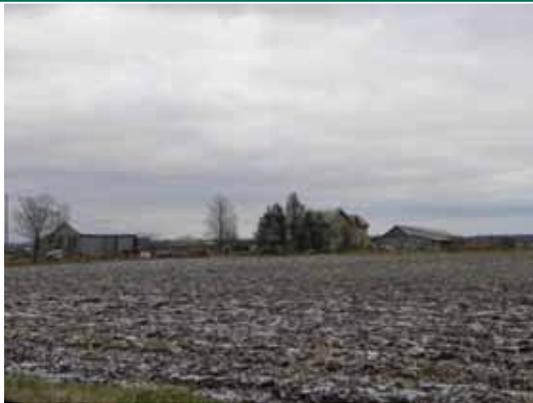
Date: Various (19th and 20th century)

Description: English styled barn with two shed additions and possible rear addition. Metal roof sits on a primarily timber frame and undetermined foundation. Shed structure contains a metal roof on timber frame with an undetermined foundation and rear metal bin.

Mitigation of Negative Impacts: No negative impacts identified, therefore no further mitigation recommended.

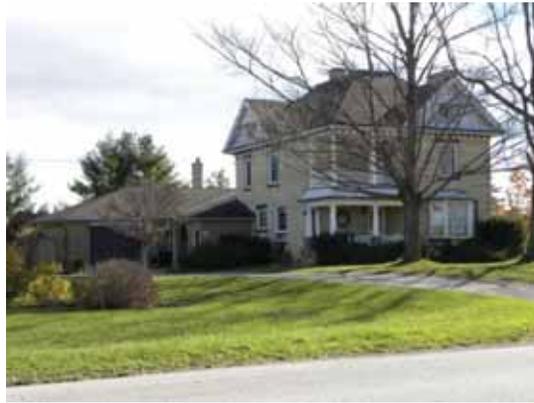
Site #7 – 72020 Bronson Line (Municipality of Bluewater)

Date: 1890 – 1920s

Description: Two storey, yellow brick, asymmetrical, hipped roof house on undetermined foundation with two storey gabled projection on front and gabled dormer on rear side. Vernacular Queen Anne design elements include wood columned and railed first and second storey porches, bay window, eaves with decorative cut outs and some decorative brackets. Rear addition.

Mitigation of Negative Impacts: No negative impacts identified, therefore no further mitigation recommended.

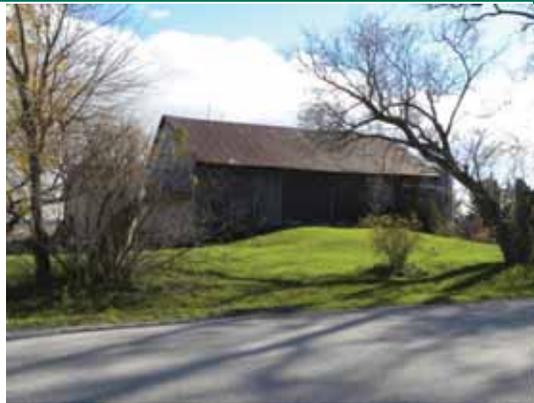
Date: 19th – early 20th century

Description: Timber framed, wood sided, metal roofed, side gabled barn with rear addition. Modern metal bin at rear.

Mitigation of Negative Impacts: No negative impacts identified, therefore no further mitigation recommended.

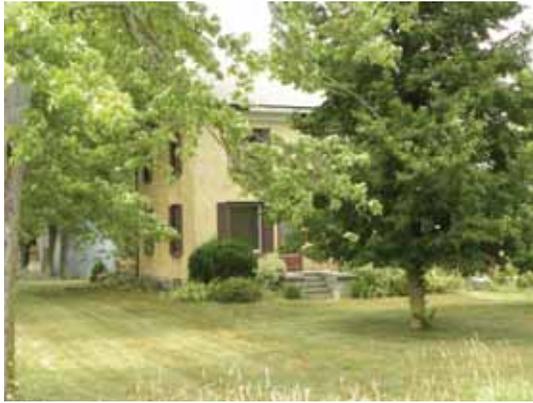
Site #8 – 38554 Dashwood Road (Municipality of Bluewater)

Date: 1890s – 1920s

Description: Two storey, yellow brick hipped roof house on a stone foundation. Symmetrical facade with decorative brackets and wide eaves. Rear addition. Modern garage at rear.

Mitigation of Negative Impacts: No negative impacts identified, therefore no further mitigation recommended.

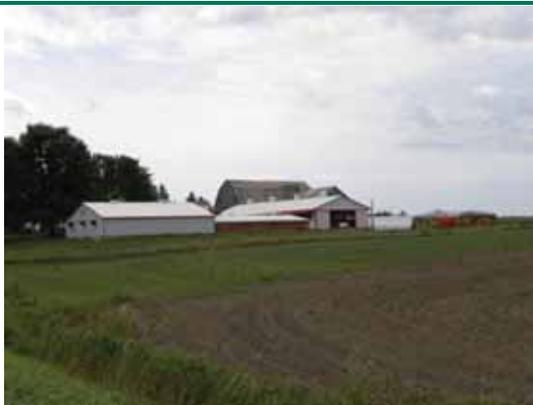
Date: 19th – 20th century

Description: Timber frame, gambrel roofed barn with metal roof and undetermined foundation. One large gable roof addition creates an L-plan. Modern shed buildings in foreground.

Mitigation of Negative Impacts: No negative impacts identified, therefore no further mitigation recommended.

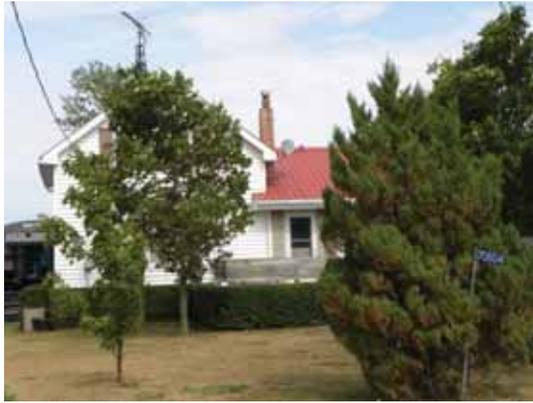
Site #9 – 70604 Shirpka Line (Municipality of South Huron)

Date: Late 19th century

Description: One and one half storey T-plan house on an undetermined foundation. Modern siding, windows and doors.

Mitigation of Negative Impacts: Impacts were not identified, therefore mitigation is not recommended or necessary.

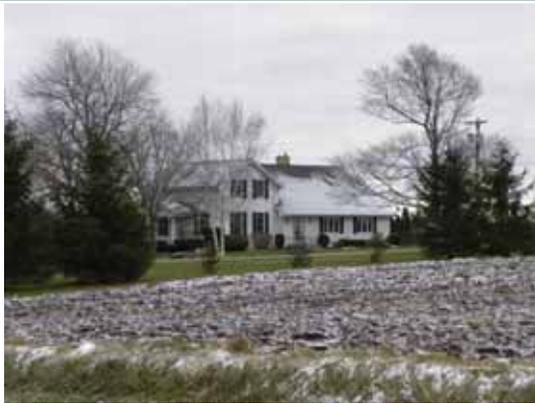
Site #10 – 38565 Dashwood Road (Municipality of South Huron)

Date: Late 19th century

Description: One and one half storey side gabled house with medium roof pitch, modern siding and undetermined foundation. Symmetrical in design. Extensive rear addition and single storey central porch.

Mitigation of Negative Impacts: Impacts were not identified, therefore mitigation is not recommended or necessary.

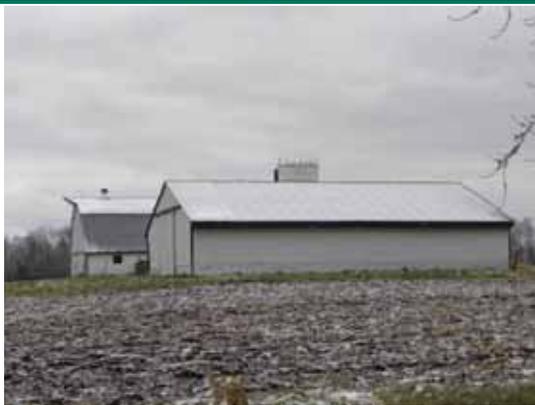
Date: Various (20th century)

Description: Two barns and single concrete silo onsite. First has a gambrel roof, mixed material exterior (timber, metal, apparent concrete), and undetermined foundation. Second is a front gabled barn with metal roof, metal siding, and concrete foundation.

Mitigation of Negative Impacts: Impacts were not identified, therefore mitigation is not recommended or necessary.

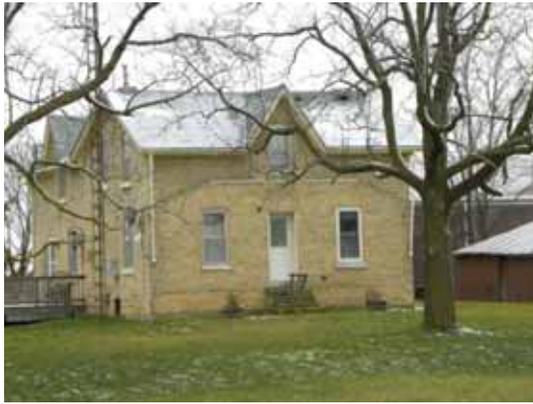
Site #11 – 70865 Babylon Line (Municipality of South Huron)

Date: 1860s – 1890s

Description: One and one half storey side gabled house with a medium roof pitch and central gable, yellow brick exterior and concrete foundation. Vernacular Gothic Revival design elements include symmetrical design, central window extending into the steeply pitched central gable and remnants of decorative brackets. Modern addition at rear.

Mitigation of Negative Impacts: No negative impacts identified, therefore no further mitigation recommended.

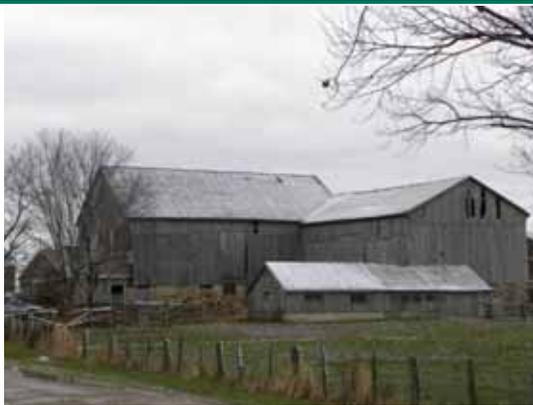
Date: Various (19th and 20th century)

Description: Barn appears to be a frame barn with third gable addition and later single storey shed addition, with metal roofs, timber frames and a variety of foundations (stone, brick and concrete).

Mitigation of Negative Impacts: No negative impacts identified, therefore no further mitigation recommended.

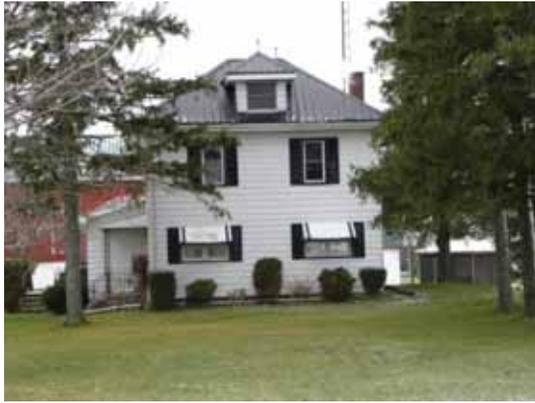
Site #12 – 70963 Babylon Line (Municipality of South Huron)

Date: 1890s – 1920s

Description: Two storey hipped roof house with a medium roof pitch, central hipped dormer, modern siding and undetermined foundation. Symmetrical front facade with extensive modifications throughout and large rear addition.

Potential Direct and Indirect Impacts to the Heritage Attributes: None anticipated; see *Heritage Assessment Report* Section 6.1 for more information.

Mitigation of Negative Impacts: No negative impacts identified, therefore no further mitigation recommended.

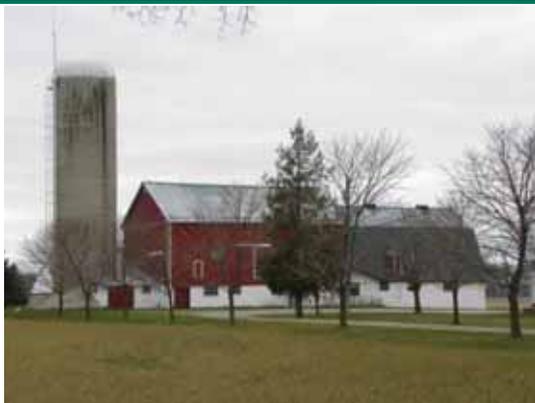
Date: 20th century

Description: Frame barn with gambrel roof addition and concrete silo. Both barns have metal roofs, modern siding and (possibly covered) concrete foundation.

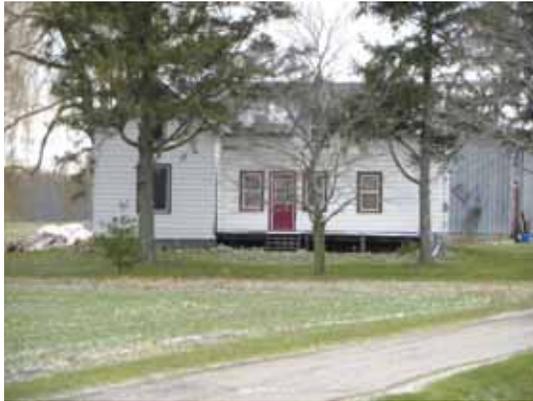
Site #13 – 70683 Babylon Line (Municipality of South Huron)

Date: 1860s – 1890s

Description: One and one half storey L-shaped cross gabled house with a steep roof pitch and central gable, modern siding and a stone foundation. Vernacular Gothic Revival design influences include asymmetrical design and the central window extending into the steeply pitched central gable.

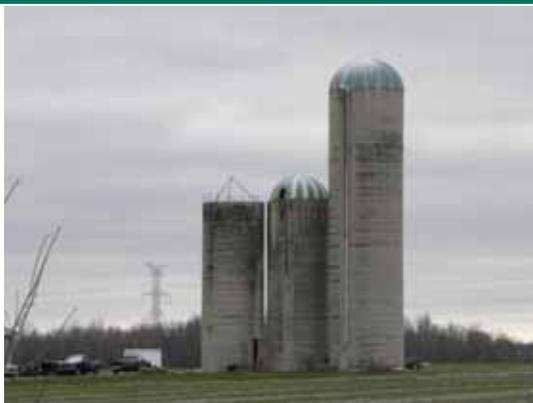
Date: 20th century

Description: Three concrete silos at the rear of the house.

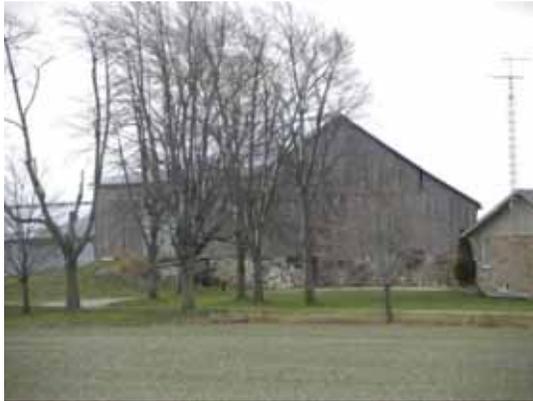
Site #14 – 70524 Babylon Line (Municipality of South Huron)

Description: Frame barn with rear shed addition, metal roof, timber frame and stone foundation.

Mitigation of Negative Impacts: No negative impacts identified, therefore no further mitigation recommended.

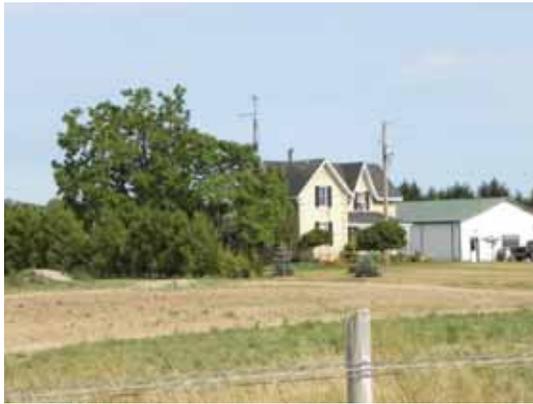
Site #15 – 69865 Grand Bend Line (Municipality of South Huron)

Description: One and one half storey side gabled house with a medium roof pitch and prominent central gable, yellow brick exterior and stone foundation. Vernacular Gothic Revival design elements include symmetrical design, central door, steeply pitched central gable with a decorative rounded window arch and bargeboard with cross-bracing and open rake.

Mitigation of Negative Impacts: No negative impacts identified, therefore no further mitigation recommended.

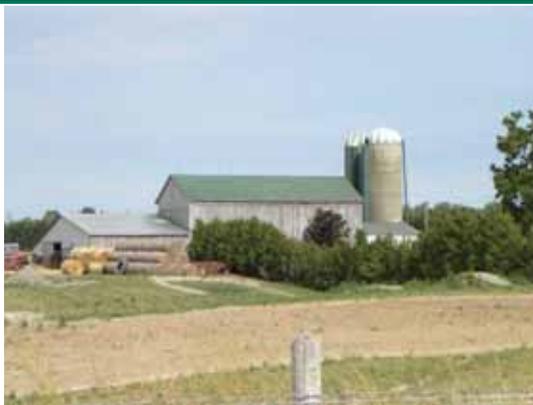
Description: Side gabled timber framed barn with metal roof and undetermined foundation. Two side shed additions and two concrete silos on site.

Mitigation of Negative Impacts: No negative impacts identified, therefore no further mitigation recommended.

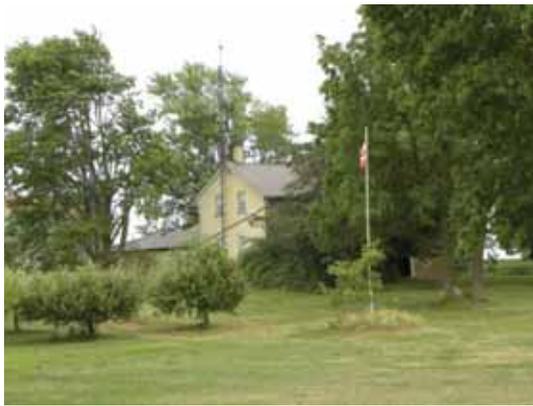
Site #16 – 70260 Kirkton Line (Municipality of Bluewater)

Description: One and one half storey T-shaped side gabled house with a medium roof pitch, prominent central gable, yellow brick exterior, and stone foundation. Vernacular Gothic Revival design elements include symmetrical design with central porch and door, steeply pitched central gable with a decorative rounded window arch and brickwork. Rear addition.

Mitigation of Negative Impacts: No negative impacts identified, therefore no further mitigation recommended.

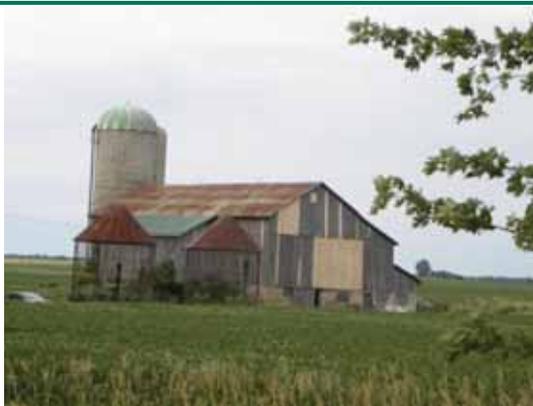
Description: Timber frame, side gabled barn with a metal roof and wood siding, on a brick and concrete foundation. Concrete silo sits adjacent to barn.

Mitigation of Negative Impacts: No negative impacts identified, therefore no further mitigation recommended.

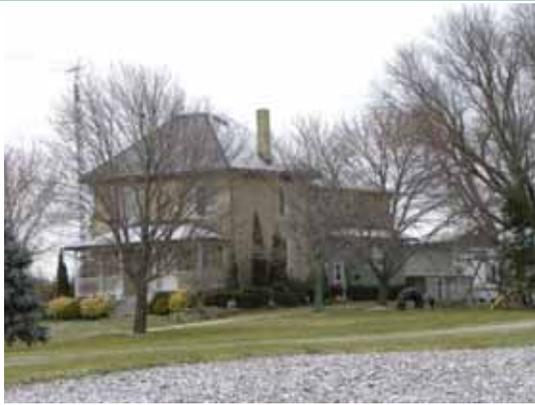
Site #17 – 71002 Goshen Line (Municipality of South Huron)

Description: Two storey hipped roof house with a steep roof pitch, yellow brick exterior and undetermined foundation. Vernacular four-square design elements include symmetrical design, full width single storey roof pitch and square plan. Modern addition at rear.

Mitigation of Negative Impacts: No negative impacts identified, therefore no further mitigation recommended.

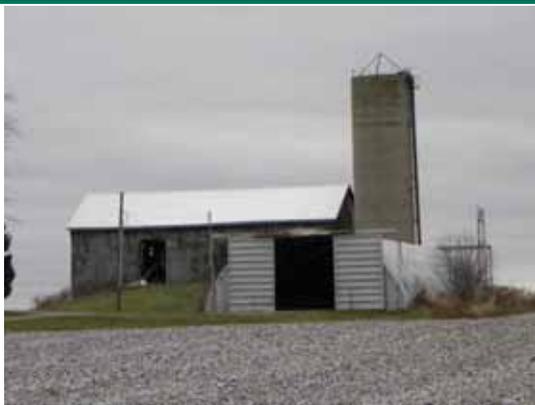
Description: Frame barn with concrete silo and modern outbuilding. Barn has a metal roof, timber frame and undetermined foundation.

Mitigation of Negative Impacts: No negative impacts identified, therefore no further mitigation recommended.

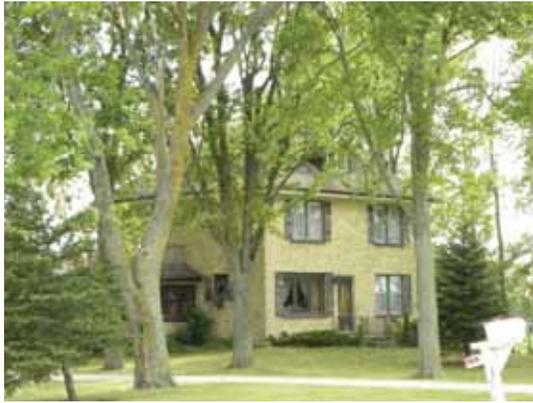
Site #18 – 38439 Crediton Line (Municipality of South Huron)

Description: Two storey hipped roof house with a medium roof pitch, central hipped dormer, brick exterior and stone foundation. Symmetrical front facade with central doorway. Rear addition.

Mitigation of Negative Impacts: No negative impacts identified, therefore no further mitigation recommended.

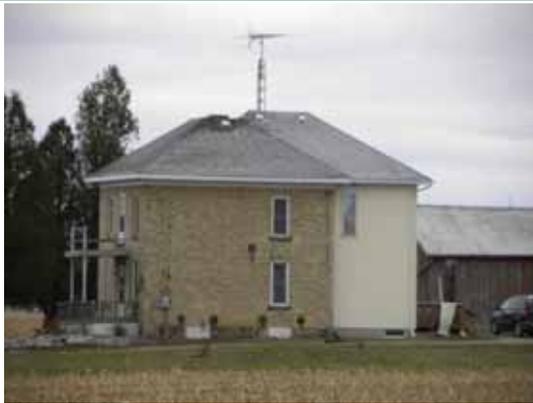
Site #19 – 71002 Goshen Line (Municipality of South Huron)

Description: Two storey hipped roof house with medium roof pitch, yellow brick exterior and stone foundation. Vernacular design characteristics include symmetrical four-square design, small front entry porch, wide eaves and remnants of decorative brackets. Extensive addition at rear.

Mitigation of Negative Impacts: No negative impacts identified, therefore no further mitigation recommended.

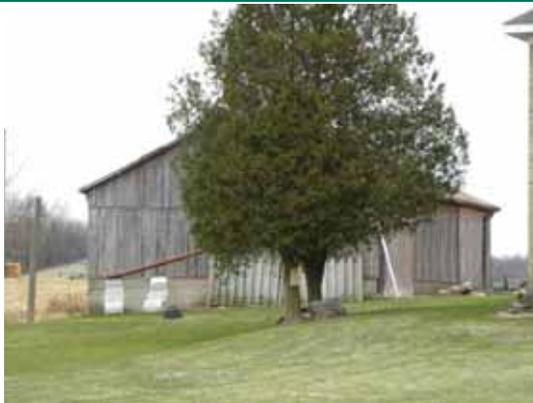
Description: Two-bay shed with metal roof, timber frame and concrete foundation.

Mitigation of Negative Impacts: No negative impacts identified, therefore no further mitigation recommended.

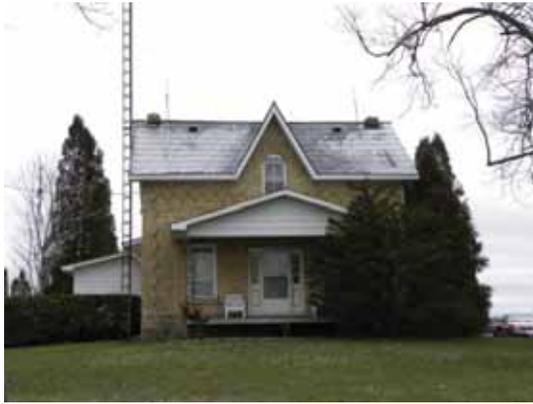
Site #20 – 38060 Huron Street (Municipality of South Huron)

Description: One and one half storey T-shaped side gabled house with a medium roof pitch and prominent central gable, yellow brick exterior, and concrete covered foundation. Vernacular Gothic Revival design elements include symmetrical design, central door, steeply pitched central gable with a decorative rounded window arch and brickwork. Rear addition.

Mitigation of Negative Impacts: No negative impacts identified, therefore no further mitigation recommended.

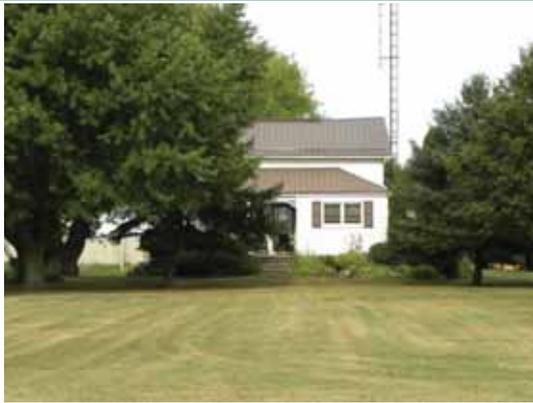
Site #21 – 70112 Bronson Line (Municipality of Bluewater)

Description: One and one half storey side gabled house with medium roof pitch, modern siding and concrete foundation. Symmetrical in design with a full front porch.

Mitigation of Negative Impacts: Impacts were not identified, therefore mitigation is not recommended or necessary.

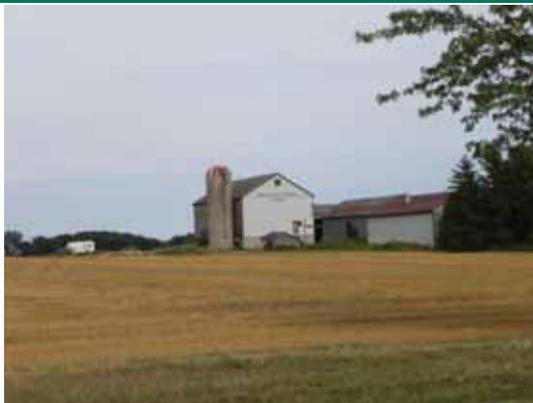
Description: Timber framed side gabled barn with a metal roof and wood siding, on a concrete foundation. Rear and side additions. Concrete silo sits adjacent to barn.

Mitigation of Negative Impacts: Impacts were not identified, therefore mitigation is not recommended or necessary.

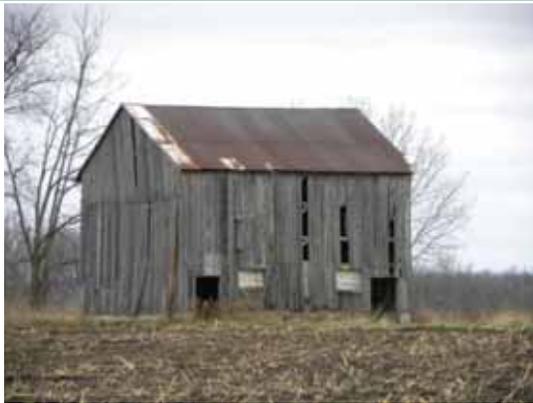
Site #22 – 35526 South Road (Municipality of South Huron)

Description: Frame barn with metal roof, timber frame and concrete foundation. Barn is situated at the centre of an agricultural field.

Mitigation of Negative Impacts: No negative impacts identified, therefore no further mitigation recommended.

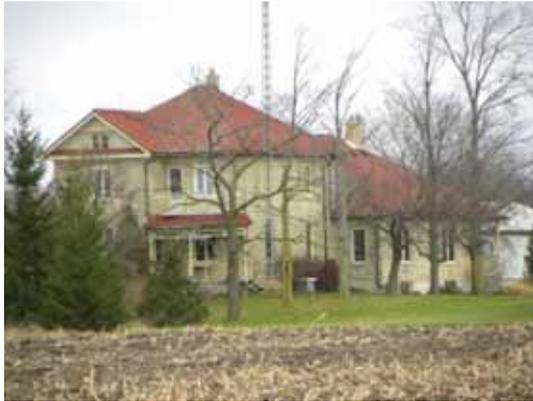
Site #23 – 69436 Mollard Line (Municipality of South Huron)

Description: Two storey, asymmetrical house, with a hipped roof, yellow brick and an undetermined foundation. Vernacular Queen Anne design elements include two storey gabled projection, decorative spindle work and turned wood columns. Rear addition.

Mitigation of Negative Impacts: No negative impacts identified, therefore no further mitigation recommended.

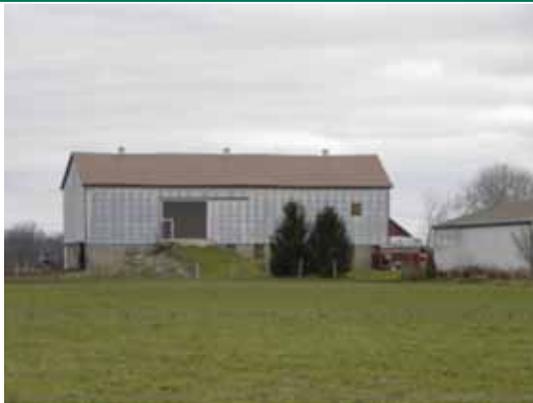
Description: Side gabled, timber frame barn on a concrete or concrete foundation. Roof and sidewalls appear to be painted metal.

Mitigation of Negative Impacts: No negative impacts identified, therefore no further mitigation recommended.

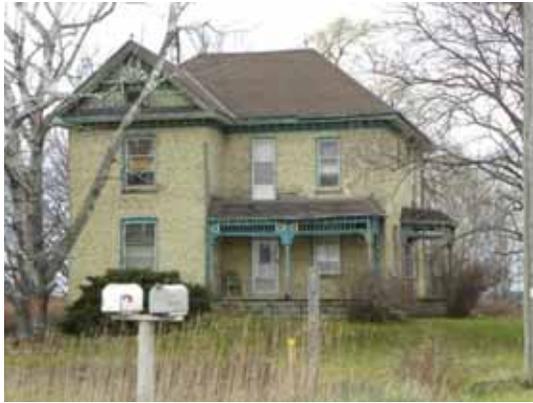
Site #24 – 35652 Greenway Drive (Municipality of South Huron)

Description: Two storey hipped roof house with lower cross gable on the front facade and medium roof pitch, yellow brick exterior and rusticated concrete block foundation. Vernacular Queen Anne design elements include asymmetrical design, front facing gables, decorative gable ornaments featuring a sunburst, dentil-like brackets, and front and side porches with delicate spindle work along porch columns. Rear addition.

Mitigation of Negative Impacts: No negative impacts identified, therefore no further mitigation recommended.

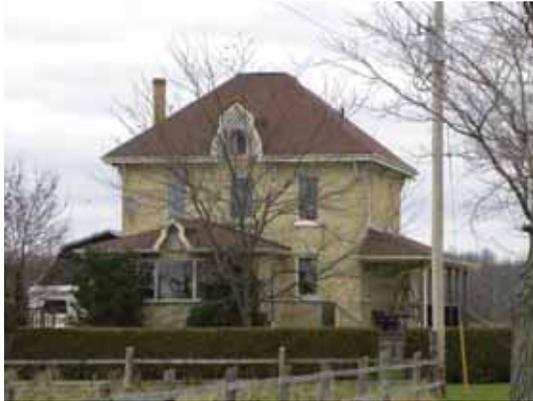
Site #25 – 69668 Grand Bend Line (Municipality of South Huron)

Description: Two storey hipped roof house with steep pitch, yellow brick exterior and stone foundation. Vernacular design characteristics include symmetrical rectangular design, decorative dentils and brackets as well as a central dormer with rounded central window. Addition at rear.

Mitigation of Negative Impacts: No negative impacts identified, therefore no further mitigation recommended.

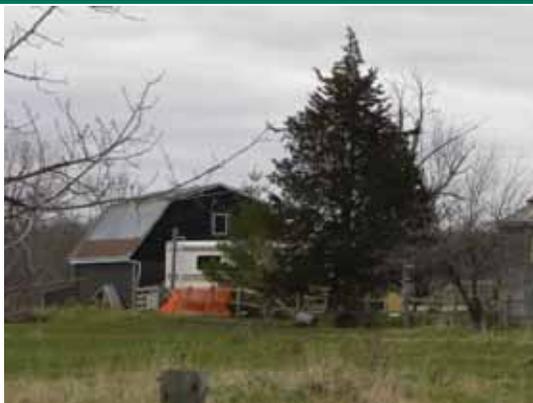
Description: Gambrel roof shed with metal roof, modern siding and an undetermined foundation.

Mitigation of Negative Impacts: No negative impacts identified, therefore no further mitigation recommended.

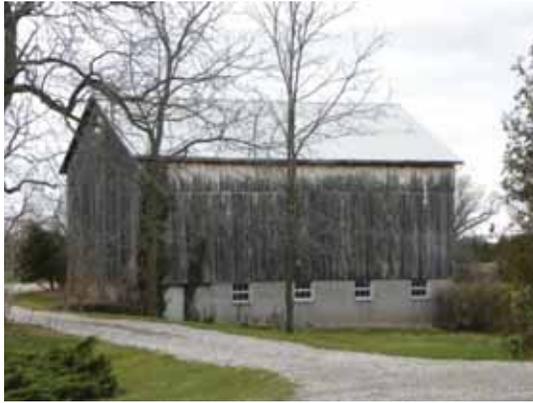
Site #26 – 69689 Grand Bend Line (Municipality of South Huron)

Description: Frame barn with metal roof, timber siding and a concrete foundation with windows.

Mitigation of Negative Impacts: No negative impacts identified, therefore no further mitigation recommended.

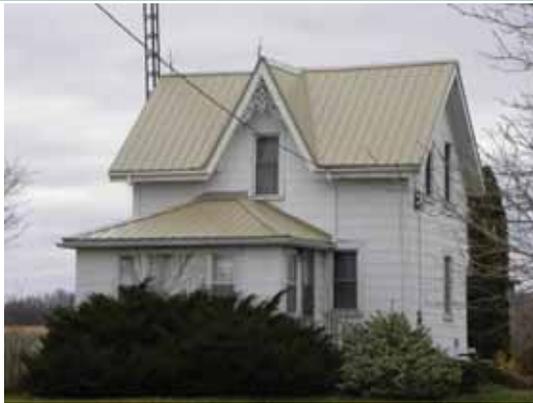
Site #27 – 69724 Grand Bend Line (Municipality of South Huron)

Description: One and one half storey side gabled house with a steep roof pitch and prominent central gable, modern siding and stone foundation. Vernacular Gothic Revival design elements include symmetrical design, central window extended into a steeply pitched gable and decorative cross bracing. Rear addition.

Mitigation of Negative Impacts: No negative impacts identified, therefore no further mitigation recommended.

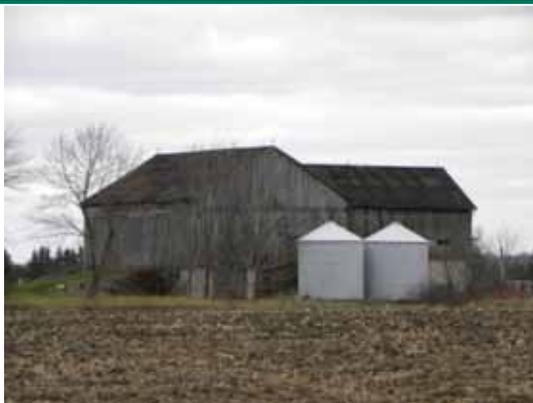
Description: Frame barn with asphalt sheet roof, timber frame and concrete block foundation. Two metal bins adjacent.

Mitigation of Negative Impacts: No negative impacts identified, therefore no further mitigation recommended.

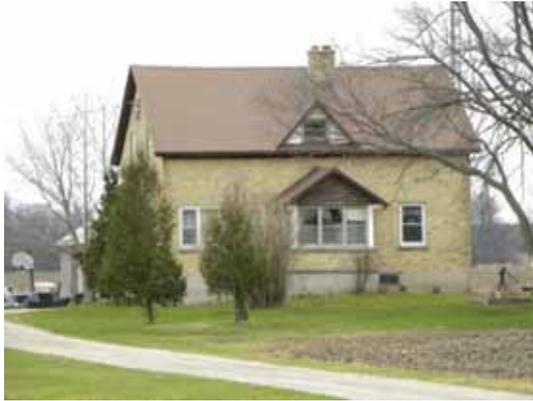
Site #28– 69804 Shipka Line (Municipality of South Huron)

Description: One and one half storey yellow brick, side gabled, metal roofed, house on a concrete foundation. House has a small central gabled dormer over a gable roofed, enclosed porch/entry hall with a half-height brick wall on a similar foundation as the house.

Mitigation of Negative Impacts: Impacts were not identified, therefore mitigation is not recommended or necessary.

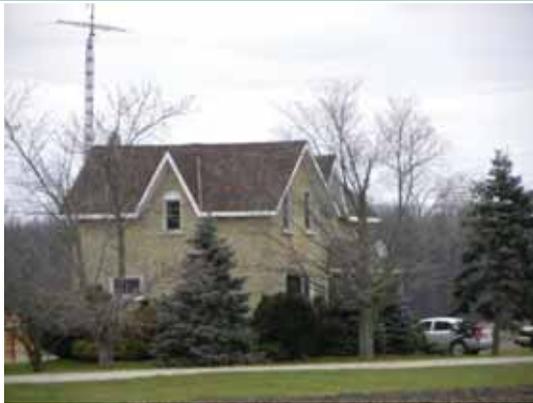
Site #29 – 69872 Shipka Line (Municipality of South Huron)

Description: One and one half storey yellow brick, side gabled, metal roofed, house on an undetermined foundation. House has a small central gable over a side gable roofed, enclosed porch/entry hall with a half-height brick wall on a similar foundation as the house.

Mitigation of Negative Impacts: No negative impacts identified, therefore no further mitigation recommended.

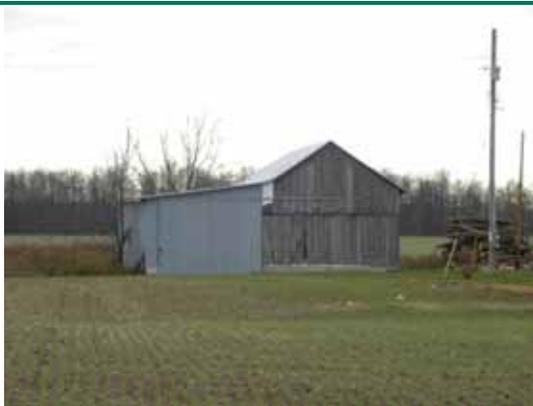
Description: Timber framed, wood sided, metal roofed, side gabled barn on a concrete foundation. Side shed addition.

Mitigation of Negative Impacts: No negative impacts identified, therefore no further mitigation recommended.

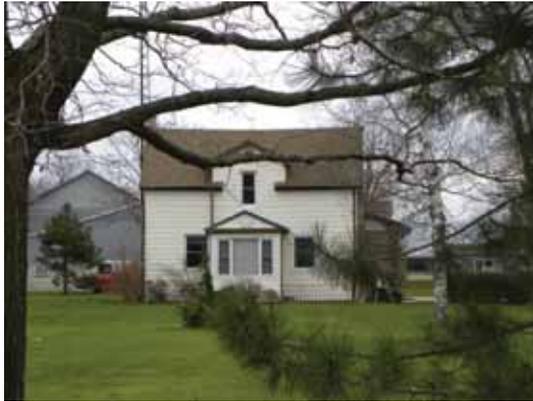
Site #30 – 69872 Shipka Line (Municipality of South Huron)

Description: One and one half storey side gabled house with a steep roof pitch and prominent central dormer, modern siding and undetermined foundation. Vernacular design elements include symmetrical design, central window extending into the dormer. Rear addition and modern front porch entrance.

Mitigation of Negative Impacts: Impacts were not identified, therefore mitigation is not recommended or necessary.

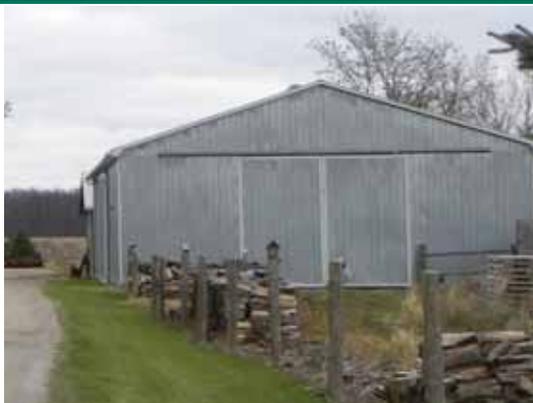
Description: Front gabled shed with metal roof, metal exterior and undetermined foundation.

Mitigation of Negative Impacts: Impacts were not identified, therefore mitigation is not recommended or necessary.

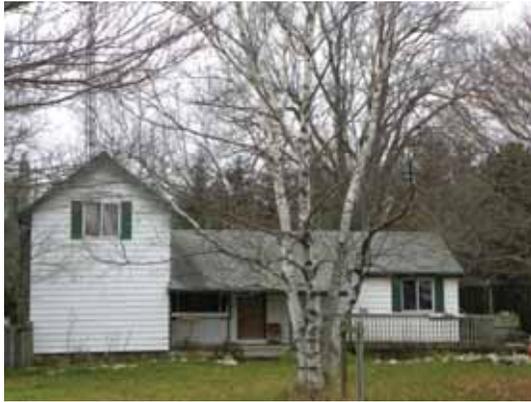
Site #31 – 69881 Shipka Line (Municipality of South Huron)

Description: One and one half storey L-shaped house with cross gabled roof with a medium pitch, modern siding and stone foundation. Front gabled single storey extends from side gabled one and one half storey portion. Modern rear and side additions.

Mitigation of Negative Impacts: Impacts were not identified, therefore mitigation is not recommended or necessary.

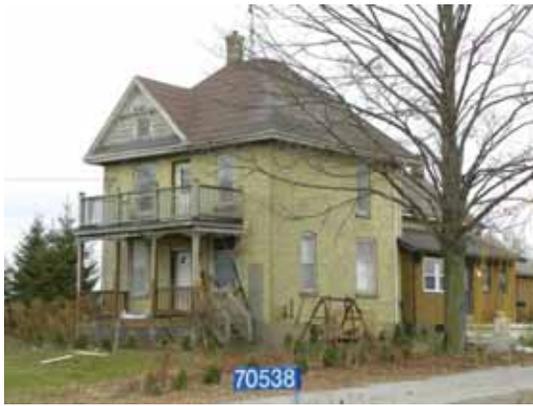
Site #32 – 70538 Shipka Line (Municipality of South Huron)

Description: Two storey hipped roof house with lower cross gable and medium roof pitch, yellow brick exterior with two storey porch and concrete covered foundation. Vernacular Queen Anne design elements include asymmetrical design, front facing gables, decorative gable ornaments including starburst, and dentils. Rear addition.

Mitigation of Negative Impacts: No negative impacts identified, therefore no further mitigation recommended.

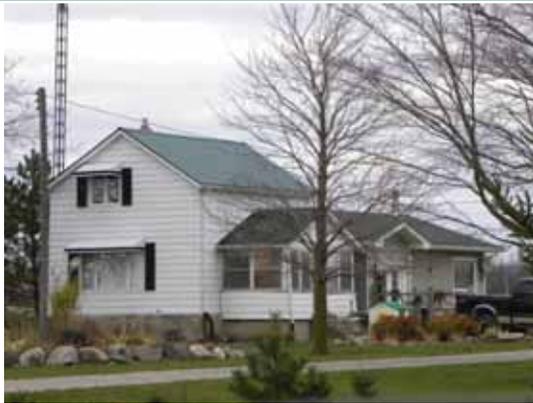
Site #33 – 70352 Shipka Line (Municipality of South Huron)

Description: One and one half storey side gabled house with a medium roof pitch, modern siding and concrete foundation. Rear addition and modern covered central entryway.

Mitigation of Negative Impacts: No negative impacts identified, therefore no further mitigation recommended.

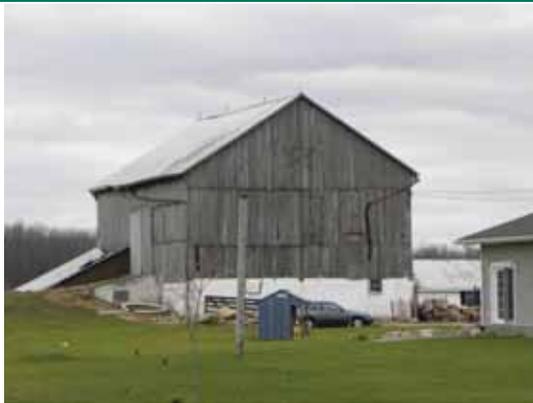
Description: Primary barn structure is a frame barn with metal roof, timber frame and concrete covered foundation. Single storey shed addition located at rear.

Mitigation of Negative Impacts: No negative impacts identified, therefore no further mitigation recommended.

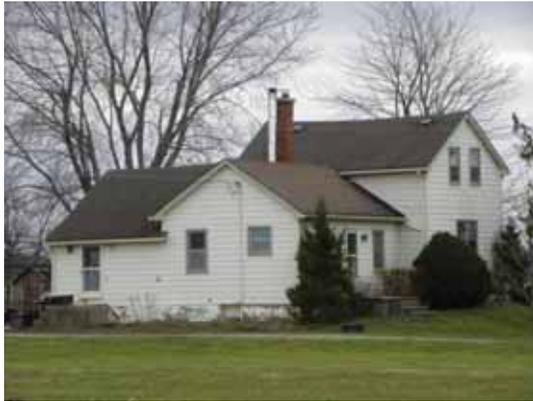
Site #34 – 70298 Shipka Line (Municipality of South Huron)

Description: One and one half storey front gabled house with single storey side gable, medium roof pitch, modern siding and painted concrete foundation.

Mitigation of Negative Impacts: Impacts were not identified, therefore mitigation is not recommended or necessary

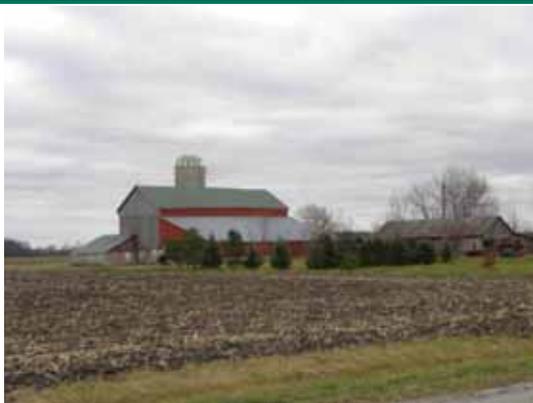
Date: Various (19th and 20th century)

Description: Primary barn is a frame barn with multiple shed additions, metal roof, timber frame and stone foundation. Concrete silo at rear and single storey shed with metal roof, timber frame and undetermined foundation.

Mitigation of Negative Impacts: No negative impacts identified, therefore no further mitigation recommended.

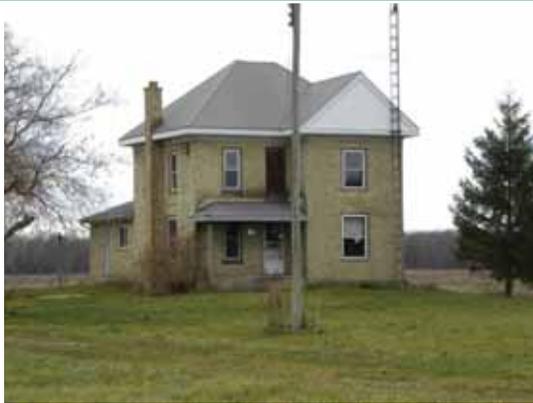
Site #35 – 70205 Shipka Line (Municipality of South Huron)

Date: 1890s – 1920s

Description: Two storey hipped roof house with lower cross gable and medium roof pitch, yellow brick exterior and apparent concrete foundation. Vernacular Queen Anne design elements include asymmetrical design, front facing gable, decorative cornices and two storey front porch. Covered front cross gable and modern porch.

Mitigation of Negative Impacts: No negative impacts identified, therefore no further mitigation recommended.

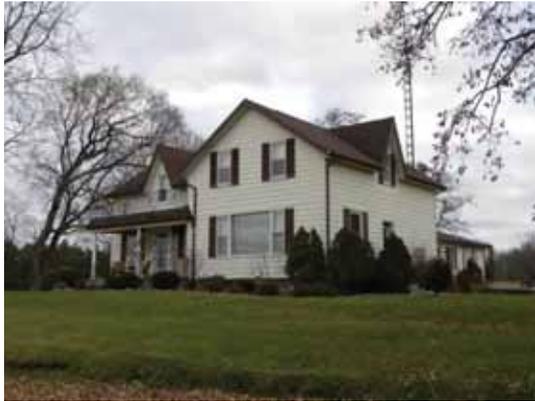
Site #36 – 37343 Crediton Line (Municipality of South Huron)

Date: 1860s – 1890s

Description: One and one half storey cross gabled yellow brick house with a medium roof pitch and multiple steeply pitched cross gables, modern siding and undetermined foundation. Asymmetrical design with central window that extends into front gable. Front porch with central entryway. Addition at rear.

Mitigation of Negative Impacts: No negative impacts identified, therefore no further mitigation recommended.

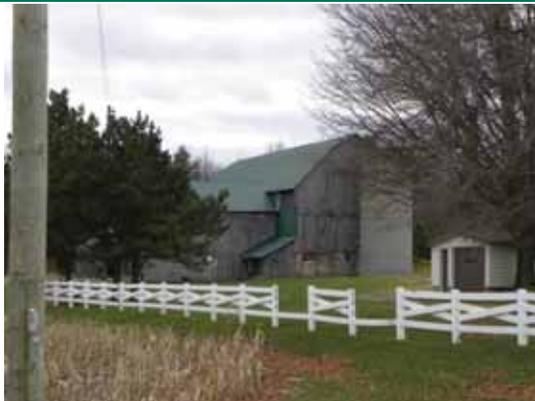
Date: Various (19th and 20th century)

Description: Primary barn is a gambrel roofed frame barn with rear gable addition, a metal roof, timber frame and stone foundation. The site contains multiple out buildings including a single storey yellow brick structure.

Mitigation of Negative Impacts: No negative impacts identified, therefore no further mitigation recommended.
