HERITAGE ASSESSMENT REPORT

**NextEra Energy Canada, ULC
Goshen Wind Energy Centre
Municipalities of Bluewater
and South Huron
Huron County, Ontario**

Report Number: 10-1151-0201-3000-3200-R01

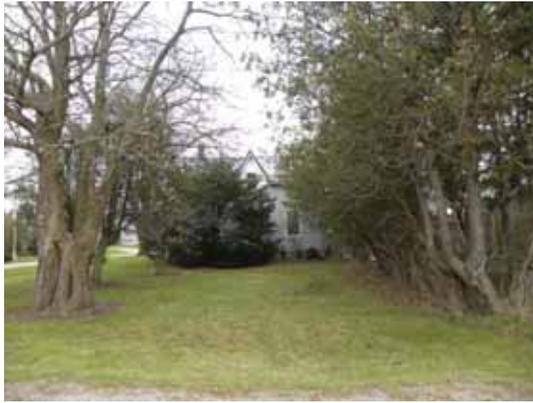
Site #37 – 37391 Crediton Line (Municipality of South Huron)

Date: 1860s – 1890s

Description: One and one half storey side gabled house with a steep roof pitch and prominent central gable, modern siding and concrete foundation. Vernacular Gothic Revival design elements include symmetrical design and a central window extending into the gable with possible wood shingles.

Mitigation of Negative Impacts: No negative impacts identified, therefore no further mitigation recommended.

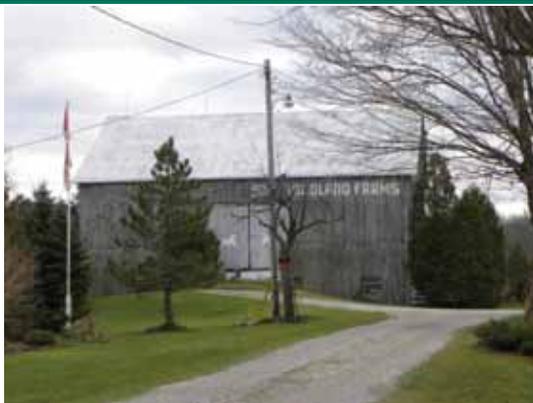
Date: 19th – early 20th century

Description: Frame barn with metal roof, timber frame and undetermined foundation.

Mitigation of Negative Impacts: No negative impacts identified, therefore no further mitigation recommended.

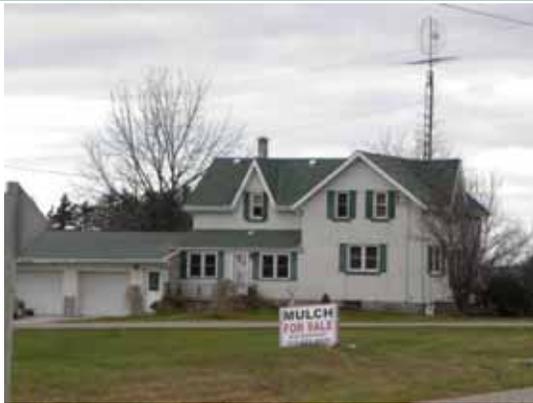
Site #38 – 69661 Bronson Line (Municipality of South Huron)

Date: 1860s – 1890s

Description: One and one half storey cross gabled brick veneer house with a medium roof pitch, medium pitched cross gable, steeply pitched gable and concrete foundation. Symmetrical design appears to be a T-plan with a central window that reaches into the central gable. Modern addition at rear, small front porch and covered side porch.

Mitigation of Negative Impacts: No negative impacts identified, therefore no further mitigation recommended.

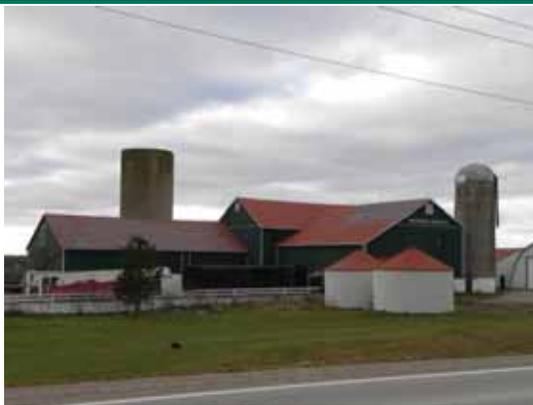
Date: Various (19th and 20th century)

Description: Primary barn appears to be a frame barn with two shed additions, metal roof, timber frame and concrete foundation. Two concrete silos onsite and two metal bins onsite with additional outbuildings.

Mitigation of Negative Impacts: No negative impacts identified, therefore no further mitigation recommended.

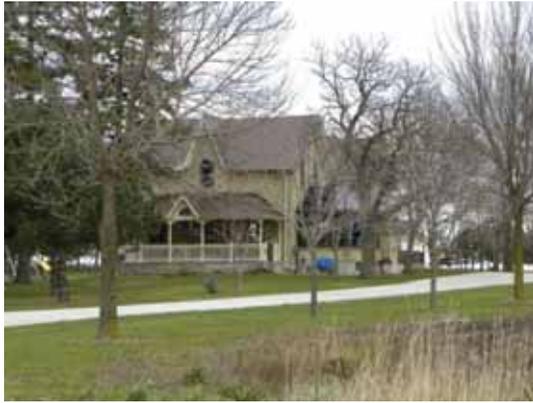
Site #39 –69562 Bronson Line (Municipality of South Huron)

Date: 1860s – 1890s

Description: One and one half storey side gabled house with a steep roof pitch and prominent central gable, yellow brick exterior and concrete covered foundation. Vernacular Gothic Revival design elements include symmetrical design, rounded window extending into the steeply pitched central gable, detailed brick work throughout including the quoin-like detailing. Side and rear additions.

Mitigation of Negative Impacts: No negative impacts identified, therefore no further mitigation recommended.

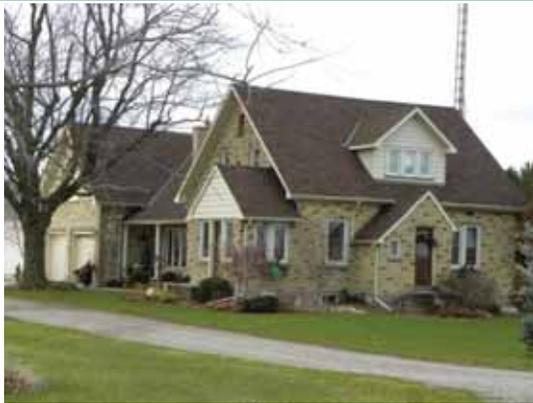
Site #40 – 69881 Babylon Line (Municipality of South Huron)

Date: Mid 20th century

Description: One and one half storey side gabled house with a steep roof pitch and prominent central dormer, poly chromatic yellow and red brick exterior and covered concrete foundation. Extensive rear addition and modifications throughout.

Mitigation of Negative Impacts: Impacts were not identified, therefore mitigation is not recommended or necessary.

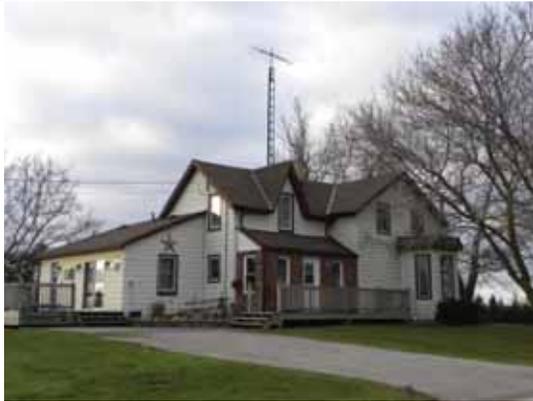
Site #41 – 69855 King Street South/Parr Line (Municipality of South Huron)

Date: 1860s – 1890s

Description: One and one half storey cross gabled house with a steep roof pitch, medium pitched cross gable steeply pitched front gable, modern siding and undetermined foundation. Design appears to be an L-plan with a window that reaches into the central gable. Side addition and covered front porch with brick veneer.

Mitigation of Negative Impacts: No negative impacts identified, therefore no further mitigation recommended.

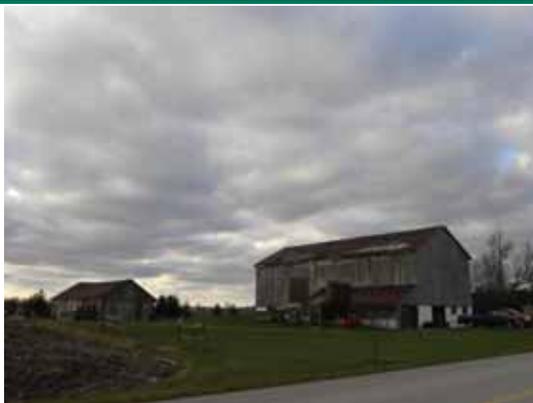
Date: Various (19th and 20th century)

Description: Frame barn with metal roof, timber frame and concrete foundation. Secondary structure is a single storey shed with metal roof, timber frame and undetermined foundation.

Mitigation of Negative Impacts: No negative impacts identified, therefore no further mitigation recommended.

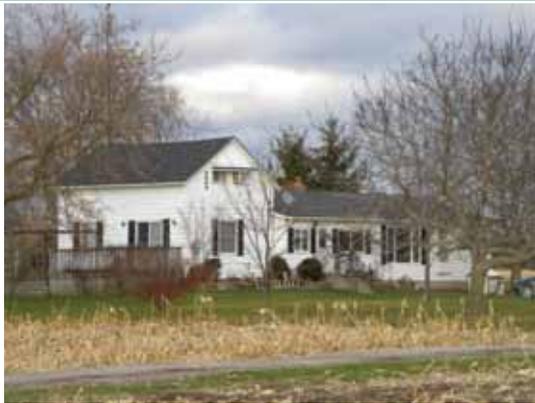
Site #42 – 70548 Blackbush Line (Municipality of South Huron)

Date: Late 19th century

Description: One and one half storey side gabled house with medium roof pitch, modern siding and undetermined foundation. Extensive addition at rear.

Mitigation of Negative Impacts: Impacts were not identified, therefore mitigation is not recommended or necessary.

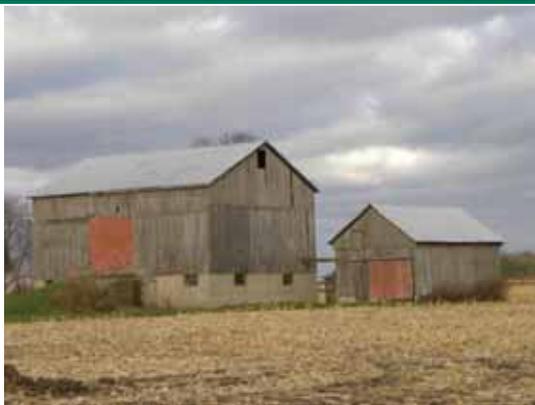
Date: 19th – early 20th century

Description: Frame barn with single storey shed adjacent to barn. Both structures have metal roofs, timber frames and concrete foundations.

Mitigation of Negative Impacts: No negative impacts identified, therefore no further mitigation recommended.

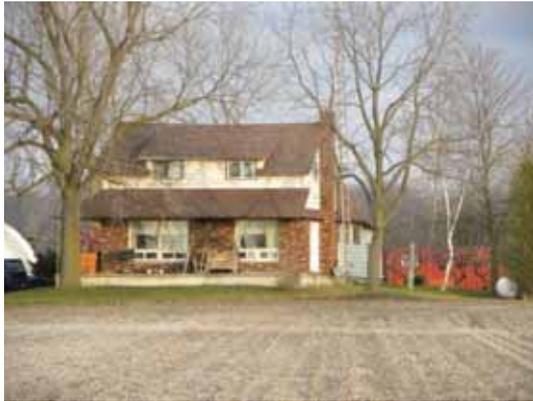
Site #43 – 70600 Blackbush Line (Municipality of South Huron)

Date: Mid 20th century

Description: One and one half storey side gabled house with steep roof pitch, central shed dormer, modern siding and brick veneer exterior and undetermined foundation. Symmetrical design with covered front porch. Addition at rear.

Mitigation of Negative Impacts: Impacts were not identified, therefore mitigation is not recommended or necessary.

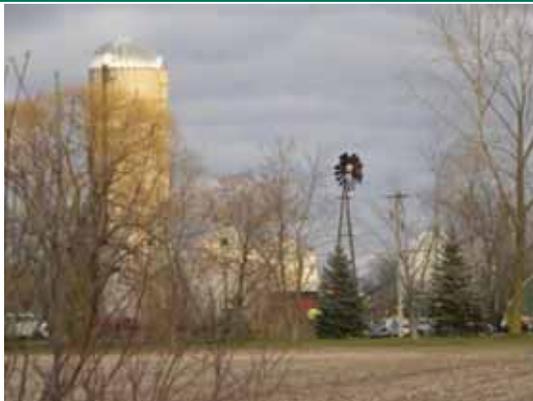
Date: 20th century

Description: Single concrete silo with at least three metal bins onsite.

Mitigation of Negative Impacts: Impacts were not identified, therefore mitigation is not recommended or necessary.

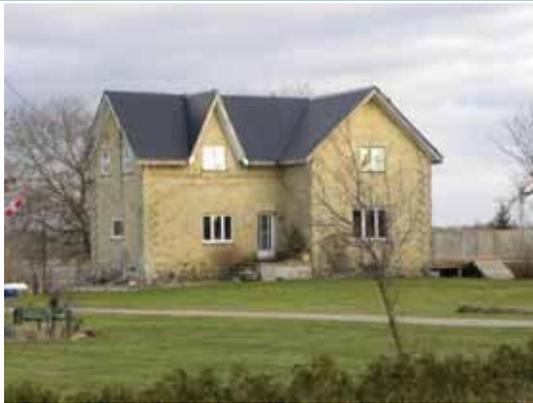
Site #44 – 70370A and 70370B Goshen Line (Municipality of South Huron)

Date: 1860s – 1890s

Description: One and one half storey side gabled house with a steep roof pitch and steeply pitched gable, yellow brick exterior and stone foundation. Asymmetrical in design with Vernacular Gothic Revival design characteristics including a window extending into the dormer of the front facade, open rakes with remnants of brackets, intricate brick frieze and quoin-like triangular detailing.

Mitigation of Negative Impacts: No negative impacts identified, therefore no further mitigation recommended.

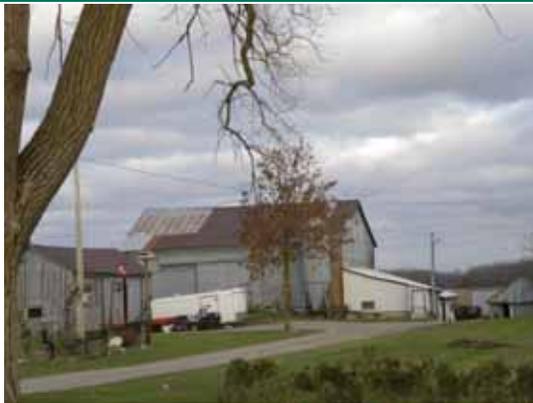
Date: Various (20th century)

Description: Frame barn with later shed addition. Barn has a metal roof, metal siding, and concrete foundation. Various outbuildings onsite.

Mitigation of Negative Impacts: No negative impacts identified, therefore no further mitigation recommended.

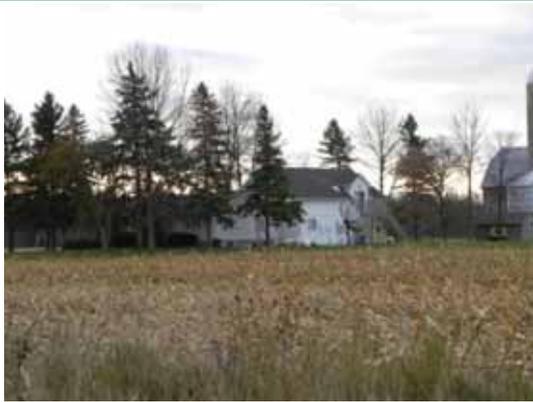
Site #45 – 35545 South Road (Municipality of South Huron)

Date: Late 19th century

Description: One and one half storey end-gabled house at the rear. Second structure has white vertical wood siding and asphalt shingle roof with one visible gabled dormer with attached second storey porch. Modern single-storey, low pitched, side gabled addition on concrete foundation.

Mitigation of Negative Impacts: Impacts were not identified, therefore mitigation is not recommended or necessary.

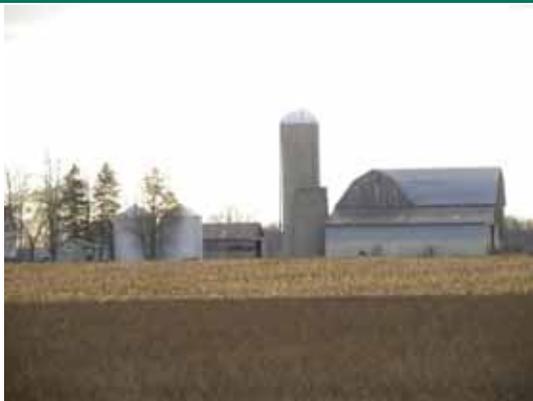
Date: Various (19th and 20th century)

Description: Multi-structure barn complex includes a timber framed, wood sided, gambrel roofed, T-plan barn with metal roof panels. A full length metal roofed, metal-sided, shed addition attached. Two concrete silos, two metal bins, and one end-gabled metal-roofed, wood-sided out building.

Mitigation of Negative Impacts: No negative impacts identified, therefore no further mitigation recommended.

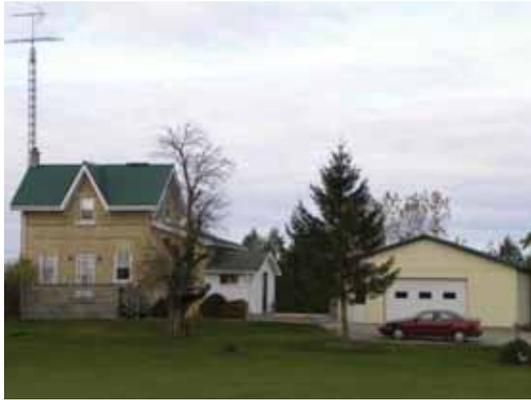
Site #46 – 69481 Bronson Line (Municipality of South Huron)

Date: 1860-1890s

Description: One and one half storey side gabled, yellow brick house with a green painted metal roof, steeply pitched center gabled dormer with a single window on an undetermined foundation. House has inset decorative-frieze brickwork and yellow brick shed addition to one gable end with a wood framed, metal sided, asphalt shingled addition attached to it. Modern garage.

Mitigation of Negative Impacts: No negative impacts identified, therefore no further mitigation recommended.

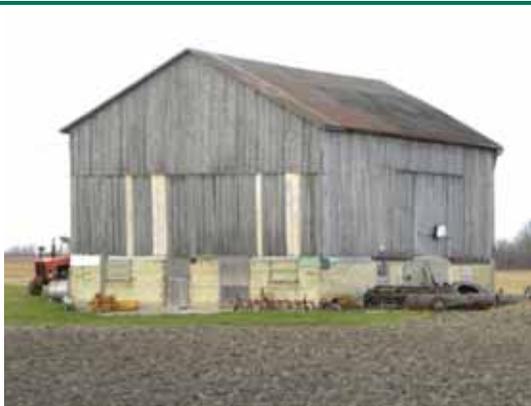
Date: 19th – early 20th century

Description: Timber framed, wood sided, metal roofed, side gabled barn on a yellow brick foundation.

Mitigation of Negative Impacts: No negative impacts identified, therefore no further mitigation recommended.

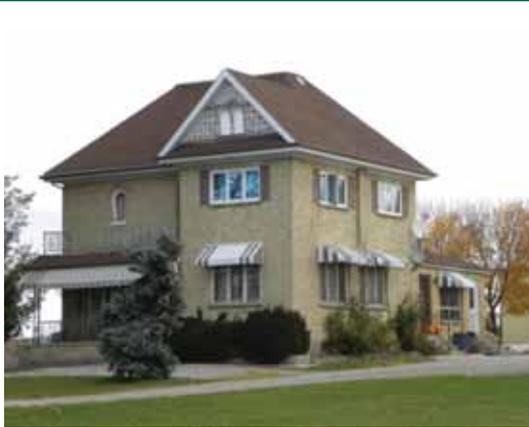
Site #47 – 69482 Bronson Line (Municipality of South Huron)

Date: 1890s – 1920s

Description: Two storey, hipped roof, yellow brick house on a concrete foundation with a double window and decorative gingerbread work in L gable end. Second storey porch sits in L crux and forms the roof of the first floor porch with modern metal railings and columns. Second storey has a keyhole window above porch and first floor windows are covered with metal awnings. Rear addition with an undetermined roof line and foundation. Modern garage at rear.

Mitigation of Negative Impacts: No negative impacts identified, therefore no further mitigation recommended.

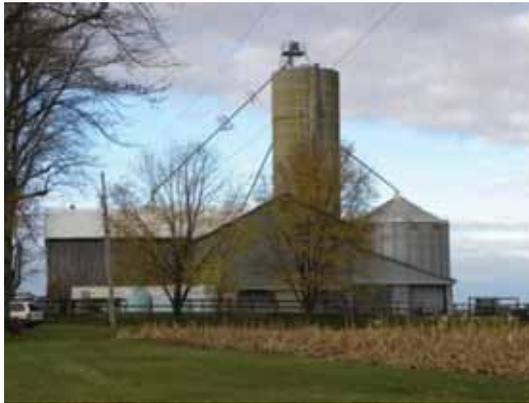
Site #48 – 69713 Goshen Line (Municipality of South Huron)

Date: Various (19th and 20th century)

Description: Wood-sided, white-painted gabled metal roof, on an L-plan barn with metal sided, metal roofed shed addition attached to L. Concrete silo and metal bin adjacent.

Mitigation of Negative Impacts: No negative impacts identified, therefore no further mitigation recommended.

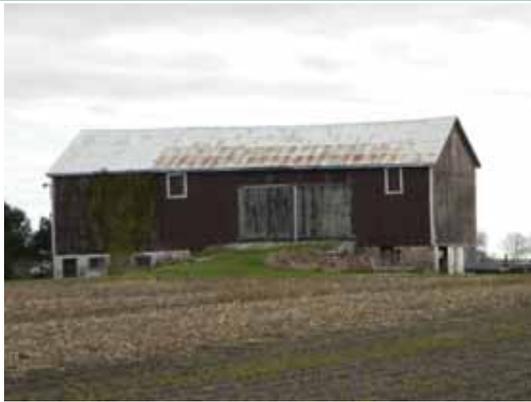
Site #49 – 38425 Dashwood Line (Municipality of South Huron)

Date: 20th century

Description: Side gabled, timber framed, white painted metal roofed barn with brown painted wood-siding on a brick foundation. Barn has one wood sided, metal roofed, one bay, full height gabled addition on a concrete foundation attached to one of the gabled ends, extending the original roof and sidewall lines.

Mitigation of Negative Impacts: No negative impacts identified, therefore no further mitigation recommended.

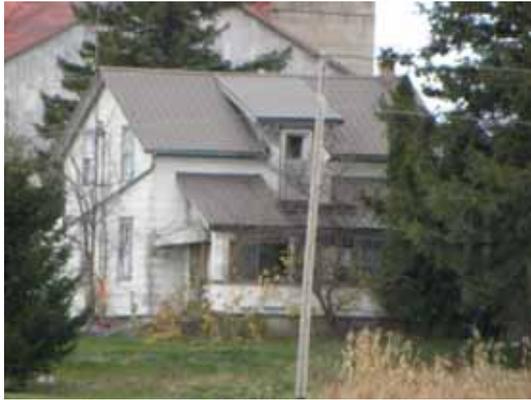
Site #50 – 72299 Babylon Line (Municipality of Bluewater)

Date: Late 19th century

Description: One and one half storey side gabled, metal roofed, metal sided, house with a shed dormer and three quarter length enclosed porch under a metal panel shed roof.

Mitigation of Negative Impacts: Impacts were not identified, therefore mitigation is not recommended or necessary.

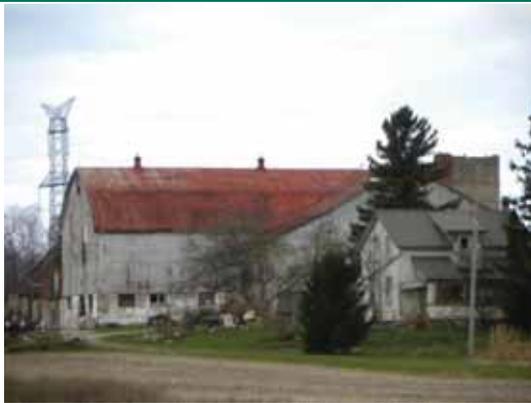
Date: 19th century

Description: Timber framed gambrel roofed barn with metal panel roof, wood siding, on a concrete foundation. One large gable-roofed addition creates an L-plan while a shed roof addition at the rear.

Mitigation of Negative Impacts: No negative impacts identified, therefore no further mitigation recommended.

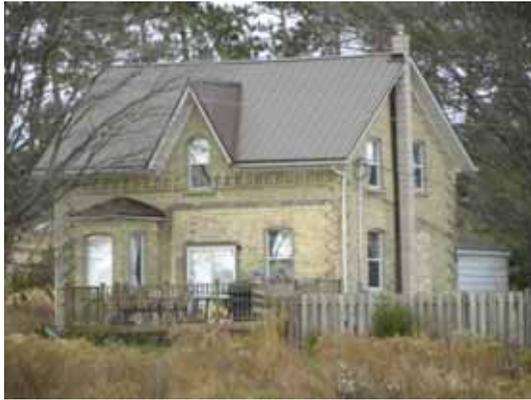
Site #51 – 72257 Babylon Line (Municipality of Bluewater)

Date: 1860-1890s

Description: One and one half storey yellow brick, side gabled, house with a peaked central dormer over an arched window on an undetermined foundation. House has modern metal panel roof, with decorative raised brick frieze and triangular quoin-like detailing. Unroofed deck porch, modern windows and front door.

Mitigation of Negative Impacts: No negative impacts identified, therefore no further mitigation recommended.

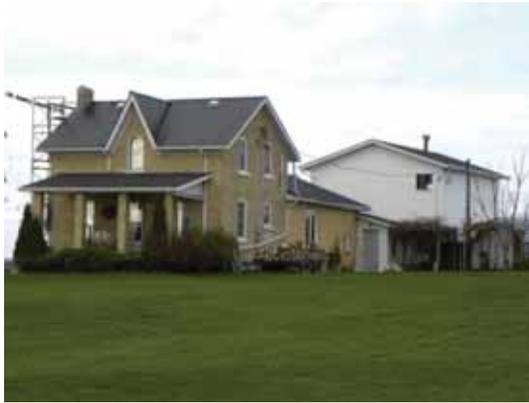
Site #52 – 71953 Babylon Line (Municipality of Bluewater)

Date: 1860-1890s

Description: One and one half storey yellow brick, side gabled house with a steeply peaked central dormer over an arched window on an undetermined foundation. House has a full width covered front porch with a shed roof supported by yellow brick columns. A yellow brick, gable roofed, single storey addition is attached to the back of the house. Two storey modern gabled garage at the rear.

Mitigation of Negative Impacts: No negative impacts identified, therefore no further mitigation recommended.

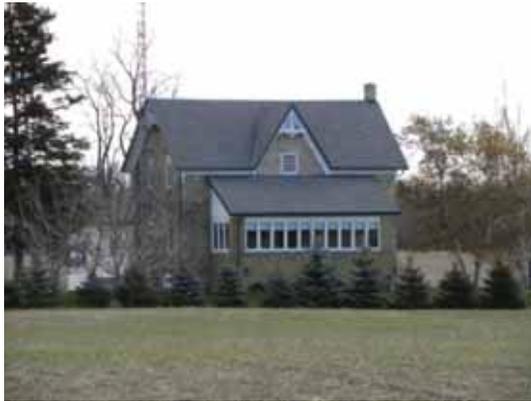
Site #53 – 72362 Goshen Line (Municipality of Bluewater)

Date: 1860-1890s

Description: One and one half storey side gabled yellow brick house with peaked central gable over a single square window on a stone foundation. House has decorative raised brick work at frieze, over gable-end windows, triangular quoin-like detailing and gingerbread work in gables and along eaves with some decorative brackets. House has a modern enclosed yellow brick, shed roof porch with modern windows.

Potential Direct and Indirect Impacts to the Heritage Attributes: None anticipated; see *Heritage Assessment Report* Section 6.1 for more information.

Mitigation of Negative Impacts: No negative impacts identified, therefore no further mitigation recommended.

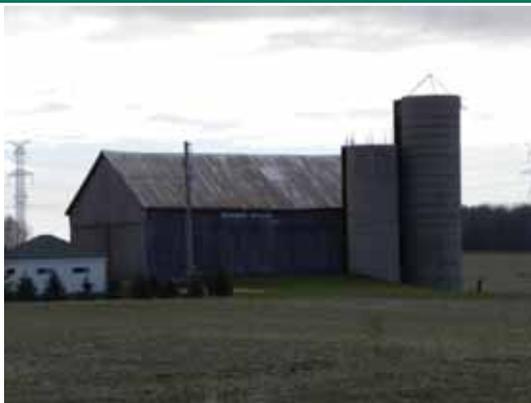
Date: 19th – early 20th century

Description: Timber framed, metal roofed, wood sided, side gabled barn with two concrete silos. Additional outbuilding adjacent.

Mitigation of Negative Impacts: No negative impacts identified, therefore no further mitigation recommended.

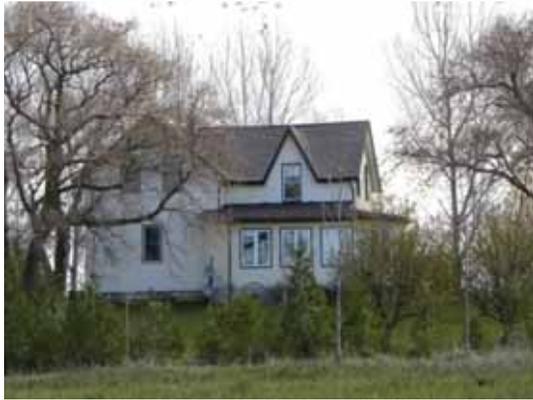
Site #54 – 72204 Goshen Line (Municipality of Bluewater)

Date: 1860-1890s

Description: One and one half storey L plan house with modern siding, stone foundation and a steeply pitched dormer in L length over a single square window. Covered inset porch. House roof covered in asphalt shingles and has modern windows.

Potential Direct and Indirect Impacts to the Heritage Attributes: None anticipated; see *Heritage Assessment Report* Section 6.1 for more information.

Mitigation of Negative Impacts: No negative impacts identified, therefore no further mitigation recommended.

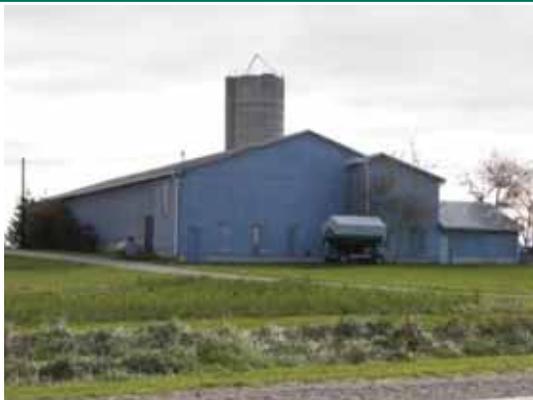
Date: Various (19th and 20th century)

Description: Wood framed, metal roofed, side gabled barn on concrete foundation. One asymmetrically roofed, gable end projection attached to barn gable end, with another gabled addition attached to both the initial addition and the original barn side. Concrete silo sits adjacent to barn.

Mitigation of Negative Impacts: No negative impacts identified, therefore no further mitigation recommended.

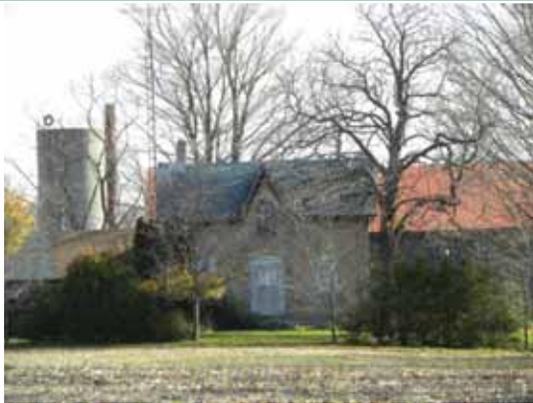
Site #55 – 71962 Bronson Line (Municipality of Bluewater)

Date: 1860-1890s

Description: One and one half storey side gabled yellow brick house on a symmetrical plan with a steeply peaked central dormer over an arched single window on an undetermined foundation. House has decorative raised brick quoin-like detailing and similar features framing the front door and central dormer.

Potential Direct and Indirect Impacts to the Heritage Attributes: None anticipated; see *Heritage Assessment Report* Section 6.1 for more information.

Mitigation of Negative Impacts: No negative impacts identified, therefore no further mitigation recommended.

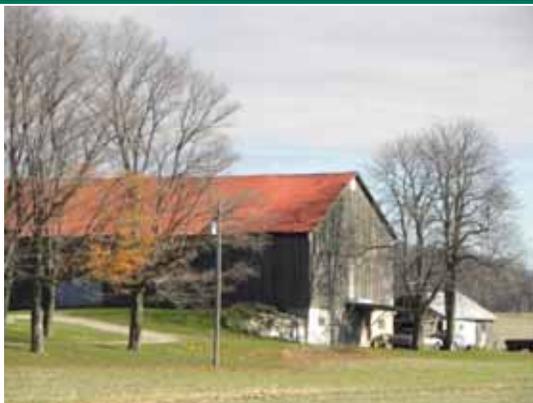
Date: 19th – early 20th century

Description: Timber framed side gabled barn with metal roof and wood siding on a concrete foundation. Small end gabled garage or out building behind barn.

Mitigation of Negative Impacts: No negative impacts identified, therefore no further mitigation recommended.

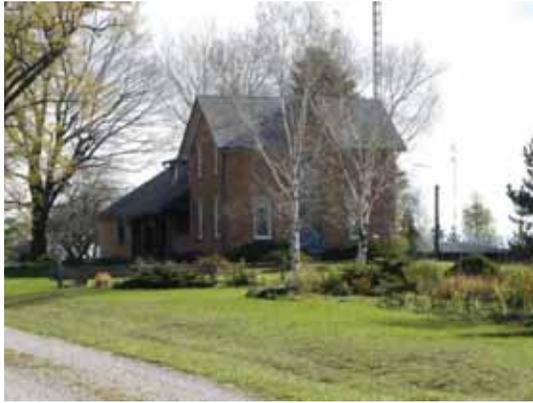
Site #56 – 71726 Bronson Line (Municipality of Bluewater)

Date: 1860s-1890s

Description: One and one half storey, red brick, side gabled house with a steeply peaked central dormer on a symmetrical plan with an undetermined foundation. Gabled addition at rear with a single shed dormer and porch.

Potential Direct and Indirect Impacts to the Heritage Attributes: None anticipated; see *Heritage Assessment Report* Section 6.1 for more information.

Mitigation of Negative Impacts: No negative impacts identified, therefore no further mitigation recommended.

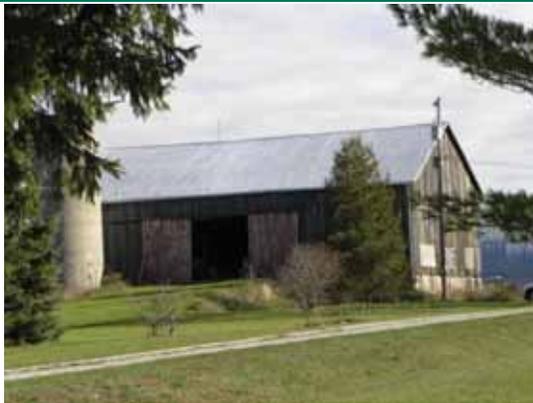
Date: Various (19th and 20th century)

Description: Timber framed side gabled barn with a metal roof and wood siding on a stone foundation. Concrete silo sits adjacent to barn.

Mitigation of Negative Impacts: No negative impacts identified, therefore no further mitigation recommended.

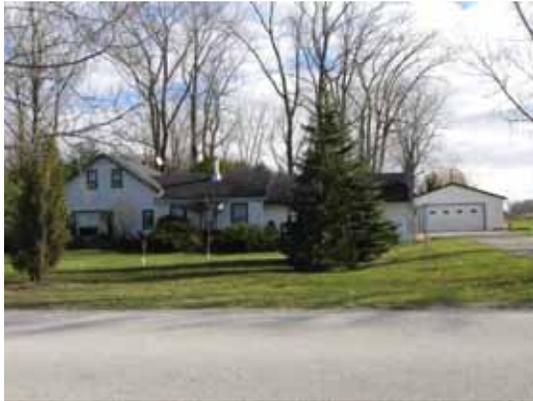
Site #57 – 71684 Bronson Line (Municipality of Bluewater)

Date: 19th – 20th century

Description: One and one half storey T plan or end gabled house with a single-storey addition creating a T plan on an undetermined foundation. Additional single-storey addition at gable end. Windows and doors are modern and a gabled garage sits behind the property.

Mitigation of Negative Impacts: Impacts were not identified, therefore mitigation is not recommended or necessary.

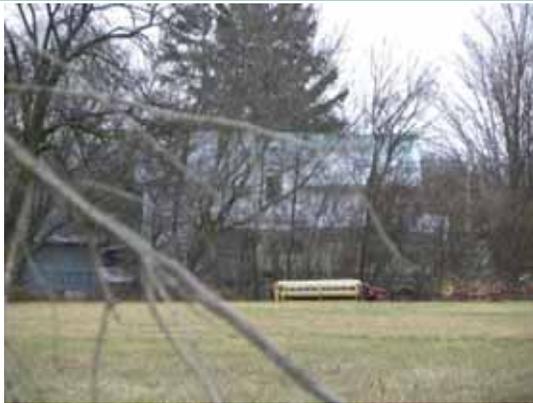
Site #58 – 71642 Bronson Line (Municipality of Bluewater)

Date: 1860s – 1880s

Description: One and one half storey side gabled house with a medium roof pitch and prominent central gable, white sided exterior and undetermined foundation. Vernacular Gothic Revival design elements include symmetrical design and single window extending into the steeply pitched front gable. Modern rear addition.

Potential Direct and Indirect Impacts to the Heritage Attributes: None anticipated; see *Heritage Assessment Report* Section 6.1 for more information.

Mitigation of Negative Impacts: No negative impacts identified, therefore no further mitigation recommended.

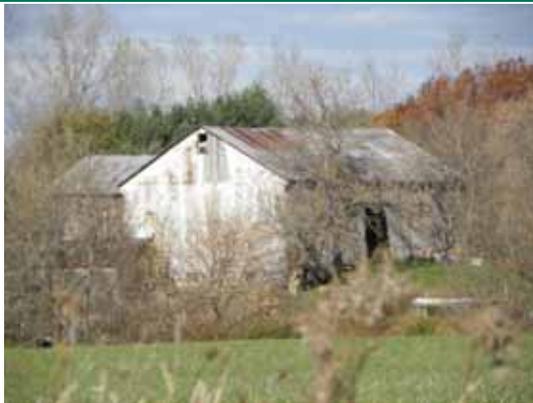
Date: 19th – early century

Description: Timber framed side gabled barn with a metal roof and white painted wood siding on a stone foundation. Smaller metal framed, wood sided outbuilding near barn.

Mitigation of Negative Impacts: No negative impacts identified, therefore no further mitigation recommended.

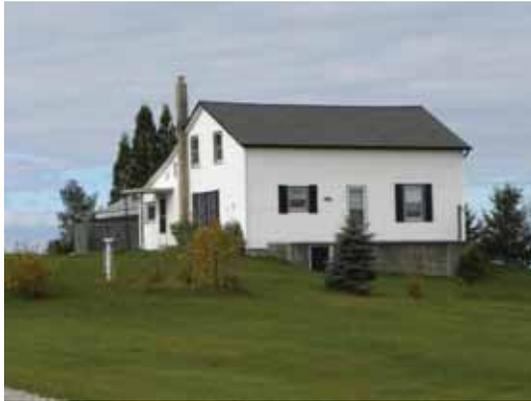
Site #59 – 72199 Bronson Line (Municipality of Bluewater)

Date: Late 19th century

Description: One and one half storey side gabled house, with medium roof pitch, modern siding and concrete foundation. Likely originally symmetrical in design although heavily modified throughout including rear ‘salt-box’ addition.

Mitigation of Negative Impacts: Impacts were not identified, therefore mitigation is not recommended or necessary.
