**HERITAGE ASSESSMENT REPORT
NEXTERA ENERGY CANADA, ULC
GOSHEN WIND ENERGY CENTRE
MUNICIPALITIES OF BLUEWATER
AND SOUTH HURON
HURON COUNTY, ONTARIO**

**APPENDIX A
BUILT HERITAGE INVENTORY ADDENDUM**

3.0 BUILT HERITAGE INVENTORY

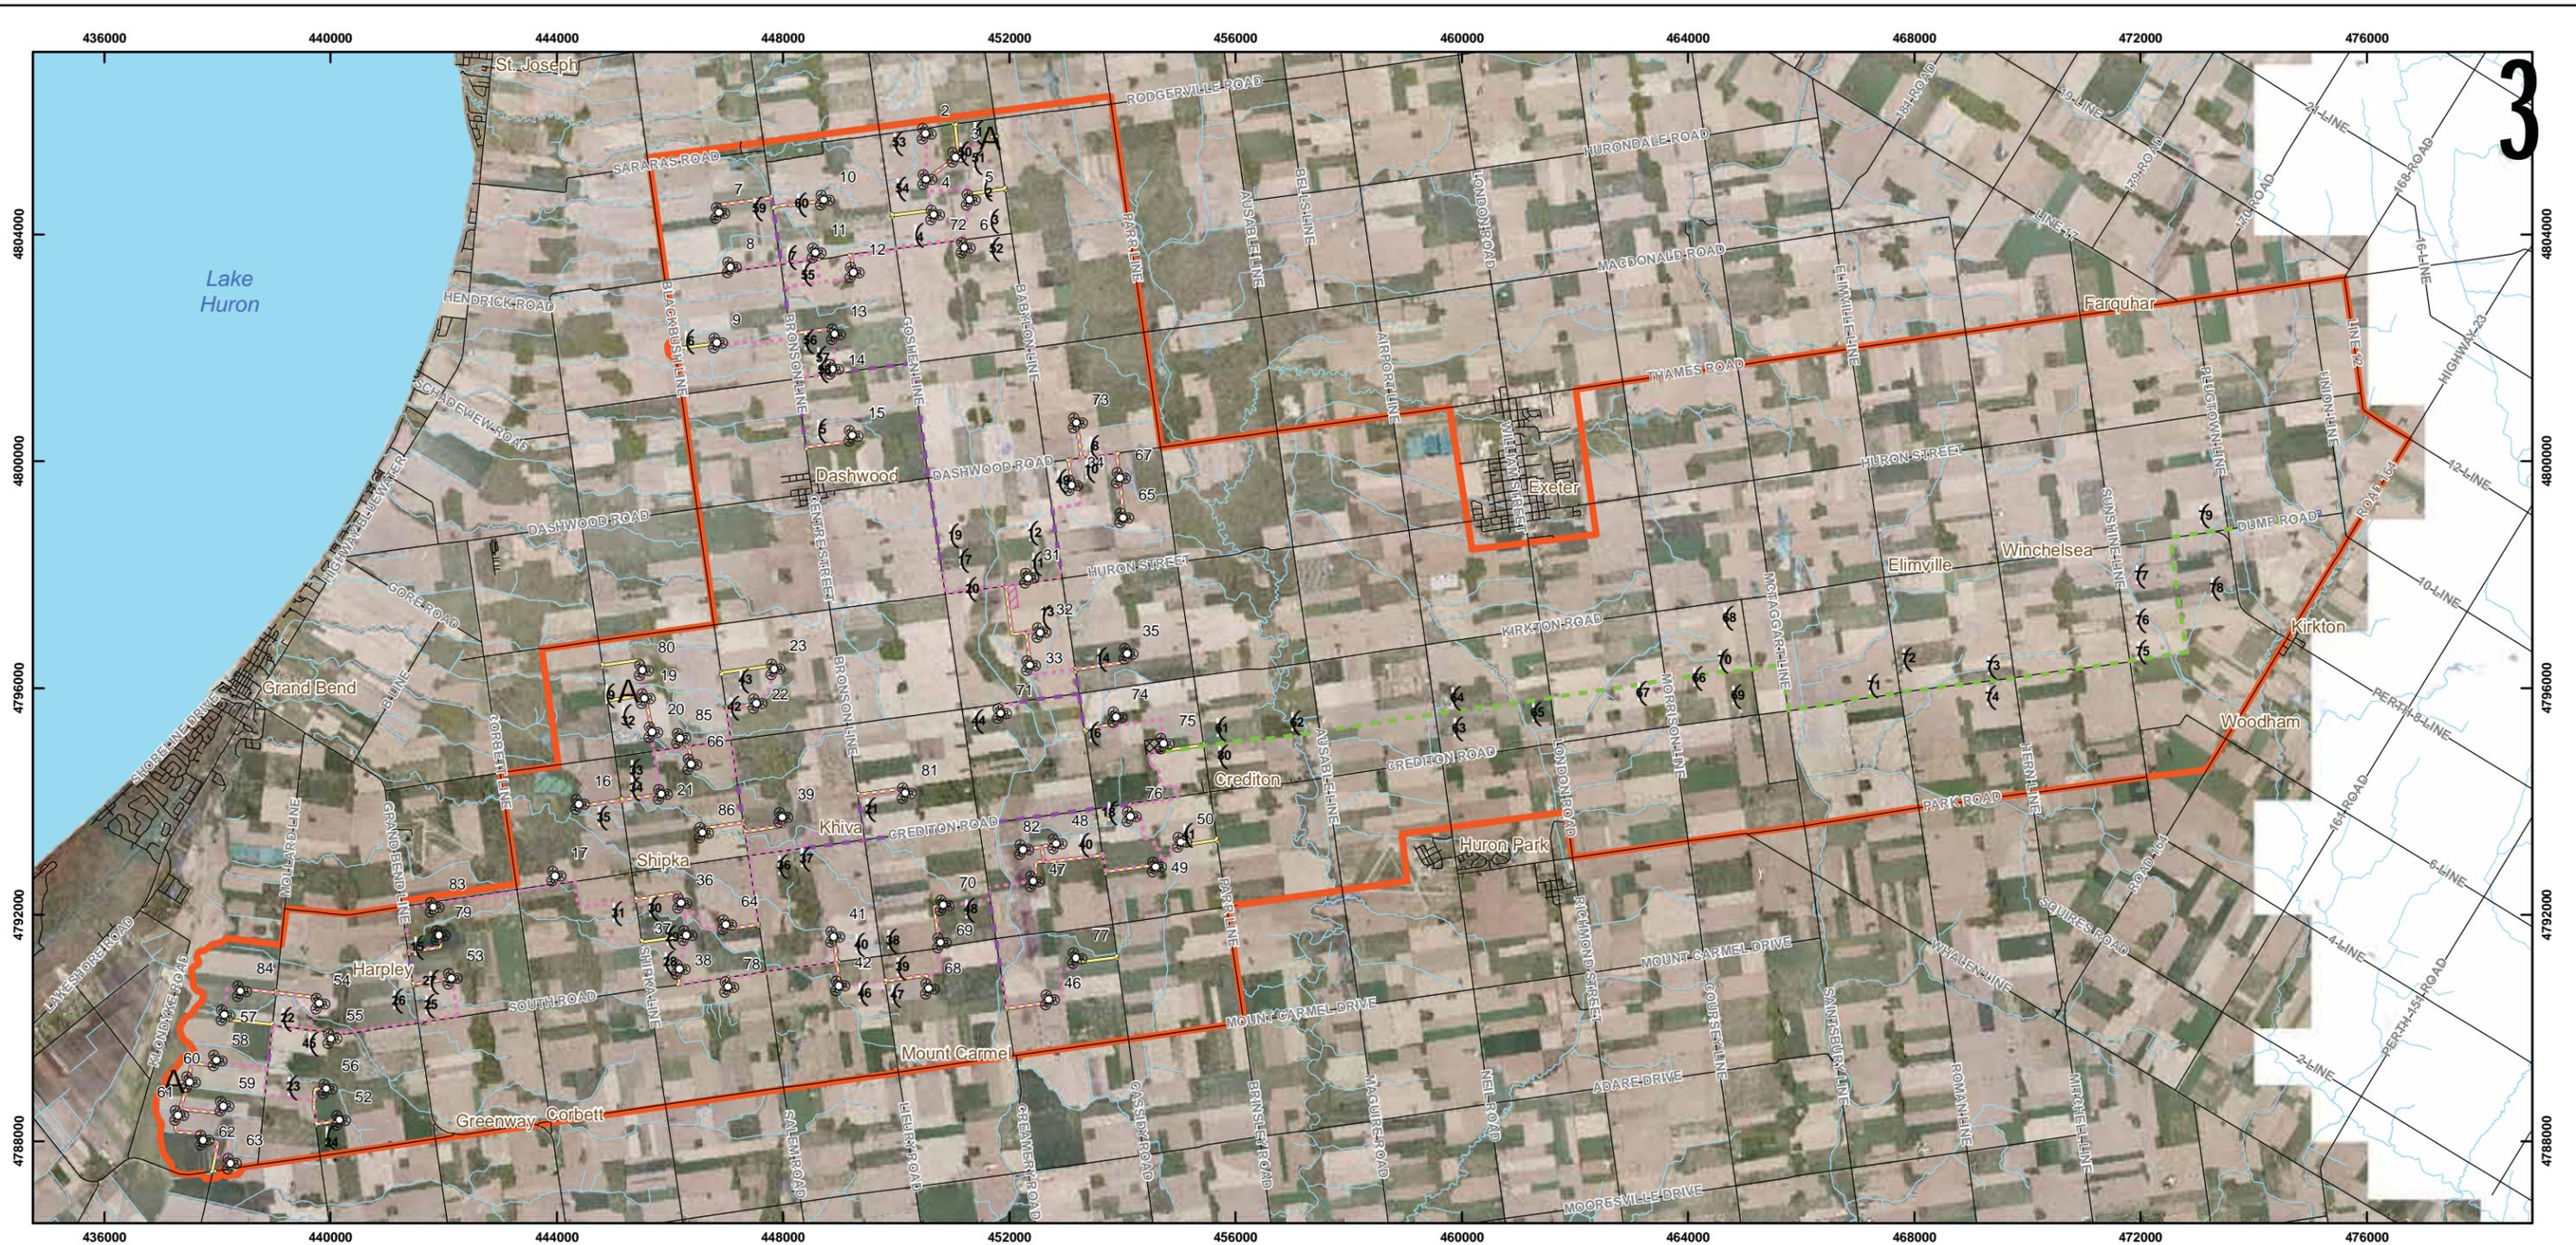
PROJECT	NEXTERA ENERGY CANADA, ULC GOSHEN WIND ENERGY CENTRE, HURON COUNTY, ONTARIO		
TITLE	LOCATION OF STRUCTURES FOR CULTURAL FEATURE INVENTORY		
PROJECT NO.	10-1151-0201	SCALE AS SHOWN	REV. 0.0
DESIGN	BC 23 Aug. 2012	<div style="text-align: center;">

- () Feature Site Location
- Roads
- Watercourse
- Waterbody
- Wetland
- Study Area
- ⊗ Turbine
- A MET Tower
- Collector Cable - Private Land
- Collector Cable - Right of Way
- Transmission Line
- Access Road
- Substation
- Breaker Switch Station
- Laydown Area

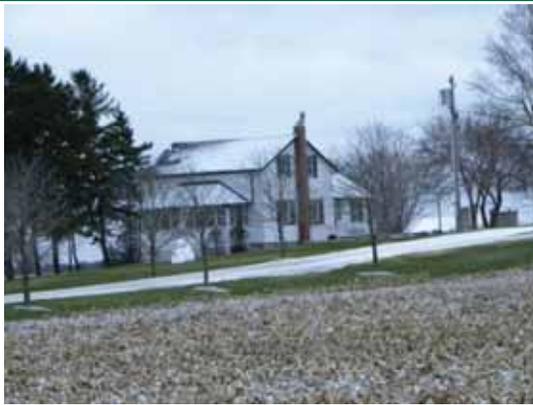
Site #1 – 38309 Rogerville Road (Municipality of Bluewater)

Date: Late 19th century

Description: One and one half storey side gabled house with medium roof pitch, modern siding and undetermined foundation. Symmetrical in design. Rear addition, red brick chimney with modern elements, and covered porch on the front facade.

Mitigation of Negative Impacts: Impacts were not identified, therefore mitigation is not recommended or necessary.

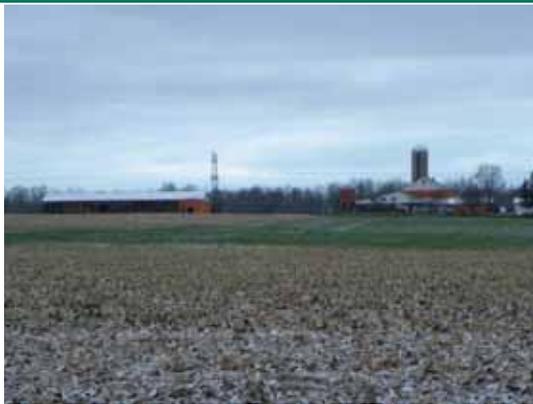
Date: Various (20th century)

Description: Frame barn with a stone foundation and rear shed addition. One concrete silo and two metal bins onsite with various outbuildings. Additional buildings onsite.

Mitigation of Negative Impacts: Impacts were not identified, therefore mitigation is not recommended or necessary.

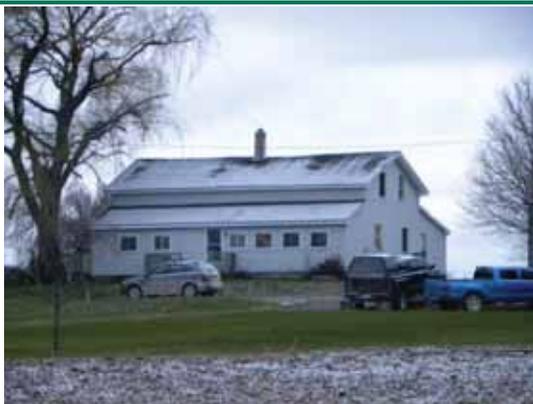
Site #2 – 72167 Babylon Line (Municipality of Bluewater)

Date: 20th century

Description: One and one half storey side gabled house with medium roof pitch, modern siding and concrete covered foundation. Full width covered front porch and apparent rear addition. Modern outbuildings onsite.

Mitigation of Negative Impacts: Impacts were not identified, therefore mitigation is not recommended or necessary.

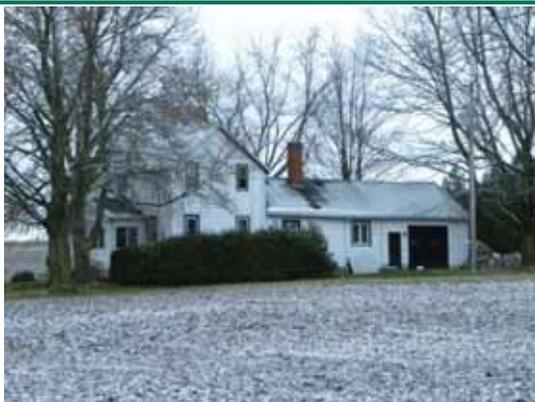
Site #3 – 72039 Babylon Line (Municipality of Bluewater)

Date: Late 19th century

Description: One and one half storey side gabled house with medium roof pitch, modern siding and concrete foundation. Symmetrical in design with a central double hung paired window. Addition at rear and covered central entryway with front gable.

Mitigation of Negative Impacts: Impacts were not identified, therefore mitigation is not recommended or necessary.

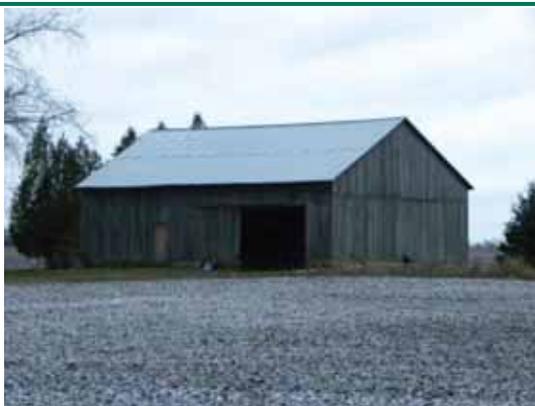
Date: 20th century

Description: Timber barn with metal roof, timber frame and concrete foundation.

Mitigation of Negative Impacts: Impacts were not identified, therefore mitigation is not recommended or necessary.

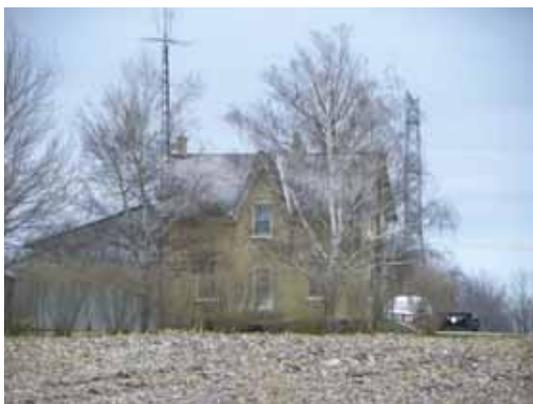
Site #4 – 72048 Goshen Line (Municipality of Bluewater)

Date: 1860s – 1890s

Description: One and one half storey side gabled house with a medium roof pitch and prominent central gable, yellow brick exterior and stone foundation. Vernacular Gothic Revival design elements include symmetrical design, central door, steeply pitched central gable with a decorative rounded window arch and bargeboard with cross-bracing and open rake. Timber addition at rear.

Mitigation of Negative Impacts: No negative impacts identified, therefore no further mitigation recommended.

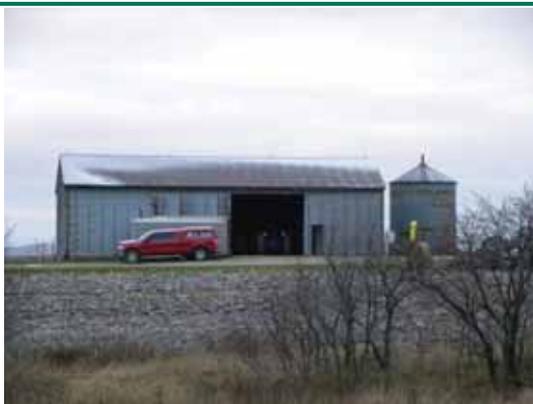
Date: 20th century

Description: Storage shed with metal roof, metal exterior on an undetermined foundation. Metal bin located at the rear.

Mitigation of Negative Impacts: No negative impacts identified, therefore no further mitigation recommended.

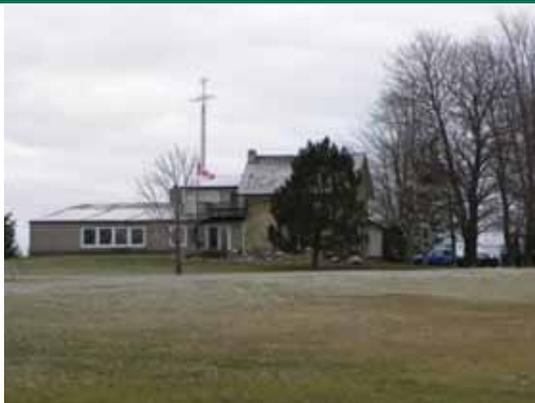
Site #5 – 71416 Bronson Line (Municipality of Bluewater)

Date: Late 19th century

Description: One and one half storey, side gabled, yellow brick house on an undetermined foundation. House has long, multi room/garage, single-storey metal-roofed gabled addition with a second storey addition attached to the house.

Mitigation of Negative Impacts: Impacts were not identified, therefore mitigation is not recommended or necessary.

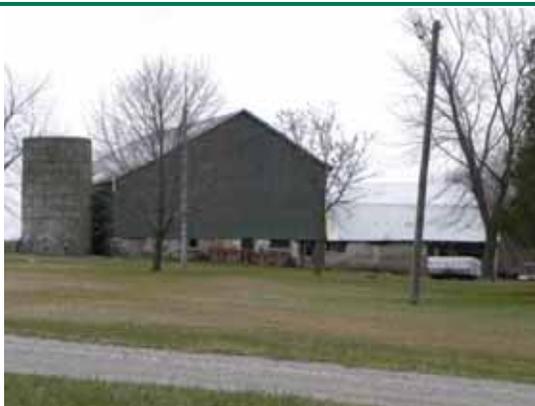
Date: Various (19th and 20th century)

Description: Frame barn with side shed addition, metal roof, timber frame and stone foundation. Silo attached to the shed addition. Side addition with metal gambrel roof and concrete foundation.

Mitigation of Negative Impacts: No negative impacts identified, therefore no further mitigation recommended.

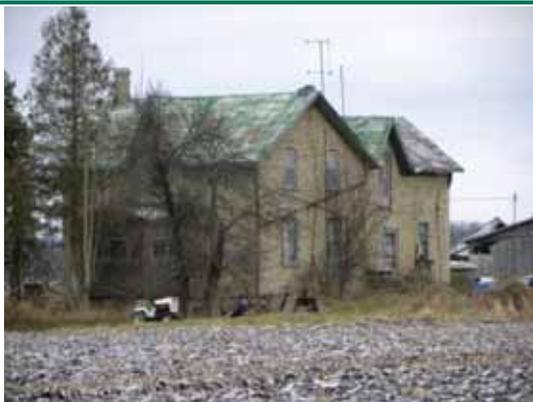
Site #6 – 71778 Blackbush Line (Municipality of Bluewater)

Date: 1860s – 1890s

Description: One and one half storey side gabled t-shaped house with a medium roof pitch and steeply pitched gables throughout, yellow brick exterior, and stone foundation. Vernacular Gothic Revival design elements include symmetrical design, central (covered) door, central gable, extensive brick detailing along cornice and rounded window arch, and remnants of decorative brackets. Possibly abandoned.

Mitigation of Negative Impacts: No negative impacts identified, therefore no further mitigation recommended.

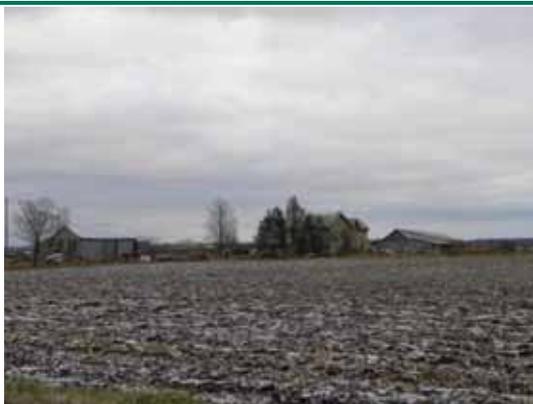
Date: Various (19th and 20th century)

Description: English styled barn with two shed additions and possible rear addition. Metal roof sits on a primarily timber frame and undetermined foundation. Shed structure contains a metal roof on timber frame with an undetermined foundation and rear metal bin.

Mitigation of Negative Impacts: No negative impacts identified, therefore no further mitigation recommended.

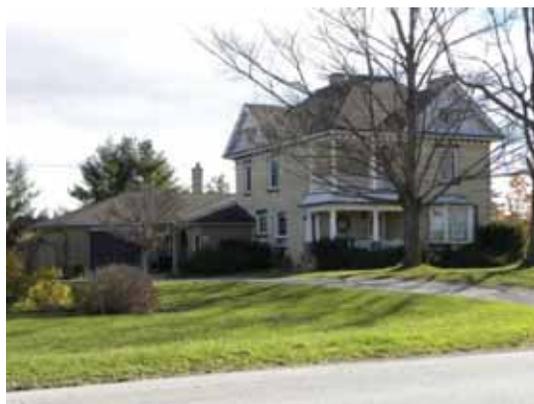
Site #7 – 72020 Bronson Line (Municipality of Bluewater)

Date: 1890 – 1920s

Description: Two storey, yellow brick, asymmetrical, hipped roof house on undetermined foundation with two storey gabled projection on front and gabled dormer on rear side. Vernacular Queen Anne design elements include wood columned and railed first and second storey porches, bay window, eaves with decorative cut outs and some decorative brackets. Rear addition.

Mitigation of Negative Impacts: No negative impacts identified, therefore no further mitigation recommended.

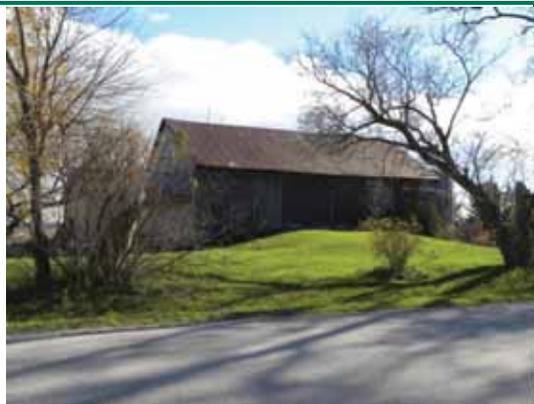
Date: 19th – early 20th century

Description: Timber framed, wood sided, metal roofed, side gabled barn with rear addition. Modern metal bin at rear.

Mitigation of Negative Impacts: No negative impacts identified, therefore no further mitigation recommended.

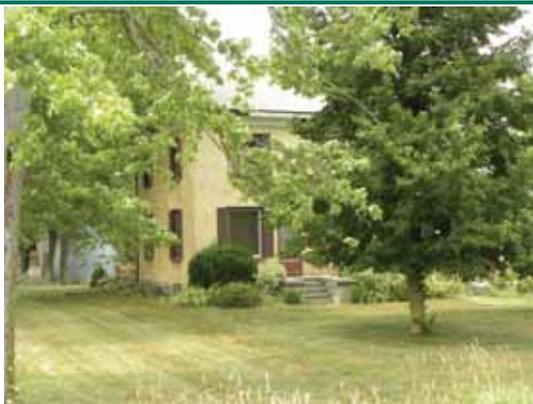
Site #8 – 38554 Dashwood Road (Municipality of Bluewater)

Date: 1890s – 1920s

Description: Two storey, yellow brick hipped roof house on a stone foundation. Symmetrical facade with decorative brackets and wide eaves. Rear addition. Modern garage at rear.

Mitigation of Negative Impacts: No negative impacts identified, therefore no further mitigation recommended.

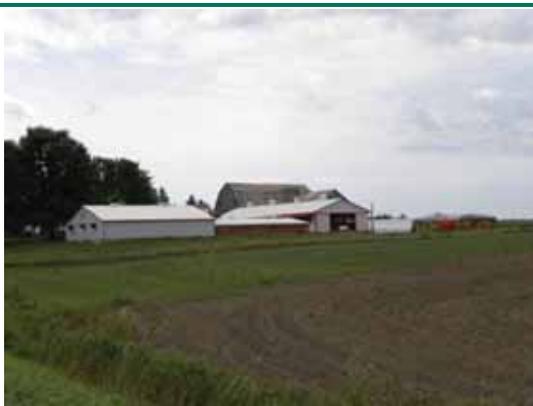
Date: 19th – 20th century

Description: Timber frame, gambrel roofed barn with metal roof and undetermined foundation. One large gable roof addition creates an L-plan. Modern shed buildings in foreground.

Mitigation of Negative Impacts: No negative impacts identified, therefore no further mitigation recommended.

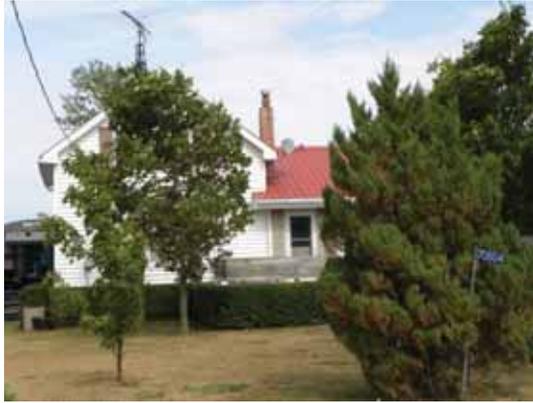
Site #9 – 70604 Shirpka Line (Municipality of South Huron)

Date: Late 19th century

Description: One and one half storey T-plan house on an undetermined foundation. Modern siding, windows and doors.

Mitigation of Negative Impacts: Impacts were not identified, therefore mitigation is not recommended or necessary.

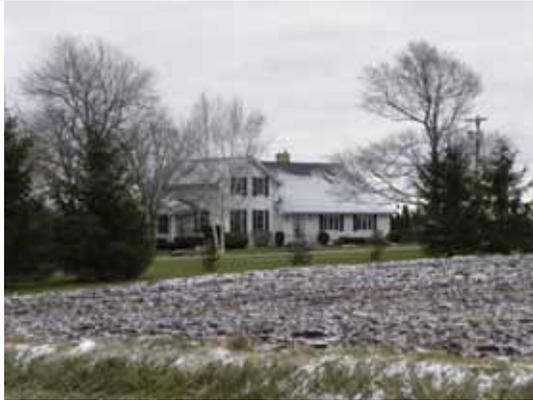
Site #10 – 38565 Dashwood Road (Municipality of South Huron)

Date: Late 19th century

Description: One and one half storey side gabled house with medium roof pitch, modern siding and undetermined foundation. Symmetrical in design. Extensive rear addition and single storey central porch.

Mitigation of Negative Impacts: Impacts were not identified, therefore mitigation is not recommended or necessary.

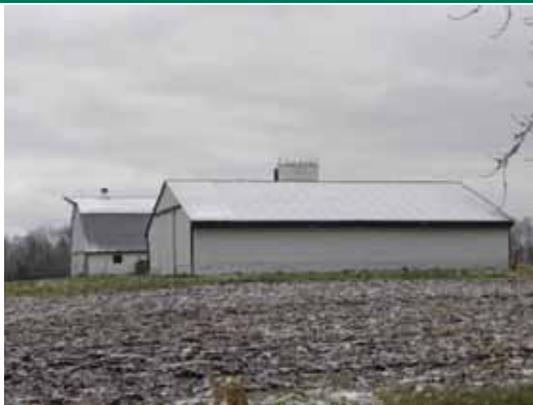
Date: Various (20th century)

Description: Two barns and single concrete silo onsite. First has a gambrel roof, mixed material exterior (timber, metal, apparent concrete), and undetermined foundation. Second is a front gabled barn with metal roof, metal siding, and concrete foundation.

Mitigation of Negative Impacts: Impacts were not identified, therefore mitigation is not recommended or necessary.

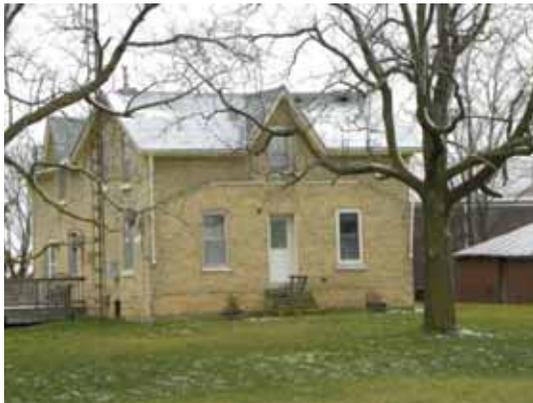
Site #11 – 70865 Babylon Line (Municipality of South Huron)

Date: 1860s – 1890s

Description: One and one half storey side gabled house with a medium roof pitch and central gable, yellow brick exterior and concrete foundation. Vernacular Gothic Revival design elements include symmetrical design, central window extending into the steeply pitched central gable and remnants of decorative brackets. Modern addition at rear.

Potential Direct and Indirect Impacts to the Heritage Attributes: None anticipated; see *Heritage Assessment Report* Section 6.1 for more information.

Mitigation of Negative Impacts: No negative impacts identified, therefore no further mitigation recommended.

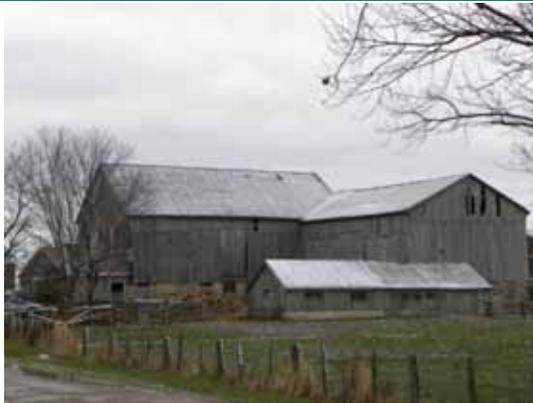
Date: Various (19th and 20th century)

Description: Timber frame barn with third gable addition and later single storey shed addition, with metal roofs, timber frames and a variety of foundations (stone, brick and concrete).

Mitigation of Negative Impacts: No negative impacts identified, therefore no further mitigation recommended.

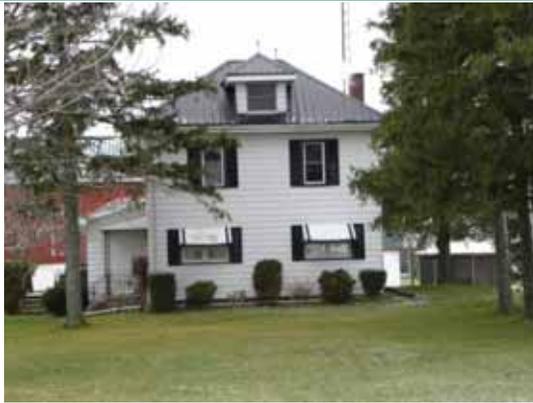
Site #12 – 70963 Babylon Line (Municipality of South Huron)

Date: 1890s – 1920s

Description: Two storey hipped roof house with a medium roof pitch, central hipped dormer, modern siding and undetermined foundation. Symmetrical front facade with extensive modifications throughout and large rear addition.

Mitigation of Negative Impacts: No negative impacts identified, therefore no further mitigation recommended.

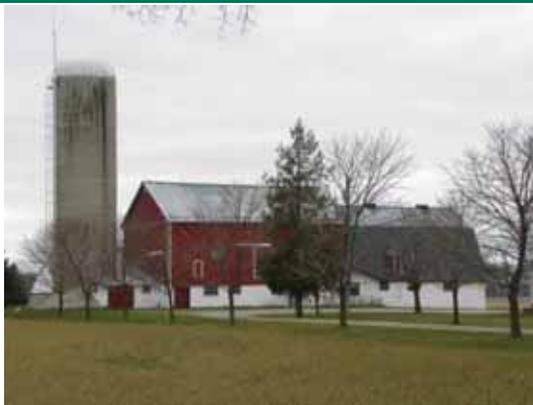
Date: 20th century

Description: Frame barn with gambrel roof addition and concrete silo. Both barns have metal roofs, modern siding and (possibly covered) concrete foundation.

Mitigation of Negative Impacts: No negative impacts identified, therefore no further mitigation recommended.

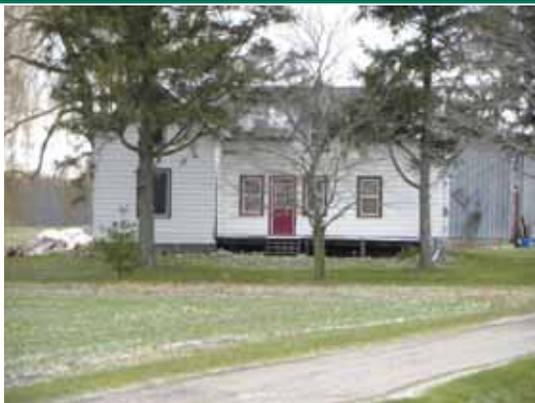
Site #13 – 70683 Babylon Line (Municipality of South Huron)

Date: 1860s – 1890s

Description: One and one half storey L-shaped cross gabled house with a steep roof pitch and central gable, modern siding and a stone foundation. Vernacular Gothic Revival design influences include asymmetrical design and the central window extending into the steeply pitched central gable.

Mitigation of Negative Impacts: No negative impacts identified, therefore no further mitigation recommended.

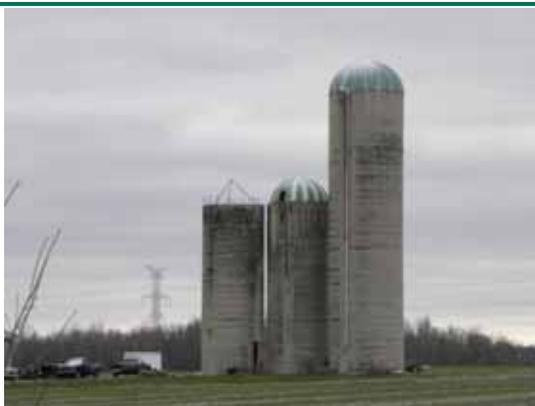
Date: 20th century

Description: Three concrete silos at the rear of the house.

Mitigation of Negative Impacts: No negative impacts identified, therefore no further mitigation recommended.

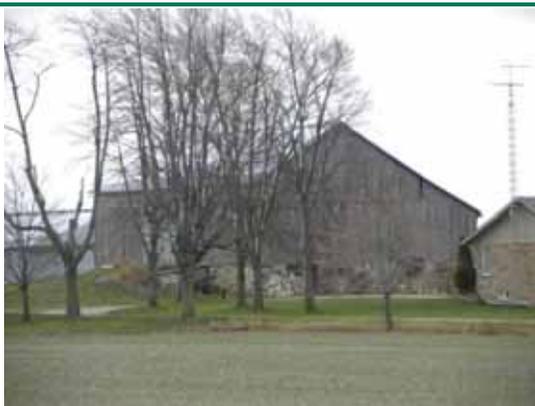
Site #14 – 70524 Babylon Line (Municipality of South Huron)

Date: 19th – early 20th century

Description: Frame barn with rear shed addition, metal roof, timber frame and stone foundation.

Mitigation of Negative Impacts: No negative impacts identified, therefore no further mitigation recommended.

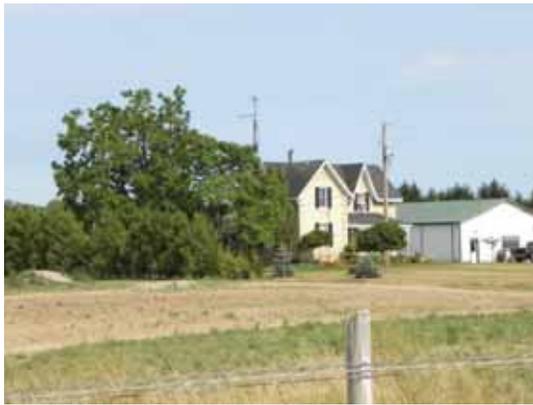
Site #15 – 69865 Grand Bend Line (Municipality of South Huron)

Date: 1860s – 1890s

Description: One and one half storey side gabled house with a medium roof pitch and prominent central gable, yellow brick exterior and stone foundation. Vernacular Gothic Revival design elements include symmetrical design, central door, steeply pitched central gable with a decorative rounded window arch and bargeboard with cross-bracing and open rake.

Mitigation of Negative Impacts: No negative impacts identified, therefore no further mitigation recommended.

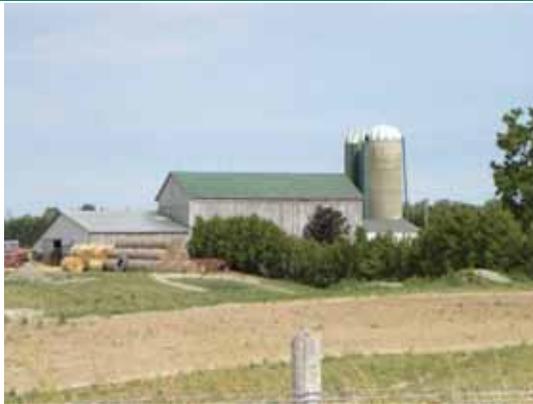
Date: 19th – 20th century

Description: Side gabled timber framed barn with metal roof and undetermined foundation. Two side shed additions and two concrete silos on site.

Mitigation of Negative Impacts: No negative impacts identified, therefore no further mitigation recommended.

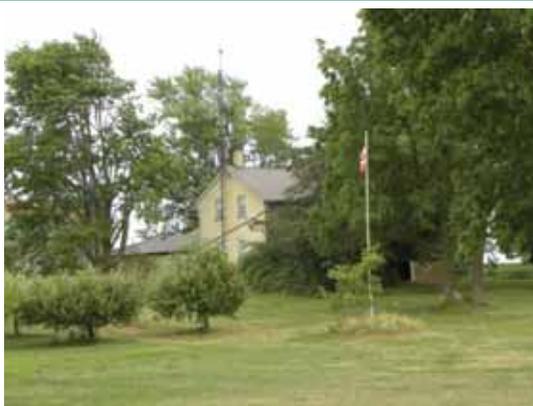
Site #16 – 70260 Kirkton Line (Municipality of Bluewater)

Date: 1860s – 1890s

Description: One and one half storey T-shaped side gabled house with a medium roof pitch, prominent central gable, yellow brick exterior, and stone foundation. Vernacular Gothic Revival design elements include symmetrical design with central porch and door, steeply pitched central gable with a decorative rounded window arch and brickwork. Rear addition.

Mitigation of Negative Impacts: No negative impacts identified, therefore no further mitigation recommended.

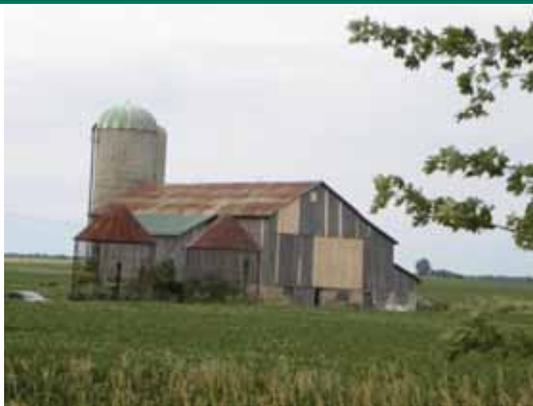
Date: 19th – early 20th century

Description: Timber frame, side gabled barn with a metal roof and wood siding, on a brick and concrete foundation. Concrete silo sits adjacent to barn.

Mitigation of Negative Impacts: No negative impacts identified, therefore no further mitigation recommended.

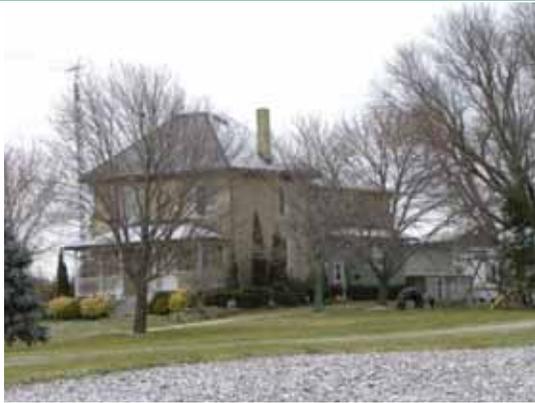
Site #17 – 71002 Goshen Line (Municipality of South Huron)

Date: 1890s – 1920s

Description: Two storey hipped roof house with a steep roof pitch, yellow brick exterior and undetermined foundation. Vernacular four-square design elements include symmetrical design, full width single storey roof porch and square plan. Modern addition at rear.

Mitigation of Negative Impacts: No negative impacts identified, therefore no further mitigation recommended.

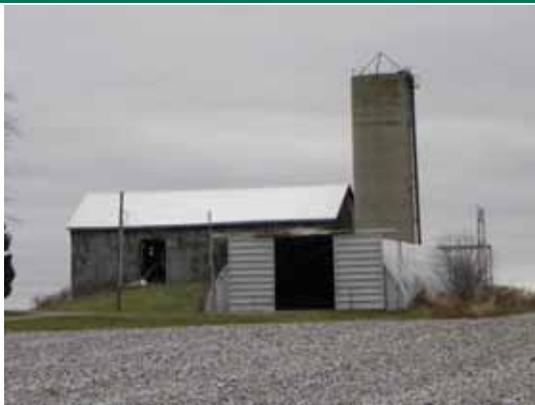
Date: Various (19th and 20th century)

Description: Frame barn with concrete silo and modern outbuilding. Barn has a metal roof, timber frame and undetermined foundation.

Mitigation of Negative Impacts: No negative impacts identified, therefore no further mitigation recommended.

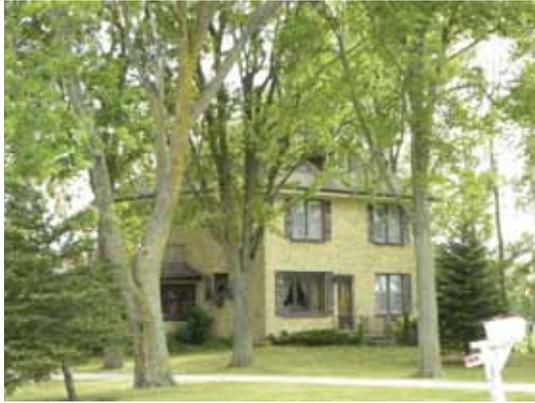
Site #18 – 38439 Crediton Line (Municipality of South Huron)

Date: 1890s – 1920s

Description: Two storey hipped roof house with a medium roof pitch, central hipped dormer, brick exterior and stone foundation. Symmetrical front facade with central doorway. Rear addition.

Mitigation of Negative Impacts: No negative impacts identified, therefore no further mitigation recommended.

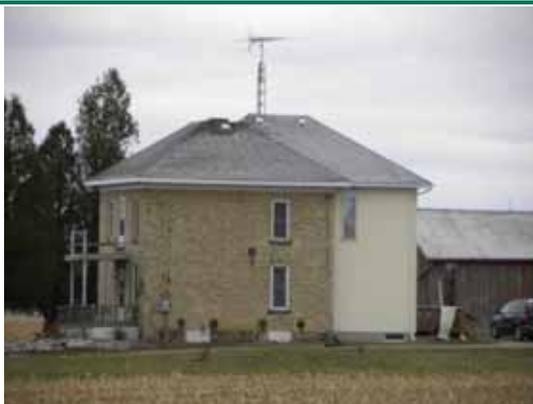
Site #19 – 71002 Goshen Line (Municipality of South Huron)

Date: 1890s – 1920s

Description: Two storey hipped roof house with medium roof pitch, yellow brick exterior and stone foundation. Vernacular design characteristics include symmetrical four-square design, small front entry porch, wide eaves and remnants of decorative brackets. Extensive addition at rear.

Potential Direct and Indirect Impacts to the Heritage Attributes: None anticipated; see *Heritage Assessment Report* Section 6.1 for more information.

Mitigation of Negative Impacts: No negative impacts identified, therefore no further mitigation recommended.

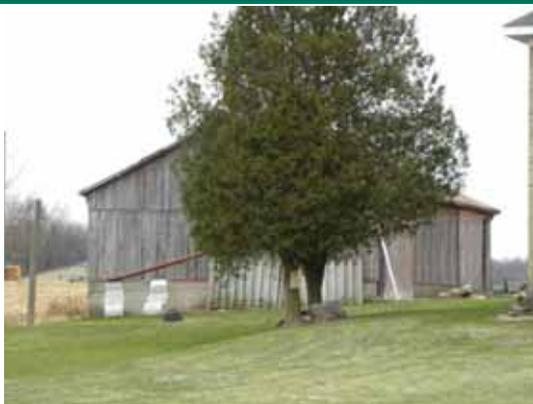
Date: 20th century

Description: Two-bay shed with metal roof, timber frame and concrete foundation.

Mitigation of Negative Impacts: No negative impacts identified, therefore no further mitigation recommended.

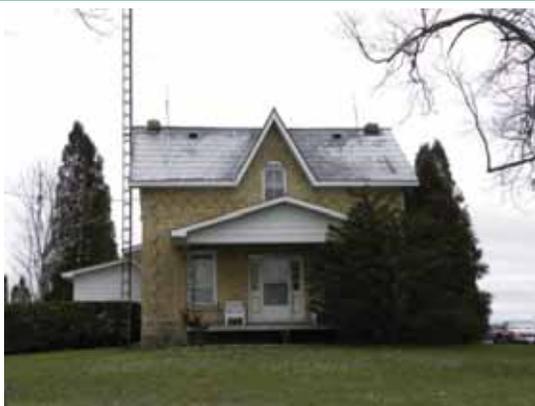
Site #20 – 38060 Huron Street (Municipality of South Huron)

Date: 1860s – 1890s

Description: One and one half storey T-shaped side gabled house with a medium roof pitch and prominent central gable, yellow brick exterior, and concrete covered foundation. Vernacular Gothic Revival design elements include symmetrical design, central door, steeply pitched central gable with a decorative rounded window arch and brickwork. Rear addition.

Mitigation of Negative Impacts: No negative impacts identified, therefore no further mitigation recommended.

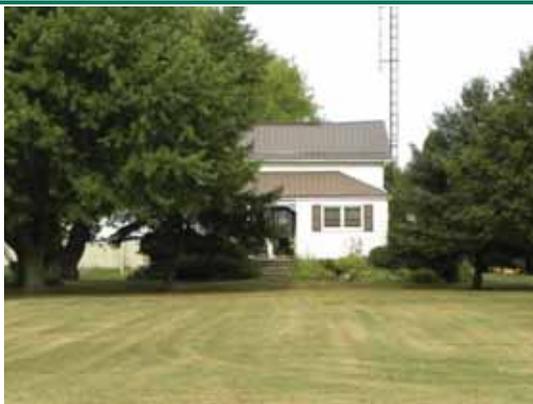
Site #21 – 70112 Bronson Line (Municipality of Bluewater)

Date: Late 19th century

Description: One and one half storey side gabled house with medium roof pitch, modern siding and concrete foundation. Symmetrical in design with a full front porch.

Potential Direct and Indirect Impacts to the Heritage Attributes: CHVI was not identified, therefore impacts were not assessed.

Mitigation of Negative Impacts: Impacts were not identified, therefore mitigation is not recommended or necessary.

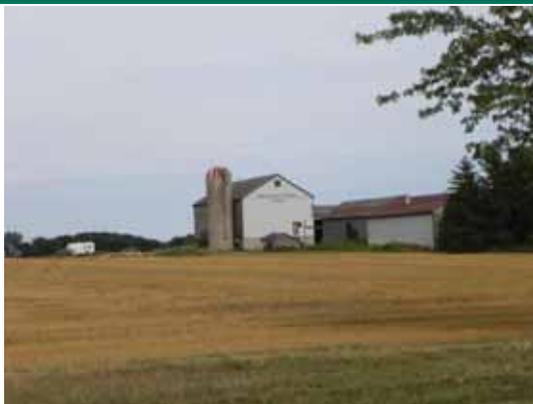
Date: 19th – 20th century

Description: Timber framed side gabled barn with a metal roof and wood siding, on a concrete foundation. Rear and side additions. Concrete silo sits adjacent to barn.

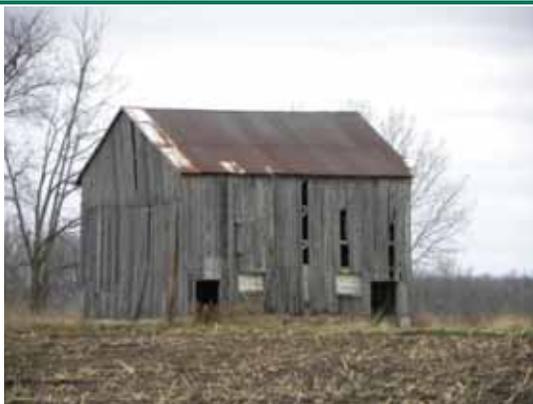
Site #22 – 35526 South Road (Municipality of South Huron)

Date: 19th – early 20th century

Description: Frame barn with metal roof, timber frame and concrete foundation. Barn is situated at the centre of an agricultural field.

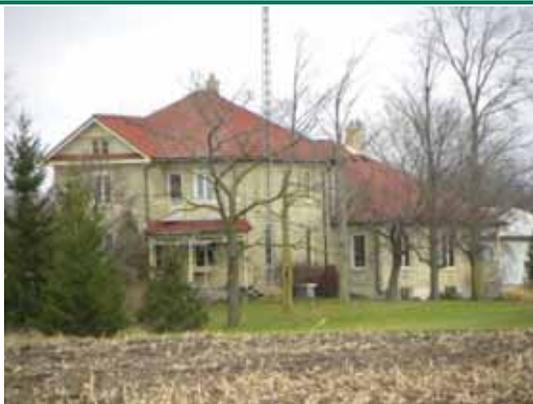
Site #23 – 69436 Mollard Line (Municipality of South Huron)

Date: 1890s – 1920s

Description: Two storey, asymmetrical house, with a hipped roof, yellow brick and an undetermined foundation. Vernacular Queen Anne design elements include two storey gabled projection, decorative spindle work and turned wood columns. Rear addition.

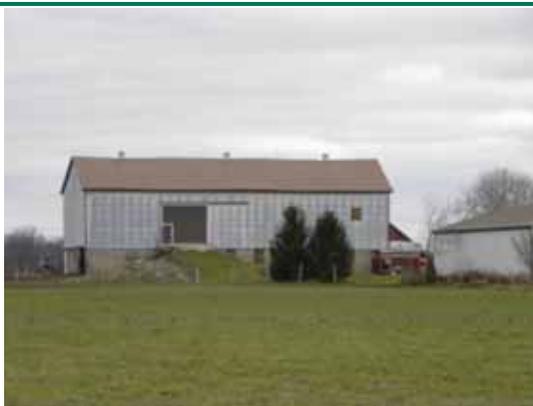
Date: 20th century

Description: Side gabled, timber frame barn on a concrete or concrete foundation. Roof and sidewalls appear to be painted metal.

Mitigation of Negative Impacts: No negative impacts identified, therefore no further mitigation recommended.

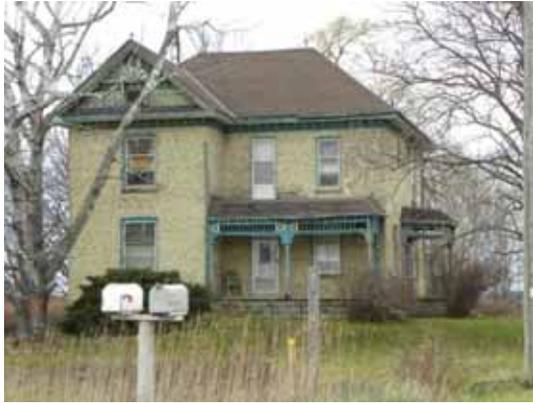
Site #24 – 35652 Greenway Drive (Municipality of South Huron)

Date: 1890s – 1920s

Description: Two storey hipped roof house with lower cross gable on the front facade and medium roof pitch, yellow brick exterior and rusticated concrete block foundation. Vernacular Queen Anne design elements include asymmetrical design, front facing gables, decorative gable ornaments featuring a sunburst, dentil-like brackets, and front and side porches with delicate spindle work along porch columns. Rear addition.

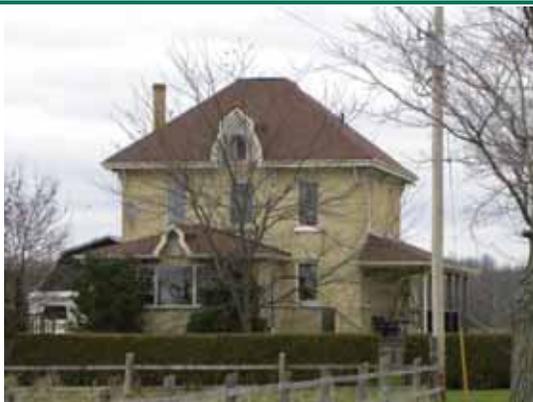
Site #25 – 69668 Grand Bend Line (Municipality of South Huron)

Date: 1890s – 1920s

Description: Two storey hipped roof house with steep pitch, yellow brick exterior and stone foundation. Vernacular design characteristics include symmetrical rectangular design, decorative dentils and brackets as well as a central dormer with rounded central window. Addition at rear.

Potential Direct and Indirect Impacts to the Heritage Attributes: None anticipated; see *Heritage Assessment Report* Section 6.1 for more information.

Mitigation of Negative Impacts: No negative impacts identified, therefore no further mitigation recommended.

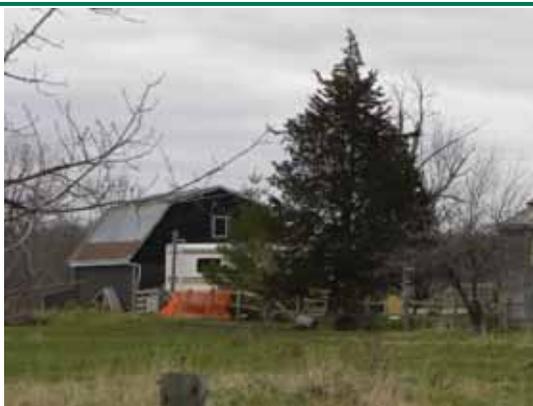
Date: 20th century

Description: Gambrel roof shed with metal roof, modern siding and an undetermined foundation.

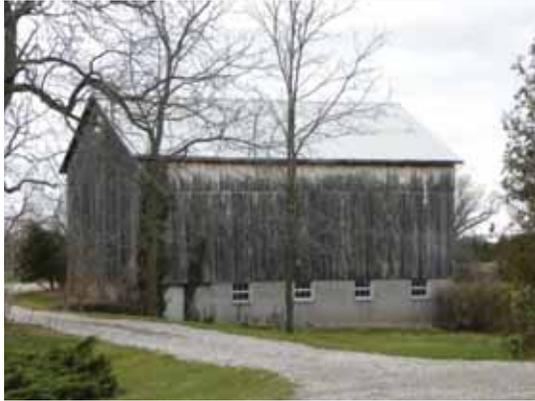
Site #26 – 69689 Grand Bend Line (Municipality of South Huron)

Date: 19th – early 20th century

Description: Frame barn with metal roof, timber siding and a concrete foundation with windows.

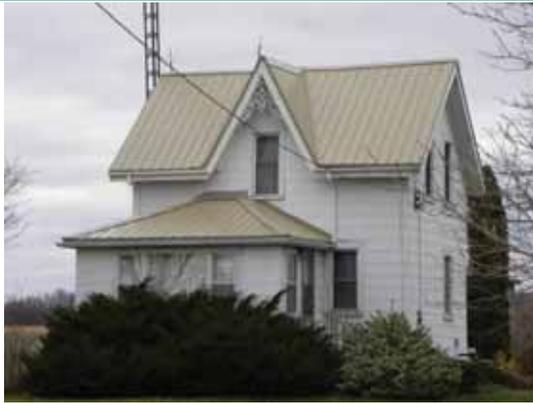
Site #27 – 69724 Grand Bend Line (Municipality of South Huron)

Date: 1860s – 1890s

Description: One and one half storey side gabled house with a steep roof pitch and prominent central gable, modern siding and stone foundation. Vernacular Gothic Revival design elements include symmetrical design, central window extended into a steeply pitched gable and decorative cross bracing. Rear addition.

Potential Direct and Indirect Impacts to the Heritage Attributes: None anticipated; see *Heritage Assessment Report* Section 6.1 for more information.

Mitigation of Negative Impacts: No negative impacts identified, therefore no further mitigation recommended.

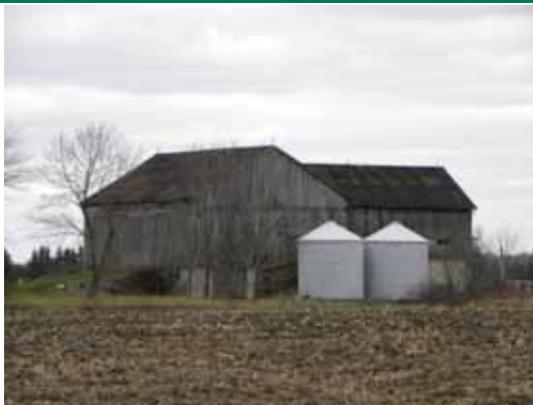
Date: 19th – early 20th century

Description: Frame barn with asphalt sheet roof, timber frame and concrete block foundation. Two metal bins adjacent.

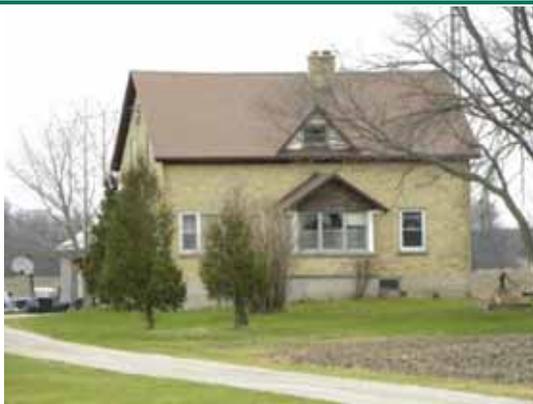
Site #28– 69804 Shipka Line (Municipality of South Huron)

Date: Late 19th century

Description: One and one half storey yellow brick, side gabled, metal roofed, house on a concrete foundation. House has a small central gabled dormer over a gable roofed, enclosed porch/entry hall with a half-height brick wall on a similar foundation as the house.

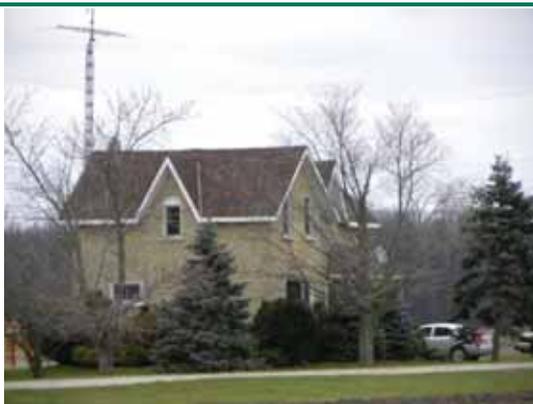
Site #29 – 69872 Shipka Line (Municipality of South Huron)

Date: Late 19th century

Description: One and one half storey yellow brick, side gabled, metal roofed, house on an undetermined foundation. House has a small central gable over a side gable roofed, enclosed porch/entry hall with a half-height brick wall on a similar foundation as the house.

Potential Direct and Indirect Impacts to the Heritage Attributes: None anticipated; see *Heritage Assessment Report* Section 6.1 for more information.

Mitigation of Negative Impacts: No negative impacts identified, therefore no further mitigation recommended.

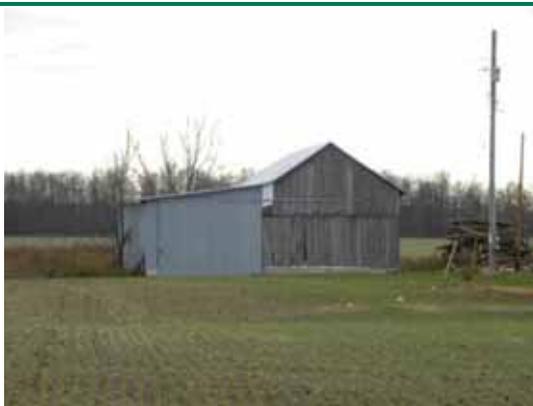
Date: 19th – 20th century

Description: Timber framed, wood sided, metal roofed, side gabled barn on a concrete foundation. Side shed addition.

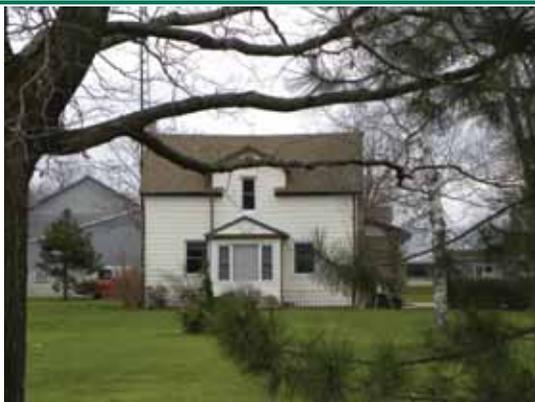
Site #30 – 69872 Shipka Line (Municipality of South Huron)

Date: Late 19th century

Description: One and one half storey side gabled house with a steep roof pitch and prominent central dormer, modern siding and undetermined foundation. Vernacular design elements include symmetrical design, central window extending into the dormer. Rear addition and modern front porch entrance.

Potential Direct and Indirect Impacts to the Heritage Attributes: CHVI was not identified, therefore impacts were not assessed.

Mitigation of Negative Impacts: Impacts were not identified, therefore mitigation is not recommended or necessary.

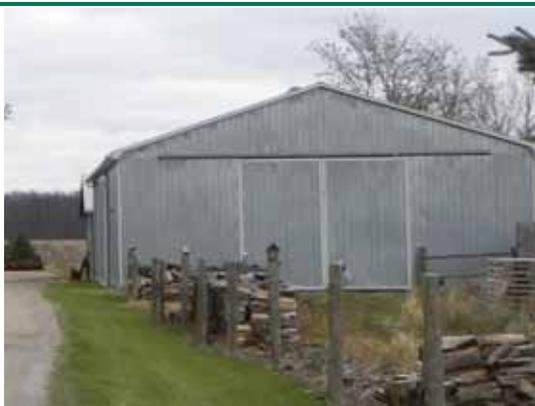
Date: 20th century

Description: Front gabled shed with metal roof, metal exterior and undetermined foundation.

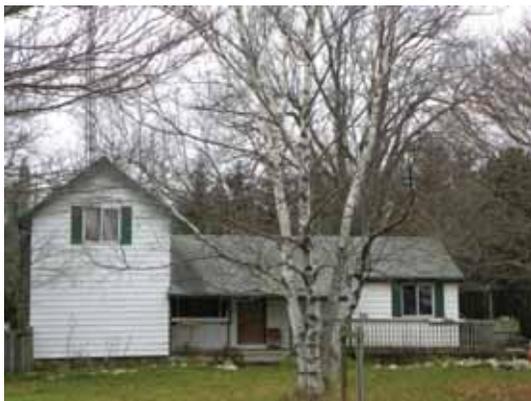
Site #31 – 69881 Shipka Line (Municipality of South Huron)

Date: Various (19th and 20th century)

Description: One and one half storey L-shaped house with cross gabled roof with a medium pitch, modern siding and stone foundation. Front gabled single storey extends from side gabled one and one half storey portion. Modern rear and side additions.

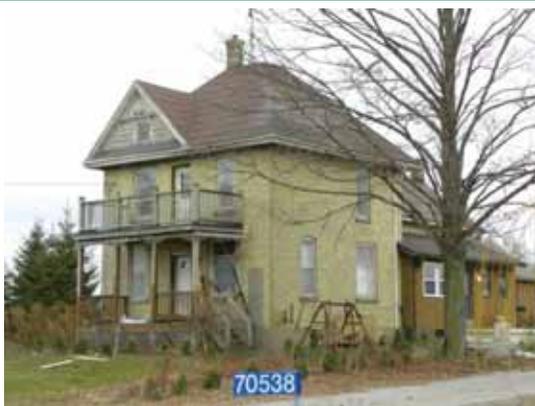
Site #32 – 70538 Shipka Line (Municipality of South Huron)

Date: 1890s – 1920s

Description: Two storey hipped roof house with lower cross gable and medium roof pitch, yellow brick exterior with two storey porch and concrete covered foundation. Vernacular Queen Anne design elements include asymmetrical design, front facing gables, decorative gable ornaments including starburst, and dentils. Rear addition.

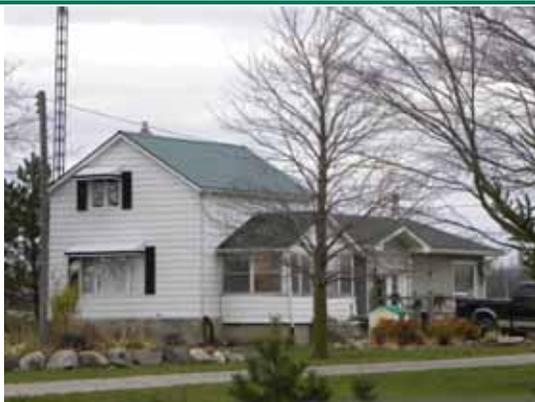
Site #33 – 70352 Shipka Line (Municipality of South Huron)

Date: 19th – early 20th century

Description: One and one half storey side gabled house with a medium roof pitch, modern siding and concrete foundation. Rear addition and modern covered central entryway.

Potential Direct and Indirect Impacts to the Heritage Attributes: CHVI was not identified, therefore impacts were not assessed.

Mitigation of Negative Impacts: No negative impacts identified, therefore no further mitigation recommended.

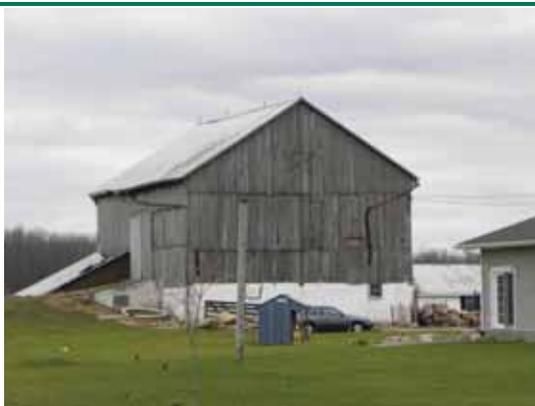
Date: Various (19th and 20th century)

Description: Primary barn structure is a frame barn with metal roof, timber frame and concrete covered foundation. Single storey shed addition located at rear.

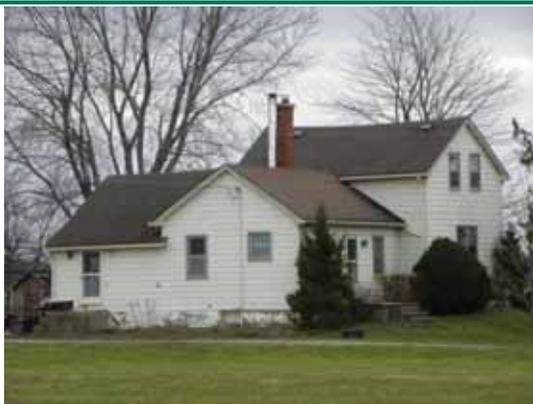
Site #34 – 70298 Shipka Line (Municipality of South Huron)

Date: 19th – early 20th century

Description: One and one half storey front gabled house with single storey side gable, medium roof pitch, modern siding and painted concrete foundation.

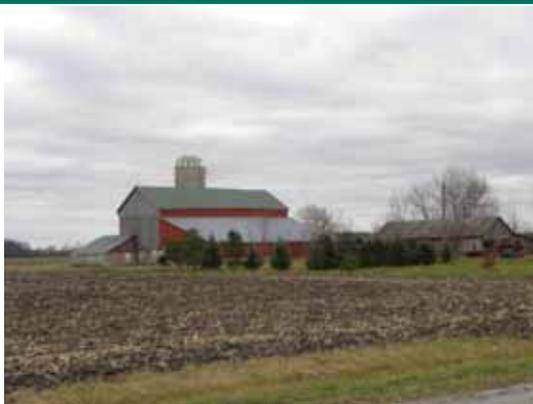
Date: Various (19th and 20th century)

Description: Primary barn is a frame barn with multiple shed additions, metal roof, timber frame and stone foundation. Concrete silo at rear and single storey shed with metal roof, timber frame and undetermined foundation.

Mitigation of Negative Impacts: No negative impacts identified, therefore no further mitigation recommended.

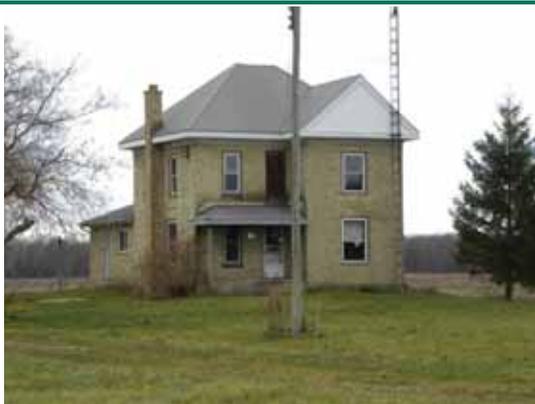
Site #35 – 70205 Shipka Line (Municipality of South Huron)

Date: 1890s – 1920s

Description: Two storey hipped roof house with lower cross gable and medium roof pitch, yellow brick exterior and apparent concrete foundation. Vernacular Queen Anne design elements include asymmetrical design, front facing gable, decorative cornices and two storey front porch. Covered front cross gable and modern porch.

Mitigation of Negative Impacts: No negative impacts identified, therefore no further mitigation recommended.

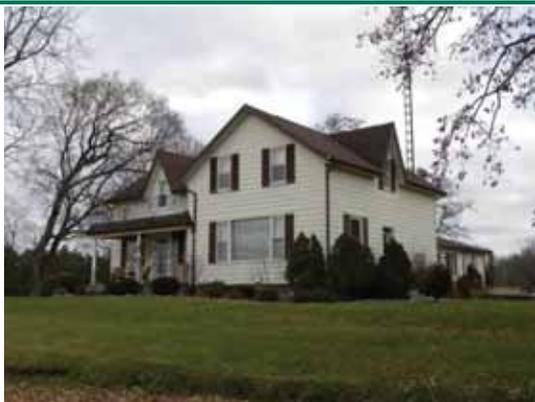
Site #36 – 37343 Crediton Line (Municipality of South Huron)

Date: 1860s – 1890s

Description: One and one half storey cross gabled yellow brick house with a medium roof pitch and multiple steeply pitched cross gables, modern siding and undetermined foundation. Asymmetrical design with central window that extends into front gable. Front porch with central entryway. Addition at rear.

Mitigation of Negative Impacts: No negative impacts identified, therefore no further mitigation recommended.
