**HERITAGE ASSESSMENT REPORT
NEXTERA ENERGY CANADA, ULC
GOSHEN WIND ENERGY CENTRE
MUNICIPALITIES OF BLUEWATER
AND SOUTH HURON
HURON COUNTY, ONTARIO**

**APPENDIX A
BUILT HERITAGE INVENTORY ADDENDUM**

3.0 BUILT HERITAGE INVENTORY

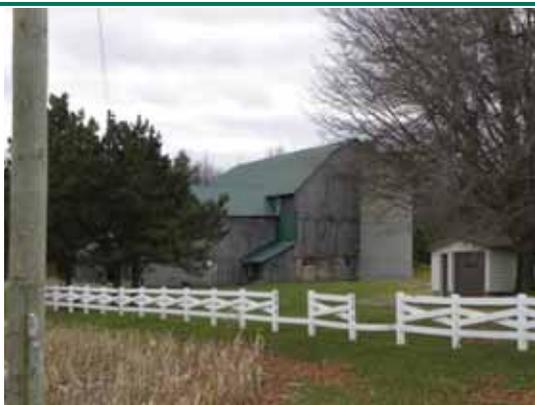
Date: Various (19th and 20th century)

Description: Primary barn is a gambrel roofed frame barn with rear gable addition, a metal roof, timber frame and stone foundation. The site contains multiple out buildings including a single storey yellow brick structure.

Mitigation of Negative Impacts: No negative impacts identified, therefore no further mitigation recommended.

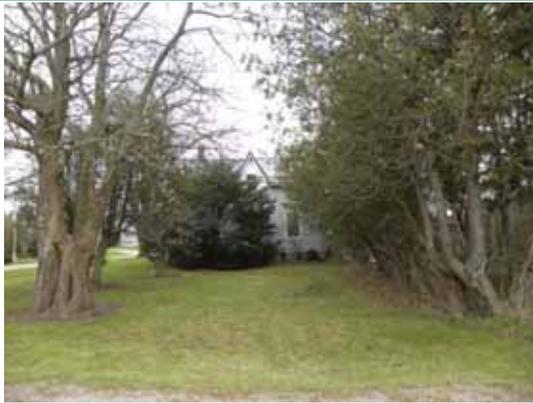
Site #37 – 37391 Crediton Line (Municipality of South Huron)

Date: 1860s – 1890s

Description: One and one half storey side gabled house with a steep roof pitch and prominent central gable, modern siding and concrete foundation. Vernacular Gothic Revival design elements include symmetrical design and a central window extending into the gable with possible wood shingles.

Mitigation of Negative Impacts: No negative impacts identified, therefore no further mitigation recommended.

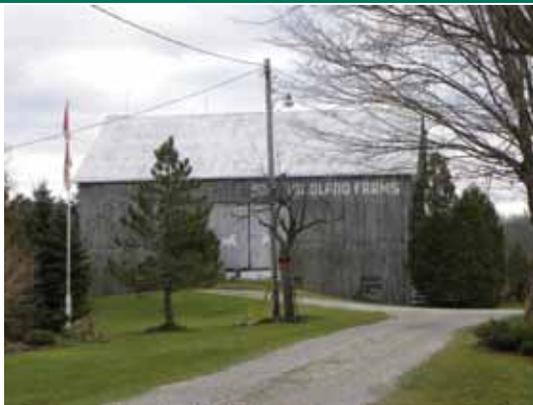
Date: 19th – early 20th century

Description: Frame barn with metal roof, timber frame and undetermined foundation.

Mitigation of Negative Impacts: No negative impacts identified, therefore no further mitigation recommended.

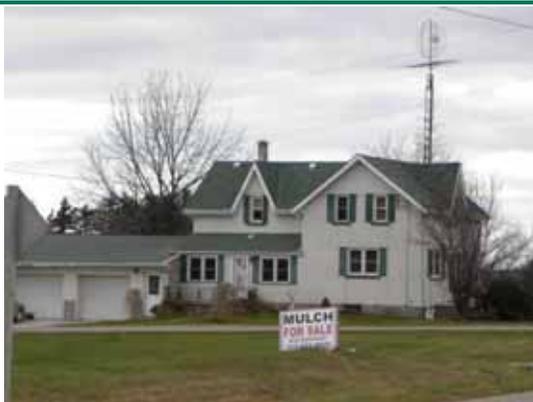
Site #38 – 69661 Bronson Line (Municipality of South Huron)

Date: 1860s – 1890s

Description: One and one half storey cross gabled brick veneer house with a medium roof pitch, medium pitched cross gable, steeply pitched gable and concrete foundation. Symmetrical design appears to be a T-plan with a central window that reaches into the central gable. Modern addition at rear, small front porch and covered side porch.

Mitigation of Negative Impacts: No negative impacts identified, therefore no further mitigation recommended.

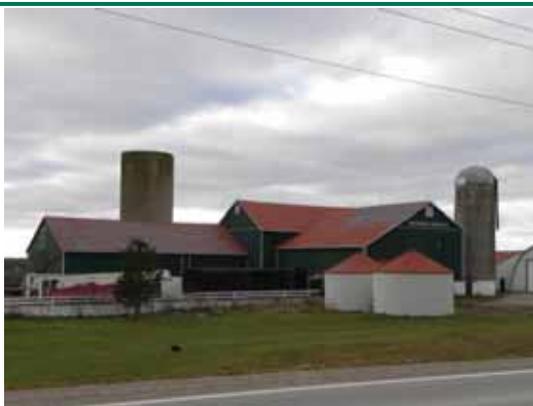
Date: Various (19th and 20th century)

Description: Primary barn appears to be a frame barn with two shed additions, metal roof, timber frame and concrete foundation. Two concrete silos onsite and two metal bins onsite with additional outbuildings.

Mitigation of Negative Impacts: No negative impacts identified, therefore no further mitigation recommended.

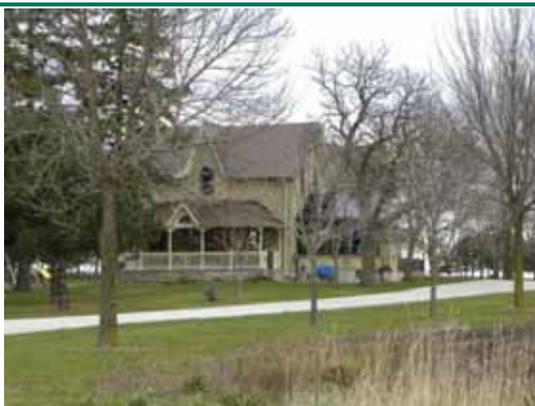
Site #39 –69562 Bronson Line (Municipality of South Huron)

Date: 1860s – 1890s

Description: One and one half storey side gabled house with a steep roof pitch and prominent central gable, yellow brick exterior and concrete covered foundation. Vernacular Gothic Revival design elements include symmetrical design, rounded window extending into the steeply pitched central gable, detailed brick work throughout including the quoin-like detailing. Side and rear additions.

Mitigation of Negative Impacts: No negative impacts identified, therefore no further mitigation recommended.

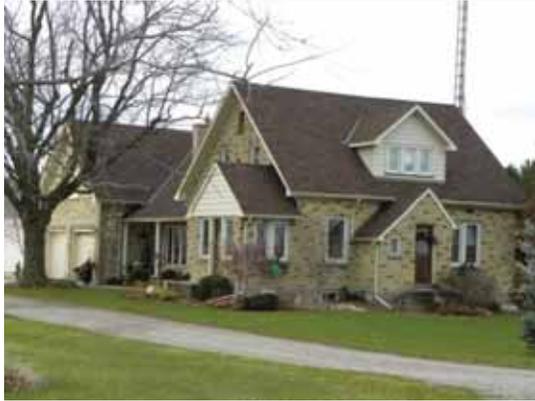
Site #40 – 69881 Babylon Line (Municipality of South Huron)

Date: Mid 20th century

Description: One and one half storey side gabled house with a steep roof pitch and prominent central dormer, poly chromatic yellow and red brick exterior and covered concrete foundation. Extensive rear addition and modifications throughout.

Mitigation of Negative Impacts: Impacts were not identified, therefore mitigation is not recommended or necessary.

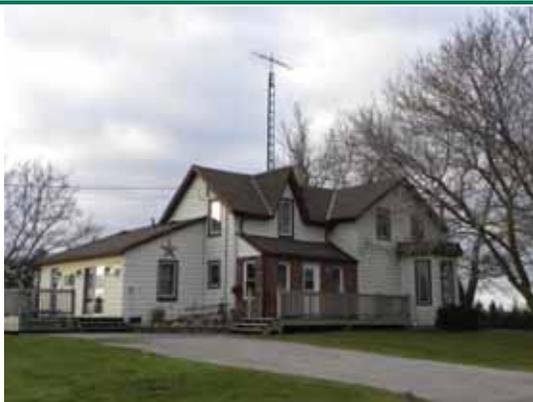
Site #41 – 69855 King Street South/Parr Line (Municipality of South Huron)

Date: 1860s – 1890s

Description: One and one half storey cross gabled house with a steep roof pitch, medium pitched cross gable steeply pitched front gable, modern siding and undetermined foundation. Design appears to be an L-plan with a window that reaches into the central gable. Side addition and covered front porch with brick veneer.

Mitigation of Negative Impacts: No negative impacts identified, therefore no further mitigation recommended.

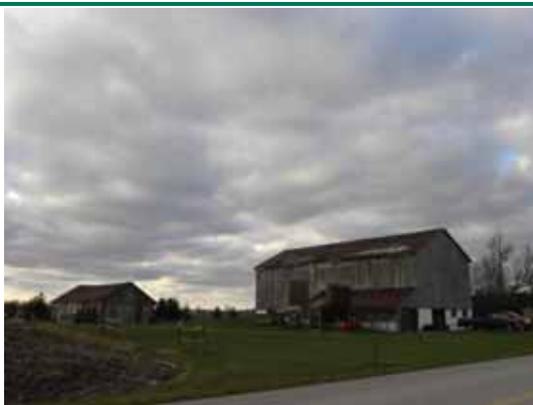
Date: Various (19th and 20th century)

Description: Frame barn with metal roof, timber frame and concrete foundation. Secondary structure is a single storey shed with metal roof, timber frame and undetermined foundation.

Mitigation of Negative Impacts: No negative impacts identified, therefore no further mitigation recommended.

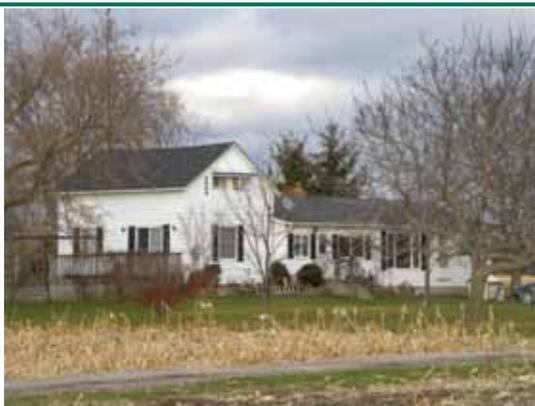
Site #42 – 70548 Blackbush Line (Municipality of South Huron)

Date: Late 19th century

Description: One and one half storey side gabled house with medium roof pitch, modern siding and undetermined foundation. Extensive addition at rear.

Mitigation of Negative Impacts: Impacts were not identified, therefore mitigation is not recommended or necessary.

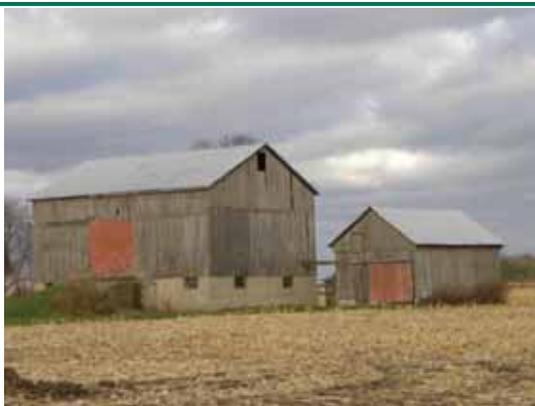
Date: 19th – early 20th century

Description: Frame barn with single storey shed adjacent to barn. Both structures have metal roofs, timber frames and concrete foundations.

Mitigation of Negative Impacts: No negative impacts identified, therefore no further mitigation recommended.

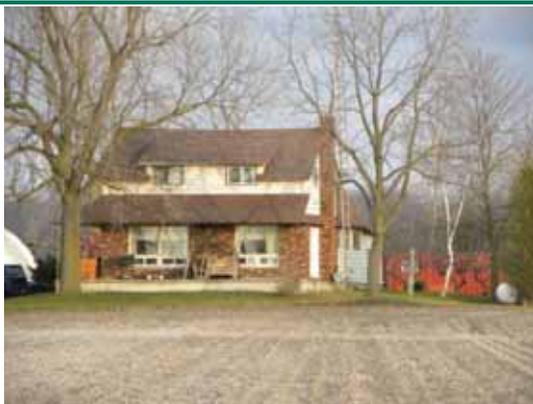
Site #43 – 70600 Blackbush Line (Municipality of South Huron)

Date: Mid 20th century

Description: One and one half storey side gabled house with steep roof pitch, central shed dormer, modern siding and brick veneer exterior and undetermined foundation. Symmetrical design with covered front porch. Addition at rear.

Mitigation of Negative Impacts: Impacts were not identified, therefore mitigation is not recommended or necessary.

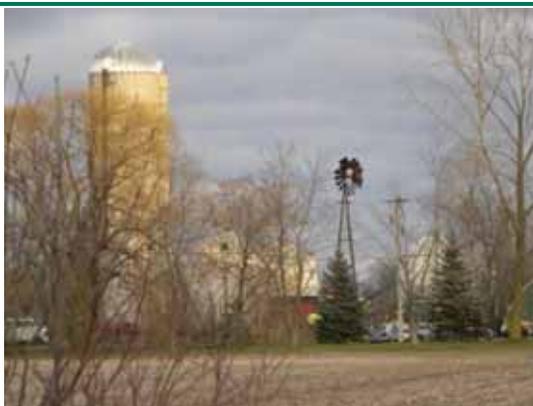
Date: 20th century

Description: Single concrete silo with at least three metal bins onsite.

Mitigation of Negative Impacts: Impacts were not identified, therefore mitigation is not recommended or necessary.

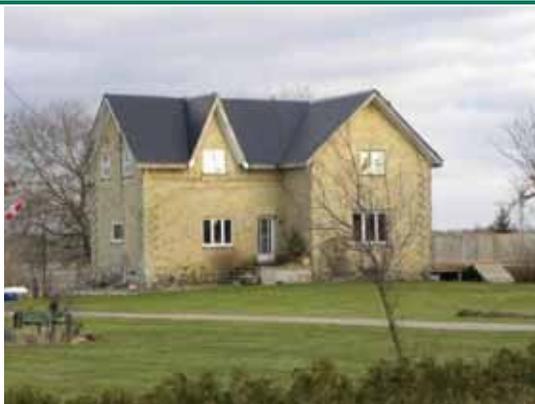
Site #44 – 70370A and 70370B Goshen Line (Municipality of South Huron)

Date: 1860s – 1890s

Description: One and one half storey side gabled house with a steep roof pitch and steeply pitched gable, yellow brick exterior and stone foundation. Asymmetrical in design with Vernacular Gothic Revival design characteristics including a window extending into the dormer of the front facade, open rakes with remnants of brackets, intricate brick frieze and quoin-like triangular detailing.

Mitigation of Negative Impacts: No negative impacts identified, therefore no further mitigation recommended.

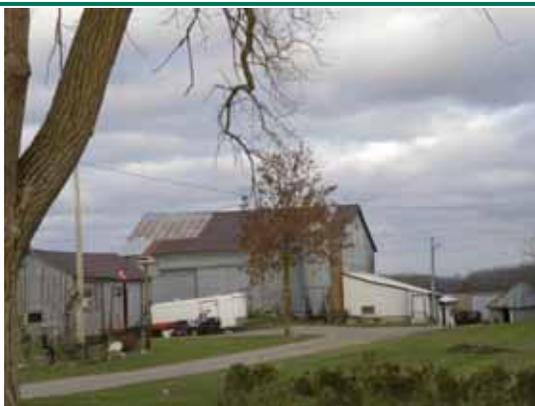
Date: Various (20th century)

Description: Frame barn with later shed addition. Barn has a metal roof, metal siding, and concrete foundation. Various outbuildings onsite.

Mitigation of Negative Impacts: No negative impacts identified, therefore no further mitigation recommended.

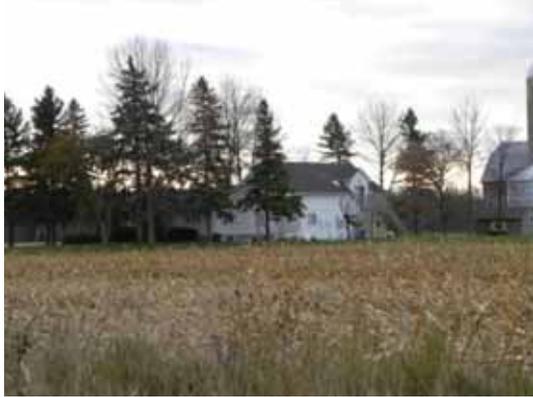
Site #45 – 35545 South Road (Municipality of South Huron)

Date: Late 19th century
Description: One and one half storey end-gabled house at the rear. Second structure has white vertical wood siding and asphalt shingle roof with one visible gabled dormer with attached second storey porch. Modern single-storey, low pitched, side gabled addition on concrete foundation.

Potential CHVI According to O. Reg. 9/06:
1) Design or Physical Value: None identified.
2) Historical or Associate Value: None identified.
3) Contextual Value: None identified.
 Not determined to have cultural heritage value or interest.

Mitigation of Negative Impacts: Impacts were not identified, therefore mitigation is not recommended or necessary.

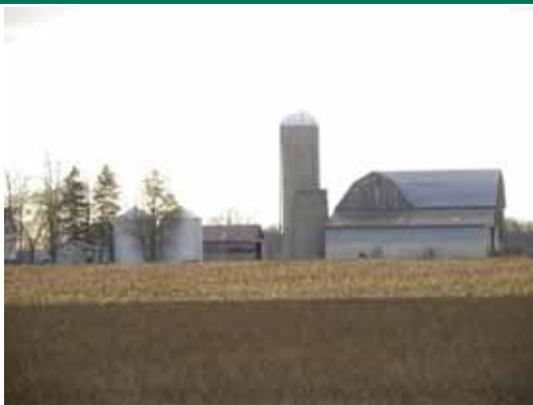
Date: Various (19th and 20th century)
Description: Multi-structure barn complex includes a timber framed, wood sided, gambrel roofed, T-plan barn with metal roof panels. A full length metal roofed, metal-sided, shed addition attached. Two concrete silos, two metal bins, and one end-gabled metal-roofed, wood-sided out building.

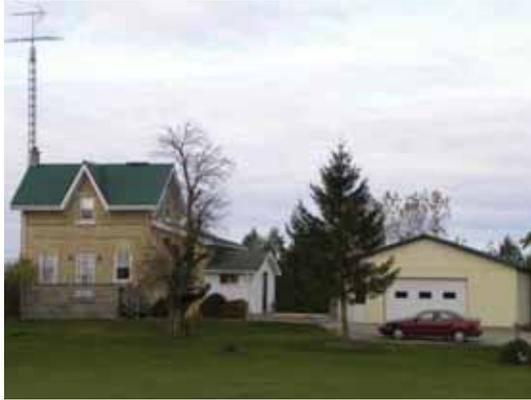
Site #46 – 69481 Bronson Line (Municipality of South Huron)

Date: 1860-1890s

Description: One and one half storey side gabled, yellow brick house with a green painted metal roof, steeply pitched center gabled dormer with a single window on an undetermined foundation. House has inset decorative-frieze brickwork and yellow brick shed addition to one gable end with a wood framed, metal sided, asphalt shingled addition attached to it. Modern garage.

Mitigation of Negative Impacts: No negative impacts identified, therefore no further mitigation recommended.

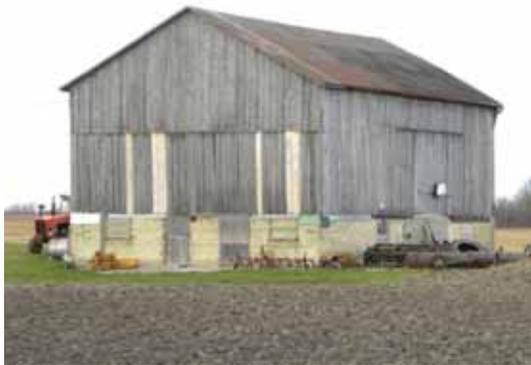
Date: 19th – early 20th century

Description: Timber framed, wood sided, metal roofed, side gabled barn on a yellow brick foundation.

Mitigation of Negative Impacts: No negative impacts identified, therefore no further mitigation recommended.

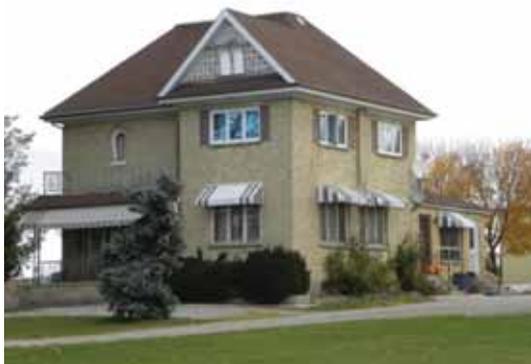
Site #47 – 69482 Bronson Line (Municipality of South Huron)

Date: 1890s – 1920s

Description: Two storey, hipped roof, yellow brick house on a concrete foundation with a double window and decorative gingerbread work in L gable end. Second storey porch sits in L crux and forms the roof of the first floor porch with modern metal railings and columns. Second storey has a keyhole window above porch and first floor windows are covered with metal awnings. Rear addition with an undetermined roof line and foundation. Modern garage at rear.

Mitigation of Negative Impacts: No negative impacts identified, therefore no further mitigation recommended.

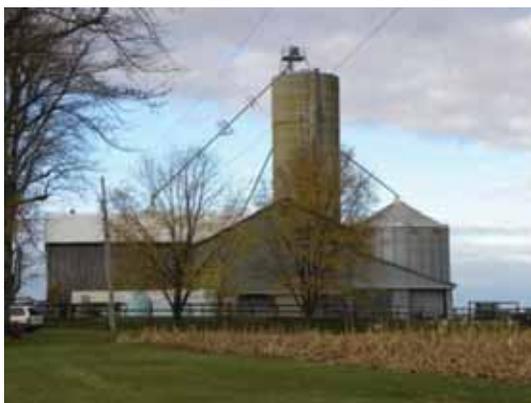
Site #48 – 69713 Goshen Line (Municipality of South Huron)

Date: Various (19th and 20th century)

Description: Wood-sided, white-painted gabled metal roof, on an L-plan barn with metal sided, metal roofed shed addition attached to L. Concrete silo and metal bin adjacent.

Mitigation of Negative Impacts: No negative impacts identified, therefore no further mitigation recommended.

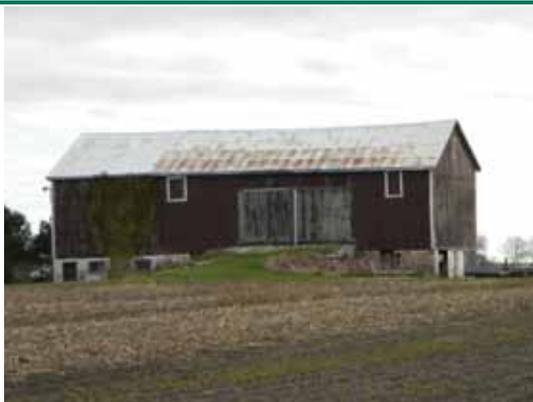
Site #49 – 38425 Dashwood Line (Municipality of South Huron)

Date: 20th century

Description: Side gabled, timber framed, white painted metal roofed barn with brown painted wood-siding on a brick foundation. Barn has one wood sided, metal roofed, one bay, full height gabled addition on a concrete foundation attached to one of the gabled ends, extending the original roof and sidewall lines.

Mitigation of Negative Impacts: No negative impacts identified, therefore no further mitigation recommended.

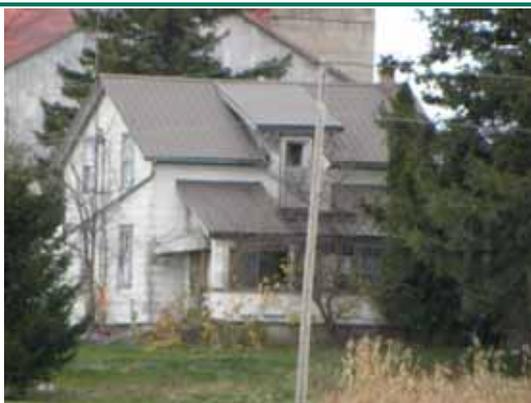
Site #50 – 72299 Babylon Line (Municipality of Bluewater)

Date: Late 19th century

Description: One and one half storey side gabled, metal roofed, metal sided, house with a shed dormer and three quarter length enclosed porch under a metal panel shed roof.

Mitigation of Negative Impacts: Impacts were not identified, therefore mitigation is not recommended or necessary.

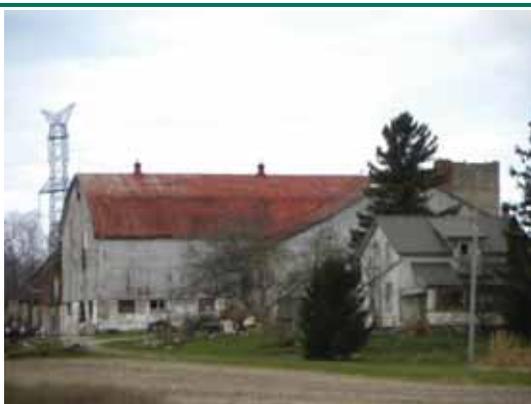
Date: 19th century

Description: Timber framed gambrel roofed barn with metal panel roof, wood siding, on a concrete foundation. One large gable-roofed addition creates an L-plan while a shed roof addition at the rear.

Mitigation of Negative Impacts: No negative impacts identified, therefore no further mitigation recommended.

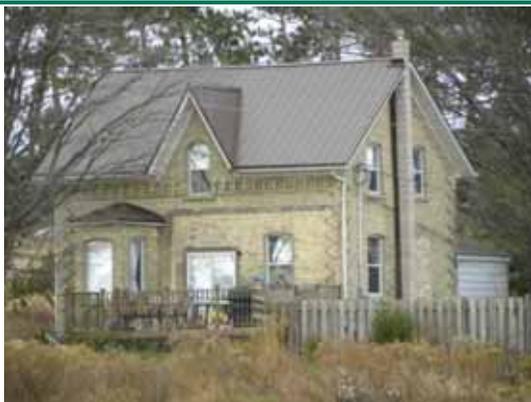
Site #51 – 72257 Babylon Line (Municipality of Bluewater)

Date: 1860-1890s

Description: One and one half storey yellow brick, side gabled, house with a peaked central dormer over an arched window on an undetermined foundation. House has modern metal panel roof, with decorative raised brick frieze and triangular quoin-like detailing. Unroofed deck porch, modern windows and front door.

Mitigation of Negative Impacts: No negative impacts identified, therefore no further mitigation recommended.

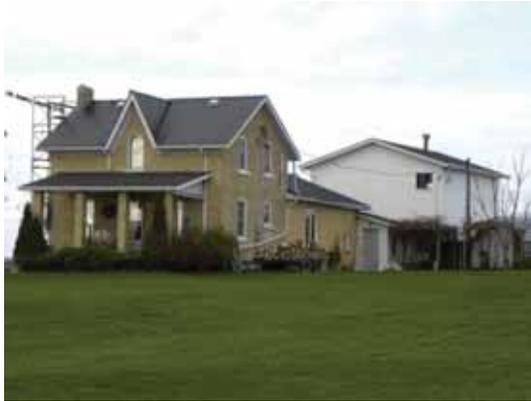
Site #52 – 71953 Babylon Line (Municipality of Bluewater)

Date: 1860-1890s

Description: One and one half storey yellow brick, side gabled house with a steeply peaked central dormer over an arched window on an undetermined foundation. House has a full width covered front porch with a shed roof supported by yellow brick columns. A yellow brick, gable roofed, single storey addition is attached to the back of the house. Two storey modern gabled garage at the rear.

Mitigation of Negative Impacts: No negative impacts identified, therefore no further mitigation recommended.

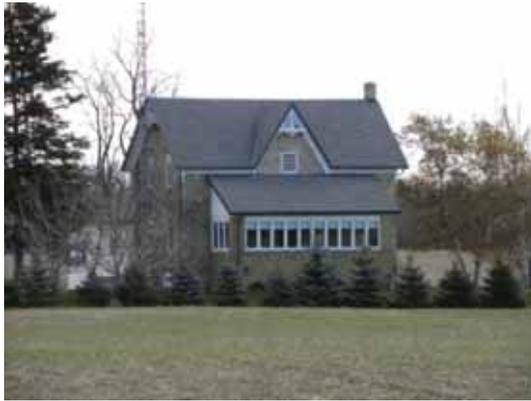
Site #53 – 72362 Goshen Line (Municipality of Bluewater)

Date: 1860-1890s

Description: One and one half storey side gabled yellow brick house with peaked central gable over a single square window on a stone foundation. House has decorative raised brick work at frieze, over gable-end windows, triangular quoin-like detailing and gingerbread work in gables and along eaves with some decorative brackets. House has a modern enclosed yellow brick, shed roof porch with modern windows.

Mitigation of Negative Impacts: No negative impacts identified, therefore no further mitigation recommended.

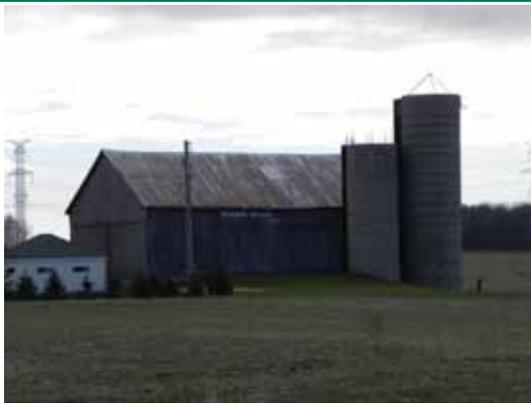
Date: 19th – early 20th century

Description: Timber framed, metal roofed, wood sided, side gabled barn with two concrete silos. Additional outbuilding adjacent.

Mitigation of Negative Impacts: No negative impacts identified, therefore no further mitigation recommended.

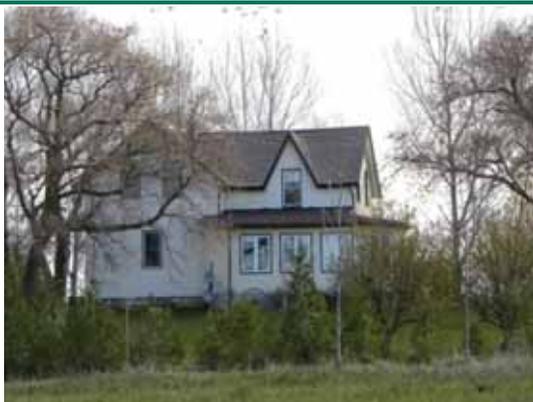
Site #54 – 72204 Goshen Line (Municipality of Bluewater)

Date: 1860-1890s

Description: One and one half storey L plan house with modern siding, stone foundation and a steeply pitched dormer in L length over a single square window. Covered inset porch. House roof covered in asphalt shingles and has modern windows.

Mitigation of Negative Impacts: No negative impacts identified, therefore no further mitigation recommended.

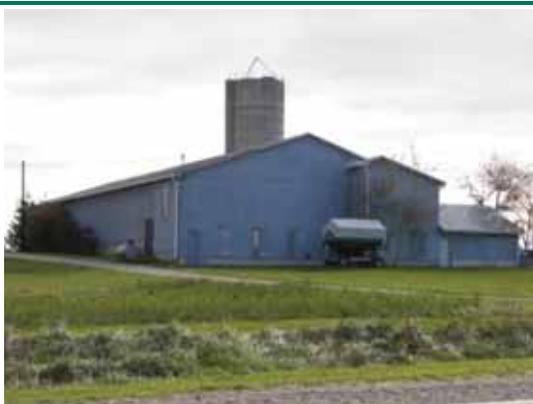
Date: Various (19th and 20th century)

Description: Wood framed, metal roofed, side gabled barn on concrete foundation. One asymmetrically roofed, gable end projection attached to barn gable end, with another gabled addition attached to both the initial addition and the original barn side. Concrete silo sits adjacent to barn.

Mitigation of Negative Impacts: No negative impacts identified, therefore no further mitigation recommended.

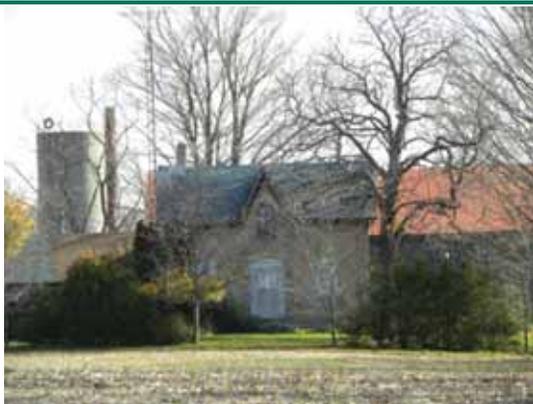
Site #55 – 71962 Bronson Line (Municipality of Bluewater)

Date: 1860-1890s

Description: One and one half storey side gabled yellow brick house on a symmetrical plan with a steeply peaked central dormer over an arched single window on an undetermined foundation. House has decorative raised brick quoin-like detailing and similar features framing the front door and central dormer.

Mitigation of Negative Impacts: No negative impacts identified, therefore no further mitigation recommended.

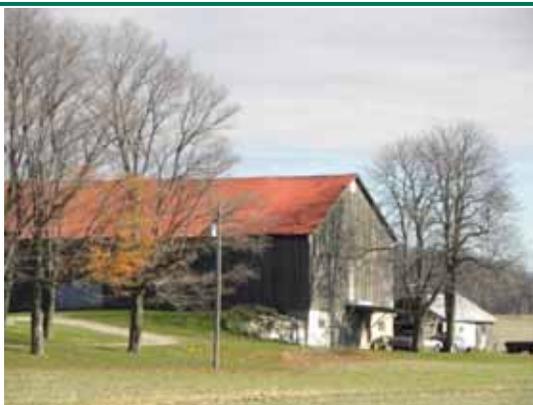
Date: 19th – early 20th century

Description: Timber framed side gabled barn with metal roof and wood siding on a concrete foundation. Small end gabled garage or out building behind barn.

Mitigation of Negative Impacts: No negative impacts identified, therefore no further mitigation recommended.

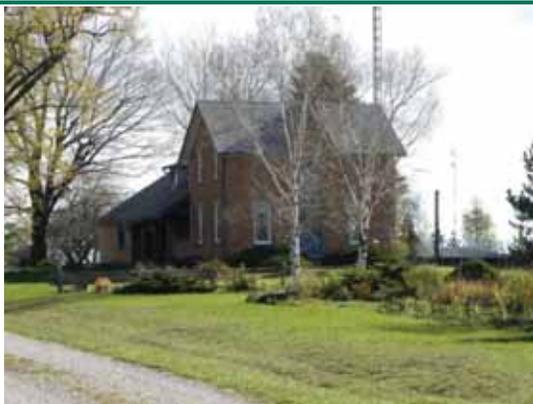
Site #56 – 71726 Bronson Line (Municipality of Bluewater)

Date: 1860s-1890s

Description: One and one half storey, red brick, side gabled house with a steeply peaked central dormer on a symmetrical plan with an undetermined foundation. Gabled addition at rear with a single shed dormer and porch.

Mitigation of Negative Impacts: No negative impacts identified, therefore no further mitigation recommended.

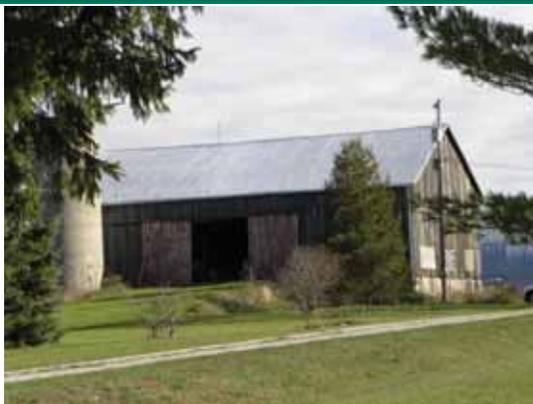
Date: Various (19th and 20th century)

Description: Timber framed side gabled barn with a metal roof and wood siding on a stone foundation. Concrete silo sits adjacent to barn.

Mitigation of Negative Impacts: No negative impacts identified, therefore no further mitigation recommended.

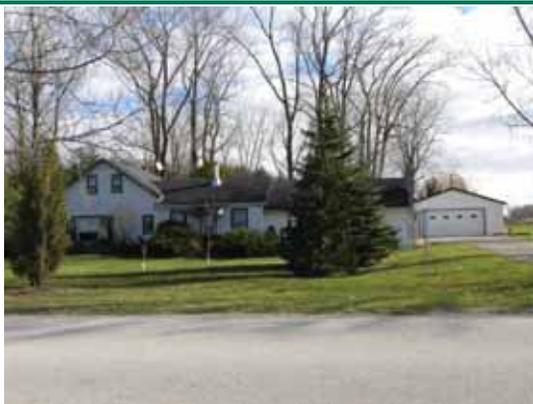
Site #57 – 71684 Bronson Line (Municipality of Bluewater)

Date: 19th – 20th century

Description: One and one half storey T plan or end gabled house with a single-storey addition creating a T plan on an undetermined foundation. Additional single-storey addition at gable end. Windows and doors are modern and a gabled garage sits behind the property.

Mitigation of Negative Impacts: Impacts were not identified, therefore mitigation is not recommended or necessary.

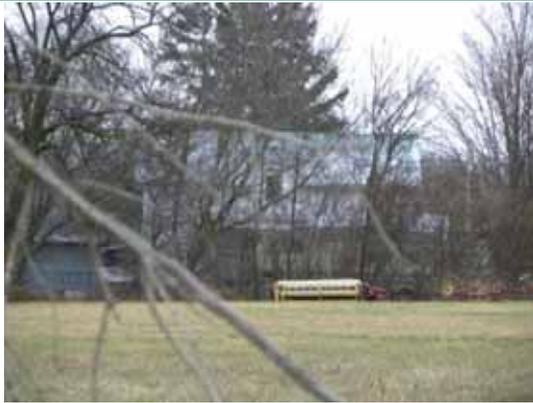
Site #58 – 71642 Bronson Line (Municipality of Bluewater)

Date: 1860s – 1880s

Description: One and one half storey side gabled house with a medium roof pitch and prominent central gable, white sided exterior and undetermined foundation. Vernacular Gothic Revival design elements include symmetrical design and single window extending into the steeply pitched front gable. Modern rear addition.

Mitigation of Negative Impacts: No negative impacts identified, therefore no further mitigation recommended.

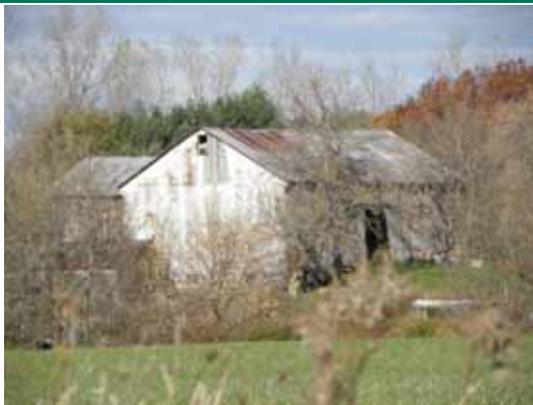
Date: 19th – early century

Description: Timber framed side gabled barn with a metal roof and white painted wood siding on a stone foundation. Smaller metal framed, wood sided outbuilding near barn.

Mitigation of Negative Impacts: No negative impacts identified, therefore no further mitigation recommended.

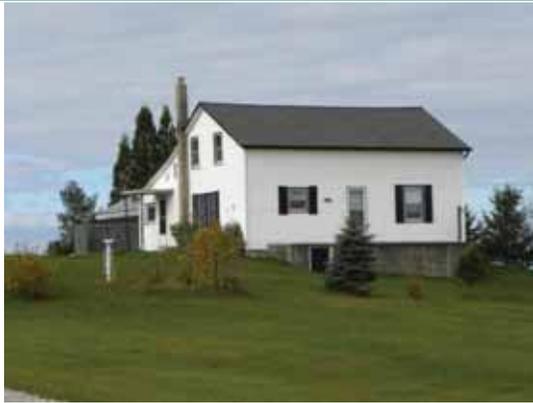
Site #59 – 72199 Bronson Line (Municipality of Bluewater)

Date: Late 19th century

Description: One and one half storey side gabled house, with medium roof pitch, modern siding and concrete foundation. Likely originally symmetrical in design although heavily modified throughout including rear ‘salt-box’ addition.

Mitigation of Negative Impacts: Impacts were not identified, therefore mitigation is not recommended or necessary.

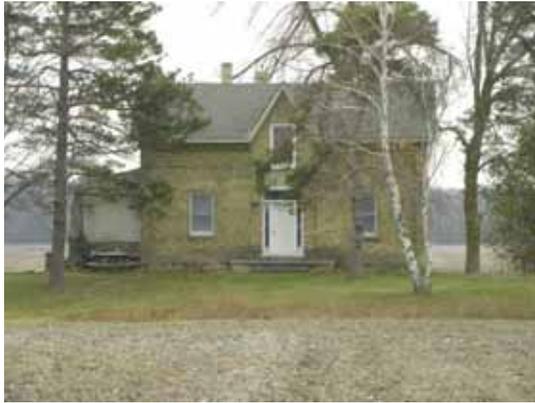
Site #61 – 70204 Parr Line (Municipality of South Huron)

Date: 1860-1890s

Description: One and one half storey side gabled, yellow brick house with a moderate roof pitch, steeply pitched central gable with a single window on stone foundation. Vernacular Gothic Revival design elements include symmetrical design, window extending into the steeply pitched central gable, sidelights and transom surrounding door and detailed brick work throughout. Rear addition.

Mitigation of Negative Impacts: No negative impacts identified, therefore no further mitigation recommended.

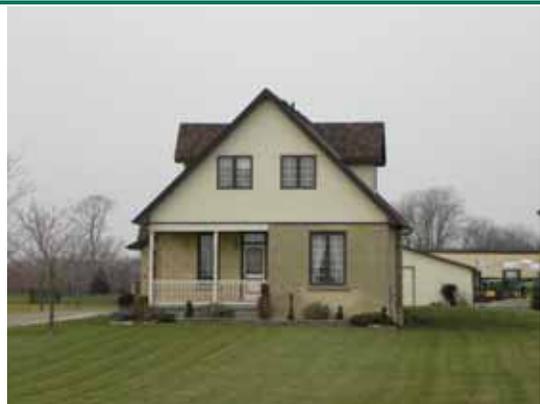
Site #62 – 70281 Ausable Line (Municipality of South Huron)

Date: 20th century

Description: One and one half storey front gabled brick house, partially clad in modern siding, medium roof pitch, symmetrical dormers and undetermined foundation. Partial inset porch.

Mitigation of Negative Impacts: Impacts were not identified, therefore mitigation is not recommended or necessary

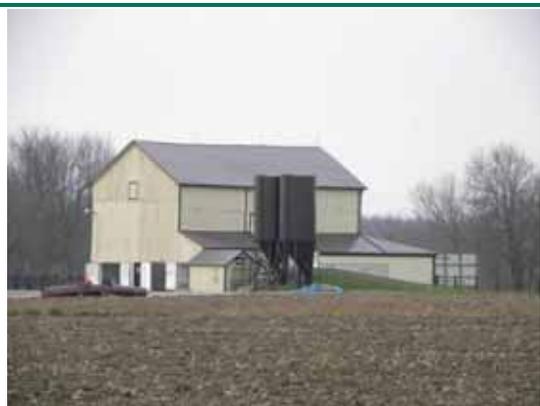
Date: Various (19th and 20th century)

Description: Frame barn with metal roof, timber siding and concrete foundation. Front shed addition.

Mitigation of Negative Impacts: No negative impacts identified, therefore no further mitigation recommended.

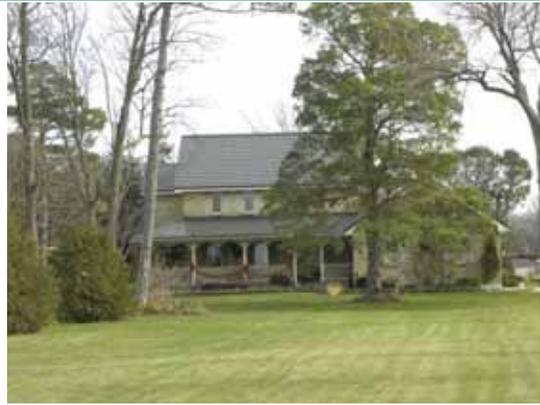
Site #63 – 70082 Airport Line (Municipality of South Huron)

Date: 19th century

Description: One and one half storey side gabled house with steep roof pitch, yellow brick exterior and undetermined foundation. Symmetrical design and full wrap-around porch. Highly modified exterior with side and rear additions.

Mitigation of Negative Impacts: No negative impacts identified, therefore no further mitigation recommended.

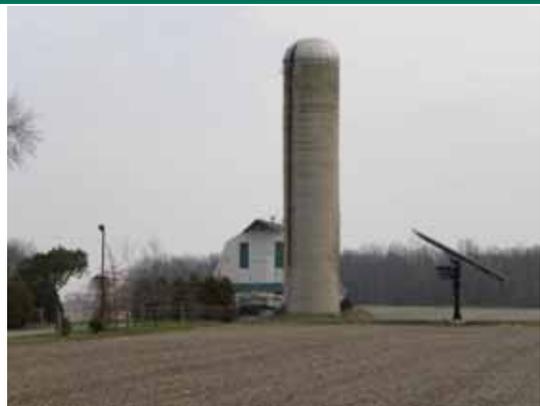
Date: 20th century

Description: Barn with gambrel roof, timber frame with modern siding and undetermined foundation. Concrete silo.

Mitigation of Negative Impacts: No negative impacts identified, therefore no further mitigation recommended.

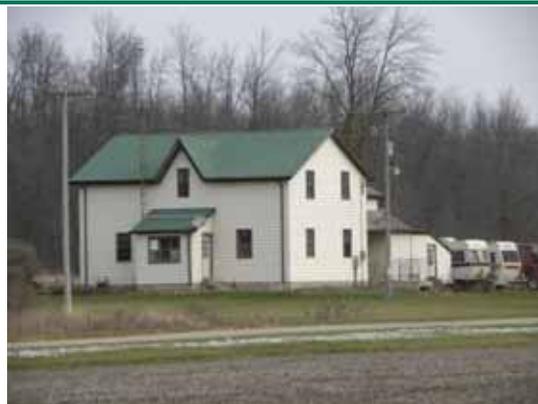
Site #64 – 70180 Airport Line (Municipality of South Huron)

Date: 1860s – 1890s

Description: One and one half storey side gabled house with a medium roof pitch and central gable, modern siding and concrete foundation. Vernacular Gothic Revival design elements include symmetrical design and a central window extending into the gable. Modern front entry porch and rear addition.

Mitigation of Negative Impacts: No negative impacts identified, therefore no further mitigation recommended.

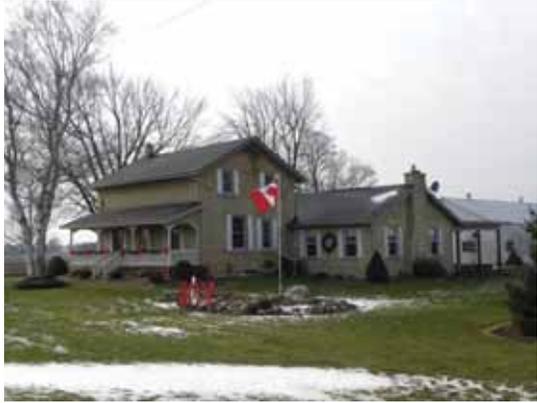
Site #65 – 70129 London Road (Municipality of South Huron)

Date: Late 19th century

Description: One and one half storey side gabled house with medium roof pitch, yellow brick exterior and undetermined foundation. Symmetrical design with decorative brickwork and quoin-like detailing. Rear and side additions and full width covered front porch.

Mitigation of Negative Impacts: No negative impacts identified, therefore no further mitigation recommended.

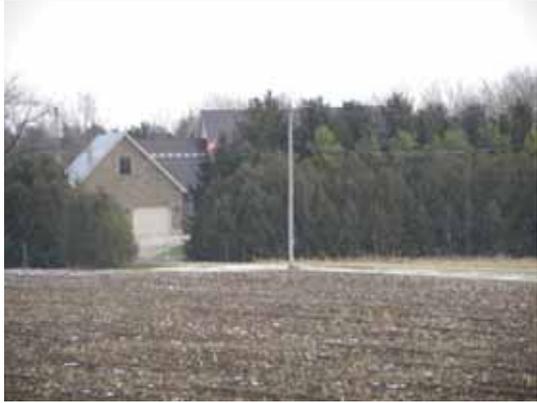
Site #66 – 70126 Morrison Line (Municipality of South Huron)

Date: Undetermined

Description: One and one half storey house with modern metal roof and modern garage. Extensive foliage restricts further identification.

Mitigation of Negative Impacts: No negative impacts identified, therefore no further mitigation recommended.

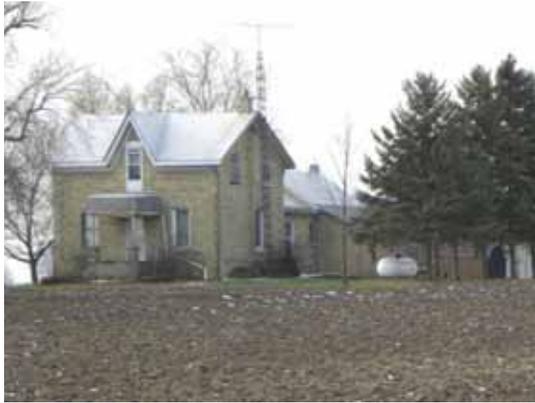
Site #67 – 70133 Morrison Line (Municipality of South Huron)

Date: 1860s – 1890s

Description: One and one half storey side gabled house with a steep roof pitch and prominent central gable, yellow brick exterior and undetermined foundation. Vernacular Gothic Revival design elements include symmetrical design, brick detailing throughout including quoin-like brickwork and a central doorway extending into the gable. Central entry porch with a mansard roof and modern rear addition.

Mitigation of Negative Impacts: No negative impacts identified, therefore no further mitigation recommended.

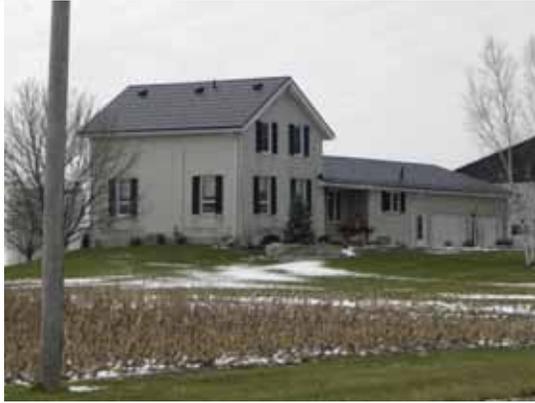
Site #68 – 40667 Kirkton Road (Municipality of South Huron)

Date: Late 19th century

Description: One and one half storey front gabled house with side addition, medium roof pitch, white brick exterior and concrete foundation. Main block symmetrical in design with remnant barge board in front gable.

Mitigation of Negative Impacts: Impacts were not identified, therefore mitigation is not recommended or necessary.

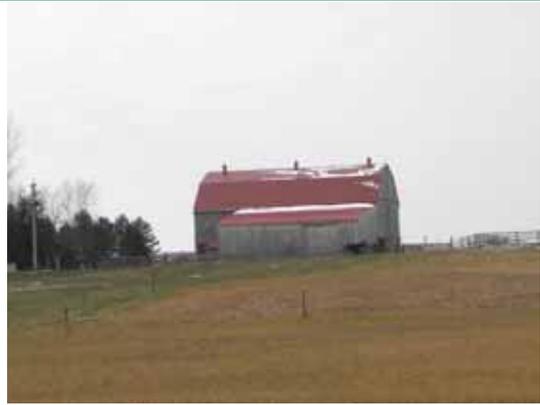
Site #69 – 70129 Evergreen Line (Municipality of South Huron)

Date: 20th century

Description: Frame barn with metal gambrel roof, timber siding, and concrete foundation.

Mitigation of Negative Impacts: No negative impacts identified, therefore no further mitigation recommended.

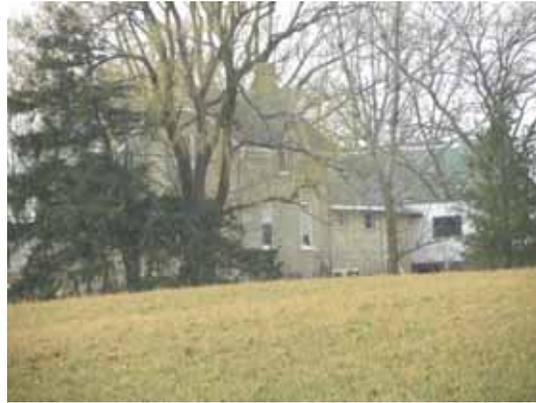
Site #70 – 70209 Evergreen Line (Municipality of South Huron)

Date: 1860s – 1890s

Description: One and one half storey house with a steep roof pitch and steeply pitched gables, yellow brick exterior and stone foundation. Asymmetrical in design with Vernacular Gothic Revival design characteristics including a window extending into the dormer of the front facade, rounded windows, barge board, intricate brick frieze and quoin-like detailing. Side and rear addition.

Mitigation of Negative Impacts: No negative impacts identified, therefore no further mitigation recommended.

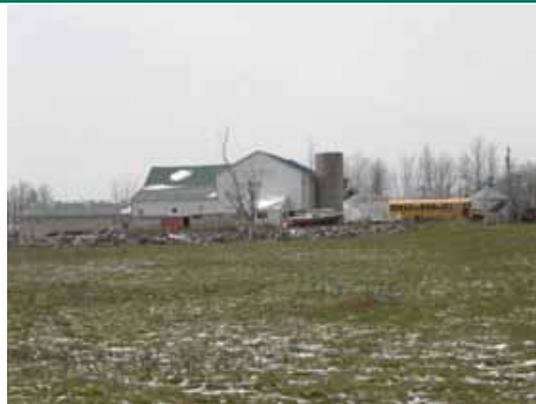
Date: Various (19th – 20th century)

Description: Frame barn with metal roof, metal siding and with concrete foundation. Multiple shed additions, concrete silo and three metal bins.

Mitigation of Negative Impacts: No negative impacts identified, therefore no further mitigation recommended.

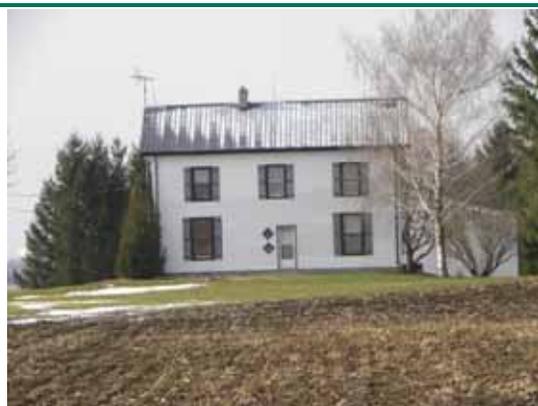
Site #71 – 70045 Elmville Line (Municipality of South Huron)

Date: Mid – late 19th century

Description: Two storey side gabled house with medium pitched roof, clad in modern siding with a concrete foundation. Symmetrical façade with wide eaves, modern door and side windows. Rear addition and rear shed.

Mitigation of Negative Impacts: No negative impacts identified, therefore no further mitigation recommended.

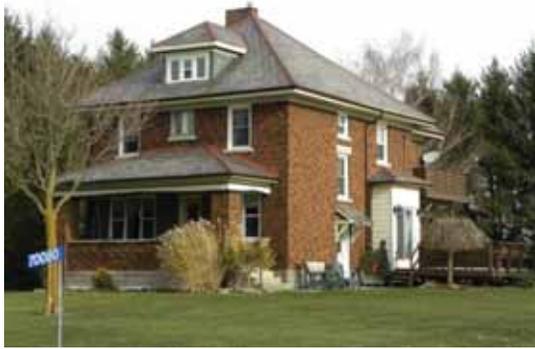
Site #72 – 70080 Elmvile Line (Municipality of South Huron)

Date: 1890s – 1920s

Description: Two storey house with a slate pyramidal roof, medium pitch, central hipped dormer, red brick exterior and rusticated concrete block foundation. Vernacular ‘four-square’ design elements include symmetrical design, full width single storey roof porch and square plan. Rear addition.

Mitigation of Negative Impacts: No negative impacts identified, therefore no further mitigation recommended.

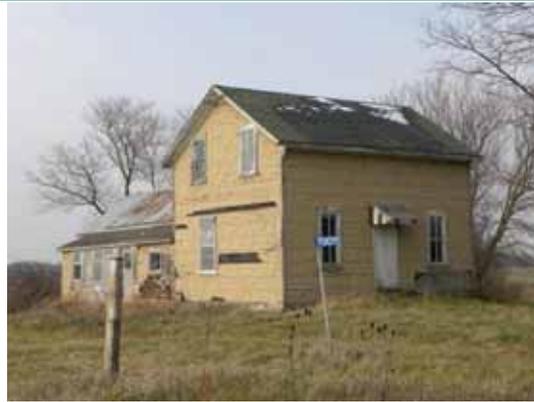
Site #73 – 70011 Henry Line (Municipality of South Huron)

Date: Late 19th century

Description: One and one half storey side gabled frame house with medium roof pitch, insulbrick siding and stone foundation. Symmetrical in design with remnants of brackets apparent. Rear addition with metal roof and front entry porch.

Mitigation of Negative Impacts: Impacts were not identified, therefore mitigation is not recommended or necessary.

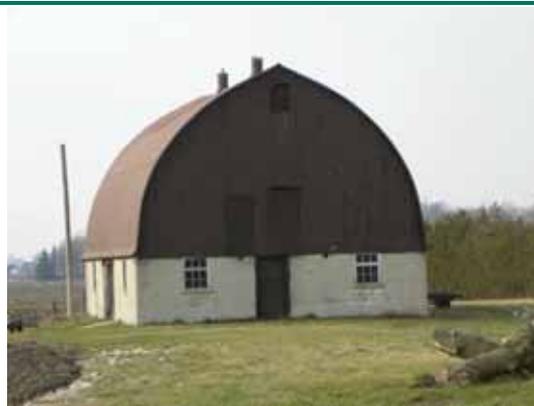
Date: 20th century

Description: Round roof barn with metal roof, metal siding and concrete block foundation. Modern rear addition.

Mitigation of Negative Impacts: No negative impacts identified, therefore no further mitigation recommended.

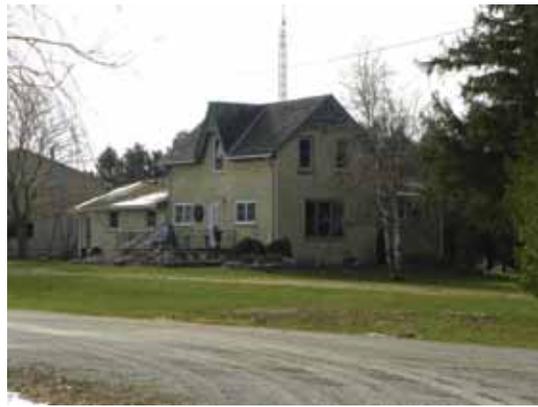
Site #74 – 41513 Centennial Road (Municipality of South Huron)

Date: 1860s – 1890s

Description: One and one half storey T-shaped side gabled house with a medium roof pitch and prominent central gable, yellow brick exterior, and stone foundation. Vernacular Gothic Revival design elements include symmetrical design, central door, steeply pitched central gable with a decorative rounded window arch and barge board. Rear and side additions.

Mitigation of Negative Impacts: No negative impacts identified, therefore no further mitigation recommended.

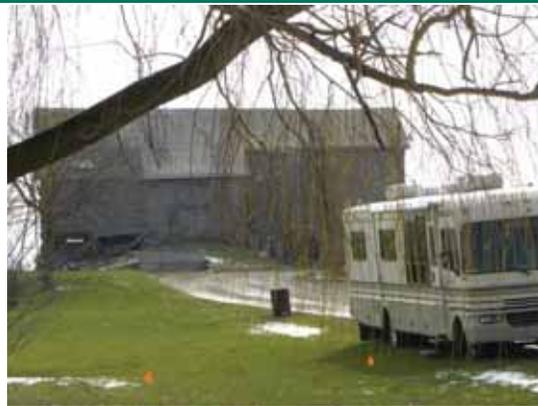
Date: 19th – early 20th century

Description: Frame barn with metal roof, timber siding and stone foundation.

Mitigation of Negative Impacts: No negative impacts identified, therefore no further mitigation recommended.

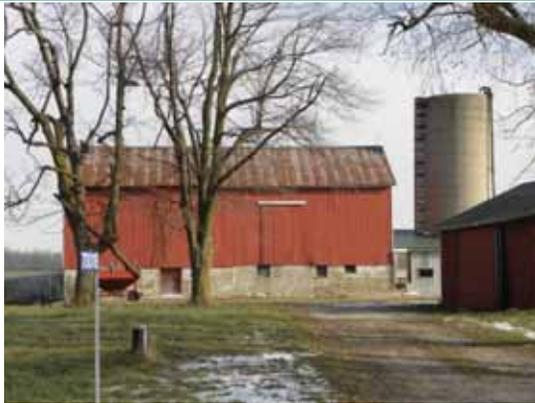
Site #75 – 70018 Sunshine Line (Municipality of South Huron)

Date: 19th – early 20th century

Description: Frame barn with metal roof, timber frame clad with metal siding and mixed brick and concrete foundation. Side addition with concrete silo and modern outbuilding.

Mitigation of Negative Impacts: No negative impacts identified, therefore no further mitigation recommended.

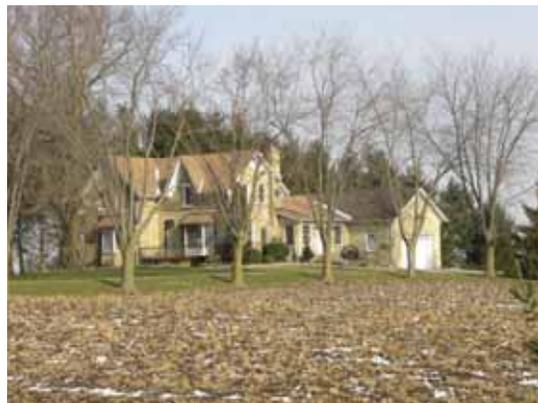
Site #76 – 70148 Sunshine Line (Municipality of South Huron)

Date: 1860s – 1890s

Description: One and one half storey side gabled house with projecting front dormer, steep roof pitch with steeply pitched gable, yellow brick exterior and stone foundation. Asymmetrical in design with Vernacular Gothic Revival design characteristics including a front bay window, rounded window extending into the dormer, open rakes, intricate brick frieze and quoin-like brick detailing. Rear addition and modern garage.

Mitigation of Negative Impacts: No negative impacts identified, therefore no further mitigation recommended.

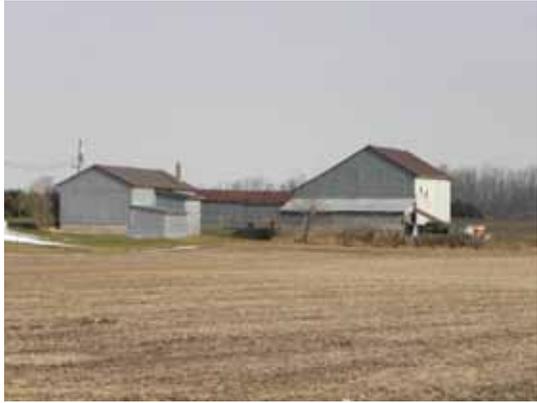
Site #77 – 703165 Sunshine Line (Municipality of South Huron)

Date: Various (19th and 20th century)

Description: Frame barn with metal roof, metal siding and undetermined foundation. Multiple additions including side shed addition, rear addition, and adjacent outbuilding.

Mitigation of Negative Impacts: No negative impacts identified, therefore no further mitigation recommended.

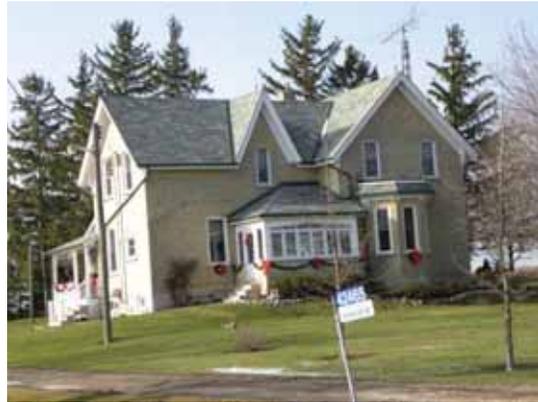
Site #78 – 42465 Plugtown Line (Municipality of South Huron)

Date: 1860s – 1890s

Description: One and one half storey side gabled house with projecting front dormer, steep roof pitch with steeply pitched central gable, yellow brick exterior and stone foundation. Asymmetrical in design with Vernacular Gothic Revival design characteristics including a front bay window with dentils and brackets, rounded window extending into the dormer and decorative brackets throughout. Inset covered front porch and rear addition.

Potential Direct and Indirect Impacts to the Heritage Attributes: None anticipated; see *Heritage Assessment Report* Section 6.1 for more information.

Mitigation of Negative Impacts: No negative impacts identified, therefore no further mitigation recommended.

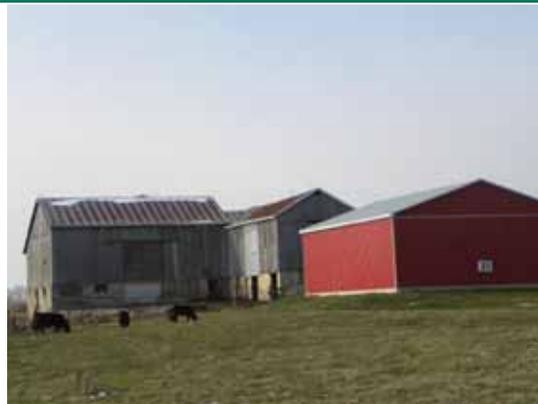
Date: Various (19th and 20th century)

Description: Two frame barns with metal roof, timber siding and a mixture of stone, concrete block and brick foundations. Modern barn adjacent.

Mitigation of Negative Impacts: No negative impacts identified, therefore no further mitigation recommended.

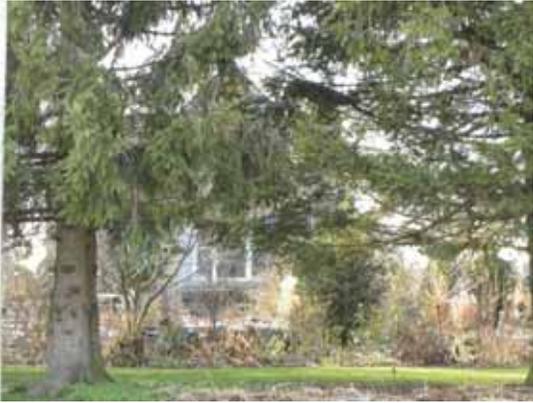
Site #79 – 70456 Plugtown Line (Municipality of South Huron)

Date: Undetermined

Description: One and one half storey brick house. Extensive foliage restricts further identification.

Mitigation of Negative Impacts: No negative impacts identified, therefore no further mitigation recommended.

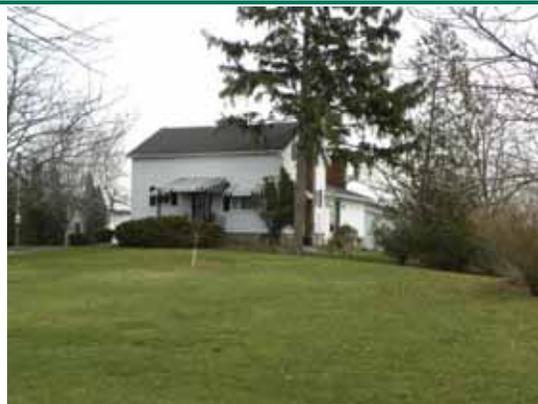
Site #80 – 70136 Parr Line (Municipality of South Huron)

Date: 19th century

Description: One and one half storey side gabled house with medium roof pitch clad in modern siding on a stone foundation. Central entry porch and rear addition.

Mitigation of Negative Impacts: Impacts were not identified, therefore mitigation is not recommended or necessary.
