Goshen Wind, Inc.

Goshen Wind Energy Centre Heritage Assessment Addendum

September 4, 2013

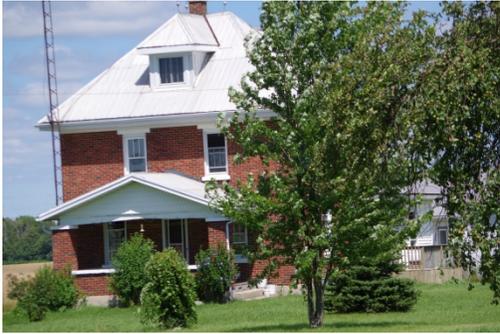
Addendum Site #1: 70122A Parr Line, Municipality of Bluewater

Date: Early 20th Century

Description: A 2 ½-storey red brick steeply pitched hipped steel roof structure with a hipped roofed dormer window on an undermined foundation. A central red brick chimney and covered front red brick porch accent the house.

Heritage Attributes: A 2 ½-storey red brick house is representative of the brick, steeply sloped hip roof with hip roofed dormer.

Design or Physical Value: Representative of a typical early 20th century red brick hipped roof and dormer house

Heritage Attributes Potential Direct or Indirect Impact: None anticipated.

Proposed Mitigation of Negative Impacts: No direct or indirect impacts identified, therefore no further mitigation is recommended.

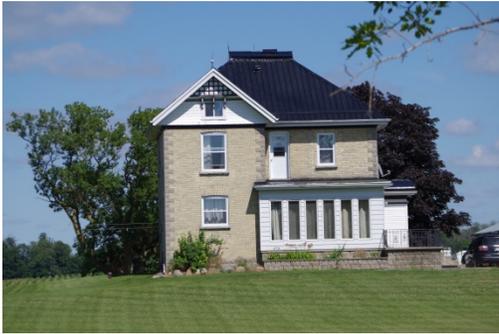
Addendum Site #2: 70016 Hern Line, Woodham, Ontario

Date: 1890s – 1920s

Description: A yellow brick 2-storey hipped roof house structure on top of a concrete block foundation, with an enclosed front porch. The vernacular is identified as that of Queen Anne design, based on the hipped roof, asymmetrical design, front gable and ornate quoins.

Heritage Attributes: A yellow brick 2-storey L-plan structure with a hipped roof and gabled front dormer.

Design or Physical Value: Representative of a typical Late 19th to Early 20th century brick L-shaped hipped structure with a single gabled dormer.

Heritage Attributes Potential Direct or Indirect Impact: None anticipated.

Proposed Mitigation of Negative Impacts: No direct or indirect impacts identified, therefore no further mitigation is recommended.

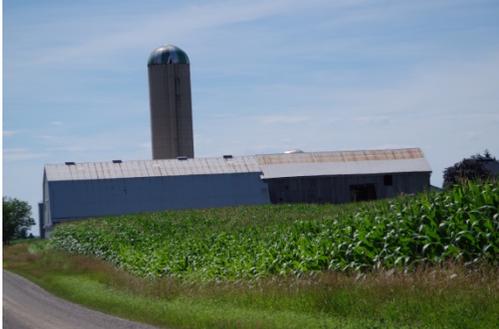
Date: 19th - 20th Century

Description: A timber framed, metal roof Bank Barn with a stone foundation on the north (right) and a more recent hipped metal roof barn with a stone foundation to the south (left), adjacent to a concrete silo.

Heritage Attributes: Timber framed Bank Barn with the attached hipped roof barn.

Design or Physical Value: Representative of a 19th timber frame bank barn and a 20th century timber frame hip roof barn, typical of the Study Area.

Heritage Attributes Potential Direct or Indirect Impact: None anticipated.

Proposed Mitigation of Negative Impacts: No direct or indirect impacts identified, therefore no further mitigation is recommended.

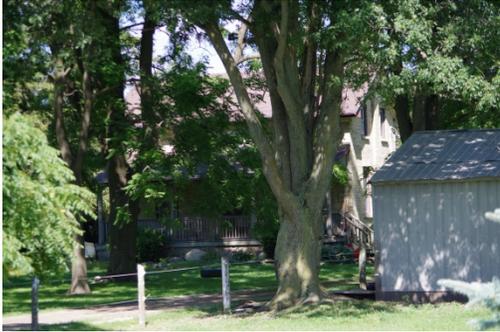
Addendum Site #3: 69976 Sunshine Line, Woodham, Ontario

Date: 19th Century

Description: A 1 ½ -storey yellow brick symmetrical house structure with a central doorway. The front porch extends across the entire front of the house.

Heritage Attributes: A symmetrical 1 ½ -storey brick house with covered front porch.

Design or Physical Value: Representative of a typical 19th century symmetrical brick house structure.

Heritage Attributes Potential Direct or Indirect Impact: None anticipated.

Proposed Mitigation of Negative Impacts: No direct or indirect impacts identified, therefore no further mitigation is recommended.

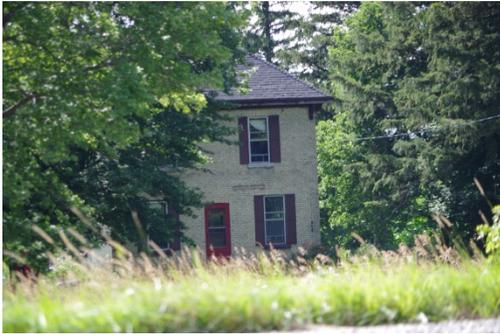
Addendum Site #4: 42489 Plugtown Line, Kirkton, Ontario

Date: 1890s – 1920s

Description: A 2-storey yellow brick hipped roof house on a stone foundation. A symmetrical hipped roof house. A symmetrical façade with fixed shutters.

Heritage Attributes: A 2-storey brick symmetrical hip roofed structure.

Design or Physical Value: Representative of a typical Late 19th to Early 20th century symmetrical hipped roof house.

Heritage Attributes Potential Direct or Indirect Impact: None anticipated.

Proposed Mitigation of Negative Impacts: No direct or indirect impacts identified, therefore no further mitigation is recommended.

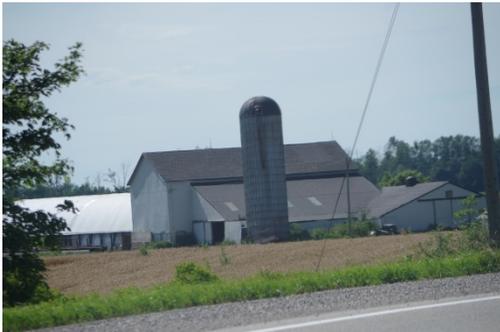
Date: 19th - 20th Century

Description: A 2-storey timber framed, metal roof, raised 3-bay barn with additions to the front with a sloped roof enclosed wooden drive shed with a metal roof. To the northwest of the drive shed is a wood framed, metal roof shed. At the rear, a 1-storey barn is attached.

Heritage Attributes: Timber framed 3-bay barn construction that compliments the vernacular rural landscape and adjacent house structure.

Design or Physical Value: Representative of a 19th - 20th century timber frame barn, typical of the Study Area, but becoming a rarity in southwestern Ontario.

Heritage Attributes Potential Direct or Indirect Impact: None anticipated.

Proposed Mitigation of Negative Impacts: No direct or indirect impacts identified, therefore no further mitigation is recommended.

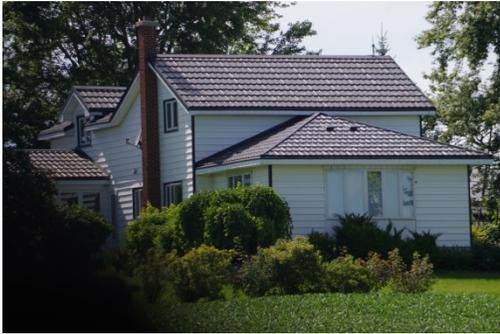
Addendum Site #5: 42433 Plugtown Line, Kirkton, Ontario

Date: Early 20th Century

Description: A 1 ½ -storey sided house structure that is asymmetrical in general appearance. An addition was added to the front of the house as a single storey room and an addition to the south (left). A single brick chimney runs up the exterior south wall of the original house structure.

Heritage Attributes: A sided asymmetrical house structure.

Design or Physical Value: Representative of a 20th century asymmetrical sided house structure.

Heritage Attributes Potential Direct or Indirect Impact: None anticipated.

Proposed Mitigation of Negative Impacts: No direct or indirect impacts identified, therefore no further mitigation is recommended.

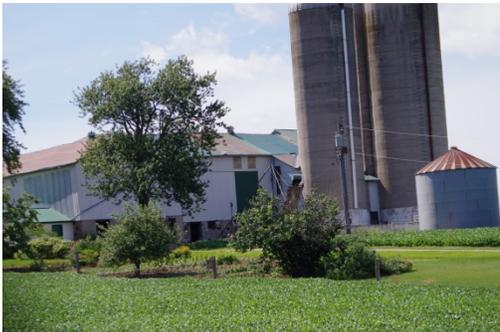
Date: 19th - 20th Century

Description: A timber framed, metal roof and siding, raised 3-bay barn with field stone foundation

Heritage Attributes: Timber framed 3-bay barn construction that compliments the vernacular rural landscape.

Design or Physical Value: Representative of a 19th - 20th century timber frame barn, typical of the Study Area, but becoming a rarity in southwestern Ontario.

Heritage Attributes Potential Direct or Indirect Impact: None anticipated.

Proposed Mitigation of Negative Impacts: No direct or indirect impacts identified, therefore no further mitigation is recommended.

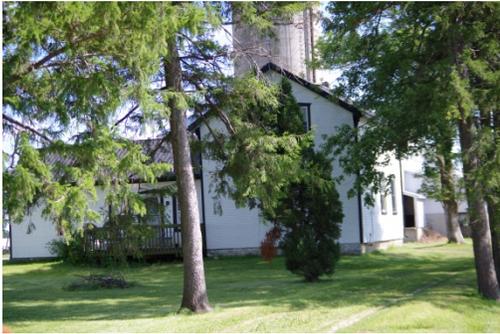
Addendum Site #6: 42477 Dump Road, Kirkton, Ontario

Date: 19th Century

Description: A 1 ½ -storey sided L-shaped house with a front porch and cinder block foundation.

Heritage Attributes: A 1 ½ -storey L-plan sided house structure.

Design or Physical Value: Representative of a typical 19th century L-shaped sided house structure.

Heritage Attributes Potential Direct or Indirect Impact: None anticipated.

Proposed Mitigation of Negative Impacts: No direct or indirect impacts identified, therefore no further mitigation is recommended.

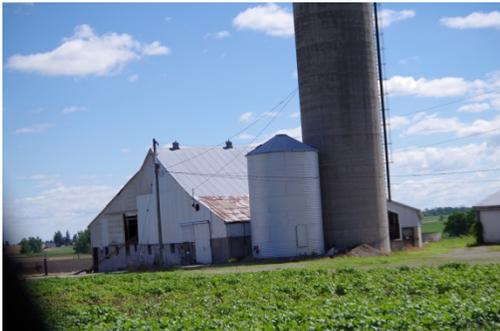
Date: Late 19th - 20th Century

Description: A timber framed, metal roof barn with a concrete and metal silos adjacent.

Heritage Attributes: Timber framed barn construction that compliments the vernacular rural landscape of Centennial Road.

Design or Physical Value: Representative of a Late 19th - 20th century timber frame barn.

Heritage Attributes Potential Direct or Indirect Impact: None anticipated.

Proposed Mitigation of Negative Impacts: No direct or indirect impacts identified, therefore no further mitigation is recommended.
