APPENDIX A
CULTURAL STRUCTURES LOCATED ON OPTIONAL PROPERTIES WITH
PROPOSED TURBINE RELATED ACTIVITIES

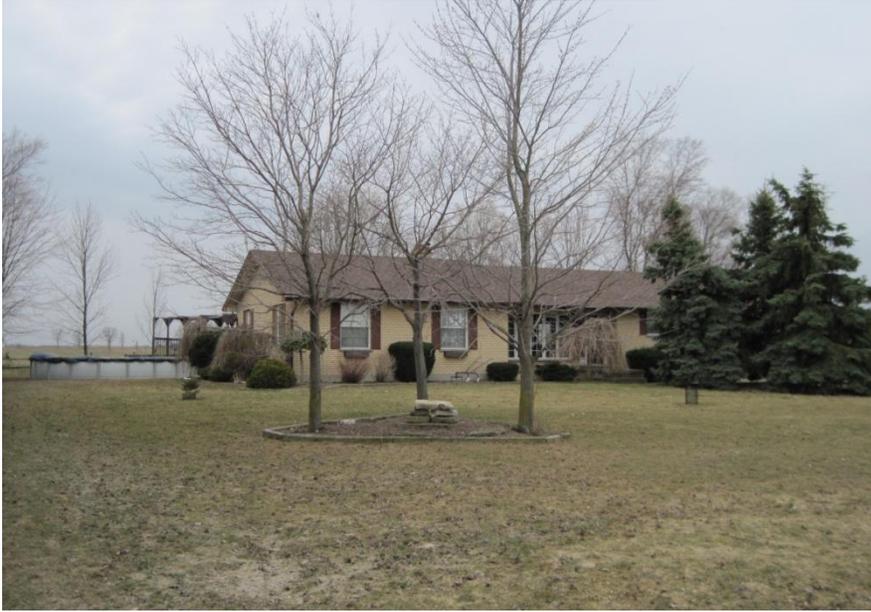
Site #8

Date: 1960s

Description: one storey Ranch style, gable-roof, brick-siding

- 1. Design/Physical Value: Typical design of 1960s**
- 2. Historical Value: None noted**
- 3. Contextual Value: None noted**

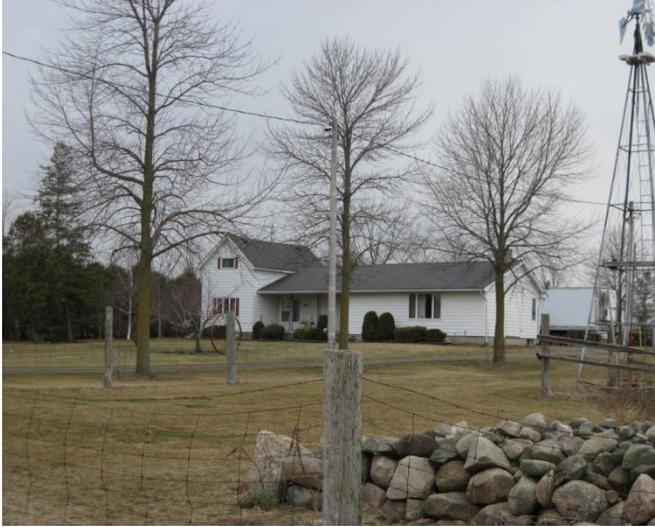
HOUSE

Date: c. 1900 ?

Description: Possible one and a half storey, medium pitch gable end roof; frame house, modern one storey addition

1. Design/Physical Value: Heavily modified
2. Historical Value: None identified
3. Contextual Value: Contributes to early 20th century agricultural activity of study area

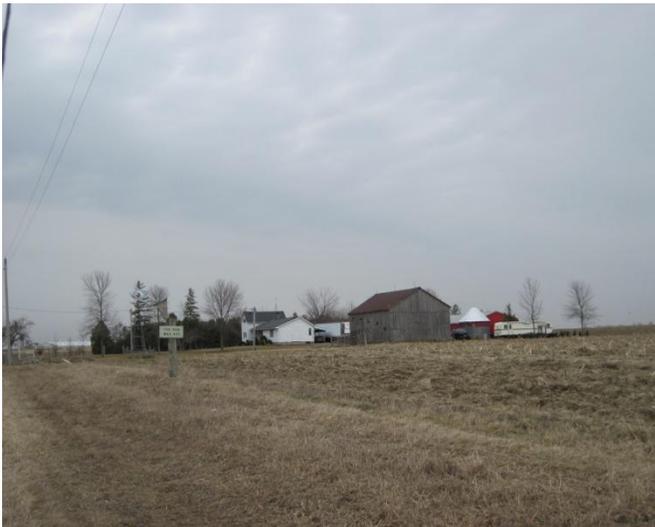
BARN

Date: late 19th century/ early 20th century

Description: medium pitch roof; timber frame

1. Design/Physical Value: Once popular style of barn. Many still standing in the area.
2. Historical Value: None identified
3. Contextual Value: Contributes to early 20th century agricultural activity of study area

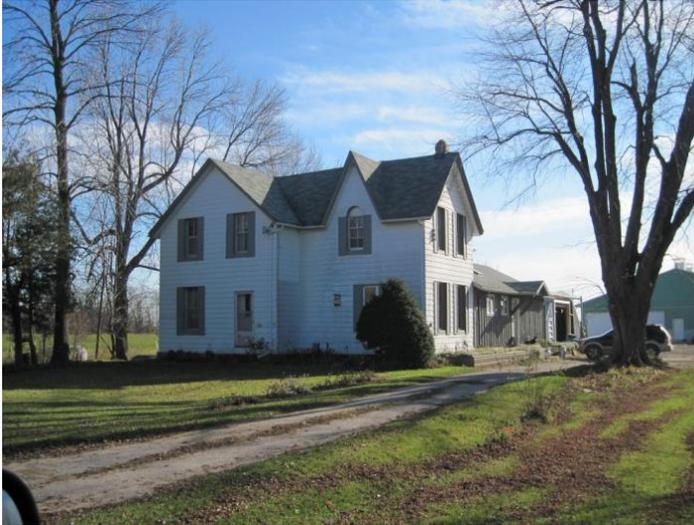
Site #10

Date: c. 1890-1900?

Description: One and a half storey, "L" plan frame; medium pitch roof; steep pitch dormer possibly modern

1. Design/Physical Value: Large example of farm house
2. Historical Value: None identified
3. Contextual Value: Modern farm buildings

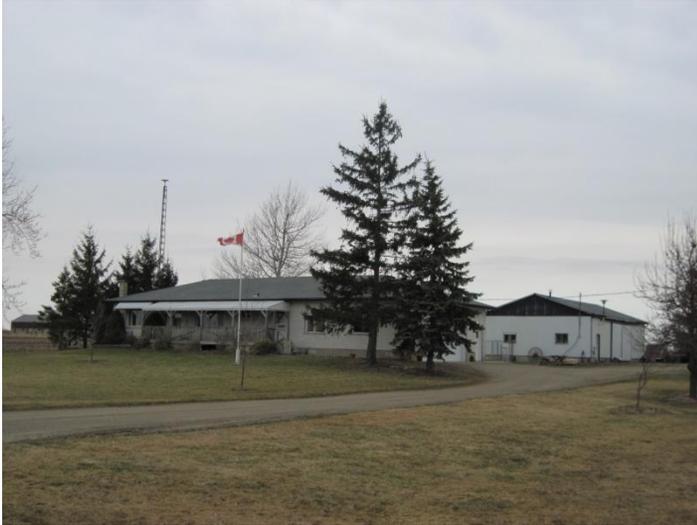
Site #11

Date: c. 1960s

Description: One and storey Ranch style, hip-roof, brick-siding

1. Design/Physical Value: Typical design of 1960s
2. Historical Value: None noted
3. Contextual Value: None noted

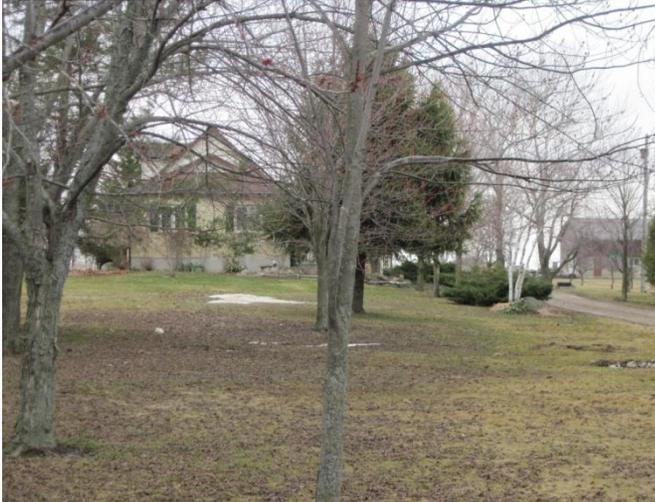
HOUSE

Date: Mid 20th century

Description: Possible one storey brick, steep pitch roof with one storey brick hip roof addition on front.

1. Design/Physical Value: Not visible
2. Historical Value: None identified
3. Contextual Value: Contributes to early 20th century agricultural activity of study area.

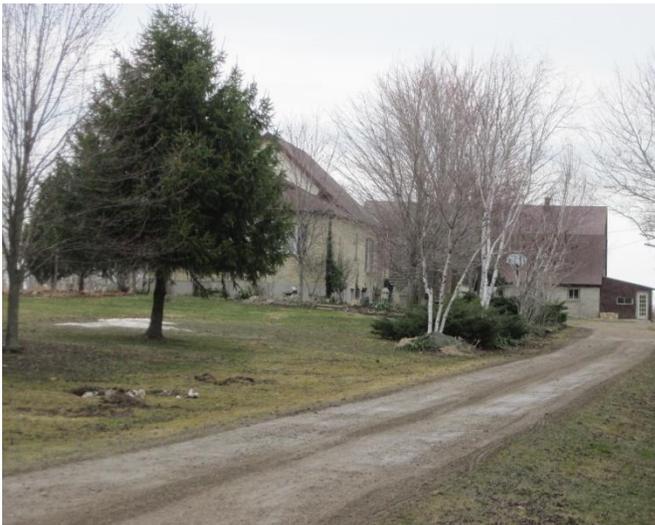
BARN

Date: Mid 20th century

Description: Gambrel roof, concrete walls

1. Design/Physical Value: Once popular style of barn. Many still standing in the area.
2. Historical Value: None identified
3. Contextual Value: Contributes to early 20th century agricultural activity of study area.

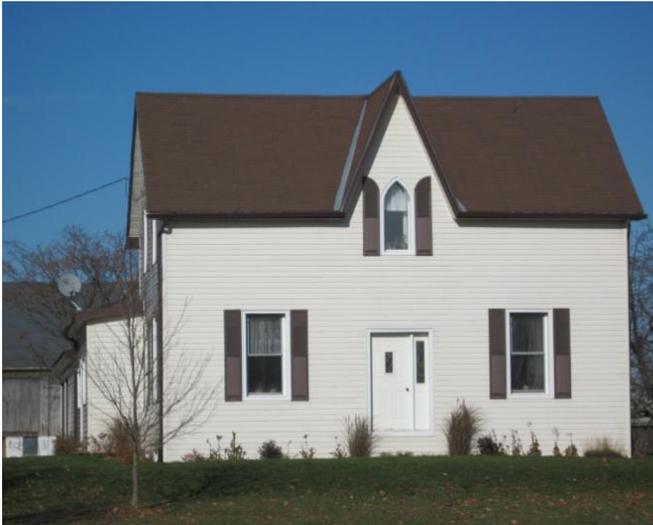
HOUSE

Date: Late 19th century

Description: Vernacular, one and a half storey frame with elements of Gothic revival style; steep pitch gable end roof; symmetrical main façade but original porch probably removed

1. Design/Physical Value: Well maintained house despite modifications.
2. Historical Value: None identified
3. Contextual Value: Contributes to early 20th century agricultural activity of study area.

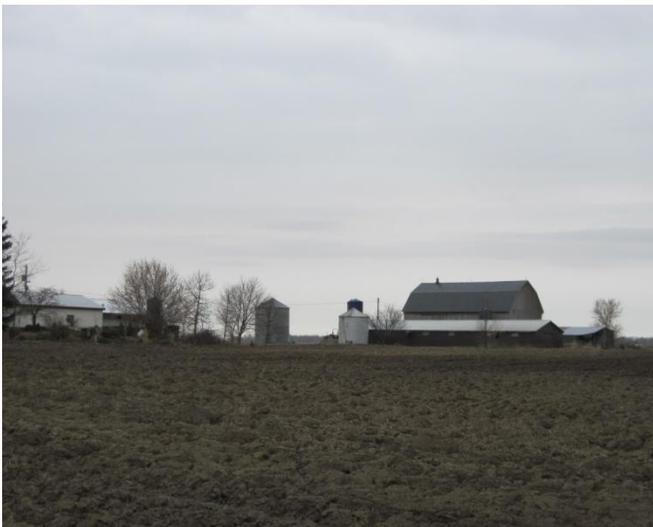
BARN

Date: Late 19th century early 20th century
Description: Gambrel roof

1. Design/Physical Value: Once popular style of barn. Many still standing in the area.
2. Historical Value: None identified
3. Contextual Value: Contributes to early 20th century agricultural activity of study area.

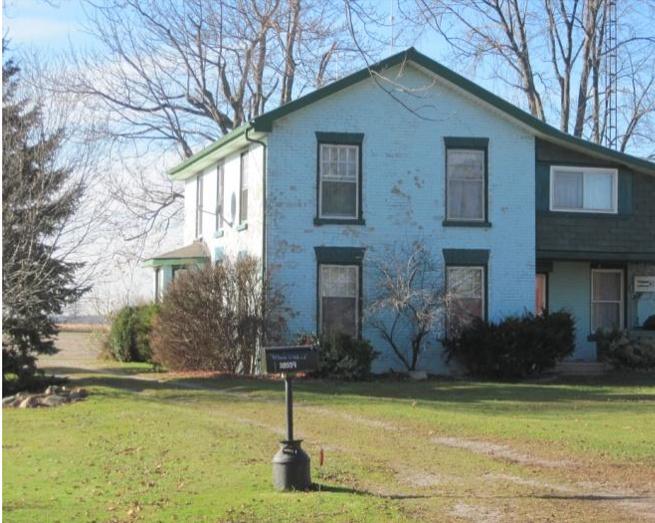
HOUSE

Date: mid-late 19th century

Description: Two storey painted brick; low pitch gable end roof, modern addition at rear

1. Design/Physical Value: Possibly an early house; heavily modified.
2. Historical Value: None identified
3. Contextual Value: Contributes to early 20th century agricultural activity of study area.

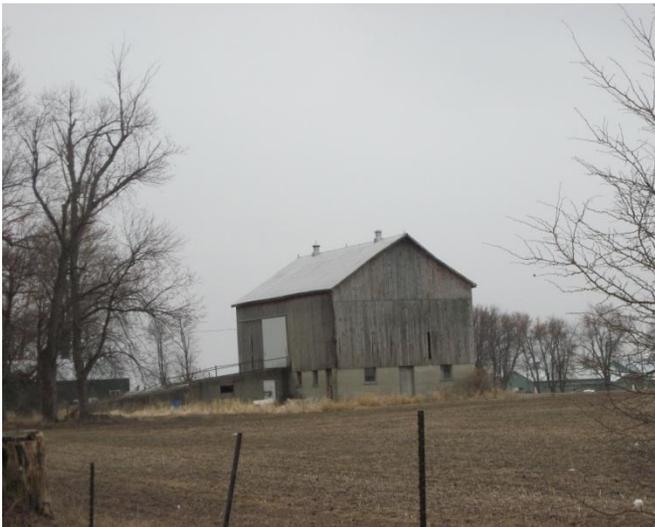
BARN

Date: mid-late 19th century

Description: Timber frame, rectangular, medium pitch metal clad roof

1. Design/Physical Value: Once popular style of barn. Many still standing in the area.
2. Historical Value: None identified
3. Contextual Value: Contributes to early 20th century agricultural activity of study area.

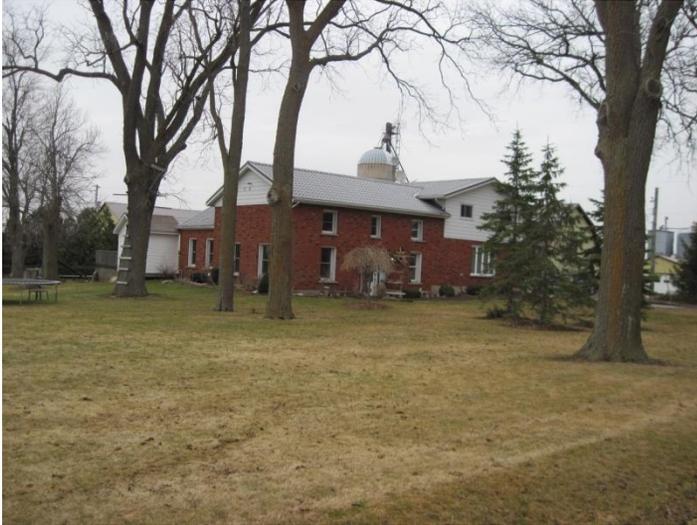
Site #15

Date: c. 1960's-1970's

Description: Split level, hip roof Ranch style, brick siding

- 1. Design/Physical Value: Typical design of 1960s**
- 2. Historical Value: None noted**
- 3. Contextual Value: None noted**

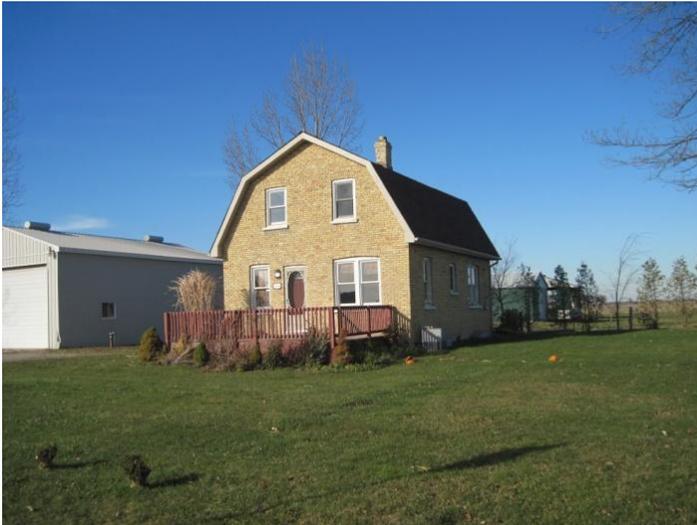
Site #16

Date: c. 1920's

Description: One and a half storey brick, gambrel roof

1. Design/Physical Value: Relatively uncommon style in the area.
2. Historical Value: None identified
3. Contextual Value: Contributes to early 20th century agricultural activity of study area.

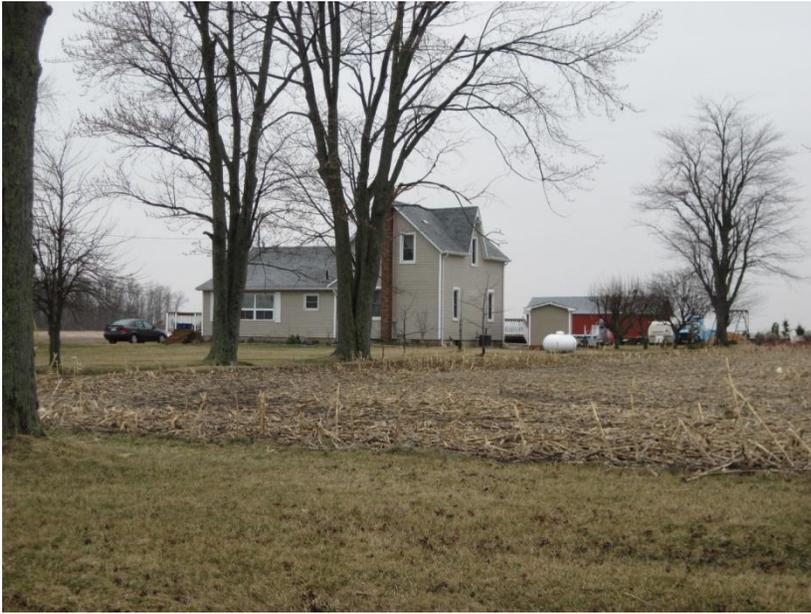
Site #17

Date: c. 1900 ? ; modern addition

Description: Possible one and a half storey, medium pitch gable end roof; frame house, modern one storey addition

1. Design/Physical Value: Heavily modified
2. Historical Value: None identified
3. Contextual Value: Contributes to early 20th century agricultural activity of study area.

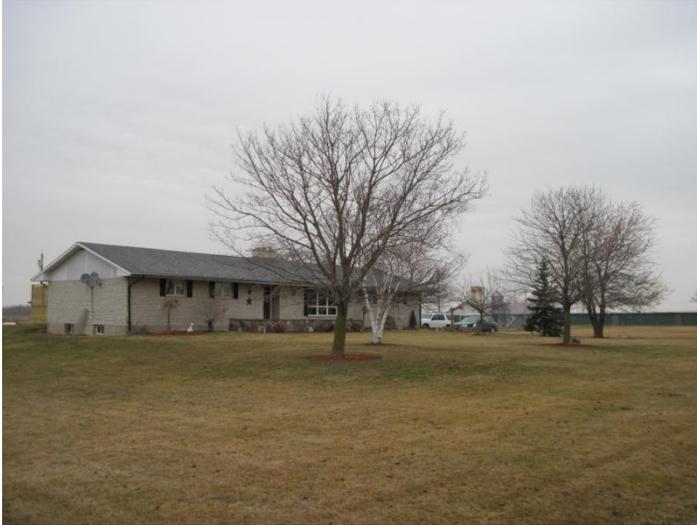
Site #18

Date: c. 1960s

Description: One storey Ranch style, gable-roof, brick-siding

1. Design/Physical Value: Typical design of the 1960's
2. Historical Value: None noted
3. Contextual Value: None noted

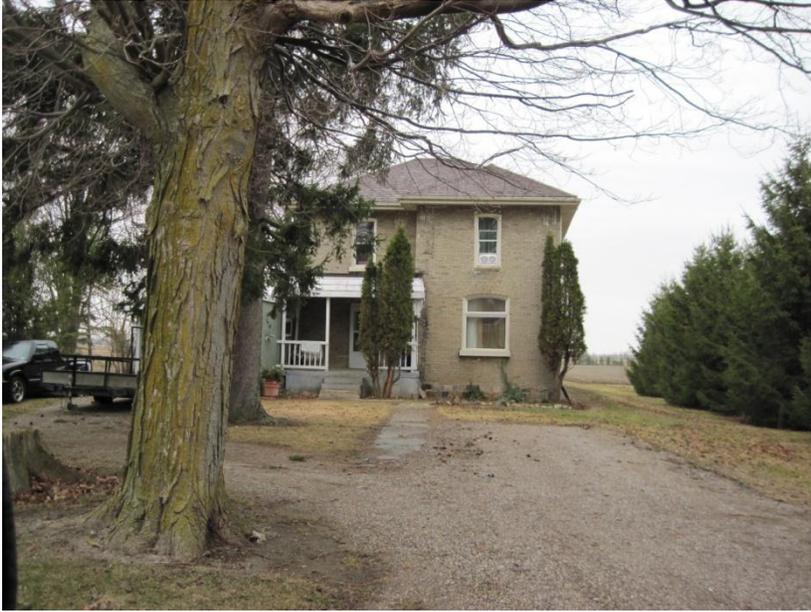
Site #19

Date: c. 1880's-1900

Description: Two storey brick; "L" plan; shallow pitch hipped roof porch on main façade

1. Design/Physical Value: Large house; good condition
2. Historical Value: None identified
3. Contextual Value: Contributes to early 20th century agricultural activity of study area

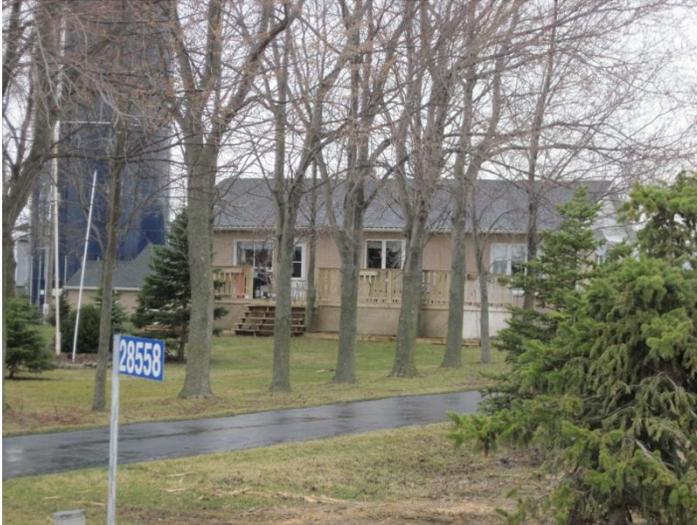
Site #20

Date: 1960's-1970's

Description: One storey Ranch style, gable-roof, brick-siding

1. Design/Physical Value: Typical design of 1960s
2. Historical Value: None noted
3. Contextual Value: None noted

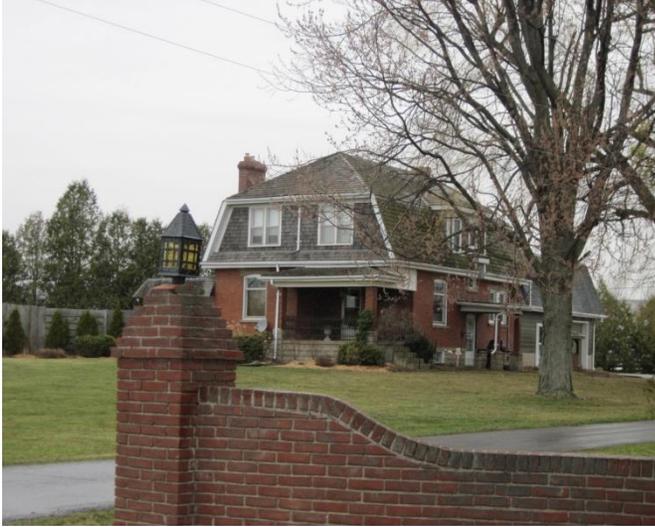
HOUSE

Date: 1920's-1930's

Description: red brick, one and a half storey, hipped gambrel roof with side dormer, porch on end wall

1. Design/Physical Value: Unusual roof design
2. Historical Value: None identified
3. Contextual Value: Contributes to early 20th century agricultural activity of study area

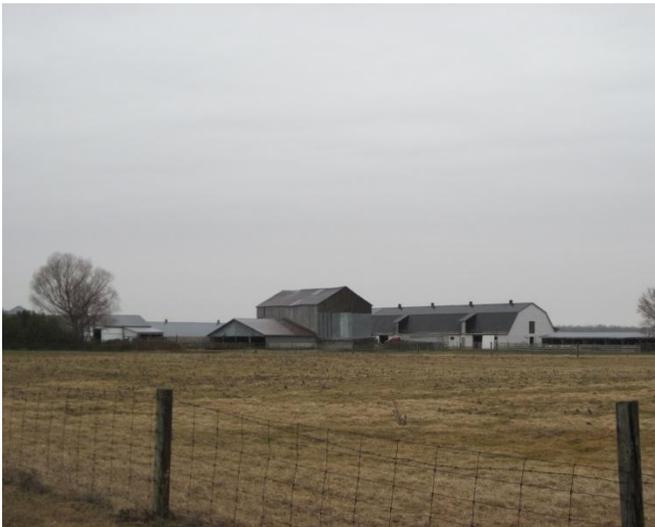
BARN

Description: timber frame; medium pitch metal clad roof

4. Design/Physical Value: Once popular style of barn. Many still standing in the area
5. Historical Value: None identified
6. Contextual Value: Contributes to early 20th century agricultural activity of study area

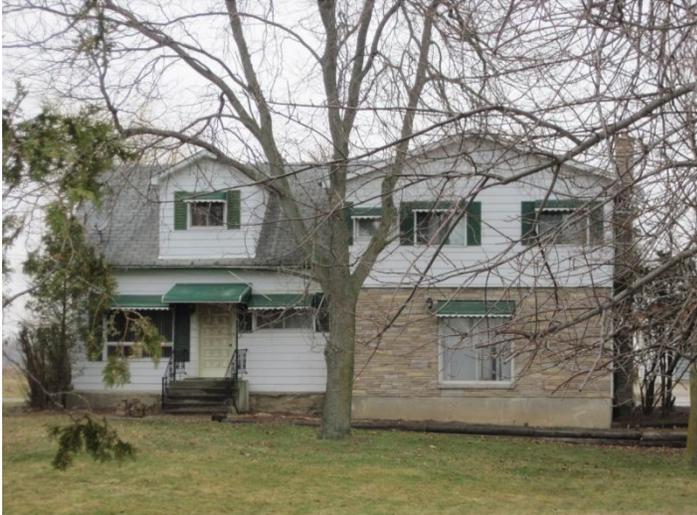
Site #22

Date: c. 1920's ? modern addition

Description: One and a half storey house, steep pitch roof; modern two storey addition

1. Design/Physical Value: Heavily modified
2. Historical Value: None identified
3. Contextual Value: Contributes to early 20th century agricultural activity of study area

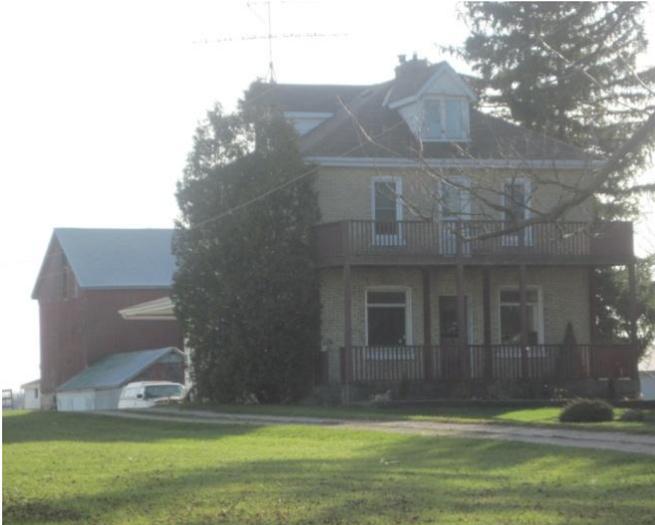
HOUSE

Date: c. 1890-1900

Description: Two storey brick; low pitch hip gable roof, modern two storey porch

1. Design/Physical Value: Large house; good condition
2. Historical Value: None identified
3. Contextual Value: Contributes to early 20th century agricultural activity of study area

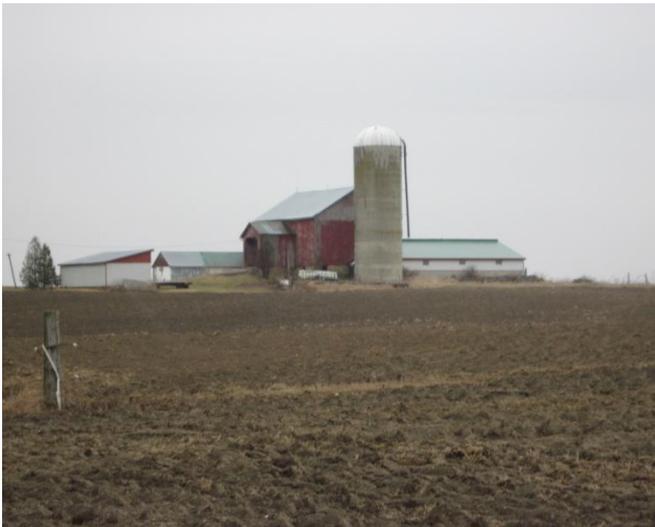
BARN

Date: late 19th /early 20th century

Description: Timber frame, medium pitch gable end roof; concrete silo

4. Design/Physical Value: Once popular style of barn. Many still standing in the area
5. Historical Value: None identified
6. Contextual Value: Contributes to early 20th century agricultural activity of study area

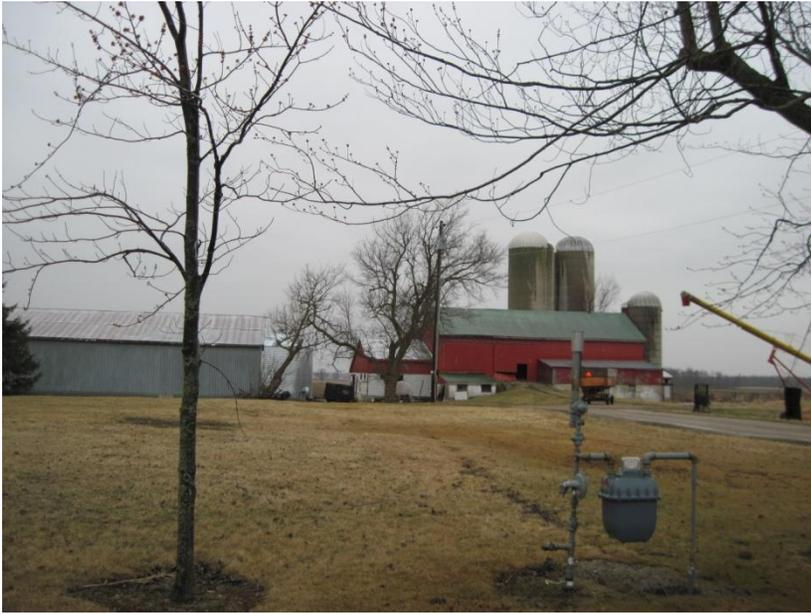
Site #24

Date: c.1900

Description: Timber frame, medium pitch gable end roof, concrete silos.

1. Design/Physical Value: Once popular style of barn. Many still standing in the area
2. Historical Value: None identified
3. Contextual Value: Contributes to early 20th century agricultural activity of study area

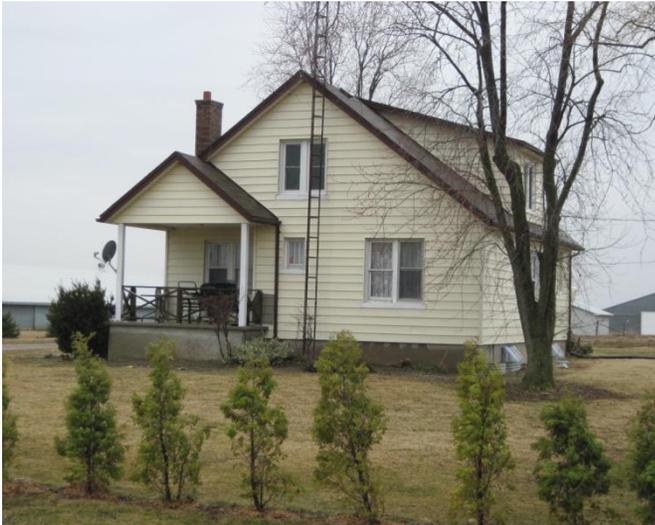
HOUSE

Date: c. 1920-1930

Description: One and a half storey; modern vinyl siding; medium pitch roof

1. Design/Physical Value: Heavily modified
2. Historical Value: None identified
3. Contextual Value: Contributes to early 20th century agricultural activity of study area

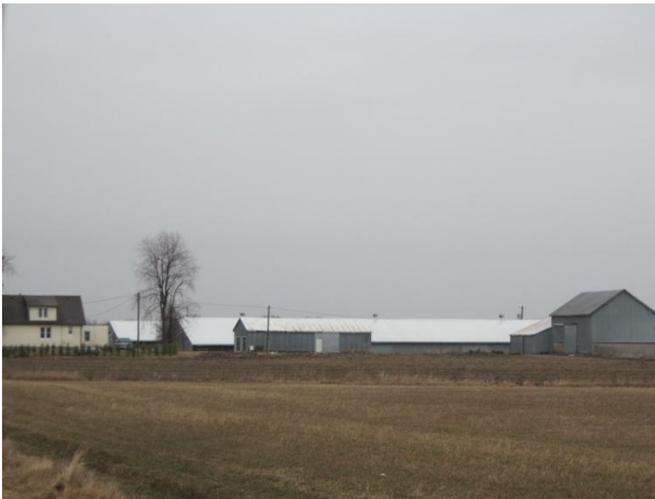
BARN

Date: late 19th /early 20th century

Description: Timber frame, medium pitch gable end roof

4. Design/Physical Value: Once popular style of barn. Many still standing in the area.
5. Historical Value: None identified
6. Contextual Value: Contributes to early 20th century agricultural activity of study area

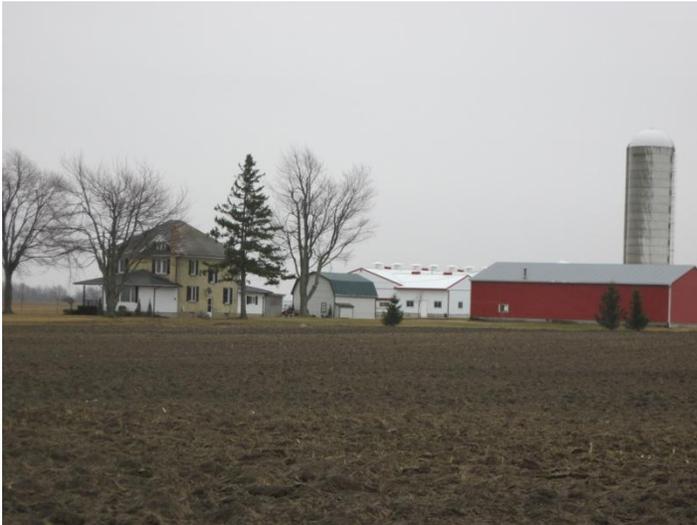
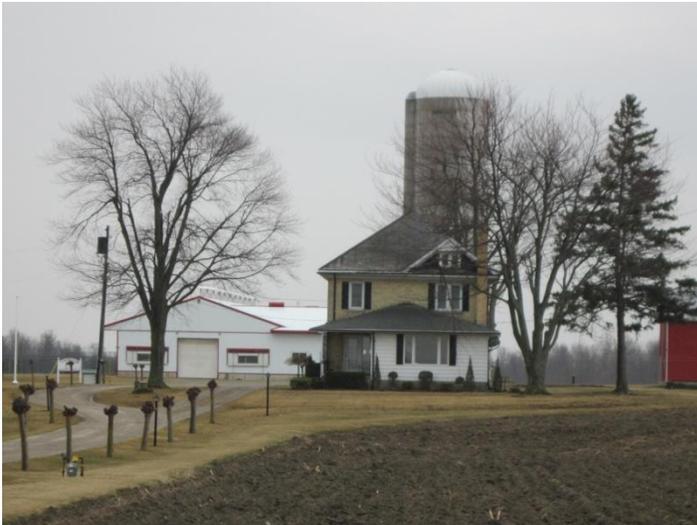
Site #26

Date: c. 1890-1910

Description: Two storey brick, steep pitch hip roof with Queen Anne style dormer on main façade; modern addition to ground floor main façade

1. Design/Physical Value: Large house; good condition
2. Historical Value: None identified
3. Contextual Value: Contributes to early 20th century agricultural activity of study area

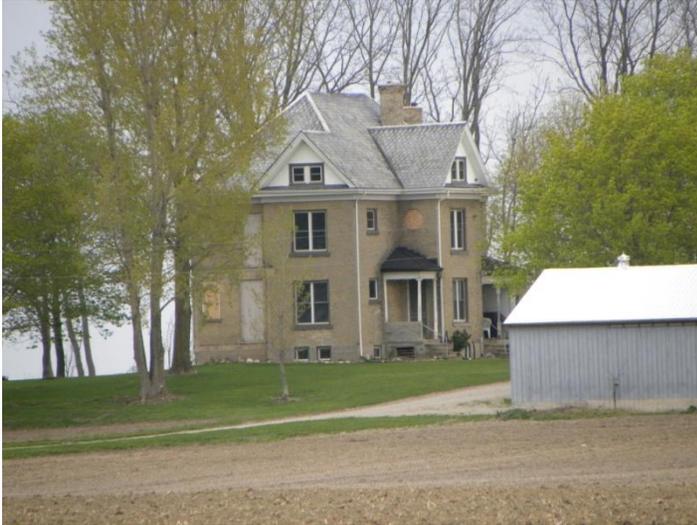
Site #27

Date: 1890s-1910

Description: Two and a half storey, brick, steeply pitched slate roof

1. Design/Physical Value: Large house
2. Historical Value: None identified
3. Contextual Value: Contributes to early 20th century agricultural activity of study area

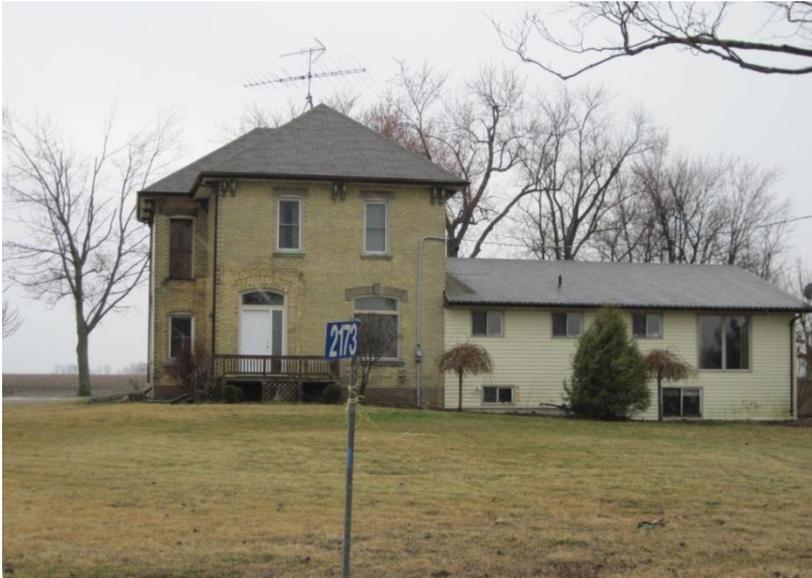
Site #28

Date: c. 1870's-1880's

Description: Similar to Site #1; paired brackets modern roof; large modern addition at rear

1. Design/Physical Value: Large house, in good condition; brackets are prominent; exterior largely unaltered except for removal of porches.
2. Historical Value: Indicative that original owner had been prosperous
3. Contextual Value: All farm buildings new

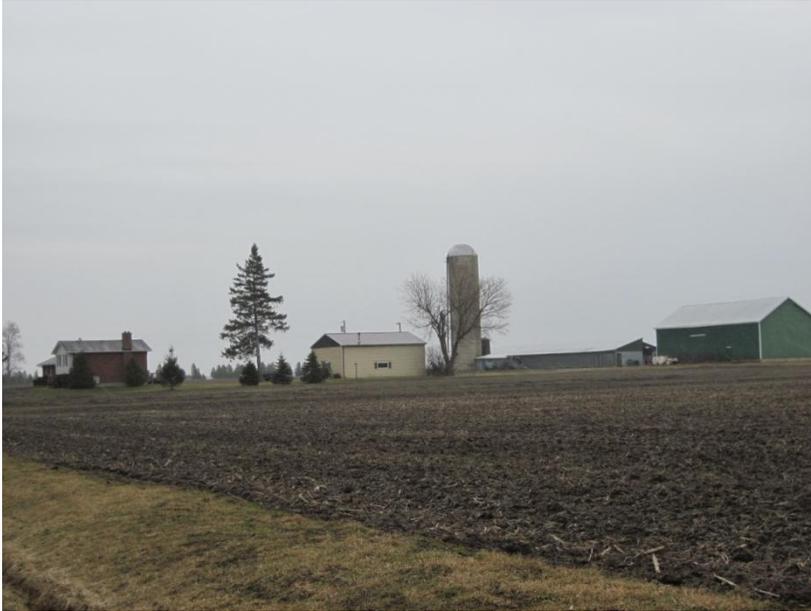
BARN (right side of photo)

Date: 1960's-1970's

Description: Similar gable roof, medium pitch

1. **Design/Physical Value:** Once popular style of barn. Many still standing in the area
2. **Historical Value:** None identified
3. **Contextual Value:** Contribute to early 20th century agriculture activity of study area

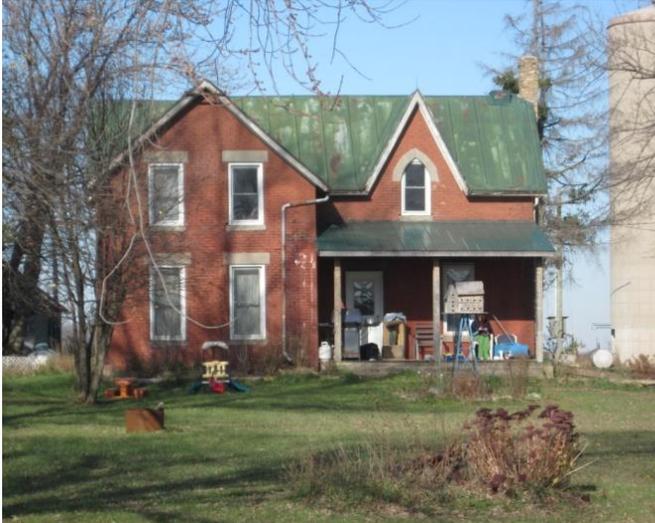
HOUSE

Date: c. 1860-1880's

Description: One and a half storey brick, "L" plan; medium pitch roof, gable end, porch on main

1. Design/Physical Value: Early use of red brick
2. Historical Value: None identified
3. Contextual Value: Contributes to early 20th century agricultural activity of study area

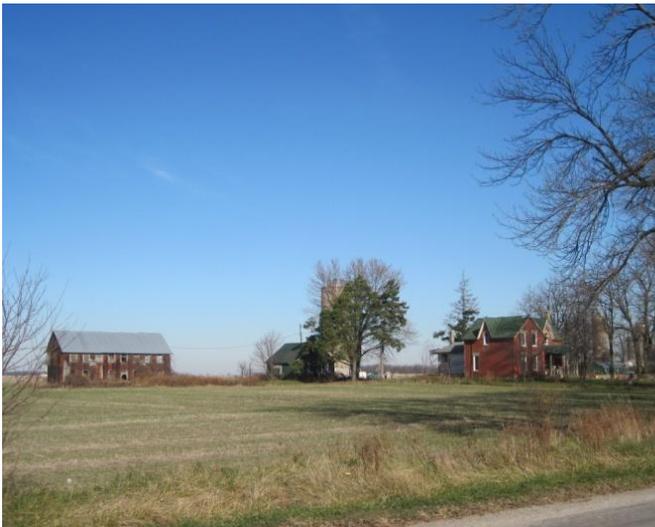
BARN

Date: early 20th century

Description: Small, two storey timber barn with multiple windows; possibly former poultry/pig barn

1. Design/Physical Value: Once popular style of barn. Many still standing in the area
2. Historical Value: Example of non-cattle barn noted in study area
3. Contextual Value: Contributes to early 20th century agricultural activity of study area

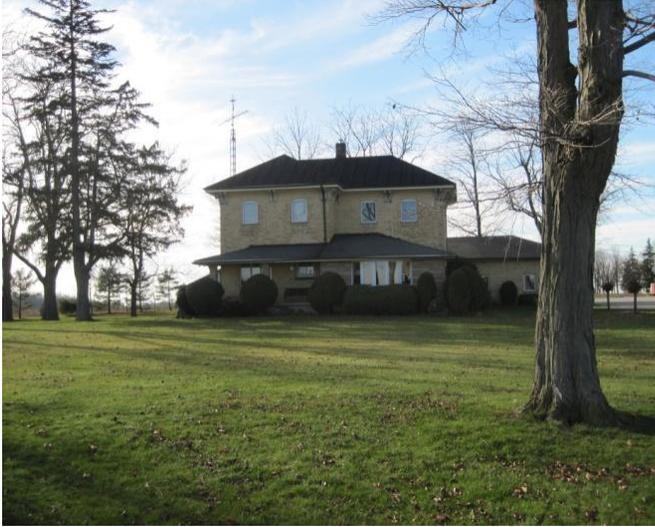
HOUSE

Date: c. 1870's-1880's
Description: Similar to Site #1; paired brackets modern roof; new porch

1. Design/Physical Value: Large house; good condition; brackets are prominent; exterior largely unaltered except for removal of porches
2. Historical Value: Indicative that original owner had been prosperous
3. Contextual Value: Contributes to early 20th century agricultural activity of study area

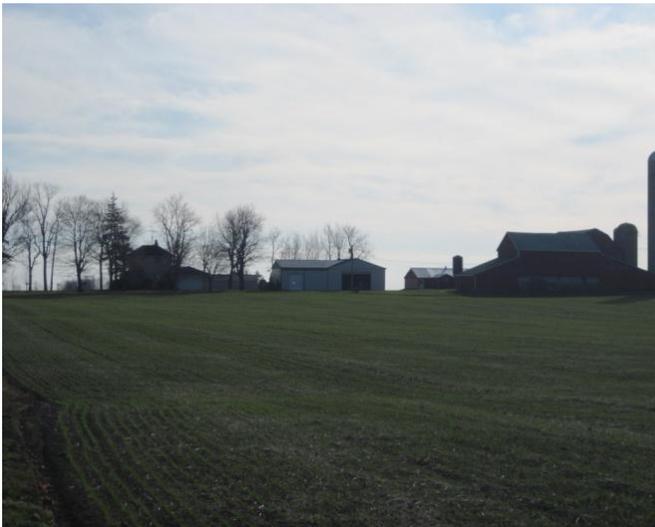
BARN

Date: late 19th /early 20th century
Description: Gambrel roof, frame barn with smaller gable roof barn

1. Design/Physical Value: Once popular style of barn. Many still standing in the area
2. Historical Value: None identified
3. Contextual Value: Contributes to early 20th century agricultural activity of study area
