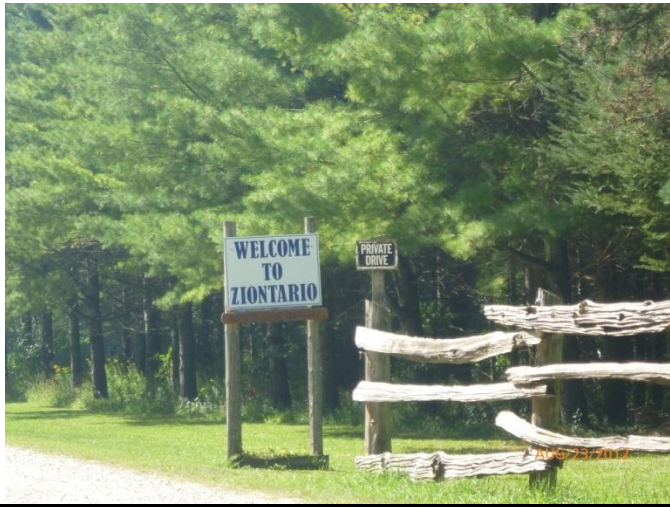
Description - Ziontario.ca campground, community of Christ camp, no photograph of house, but modern bungalow.	X
	Date Range – post 1972	Further Evaluation for Potential Cultural Heritage Value or Interest
	Status – non-participating	
BF#75 – 344511 North Line, Map #75		
No photo available	Description - not visible from roadway	X
	Date Range	Further Evaluation for Potential Cultural Heritage Value or Interest
	Status – non-participating

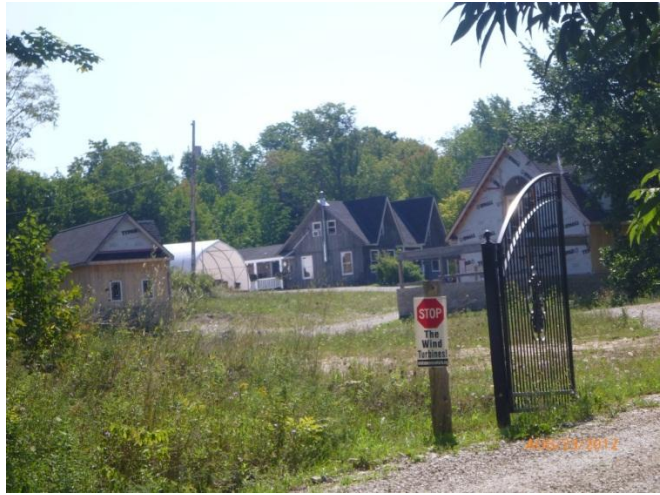
BF#77 – 344316 North Line, Map #77

Description - new construction, possibly board and batten siding

Date Range – post 1972

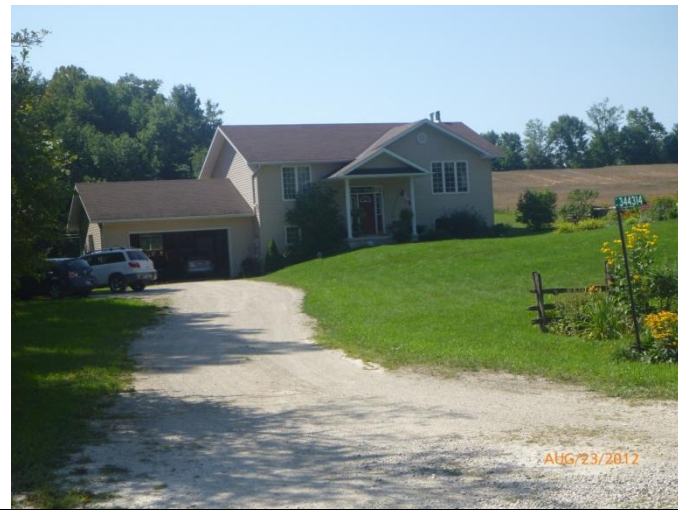
BF#78 – 344314 North Line, Map #78

Description - raised 2 storey bungalow, late 20th century, built into hillside, vinyl siding, attached 1 door garage

Date Range – post 1972

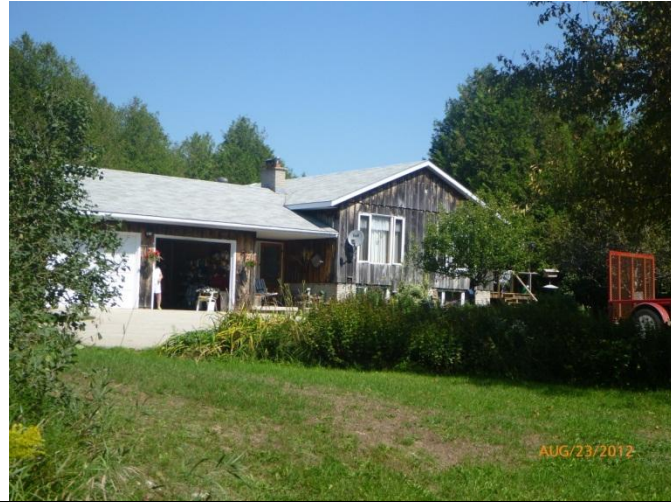
BF#79 – 344303 North Line, Map #79

Description - modern house with board and batten cladding, detached 2 car garage

Date Range – post 1972

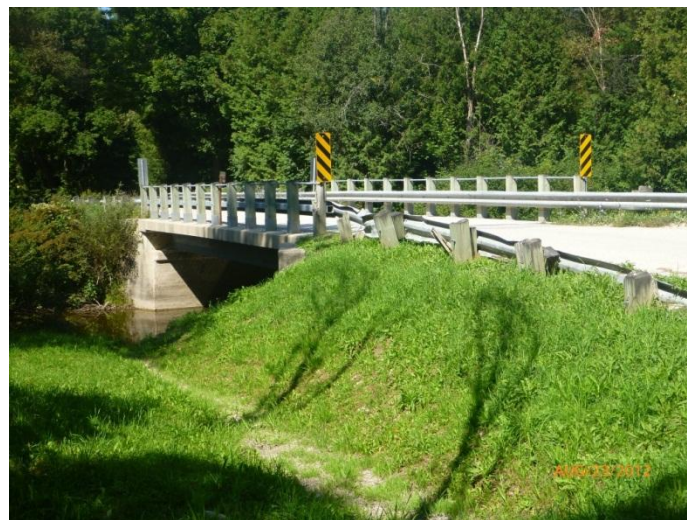
BF#81 – North Line Bridge, Map #81

Description - modern concrete bridge with wood bracing and steel guard rail

Date Range – post 1972

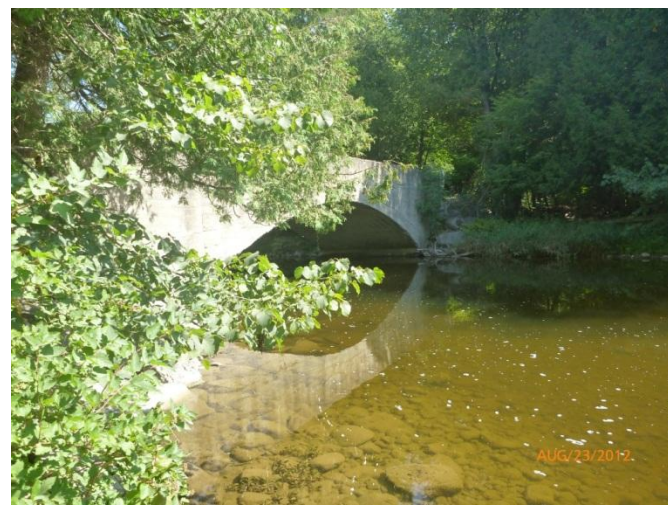
BF#82 – North Line Bridge, Map #82

Description - concrete arch construction over stream, reduced to single lane

Date Range – early to mid 20th century

Potential Cultural Heritage Value or Interest (O.Reg 9/06)
Design Value or Physical Value – Bridge is representative of engineering structures of late 19th / early 20th century.
Historical Value or Associative Value - none
Contextual Value – none

Heritage Attributes – graceful arch spanning the stream, concrete material, 1 lane (representative of an earlier era)
Potential Impacts – none
Mitigation Recommended – none required

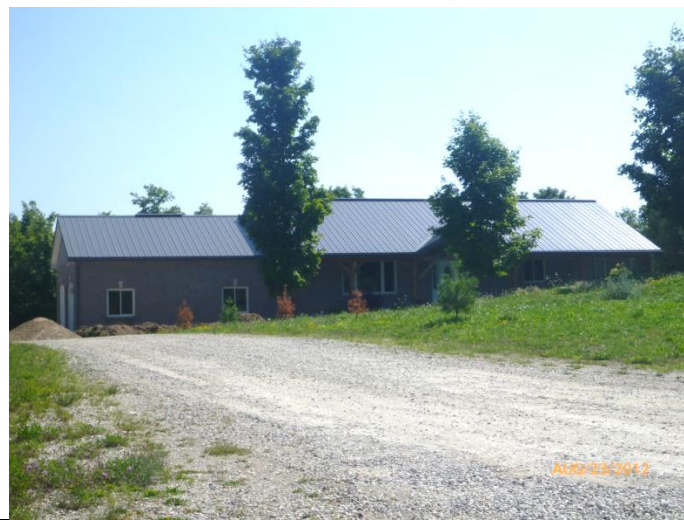
BF#83 –553707 Grey Road 23, Map #83

Description - modern single storey brick house with steel roof, and attached 2 car garage

Date Range – post 1972

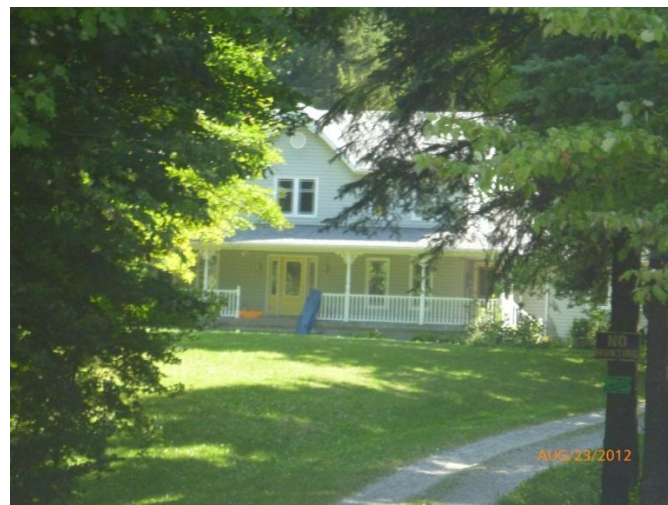
BF#84 – 553733 Grey Road 23, Map #84

Description - 2 storey house with vinyl siding, attached garage, detached shed, not well seen from roadway.

Date Range – mid-20th century

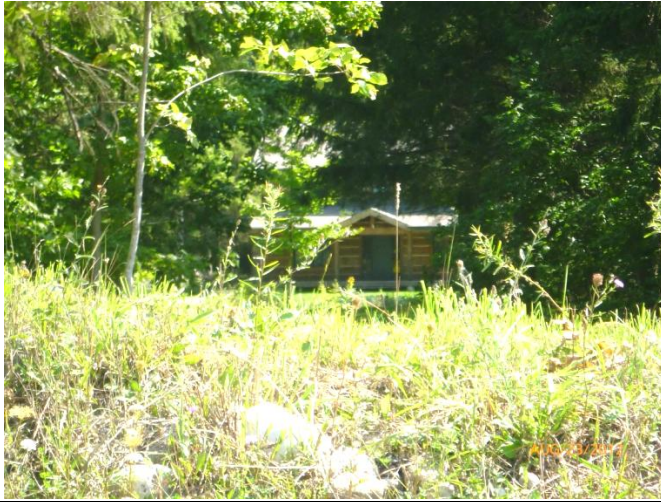
BF#85 – 553745 Grey Road 23, Map #85

Description - 2 storey modern log construction

Date Range – post 1972

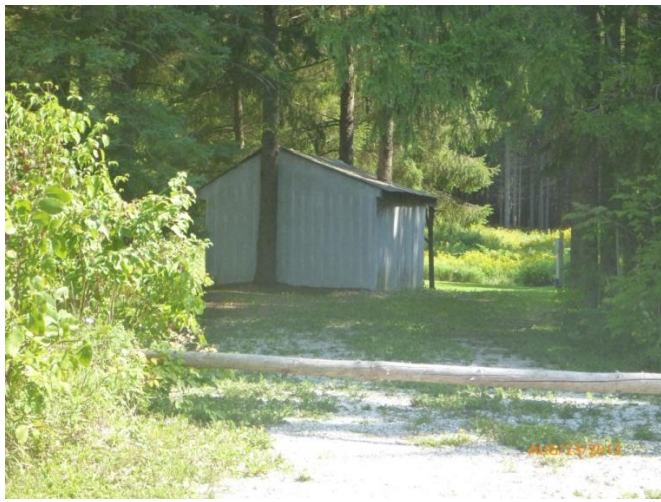
BF#86 – 553755 Grey Road 23, Map #86

Description - only a steel shed visible from roadway

Date Range – post 1972

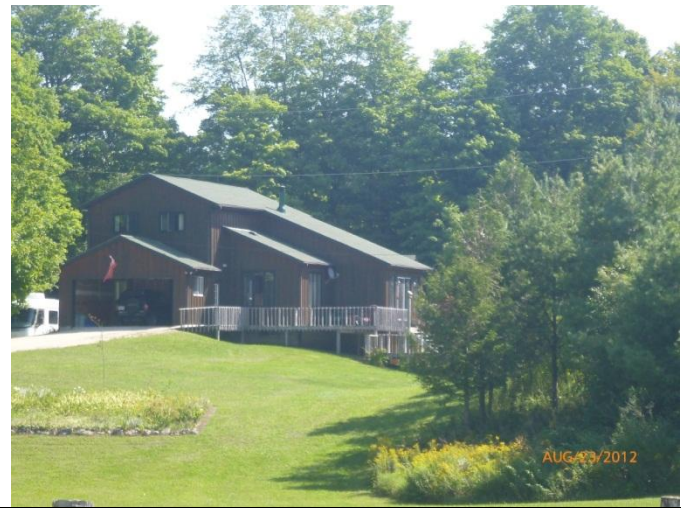
BF#88 – 553771 Grey Road 23, Map #88

<p>Description - split level house with board and batten, built into hillside, 2 car attached garage, late 20th c construction</p>	<p>X</p>
	<p>Date Range – post 1972</p>	<p>Further Evaluation for Potential Cultural Heritage Value or Interest</p>
	<p>Status – non-participating</p>

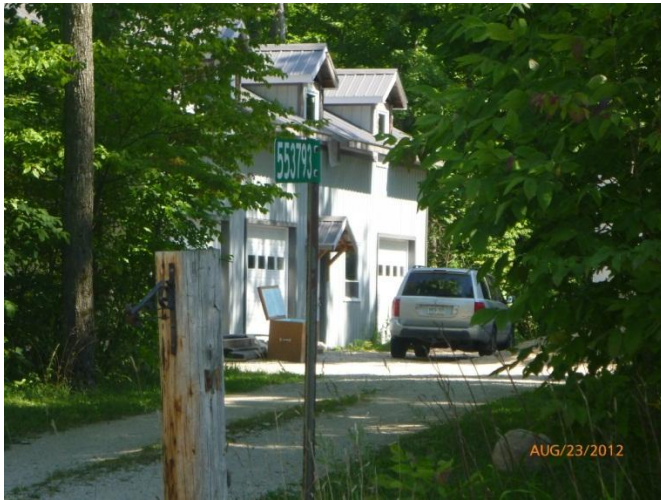
BF#89 – 553793 Grey Road 23, Map #89

Description - only part of house is visible from roadway, gabled, modern garage

Date Range – post 1972

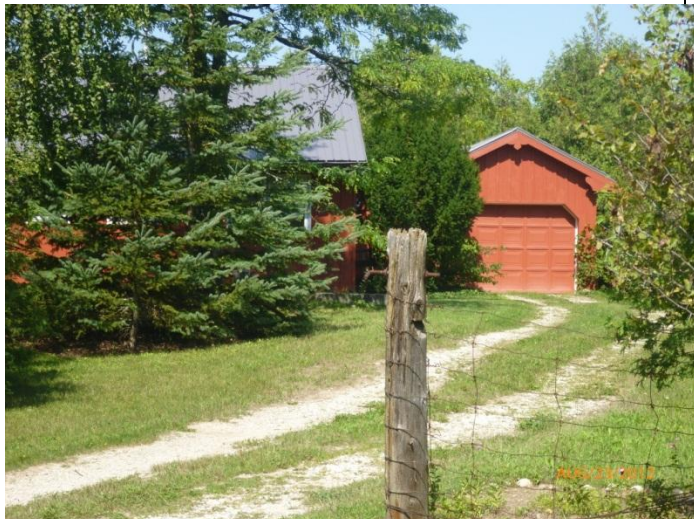
BF#92 – 344183 North Line, Map #92

<p>Description - modern garage and house, board and batten, not fully visible from roadway.</p>	<p>X</p>
	<p>Date Range – post 1972</p>	<p>Further Evaluation for Potential Cultural Heritage Value or Interest</p>
	<p>Status – non-participating</p>

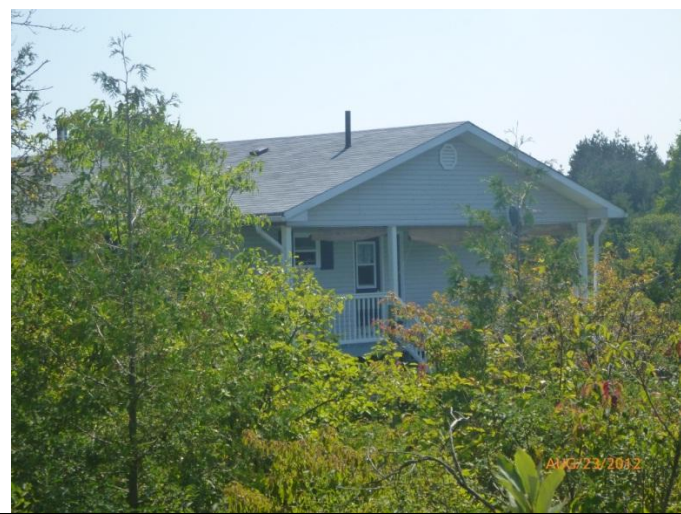
BF#93 – 344182 North Line, Map #93

Description - modern raised bungalow, vinyl clad

Date Range – post 1972
