### **3.0 SITE INVESTIGATION**

### 3.2 RESULTS OF SITE INVESTIGATION

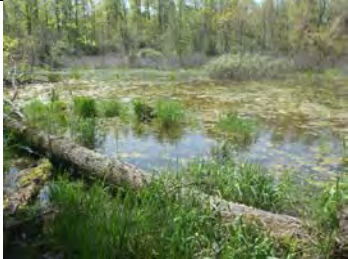
<p>ELC unit 120 (W23) – photo: May 15, 2012</p>

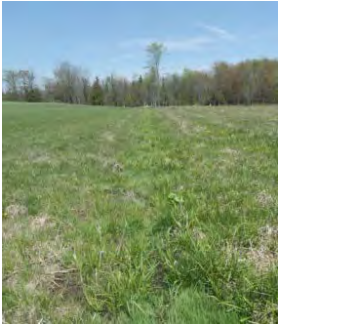
<p>W1 has been replaced with a straightened, grassed channel in agricultural field of tilled crop and pasture. Approximately 5cm of water was pooled in the channel on May 15, 2012. On following visits the channel was dry.</p>

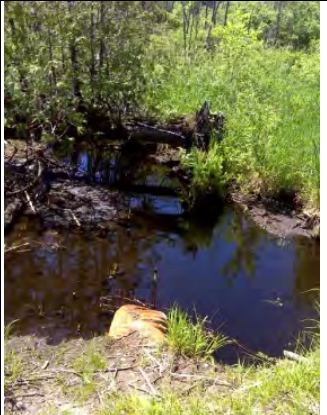
<p>W2 - Water pooling on upstream of Concession 4 Road at W2 (photo: June 14, 2012).</p>	<p>W1= not carried forward as a water body  <b>W2= permanent stream and seepage area</b>                  W23= not carried forward as a water body                  W29= not carried forward as a water body</p>

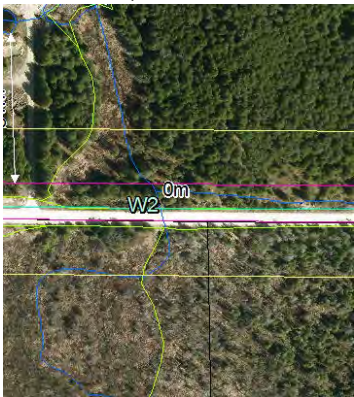
<p>W2 - 0m from underground collection line in existing road right of way.</p>	<p>Site investigation determined that W1 as it appeared on LIO mapping had been replaced with an artificially straightened, grassed channel through an active agricultural field between two low lying wetland features (ELC units 118 and 242). No flow was detected at the time of survey; approximately 5 cm of standing water was documented within the grassed channel in May 2012. Channel was dry on subsequent visits (June/July 2012).</p> <p>W23 was determined to be a significant wetland feature and was addressed as such in the NHA; W1 was determined to be a grassed channel under agricultural use, and at W29 although soils were documented as saturated, no standing or flowing water was observed during site investigation, such that W29 was determined to be a temporary drainage area during high flow events that was being used agriculturally as part of a tilled fields and as grazing pasture. W1, W23 and W29</p>		<p>Photo taken facing north from W1.</p>

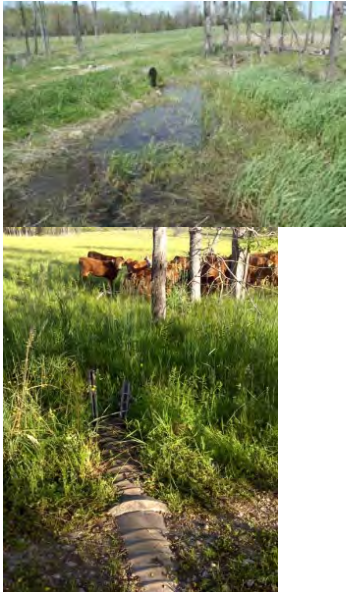
<p>Existing farm land crossing of W1 - water collecting in grassy vegetation on north west (downstream) side of existing farm lane crossing on May 15, 2012 (top); channel dry on July 5, 2012 (bottom).</p>

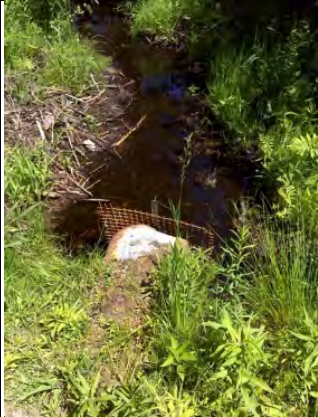
<p>W2 - Downstream side (North) of Concession 4 Road channel narrows and flows into a white cedar coniferous swamp (photo: June 14, 2012).</p>

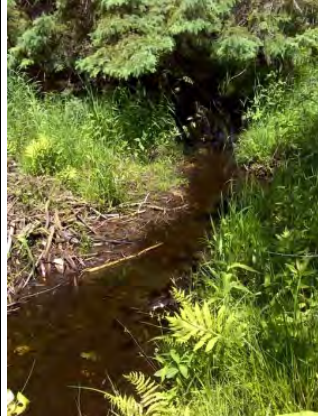
<p>W2 Channel narrows and becomes more defined downstream of Concession 4 Road (photo: June 14, 2012)</p>

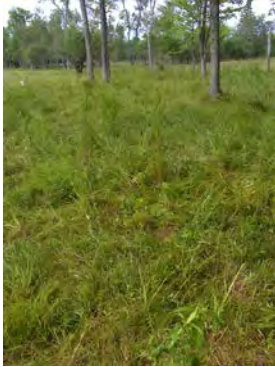
<p>W29 on July 5, 2012 – under agricultural use as pasture. Soils moist but no standing water.</p>

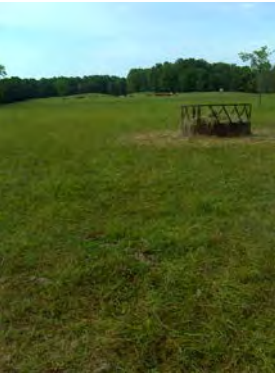
<p>Looking south from ELC unit 115 to W29 on July 5, 2012 – under agricultural use as pasture. Evidence of wet soils in spring, no open water feature.</p>

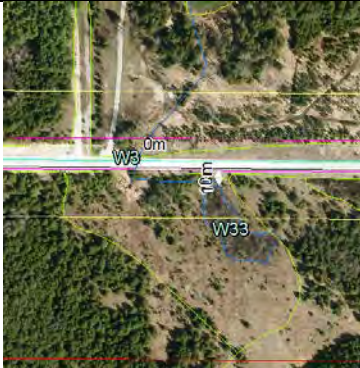
<p>Buried culvert on north side of Concession 4 Road at W3 (photo: June 14, 2012).</p>

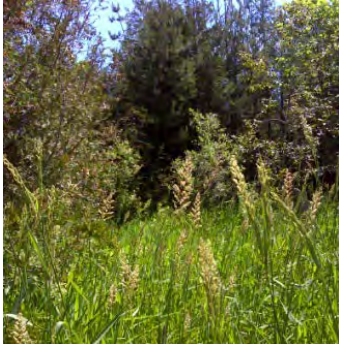
<p>No defined channel or pond feature found at W33. This feature is part of ELC unit 294 (SWT2-2) and was addressed as a wetland feature in the NHA for the Project (photo: June 14, 2012).</p>

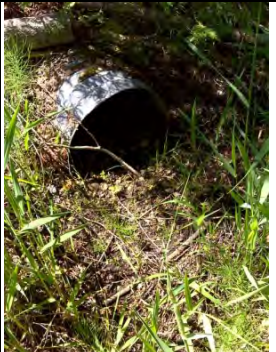
<p>Culvert somewhat buried and dry on south side of Concession 4 Road. Grasses in channel suggest pooling of water under spring melt conditions (photo: June 14, 2012).</p>

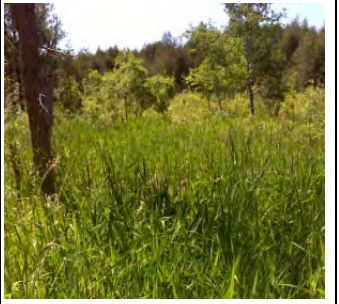
<p>No defined channel on north side of Concession 4 Road at W3 (photo: June 14, 2012).</p>	<p>W3= not carried forward as a water body                      W33= not carried forward as a water body</p>

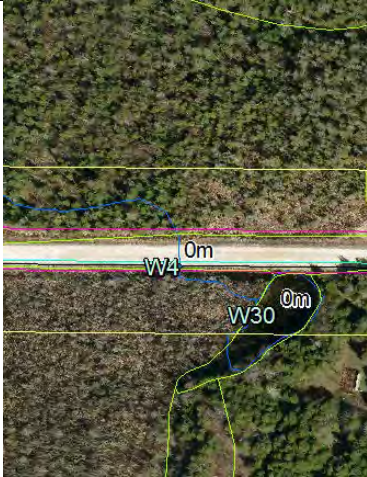
<p>Roadside channel on south side of Concession 4 Road just upstream of W4 crossing – dominated by emergent vegetation (photo: August 1, 2012).</p>

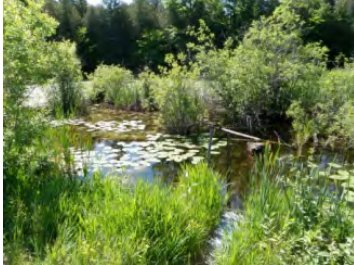
<p>Culvert (W4) conveys water from wetland on south side of road to wetland on north side of road (photo: June 14, 2012).</p>

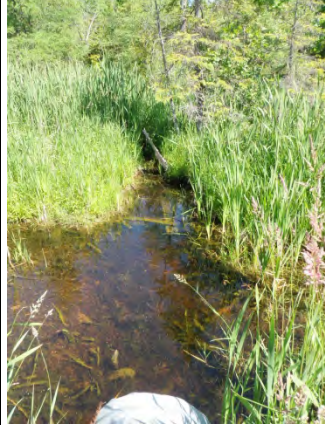
<p>W4 – culvert on north side conveys water to wetland feature.</p>	<p><b>W4= intermittent stream</b> W30= not carried forward as a water body</p>

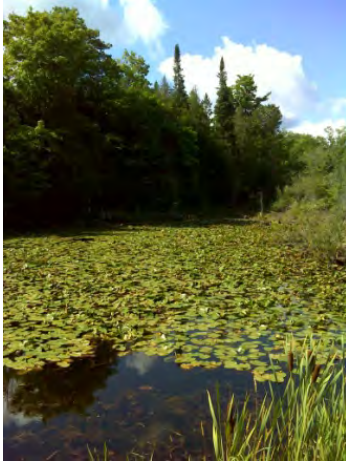
<p>W30 – wetland feature (photo: August 1, 2012).</p>

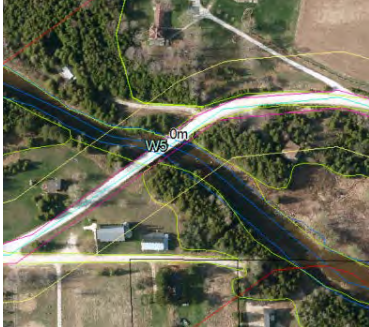
W5 – existing bridge structure (photo: June 14, 2012).

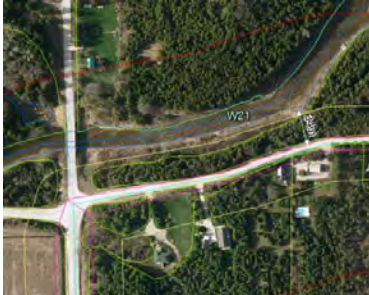
W21 – 34m from underground electrical collection line within existing road right of way;	The following details were documented: W5: bankfull width = 16-17 m Bankfull depth = 1-1.5m Banks are stable (include riprap at the bridge crossing); substrate is comprised mostly of cobble and boulder; little instream cover in the form of vegetation is available; combination of riffle, run and flats. Undercut bank of

W5 – upstream of bridge on Concession 4 Road (photo: June 14, 2012).

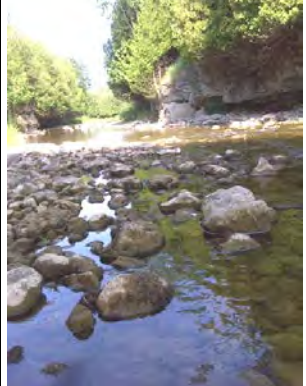
W5 – limestone bank on downstream side of crossing (photo: July 5, 2012)

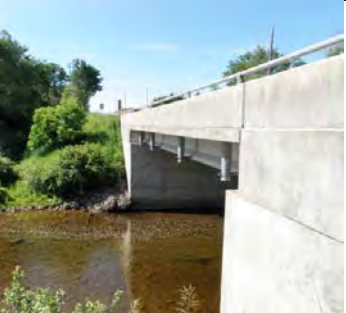
<p>W21 - existing bridge structure (photo: June 14, 2012).</p>

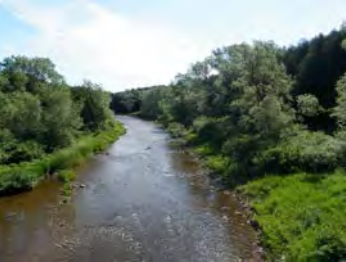
<p>W21- upstream of bridge on County Rd 23 (photo: June 14, 2012).</p>

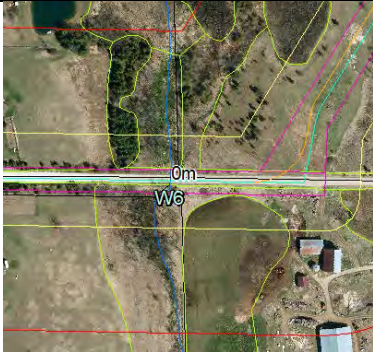
<p>W6 - 0m from underground collection line in existing road right of way and 79m from access road and underground collection into Turbine 13.</p>

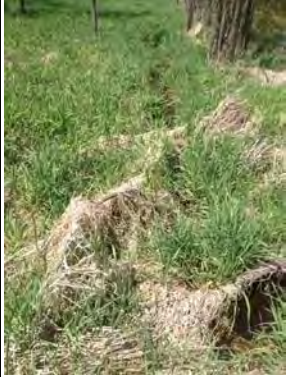
<p>W6 – no water on north side of Southline (photo: May 15, 2012)</p>	<p>W6 - not carried forward as a water body                  W8 - not carried forward as a water body</p>

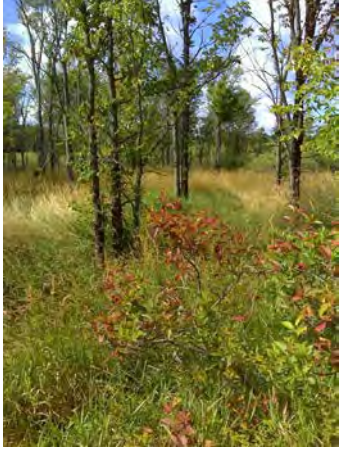
<p>W6 upstream - August 1, 2012, feature dominated by wetland vegetation (ELC unit 250)</p>

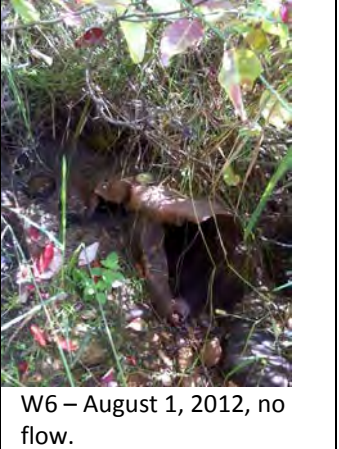
<p>W6 – August 1, 2012, no flow.</p>

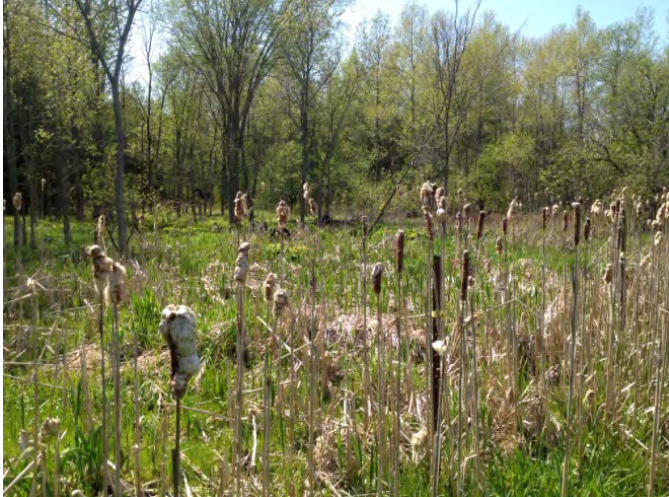
<p>W8 – feature dominated by wetland vegetation(photo: May 15, 2012)</p>

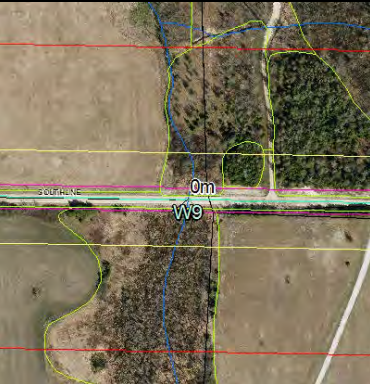
W9 - 0m from underground collection line in existing road right of way.	Property access was not provided for the property where this feature was located and for that reason a roadside survey was conducted.  Water in channel was pooling close to the road such that the bankfull width was approximately 1m, and bankfull depth approximately 0.5m. Upstream of the road crossing the channel was much narrower (20-30cm) with a grassy riparian	May 15, 2012 August 1, 2012

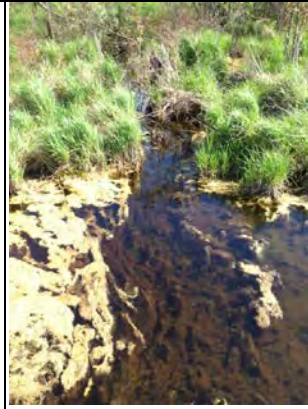
W9- South side of Southline Rd (photo: May 15, 2012)

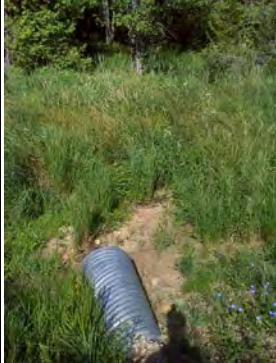
<p>W10 on west side of Boot Jack Ranch Road (photo: August 1, 2012)</p>	<p>W10 - not carried forward as a water body</p>

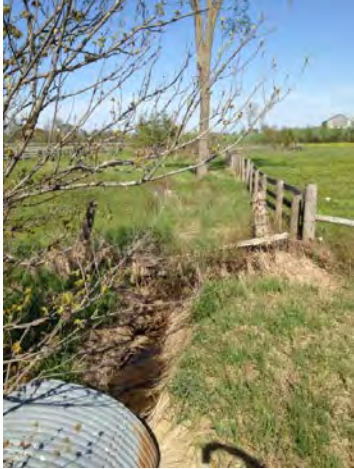
<p>May 15, 2012 – east side of Boot Jack Ranch Road. Conveys water seasonally from agricultural field and dugout pond on east side of the road to wetland on west side of road.</p>

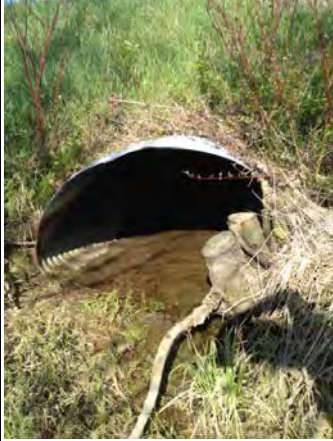
<p>May 15, 2012 – grassy channel downstream of road.</p>	<p><b>W11 – intermittent stream</b> W45 - not carried forward as a water body W51 - not carried forward as a water body</p>

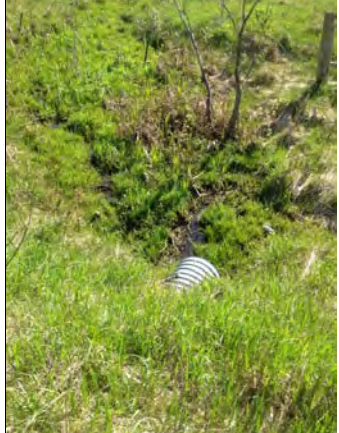
<p>W12 on west side of Boot Jack Ranch Road where vegetation is predominantly hydrophytic in nature (photo: May 15, 2012)</p>	<p>W12 - not carried forward as a water body</p>

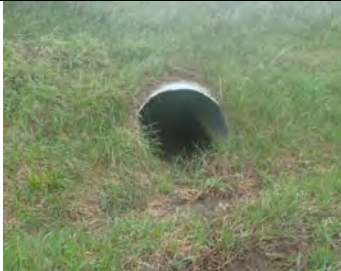
<p>Culvert on south side of County Rd. 4 drains into agricultural field. Standing water in culvert at time of survey – no detectable flow (photo: May 16, 2012).</p>

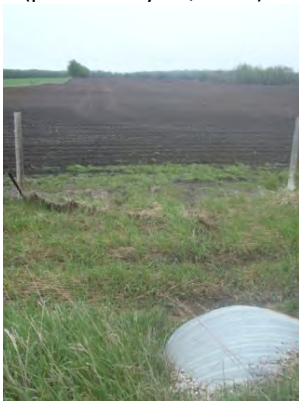
<p>Looking south from County 4 Rd to W24 May 16, 2012 – no agricultural swale/drainage evident.</p>

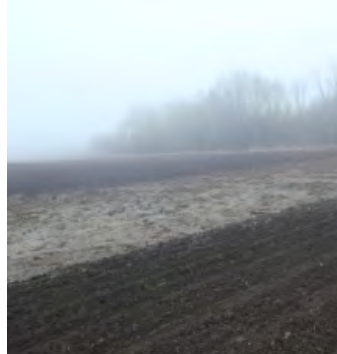
<p>Evidence of saturated soils in field; however, tilled through as part of agricultural field.</p>

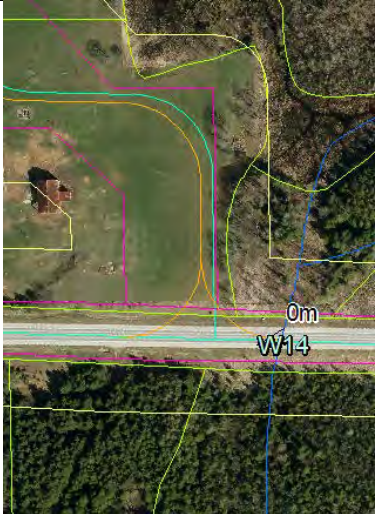
<p>W14 – 0m from underground collection line in existing road right of way.</p>	<p>Property access was not provided for the property on the south side of the road and for that reason a roadside survey was conducted of the upstream portion.</p> <p>W14 functions to provide seasonal conveyance of water from one wetland feature to another. ELC unit 85 (a tamarack coniferous swamp) is located on the south side of County Road 4, and ELC unit 62 (a white cedar coniferous swamp) is located on the north side of the road. Both of these features are dominated by wetland species and are within the boundary of Beaver Meadow PSW. These features were addressed as significant wetlands through the NHA and determined not to meet the definition of a 'water body' under O.Reg. 359/09.</p>

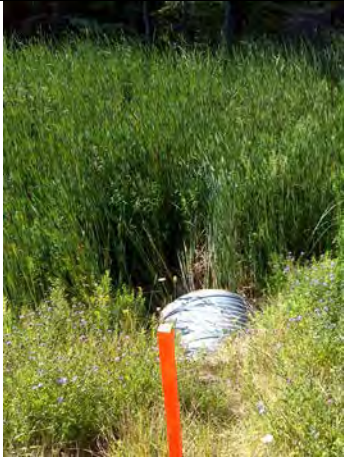
<p>Culvert on south side of County Rd. 4 at ELC unit 85 (photo: August 1, 2012).</p>

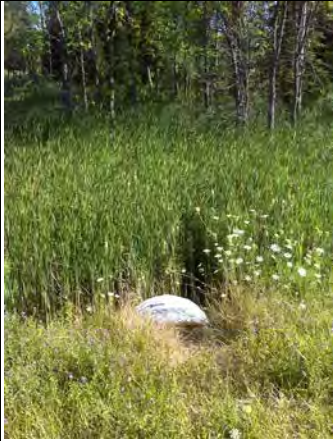
<p>Culvert on north side of County Rd. 4 at ELC unit 62 (photo: August 1, 2012).</p>	W14 - not carried forward as a water body

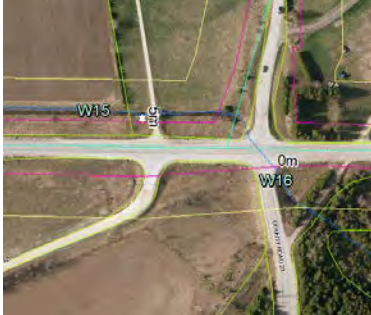
<p>W15 – 5m from underground electrical collection line in road right of way;                      W16 - underground electrical collection line in road right of way crosses the feature (0m);</p>	<p>Property access was not provided for the property where these features were located and for that reason a roadside survey was conducted. NRVIS data indicated a connection between W16 (furthest upstream )and flow continuing from there to W15, to W28, to W26, and to W18. Mapping obtained from SSWPC (2011) classifies these sites as a cold water stream.</p> <p>Description of feature at W16 :                      Pool at culvert = 0.37m deep                      Bankfull width = 1.5m; channel wider upstream (approximately 3m) with fast riffle (0.15m deep)                      Substrate was a mix of cobble/gravel/boulder.                      Instream cover was available in the form of willow.                      Banks were stable.                      No fish were observed at the time of survey.                      Water temperature = 16C (May 15, 2012), 18C (Aug. 1, 2012)                      Immediate riparian vegetation is mostly manicured lawn, with</p>	<p>May 15, 2012                      Aug. 1, 2012</p>

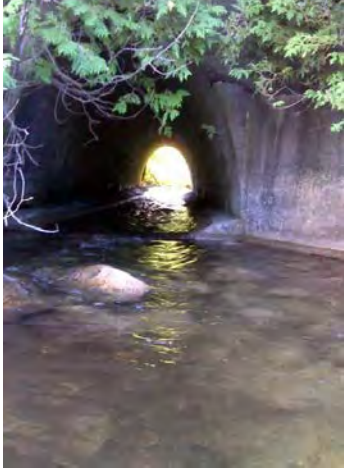
<p>W16 as it passes under old railway line. Large boulder and cobble substrate.                      (photo: Aug. 1, 2012</p>

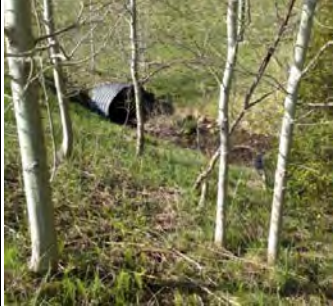
<p>W16 as it approaches culvert at County Rd. 4                      (photo: May 15, 2012)</p>	<p><b>W16 – part of permanent stream</b></p>

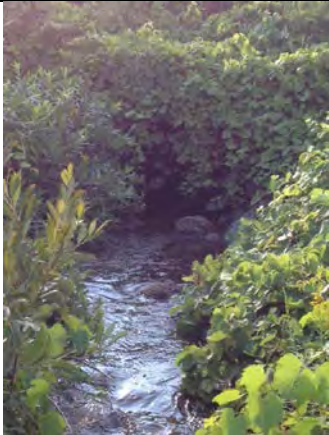
<p>W15 as it begins at the culvert after crossing the road and continues along the north side of County 4Rd. (photo: August 1, 2012)</p>

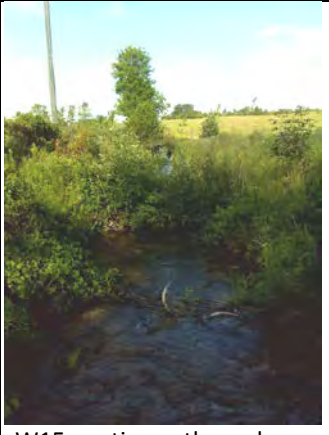
<p>W15 continues through a series of culverts along the roadside until it crosses back over to the south side of County Rd. 4 (photo: August 1, 2012)</p>	<p><b>W15 – part of permanent stream</b></p>

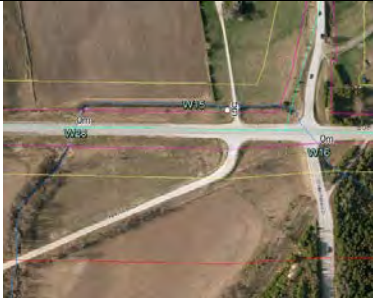
<p>W28 – 0m from underground electrical collection line in road right of way</p>	Description of feature at W28: This feature passes under County Rd. 4 and under The Glen Road. No property access was provided, therefore survey was conducted from crossing at the Glen Road. Upstream of The Glen Road: Wetted depth at roadside = 0.43m Bankfull width = 1.5 – 2m Greater than 95% of substrate is fines/silt with random dispersal of cobble (<5%). Young of year fish and green frog observed. In stream cover provided by emergent vegetation. Overhanging vegetation upstream provides additional cover. Little cover available at roadside. Banks are stable. Narrow riparian (<5m)	August 1, 2012

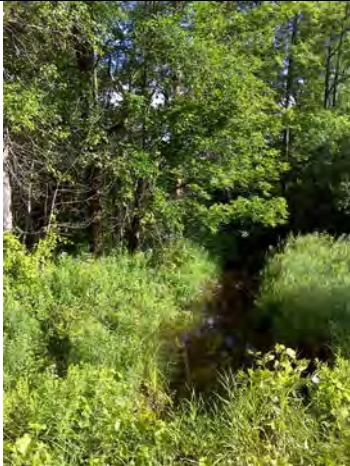
<p>W28 - Channel on upstream side (north) of The Glen Road. With riparian vegetation primarily meadow species at roadside with ash and maple beyond upstream (photo: August 1, 2012)</p>

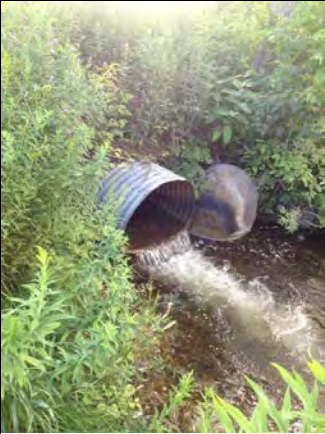
<p>W28 – 0.8m perched culvert has created a plunge pool on south (downstream) side of Glen Road. Channel in this area is 3m wide and 0.5-0.7m deep; beyond plunge pool watercourse becomes shallower and narrower (photo: August 1, 2012).</p>	<b>W28 – part of permanent stream</b>

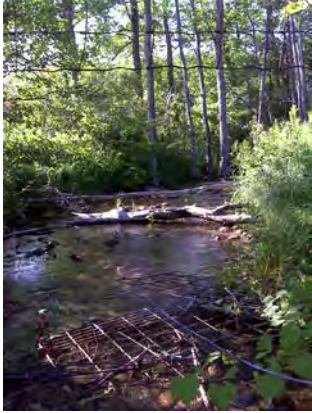
<p>W28 – downstream of The Glen Road, channel wide at roadside and narrow downstream (photo: August 1, 2012)</p>

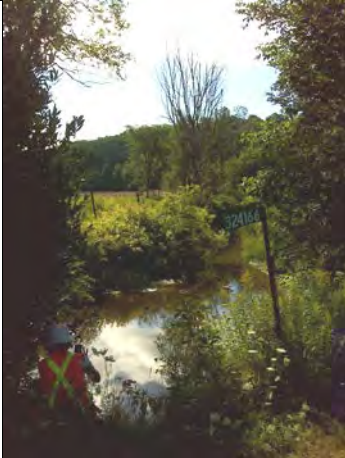
<p>W26 on upstream side (south) of The Glen Road – riparian vegetation is limited (photo: August 1, 2012).</p>

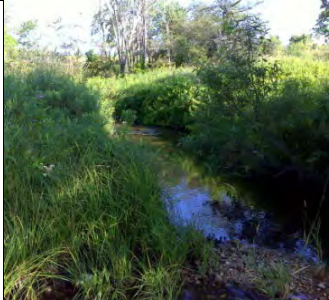
<p>W26 – facing downstream (north toward County Rd. 4).</p>

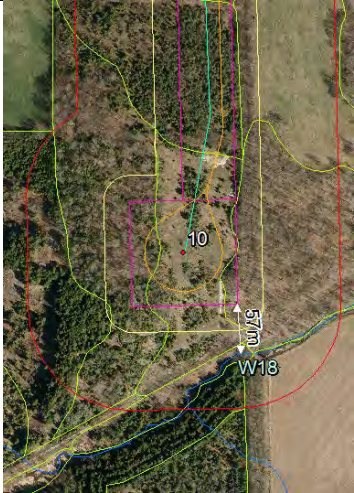
<p>W18 – 57m from turbine 10 and associated access road and underground electrical collection</p>	<p>Description of feature at W18:                      Located adjacent to an old railway line in a valley. Steep slope from north to access the stream below. Stream is crossed by an unmaintained road with double culverts.                      Upstream:                      No property access was provided to portion of W18 upstream of the road crossing such that data was collected from roadside.                      Large pool (10m wide) on upstream side of farm lane. Fine substrates.                      Immediately adjacent to agricultural field. Riparian edge is restricted to sedges and occasional mature trees.                      Instream cover limited - available in vicinity of the crossing as thickety vegetation overhanging culverts.                      No fish observed.                      Downstream:                      Riparian vegetation is primarily Norway spruce plantation on the south side and sugar maple deciduous forest to the north.                      Downstream of the farmlane immediate riparian is restricted primarily to sedge species.</p>	<p>May 16, 2012</p>

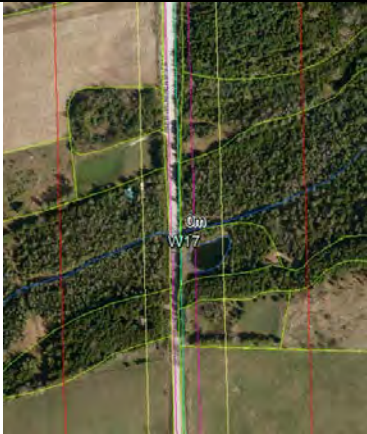
<p>W17 - 0m from underground electrical collection line in road right of way</p>	<p>Property access was not provided for the property where this feature was located and for that reason a roadside survey was conducted.</p> <p>Description of feature at W17: This feature is part of Durham Creek and is a permanent cold water stream that conveys water through a Coniferous swamp (dominated by tamarack and balsam fir with occasional black ash and red maple). Watercress was observed in the channel as evidence of groundwater seepage. Substrate mix of cobble and boulder. Large (&gt;1m wide), deep plunge pool on downstream side resulting from perched culvert. Visible portion of channel beyond pool is riffle. Upstream is predominantly riffle. Wide riparian buffer that functions as a wildlife corridor. Abundant in-stream cover in the form of emergent vegetation and woody debris. Banks stable. Water temperature= 11C</p>	<p>May 15, 2012                      July 5, 2012</p>

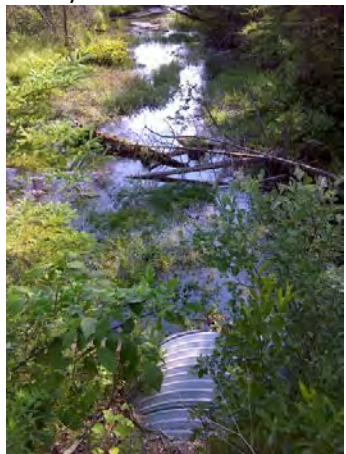
<p>July 5, 2012 – upstream of County Rd. 23</p>

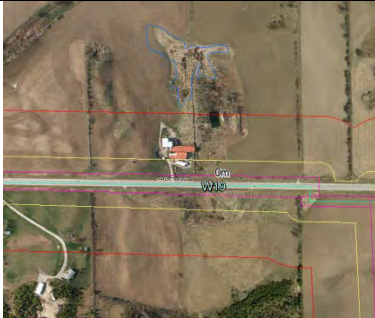
<p>W19 – 0m from underground electrical collection line in road right of way</p>	<p>Low spot in agricultural field with some cattail and other hydrophytic vegetation investigated during field surveys was determined not to meet the definition of a water body under O. Reg. 359/09.</p> <p>Water temperatures (9C) and vegetation suggest seepage on north side of road.</p>	<p>May 16, 2012</p>

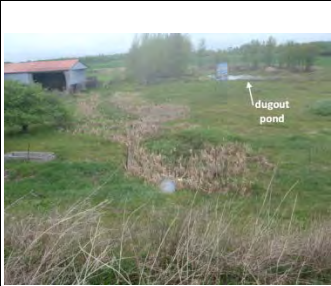
<p>W19 – culvert ends at cattail vegetation on north side of Road with dugout pond beyond in agricultural field (photo: May 16, 2012).</p>
