Feature ID & Distance to Project Component (refer to Figures 4-7 for location of each water feature)	Description of Water Feature (ELC units shown on Figures a-c in Appendix B)	Date of Field Investigation (field notes in Appendix C0)	Photographic Records from Field Investigation		Type of REA Water Body Feature (as defined by O. Reg. 359/09)
			Upstream	Downstream	
Feature ID (source of information)	W41 (site investigation, aerial photography)

NHA – East Durham Wind Energy Centre Natural Heritage Assessment (LGL 2012)

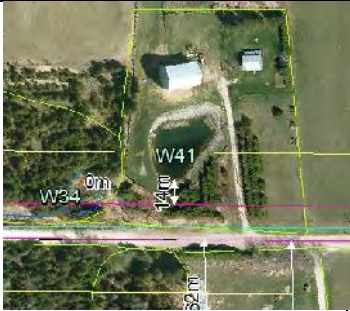
<p>W41 – 14m to underground electrical collection in existing road right of way.</p>	<p>Property access was not provided for the property where this feature was located and for that reason a roadside survey was conducted.</p> <p>This feature was determined through site investigation to be a dugout pond. W41 was determined not to meet the definition of a 'water body' as outlined in O. Reg. 359/09.</p>	June 14, 2012

<p>Dugout pond at W41</p>		W41 - not carried forward as a water body

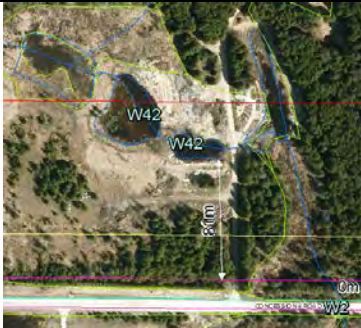
<p>W42 – 81m from underground electrical collection in existing road right of way.</p>	<p>Property access was not provided for the property where this feature was located and for that reason an alternative site investigation through review of aerial photography and background information was conducted.</p> <p>This feature was determined to be a cattail shallow marsh through ELC analysis. This classification is consistent with other features of similar appearance that were field surveyed; and, as no open water component was noted through aerial photography W42 was determined not to meet the definition of a ‘water body’ as outlined in O. Reg. 359/09. This feature was identified as part of a significant wetland in the NHA process (see mapping in Appendix B).</p>	June 14, 2012

<p>Aerial photography demonstrates W42 to be a mix of open water and emergent vegetation. Based on ELC this feature was determined to be dominated by emergent vegetation and similar to other cattail shallow marshes in the area.</p>	W42 - not carried forward as a water body

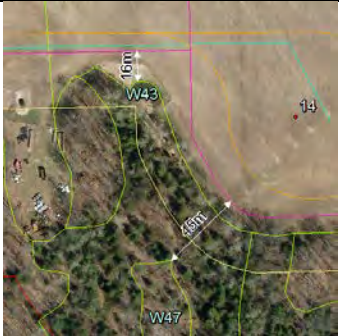
<p>W43 – 16m from underground electrical collection and access road to Turbine 14</p>	<p>This feature was determined during site investigation to be a dugout pond. W43 was determined not to meet the definition of a ‘water body’ as outlined in O. Reg. 359/09.</p>	<p>May 15, 2012</p>

<p>Dugout pond at W43 on edge of agricultural field – May 15, 2012</p>	<p>W43 - not carried forward as a water body</p>

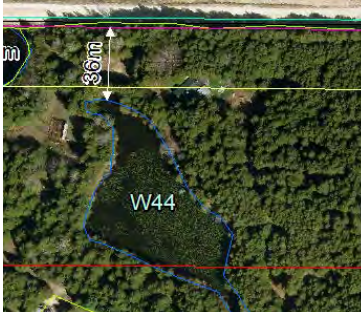
<p>W44 – 36m from underground electrical collection in existing road right of way</p>	<p>Property access was not provided for the property where this feature was located and for that reason an alternative site investigation through review of aerial photography and background information was conducted. This feature was determined to be part of ELC unit 405 a white cedar coniferous forest. The forest was dominated by eastern white cedar which is often the result of secondary growth from managed sites. No evidence of an open water component was provided by aerial photography. W44 was determined not to meet the definition of a 'water body' as outlined in O. Reg. 359/09.</p>	June 14, 2012

<p>Through use of aerial photography the surface area of this feature was determined to be dominated by vegetation and was treated as a wetland feature.</p>		W44 - not carried forward as a water body

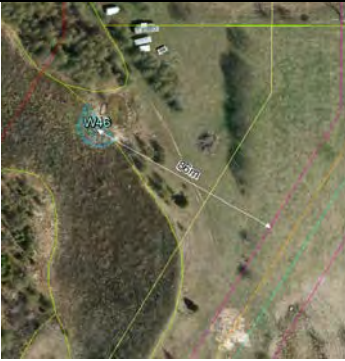
<p>W46 – 86m to underground electrical collection and access road to Turbine 13</p>	<p>This area was determined through site investigation to be an area of seepage, as was evident from the iron staining. W46 is within a willow swamp thicket (ELC unit 106) dominated by willows and red-osier dogwood. The seepage area is dominated by watercress and spike rush with Loesel's tway blade around the perimeter. This feature was also identified through the NHA process to be a significant wetland (see mapping in Appendix B).</p>	<p>May 15, 2012</p>

<p>Seepage area identified May 15, 2012.</p>	<p><b>W46 - seepage area</b></p>

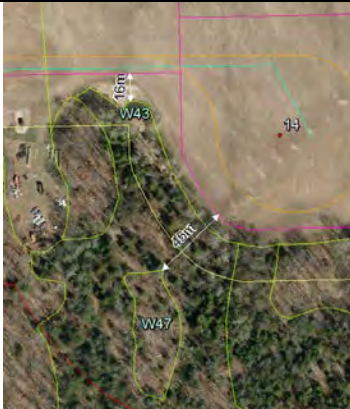
<p>W47 – 45m from Turbine 14 and associated underground electrical collection and access road.</p>	<p>This area was determined through site investigation to be an area of seepage, as was evident from the marsh marigolds and cold water temperatures (temperature of 11C on May 15, 2012). W47 is within a forb mineral deciduous swamp dominated by such as spotted joe-pye weed, buttercup, lance leaved goldenrod, ferns and sedges. This feature was also identified through the NHA process to be a significant wetland (see mapping in Appendix B).</p>	<p>May 15, 2012</p>

<p>Seepage area identified May 15, 2012.</p>	<p><b>W47 - seepage area</b></p>

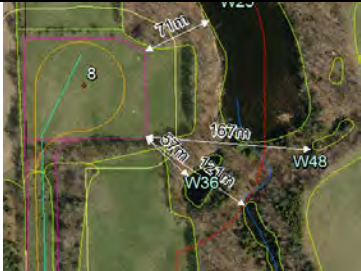
<p>W48 - 167m from Turbine 8 and access road and underground electrical collection.</p>	<p>Feature was determined to be greater than 120m from the final project location.</p>	<p>May 16, 2012                      July 24, 2012</p>

<p>Vernal pool within ELC unit 57.</p>	<p>W48 &gt; 120m from Project Location; not assessed further</p>

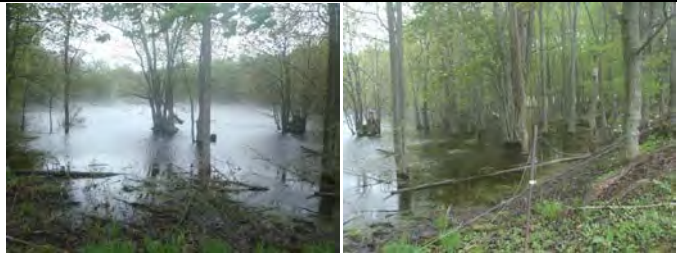
<p>W49 – 33m from access road and underground electrical collection line to Turbine 17.</p>	<p>This feature was identified as an open water feature as part of a larger wetland unit during site investigation. The pond is surrounded by predominantly red maples and occasional white elm. Species found around or emerging from the open water include sedges, manna grass, water parsnip, reed-canary grass, and sensitive fern. Abundant cover is available within the pond in the form of woody debris and vegetation. American toad, Midland painted turtle, spring peeper, leopard frog, green frog and Northern leopard frog documented during site investigations. No fish observed from pond edges; however, review of background information (Natural Environment Technical Report as part of an Aggregate Extraction Application for the property) documents baitfish within the pond. This feature was also identified as significant wildlife habitat within the NHA process.</p>	May 16, 2012

<p>Pond condition on May 16, 2012. Photo taken facing south.</p>	<b>W49- pond</b>

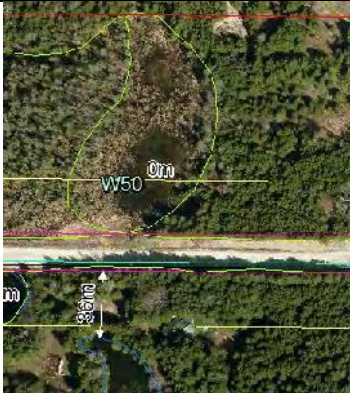
<p>W50 – 0m from underground electrical collection in existing road right of way</p>	<p>This feature was classified as a cattail shallow marsh (ELC unit 289) during field surveys. It is a broad leaved cattail dominated wetland with a few tamarack, white cedar, and balsam poplar scattered along the edge. Abundant bull-head pond lily was also be found in the ground layer. Green frog, leopard frog and basking Midland painted turtle observed during site visit. Hydrophytic vegetation was dominant within the feature; therefore it was treated as a wetland and addressed within the NHA as a significant wetland (see mapping in Appendix B). W50 was determined not to meet the definition of a ‘water body’ as outlined in O. Reg. 359/09.</p>	June 14, 2012

<p>W50 - Shallow cattail marsh (ELC unit 289), June 14, 2012.</p>		W50- not carried forward as a water body

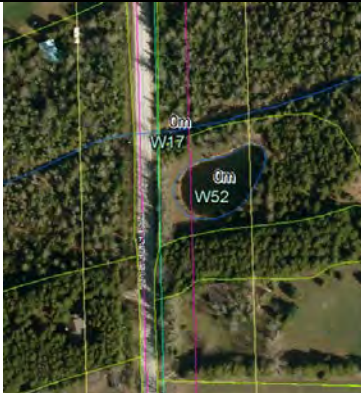
<p>W52 – 0m from underground electrical collection in existing road right of way.</p>	<p>Property access was not provided for the property where this feature was located and for that reason an alternative site investigation through review of aerial photography and background information was conducted.</p> <p>The structure, shape and surrounding features shown through aerial photography suggest this feature is a dugout pond. W52 was determined not to meet the definition of a 'water body' as outlined in O. Reg. 359/09.</p>	June 14, 2012

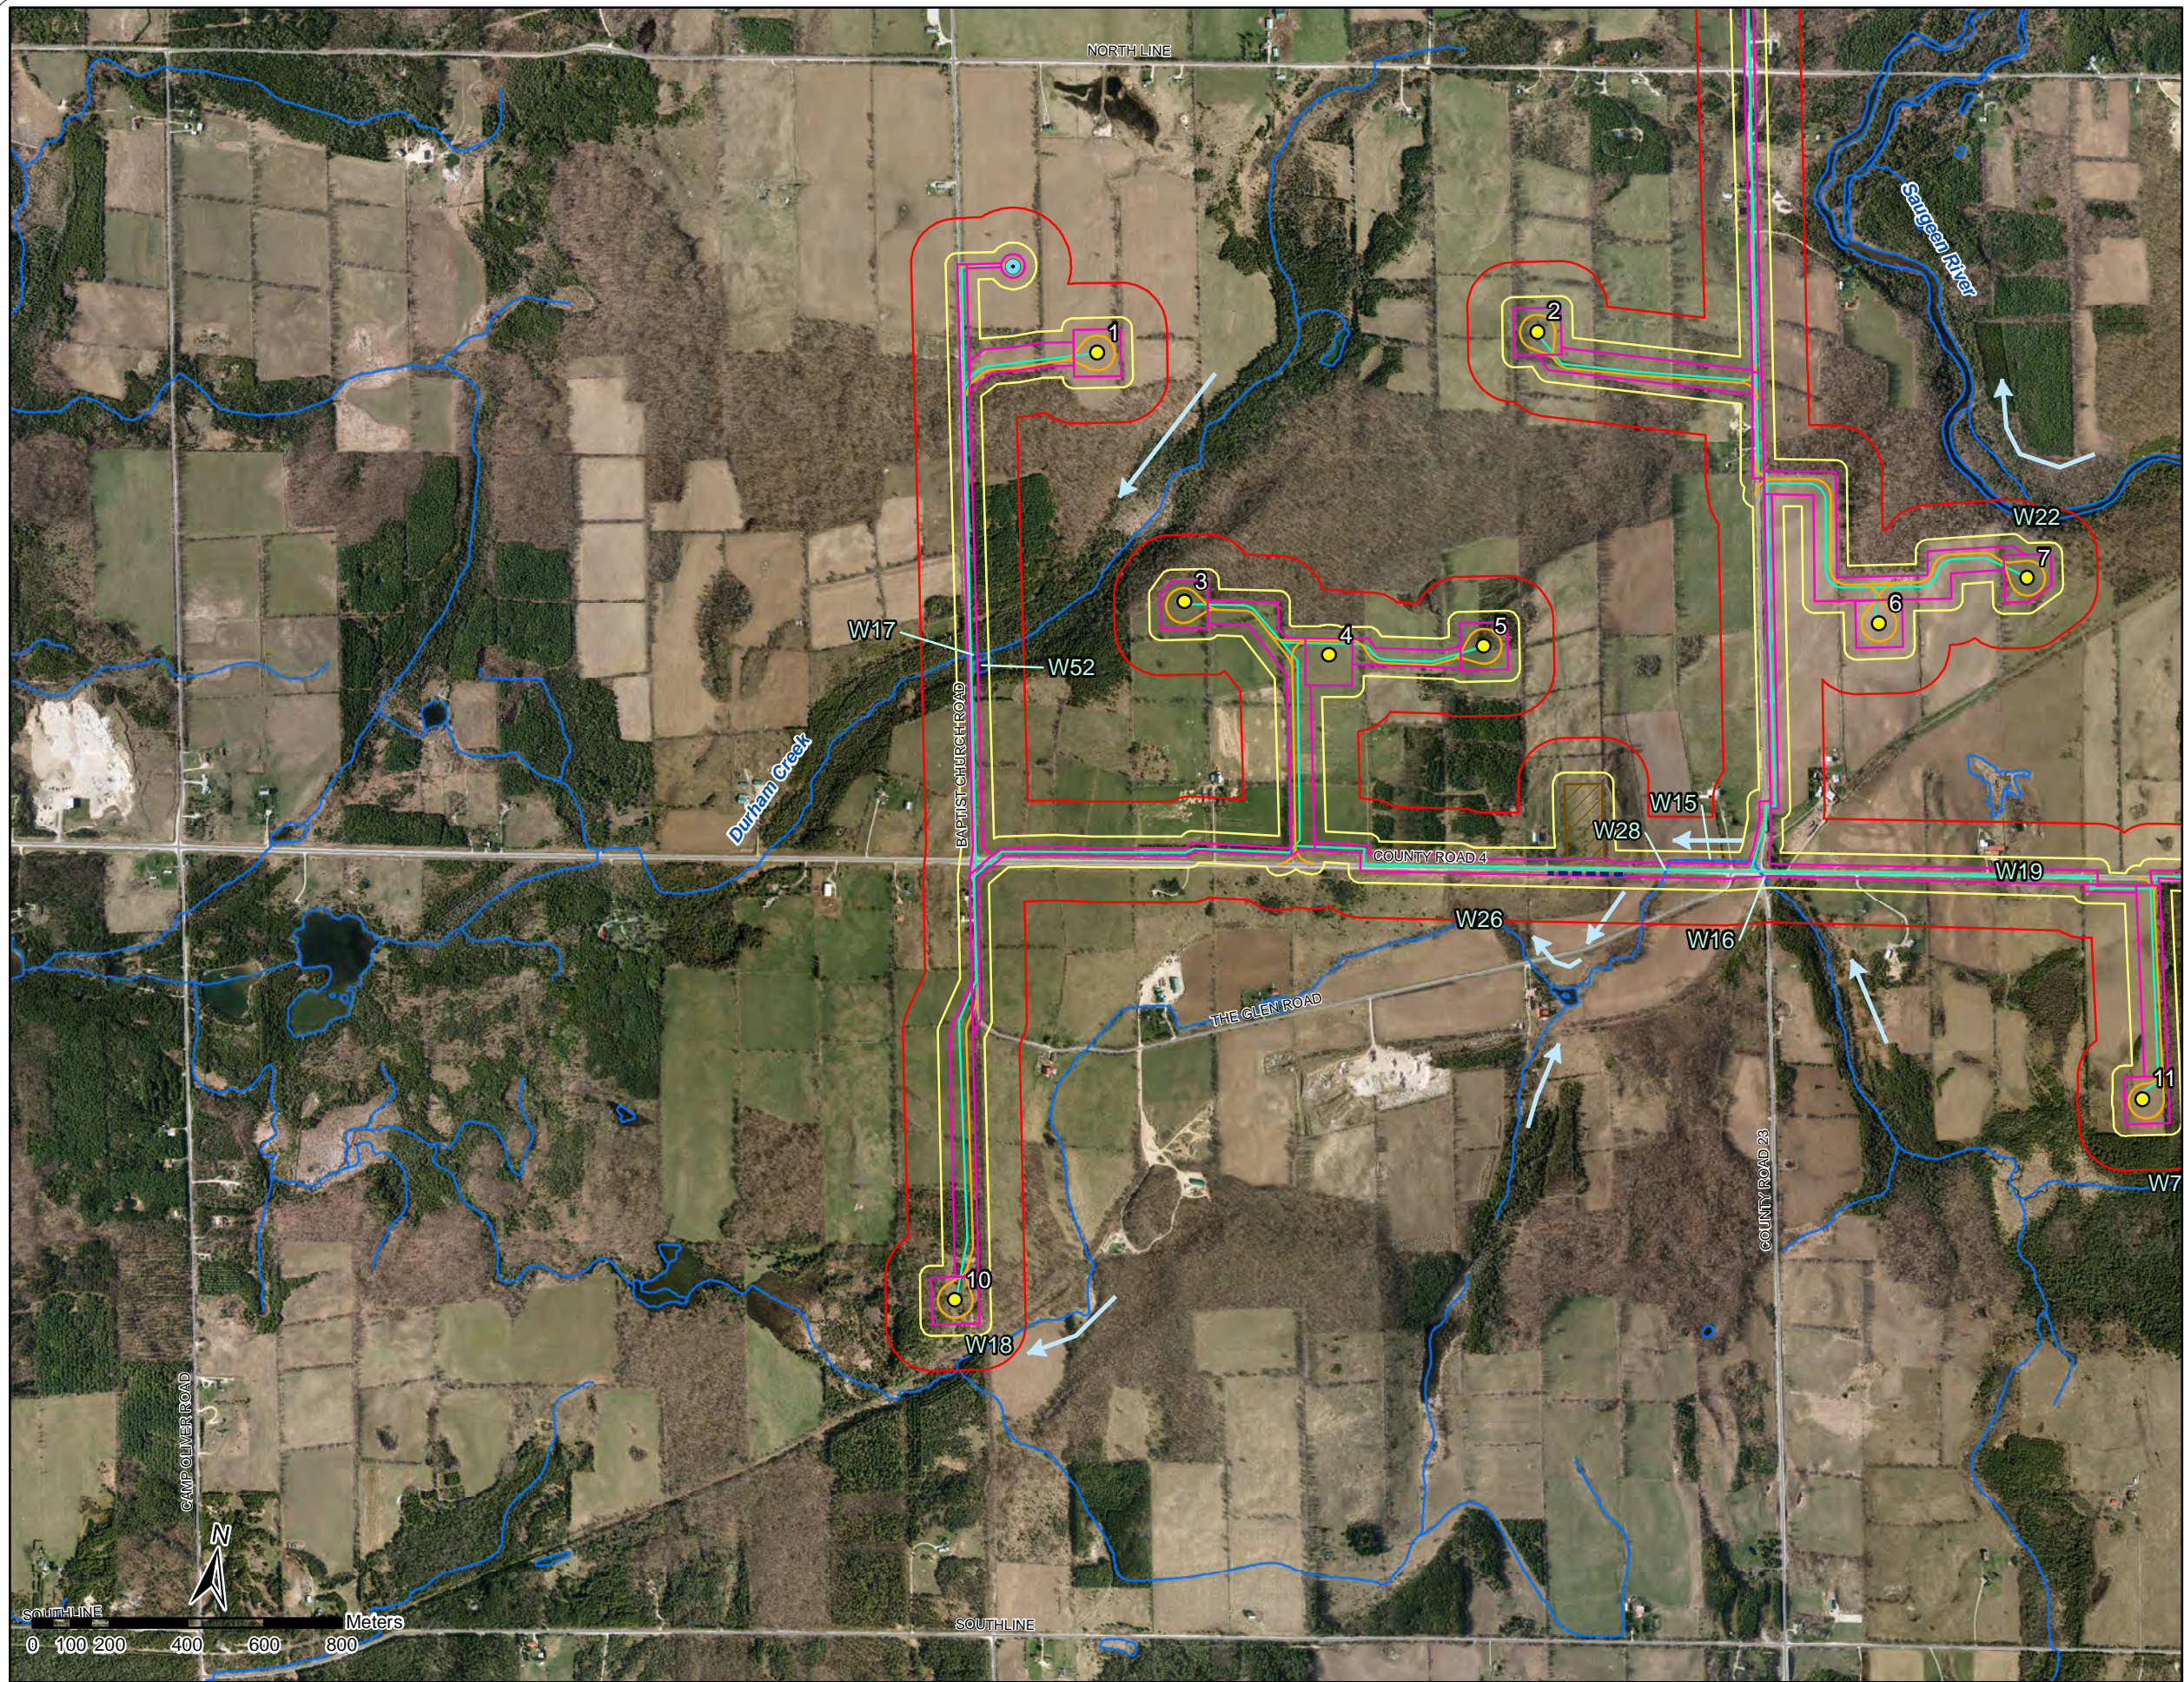
Project	TA8119	Figure	4
Date	Dec, 2012	Prepared By:	KC
Scale	1:17,000	Verified By:	LKR

**Water Features Identified Through Records Review & Site Investigation**
