## HERITAGE ASSESSMENT REPORT

**NextEra Energy Canada, ULC  
Goshen Wind Energy Centre  
Municipalities of Bluewater  
and South Huron  
Huron County, Ontario**

**Report Number:** 10-1151-0201-3200-R01

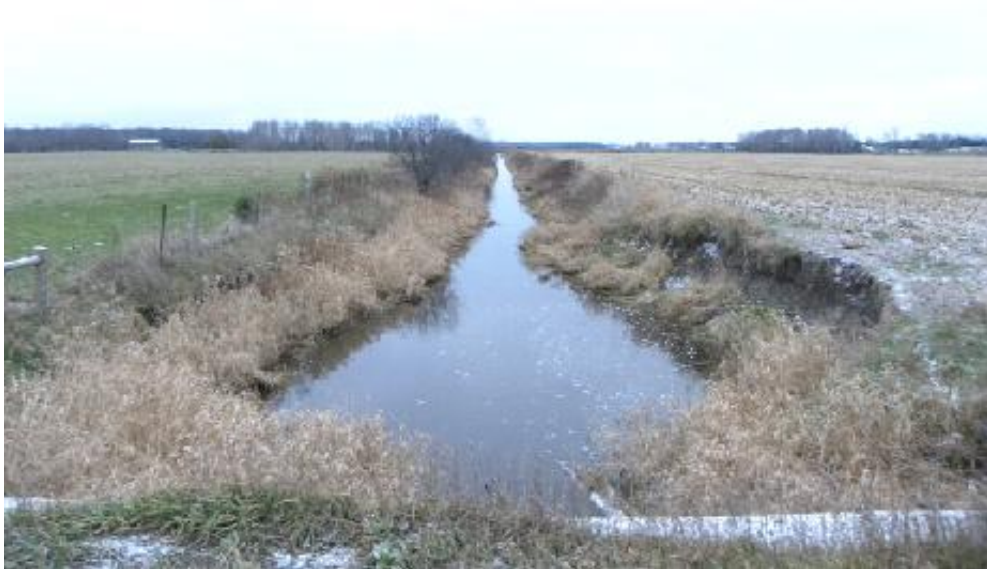
The human response to the wet and swampy conditions was a series of drainage ditches. These numerous ditches are found throughout the Study Area (Plate 9). Visually distinct due to the straight cuts made in the surrounding landscape, these ditches are a common flood aversion technique throughout the province.

*Plate 9: Drainage ditch crossing beneath the Zurich Hensall Road between Parr Line and Babylon Line, looking south.*

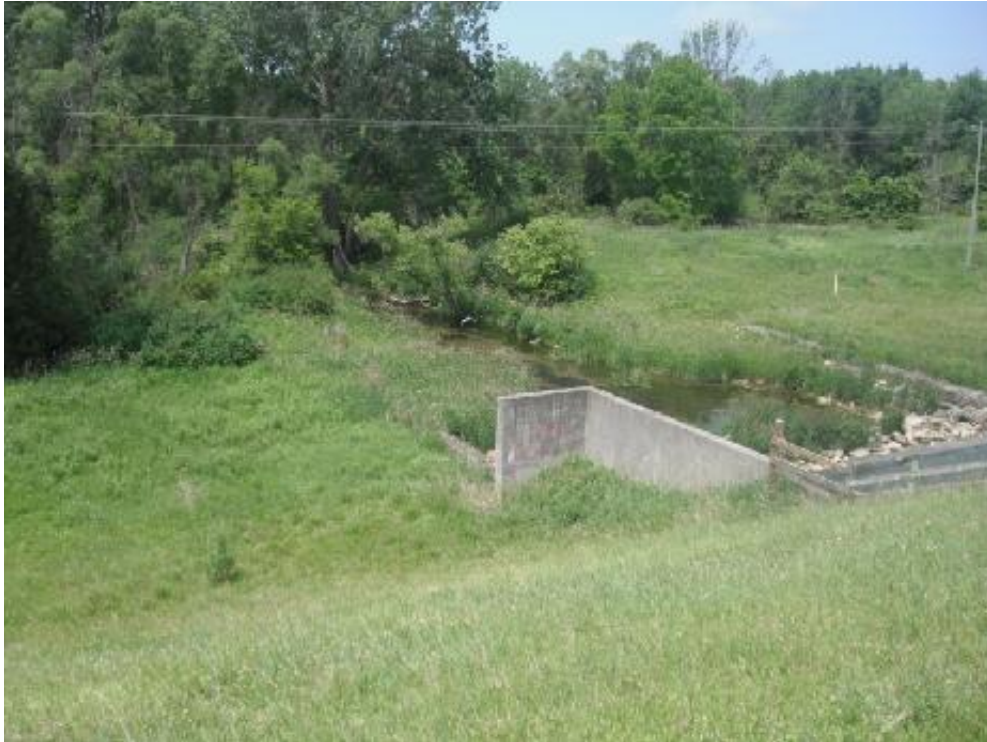
The man-made Morrison Dam reservoir is located within the Study Area, east of Exeter and is maintained by the Ausable Bayfield Conservation Authority (ABCA) (Plates 11 and 12). Much like the Hay Swamp, the ecological significance of the reservoir located within the Study Area is assumed at this time to be the matter of Natural Heritage and not of cultural heritage value or interest.

*Plate 12: Morrison Dam, east of Exeter, looking downstream from Morrison Line.*

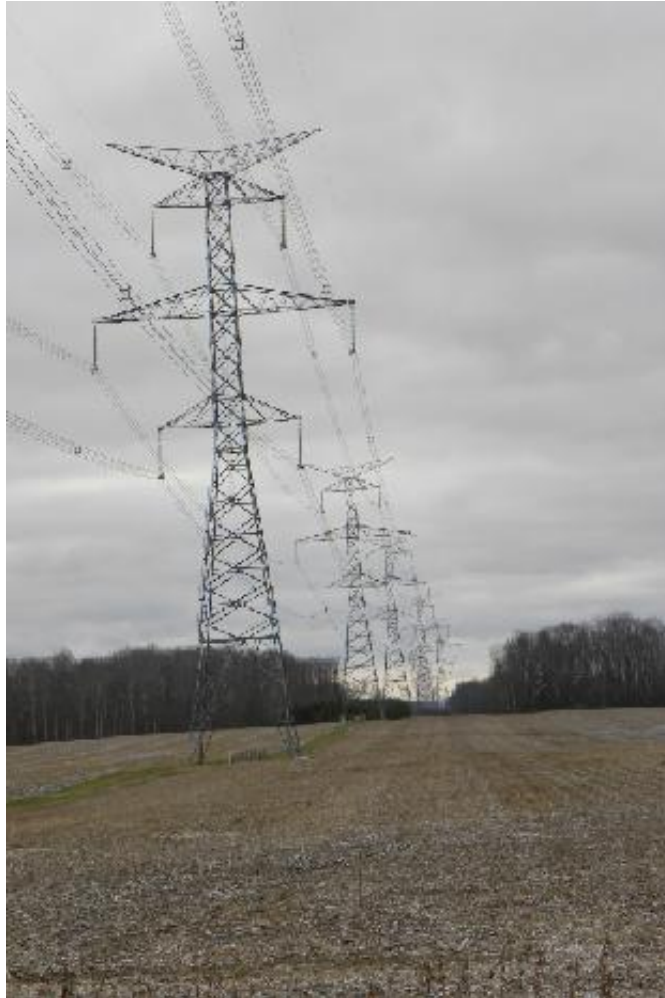
The third landscape identified within the Study Area is a hydro corridor. This represents a prominent feature in the rural landscape, particularly given the flat landscape within the Study Area. A single visually prominent corridor crosses through the entire Study Area from north to south between Goshen and Babylon Lines. It contains a single row of hydro towers (Plate 13).

*Plate 13: Hydro corridor, looking south from Dashwood Road, between Goshen Line and Babylon Line.*

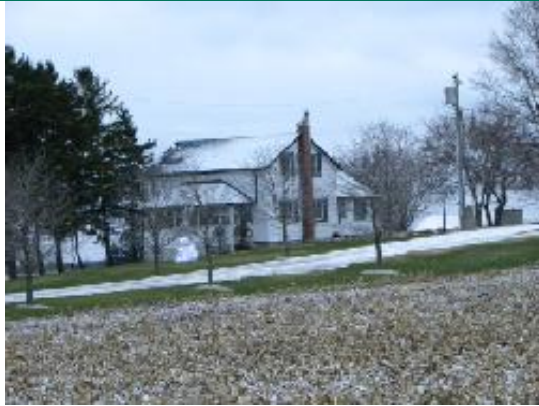
**Site #1 – 38309 Rogerville Road (Municipality of Bluewater)**

**Date:** Late 19<sup>th</sup> century

**Description:** One and one half storey side gabled house with medium roof pitch, modern siding and undetermined foundation. Symmetrical in design. Rear addition, red brick chimney with modern elements, and covered porch on the front facade.

**Mitigation of Negative Impacts:** Impacts were not identified, therefore mitigation is not recommended or necessary.

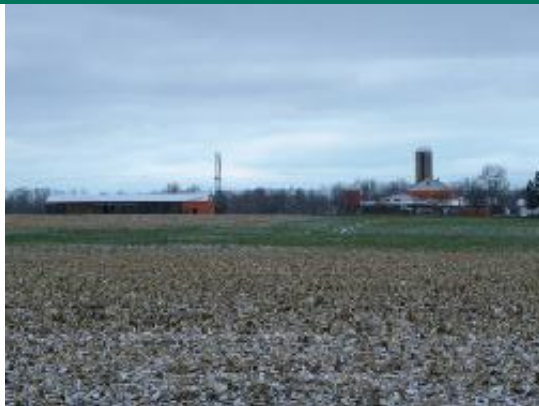
**Date:** Various (20<sup>th</sup> century)

**Description:** Frame barn with a stone foundation and rear shed addition. One concrete silo and two metal bins onsite with various outbuildings. Additional buildings onsite.

**Mitigation of Negative Impacts:** Impacts were not identified, therefore mitigation is not recommended or necessary.

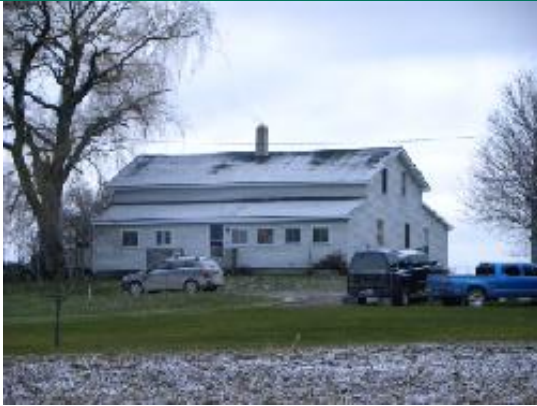
### Site #2 – 72167 Babylon Line (Municipality of Bluewater)

**Date:** 20<sup>th</sup> century

**Description:** One and one half storey side gabled house with medium roof pitch, modern siding and concrete covered foundation. Full width covered front porch and apparent rear addition. Modern outbuildings onsite.

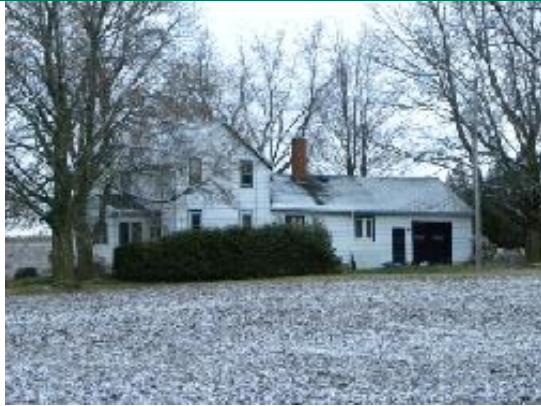
**Site #3 – 72039 Babylon Line (Municipality of Bluewater)**

**Date:** Late 19<sup>th</sup> century

**Description:** One and one half storey side gabled house with medium roof pitch, modern siding and concrete foundation. Symmetrical in design with a central double hung paired window. Addition at rear and covered central entryway with front gable.

**Mitigation of Negative Impacts:** Impacts were not identified, therefore mitigation is not recommended or necessary.

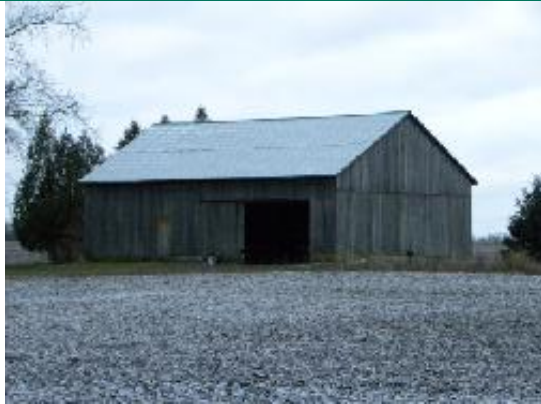
**Date:** 20<sup>th</sup> century

**Description:** Timber barn with metal roof, timber frame and concrete foundation.

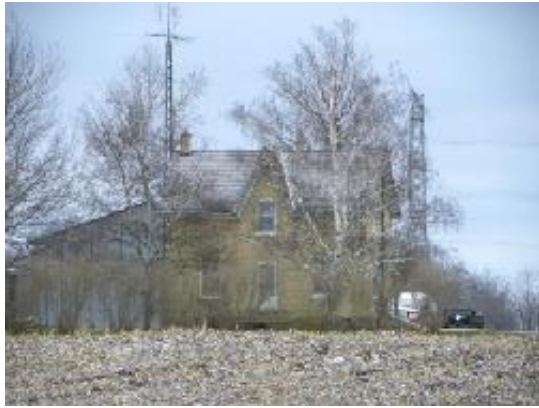
**Site #4 – 72048 Goshen Line (Municipality of Bluewater)**

**Date:** 1860s – 1890s

**Description:** One and one half storey side gabled house with a medium roof pitch and prominent central gable, yellow brick exterior and stone foundation. Vernacular Gothic Revival design elements include symmetrical design, central door, steeply pitched central gable with a decorative rounded window arch and bargeboard with cross-bracing and open rake. Timber addition at rear.

**Mitigation of Negative Impacts:** No negative impacts identified, therefore no further mitigation recommended.

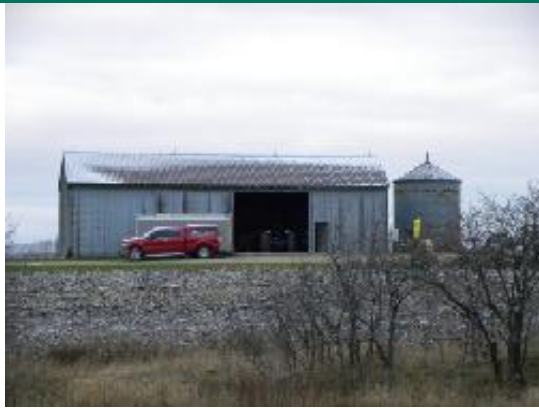
**Date:** 20<sup>th</sup> century

**Description:** Storage shed with metal roof, metal exterior on an undetermined foundation. Metal bin located at the rear.

**Mitigation of Negative Impacts:** No negative impacts identified, therefore no further mitigation recommended.

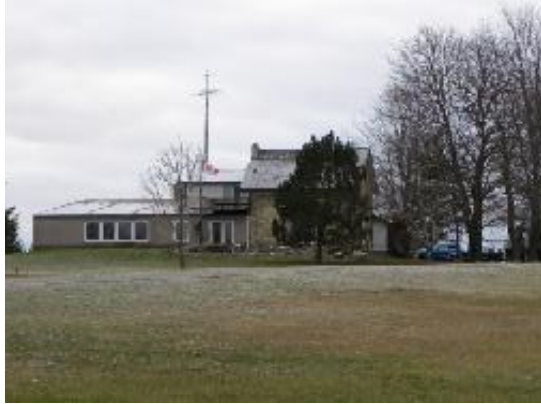
**Site #5 – 71416 Bronson Line (Municipality of Bluewater)**

**Date:** Late 19<sup>th</sup> century

**Description:** One and one half storey, side gabled, yellow brick house on an undetermined foundation. House has long, multi room/garage, single-storey metal-roofed gabled addition with a second storey addition attached to the house.

**Mitigation of Negative Impacts:** Impacts were not identified, therefore mitigation is not recommended or necessary.

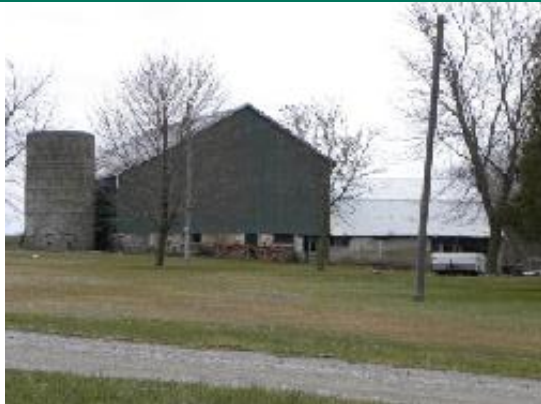
**Date:** Various (19<sup>th</sup> and 20<sup>th</sup> century)

**Description:** Frame barn with side shed addition, metal roof, timber frame and stone foundation. Silo attached to the shed addition. Side addition with metal gambrel roof and concrete foundation.

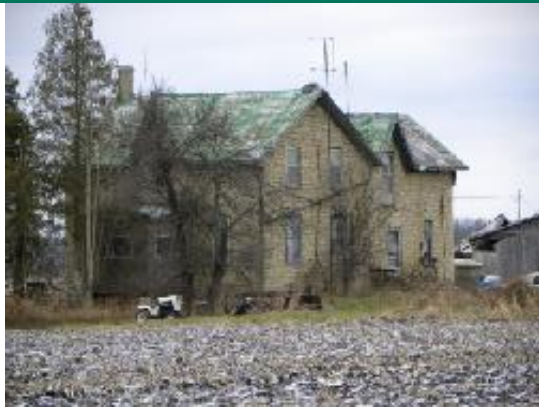
**Site #6 – 71778 Blackbush Line (Municipality of Bluewater)**

**Date:** 1860s – 1890s

**Description:** One and one half storey side gabled t-shaped house with a medium roof pitch and steeply pitched gables throughout, yellow brick exterior, and stone foundation. Vernacular Gothic Revival design elements include symmetrical design, central (covered) door, central gable, extensive brick detailing along cornice and rounded window arch, and remnants of decorative brackets. Possibly abandoned.

**Mitigation of Negative Impacts:** No negative impacts identified, therefore no further mitigation recommended.

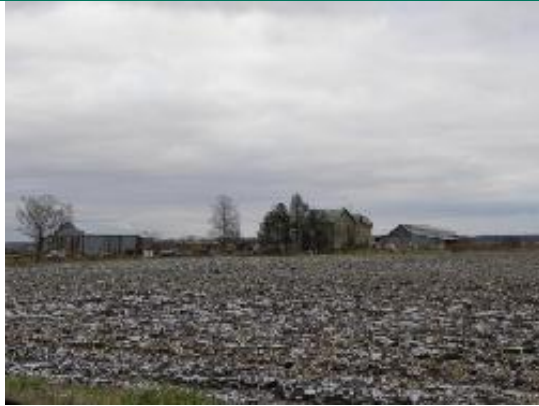
**Date:** Various (19<sup>th</sup> and 20<sup>th</sup> century)

**Description:** English styled barn with two shed additions and possible rear addition. Metal roof sits on a primarily timber frame and undetermined foundation. Shed structure contains a metal roof on timber frame with an undetermined foundation and rear metal bin.

**Mitigation of Negative Impacts:** No negative impacts identified, therefore no further mitigation recommended.

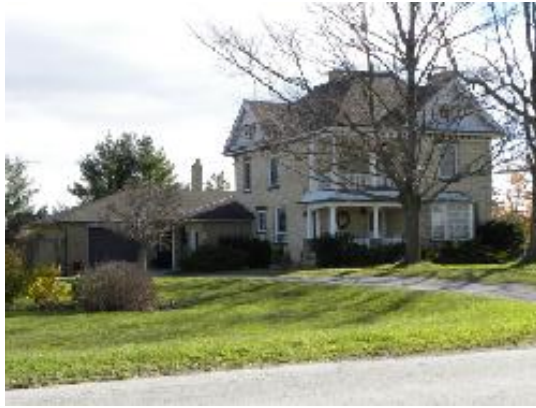
**Site #7 – 72020 Bronson Line (Municipality of Bluewater)**

**Date:** 1890 – 1920s

**Description:** Two storey, yellow brick, asymmetrical, hipped roof house on undetermined foundation with two storey gabled projection on front and gabled dormer on rear side. Vernacular Queen Anne design elements include wood columned and railed first and second storey porches, bay window, eaves with decorative cut outs and some decorative brackets. Rear addition.

**Mitigation of Negative Impacts:** No negative impacts identified, therefore no further mitigation recommended.

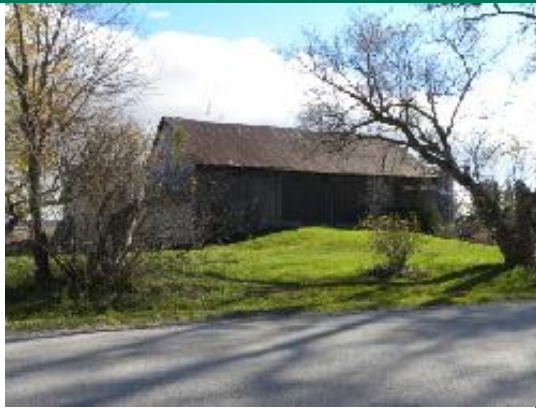
**Date:** 19<sup>th</sup> – early 20<sup>th</sup> century

**Description:** Timber framed, wood sided, metal roofed, side gabled barn with rear addition. Modern metal bin at rear.

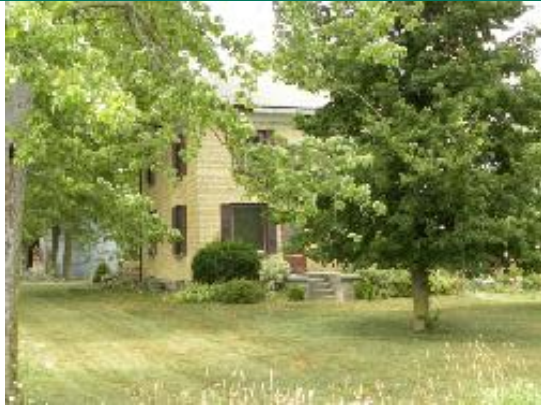
**Site #8 – 38554 Dashwood Road (Municipality of Bluewater)**

**Date:** 1890s – 1920s

**Description:** Two storey, yellow brick hipped roof house on a stone foundation. Symmetrical facade with decorative brackets and wide eaves. Rear addition. Modern garage at rear.

**Mitigation of Negative Impacts:** No negative impacts identified, therefore no further mitigation recommended.

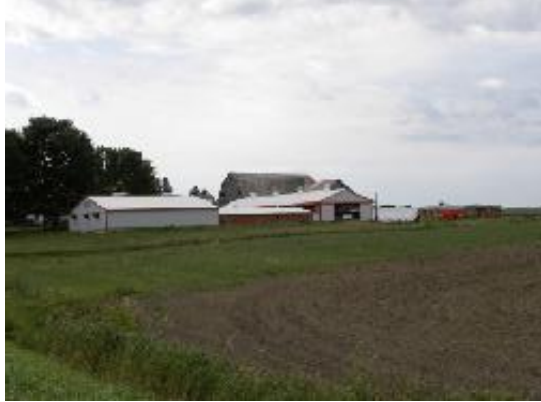
**Date:** 19<sup>th</sup> – 20<sup>th</sup> century

**Description:** Timber frame, gambrel roofed barn with metal roof and undetermined foundation. One large gable roof addition creates an L-plan. Modern shed buildings in foreground.

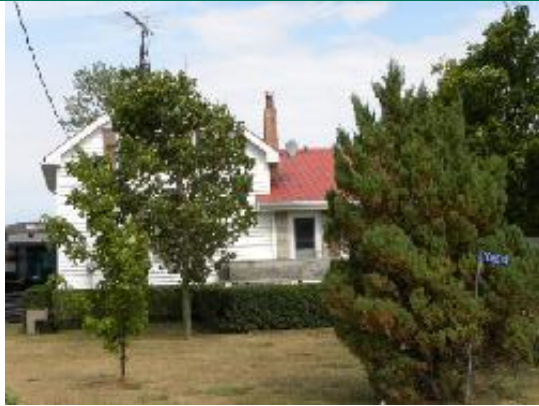
**Site #9 – 70604 Shirpka Line (Municipality of South Huron)**

**Date:** Late 19<sup>th</sup> century

**Description:** One and one half storey T-plan house on an undetermined foundation. Modern siding, windows and doors.

**Mitigation of Negative Impacts:** Impacts were not identified, therefore mitigation is not recommended or necessary.

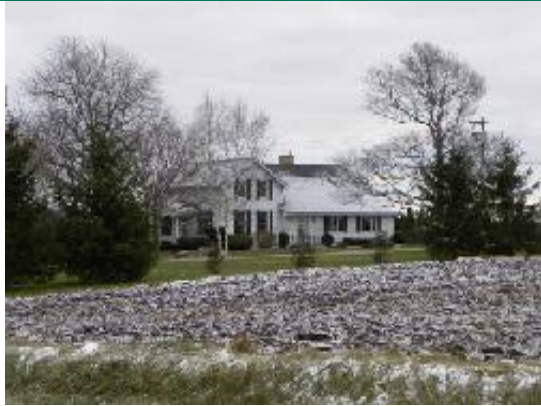
### Site #10 – 38565 Dashwood Road (Municipality of South Huron)

**Date:** Late 19<sup>th</sup> century

**Description:** One and one half storey side gabled house with medium roof pitch, modern siding and undetermined foundation. Symmetrical in design. Extensive rear addition and single storey central porch.

**Mitigation of Negative Impacts:** Impacts were not identified, therefore mitigation is not recommended or necessary.

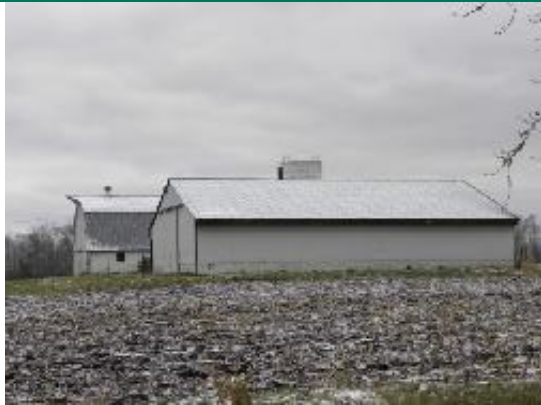
**Date:** Various (20<sup>th</sup> century)

**Description:** Two barns and single concrete silo onsite. First has a gambrel roof, mixed material exterior (timber, metal, apparent concrete), and undetermined foundation. Second is a front gabled barn with metal roof, metal siding, and concrete foundation.

**Mitigation of Negative Impacts:** Impacts were not identified, therefore mitigation is not recommended or necessary.

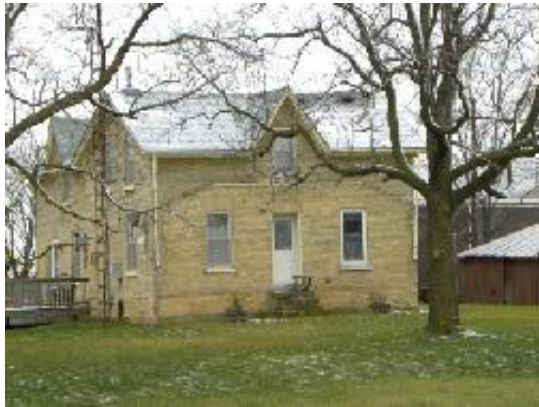
**Site #11 – 70865 Babylon Line (Municipality of South Huron)**

**Date:** 1860s – 1890s

**Description:** One and one half storey side gabled house with a medium roof pitch and central gable, yellow brick exterior and concrete foundation. Vernacular Gothic Revival design elements include symmetrical design, central window extending into the steeply pitched central gable and remnants of decorative brackets. Modern addition at rear.

**Mitigation of Negative Impacts:** No negative impacts identified, therefore no further mitigation recommended.

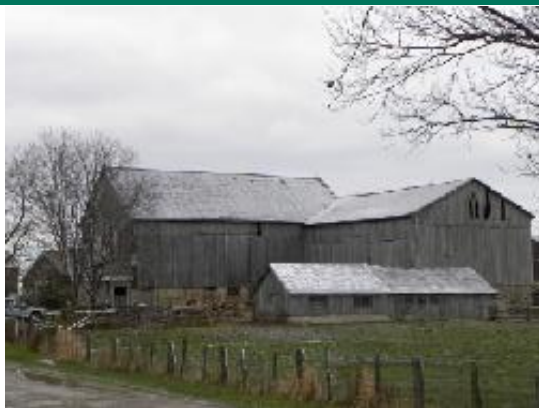
**Date:** Various (19<sup>th</sup> and 20<sup>th</sup> century)

**Description:** Barn appears to be a frame barn with third gable addition and later single storey shed addition, with metal roofs, timber frames and a variety of foundations (stone, brick and concrete).

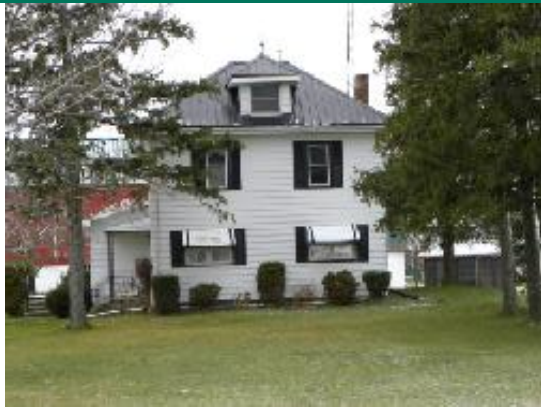
**Site #12 – 70963 Babylon Line (Municipality of South Huron)**

**Date:** 1890s – 1920s

**Description:** Two storey hipped roof house with a medium roof pitch, central hipped dormer, modern siding and undetermined foundation. Symmetrical front facade with extensive modifications throughout and large rear addition.

**Mitigation of Negative Impacts:** No negative impacts identified, therefore no further mitigation recommended.

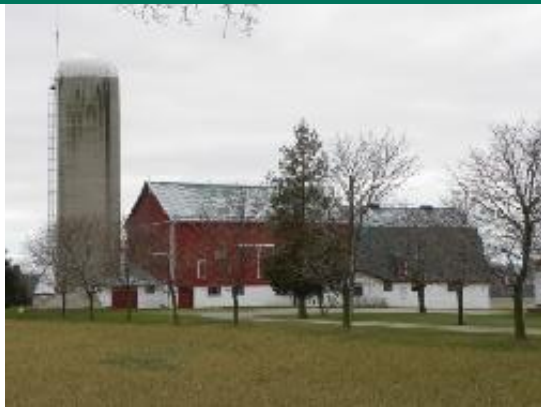
**Date:** 20<sup>th</sup> century

**Description:** Frame barn with gambrel roof addition and concrete silo. Both barns have metal roofs, modern siding and (possibly covered) concrete foundation.

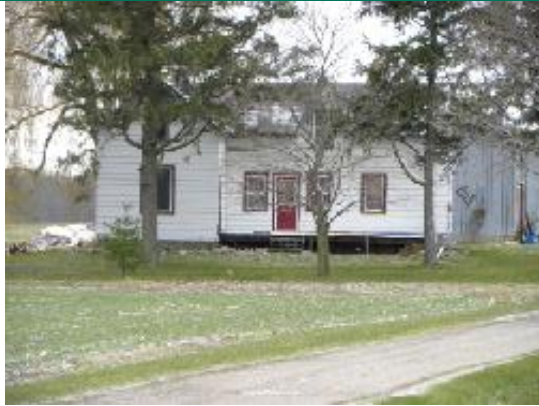
### Site #13 – 70683 Babylon Line (Municipality of South Huron)

**Date:** 1860s – 1890s

**Description:** One and one half storey L-shaped cross gabled house with a steep roof pitch and central gable, modern siding and a stone foundation. Vernacular Gothic Revival design influences include asymmetrical design and the central window extending into the steeply pitched central gable.

**Mitigation of Negative Impacts:** No negative impacts identified, therefore no further mitigation recommended.

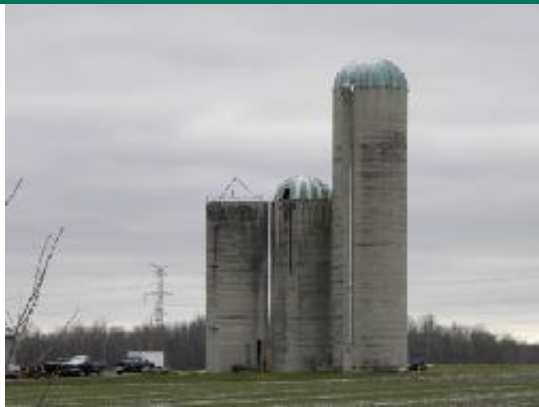
**Date:** 20<sup>th</sup> century

**Description:** Three concrete silos at the rear of the house.

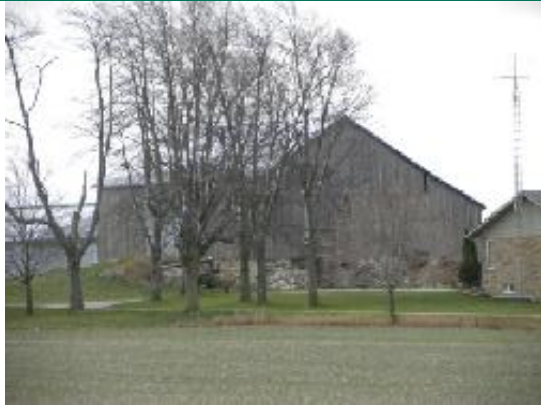
**Site #14 – 70524 Babylon Line (Municipality of South Huron)**

**Date:** 19<sup>th</sup> – early 20<sup>th</sup> century

**Description:** Frame barn with rear shed addition, metal roof, timber frame and stone foundation.

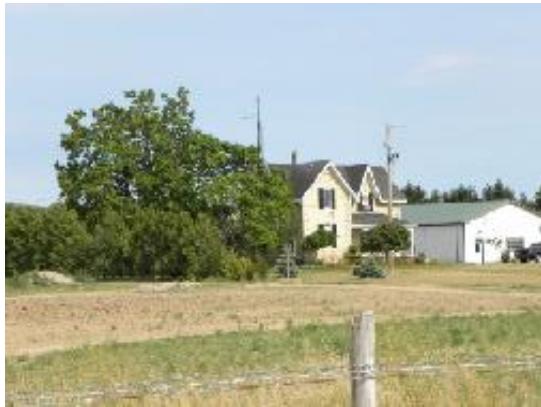
**Site #15 – 69865 Grand Bend Line (Municipality of South Huron)**

**Date:** 1860s – 1890s

**Description:** One and one half storey side gabled house with a medium roof pitch and prominent central gable, yellow brick exterior and stone foundation. Vernacular Gothic Revival design elements include symmetrical design, central door, steeply pitched central gable with a decorative rounded window arch and bargeboard with cross-bracing and open rake.

**Mitigation of Negative Impacts:** No negative impacts identified, therefore no further mitigation recommended.

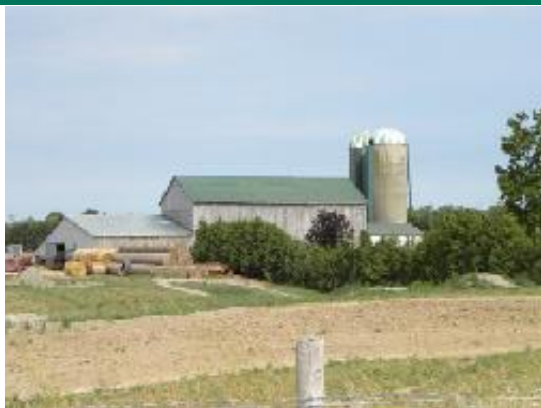
**Date:** 19<sup>th</sup> – 20<sup>th</sup> century

**Description:** Side gabled timber framed barn with metal roof and undetermined foundation. Two side shed additions and two concrete silos on site.

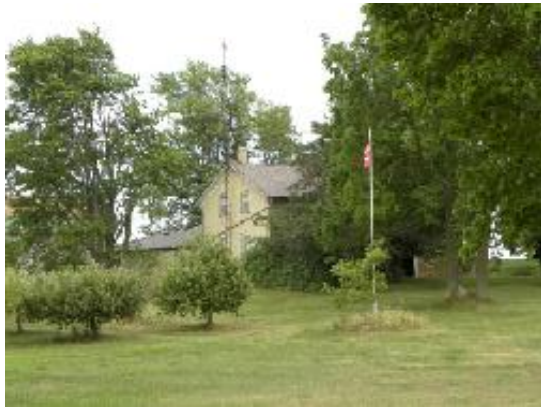
**Site #16 – 70260 Kirkton Line (Municipality of Bluewater)**

**Date:** 1860s – 1890s

**Description:** One and one half storey T-shaped side gabled house with a medium roof pitch, prominent central gable, yellow brick exterior, and stone foundation. Vernacular Gothic Revival design elements include symmetrical design with central porch and door, steeply pitched central gable with a decorative rounded window arch and brickwork. Rear addition.

**Mitigation of Negative Impacts:** No negative impacts identified, therefore no further mitigation recommended.

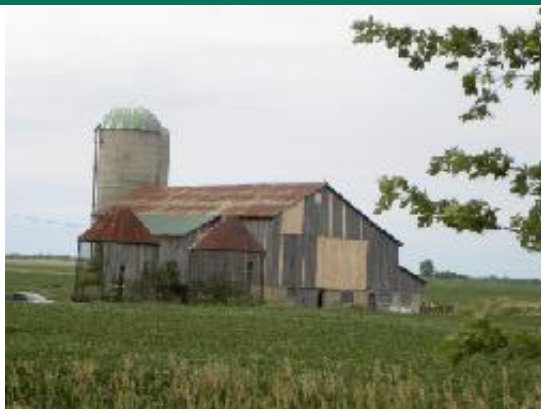
**Date:** 19<sup>th</sup> – early 20<sup>th</sup> century

**Description:** Timber frame, side gabled barn with a metal roof and wood siding, on a brick and concrete foundation. Concrete silo sits adjacent to barn.

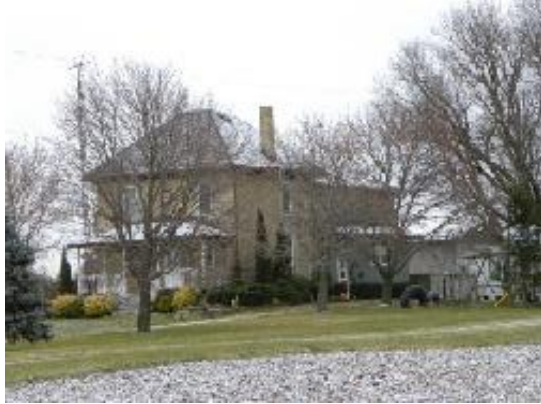
**Site #17 – 71002 Goshen Line (Municipality of South Huron)**

**Date:** 1890s – 1920s

**Description:** Two storey hipped roof house with a steep roof pitch, yellow brick exterior and undetermined foundation. Vernacular four-square design elements include symmetrical design, full width single storey roof pitch and square plan. Modern addition at rear.

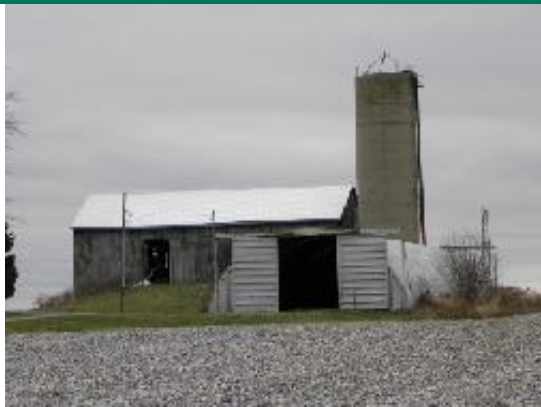
**Date:** Various (19<sup>th</sup> and 20<sup>th</sup> century)

**Description:** Frame barn with concrete silo and modern outbuilding. Barn has a metal roof, timber frame and undetermined foundation.

**Mitigation of Negative Impacts:** No negative impacts identified, therefore no further mitigation recommended.

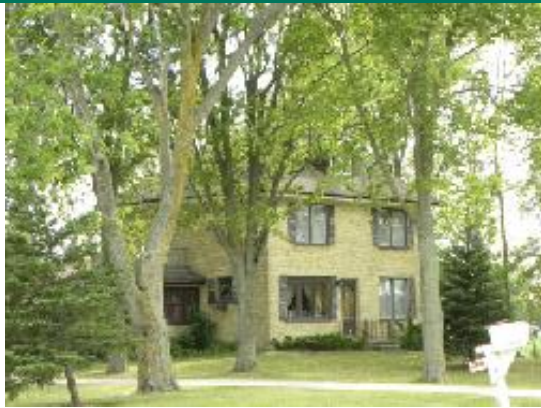
**Site #18 – 38439 Crediton Line (Municipality of South Huron )**

**Date:** 1890s – 1920s

**Description:** Two storey hipped roof house with a medium roof pitch, central hipped dormer, brick exterior and stone foundation. Symmetrical front facade with central doorway. Rear addition.

**Mitigation of Negative Impacts:** No negative impacts identified, therefore no further mitigation recommended.

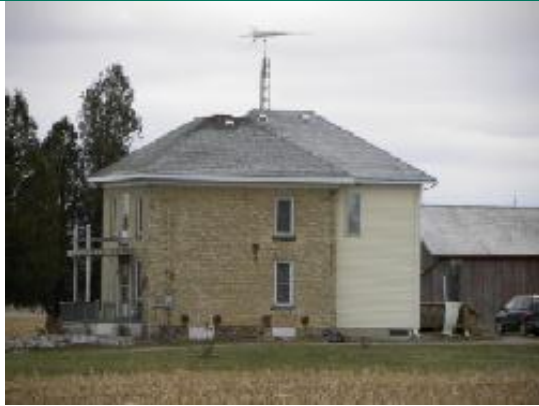
**Site #19 – 71002 Goshen Line (Municipality of South Huron)**

**Date:** 1890s – 1920s

**Description:** Two storey hipped roof house with medium roof pitch, yellow brick exterior and stone foundation. Vernacular design characteristics include symmetrical four-square design, small front entry porch, wide eaves and remnants of decorative brackets. Extensive addition at rear.

**Mitigation of Negative Impacts:** No negative impacts identified, therefore no further mitigation recommended.

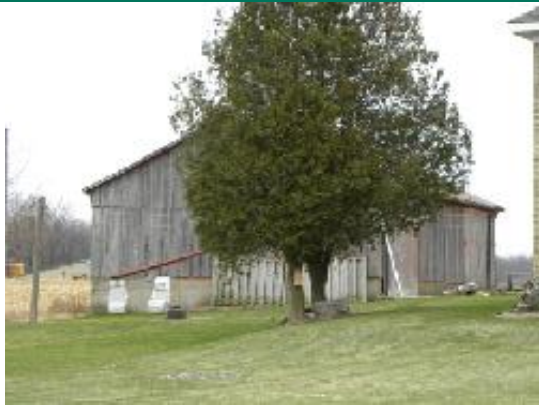
**Date:** 20<sup>th</sup> century

**Description:** Two-bay shed with metal roof, timber frame and concrete foundation.

**Mitigation of Negative Impacts:** No negative impacts identified, therefore no further mitigation recommended.

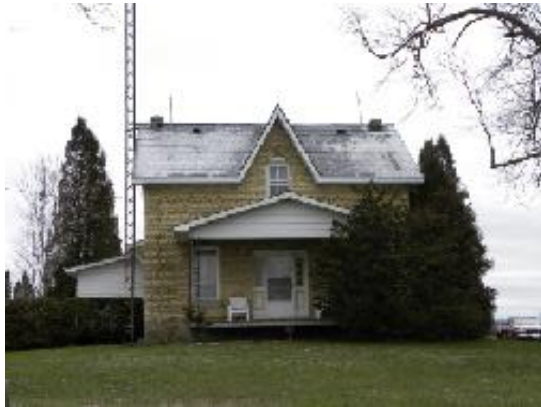
### Site #20 – 38060 Huron Street (Municipality of South Huron)

**Date:** 1860s – 1890s

**Description:** One and one half storey T-shaped side gabled house with a medium roof pitch and prominent central gable, yellow brick exterior, and concrete covered foundation. Vernacular Gothic Revival design elements include symmetrical design, central door, steeply pitched central gable with a decorative rounded window arch and brickwork. Rear addition.

**Mitigation of Negative Impacts:** No negative impacts identified, therefore no further mitigation recommended.

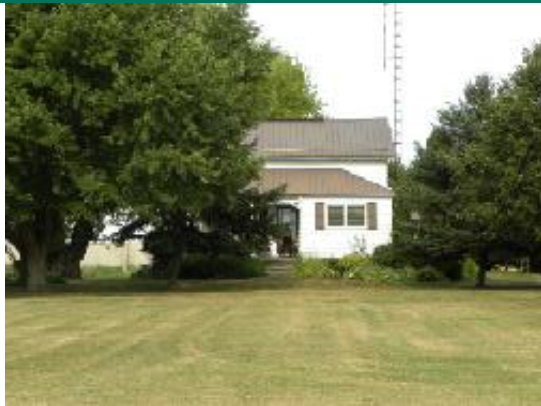
**Site #21 – 70112 Bronson Line (Municipality of Bluewater)**

**Date:** Late 19<sup>th</sup> century

**Description:** One and one half storey side gabled house with medium roof pitch, modern siding and concrete foundation. Symmetrical in design with a full front porch.

**Mitigation of Negative Impacts:** Impacts were not identified, therefore mitigation is not recommended or necessary.

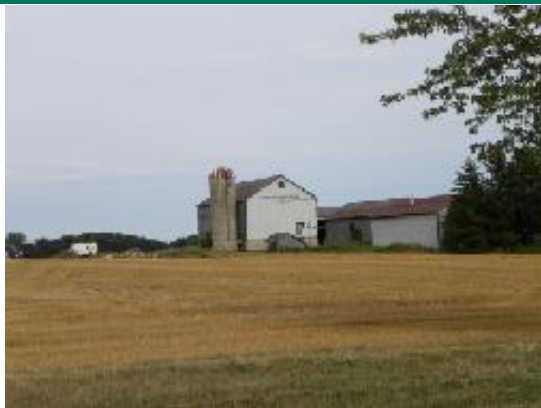
**Date:** 19<sup>th</sup> – 20<sup>th</sup> century

**Description:** Timber framed side gabled barn with a metal roof and wood siding, on a concrete foundation. Rear and side additions. Concrete silo sits adjacent to barn.

**Mitigation of Negative Impacts:** Impacts were not identified, therefore mitigation is not recommended or necessary.

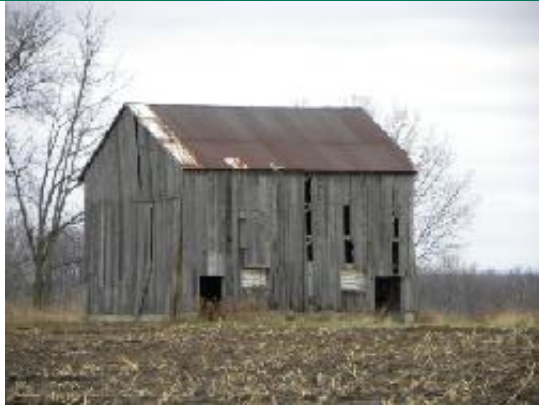
### Site #22 – 35526 South Road (Municipality of South Huron)

**Date:** 19<sup>th</sup> – early 20<sup>th</sup> century

**Description:** Frame barn with metal roof, timber frame and concrete foundation. Barn is situated at the centre of an agricultural field.

**Mitigation of Negative Impacts:** No negative impacts identified, therefore no further mitigation recommended.

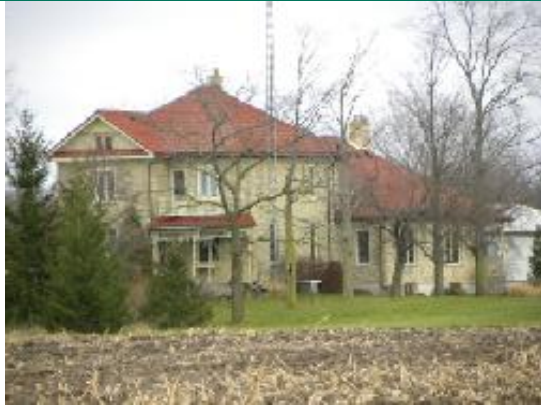
**Site #23 – 69436 Mollard Line (Municipality of South Huron)**

**Date:** 1890s – 1920s

**Description:** Two storey, asymmetrical house, with a hipped roof, yellow brick and an undetermined foundation. Vernacular Queen Anne design elements include two storey gabled projection, decorative spindle work and turned wood columns. Rear addition.

**Mitigation of Negative Impacts:** No negative impacts identified, therefore no further mitigation recommended.

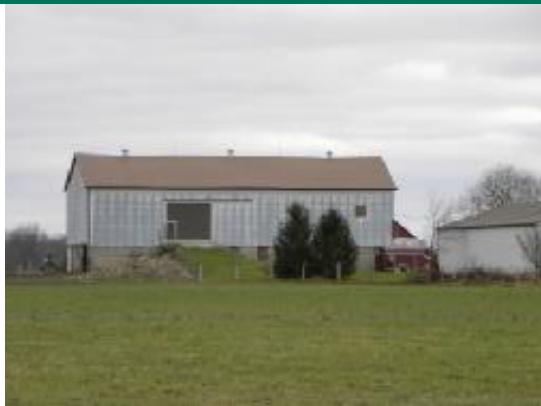
**Date:** 20<sup>th</sup> century

**Description:** Side gabled, timber frame barn on a concrete or concrete foundation. Roof and sidewalls appear to be painted metal.

**Mitigation of Negative Impacts:** No negative impacts identified, therefore no further mitigation recommended.

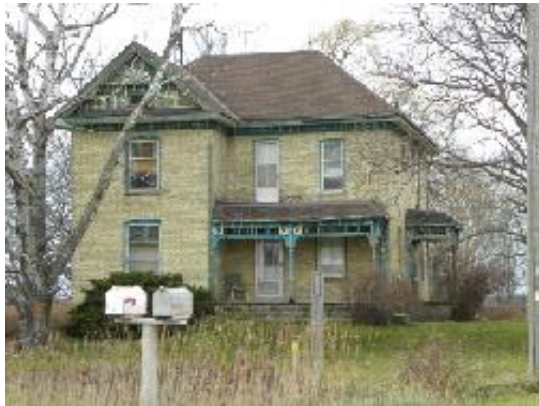
### Site #24 – 35652 Greenway Drive (Municipality of South Huron)

**Date:** 1890s – 1920s

**Description:** Two storey hipped roof house with lower cross gable on the front facade and medium roof pitch, yellow brick exterior and rusticated concrete block foundation. Vernacular Queen Anne design elements include asymmetrical design, front facing gables, decorative gable ornaments featuring a sunburst, dentil-like brackets, and front and side porches with delicate spindle work along porch columns. Rear addition.

**Mitigation of Negative Impacts:** No negative impacts identified, therefore no further mitigation recommended.

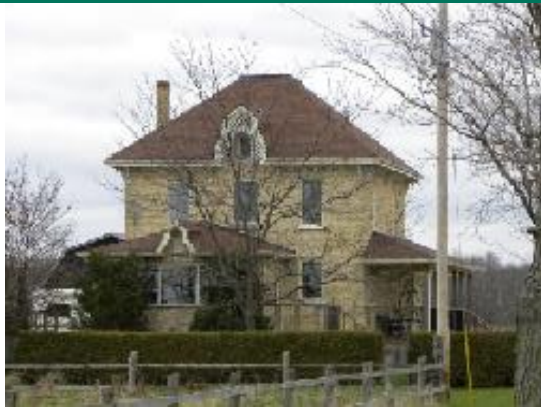
**Site #25 – 69668 Grand Bend Line (Municipality of South Huron)**

**Date:** 1890s – 1920s

**Description:** Two storey hipped roof house with steep pitch, yellow brick exterior and stone foundation. Vernacular design characteristics include symmetrical rectangular design, decorative dentils and brackets as well as a central dormer with rounded central window. Addition at rear.

**Mitigation of Negative Impacts:** No negative impacts identified, therefore no further mitigation recommended.

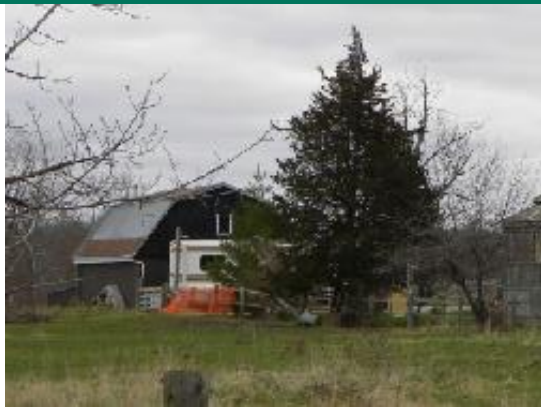
**Date:** 20<sup>th</sup> century

**Description:** Gambrel roof shed with metal roof, modern siding and an undetermined foundation.

**Mitigation of Negative Impacts:** No negative impacts identified, therefore no further mitigation recommended.

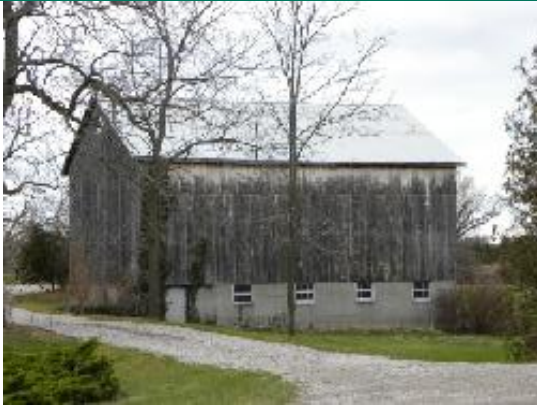
**Site #26 – 69689 Grand Bend Line (Municipality of South Huron)**

**Date:** 19<sup>th</sup> – early 20<sup>th</sup> century

**Description:** Frame barn with metal roof, timber siding and a concrete foundation with windows.

**Mitigation of Negative Impacts:** No negative impacts identified, therefore no further mitigation recommended.

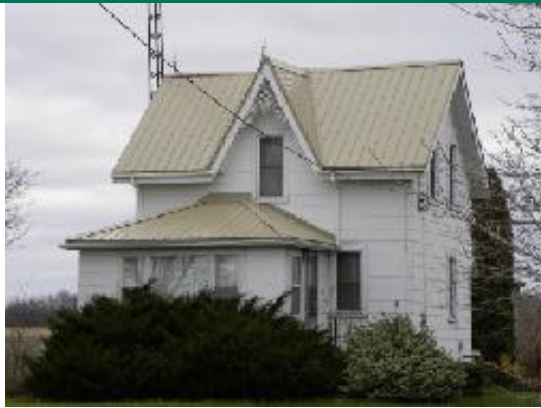
**Site #27 – 69724 Grand Bend Line (Municipality of South Huron)**

**Date:** 1860s – 1890s

**Description:** One and one half storey side gabled house with a steep roof pitch and prominent central gable, modern siding and stone foundation. Vernacular Gothic Revival design elements include symmetrical design, central window extended into a steeply pitched gable and decorative cross bracing. Rear addition.

**Mitigation of Negative Impacts:** No negative impacts identified, therefore no further mitigation recommended.

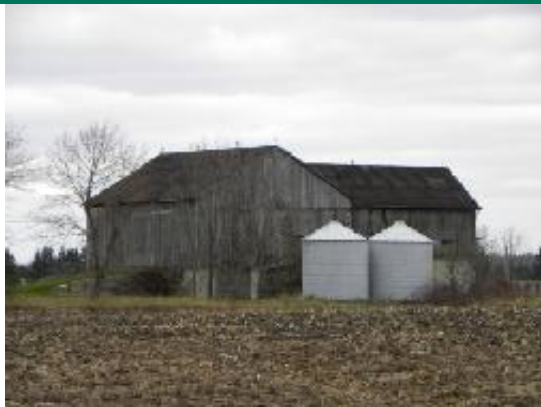
**Date:** 19<sup>th</sup> – early 20<sup>th</sup> century

**Description:** Frame barn with asphalt sheet roof, timber frame and concrete block foundation. Two metal bins adjacent.

**Mitigation of Negative Impacts:** No negative impacts identified, therefore no further mitigation recommended.

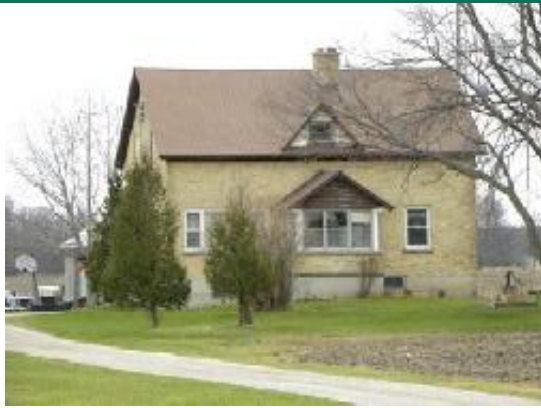
### Site #28– 69804 Shipka Line (Municipality of South Huron)

**Date:** Late 19<sup>th</sup> century

**Description:** One and one half storey yellow brick, side gabled, metal roofed, house on a concrete foundation. House has a small central gabled dormer over a gable roofed, enclosed porch/entry hall with a half-height brick wall on a similar foundation as the house.

**Mitigation of Negative Impacts:** Impacts were not identified, therefore mitigation is not recommended or necessary.

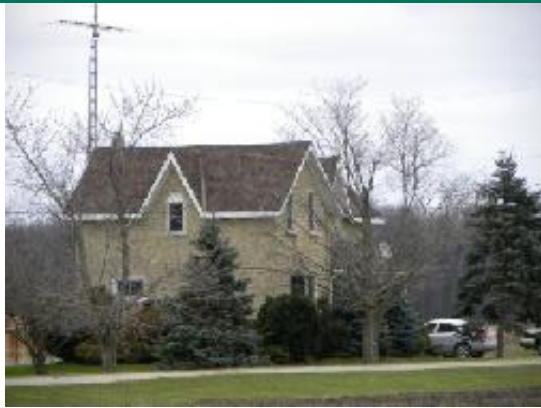
**Site #29 – 69872 Shipka Line (Municipality of South Huron)**

**Date:** Late 19<sup>th</sup> century

**Description:** One and one half storey yellow brick, side gabled, metal roofed, house on an undetermined foundation. House has a small central gable over a side gable roofed, enclosed porch/entry hall with a half-height brick wall on a similar foundation as the house.

**Mitigation of Negative Impacts:** No negative impacts identified, therefore no further mitigation recommended.

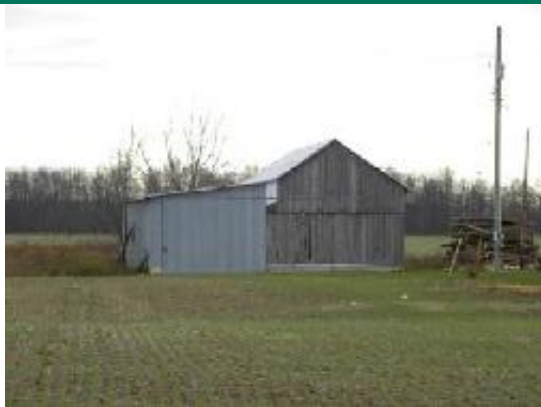
**Date:** 19<sup>th</sup> – 20<sup>th</sup> century

**Description:** Timber framed, wood sided, metal roofed, side gabled barn on a concrete foundation. Side shed addition.

**Mitigation of Negative Impacts:** No negative impacts identified, therefore no further mitigation recommended.

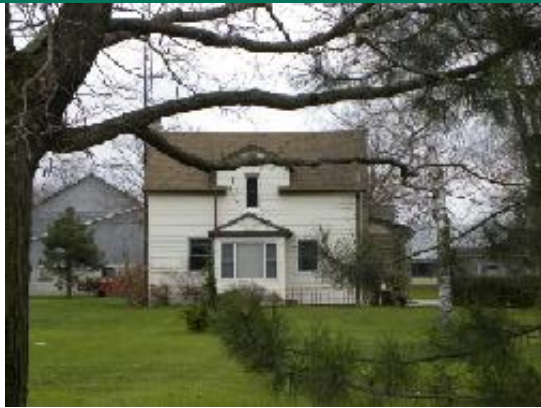
**Site #30 – 69872 Shipka Line (Municipality of South Huron)**

**Date:** Late 19<sup>th</sup> century

**Description:** One and one half storey side gabled house with a steep roof pitch and prominent central dormer, modern siding and undetermined foundation. Vernacular design elements include symmetrical design, central window extending into the dormer. Rear addition and modern front porch entrance.

**Mitigation of Negative Impacts:** Impacts were not identified, therefore mitigation is not recommended or necessary.

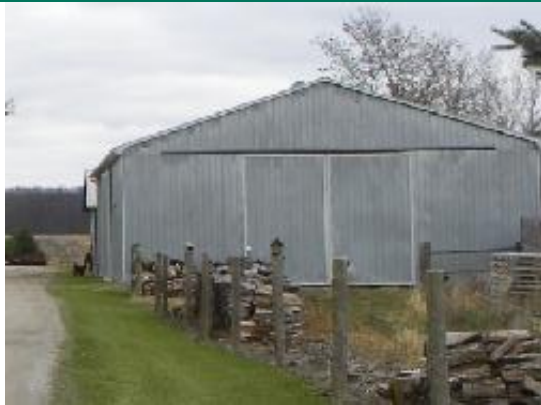
**Date:** 20<sup>th</sup> century

**Description:** Front gabled shed with metal roof, metal exterior and undetermined foundation.

**Mitigation of Negative Impacts:** Impacts were not identified, therefore mitigation is not recommended or necessary.

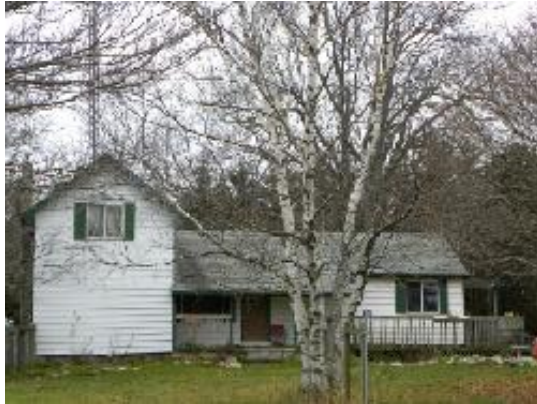
### Site #31 – 69881 Shipka Line (Municipality of South Huron)

**Date:** Various (19<sup>th</sup> and 20<sup>th</sup> century)

**Description:** One and one half storey L-shaped house with cross gabled roof with a medium pitch, modern siding and stone foundation. Front gabled single storey extends from side gabled one and one half storey portion. Modern rear and side additions.

**Mitigation of Negative Impacts:** Impacts were not identified, therefore mitigation is not recommended or necessary.

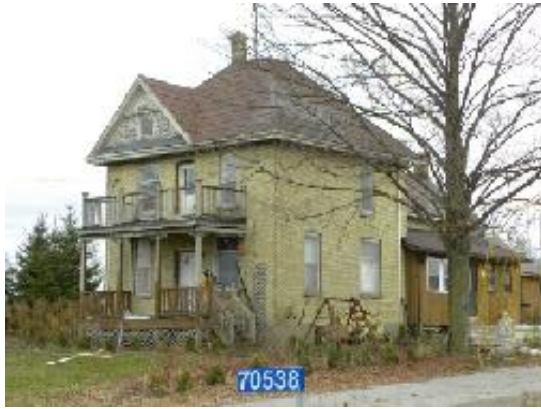
### Site #32 – 70538 Shipka Line (Municipality of South Huron)

**Date:** 1890s – 1920s

**Description:** Two storey hipped roof house with lower cross gable and medium roof pitch, yellow brick exterior with two storey porch and concrete covered foundation. Vernacular Queen Anne design elements include asymmetrical design, front facing gables, decorative gable ornaments including starburst, and dentils. Rear addition.

**Mitigation of Negative Impacts:** No negative impacts identified, therefore no further mitigation recommended.

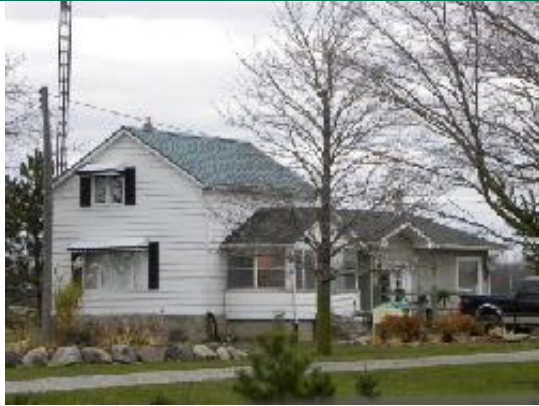
**Site #33 – 70352 Shipka Line (Municipality of South Huron)**

**Date:** 19<sup>th</sup> – early 20<sup>th</sup> century

**Description:** One and one half storey side gabled house with a medium roof pitch, modern siding and concrete foundation. Rear addition and modern covered central entryway.

**Mitigation of Negative Impacts:** No negative impacts identified, therefore no further mitigation recommended.

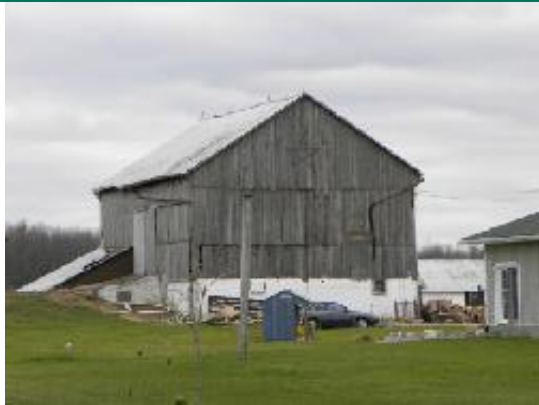
**Date:** Various (19<sup>th</sup> and 20<sup>th</sup> century)

**Description:** Primary barn structure is a frame barn with metal roof, timber frame and concrete covered foundation. Single storey shed addition located at rear.

**Mitigation of Negative Impacts:** No negative impacts identified, therefore no further mitigation recommended.

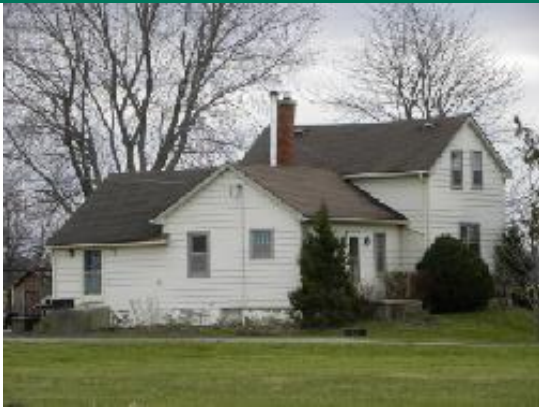
**Site #34 – 70298 Shipka Line (Municipality of South Huron)**

**Date:** 19<sup>th</sup> – early 20<sup>th</sup> century

**Description:** One and one half storey front gabled house with single storey side gable, medium roof pitch, modern siding and painted concrete foundation.

**Mitigation of Negative Impacts:** Impacts were not identified, therefore mitigation is not recommended or necessary

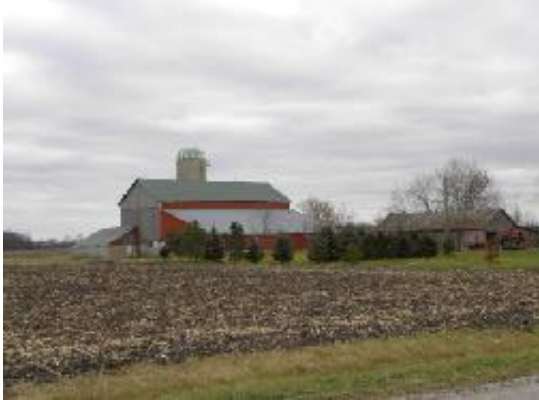
**Date:** Various (19<sup>th</sup> and 20<sup>th</sup> century)

**Description:** Primary barn is a frame barn with multiple shed additions, metal roof, timber frame and stone foundation. Concrete silo at rear and single storey shed with metal roof, timber frame and undetermined foundation.

**Mitigation of Negative Impacts:** No negative impacts identified, therefore no further mitigation recommended.

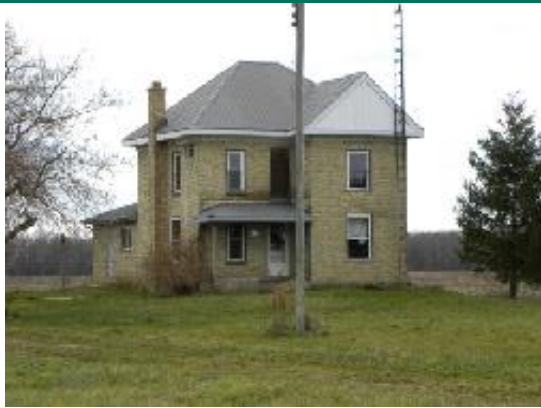
**Site #35 – 70205 Shipka Line (Municipality of South Huron)**

**Date:** 1890s – 1920s

**Description:** Two storey hipped roof house with lower cross gable and medium roof pitch, yellow brick exterior and apparent concrete foundation. Vernacular Queen Anne design elements include asymmetrical design, front facing gable, decorative cornices and two storey front porch. Covered front cross gable and modern porch.

**Mitigation of Negative Impacts:** No negative impacts identified, therefore no further mitigation recommended.

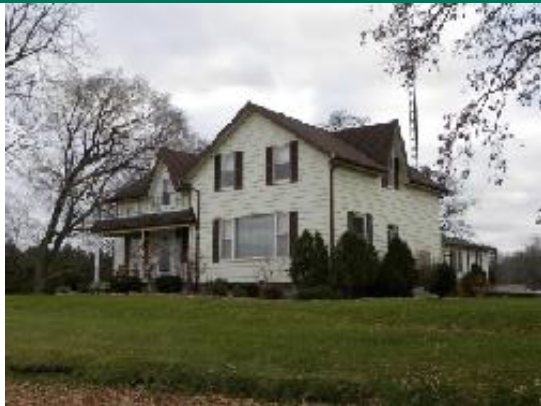
**Site #36 – 37343 Crediton Line (Municipality of South Huron)**

**Date:** 1860s – 1890s

**Description:** One and one half storey cross gabled yellow brick house with a medium roof pitch and multiple steeply pitched cross gables, modern siding and undetermined foundation. Asymmetrical design with central window that extends into front gable. Front porch with central entryway. Addition at rear.

**Mitigation of Negative Impacts:** No negative impacts identified, therefore no further mitigation recommended.

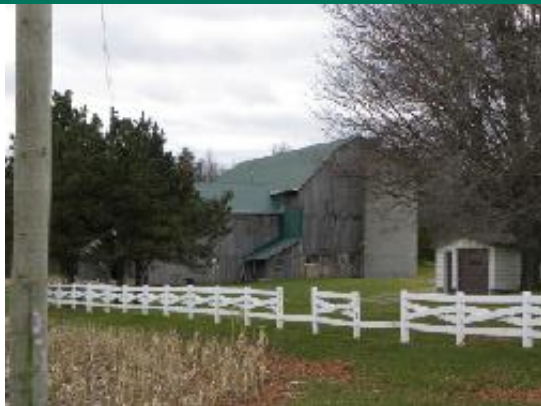
**Date:** Various (19<sup>th</sup> and 20<sup>th</sup> century)

**Description:** Primary barn is a gambrel roofed frame barn with rear gable addition, a metal roof, timber frame and stone foundation. The site contains multiple out buildings including a single storey yellow brick structure.

**Mitigation of Negative Impacts:** No negative impacts identified, therefore no further mitigation recommended.

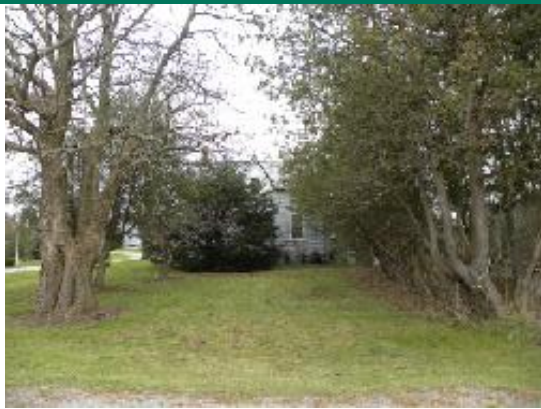
**Site #37 – 37391 Crediton Line (Municipality of South Huron)**

**Date:** 1860s – 1890s

**Description:** One and one half storey side gabled house with a steep roof pitch and prominent central gable, modern siding and concrete foundation. Vernacular Gothic Revival design elements include symmetrical design and a central window extending into the gable with possible wood shingles.

**Mitigation of Negative Impacts:** No negative impacts identified, therefore no further mitigation recommended.
