## HERITAGE ASSESSMENT REPORT

**NextEra Energy Canada, ULC  
Goshen Wind Energy Centre  
Municipalities of Bluewater  
and South Huron  
Huron County, Ontario**

**Report Number:** 10-1151-0201-3200-R01

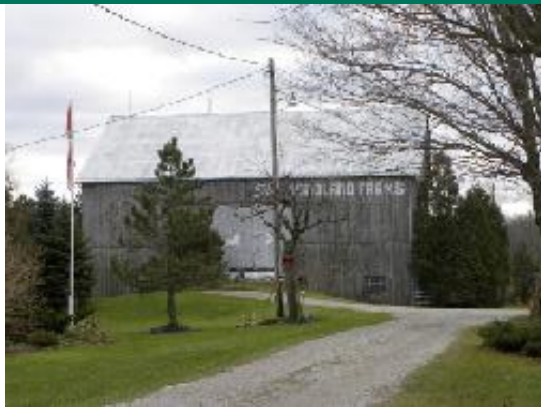
**Date:** 19<sup>th</sup> – early 20<sup>th</sup> century

**Description:** Frame barn with metal roof, timber frame and undetermined foundation.

**Mitigation of Negative Impacts:** No negative impacts identified, therefore no further mitigation recommended.

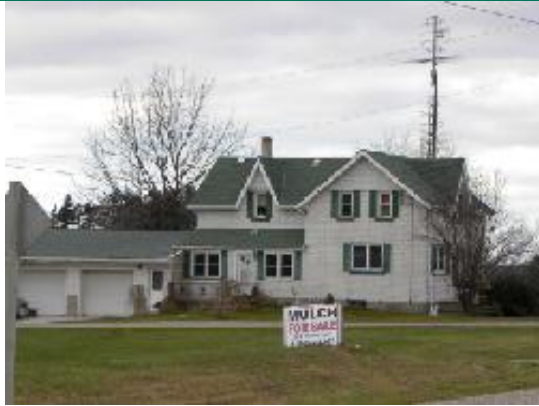
**Site #38 – 69661 Bronson Line (Municipality of South Huron)**

**Date:** 1860s – 1890s

**Description:** One and one half storey cross gabled brick veneer house with a medium roof pitch, medium pitched cross gable, steeply pitched gable and concrete foundation. Symmetrical design appears to be a T-plan with a central window that reaches into the central gable. Modern addition at rear, small front porch and covered side porch.

**Mitigation of Negative Impacts:** No negative impacts identified, therefore no further mitigation recommended.

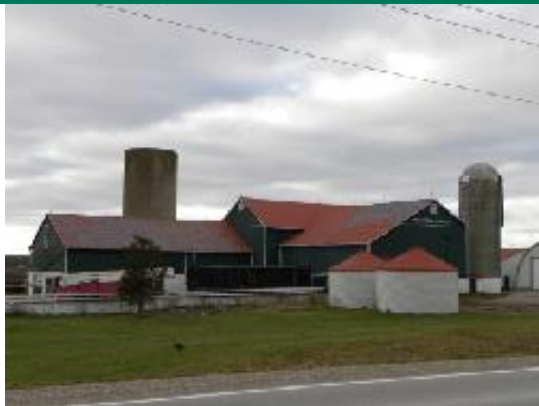
**Date:** Various (19<sup>th</sup> and 20<sup>th</sup> century)

**Description:** Primary barn appears to be a frame barn with two shed additions, metal roof, timber frame and concrete foundation. Two concrete silos onsite and two metal bins onsite with additional outbuildings.

**Mitigation of Negative Impacts:** No negative impacts identified, therefore no further mitigation recommended.

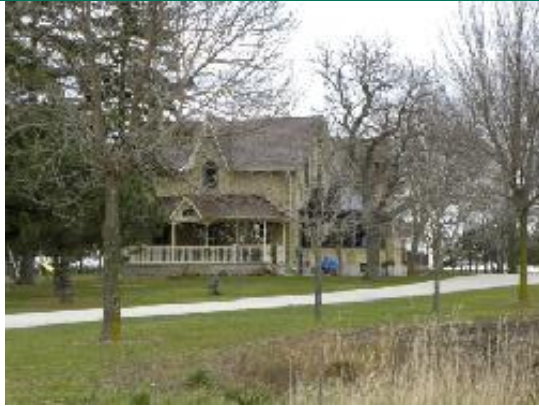
### Site #39 –69562 Bronson Line (Municipality of South Huron)

**Date:** 1860s – 1890s

**Description:** One and one half storey side gabled house with a steep roof pitch and prominent central gable, yellow brick exterior and concrete covered foundation. Vernacular Gothic Revival design elements include symmetrical design, rounded window extending into the steeply pitched central gable, detailed brick work throughout including the quoin-like detailing. Side and rear additions.

**Mitigation of Negative Impacts:** No negative impacts identified, therefore no further mitigation recommended.

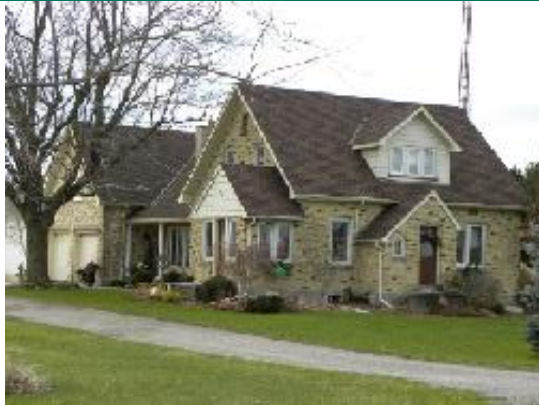
**Site #40 – 69881 Babylon Line (Municipality of South Huron)**

**Date:** Mid 20<sup>th</sup> century

**Description:** One and one half storey side gabled house with a steep roof pitch and prominent central dormer, poly chromatic yellow and red brick exterior and covered concrete foundation. Extensive rear addition and modifications throughout.

**Mitigation of Negative Impacts:** Impacts were not identified, therefore mitigation is not recommended or necessary.

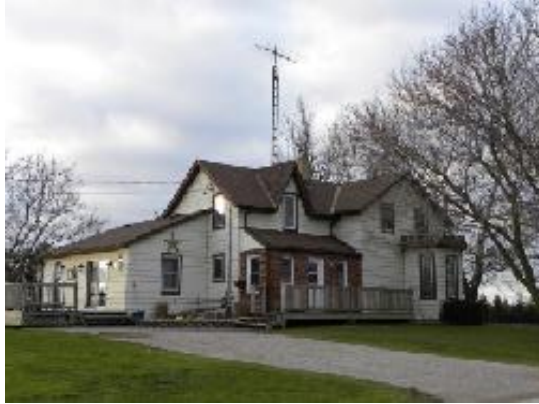
### Site #41 – 69855 King Street South/Parr Line (Municipality of South Huron)

**Date:** 1860s – 1890s

**Description:** One and one half storey cross gabled house with a steep roof pitch, medium pitched cross gable steeply pitched front gable, modern siding and undetermined foundation. Design appears to be an L-plan with a window that reaches into the central gable. Side addition and covered front porch with brick veneer.

**Mitigation of Negative Impacts:** No negative impacts identified, therefore no further mitigation recommended.

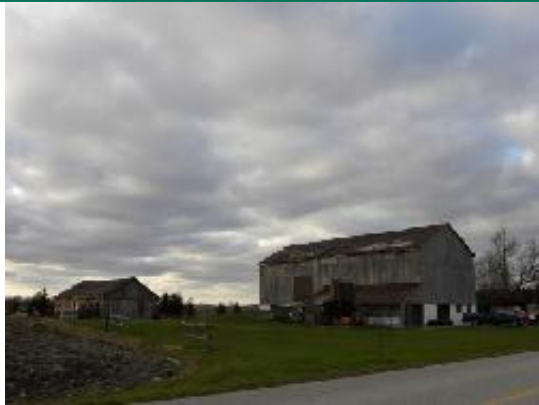
**Date:** Various (19<sup>th</sup> and 20<sup>th</sup> century)

**Description:** Frame barn with metal roof, timber frame and concrete foundation. Secondary structure is a single storey shed with metal roof, timber frame and undetermined foundation.

**Mitigation of Negative Impacts:** No negative impacts identified, therefore no further mitigation recommended.

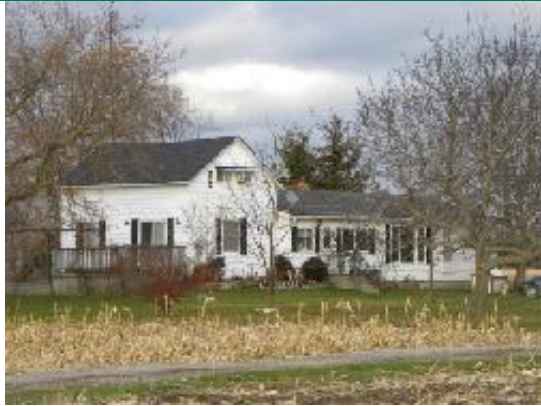
**Site #42 – 70548 Blackbush Line (Municipality of South Huron)**

**Date:** Late 19<sup>th</sup> century

**Description:** One and one half storey side gabled house with medium roof pitch, modern siding and undetermined foundation. Extensive addition at rear.

**Mitigation of Negative Impacts:** Impacts were not identified, therefore mitigation is not recommended or necessary.

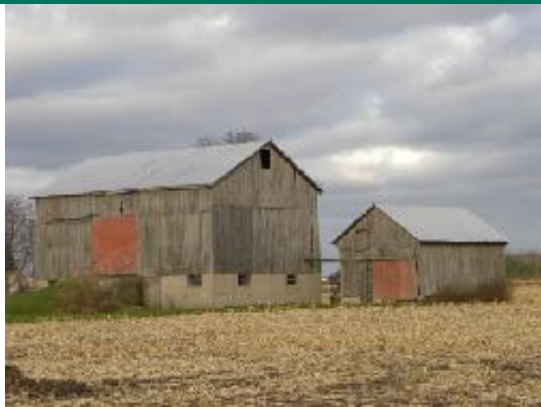
**Date:** 19<sup>th</sup> – early 20<sup>th</sup> century

**Description:** Frame barn with single storey shed adjacent to barn. Both structures have metal roofs, timber frames and concrete foundations.

**Mitigation of Negative Impacts:** No negative impacts identified, therefore no further mitigation recommended.

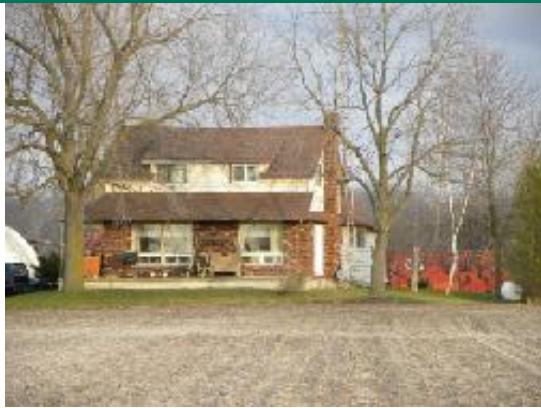
**Site #43 – 70600 Blackbush Line (Municipality of South Huron)**

**Date:** Mid 20<sup>th</sup> century

**Description:** One and one half storey side gabled house with steep roof pitch, central shed dormer, modern siding and brick veneer exterior and undetermined foundation. Symmetrical design with covered front porch. Addition at rear.

**Mitigation of Negative Impacts:** Impacts were not identified, therefore mitigation is not recommended or necessary.

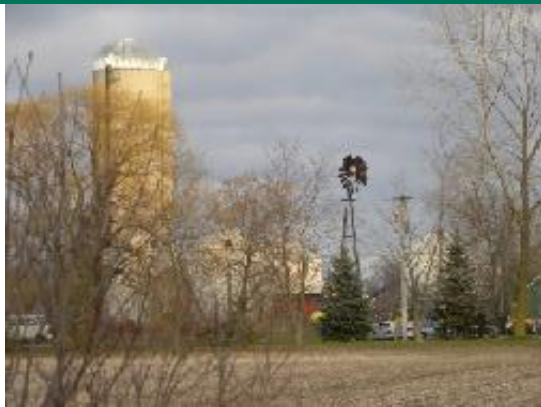
**Date:** 20<sup>th</sup> century

**Description:** Single concrete silo with at least three metal bins onsite.

**Mitigation of Negative Impacts:** Impacts were not identified, therefore mitigation is not recommended or necessary.

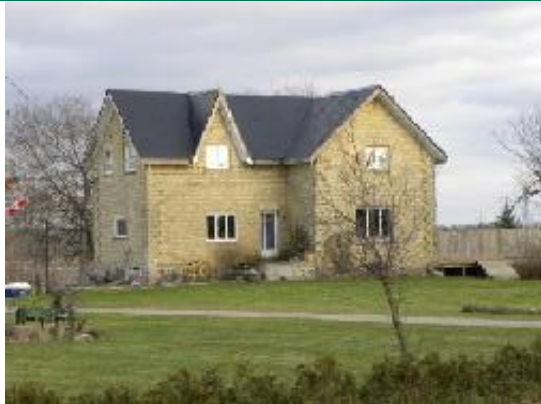
**Site #44 – 70370A and 70370B Goshen Line (Municipality of South Huron)**

**Date:** 1860s – 1890s

**Description:** One and one half storey side gabled house with a steep roof pitch and steeply pitched gable, yellow brick exterior and stone foundation. Asymmetrical in design with Vernacular Gothic Revival design characteristics including a window extending into the dormer of the front facade, open rakes with remnants of brackets, intricate brick frieze and quoin-like triangular detailing.

**Mitigation of Negative Impacts:** No negative impacts identified, therefore no further mitigation recommended.

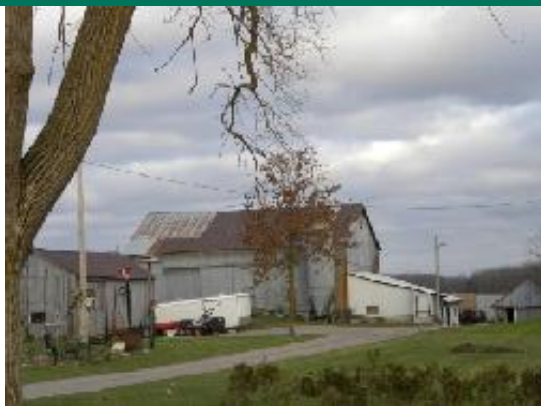
**Date:** Various (20<sup>th</sup> century)

**Description:** Frame barn with later shed addition. Barn has a metal roof, metal siding, and concrete foundation. Various outbuildings onsite.

**Mitigation of Negative Impacts:** No negative impacts identified, therefore no further mitigation recommended.

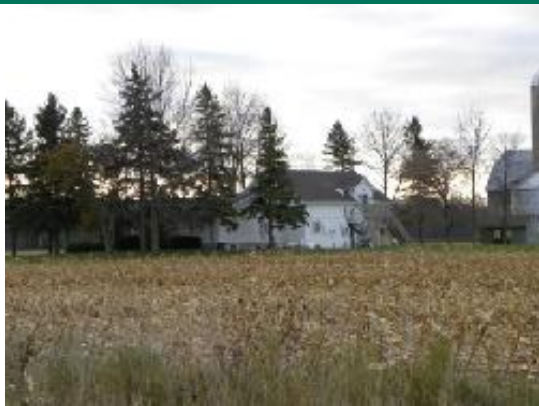
**Site #45 – 35545 South Road (Municipality of South Huron)**

**Date:** Late 19<sup>th</sup> century

**Description:** One and one half storey end-gabled house at the rear. Second structure has white vertical wood siding and asphalt shingle roof with one visible gabled dormer with attached second storey porch. Modern single-storey, low pitched, side gabled addition on concrete foundation.

**Mitigation of Negative Impacts:** Impacts were not identified, therefore mitigation is not recommended or necessary.

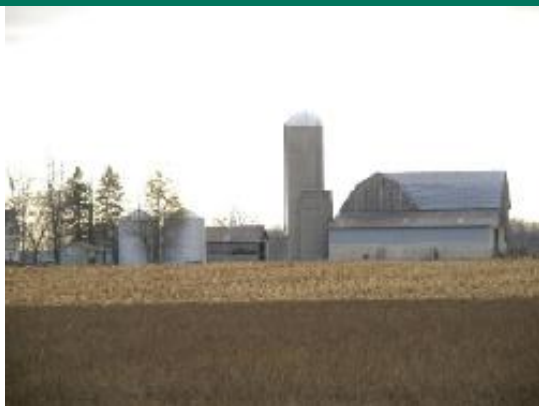
**Date:** Various (19<sup>th</sup> and 20<sup>th</sup> century)

**Description:** Multi-structure barn complex includes a timber framed, wood sided, gambrel roofed, T-plan barn with metal roof panels. A full length metal roofed, metal-sided, shed addition attached. Two concrete silos, two metal bins, and one end-gabled metal-roofed, wood-sided out building.

**Mitigation of Negative Impacts:** No negative impacts identified, therefore no further mitigation recommended.

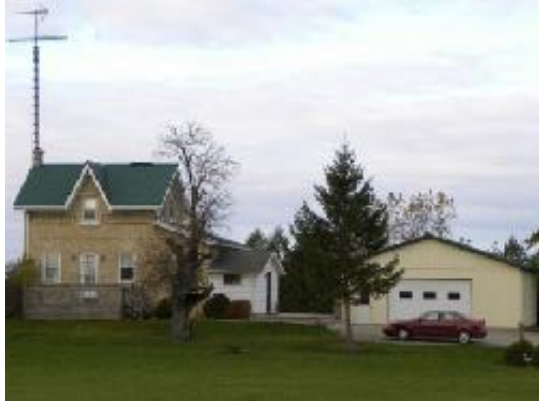
**Site #46 – 69481 Bronson Line (Municipality of South Huron )**

**Date:** 1860-1890s

**Description:** One and one half storey side gabled, yellow brick house with a green painted metal roof, steeply pitched center gabled dormer with a single window on an undetermined foundation. House has inset decorative-frieze brickwork and yellow brick shed addition to one gable end with a wood framed, metal sided, asphalt shingled addition attached to it. Modern garage.

**Mitigation of Negative Impacts:** No negative impacts identified, therefore no further mitigation recommended.

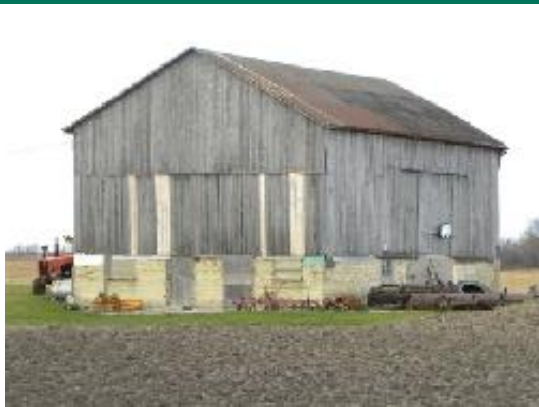
**Date:** 19<sup>th</sup> – early 20<sup>th</sup> century

**Description:** Timber framed, wood sided, metal roofed, side gabled barn on a yellow brick foundation.

**Mitigation of Negative Impacts:** No negative impacts identified, therefore no further mitigation recommended.

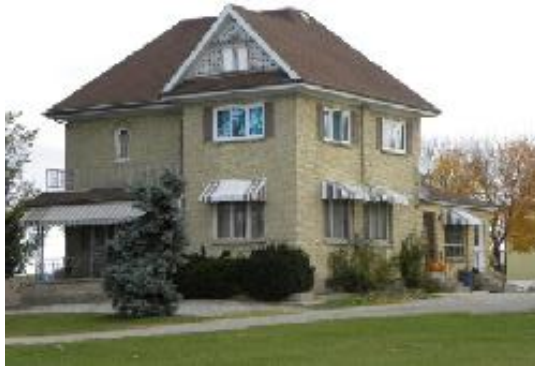
### Site #47 – 69482 Bronson Line (Municipality of South Huron)

**Date:** 1890s – 1920s

**Description:** Two storey, hipped roof, yellow brick house on a concrete foundation with a double window and decorative gingerbread work in L gable end. Second storey porch sits in L crux and forms the roof of the first floor porch with modern metal railings and columns. Second storey has a keyhole window above porch and first floor windows are covered with metal awnings. Rear addition with an undetermined roof line and foundation. Modern garage at rear.

**Mitigation of Negative Impacts:** No negative impacts identified, therefore no further mitigation recommended.

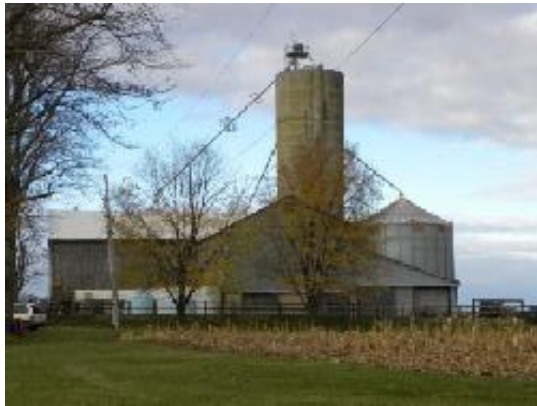
### Site #48 – 69713 Goshen Line (Municipality of South Huron)

**Date:** Various (19<sup>th</sup> and 20<sup>th</sup> century)

**Description:** Wood-sided, white-painted gabled metal roof, on an L-plan barn with metal sided, metal roofed shed addition attached to L. Concrete silo and metal bin adjacent.

**Mitigation of Negative Impacts:** No negative impacts identified, therefore no further mitigation recommended.

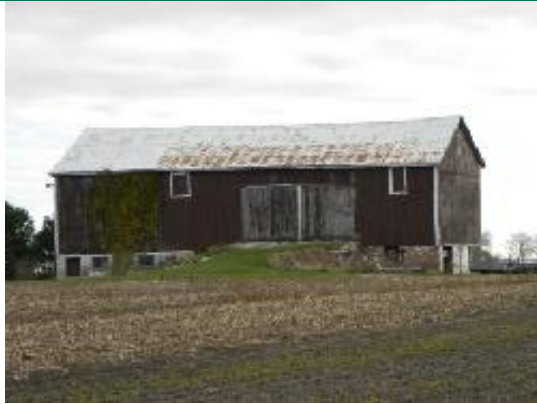
### Site #49 – 38425 Dashwood Line (Municipality of South Huron)

**Date:** 20<sup>th</sup> century

**Description:** Side gabled, timber framed, white painted metal roofed barn with brown painted wood-siding on a brick foundation. Barn has one wood sided, metal roofed, one bay, full height gabled addition on a concrete foundation attached to one of the gabled ends, extending the original roof and sidewall lines.

**Mitigation of Negative Impacts:** Impacts were not identified, therefore mitigation is not recommended or necessary.

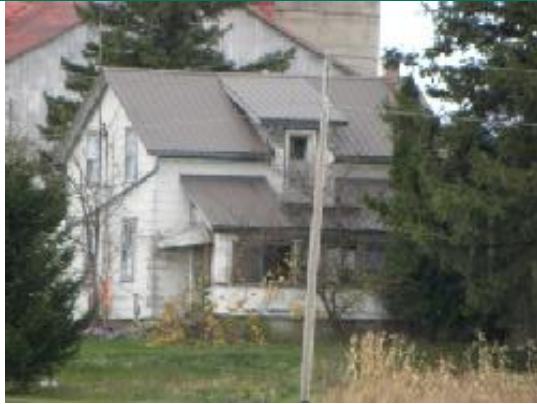
**Site #50 – 72299 Babylon Line (Municipality of Bluewater)**

**Date:** Late 19<sup>th</sup> century

**Description:** One and one half storey side gabled, metal roofed, metal sided, house with a shed dormer and three quarter length enclosed porch under a metal panel shed roof.

**Mitigation of Negative Impacts:** Impacts were not identified, therefore mitigation is not recommended or necessary.

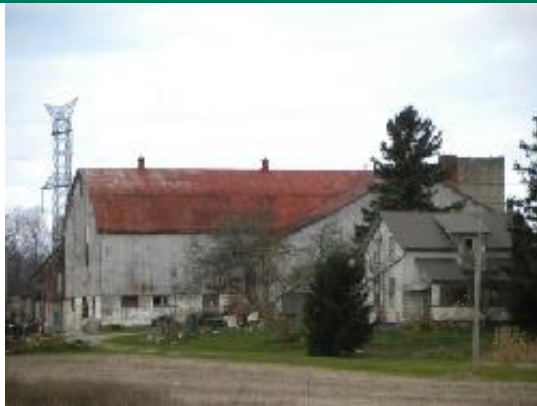
**Date:** 19<sup>th</sup> century

**Description:** Timber framed gambrel roofed barn with metal panel roof, wood siding, on a concrete foundation. One large gable-roofed addition creates an L-plan while a shed roof addition at the rear.

**Mitigation of Negative Impacts:** No negative impacts identified, therefore no further mitigation recommended.

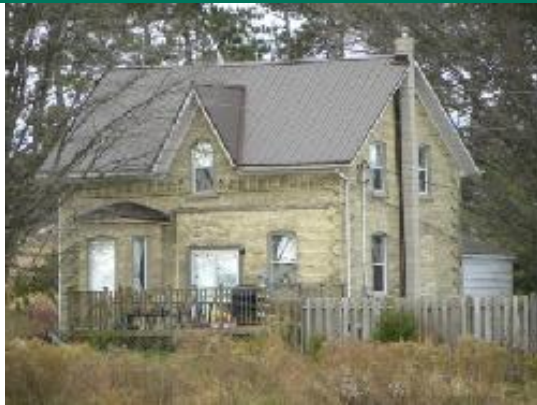
### Site #51 – 72257 Babylon Line (Municipality of Bluewater)

**Date:** 1860-1890s

**Description:** One and one half storey yellow brick, side gabled, house with a peaked central dormer over an arched window on an undetermined foundation. House has modern metal panel roof, with decorative raised brick frieze and triangular quoin-like detailing. Unroofed deck porch, modern windows and front door.

**Mitigation of Negative Impacts:** No negative impacts identified, therefore no further mitigation recommended.

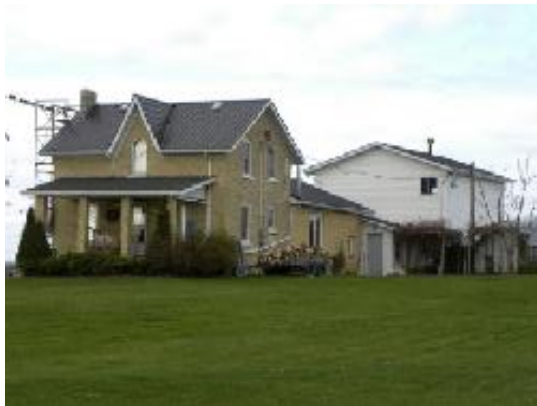
### Site #52 – 71953 Babylon Line (Municipality of Bluewater)

**Date:** 1860-1890s

**Description:** One and one half storey yellow brick, side gabled house with a steeply peaked central dormer over an arched window on an undetermined foundation. House has a full width covered front porch with a shed roof supported by yellow brick columns. A yellow brick, gable roofed, single storey addition is attached to the back of the house. Two storey modern gabled garage at the rear.

**Mitigation of Negative Impacts:** No negative impacts identified, therefore no further mitigation recommended.

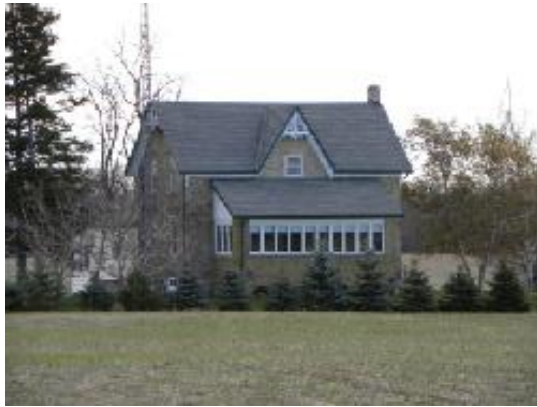
**Site #53 – 72362 Goshen Line (Municipality of Bluewater)**

**Date:** 1860-1890s

**Description:** One and one half storey side gabled yellow brick house with peaked central gable over a single square window on a stone foundation. House has decorative raised brick work at frieze, over gable-end windows, triangular quoin-like detailing and gingerbread work in gables and along eaves with some decorative brackets. House has a modern enclosed yellow brick, shed roof porch with modern windows.

**Mitigation of Negative Impacts:** No negative impacts identified, therefore no further mitigation recommended.

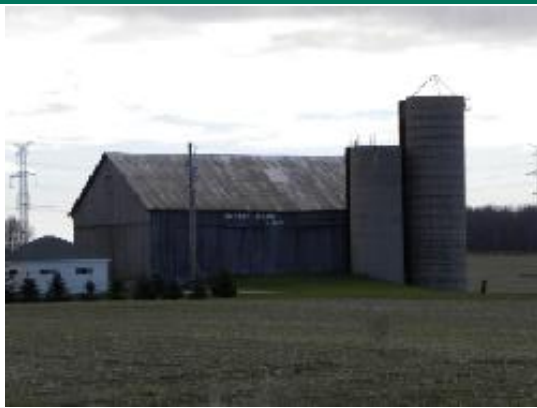
**Date:** 19<sup>th</sup> – early 20<sup>th</sup> century

**Description:** Timber framed, metal roofed, wood sided, side gabled barn with two concrete silos. Additional outbuilding adjacent.

**Mitigation of Negative Impacts:** No negative impacts identified, therefore no further mitigation recommended.

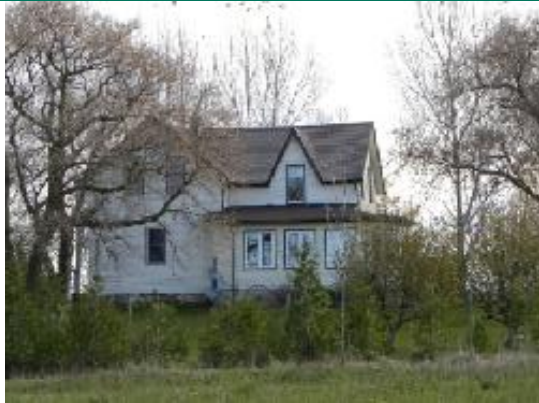
**Site #54 – 72204 Goshen Line (Municipality of Bluewater)**

**Date:** 1860-1890s

**Description:** One and one half storey L plan house with modern siding, stone foundation and a steeply pitched dormer in L length over a single square window. Covered inset porch. House roof covered in asphalt shingles and has modern windows.

**Mitigation of Negative Impacts:** No negative impacts identified, therefore no further mitigation recommended.

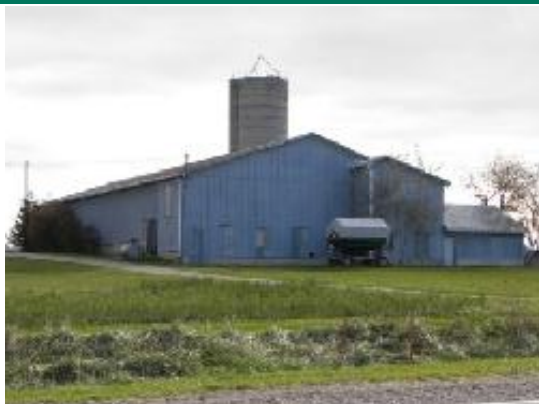
**Date:** Various (19<sup>th</sup> and 20<sup>th</sup> century)

**Description:** Wood framed, metal roofed, side gabled barn on concrete foundation. One asymmetrically roofed, gable end projection attached to barn gable end, with another gabled addition attached to both the initial addition and the original barn side. Concrete silo sits adjacent to barn.

**Mitigation of Negative Impacts:** No negative impacts identified, therefore no further mitigation recommended.

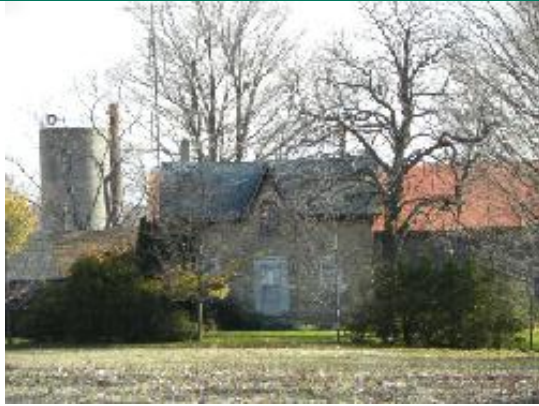
**Site #55 – 71962 Bronson Line (Municipality of Bluewater)**

**Date:** 1860-1890s

**Description:** One and one half storey side gabled yellow brick house on a symmetrical plan with a steeply peaked central dormer over an arched single window on an undetermined foundation. House has decorative raised brick quoin-like detailing and similar features framing the front door and central dormer.

**Mitigation of Negative Impacts:** No negative impacts identified, therefore no further mitigation recommended.

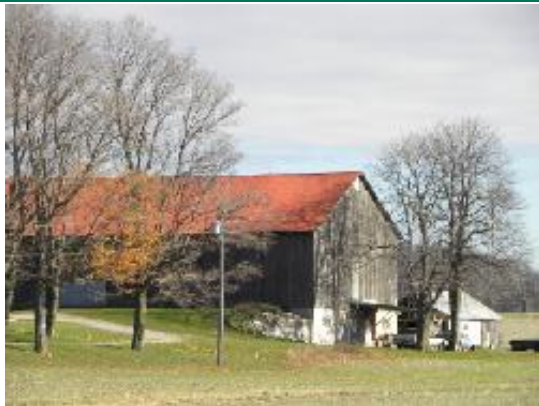
**Description:** Timber framed side gabled barn with metal roof and wood siding on a concrete foundation. Small end gabled garage or out building behind barn.

**Mitigation of Negative Impacts:** No negative impacts identified, therefore no further mitigation recommended.

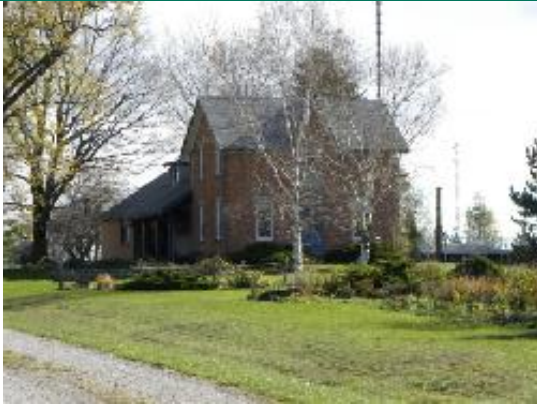
**Site #56 – 71726 Bronson Line (Municipality of Bluewater)**

**Description:** One and one half storey, red brick, side gabled house with a steeply peaked central dormer on a symmetrical plan with an undetermined foundation. Gabled addition at rear with a single shed dormer and porch.

**Mitigation of Negative Impacts:** No negative impacts identified, therefore no further mitigation recommended.

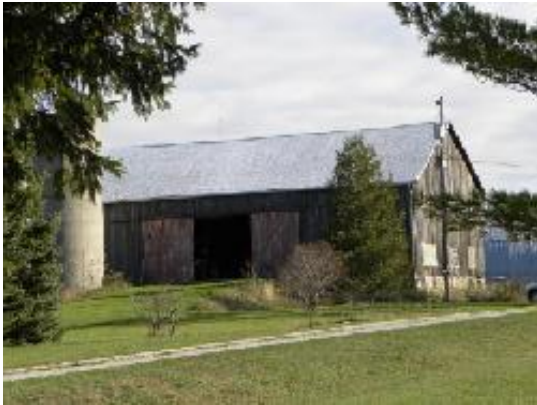
**Description:** Timber framed side gabled barn with a metal roof and wood siding on a stone foundation. Concrete silo sits adjacent to barn.

**Mitigation of Negative Impacts:** No negative impacts identified, therefore no further mitigation recommended.

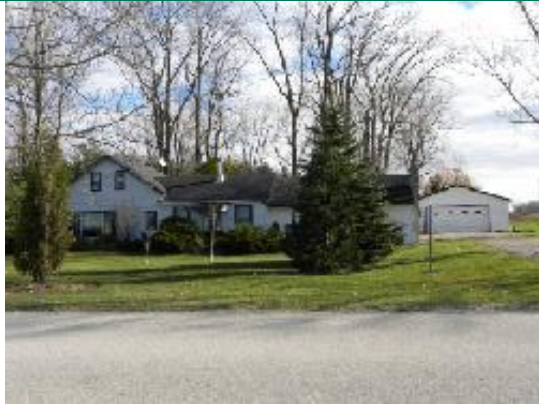
### Site #57 – 71684 Bronson Line (Municipality of Bluewater)

**Description:** One and one half storey T plan or end gabled house with a single-storey addition creating a T plan on an undetermined foundation. Additional single-storey addition at gable end. Windows and doors are modern and a gabled garage sits behind the property.

**Mitigation of Negative Impacts:** Impacts were not identified, therefore mitigation is not recommended or necessary.

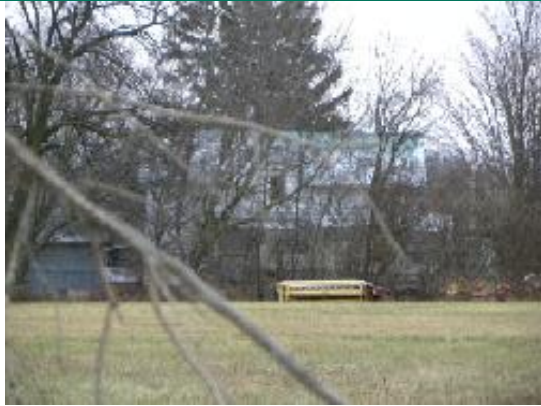
**Site #58 – 71642 Bronson Line (Municipality of Bluewater)**

**Description:** One and one half storey side gabled house with a medium roof pitch and prominent central gable, white sided exterior and undetermined foundation. Vernacular Gothic Revival design elements include symmetrical design and single window extending into the steeply pitched front gable. Modern rear addition.

**Mitigation of Negative Impacts:** No negative impacts identified, therefore no further mitigation recommended.

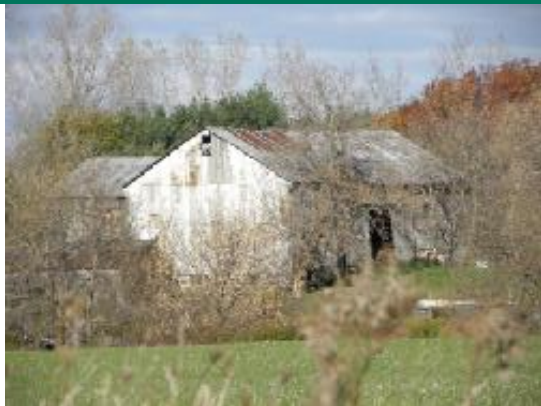
**Description:** Timber framed side gabled barn with a metal roof and white painted wood siding on a stone foundation. Smaller metal framed, wood sided outbuilding near barn.

**Mitigation of Negative Impacts:** No negative impacts identified, therefore no further mitigation recommended.

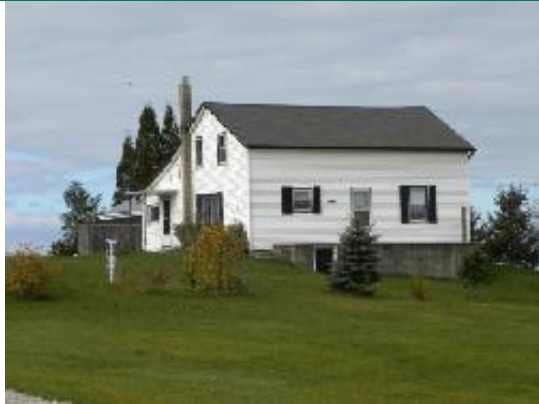
### Site #59 – 72199 Bronson Line (Municipality of Bluewater)

**Description:** One and one half storey side gabled house, with medium roof pitch, modern siding and concrete foundation. Likely originally symmetrical in design although heavily modified throughout including rear 'salt-box' addition.

**Mitigation of Negative Impacts:** Impacts were not identified, therefore mitigation is not recommended or necessary.
