Table 4-3 Site Investigations

Geoplan Wind Energy Centre
 Lambton Kent
 Identified REA and
 Non-REA Water Bodies
 September 2012
 Project #17-53

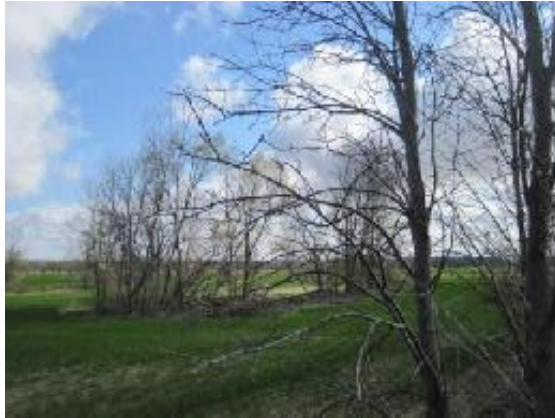
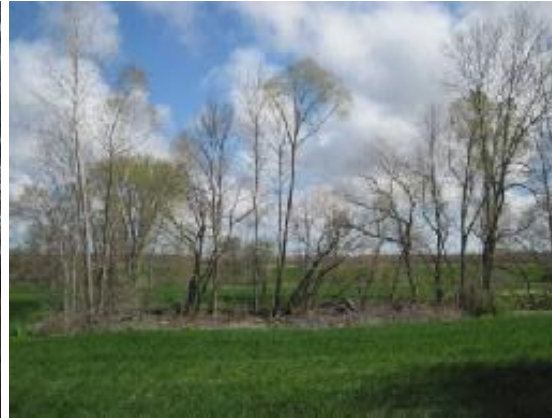
Feature ID	Project Component	Investigation Date	Description of Site	Feature Description	Feature Sensitivity
P18	<ul style="list-style-type: none"> • Collection Line Buffer • Road Buffer • Turbine 86 	April 26, 2012	<ul style="list-style-type: none"> • The pond is located in a field of winter wheat, surrounded by deciduous trees. 	<ul style="list-style-type: none"> • The pond is a dugout offline feature. 	Not Sensitive

Photograph 1. Pond overview ↑

Photograph 2. Pond overview ↑

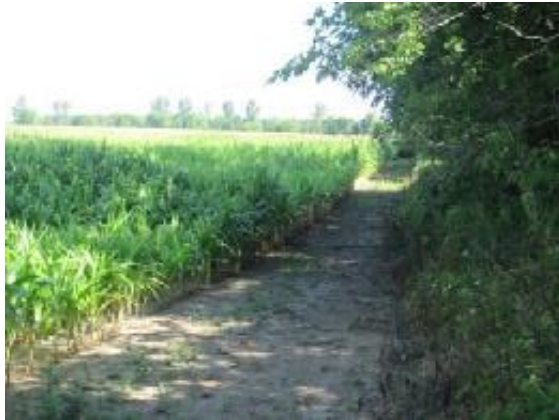
Feature ID	Project Component	Investigation Date	Description of Site	Feature Description	Feature Sensitivity
C31	• Turbine 67	July 27, 2011	<ul style="list-style-type: none"> No channel was observed as it has been ploughed through. The site is a crop agricultural field adjacent to a deciduous forest (classified as FOD, ELC Feature ID 325). 	<ul style="list-style-type: none"> No water body feature present. It is classified as tiled by ABCA. 	Not Sensitive

Photograph 1. Site overview ↑

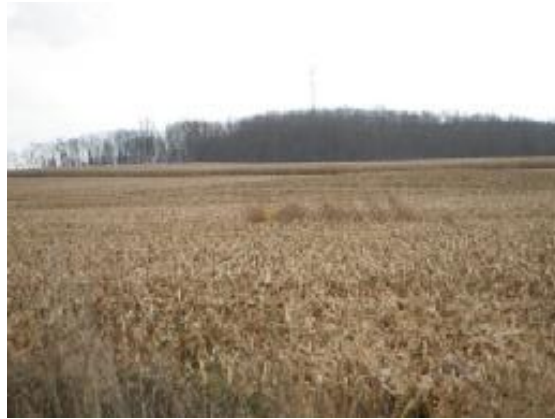
Feature ID	Project Component	Investigation Date	Description of Site	Feature Description	Feature Sensitivity
D56	<ul style="list-style-type: none"> Collection Line Buffer 	November 17, 2011	<ul style="list-style-type: none"> The feature is surrounded by agricultural fields. There was no water body present. It appears to be tile drained. 	<ul style="list-style-type: none"> The water body is not present. It is classified as tiled by ABCA. 	Not Sensitive

Photograph 1. Site overview ↑

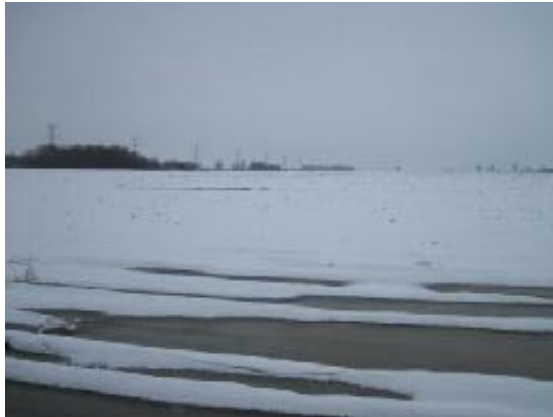
Feature ID	Project Component	Investigation Date	Description of Site	Feature Description	Feature Sensitivity
C127	• Turbine 71	December 9, 2011	• The watercourse is located in an agricultural field. The water body has been tile drained.	• The water body has been tile drained, no feature is present. It is classified as a tiled by ABCA.	Not Sensitive

Photograph 1. Site overview ↑

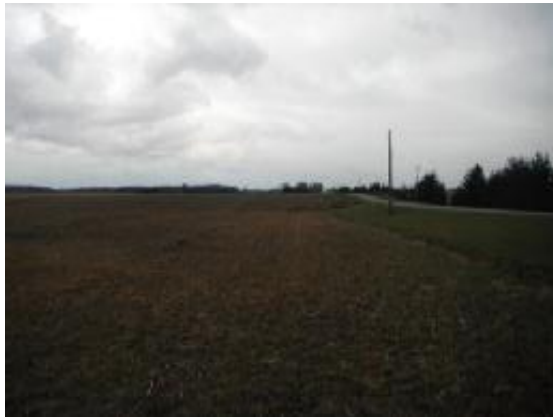
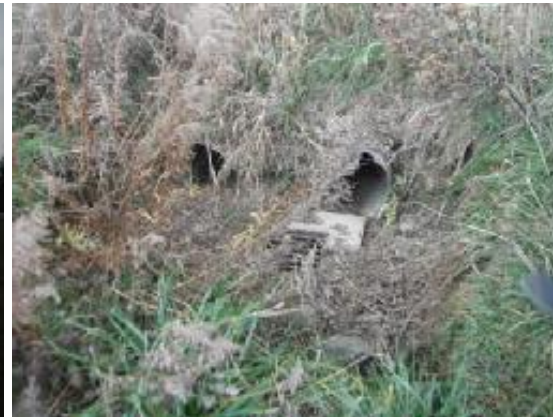
Photograph 1. Site overview ↑

Photograph 2. Tile drain Goshen Line ↑

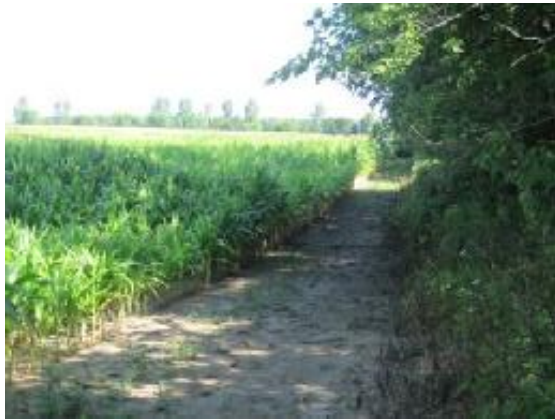
Feature ID	Project Component	Investigation Date	Description of Site	Feature Description	Feature Sensitivity
P3	• Turbine 67	July 27, 2011	• The feature is located in a corn field. No water body is present, it has been ploughed through.	• No water body present.	Not Sensitive

Photograph 1. Site overview ↑

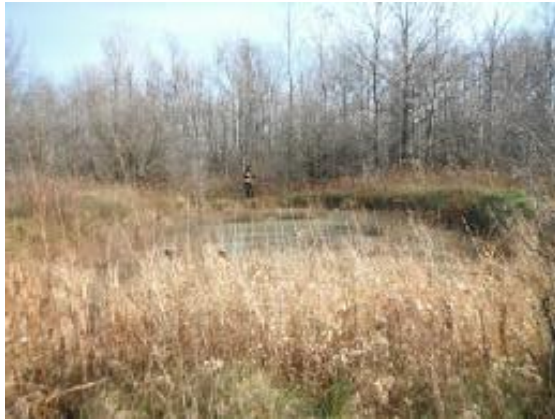
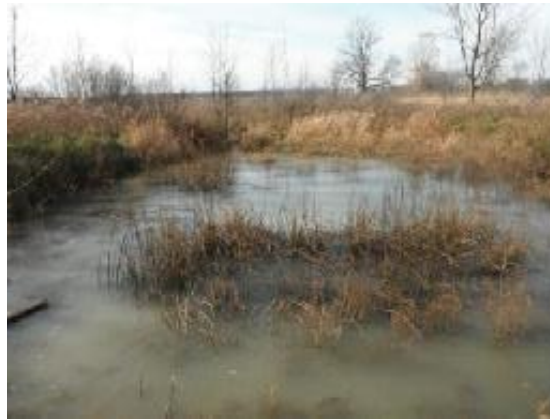
Feature ID	Project Component	Investigation Date	Description of Site	Feature Description	Feature Sensitivity
P17	<ul style="list-style-type: none"> Collection Line Buffer Turbine 37 	November 18, 2011	<ul style="list-style-type: none"> The pond is surrounded by a mix of deciduous forest, cultural meadow and cultural thicket (classified as FOC9b, CUM1-1, CUT1h, ELC Feature ID 236). The pond is 40 m long. Riparian vegetation 	<ul style="list-style-type: none"> The pond is dugout offline feature. Emergent aquatic vegetation is present. No groundwater indicators were noted at time of investigation. 	Not Sensitive

Photograph 1. Pond overview ↑

Photograph 1. Pond view ↑

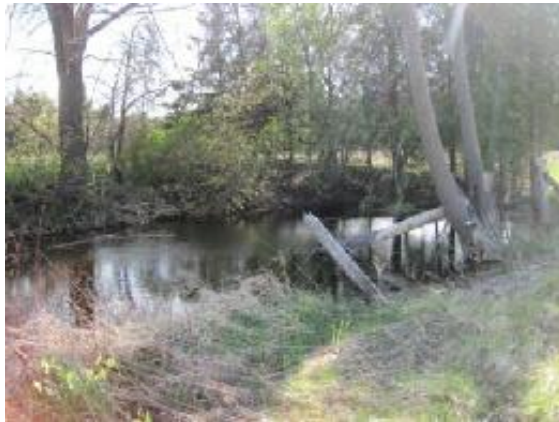
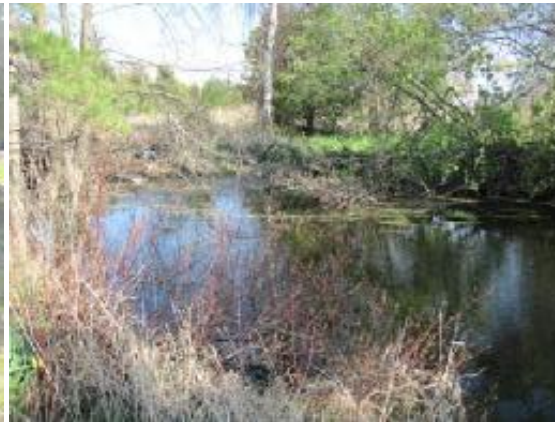
Feature ID	Project Component	Investigation Date	Description of Site	Feature Description	Feature Sensitivity
P15	<ul style="list-style-type: none"> Collection Line Buffer 	April 17, 2012	<ul style="list-style-type: none"> Pond is located on Credition Road, east of D18. It is surrounded by crop agricultural fields. Surrounding land topography is flat. Riparian buffer is 2 m of cultural meadow (CUM1-1) containing trees and shrubs. Pond is approximately 20 m by 10 m. 	<ul style="list-style-type: none"> The pond may be a dugout pond since the surrounding vegetation is not associated with a wetland. The pond appears to be offline, as no connection was evident. The pond was turbid with brown colour during the investigation. <i>In-situ</i> cover is moderate and consists of aquatic vegetation followed by woody debris. No groundwater indicators were noted. 	Not Sensitive

Photograph 1. Pond overview ↑

Photograph 2. Pond overview ↑

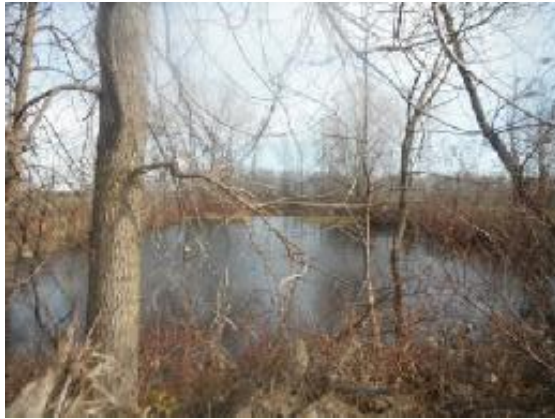
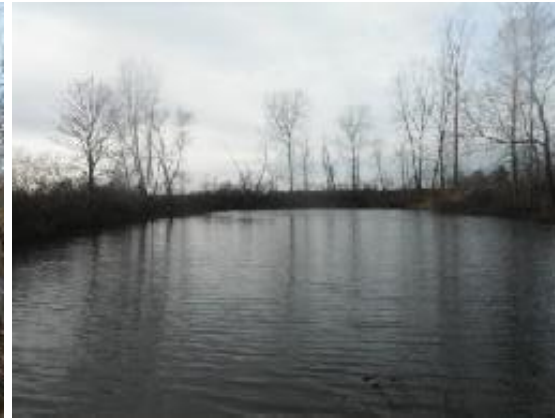
Feature ID	Project Component	Investigation Date	Description of Site	Feature Description	Feature Sensitivity
P5	• Turbine 39	November 18, 2011	• The pond is located in an agricultural field. The pond is 100 by 40 m. Riparian buffer is 10 m of trees, shrubs and grasses.	• The pond is a dugout offline feature. Substrate consists of silt, sand and gravel. There is no <i>in-situ</i> habitat cover. No groundwater indicators were observed.	Not Sensitive

Photograph 1. Pond overview ↑

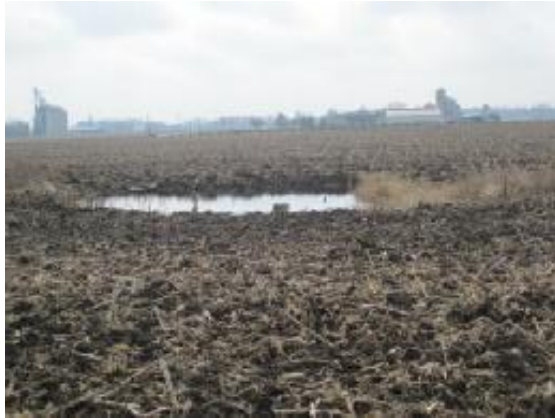
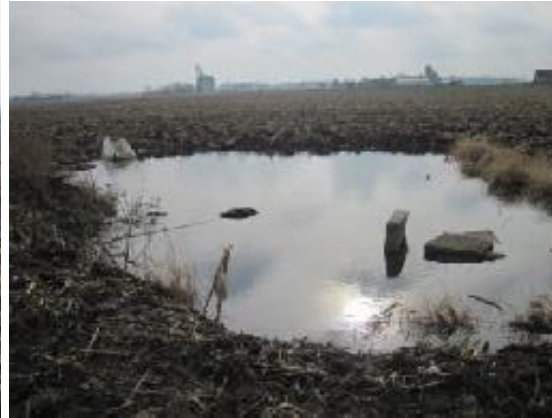
Feature ID	Project Component	Investigation Date	Description of Site	Feature Description	Feature Sensitivity
P10	<ul style="list-style-type: none"> Collection Line Buffer Road Buffer 	December 22, 2011	<ul style="list-style-type: none"> The pond is located in an agricultural field. There is no riparian buffer for the pond. 	<ul style="list-style-type: none"> The pond is a dugout offline feature that is used for farming. Substrate consists of silt. The pond was filled with garbage. No groundwater indicators were observed. 	Not Sensitive

Photograph 1. Pond overview ↑

Photograph 2. Pond view ↑

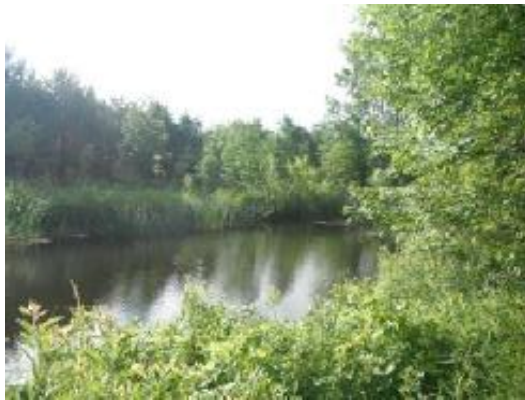
Feature ID	Project Component	Investigation Date	Description of Site	Feature Description	Feature Sensitivity
P2	• Turbine 34	July 13, 2011	<ul style="list-style-type: none"> The pond is bordered by cultural plantation (classified as CUP3-1, ELC Feature ID 759) on the east and corn field on the west. Surrounding topography is flat. Riparian buffer in the agricultural field is 3 m and is greater than 3 m in the cultural plantation. 	<ul style="list-style-type: none"> The pond is defined as a permanent feature. The water was clear and had moderate flow during the time of investigation. The banks are stable. Canopy cover is low and consists of grasses, shrubs and herbaceous vegetation. Instream habitat cover is low and consists algae, submergent and emergent vegetation. No groundwater indicators were observed. 	Not Sensitive

Photograph 1. Pond overview ↑

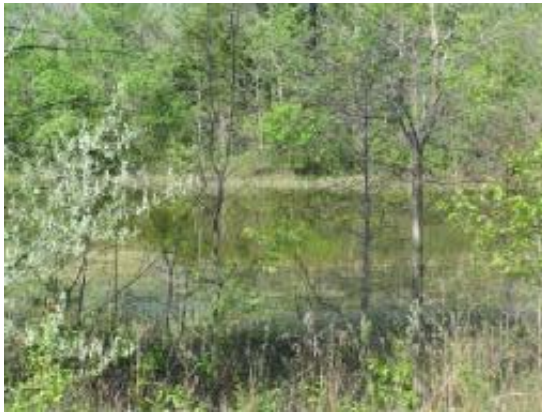
Feature ID	Project Component	Investigation Date	Description of Site	Feature Description	Feature Sensitivity
P9	<ul style="list-style-type: none"> Collection Line Buffer 	May 11, 2012	<ul style="list-style-type: none"> Pond is located in mixed forest (classified as FOM5-2, ELC Feature ID 255) with a riparian buffer of greater than 5 m along the roadsides and greater than 30 m to the north and west. 	<ul style="list-style-type: none"> The pond feature appears to be natural but could not be confirmed. The water was clear during the time of investigation. Pond was approximately 40 m by 20 m and appeared to be shallow. Cattails surrounded the pond and algae were seen in the pond. No groundwater indicators were observed. 	Not Sensitive

**Photograph 1. Pond overview ↑**

Regarding D41, the reach that was observed was buried and the upstream reach that was not accessible was shown as tiled drain on OMAFRA drainage mapping (2012). Therefore this site was not considered further. Regarding P9, this site was not considered further due to its location in relation to the Project Components (i.e., it is located across a municipal road from a collection line).

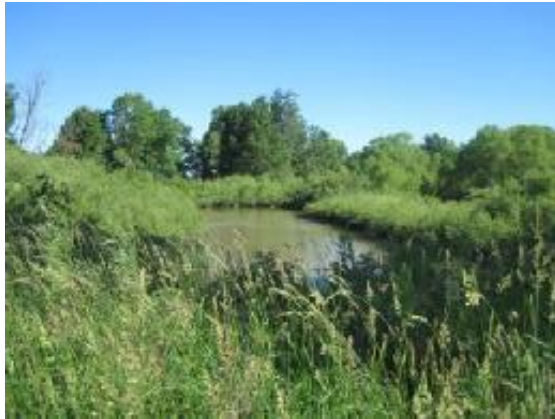
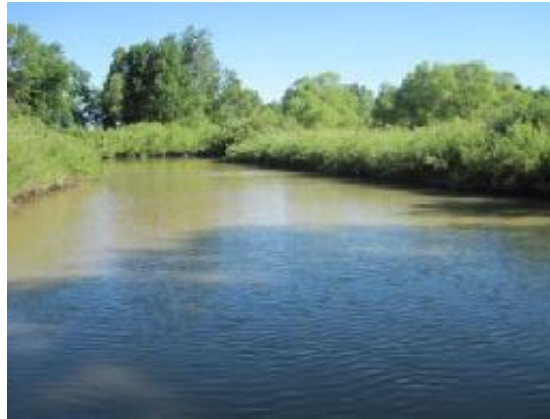
Feature ID	Project Component	Investigation Date	Description of Site	Feature Description	Feature Sensitivity
P13	<ul style="list-style-type: none"> Transmission Line Buffer 	June 13, 2012	<ul style="list-style-type: none"> The pond is located in a swamp thicket (classified as SWT2-2, ELC Feature ID 609) adjacent to corn fields. The pond is 50 by 15 m. The riparian buffer is 5-15 m of swamp thicket. 	<ul style="list-style-type: none"> The pond is dugout offline feature, which is possibly used for farming. The water was turbid at time of investigation. The substrate is silt and clay. No groundwater indicators were observed. 	Not Sensitive

Photograph 1. Pond overview ↑

Photograph 2. Pond view ↑

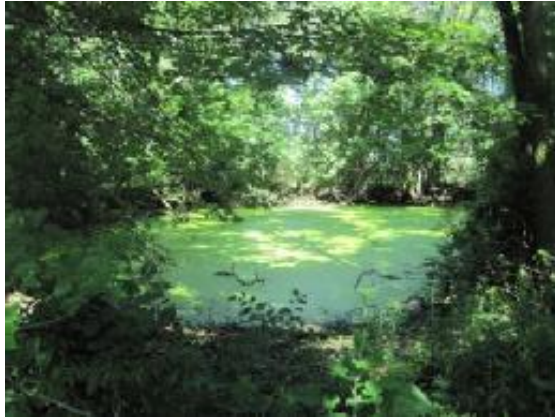
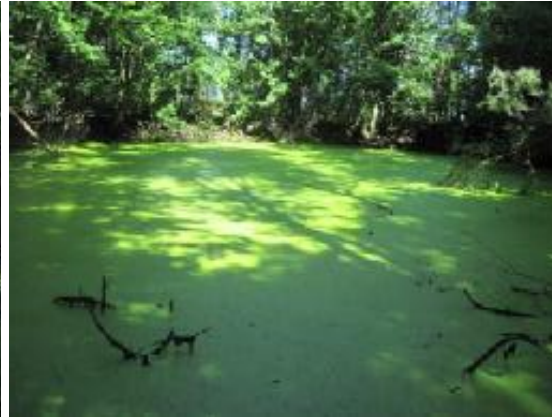
Feature ID	Project Component	Investigation Date	Description of Site	Feature Description	Feature Sensitivity
P12	<ul style="list-style-type: none"> Transmission Line Buffer 	June 22, 2012	<ul style="list-style-type: none"> Pond is located in a deciduous forest and cultural meadow (classified as FOD7f, CUM1-1, FOD6-5, ELC Feature ID 720) that is surrounded by agricultural fields. The pond is 15 by 20 m and greater than 0.3 m deep. The riparian buffer is greater than 10 m of forest. 	<ul style="list-style-type: none"> The pond is a dugout offline feature. The water was clear at time of investigation. The substrate is muck and detritus. <i>In-situ</i> cover is high and consists of aquatic vegetation followed by woody debris. The majority of aquatic vegetation is duckweed. No groundwater indicators were observed. 	Not Sensitive

Photograph 1. Pond overview ↑

Photograph 2. Pond view ↑

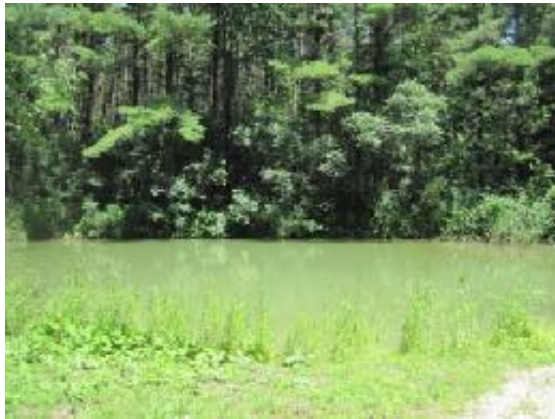
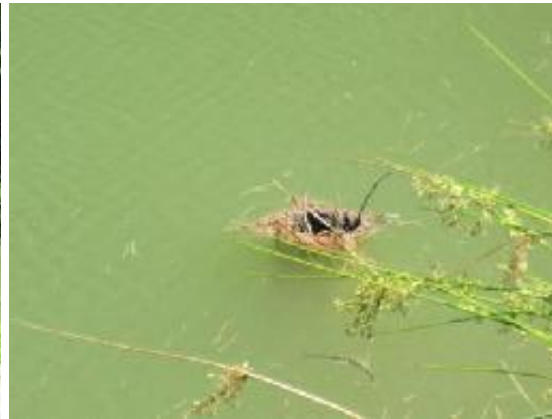
Feature ID	Project Component	Investigation Date	Description of Site	Feature Description	Feature Sensitivity
P14	<ul style="list-style-type: none"> Collection Line Buffer 	June 25, 2012	<ul style="list-style-type: none"> The pond is located in a cultural plantation (classified as CUP3-2, ELC Feature ID 209). The pond is 20 by 20 m. The riparian buffer is 5 to 15 m of cultural plantation. 	<ul style="list-style-type: none"> The pond is a dugout offline pond that has an outflow pipe directly into another pond (P8). The water was turbid at time of investigation. Substrate consists of sand and silt followed by muck. <i>In-situ</i> cover is low and consists of aquatic vegetation and woody debris. No groundwater indicators were observed. 	Not Sensitive

Photograph 1. Pond overview ↑

Photograph 2. Outflow pipe ↑

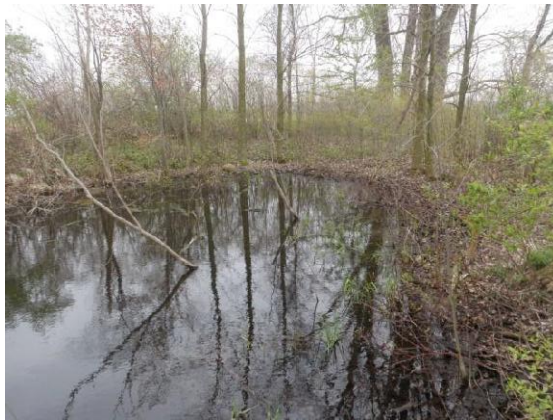
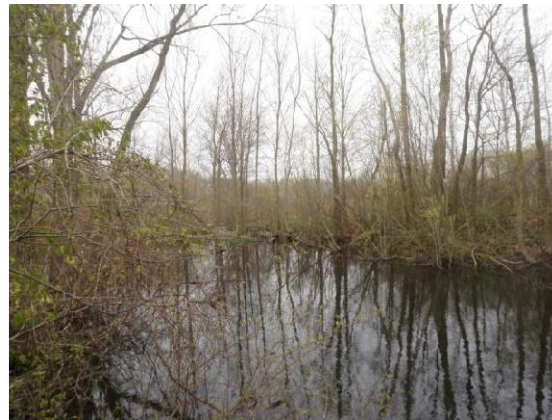
Feature ID	Project Component	Investigation Date	Description of Site	Feature Description	Feature Sensitivity
P20	<ul style="list-style-type: none"> Collection Line Buffer 	May 2, 2012	<ul style="list-style-type: none"> The pond is surrounded by swamp thicket (classified as SWT2b, ELC Feature ID 754) in an agricultural field. The pond is approximately 20 by 9 m and 2 m deep. 	<ul style="list-style-type: none"> The pond is an offline dugout feature. The water was clear at time of investigation. <i>In-situ</i> vegetation was low and consisted of emergent vegetation. 	Not Sensitive

Photograph 1. Pond overview ↑

Photograph 2. Pond view ↑

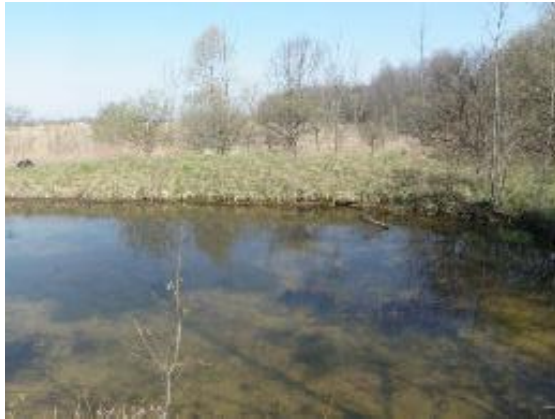
Feature ID	Project Component	Investigation Date	Description of Site	Feature Description	Feature Sensitivity
P17	<ul style="list-style-type: none"> Collection Line Buffer 	April 19, 2012	<ul style="list-style-type: none"> The pond is located in a mix of cultural meadow, cultural thicket and meadow marsh (classified as CUM1-1, CUT1h, MAM2-2, ELC Feature ID 236). The pond is 19 by 13 m and 0.55 m deep. 	<ul style="list-style-type: none"> The pond is an offline dugout features. The water was clear at time of investigation. <i>In-situ</i> cover is moderate and consists of submergent, emergent and floating vegetation 	Not Sensitive

Photograph 1. Site overview ↑
