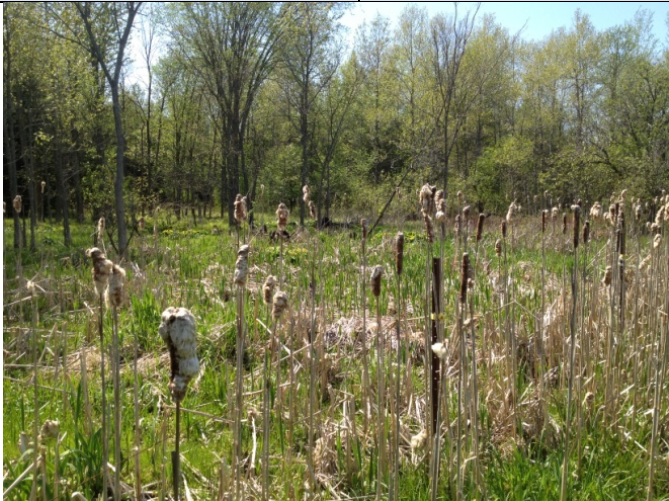
<p>W8 – feature dominated by wetland vegetation(photo: May 15, 2012)</p>

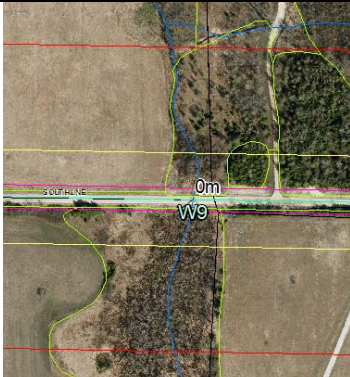
<p>W9 - 0m from underground collection line in existing road right of way.</p>	<p>Property access was not provided for the property where this feature was located and for that reason a roadside survey was conducted. Water in channel was pooling close to the road such that the bankfull width was approximately 1m, and bankfull depth approximately 0.5m. Upstream of the road crossing the channel was much narrower (20-30cm) with a grassy riparian edge. Abundant algal mats were present in May. Feature conveys water between two red maple deciduous swamps (ELC units 256 and 400). The riparian edge is predominantly Lake-bank sedge (<i>Carex lacustris</i>) with occasional red-osier dogwood, narrow-leaved cattail, and white cedar. Little in the way of instream or riparian cover available. No fish observed in channel. Substrate predominantly gravel. Water temperature = 20C on May 15, 2012</p>	<p>May 15, 2012 August 1, 2012</p>

<p>W9 - North side of Southline Rd - (photo: May 15, 2012)</p>	<p>W9 – permanent stream</p>

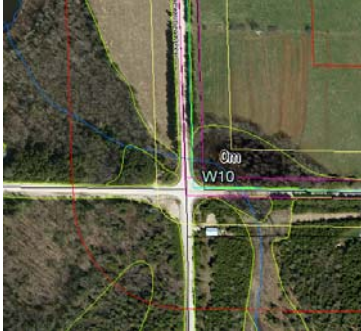
<p>W10 - 0m from underground collection line in existing road right of way.</p>	<p>Property access was not provided for the property where this feature was located and for that reason a roadside survey was conducted. Feature is characterized as part of red maple deciduous swamp (ELC units 258/411/413) comprised of slender willow, chokeberry, and narrow-leaved cattail as understory and common milkweed, spotted joe-pye weed, timothy grass, water parsnip and reed-canary grass as the dominant species within the groundcover; and coniferous forest (ELC unit 259) dominated by eastern white cedar. Hydrophytic vegetation was dominant within the feature; therefore it was treated as a wetland and addressed within the NHA. Parts of W10 are within the boundary of Beaver Meadow PSW and the remainder of the feature was treated as a significant wetland.</p> <p>W10 was determined not to meet the definition of a 'water body' as outlined in O. Reg. 359/09.</p>	<p>May 15, 2012 August 1, 2012</p>

<p>Pooling of water on upstream (south) side of Southline Road on May 15, 2012.</p>

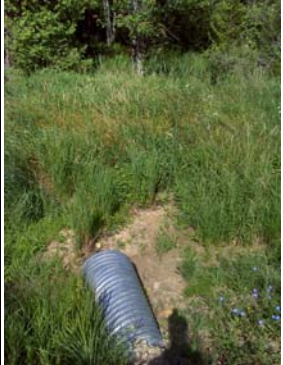
<p>W10 on west side of Boot Jack Ranch Road (photo: August 1, 2012)</p>	<p>W10 - not carried forward as a water body</p>

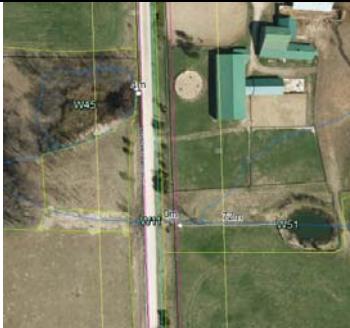
<p>W11 - 0m from underground collection line in existing road right of way. W45 - 4m from underground collection line in existing road right of way. W51 - 72m from underground collection line in existing road right of way.</p>	<p>Property access was not provided for the property where these features were located and for that reason a roadside survey was conducted.</p> <p>W11 provides seasonal conveyance of water through an intermittent channel from upstream agricultural fields and dugout pond (W51) to a meadow marsh (ELC unit 260) on the downstream side of Boot Jack Ranch Road. At the time of survey less than 5 cm of standing water was documented on the upstream side of the road and no water was observed in the channel downstream of the culvert.</p> <p>No fish were observed.</p> <p>Bankfull width= 0.5m (approx.) Water temperature=24C (May 15, 2012).</p> <p>No open water feature was found at W45. This feature was determined during ELC surveys to be part of ELC unit 413 (red maple deciduous swamp). Parts of W45 are within the boundary of Beaver Meadow PSW and was addressed as a significant wetland in the NHA for the project. W45 was dominated by hydrophytic vegetation and determined not to conform to the definition of a 'water body' as outlined in O. Reg. 359/09.</p> <p>W51 was investigated through the</p>	May 15, 2012

<p>May 15, 2012 - grassy channel downstream of road.</p>	<p>W11 – intermittent stream W45 - not carried forward as a water body W51 - not carried forward as a water body</p>

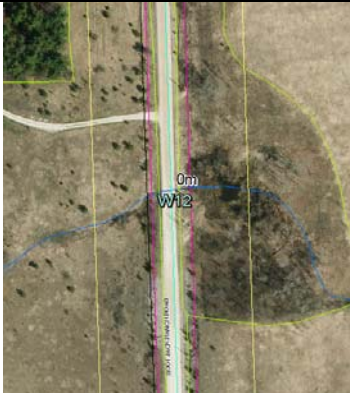
<p>W12 - 0m from underground collection line in existing road right of way.</p>	<p>Property access was not provided for the property where this feature was located and for that reason a roadside survey was conducted.</p> <p>W12 provides seasonal pooling of water in a culvert crossing of Boot Jack Ranch Road between a deciduous swamp (ELC unit 266) on the east side of the road and a small area dominated by hydrophytic vegetation on the west side of the road. Standing water was documented in the channel during survey; no flow was detected through the culvert. This area was treated as a significant wetland feature in the NHA for the Project. W12 was determined to be a grassed channel on the upstream side of the road and dominated by emergent and hydrophytic vegetation on the downstream side. This feature did not conform to the definition of a 'water body' as outlined in O. Reg. 359/09.</p>	May 15, 2012

<p>W12 - Culvert buried half way on upstream side – grassed channel suggests channel doesn't hold water on a regular basis (photo: May 15, 2012).</p>

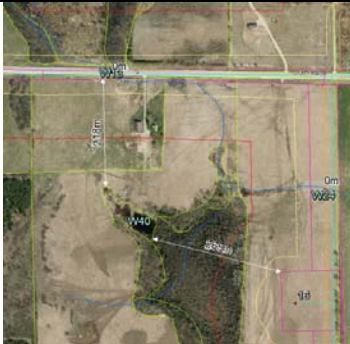
<p>W13 – 0m from underground collection line in existing road right of way. W24 - 0m from underground collection line in existing road right of way. W40 – 218m from underground collection line in existing road right of way.</p>	<p>Two features along the same watercourse were identified through Records Review and investigated further: W13 (crossing of County Rd. 4) and W24 (within an agricultural field on the south side of County Rd. 4). W40, a pond feature in the vicinity of these water features was identified during Site Investigation, but later determined to be > 120m from the Project Location.</p> <p>Property access was not provided for the property on the north side of County Rd. 4 and for that reason a roadside survey was conducted of the downstream portion of W13.</p> <p>W13 – saturated soils suggest culvert holds water seasonally during spring melt from agricultural field on the south side of County Rd. 4 and the cattail marsh (ELC unit 88) on north side of the road. At the time of survey standing water was documented within the culvert; however, grassy roadside ditch on either side of culvert was free of water. No open water component was documented. W13 was determined not to meet the definition of a ‘water body’ as outlined in O. Reg. 359/09.</p>	May 16, 2012

<p>Culvert on south side of County Rd. 4 drains into agricultural field. Standing water in culvert at time of survey – no detectable flow (photo: May 16, 2012).</p>

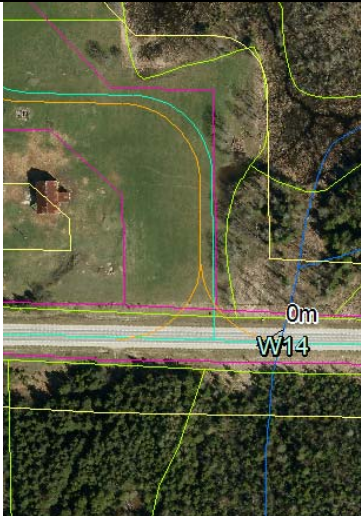
<p>W14 – 0m from underground collection line in existing road right of way.</p>	<p>Property access was not provided for the property on the south side of the road and for that reason a roadside survey was conducted of the upstream portion.</p> <p>W14 functions to provide seasonal conveyance of water from one wetland feature to another. ELC unit 85 (a tamarack coniferous swamp) is located on the south side of County Road 4, and ELC unit 62 (a white cedar coniferous swamp) is located on the north side of the road. Both of these features are dominated by wetland species and are within the boundary of Beaver Meadow PSW. These features were addressed as significant wetlands through the NHA and determined not to meet the definition of a 'water body' under O.Reg. 359/09.</p>

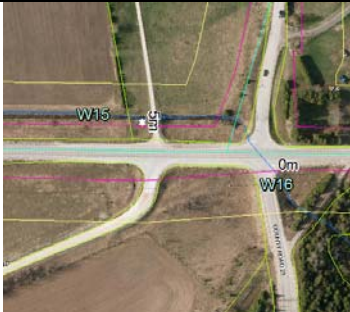
<p>W15 – 5m from underground electrical collection line in road right of way; W16 - underground electrical collection line in road right of way crosses the feature (0m);</p>	<p>Property access was not provided for the property where these features were located and for that reason a roadside survey was conducted.</p> <p>NRVIS data indicated a connection between W16 (furthest upstream) and flow continuing from there to W15, to W28, to W26, and to W18. Mapping obtained from SSWPC (2011) classifies these sites as a cold water stream.</p> <p>Description of feature at W16 : Pool at culvert = 0.37m deep Bankfull width = 1.5m; channel wider upstream (approximately 3m) with fast riffle (0.15m deep) Substrate was a mix of cobble/gravel/boulder. Instream cover was available in the form of willow. Banks were stable. No fish were observed at the time of survey. Water temperature = 16C (May 15, 2012), 18C (Aug. 1, 2012) Immediate riparian vegetation is mostly manicured lawn, with birch and cedar, adjacent land use is transportation and agricultural. Feature is highly altered as it passes under 2 structures within 20m; a metal culvert under County Rd. 4 and an old concrete bridge for rail line (no longer in use). Upstream</p>	<p>May 15, 2012 Aug. 1, 2012</p>

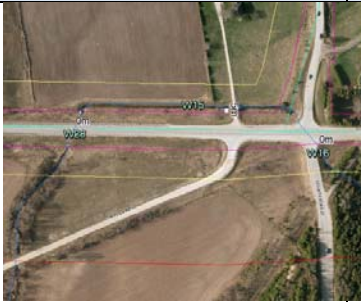
<p>W28 – 0m from underground electrical collection line in road right of way</p>	<p>Description of feature at W28: This feature passes under County Rd. 4 and under The Glen Road. No property access was provided, therefore survey was conducted from crossing at the Glen Road.</p> <p>Upstream of The Glen Road: Wetted depth at roadside = 0.43m Bankfull width = 1.5 – 2m Greater than 95% of substrate is fines/silt with random dispersal of cobble (<5%). Young of year fish and green frog observed.</p> <p>In stream cover provided by emergent vegetation. Overhanging vegetation upstream provides additional cover. Little cover available at roadside. Banks are stable. Narrow riparian (<5m) comprised of meadow plants, ash and maple; adjacent land use is agricultural.</p> <p>Downstream of The Glen Road: Bankfull width = 5m at roadside, 3m in channel Wetted width = 3m at roadside Wetted depth = 0.15m Substrate 80% cobble, 20% gravel. Large number of minnows observed. Perched culvert under low flow conditions obstructs fish movement. Narrow riparian (<10m) of meadow plants, ash and maple; adjacent land use is agricultural. Banks are stable. Water temperature = 20C (Aug 1, 2012)</p>	August 1, 2012

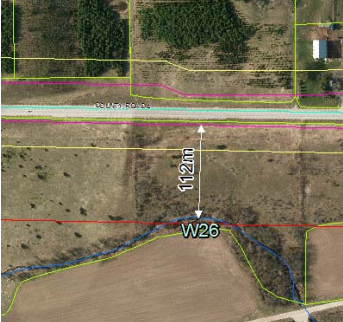
W26 – 112m from underground electrical collection line in road right of way;	Description of feature at W26: Upstream (south side of The Glen Road): Culvert buried Pool at roadside = 0.35m deep Wetted width = 2m Bankfull width = 6m Riparian comprised of cedar, ash, poplar and willow, (5-10m wide); adjacent landuse is agricultural. Young of year fish observed in channel. Banks are stable. Downstream (north side of The Glen Road): Bankfull width = 2.5m Substrate predominantly fines (80%), 10% boulder and 10%	August 1, 2012

W26 – part of permanent stream

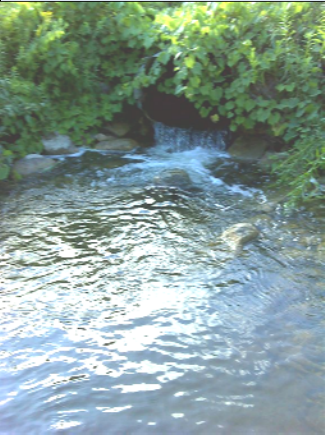
<p>Existing crossing of stream at W18 – unmaintained dirt road extends from Glen Road to Southline.</p>

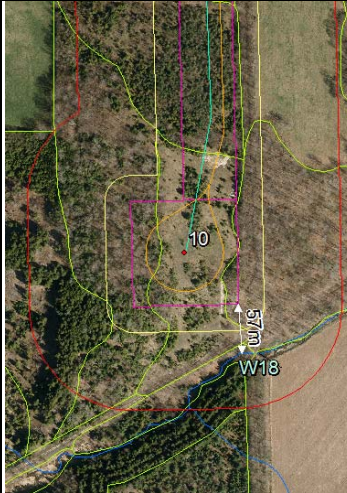
<p>W18 - Double culverts convey water under road crossing downstream to sugar maple forest and forb meadow marsh.</p>	W18 – part of permanent stream

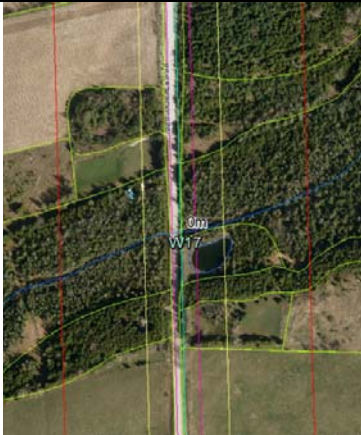
<p>W17 - 0m from underground electrical collection line in road right of way</p>	<p>Property access was not provided for the property where this feature was located and for that reason a roadside survey was conducted.</p> <p>Description of feature at W17: This feature is part of Durham Creek and is a permanent cold water stream that conveys water through a Coniferous swamp (dominated by tamarack and balsam fir with occasional black ash and red maple). Watercress was observed in the channel as evidence of groundwater seepage.</p> <p>Substrate mix of cobble and boulder. Large (>1m wide), deep plunge pool on downstream side resulting from perched culvert. Visible portion of channel beyond pool is riffle. Upstream is predominantly riffle. Wide riparian buffer that functions as a wildlife corridor. Abundant in-stream cover in the form of emergent vegetation and woody debris. Banks stable. Water temperature= 11C (May15, 2012), 11C (July 5, 2012). MNR fisheries records document Central Mudminnow, Brook Trout and Slimy Sculpin. Wetted width = 8m (May 15) Bankfull width = 10m Wetted depth = 0.3m (approx.)</p>	<p>May 15, 2012 July 5, 2012</p>

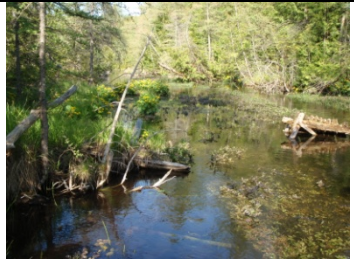
<p>May 15, 2012 – upstream of County Rd. 23</p>

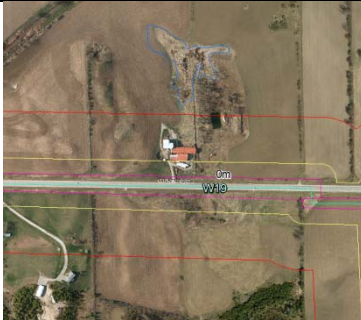
<p>W19 – 0m from underground electrical collection line in road right of way</p>	<p>Low spot in agricultural field with some cattail and other hydrophytic vegetation investigated during field surveys was determined not to meet the definition of a water body under O. Reg. 359/09.</p> <p>Water temperatures (9C) and vegetation suggest seepage on north side of road.</p>	<p>May 16, 2012</p>

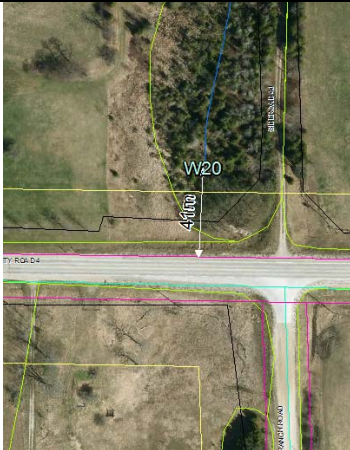
<p>W20 – 41m from underground electrical collection line in road right of way</p>	<p>Property access was not provided for the property where this feature was located and for that reason a roadside survey was conducted.</p> <p>Features investigated at the corner of Boot Jack Ranch Rd. and County 4 Rd. indicated that no open water was contained in roadside ditches and seasonal conveyance of water through culverts between small groupings of cattail vegetation suggests soils are saturated. This feature was determined to be dominated by hydrophytic vegetation; and, as such not a 'water body as defined under O.Reg. 359/09.</p>	<p>May 16, 2012 August 1, 2012</p>

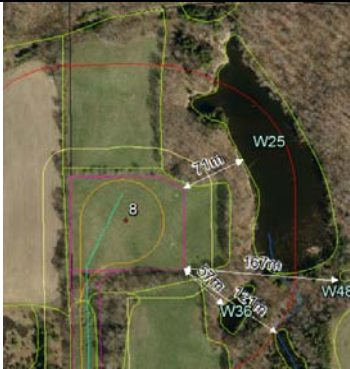
<p>W25 - 71m from Turbine 8 and associated access road and underground electrical collection.</p>	<p>This large feature is dominated by un-vegetated open water. A few trees of red maple (and yellow birch and shrubs consisting of red-osier dogwood and pussy willow occur along the edge or on elevated mounds within the pond. Horsetail, broad-leaved cattail, and lesser duckweed were common ground species that colonized the fringe. Beaver activity was noted around the pond. Midland painted turtle, snapping turtle, green heron, Abystomid egg masses, Canada goose, gray treefrog, Eastern gartersnake, Northern leopard frog, mink frog, green frog and small minnows observed at time of surveys. Abundant in-stream cover in the form of woody debris and vegetation. This feature was identified as providing several types of significant wildlife habitat through the NHA process. This feature is also included within the boundary of Beaver Meadow PSW and was addressed as such within the NHA (see mapping in Appendix B).</p>	<p>May 16, 2012 July 24, 2012</p>

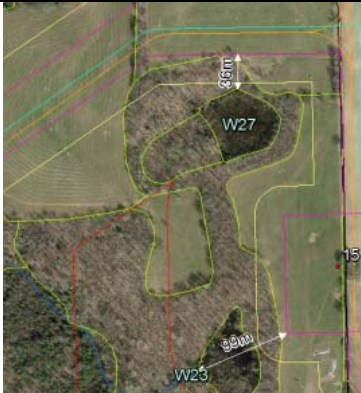
<p>W27 – 36m from Turbine 15 and associated access road and underground collection line.</p>	<p>This feature was identified as ELC unit 121 (a forb shallow marsh). This unit was dominated by marsh vegetation and was treated as a significant wetland feature and was addressed as such within the NHA (see mapping in Appendix B). W27 was determined not to conform to the definition of a ‘water body’ as outlined in O. Reg. 359/09.</p>	<p>May 15, 2012 June 15, 2012 July 5, 2012</p>

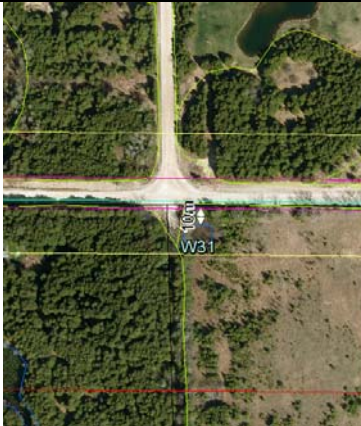
<p>W31 - 0m from underground electrical collection line in existing road right of way.</p>	<p>This feature (W31) was identified through Records Review and investigated further. Property access was not provided for the property where this feature was located and for that reason a roadside survey was conducted. No surface water feature was found at W31. The area consisted of open meadow vegetation with dogwood at the edges. No channel was found to lead into or out of the area along the two edges (Sideroad 40 and Concession 4 Rd.) that were surveyed. This feature was determined not to be a water body as defined under the REA process.</p>	<p>June 14, 2012</p>

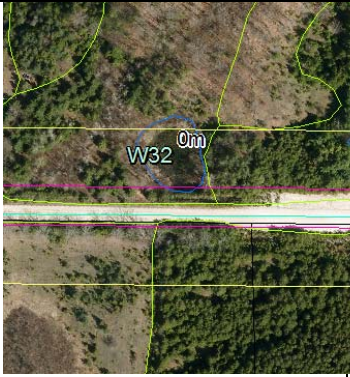
<p>Property access was not provided for the property where this feature was located and for that reason a roadside survey was conducted. This feature was determined during site investigation to be part of a balsam poplar and black ash deciduous swamp (ELC unit 293). Hydrophytic vegetation was dominant within the feature; therefore it was treated as a wetland and addressed within the NHA as a significant wetland (see mapping in Appendix B).</p> <p>W32 was determined not to meet the definition of a 'water body' as outlined in O. Reg. 359/09.</p>	June 14, 2012

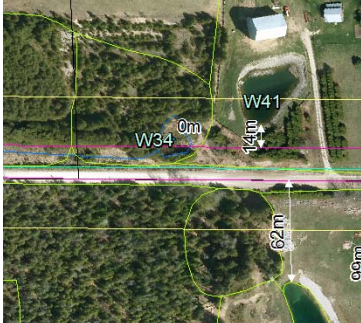
<p>W34 – 0m from underground electrical collection in road right of way.</p>	<p>Property access was not provided for the property where this feature was located and for that reason a roadside survey was conducted.</p> <p>This feature was determined during site investigation to be part of a white cedar coniferous swamp (ELC unit 410). Hydrophytic vegetation was dominant within the feature; therefore it was treated as a wetland and addressed within the NHA as a significant wetland (see mapping in Appendix B).</p> <p>W34 was determined not to meet the definition of a ‘water body’ as outlined in O. Reg. 359/09.</p>	June 14, 2012

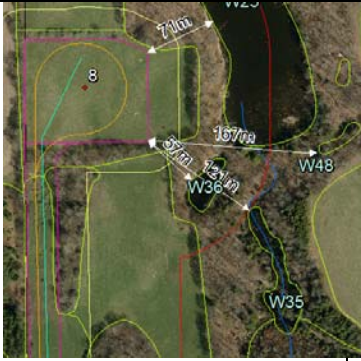
<p>W35 - 121m from Turbine 8 and associated access road and underground electrical collection.</p>	<p>Feature was determined to be greater than 120m from the final project location and not investigated further.</p>	<p>May 16, 2012 July 24, 2012</p>

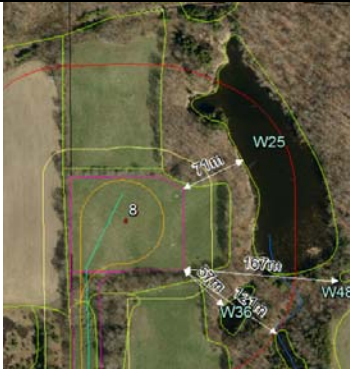
<p>W36 - 57m from Turbine 8, access road and underground electrical collection.</p>	<p>This feature was classified through site investigation as ELC unit 56 - Small pond with surface area dominated by duckweed (Lemna minor) in summer with small clusters of water parsnip, jewel weed, and sensitive fern along the edges. Surrounded by sugar maple ash deciduous forest. No fish observed within the pond. Size much reduced in summer condition. Gray tree frog, spring peeper, Canada goose, wood duck, Northern leopard frog, green frog, wood frog, Midland painted turtle observed during surveys. No fish documented in pond.</p> <p>This feature is included within the boundary of Beaver Meadow PSW and was addressed as significant wetland within the NHA (see mapping in Appendix B).</p>	May 16, 2012

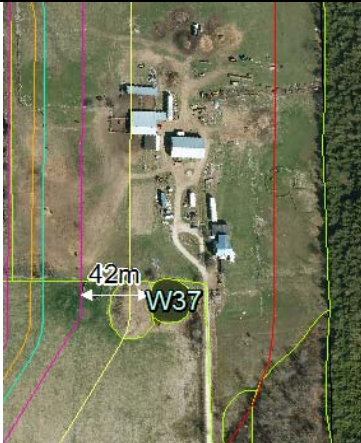
<p>W37 - 42m from access road and underground electrical collection line to Turbine 13</p>	<p>This feature was determined during site investigation to be a dugout pond. It was considered further within the NHA for the Project. W37 was determined not to meet the definition of a 'water body' as outlined in O. Reg. 359/09.</p>	<p>May 15, 2012</p>

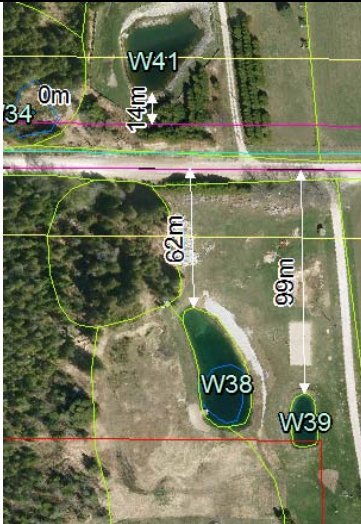
<p>W38 – 62m from underground electrical collection in road right of way.</p>	<p>This feature was determined during site investigation to be a dugout pond. It was considered further within the NHA for the Project and identified therein as significant wildlife habitat. W38 was determined not to meet the definition of a 'water body' as outlined in O. Reg. 359/09.</p>	<p>May 15, 2012</p>

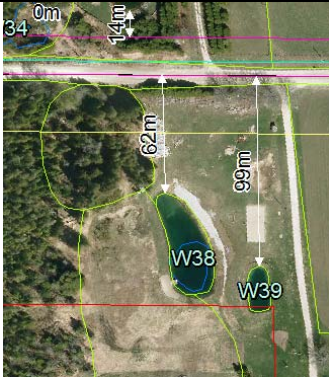
<p>W39 – 99m from underground electrical collection in road right of way.</p>	<p>This feature was determined during site investigation to be a dugout pond. It was considered further within the NHA for the Project and identified therein as significant wildlife habitat. W39 was determined not to meet the definition of a 'water body' as outlined in O. Reg. 359/09.</p>	<p>May 15, 2012</p>
