Goshen Wind Energy Centre
Water Assessment and Water Body Report

Project Location
December 2012
Project 60155032

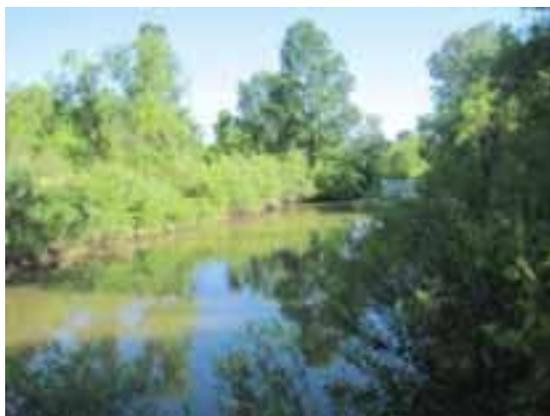
D36		D36
MWW(m):	7.0	MWD(m):	n/a
MBW(m):	8.25	MBD(m):	n/a

Photograph 1. Site overview ↑

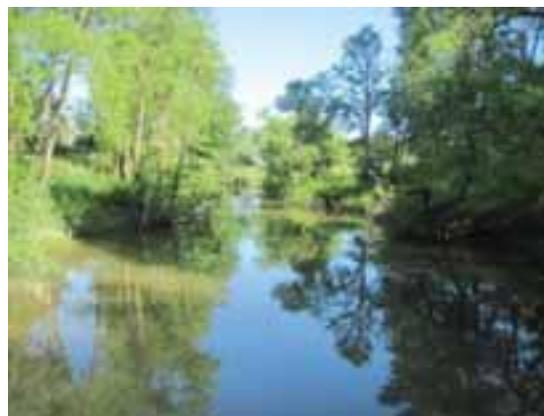
Photograph 2. Channel view ↑

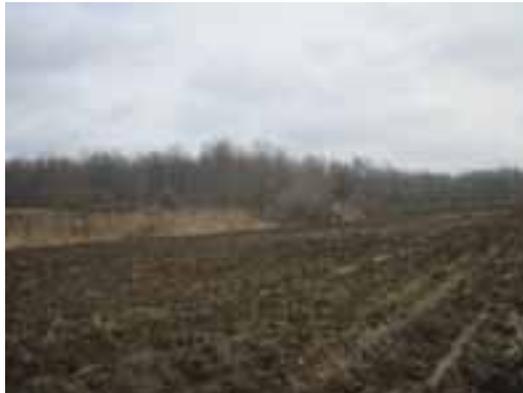
Watercourse Name	Sitter Drain	C80	MWD(m):	1.35	C80	MWD(m):	0.22
DFO Drain Classification	C		MBW(m):	2.5		MBD(m):	0.6

Photograph 1. Site overview ↑

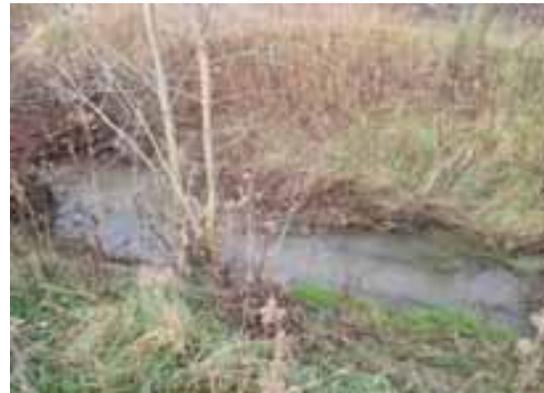
Photograph 2. Channel overview ↑

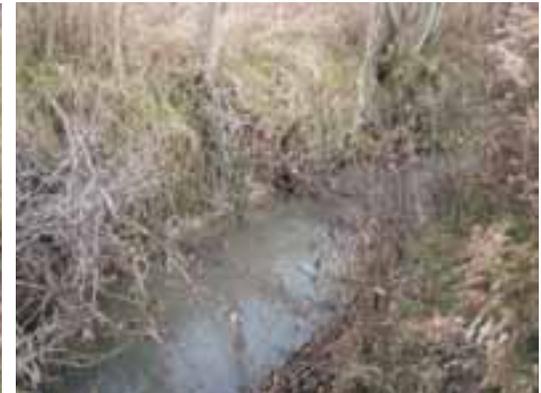
Photograph 3. Channel overview ↑

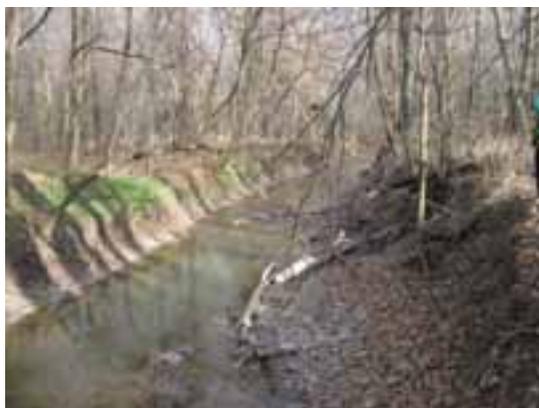
C81
MWD(m):	0.18
MBD(m):	1.3

Photograph 1. Channel overview, forest ↑

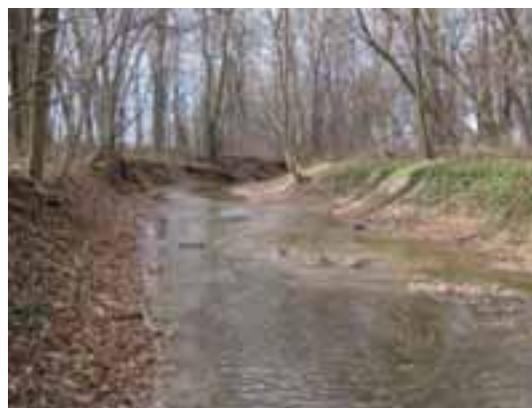
Photograph 2. Channel overview, forest ↑

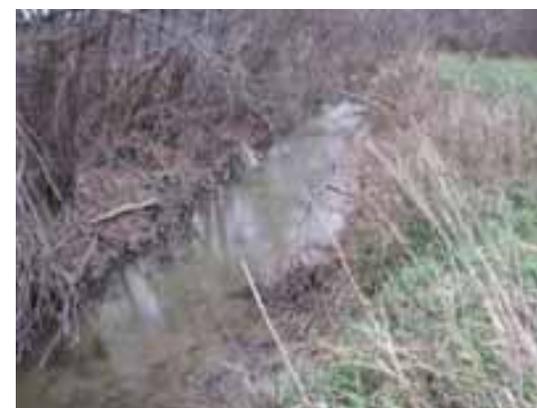
Photograph 3. Channel overview, agricultural field ↑

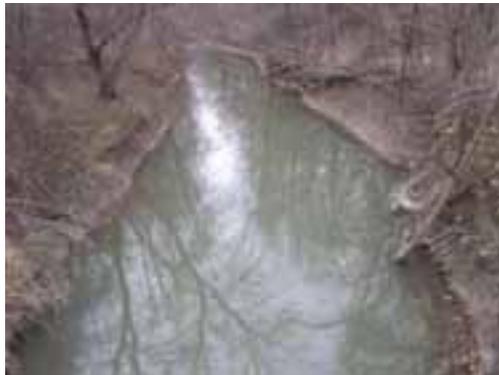
C82
MWD(m):	0.2
MBD(m):	1.3

Photograph 1. Channel overview ↑

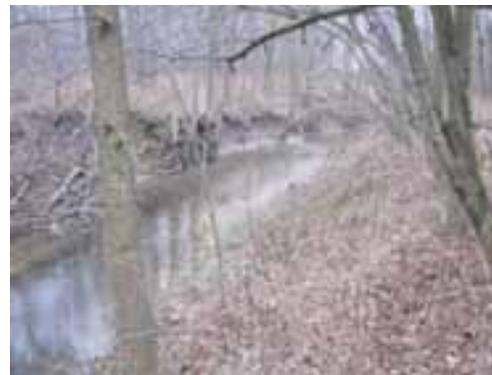
Photograph 2. Channel overview ↑

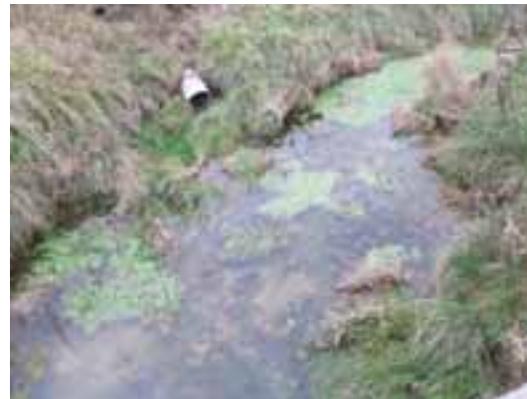
Photograph 2. Channel overview ↑

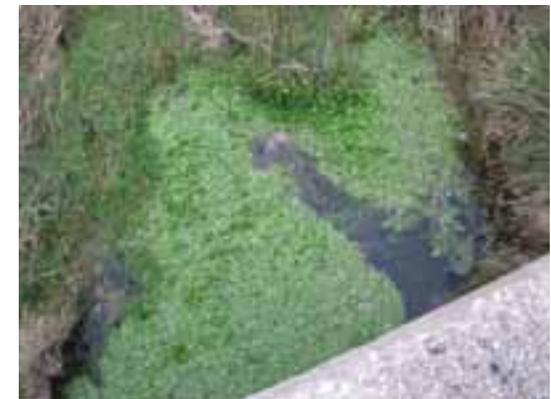
Photograph 3. Watercress ↑

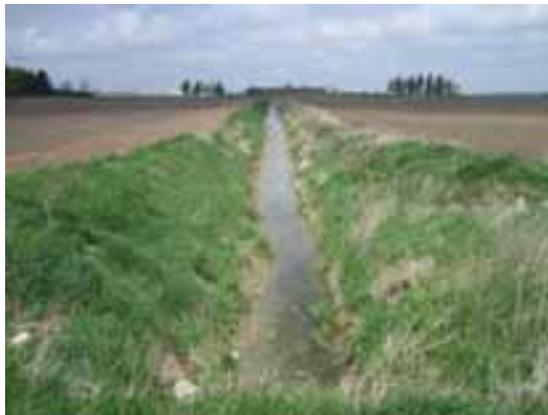
D31
MWD(m):	0.15
MBD(m):	0.4

Photograph 1. Site overview ↑

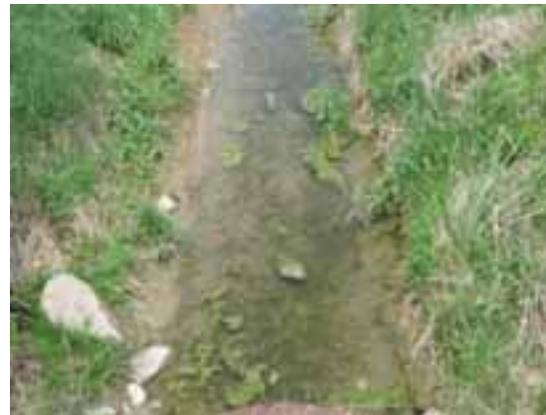
Photograph 2. Channel overview ↑

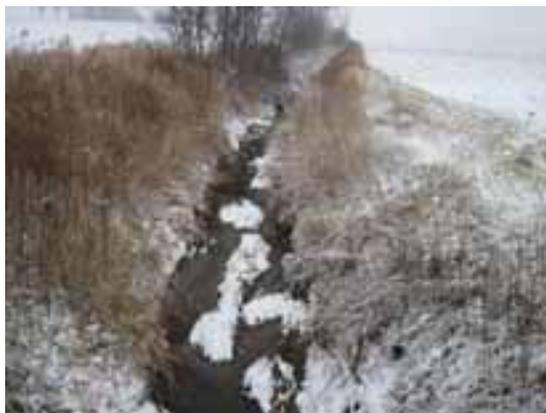
C96		C96
MWW(m):	1.3	MWD(m):	0.3
MBW(m):	1.5	MBD(m):	0.45

Photograph 1. Site overview ↑

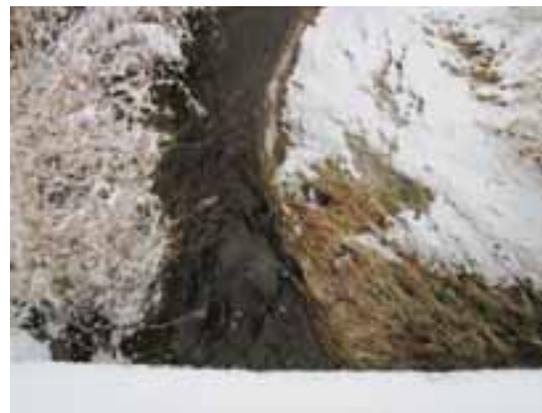
Photograph 2. Channel view ↑

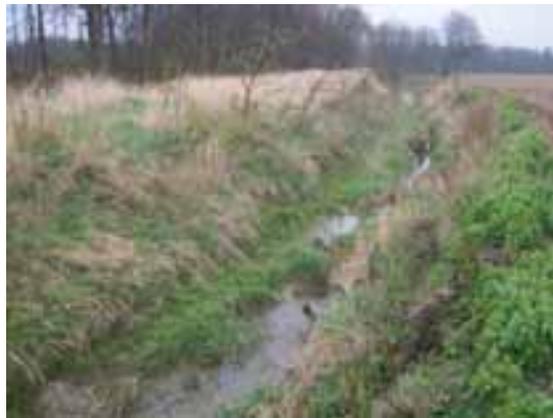
D17		D17
MWW(m):	1.2	MWD(m):	0.15
MBW(m):	6.0	MBD(m):	1.0

Photograph 1. Site overview ↑

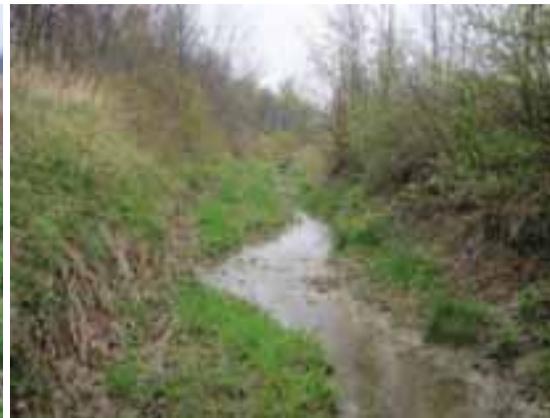
Photograph 2. Channel view ↑

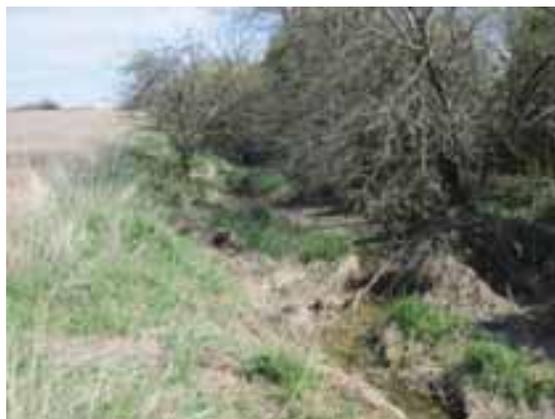
D18		D18
MWW(m):	0.9	MWD(m):	0.2
MBW(m):	3.0	MBD(m):	0.8

Photograph 1. Site overview ↑

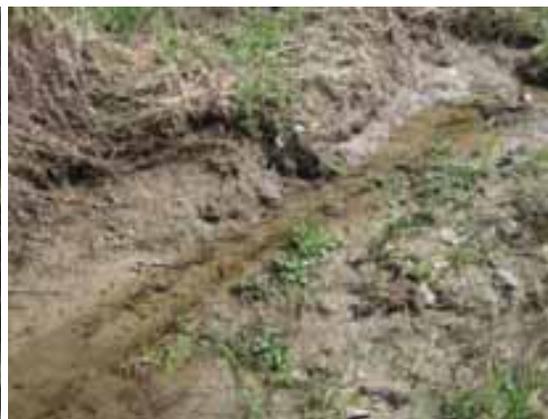
Photograph 2. Channel view ↑

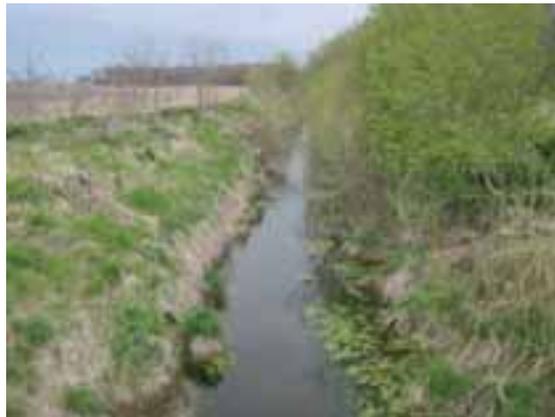
D20		D20
MWW(m):	2.6	MWD(m):	0.35
MBW(m):	4.25	MBD(m):	0.9

Photograph 1. Site overview ↑

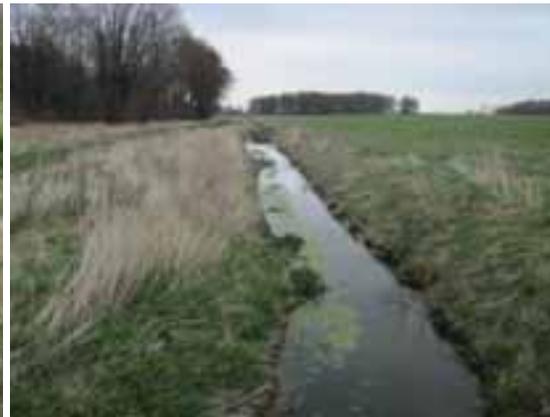
Photograph 2. Channel overview ↑

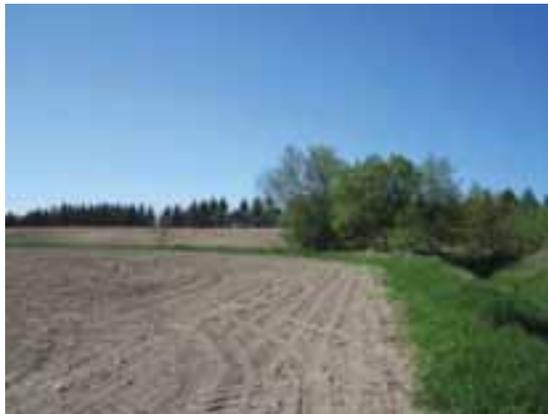
D19		D19
MWW(m):	1.4	MWD(m):	0.3
MBW(m):	2.3	MBD(m):	0.65

Photograph 1. Site overview ↑

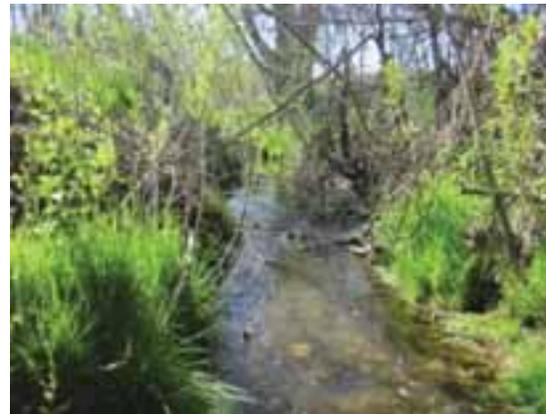
Photograph 2. Channel overview ↑

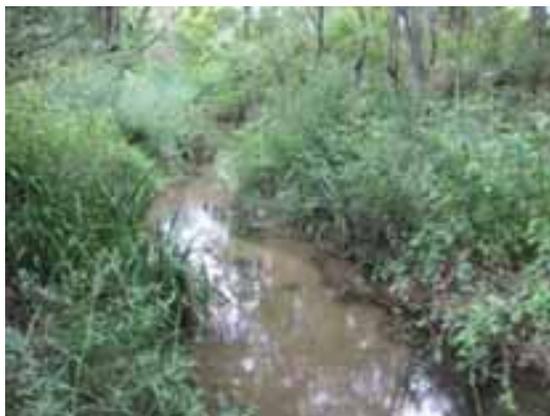
C64		C64
MWW(m):	1.5	MWD(m):	0.25
MBW(m):	2.5	MBD(m):	0.5

Photograph 1. Site overview ↑

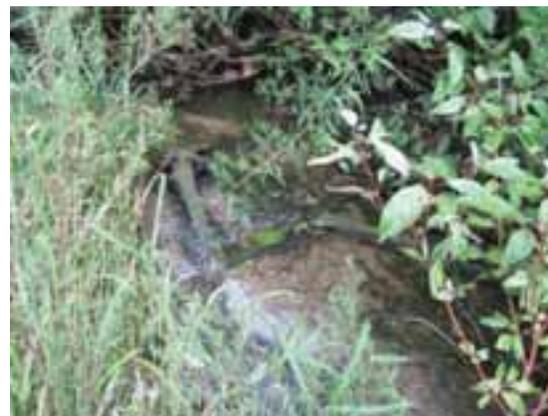
Photograph 2. Substrate ↑

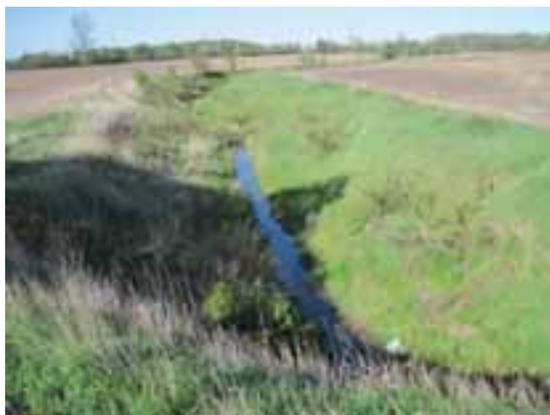
D12		D12
MWW(m):	1.25	MWD(m):	0.2
MBW(m):	1.5	MBD(m):	0.5

Photograph 1. Site overview ↑

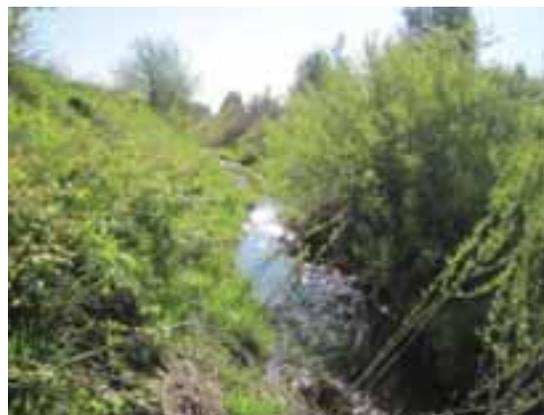
Photograph 2. Channel overview ↑

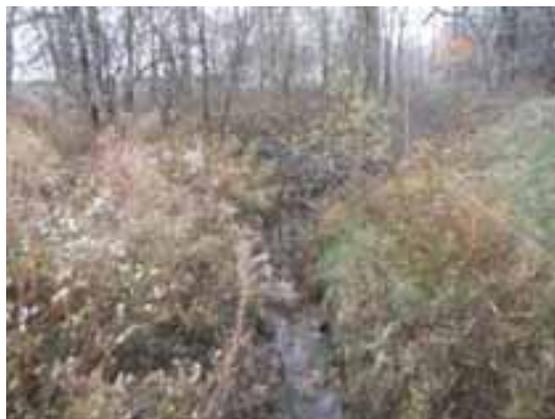
C5
MWD(m):	0.08
MBD(m):	0.80

Photograph 1. Channel overview in forest ↑

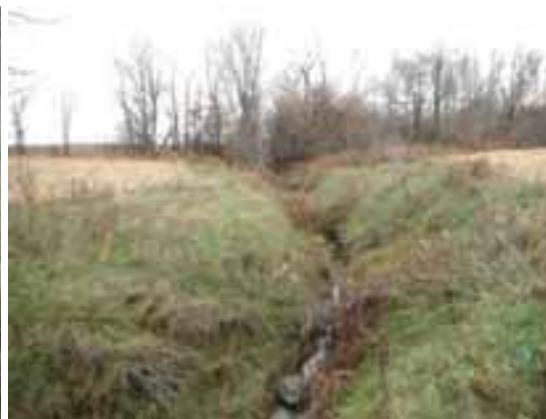
Photograph 2. Channel overview ↑

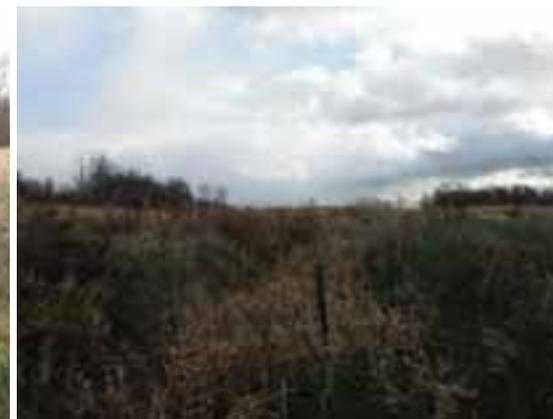
Photograph 3. Channel overview ↑

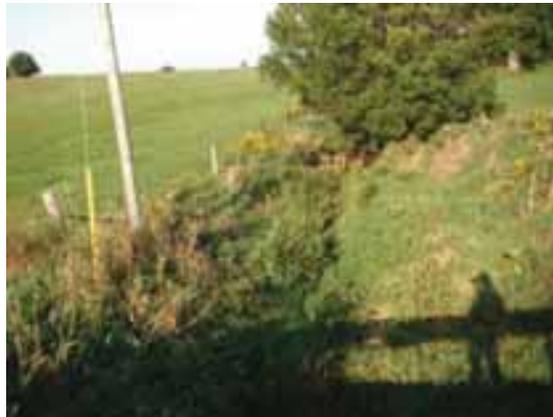
C6		C6
MWW(m):	1.5	MWD(m):	0.12
MBW(m):	3.0	MBD(m):	0.7

Photograph 1. Site overview ↑

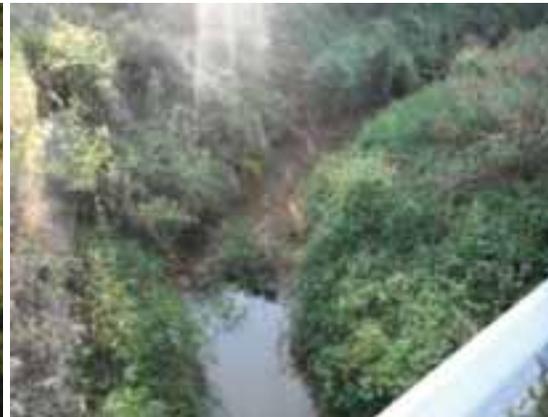
Photograph 2. Channel view ↑

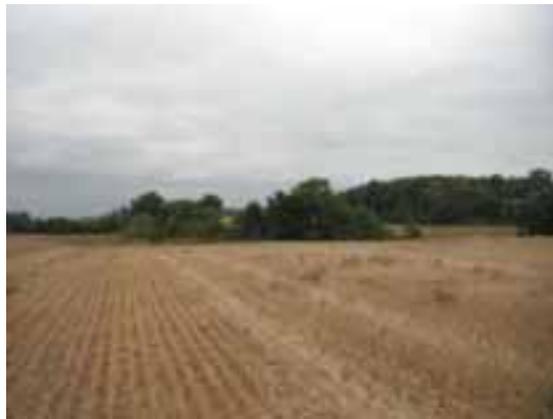
C7		C7
MWW(m):	2.0	MWD(m):	0.2
MBW(m):	6.2	MBD(m):	1.5

Photograph 1. Site overview ↑

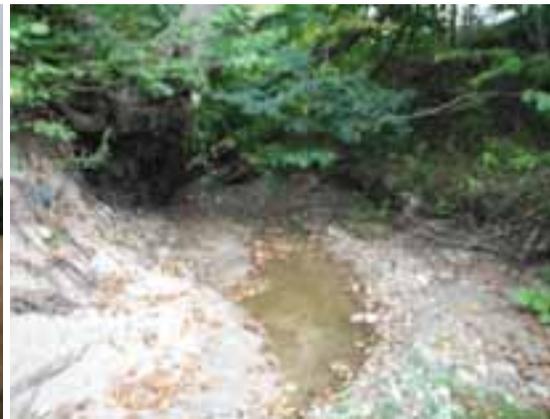
Photograph 2. Channel view ↑

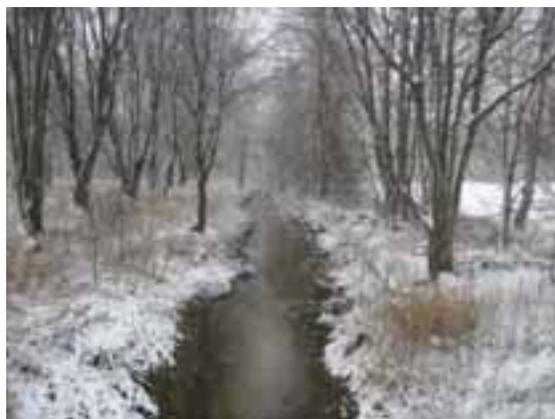
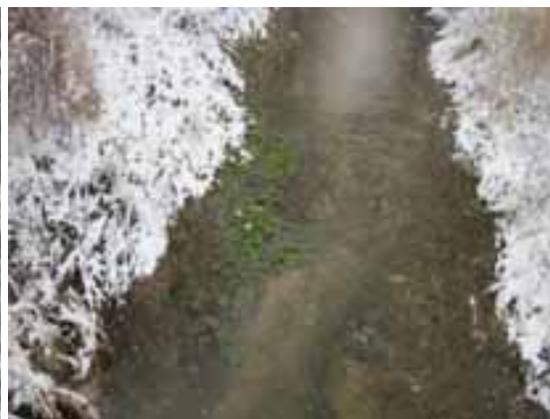
C33		C33
MWW(m):	2.0	MWD(m):	0.23
MBW(m):	3.5	MBD(m):	0.75

Feature ID	Project Component	Investigation Date	Description of Site	Feature Description	Feature Sensitivity
C33	• Collection Line Crossing	December 9, 2011	<ul style="list-style-type: none"> The watercourse flows a mix of deciduous forest and swamp (classified as FOD7-4, SWD3-3, ELC Feature ID 309) and adjacent crop agricultural field, under Huron Street, emerging in a crop agricultural field. The surrounding topography was flat. There were multiple tile drain inputs and one flowing watercourse observed to be feeding into the main channel approximately 80 m from Huron Street. Riparian buffer is 5 m on the right bank and 30 m on the forested left bank. 	<ul style="list-style-type: none"> The watercourse is a defined channelized feature, and is classified as a permanent warm water system by ABCA. It is a straight channel that is uniform run. The water was clear and had a moderate flow at the time of investigation. The banks are stable and vegetated. Substrate is dominated by sand followed by gravel and clay and then detritus. Canopy cover is high and dominated by trees then shrubs and grasses. Instream habitat cover is low and dominated by leaf detritus followed by woody debris and aquatic vegetation. Groundwater indicator watercress was noted. Upstream fish species consist of baitfish community (MNR, 1995). 	Moderate

Photograph 1. Site overview ↑

Photograph 2. Channel view ↑

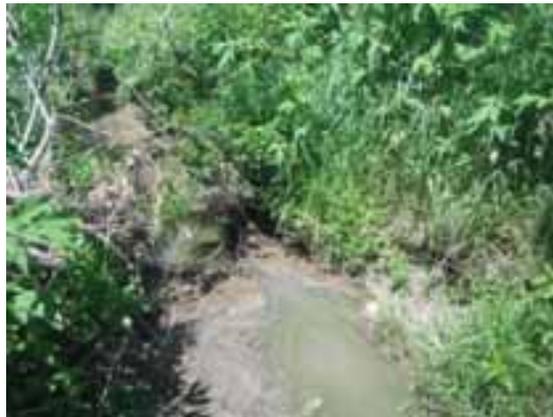
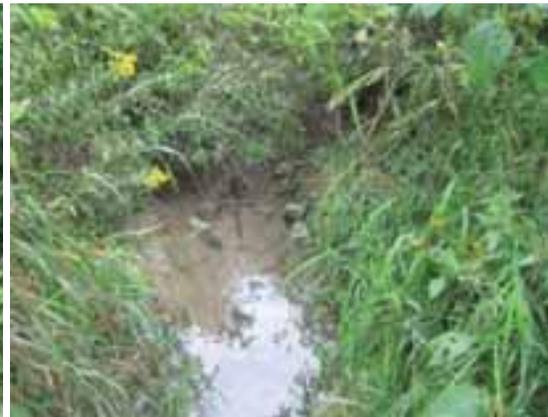
C89
MWD(m):	0.12
MBD(m):	0.5

Feature ID	Project Component	Investigation Date	Description of Site	Feature Description	Feature Sensitivity
C89	<ul style="list-style-type: none"> Turbine 42 Collection Line Buffer Road Buffer 	July 13, 2011 September 8, 2011	<ul style="list-style-type: none"> The watercourse flows along cultural woodland to the edge of a deciduous forest (classified as CUW1c, FOD9-4, ELC Feature ID 206) surrounded by agricultural fields. No tile drain inputs were noted. The surrounding topography is flat. Riparian buffer is 3.5 m along the agricultural field and greater than 3.5 m in the forest area. 	<ul style="list-style-type: none"> The watercourse is a defined natural feature. There is little morphological diversity- only run or flats. The water was clear and water was slow flowing at time of investigations. It is classified as a permanent warm water system by ABCA. The banks are slightly unstable with evidence of slumping noted. Substrate consists of silty sand with gravel, muck and cobble. Canopy cover is moderate and is a mix of grasses, shrubs and trees. Instream habitat cover is moderate and is a mix of aquatic vegetation, cobble, and woody debris. No groundwater indicators were noted. 	Moderate

Photograph 1. Channel overview ↑

Photograph 2. Channel overview ↑

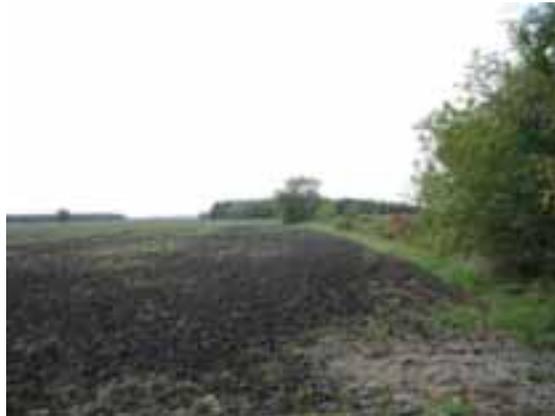
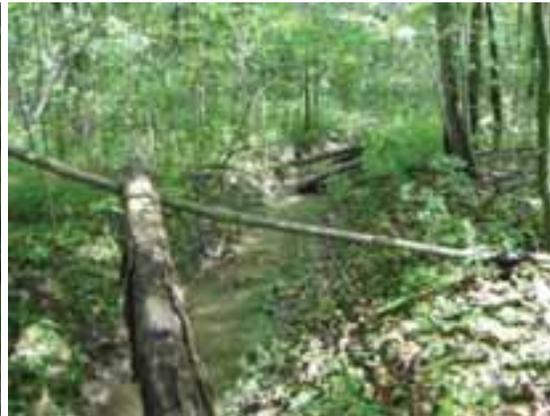
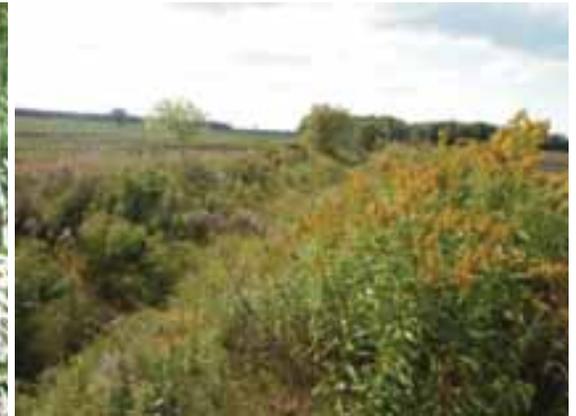
C42 forest	C42 agri		C42 forest	C42 agri
MWW(m):	1.0	2.5	MWD(m):	0.25	0.3
MBW(m):	1.5	3.0	MBD(m):	0.5	0.5

Feature ID	Project Component	Investigation Date	Description of Site	Feature Description	Feature Sensitivity
C42	• Collection Line Crossing	September 27, 2011	<ul style="list-style-type: none"> The watercourse flows through a deciduous forest (classified as FOD6-1, FOD7-2, ELC Feature ID 266), crosses Blackbush Line and continues into a crop agricultural field. No tile drain inputs observed and surrounding topography is flat. Riparian buffer is 1 m in agricultural field and greater than 5 m in the forest area. 	<ul style="list-style-type: none"> The watercourse flows through two distinct land use areas and as a result has differing characteristics throughout (forest and agricultural field). Overall the watercourse is classified as a permanent warm water system by ABCA. The section of watercourse running through the forest area is a defined natural channel. The banks are stable and substrate consists of silt muck and detritus. Canopy cover is high and is dominated by trees. Instream cover is low and dominated by woody debris. No groundwater indicators observed. The section of watercourse running through the agricultural field is a defined channelized feature. The banks are stable and substrate consists of silt and clay. Canopy cover is high and dominated by shrubs followed by grasses. Instream cover moderate and dominated by aquatic vegetation. Groundwater indicator watercress observed. Downstream fish species consists of a baitfish community (MNR, 1995). 	Moderate

Photograph 1. Site overview ↑

Photograph 2. Channel overview forest ↑

Photograph 3. Channel overview agricultural field ↑

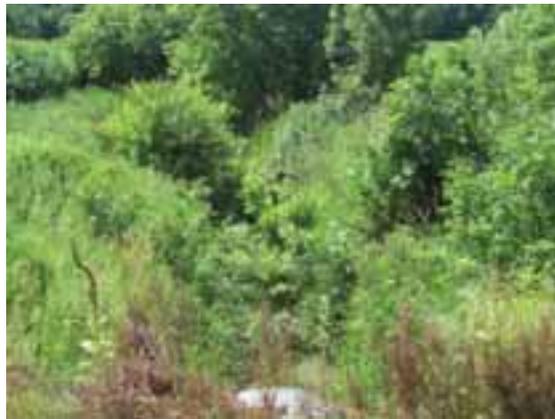
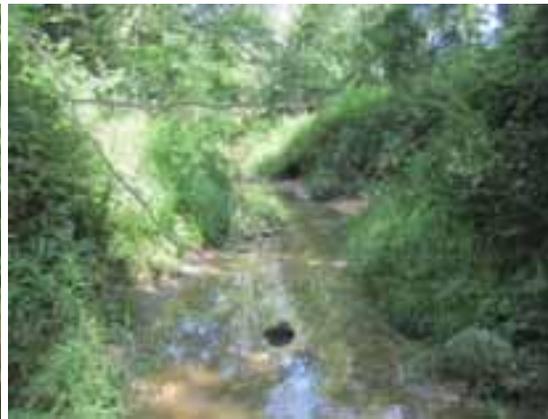
C43
MWD(m):	0.17
MBD(m):	0.5

Feature ID	Project Component	Investigation Date	Description of Site	Feature Description	Feature Sensitivity
C43	<ul style="list-style-type: none"> Turbines 20 and 66 Collection Line Crossing 	July 27, 2011	<ul style="list-style-type: none"> The watercourse runs through a crop agricultural field into a deciduous forest (classified as FOD7-2, ELC Feature ID 267) north of Kirkton Road. No tile drain inputs were noted and the surrounding area is flat. The riparian buffer in the agricultural fields is 3 m. 	<ul style="list-style-type: none"> The watercourse is a defined channelized feature. There is a slight meander with a riffle run pool sequence. The water was slightly turbid and had a slow flow during the time of investigation. It is classified as a permanent warm water system by ABCA. The banks are stable to slightly unstable. Substrate consists of silt and clay followed by gravel, sand, cobble and boulder. Canopy cover is high and a mix of grasses and trees. Instream habitat cover is moderate and a mix of undercut bank, woody debris, aquatic vegetation, cobble and boulder. Groundwater indicator watercress was noted. Fish were observed during time of investigation. Downstream and upstream fish species consists of a baitfish community and Rock Bass (MNR, 1980, 1981, 1994). 	Moderate

Photograph 1. Site overview agricultural field ↑

Photograph 2. Channel overview forest ↑

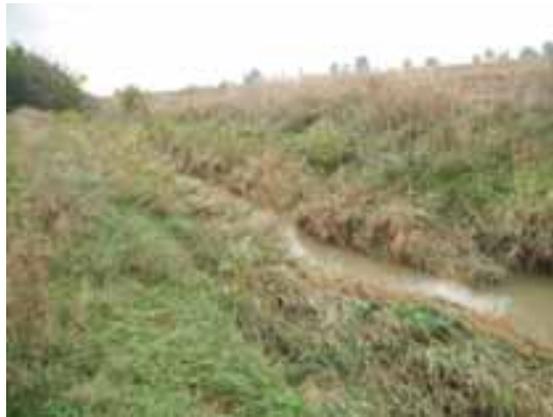
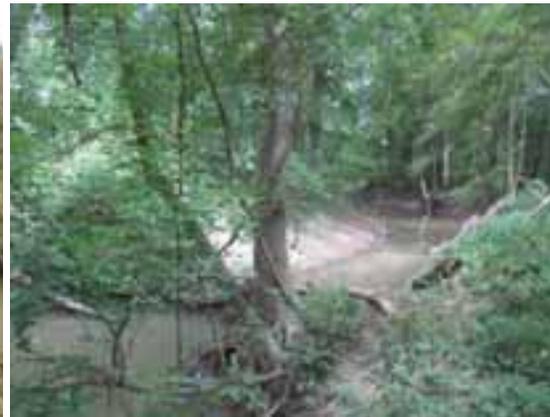
C46 Agri	C46 Forest		C46 Agri	C46 Forest
MWW(m):	1.3	4.0	MWD(m):	0.4	0.2
MBW(m):	2.0	6.0	MBD(m):	0.9	0.8

Feature ID	Project Component	Investigation Date	Description of Site	Feature Description	Feature Sensitivity
C46	<ul style="list-style-type: none"> Turbine 16 Collection Line Buffer Road Buffer 	July 27, 2011 September 28, 2011	<ul style="list-style-type: none"> The watercourse flows through a crop agricultural field that has a 1 m riparian buffer, into deciduous forest (classified as FOD7-1, ELC Feature ID 258). Tile drain inputs were observed throughout the agricultural field area. The surrounding landscape has slightly rolling hills. The morphology of the watercourse changes as it moves from agricultural field into forest and will be described separately in the feature description. 	<ul style="list-style-type: none"> The watercourse is a defined feature that begins as channelized then moves into a natural feature. In both portions of the stream it is uniform run with no obvious riffles or pools. The water was turbid and had some flow during site investigations. It is classified as a permanent warm water feature by ABCA. The banks are stable in the agricultural field, but slightly unstable in the forest. Substrate is a mix of gravel, sand, silt and clay with some cobble, boulder and detritus. Canopy cover is low in the agricultural field, but high in the forest and dominated by trees. Instream habitat cover is low in the agricultural field consisting of cobble and aquatic vegetation, but moderate in the forest which consists of woody debris followed by undercut bank, boulder and cobble. No groundwater indicators were noted. Fish observed in the forest area during site investigation in July. Upstream fish species consist of a baitfish community (MNR, 1981, 2007). 	Moderate

Photograph 1. Site overview agricultural field ↑

Photograph 2. Site overview forest ↑

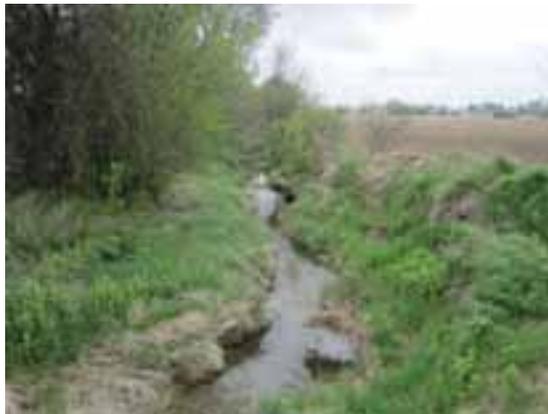
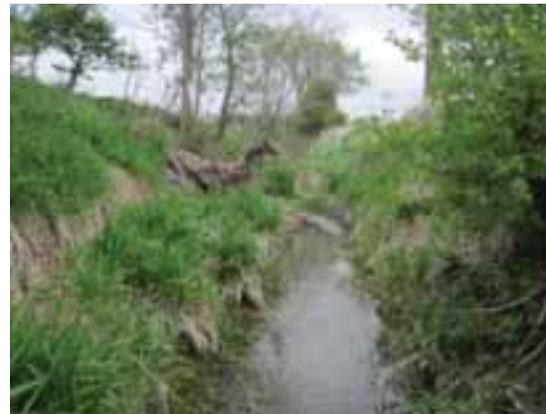
D27		D27
MWW(m):	1.0	MWD(m):	0.18
MBW(m):	2.0	MBD(m):	0.6

Photograph 1. Site overview ↑

Photograph 2. Channel overview ↑

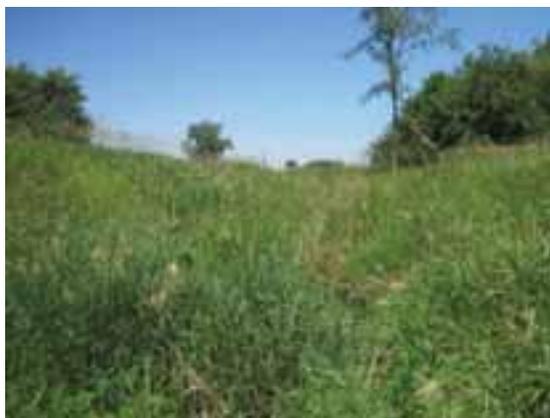
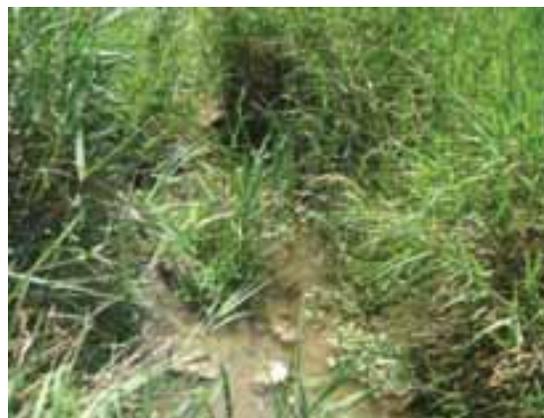
D38
MWD(m):	0.08
MBD(m):	0.9

Feature ID	Project Component	Investigation Date	Description of Site	Feature Description	Feature Sensitivity
D38	• Transmission Line Crossing	July 12, 2012	<ul style="list-style-type: none"> The watercourse flows through cultural meadow (classified as CUM1-1, ELC Feature ID 648) surrounded by soybean fields. No tile drain inputs were observed. D39 flows into watercourse. The surrounding topography is sloped towards the watercourse. Riparian buffer is 20 m of cultural meadow (CUM1-1). 	<ul style="list-style-type: none"> The watercourse is a defined channelized feature that appears to be naturalizing. The watercourse is mainly flat with some riffles present. The water was clear and had low flow at the time of investigation, however it is classified as an intermittent system by ABCA. The banks are slight unstable with signs of erosion and undercut banks. Substrate consists of silt followed by gravel and cobble. Canopy cover is moderate and is dominated by grasses. Instream habitat cover is low and consists of cobble and aquatic vegetation followed by undercut banks. Small pockets of groundwater indicator watercress were observed. Downstream and upstream fish species consist of a baitfish community (ABCA, 2009; MNR, 1980). 	Moderate

Photograph 1. Site overview ↑

Photograph 2. Channel view ↑

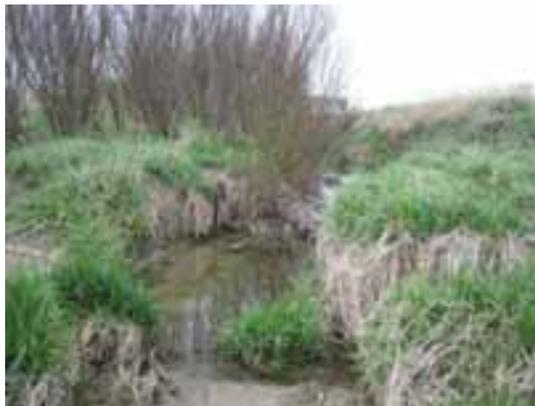
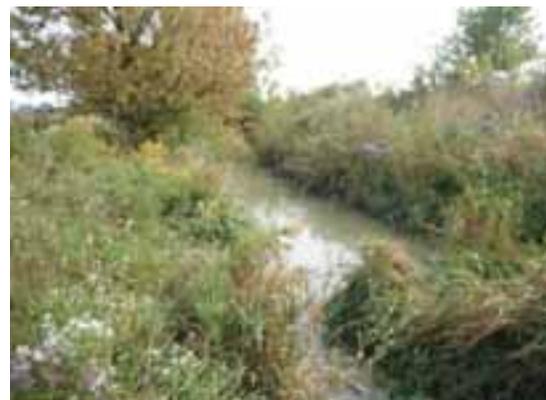
C52
MWD(m):	0.45
MBD(m):	1.0

Feature ID	Project Component	Investigation Date	Description of Site	Feature Description	Feature Sensitivity
C52	<ul style="list-style-type: none"> Collection Line Crossing Road Crossing Turbine 86 	September 28, 2011 December 16, 2011 April 26, 2012	<ul style="list-style-type: none"> The watercourse is surrounded by crop agricultural fields and crosses Blackbush Line. The northwestern reach is at the edge of deciduous swamp (classified as SWD2-2, ELC Feature ID 249). No tile drain inputs were observed. The surrounding topography is flat. Riparian buffer is 1.5 to 5 m. 	<ul style="list-style-type: none"> The watercourse is a defined channelized feature that appears to be naturalizing. The water was turbid and had a moderate flow during the time of first two site investigations. The water was clear and had low flow in April. The system is classified as a permanent warm water system by ABCA. Banks are slightly unstable. Substrate consists of silt, sand with gravel followed by clay, cobble and boulder. Canopy cover is moderate and is a mix of shrubs, trees and grasses. Instream habitat cover is moderate consisting of aquatic vegetation and woody debris. Groundwater indicator watercress was noted. An obstruction to fish passage exists at a man-made crossing of concrete dumped into the watercourse. A low flow barrier exists in the form of vehicles driving straight through the watercourse. Upstream fish species consists of baitfish community (MNR, 1981, 2007). 	Moderate

Photograph 1. Site overview ↑

Photograph 2. Channel overview ↑

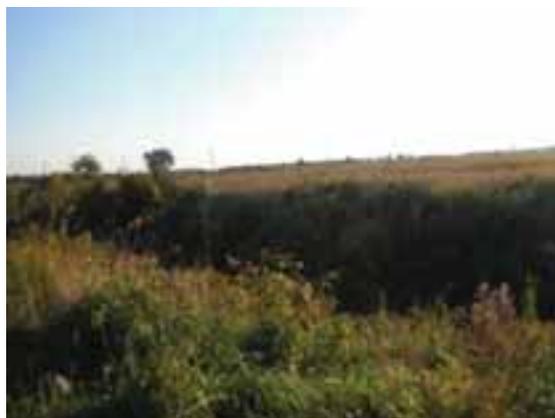
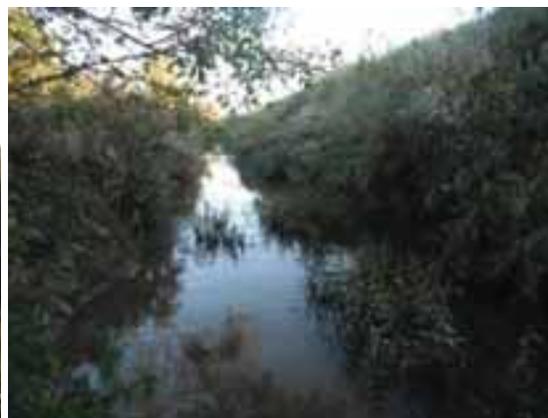
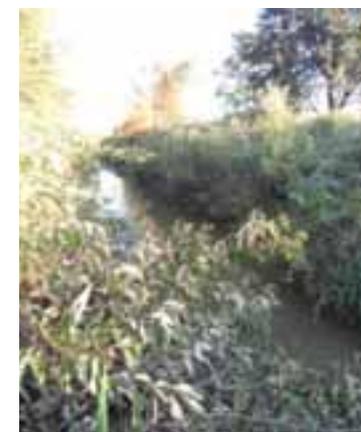
C139
MWD(m):	0.5
MBD(m):	1.0

Feature ID	Project Component	Investigation Date	Description of Site	Feature Description	Feature Sensitivity
C139	• Collection Line Crossing	October 6, 2011 November 18, 2011	• The watercourse flows through a crop agricultural field with a 1.5 m riparian buffer of cultural meadow (CUM1-1). Tile drains input were noted throughout the site. Surrounding topography is flat with a little sloping from the southwest.	• The watercourse is a defined channelized feature. There was low morphological diversity as the channel was only classified as run. The water was turbid and there was moderate flow during the time of investigations. It is classified as a permanent warm water system by ABCA. The banks are slightly unstable but vegetated. Substrate consists of silt clay followed by muck and detritus. Canopy cover is low consisting of trees, shrubs and grasses. Instream habitat cover is low and dominated by aquatic vegetation followed by woody debris and undercut banks. No groundwater indicators were noted. Upstream fish species consist of baitfish community (MNR, 1995).	Moderate

Photograph 1. Site overview ↑

Photograph 2. Channel overview ↑

Photograph 3. Channel overview ↑

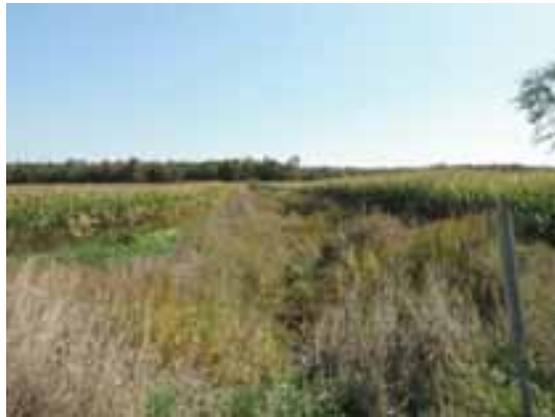
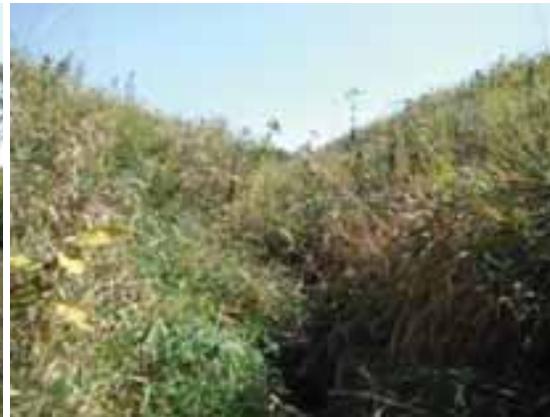
C61
MWD(m)	0.15
MBD(m):	0.45

Photograph 1. Site overview ↑

Photograph 2. Channel overview ↑

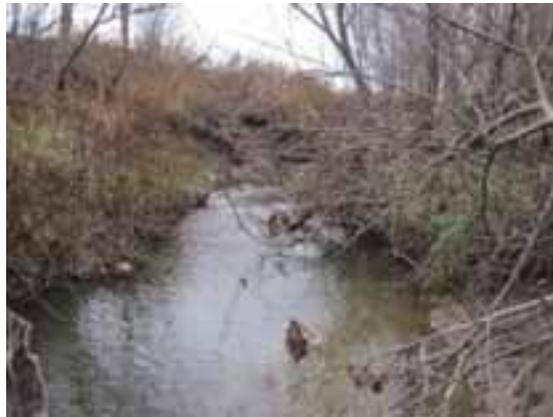
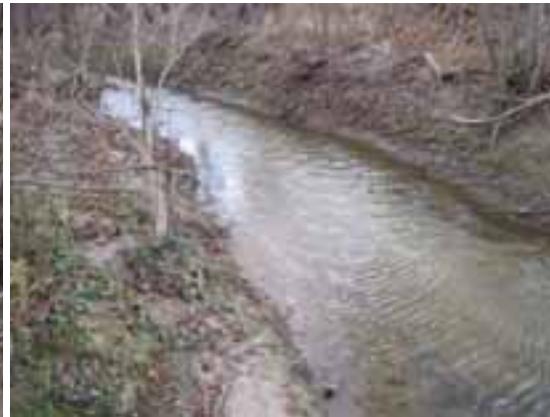
C66		C66
MWW(m):	2.1	MWD(m):	0.33
MBW(m):	3.1	MBD(m):	1.5

Feature ID	Project Component	Investigation Date	Description of Site	Feature Description	Feature Sensitivity
C66	<ul style="list-style-type: none"> Collection Line Buffer Road Buffer 	November 17, 2011	<ul style="list-style-type: none"> The watercourse flows through cultural thicket (classified as CUT1i, ELC Feature ID 210) surrounded by crop agricultural field with a 2 m riparian buffer. No tile drain inputs were observed. Surrounding topography is flat. 	<ul style="list-style-type: none"> The watercourse is defined channelized feature. The channel may be naturalizing as there are riffle, run, pool sequences is present. The water was clear and had moderate flow during time of investigation. It is classified as a permanent warm water system by ABCA. Banks are moderately unstable with exposed soils and evidence of slumping. Substrate consists of sandy silty clay with gravel. Canopy cover is moderate and is a mix of trees, grasses and shrubs. Instream habitat cover is moderate and dominated by woody debris followed by undercut banks. No groundwater indicators were noted. Upstream fish species consists of a baitfish community (ABCA, 1999). 	Moderate

Photograph 1. Channel overview ↑

Photograph 2. Channel overview ↑

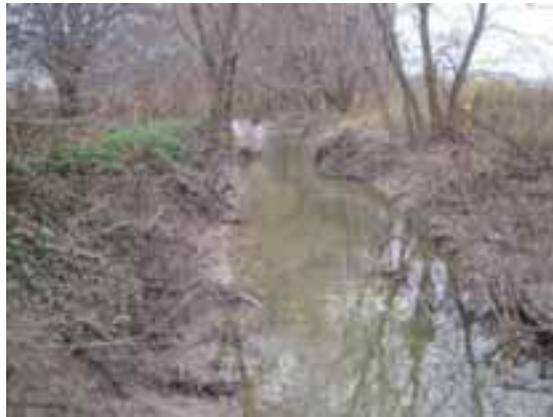
C67		C67
MWW(m):	3.0	MWD(m):	0.3
MBW(m):	5.9	MBD(m):	0.65

Feature ID	Project Component	Investigation Date	Description of Site	Feature Description	Feature Sensitivity
C67	<ul style="list-style-type: none"> Collection Line Crossing Turbine 57 	November 17, 2011	<ul style="list-style-type: none"> The watercourse flows through a deciduous forest (classified as FOD7-2, ELC Feature ID 198) surrounded by crop agricultural field with a 2 m riparian buffer. Tile drain inputs were observed. Surrounding topography is flat. 	<ul style="list-style-type: none"> The watercourse is a defined channelized feature. A riffle, run, pool sequences occur in the reach. The water was slightly turbid and had visible flow. It is a permanent warm water system by ABCA. Banks are slightly to moderately unstable with scouring and exposed tree roots present. Substrate is dominated by sand followed by gravel and clay. Canopy cover is high and dominated by trees followed by shrubs, grasses and herbaceous vegetation. Instream habitat cover is low and dominated by woody debris followed by undercut banks. No groundwater indicators were observed. Upstream fish species consist of a baitfish community (ABCA, 1999). 	Moderate

Photograph 1. Channel overview ↑

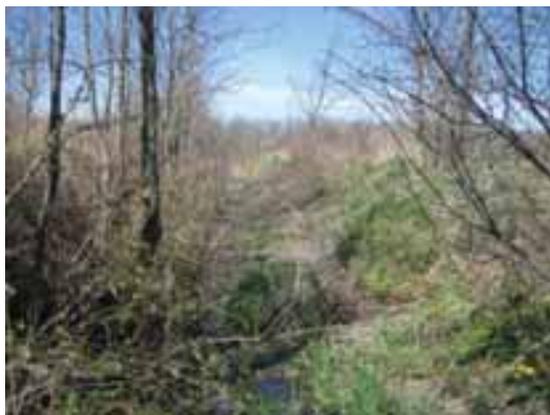
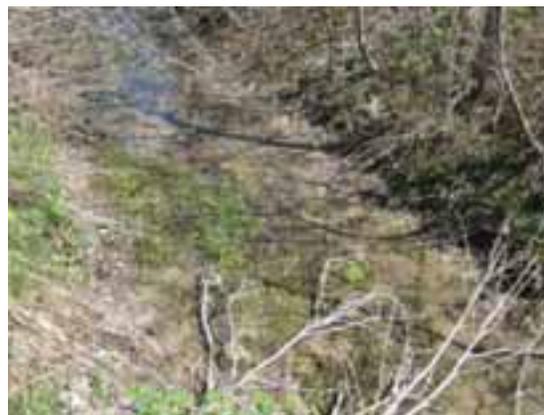
D44
MWD(m):	0.05
MBD(m):	0.5

Feature ID	Project Component	Investigation Date	Description of Site	Feature Description	Feature Sensitivity
D44	<ul style="list-style-type: none"> Collection Line Buffer Turbine 63 	April 18, 2012	<ul style="list-style-type: none"> The watercourse is located in a crop agricultural field with a 1 m riparian buffer of cultural meadow (CUM1-1). No tile drain inputs were observed. Surrounding topography is flat. 	<ul style="list-style-type: none"> The watercourse is a defined channelized feature. The watercourse is straight flat channel. The water was clear and stagnant during the time of investigation. The system is classified as intermittent by ABCA. Banks are stable and vegetated. Substrate consists of sand and silt. Canopy cover is high and is dominated by shrubs, followed by trees and grasses. Instream habitat cover is moderate and consists of aquatic vegetation and detritus followed by woody debris. Groundwater indicator watercress was observed. Small fish were observed at time of investigation. 	Moderate

Photograph 1. Site overview ↑

Photograph 1. Channel overview ↑

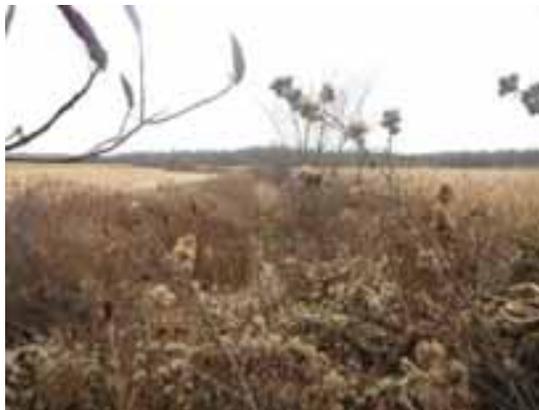
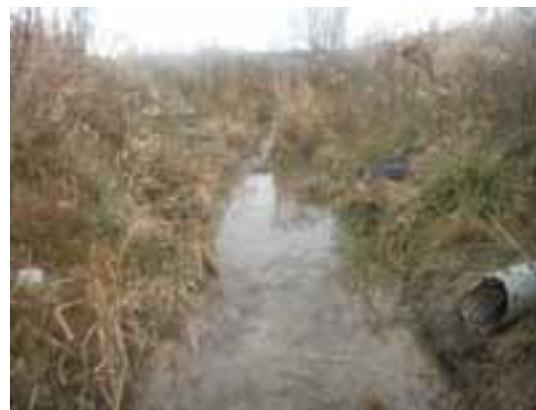
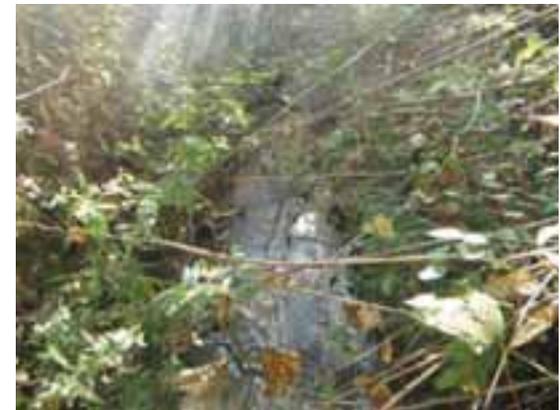
C124
MWD(m):	0.15
MBD(m):	0.65

Feature ID	Project Component	Investigation Date	Description of Site	Feature Description	Feature Sensitivity
C124	<ul style="list-style-type: none"> Collection Line Crossing Road Buffer Turbine 22 	September 27, 2011 November 18, 2011	<ul style="list-style-type: none"> The watercourse begins with a crop agricultural field to the north and a mix of deciduous swamp and forest (classified as FOD4e, SWD2-2, ELC Feature ID 266) to the south. The watercourse continues to flow in crop agricultural fields after the forest area. Tile drain inputs were observed in the agricultural fields. Surrounding topography is flat. Riparian buffer in the agricultural fields is 2 m and is greater than 15 m in the forest area. 	<ul style="list-style-type: none"> The watercourse is a defined channelized feature. The watercourse is mainly flat with some riffles, runs and pools present. The water was clear and had moderate flow during the time of investigations, however it is classified as intermittent by ABCA. Banks are slightly unstable with evidence of erosion. Substrate consists of silt, clay, sand followed by gravel, cobble and boulders. Canopy cover is high in the forest and dominated by trees and shrubs. Canopy cover is moderate in the agricultural field and is dominated by grasses and shrubs. Instream habitat cover is moderate consisting of mainly aquatic vegetation followed by detritus and woody debris. Groundwater indicator watercress was observed. 	Moderate

Photograph 1. Site overview ↑

Photograph 2. Channel overview agricultural fields ↑

Photograph 3. Channel view forest ↑

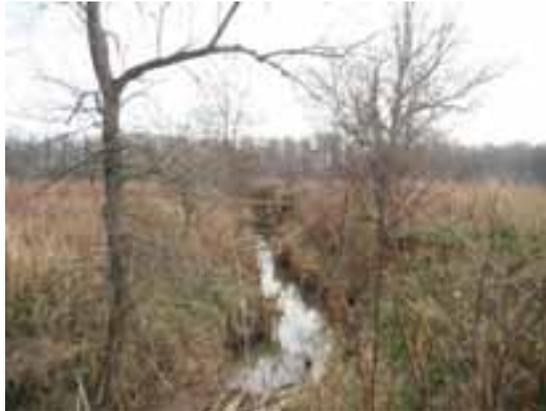
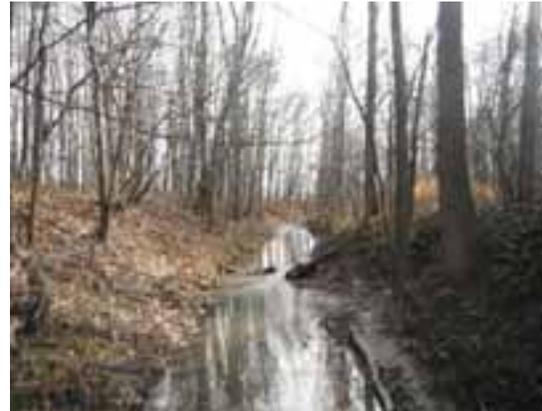
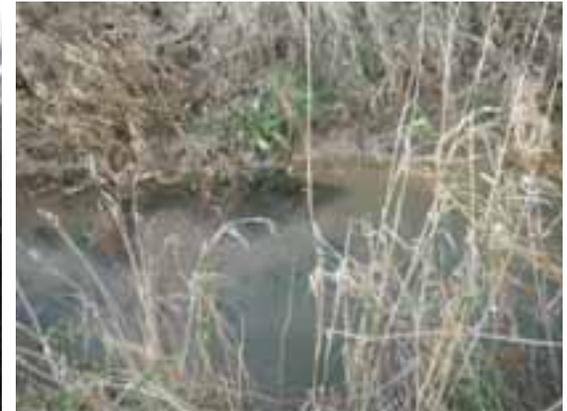
Watercourse Name	Dietrich Main Drain	C137	C137
DFO Drain Classification	E	MWW(m): 2.35	MWD(m): 0.2
		MBW(m): 3.05	MBD(m): 0.85

Feature ID	Project Component	Investigation Date	Description of Site	Feature Description	Feature Sensitivity
C137	• Collection Line Crossing	November 18, 2011	<ul style="list-style-type: none"> The watercourse begins in mix of deciduous forest, meadow marsh, cultural meadow, deciduous swamp and cultural thicket (classified as FOD9b, FOD7-2, MAM2-2, CUM1-1, CUT1h, SWD2-2, ELC Feature ID 236) emerging into agricultural fields. No tile drain inputs were noted during time of investigation. Surrounding topography is flat with a slight slope from the east. 	<ul style="list-style-type: none"> The watercourse is a defined channelized feature. A riffle, run sequences occurs in the reach. The water was turbid and had slow flow during the time of investigation. It is classified as a permanent warm water system by ABCA. Banks are slightly to moderately unstable with exposed soils and evidence of erosion. Substrate consists of silt followed by clay, silt and sand followed by gravel. Canopy cover is high in the forest area dominated by trees and is moderate in the agricultural field dominated by grasses and shrubs. Instream habitat cover is low in the forest area consisting of woody debris and moderate in the agricultural field consisting of undercut banks followed by woody debris. No groundwater indicators were observed. Downstream fish species consist of a baitfish community, Brown Bullhead (<i>Ameiurus nebulosus</i>), Rainbow Trout and Northern Pike (ABCA, 2001; MNR 2003). 	Moderate

Photograph 1. Site overview agricultural field ↑

Photograph 2. Site overview forest ↑

Photograph 3. Channel view ↑

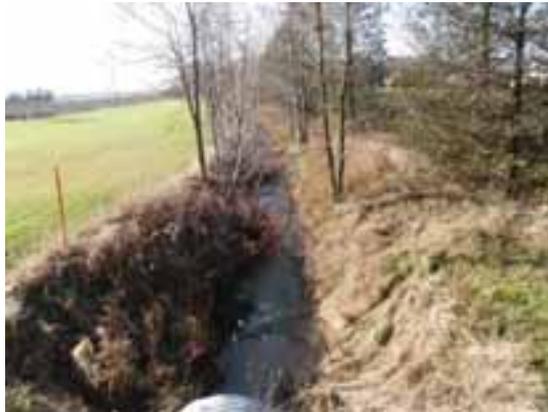
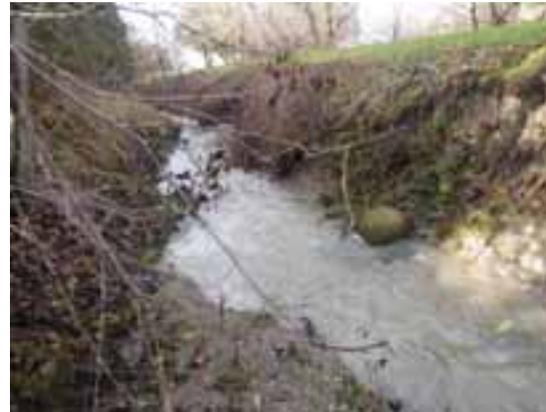
C208		C208
MWW(m):	2.0	MWD(m):	0.3
MBW(m):	3.5	MBD(m):	0.45

Photograph 1. Site overview ↑

Photograph 2. Channel overview ↑
