Goshen Wind Energy Centre
Water Assessment and Water Body Report

Project Location
December 2012
Project 60155032

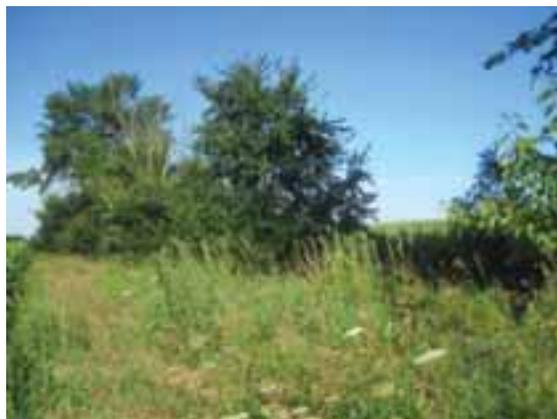
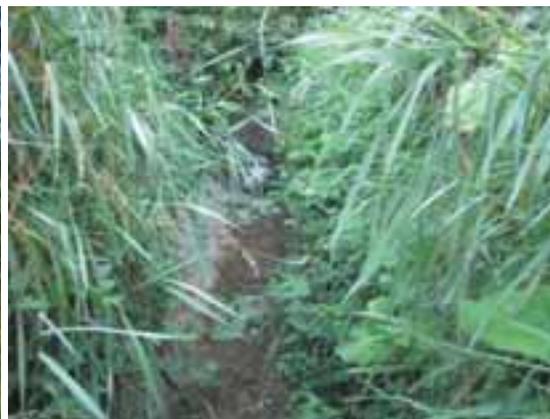
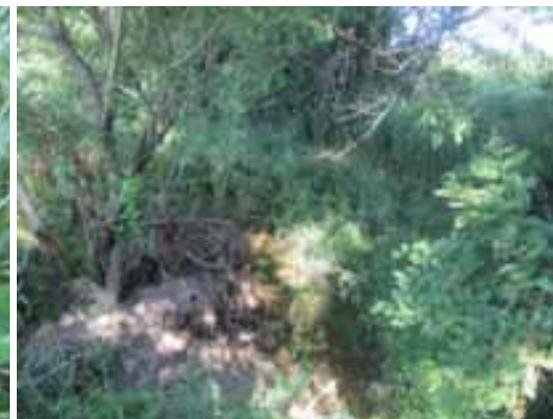
C15		C15
MWW(m):	1.0	MWD(m)	0.15
MBW(m):	1.5	MBD(m):	0.3

Feature ID	Project Component	Investigation Date	Description of Site	Feature Description	Feature Sensitivity
C15	<ul style="list-style-type: none"> Road Buffer Collection Line Crossing Turbine 13 	July 27, 2011	<ul style="list-style-type: none"> The watercourse flows from a deciduous forest (classified as FOD5-2, ELC Feature ID 352) into a crop agricultural field. No tile drain inputs were observed at time of investigation. Surrounding land topography is flat. Riparian buffer is 1 m consisting of trees and grasses. 	<ul style="list-style-type: none"> The watercourse is a defined channelized feature. Overall the channel straight uniform with some pools present. Water was clear and slow flowing at time of investigation. It is classified as a permanent warm water system by ABCA. Banks are stable and well vegetated. Substrate consists of silt and clay followed by sand, gravel, cobble and boulder. Canopy cover is high consisting of grasses and trees. Instream habitat cover is high and dominated by aquatic vegetation followed by cobble and boulders. Groundwater indicator watercress was observed. A few fish were observed during time of investigation. 	Moderate

Photograph 1. Site overview ↑

Photograph 2. Channel view ↑

Photograph 3. Channel view ↑

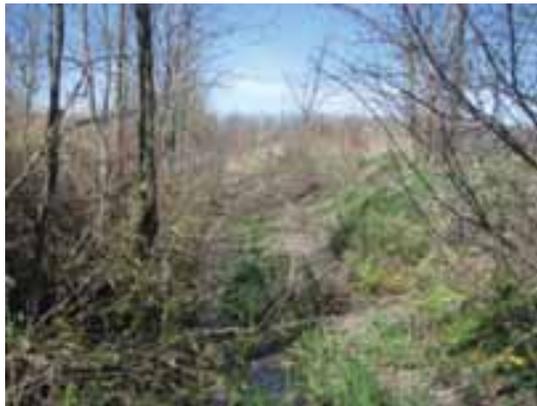
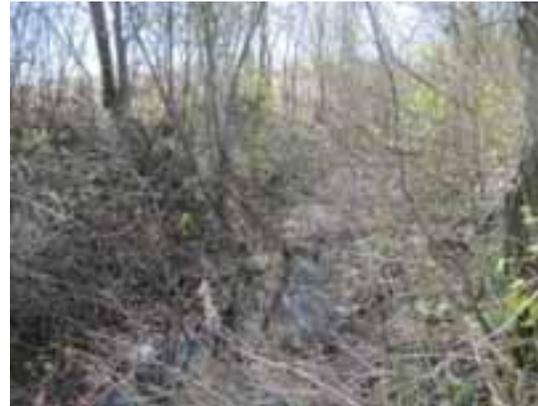
C74
MWD(m):	0.05
MBD(m):	0.6

Feature ID	Project Component	Investigation Date	Description of Site	Feature Description	Feature Sensitivity
C74	<ul style="list-style-type: none"> Collection Line Crossing Road Crossing Turbine 60 MET Tower Buffer 	July 13, 2011 April 18, 2012	<ul style="list-style-type: none"> The watercourse flows through a soybean field to the south and wheat field to the north. No tile drain inputs were noted during time of investigation. Surrounding topography is flat. Riparian buffer is 3 m of cultural meadow (CUM1-1) consisting of trees, shrubs and grasses. 	<ul style="list-style-type: none"> The watercourse is a defined channelized feature. There was no flow during the time of investigation. It is classified as intermittent system by ABCA. Banks are stable and vegetated. Substrate consists of silt and sand. Canopy cover is high consisting of shrubs, trees and grasses. Instream habitat cover is moderate and consists of aquatic vegetation, detritus and woody debris. Groundwater indicator watercress was observed. Minnows were observed during time of investigation in April. 	Moderate

Photograph 1. Site overview ↑

Photograph 2. Channel overview ↑

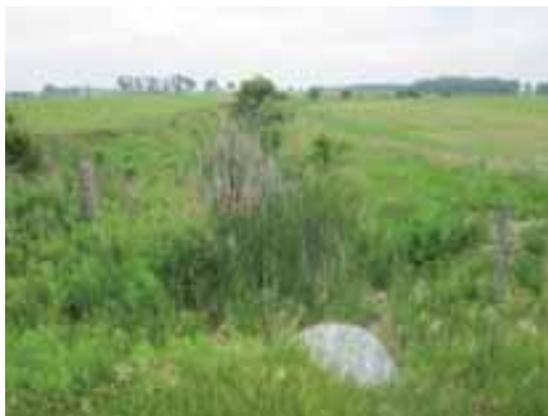
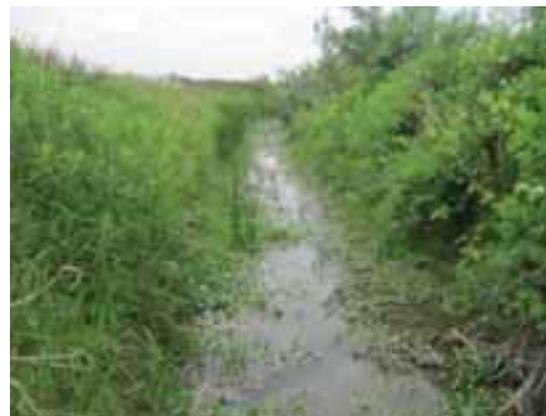
D43
MWD(m):	0.15
MBD(m):	0.5

Feature ID	Project Component	Investigation Date	Description of Site	Feature Description	Feature Sensitivity
D43	• Collection Line Crossing	June 11, 2012	<ul style="list-style-type: none"> The watercourse begins at Crediton Road and flows south through soybean fields. Tile drain inputs were noted at time of investigation with one flowing. Surrounding topography is flat. Riparian buffer is less than 0.5 m of cultural meadow (CUM1-1). 	<ul style="list-style-type: none"> The watercourse is a defined channelized feature. The watercourse is a straight flat channel with some pools present. The water was slightly turbid and had slow flow at time of investigation. It is classified as an intermittent system by ABCA. Banks are stable and well vegetated. Substrate consists of muck, silt and clay followed by sand. Canopy cover is moderate and consists of grasses, shrubs and some trees. Instream habitat cover is high and consists of aquatic vegetation followed by vegetation debris. Groundwater indicator water speedwell was observed. 	Moderate

Photograph 1. Site overview ↑

Photograph 2. Channel overview ↑

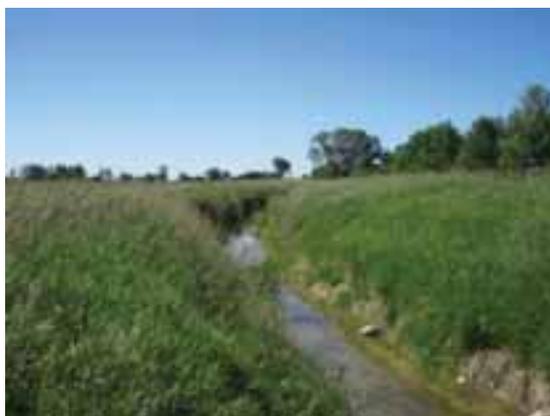
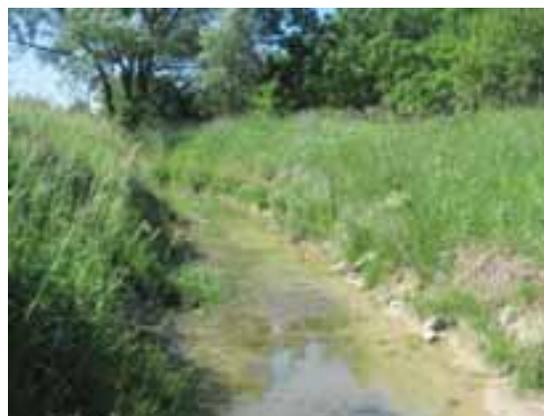
D37
MWD(m):	0.25
MBD(m):	1.0

Feature ID	Project Component	Investigation Date	Description of Site	Feature Description	Feature Sensitivity
D37	• Transmission Line Crossing	June 13, 2012	<ul style="list-style-type: none"> The watercourse flows through a 15 m cultural meadow and cultural thicket (classified as CUT1j, CUM1-1, ELC Feature ID 635) riparian buffer surrounded by agricultural fields. Tile drain inputs were observed at time of investigation with some flowing. Surrounding topography is flat. 	<ul style="list-style-type: none"> The watercourse is a defined channelized feature. The watercourse is mostly straight flat channel with some riffle pool run sequences. The water was clear and had moderate flow at time of investigation. It is classified as a permanent warm water system by ABCA. Banks were slightly unstable with some areas of erosion and bare soil. The substrate consists of clay followed by sand, silt and cobble. Canopy cover is low and dominated by grasses. Instream habitat cover is low and dominated by aquatic vegetation followed by cobble. Groundwater indicators water speedwell and watercress were observed. Cyprinids and darters were observed at time of investigation. Downstream and upstream fish species consist of a baitfish community (ABCA, 2009; MNR, 1980). 	Moderate

Photograph 1. Site overview ↑

Photograph 2. Channel overview ↑

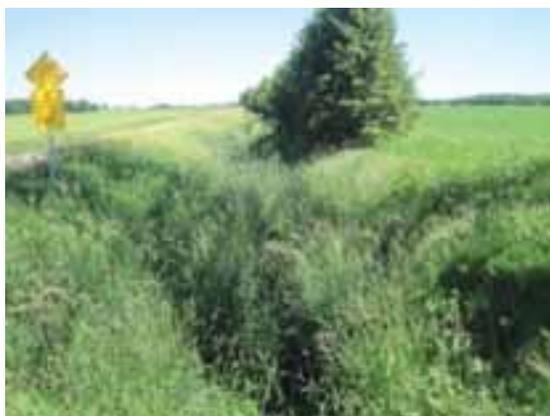
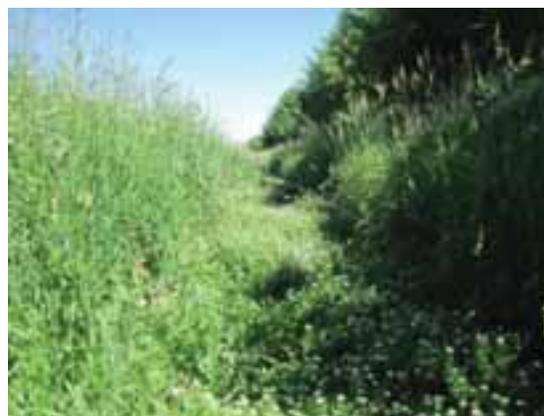
D35
MWD(m):	0.16
MBD(m):	0.75

Feature ID	Project Component	Investigation Date	Description of Site	Feature Description	Feature Sensitivity
D35	• Transmission Line Crossing	May 1, 2012 June 13, 2012	<ul style="list-style-type: none"> The watercourse runs adjacent to McTaggart Line and adjacent to a corn field. Tile drain inputs were observed at time of investigation, they were not flowing. Surrounding topography is flat. Riparian buffer is 1 m of cultural meadow (CUM1-1) on the right bank and 1.5 m of cultural meadow consisting of grasses and tree row on the left bank. 	<ul style="list-style-type: none"> The watercourse is a defined channelized feature. The watercourse is straight uniform flat channel. The water was clear and had very low flow at time of first investigation. The water was clear and was stagnant at time of second site investigation. It is classified as unknown by ABCA. The banks are stable and well vegetated. The substrate consists of muck followed by silt, sand and clay. The canopy cover is low and dominated by grasses. Instream habitat cover is high and consists of only aquatic vegetation. The majority of the channel was vegetation choked. Groundwater indicators watercress, water speedwell and bittercress were present throughout the site. Downstream fish species consist of baitfish community, Stonecat and Rock Bass (ABCA, 2000). 	Moderate

Photograph 1. Site overview ↑

Photograph 2. Channel overview ↑

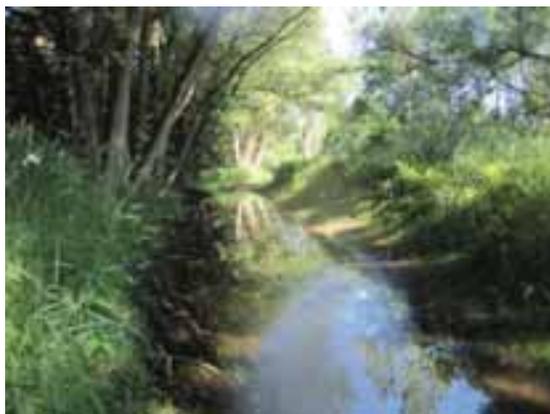
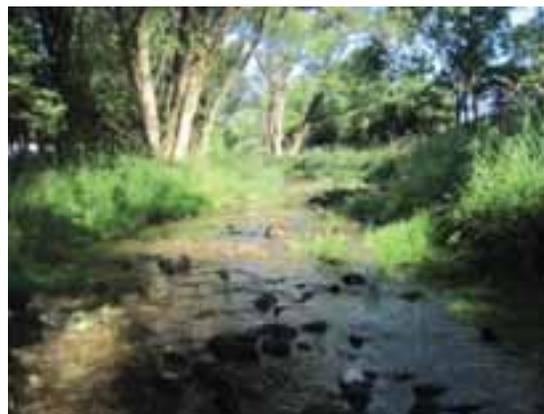
D32
MWD(m):	0.26
MBD(m):	0.9

Feature ID	Project Component	Investigation Date	Description of Site	Feature Description	Feature Sensitivity
D32	<ul style="list-style-type: none"> Transmission Line Crossing Breaker Switch Station Buffer 	May 9, 2012 June 22, 2012	<ul style="list-style-type: none"> The watercourse is surrounded by a mix of deciduous forest, swamp, cultural thicket and cultural meadow (classified as FOD5-6, SWD4-1, CUM1-1, CUT1k, ELC Feature ID 738) and agricultural fields. The watercourse also crosses Dump Road. One tile drain input that was not flowing was observed at time of investigation. Surrounding land topography is flat with slight rolling towards the watercourse. Riparian buffer is greater than 10 m in the forest area and 3 m in the agricultural area. 	<ul style="list-style-type: none"> The watercourse is a defined natural feature in the forest and channelized in the agricultural field. The watercourse meanders and follows a riffle pool run sequence in a few locations. The water was clear and had moderate flow at time of investigations. It is classified as a permanent warm water system by UTRCA. The banks are stable to slightly unstable with evidence of erosion. The substrate consists of silt, cobble, gravel and sand followed by boulders. The canopy cover is moderate and is dominated by trees in the forest and low in the agricultural field. Instream habitat cover is high and consists of aquatic vegetation and cobble followed by boulders, undercut banks and woody debris. No groundwater indicators were observed. Cyprinids and darters were observed at time of investigations. One live Giant Floater mussel was observed in June. Fish species upstream and downstream include common baitfish community, Rock Bass and Northern Pike (UTRCA, 1974, 2000, 2001, 2003, 2005, 2007, 2008). 	Moderate

Photograph 1. Site overview ↑

Photograph 2. Channel view ↑

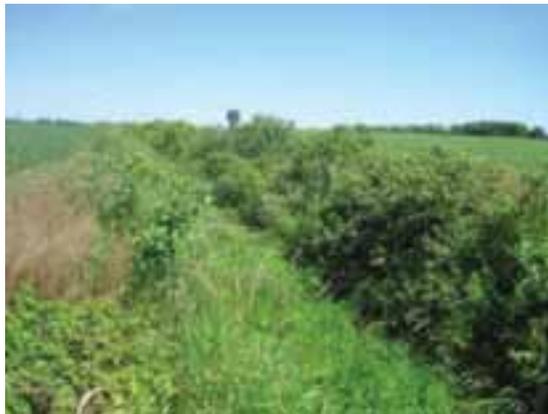
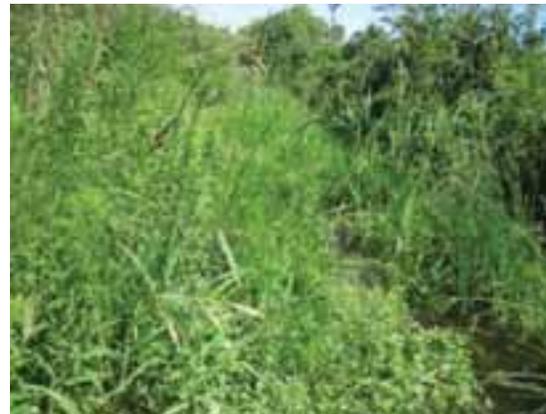
D40
MWD(m):	0.45
MBD(m):	0.7

Feature ID	Project Component	Investigation Date	Description of Site	Feature Description	Feature Sensitivity
D40	• Transmission Line Crossing	June 22, 2012	• The watercourse is located in soybean fields. Flowing tile drain inputs were observed at time of investigation. Surrounding topography is flat. Riparian buffer is 1 m of cultural meadow (CUM1-1).	• The watercourse is a defined channelized feature. The watercourse is straight flat channel. The water was clear and had slow flow at time of investigation. It is classified as a permanent warm water system by UTRCA. The banks are stable and well vegetated. Substrate consists of silt, sand and muck. Canopy cover is high and is dominated by grasses. Instream habitat cover is high and consists of aquatic vegetation followed by undercut banks. The majority of the channel is vegetation choked. Groundwater indicators watercress, water speedwell and bittercress cover the majority of the reach. A school of fish was observed in a pool near one of the culverts. Fish species found in Washburn Drain and downstream include common baitfish community, sunfish and Rock Bass (UTRCA, 2000, 2005).	Moderate

Photograph 1. Site overview ↑

Photograph 2. Channel overview ↑

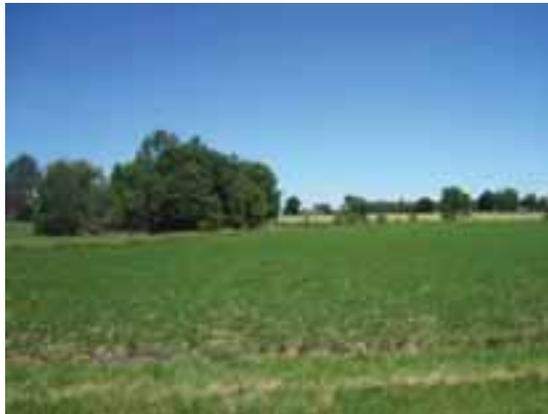
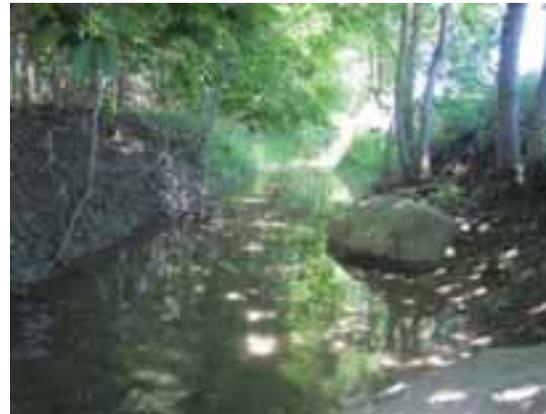
D23
MWD(m):	0.12
MBD(m):	0.25

Feature ID	Project Component	Investigation Date	Description of Site	Feature Description	Feature Sensitivity
D23	• Transmission Line Crossing	June 22, 2012	<ul style="list-style-type: none"> The watercourse is surrounded by soybean and corn fields and a residential property. No tile drain inputs were observed at time of investigation. Surrounding topography is flat. Riparian buffer is 2.5 m of cultural meadow (CUM1-1) and trees on the left bank and greater than 10 m of cultural meadow and trees on the right bank. 	<ul style="list-style-type: none"> The watercourse is a defined channelized feature. The watercourse is straight flat channel with some riffle pool fun sequences. The water was clear and had slow flow at time of investigation. It is classified as an intermittent system by ABCA. The banks are slightly unstable with some evidence of erosion. Substrate is silt, gravel and sand followed by cobble. Canopy cover is high and is dominated by trees. Instream habitat cover is moderate and consists of cobble followed by aquatic vegetation, woody debris and boulders. Small clumps of groundwater indicators watercress and water speedwell were present throughout the site. Brook Stickleback (<i>Culaea inconstans</i>) were observed at time of investigation. 	Moderate

Photograph 1. Site overview ↑

Photograph 2. Channel view ↑

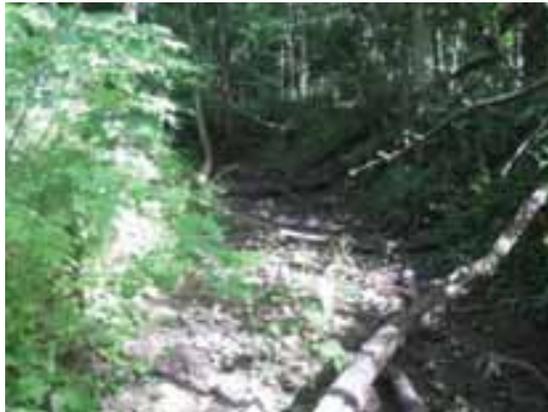
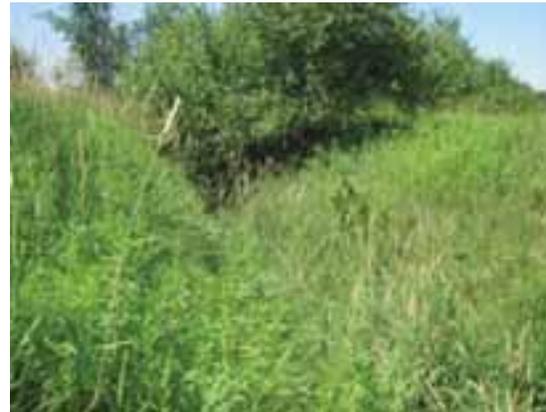
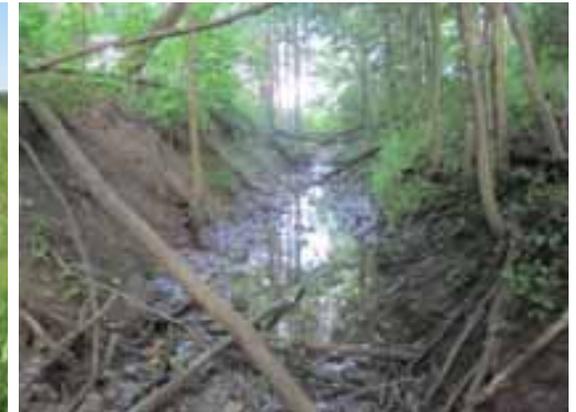
D39		D39
MWW(m):	0.75	MWD(m):	0.07
MBW(m):	2.4	MBD(m):	0.45

Photograph 1. Site overview forest ↑

Photograph 2. Site overview meadow ↑

Photograph 3. Channel view forest ↑

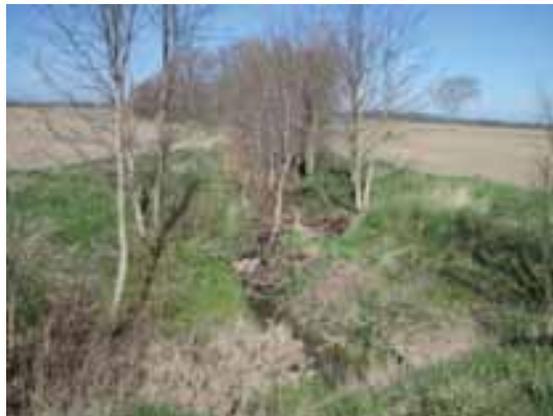
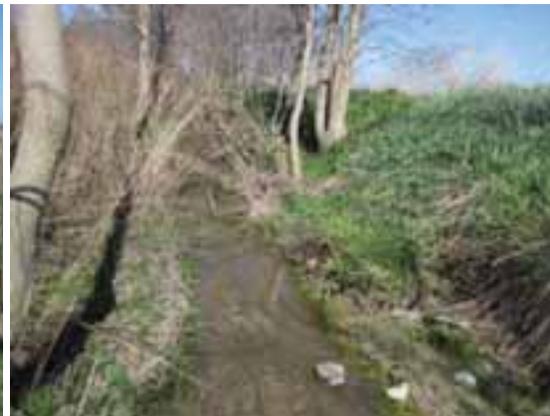
D11		D11
MWW(m):	1.3	MWD(m):	0.2
MBW(m):	3.0	MBD(m):	0.7

Photograph 1. Site overview ↑

Photograph 2. Channel view ↑

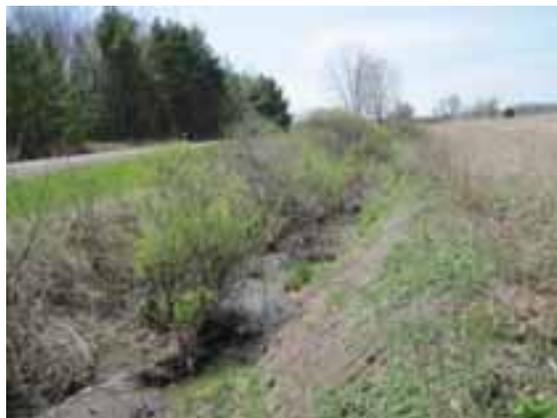
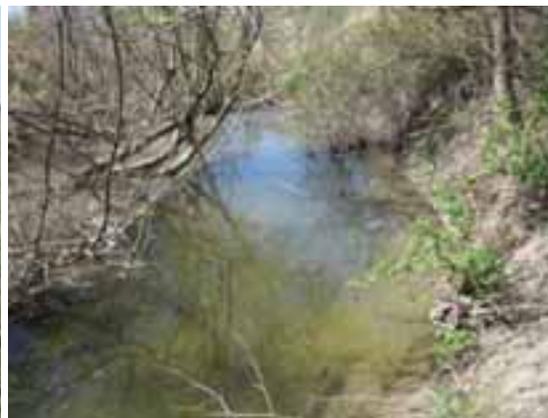
D04		D04
MWW(m):	1.5	MWD(m):	0.3
MBW(m):	3.0	MBD(m):	0.6

Photograph 1. Site overview ↑

Photograph 2. Channel view ↑

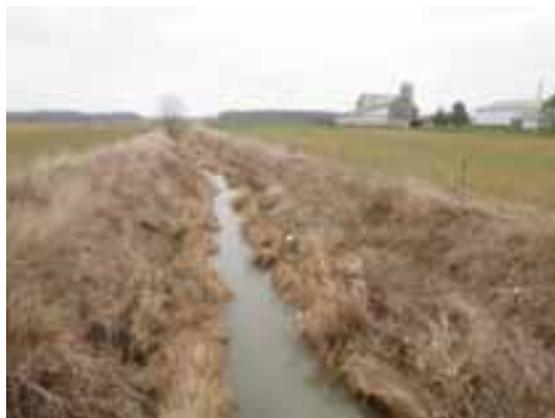
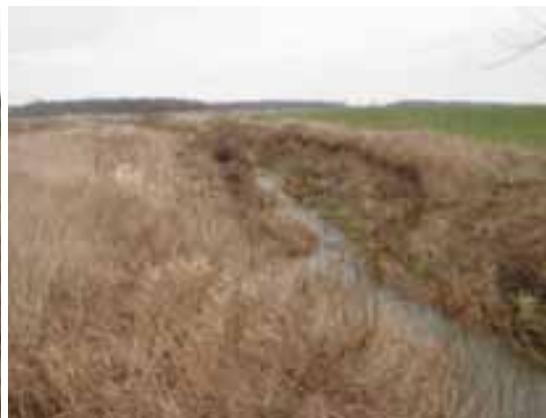
C45		C45
MWW(m):	1.5	MWD(m):	0.4
MBW(m):	3.0	MBD(m):	0.8

Feature ID	Project Component	Investigation Date	Description of Site	Feature Description	Feature Sensitivity
C45	<ul style="list-style-type: none"> Collection Line Buffer Road Buffer 	December 16, 2011	<ul style="list-style-type: none"> The watercourse is located in a crop agricultural field with livestock pasture to the south. Flowing tile drain inputs were observed at time of investigation. The surrounding topography is flat. Riparian buffer is 2.5 m of cultural meadow (CUM1-1) consisting mainly of grasses. 	<ul style="list-style-type: none"> The watercourse is a defined channelized feature. There is a slight meander in the channel however no riffles or pools were observed. The water was turbid and moderately flowing at the time of investigation. It is classified as a permanent warm water system by ABCA. The banks are stable and well vegetated. Substrate consists of silt and clay. Canopy cover is low and consists of grasses followed by few trees. Instream habitat cover could not be determined due to turbid water. No groundwater indicators were noted. Upstream fish species consist of a baitfish community (MNR, 1981, 2007). 	Moderate

Photograph 1. Site overview from Shipka Line ↑

Photograph 2. Channel overview ↑

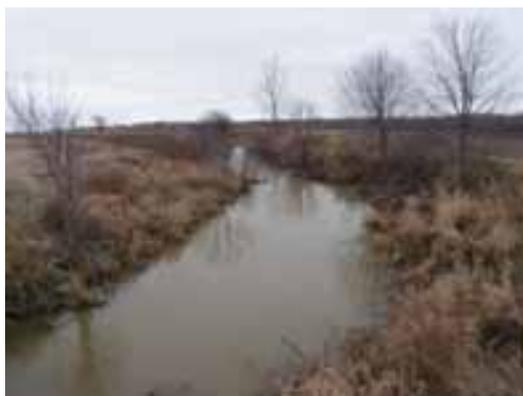
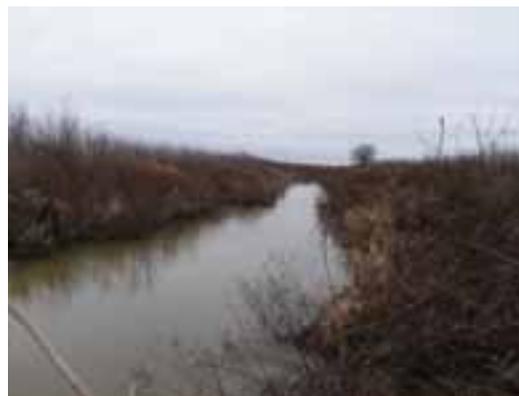
C144
MWD(m):	n/a
MBD(m):	n/a

Feature ID	Project Component	Investigation Date	Description of Site	Feature Description	Feature Sensitivity
C144	• Collection Line Crossing	December 16, 2011	• The watercourse is located in crop agricultural fields. Flowing tile drain inputs were noted. Surrounding topography is flat with some depression areas. Riparian buffer 2.5 m consisting of cultural meadow (CUM1-1).	• The watercourse is a defined channelized feature. The watercourse has uniform channel that is all run. The water was turbid and had slow flow during the time of investigation. It is classified as a permanent warm water system by ABCA. The banks are stable. Substrate consists of silt and clay. Canopy cover is low and consists of only grasses. No groundwater indicators were observed. Downstream fish species consist of baitfish community (MNR, 1995).	Moderate

Photograph 1. Site overview ↑

Photograph 2. Channel overview ↑

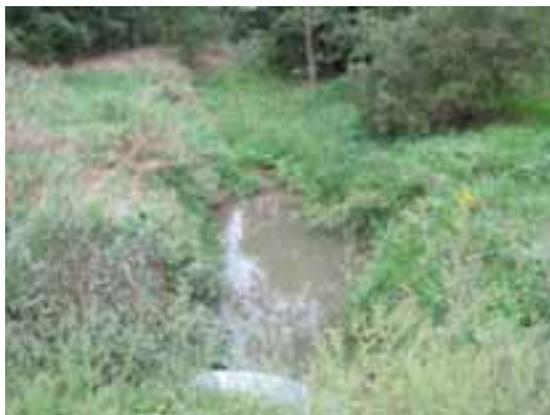
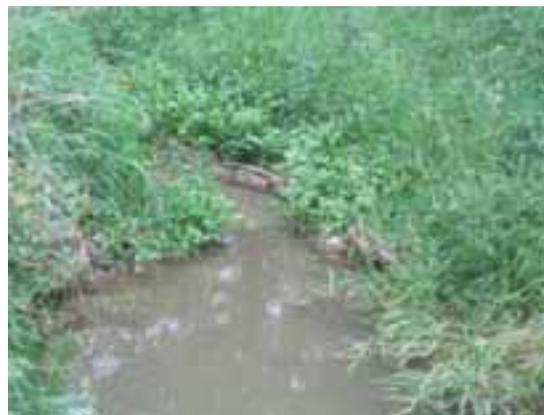
C44		C44
MWW(m):	2.0	MWD(m):	0.25
MBW(m):	n/a	MBD(m):	n/a

Feature ID	Project Component	Investigation Date	Description of Site	Feature Description	Feature Sensitivity
C44	• Collection Line Crossing	September 7, 2011	• The watercourse flows is surrounded by cultural plantation (classified as CUP1-7, CUP1a, ELC Feature ID 266) and crosses Blackbush Line. No tile drain inputs were observed at time of investigation. Surrounding topography is flat.	• The watercourse is a defined natural feature. The watercourse is flat channel. The water was turbid and had no visible flow during time of investigation. It is classified as a permanent warm water system by ABCA. The banks are stable and well vegetated. Substrate consists of muck, clay and silt. Canopy cover is moderate and dominated by trees. Instream habitat cover is low and consists of aquatic vegetation followed by woody debris. Groundwater indicator watercress was observed. Downstream fish species consists of a baitfish community and Rock Bass (MNR, 1981, 1994).	Low

Photograph 1. Site overview ↑

Photograph 2. Channel overview ↑

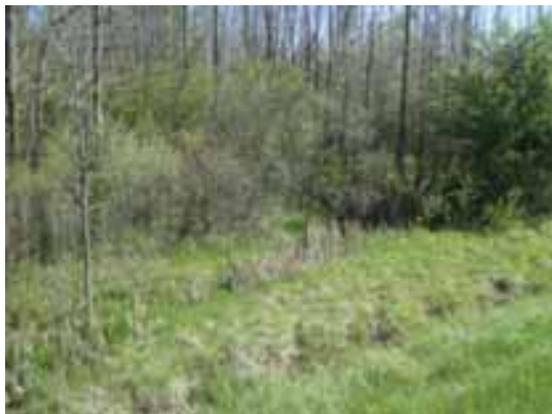
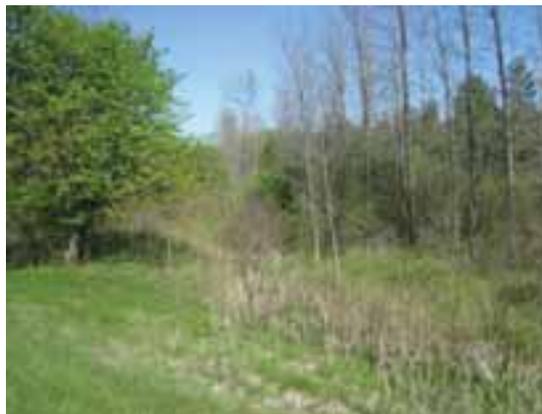
D05		D05
MWW(m):	0.5	MWD(m):	<0.2
MBW(m):	n/a	MBD(m):	n/a

Feature ID	Project Component	Investigation Date	Description of Site	Feature Description	Feature Sensitivity
D05	• Collection Line Buffer	May 11, 2012	<ul style="list-style-type: none"> The watercourse is located in mixed forest (classified as FOM5-2, ELC Feature ID 255) and runs along Credition Road for 10 m. No tile drain inputs were observed at time of investigation. Riparian buffer is greater than 5 m of mixed forest. 	<ul style="list-style-type: none"> The watercourse is classified as an intermittent system by ABCA. The channel is cattail and grass choked throughout. No groundwater indicators were observed. 	Low

Photograph 1. Site overview ↑

Photograph 2. Site overview ↑

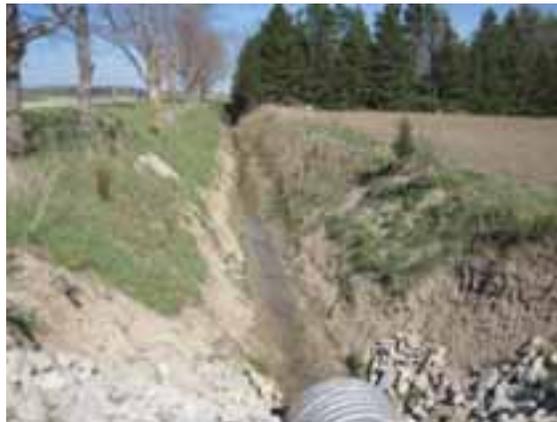
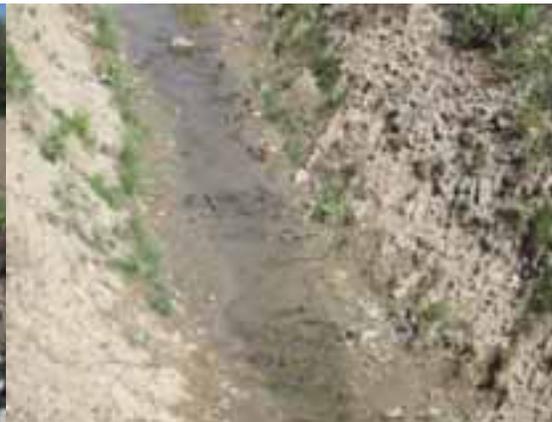
D01		D01
MWW(m):	0.75	MWD(m):	0.05
MBW(m):	1.5	MBD(m):	0.6

Feature ID	Project Component	Investigation Date	Description of Site	Feature Description	Feature Sensitivity
D01	• Collection Line Buffer	April 18, 2012	• The watercourse runs along roadside that is adjacent to crop agricultural fields and a residential property. Tile drain inputs were observed. Surrounding topography is flat. Riparian buffer is 3 m of cultural meadow (CUM1-1).	• The watercourse is a defined channelized feature. It is a straight and uniform channel – appears to have been recently dug out. The water was clear and had very low flow at time of investigation. It is classified as tiled by ABCA. The banks are stable but sparsely vegetated. Substrate consists of sand and gravel followed by cobble, silt and clay. Canopy cover low. Instream habitat cover is low and consists of aquatic vegetation and cobble. No groundwater indicators were noted.	Low

Photograph 1. Site overview ↑

Photograph 2. Channel substrate ↑

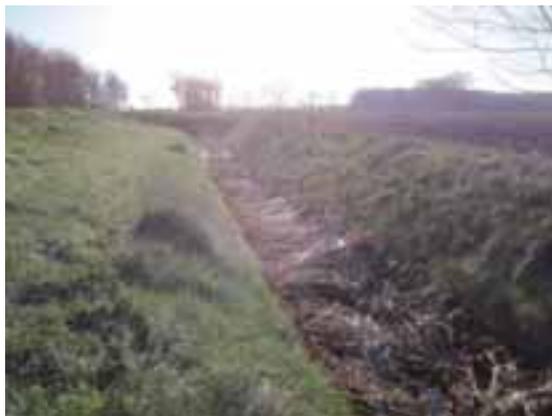
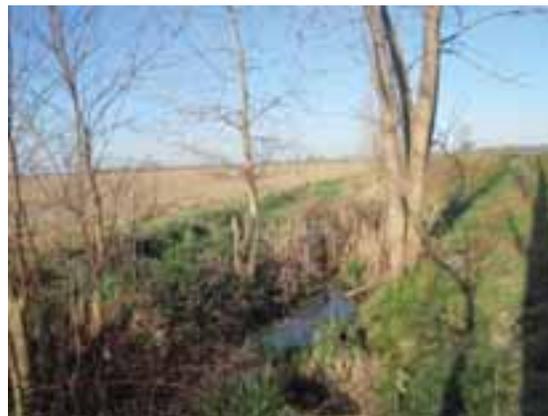
C78		C78
MWW(m):	1.0	MWD(m):	0.1
MBW(m):	1.7	MBD(m):	0.5

Photograph 1. Site overview ↑

Photograph 2. Site overview ↑

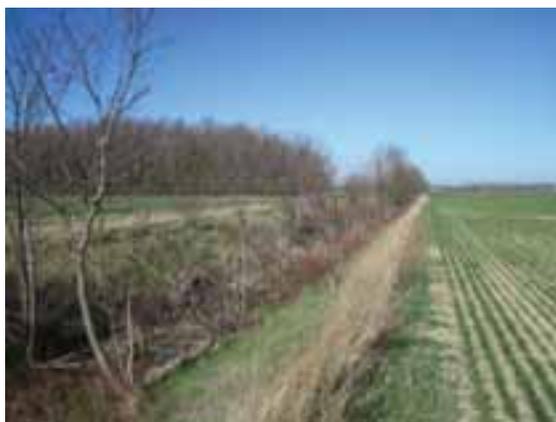
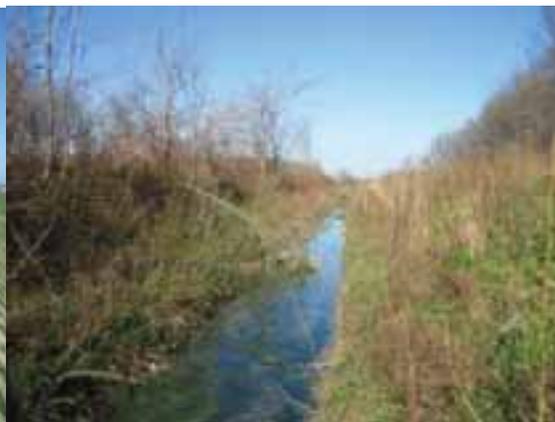
C75		C75
MWW(m):	1.5	MWD(m):	0.2
MBW(m):	2.2	MBD(m):	0.6

Feature ID	Project Component	Investigation Date	Description of Site	Feature Description	Feature Sensitivity
C75	<ul style="list-style-type: none"> Collection Line Crossing Road Crossing Turbines 61 and 59 	April 18, 2012	<ul style="list-style-type: none"> The watercourse runs between crop agricultural fields. Flowing tile drain inputs were observed. Surrounding topography is flat. There is no riparian buffer on the right bank and 1.5 m on the left bank of cultural meadow (CUM1-1). 	<ul style="list-style-type: none"> The watercourse is a defined channelized feature. The watercourse is straight and there was low flow only at tile drain inputs. It is classified as intermittent by ABCA. The banks are stable and well vegetated. Substrate consists of silt and clay. Canopy cover moderate with shrubs dominating. Instream habitat cover moderate and consists of aquatic vegetation and woody debris. Groundwater indicator watercress was the dominate instream vegetation. 	Low

Photograph 1. Site overview ↑

Photograph 2. Channel overview ↑

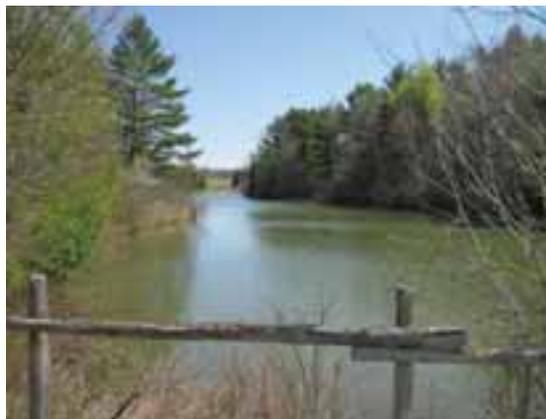
Photograph 2. Pond overview ↑

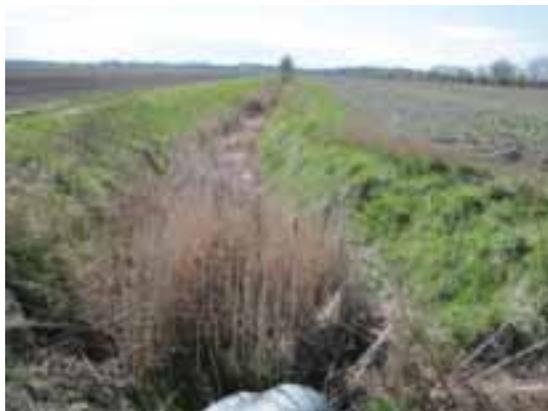
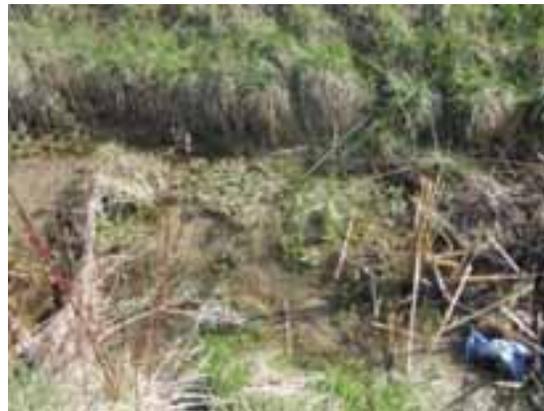
C68		C68
MWW(m):	0.8	MWD(m):	0.1
MBW(m):	1.0	MBD(m):	0.2

Photograph 1. Site overview ↑

Photograph 2. Channel view ↑

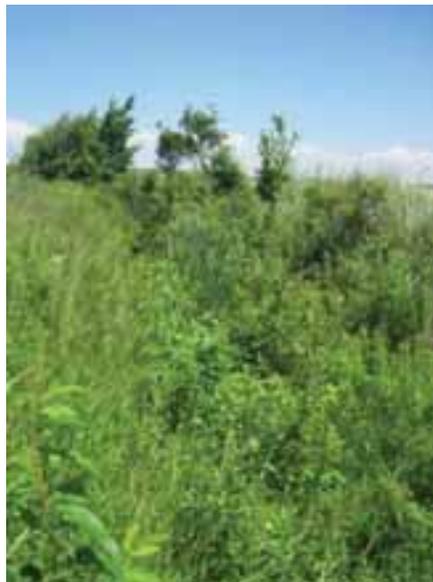
C73		C73
MWW(m):	n/a	MWD(m):	n/a
MBW(m):	1.5	MBD(m):	0.5

Feature ID	Project Component	Investigation Date	Description of Site	Feature Description	Feature Sensitivity
C73	<ul style="list-style-type: none"> Collection Line Crossing Road Crossing Turbine 58 	July 13, 2011	<ul style="list-style-type: none"> Watercourse runs through agricultural fields. No tile drain inputs were noted at time of investigation. Surrounding topography is flat. Riparian buffer is 1 m on left bank and 3 m on right bank of cultural meadow (CUM1-1) consisting of trees and grasses. 	<ul style="list-style-type: none"> The watercourse is a defined channelized feature. There was no flow at time of investigation. It is classified as a permanent warm water system by ABCA. The banks are stable and well vegetated. Substrate consists of silt and sand. Canopy cover is high and dominated by grasses. Instream habitat cover is high and consists of aquatic vegetation. The channel is cattail choked. No groundwater indicators were observed. 	Low

Photograph 1. Site overview ↑

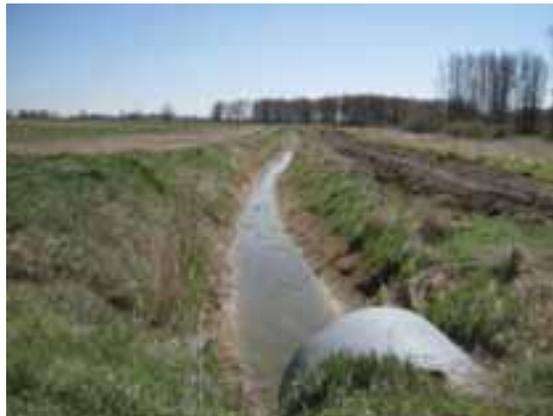
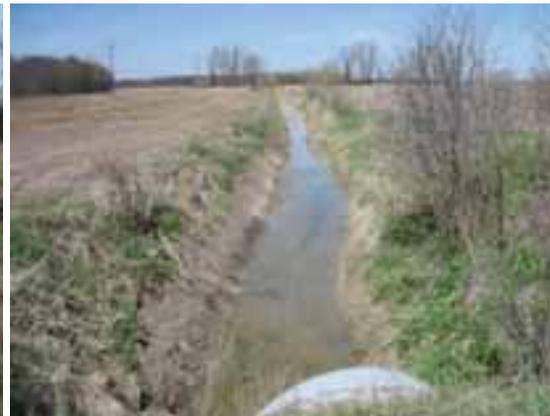
D13		D13
MWW(m):	1.5	MWD(m):	0.05
MBW(m):	2.0	MBD(m):	0.2

Photograph 1. Site overview south ↑

Photograph 2. Site overview north ↑

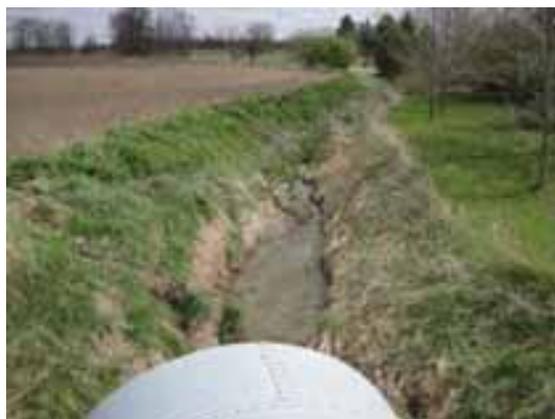
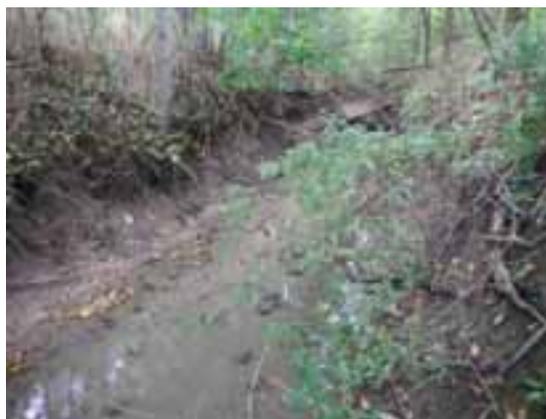
D14		D14
MWW(m):	1.0	MWD(m):	0.1
MBW(m):	3.0	MBD(m):	0.7

Feature ID	Project Component	Investigation Date	Description of Site	Feature Description	Feature Sensitivity
D14	<ul style="list-style-type: none"> Collection Line Crossing Road Buffer Turbine 76 	September 28, 2011 April 17, 2012 June 25, 2012	<ul style="list-style-type: none"> Watercourse is originates as a tile drain and flows through a deciduous forest (classified as FOD6-5, FOC6-4, ELC Feature ID 245) into crop agricultural fields. Flowing tile drains were observed throughout the site. Surrounding topography is flat. Riparian buffer was 1 m on right bank and 3 m on left bank primarily consisting of grasses in the agricultural field. In the forest the riparian buffer is greater than 15 m. 	<ul style="list-style-type: none"> The watercourse is a defined channelized feature. The watercourse has a straight flat channel in the agricultural fields and has a few riffle run pool sequences in the forest. The water was clear and had very low flow at time of investigations. It is classified as intermittent by ABCA. The banks are stable and well vegetated in the agricultural field and slightly unstable in the forest. Substrate consists of silt, clay, gravel and muck followed by cobble and boulders. Canopy cover is low in the agricultural field and high in the forest. Instream habitat cover in the agricultural field is high and consists of aquatic vegetation. Areas of the watercourse were cattail choked. Instream habitat cover in the forest is moderate and consists of cobble followed by woody debris and boulders. No groundwater indicators were noted. One low flow barrier of sediment and vegetation build up was present. Young of the year fish were observed in the forest during the second site investigation. 	Low

Photograph 1. Site overview agricultural fields ↑

Photograph 2. Channel view forest ↑

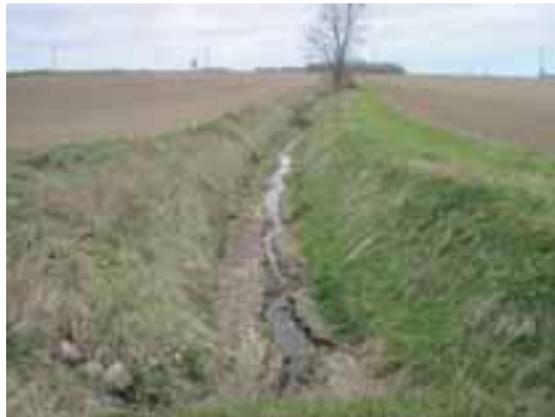
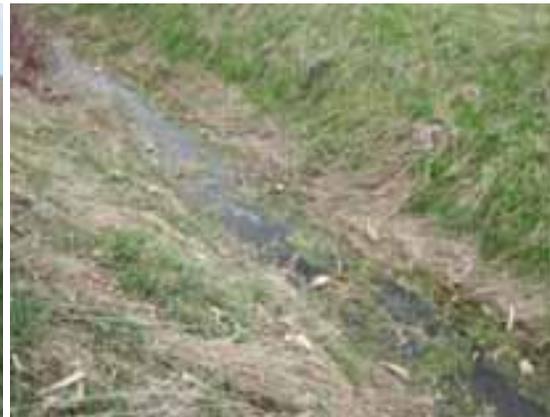
D15		D15
MWW(m):	0.7	MWD(m):	0.35
MBW(m):	2.5	MBD(m):	0.75

Photograph 1. Site overview ↑

Photograph 2. Channel view ↑

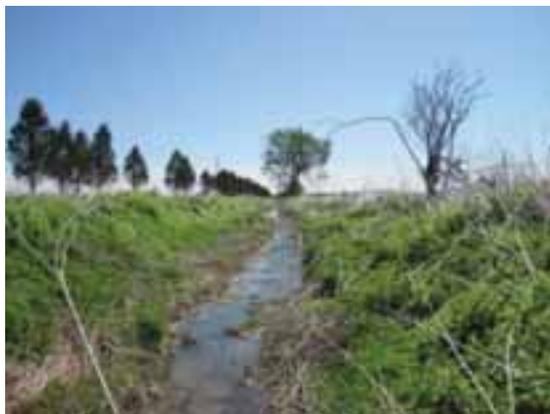
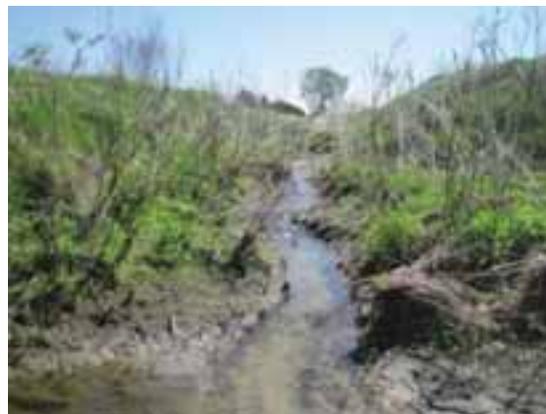
D07		D07
MWW(m):	1.5	MWD(m):	0.25
MBW(m):	2.5	MBD(m):	0.5

Photograph 1. Site overview ↑

Photograph 2. Channel overview ↑

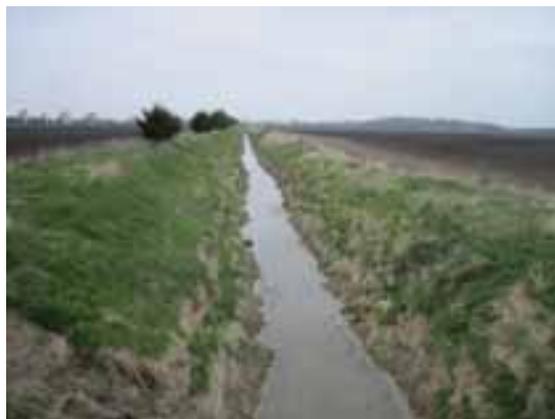
D26		D26
MWW(m):	2.2	MWD(m):	0.18
MBW(m):	3.5	MBD(m):	0.9

Feature ID	Project Component	Investigation Date	Description of Site	Feature Description	Feature Sensitivity
D26	• Transmission Line Crossing	May 1, 2012	<ul style="list-style-type: none"> Watercourse is surrounded by crop agricultural fields. Tile drain inputs were observed and flowing very slowly at time of investigation. Surrounding topography is flat. Riparian vegetation is 1 m of cultural meadow (CUM1-1) primarily consisting of grasses. 	<ul style="list-style-type: none"> The watercourse is a defined channelized feature. It is a straight and potentially a regularly maintained channel. The water was clear and had very low flow at time of investigation. It is classified as a permanent warm water system by ABCA. The banks are slightly unstable with exposed soils but no evidence of meandering. Substrate consists of silt and clay followed by gravel. Canopy cover is low. Instream habitat cover is low and consists of aquatic vegetation. No groundwater indicators were noted. Downstream fish species consist of baitfish community, Stonecat and Rock Bass (ABCA, 2000). 	Low

Photograph 1. Site overview ↑

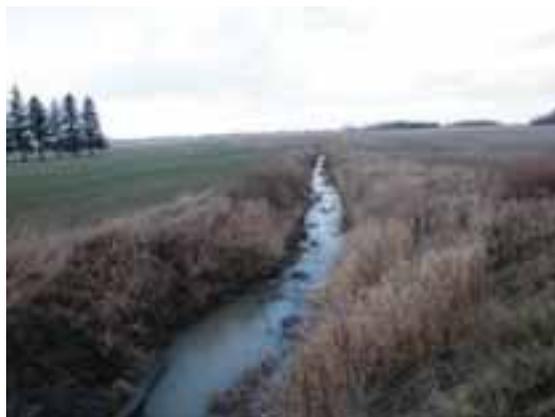
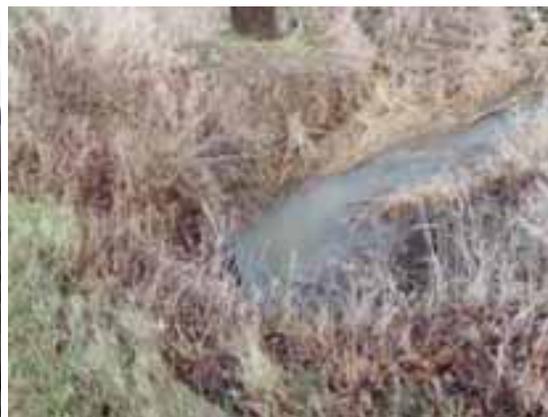
C11
MWD(m):	n/a
MBD(m):	n/a

Feature ID	Project Component	Investigation Date	Description of Site	Feature Description	Feature Sensitivity
C11	• Collection Line Crossing	December 15, 2011	• The watercourse runs through crop agricultural field and passes Bronson Line into another crop agricultural field and residence. Flowing tile drains were observed. The surrounding topography is flat. The riparian buffer is 3 m of cultural meadow (CUM1-1).	• The watercourse is a defined channelized feature. It is a straight uniform channel. The water was turbid and had high flow at the time of investigation, however it is classified as an intermittent system by ABCA. The banks are stable and well vegetated. Substrate consists of sand and gravel followed by muck and clay. Canopy cover is low and is dominated by grasses and some shrubs. Instream habitat cover is moderate consisting primarily of aquatic vegetation. No groundwater indicators were observed.	Low

Photograph 1. Site overview ↑

Photograph 2. Channel view ↑

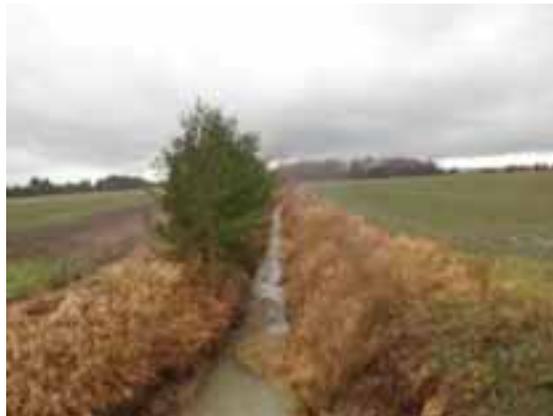
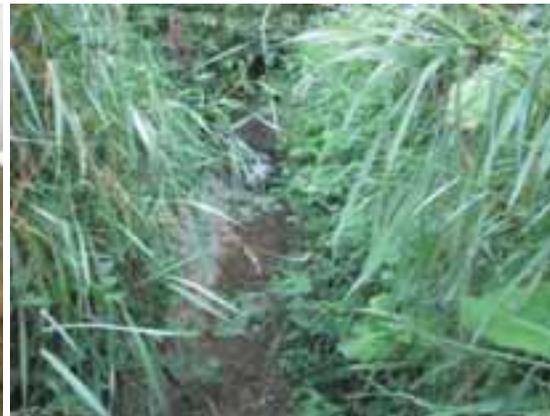
C14
MWD(m):	0.30
MBD(m):	0.8

Photograph 1. Site overview ↑

Photograph 2. Channel view in forest ↑

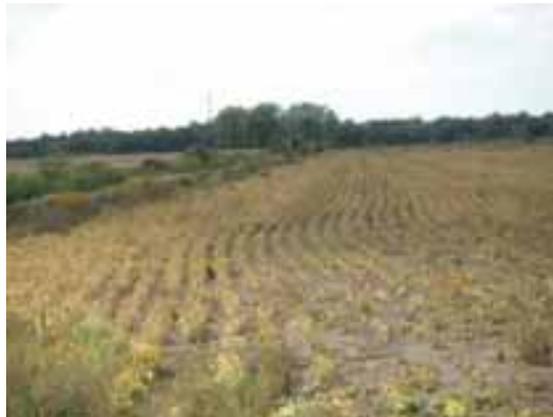
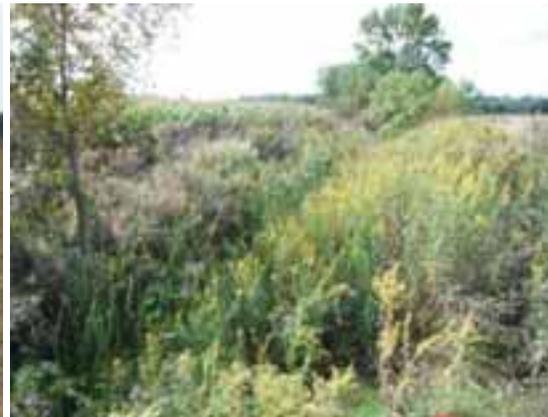
C36
MWD(m):	0.15
MBD(m):	0.4

Feature ID	Project Component	Investigation Date	Description of Site	Feature Description	Feature Sensitivity
C36	• Collection Line Crossing	September 27, 2011	• The watercourse is located in a crop agricultural field with a riparian buffer of 1.5 m. No tile drain inputs were observed and the surrounding topography is flat. A bridge with a culvert placed in the watercourse is present approximately 90 m from Babylon Line. Riparian buffer is 1.5 m of cultural meadow (CUM1-1).	• The watercourse is a defined channelized feature. It is a straight uniform channel. The water was clear and flowing at the time of investigation, however it is classified as intermittent by ABCA. The banks are stable and well vegetated. Substrate consists of silt, clay with some sand, cobble and boulder. Canopy cover is moderate and dominated by grasses followed by trees. Instream habitat cover is moderate and dominated by aquatic vegetation followed by cobble and boulder. Channel was choked with cattails. No groundwater indicators were noted.	Low

Photograph 1. Site overview ↑

Photograph 2. Channel overview ↑

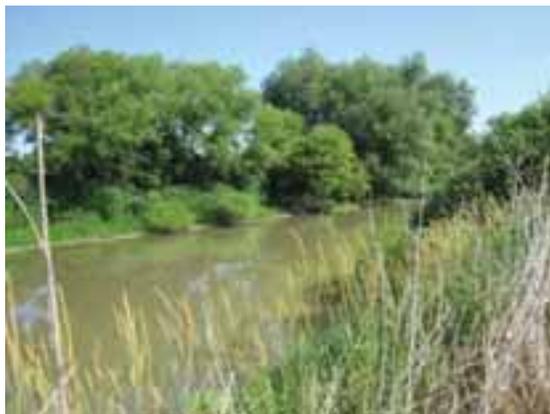
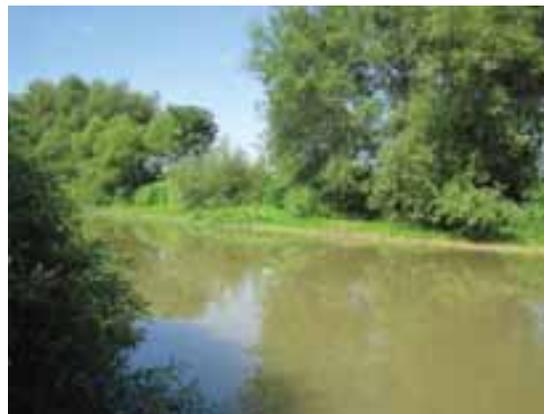
D48
MWD(m):	0.4
MBD(m):	1.3

Feature ID	Project Component	Investigation Date	Description of Site	Feature Description	Feature Sensitivity
D48	• MET Tower Buffer	July 12, 2012	<ul style="list-style-type: none"> The watercourse flows through corn fields. No tile drain inputs were observed, however several channel flow into watercourse on the left bank. The surrounding topography is flat with slight sloping towards the watercourse. Riparian buffer is 6 m of cultural meadow (CUM1-1). 	<ul style="list-style-type: none"> The watercourse is a defined natural feature. The watercourse is all flat. The water was turbid and had low at the time of investigation. It is classified as a permanent warm water feature by ABCA. The banks are stable and well vegetated. Substrate consists of silt. Canopy cover is low and consists of trees and shrubs. Instream habitat cover is low and consists of woody debris and aquatic vegetation. No groundwater indicators were observed. 	Low

Photograph 1. Site overview ↑

Photograph 2. Site Overview ↑

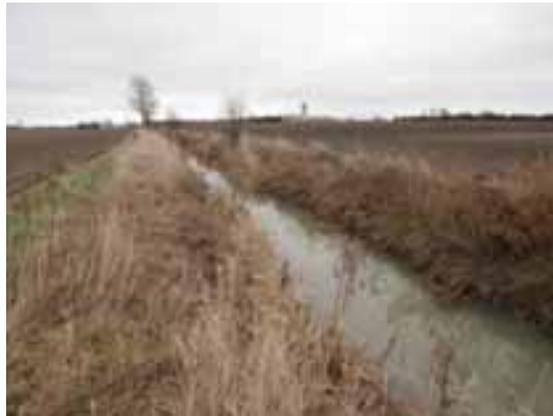
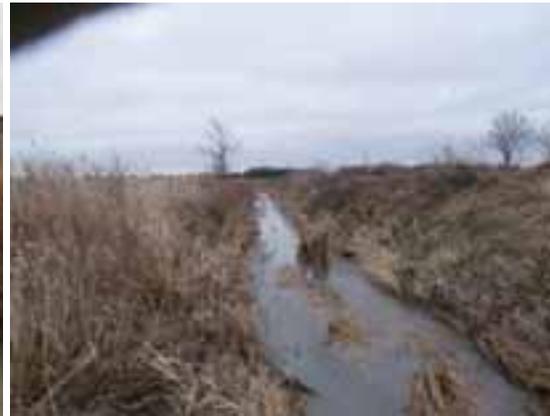
C56
MWD(m)	0.5
MBD(m):	0.8

Feature ID	Project Component	Investigation Date	Description of Site	Feature Description	Feature Sensitivity
C56	• Turbine 48	December 16, 2011	<ul style="list-style-type: none"> The watercourse flows through a crop agricultural field with a 1.5 m riparian buffer of cultural meadow (CUM1-1). Tile drain input was observed. Surrounding topography is flat. 	<ul style="list-style-type: none"> The watercourse is a defined channelized feature. It is a straight run channel. The water was turbid and had a moderate flow during the time of investigation, however it is classified as intermittent by ABCA. The banks are stable and well vegetated. Substrate consists of silt clay with gravel. Canopy cover is low and dominated by grasses. Instream habitat cover is low and dominated by grasses. No groundwater indicators were observed. 	Low

Photograph 1. Site overview ↑

Photograph 2. Channel overview ↑

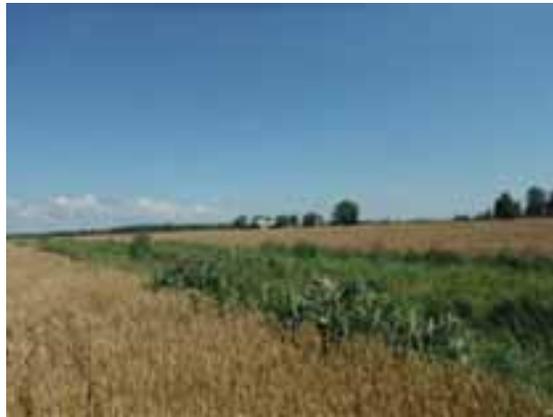
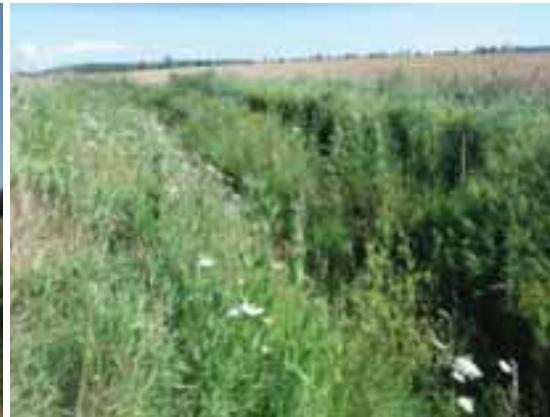
C62
MWD(m):	0.1
MBD(m):	2.0

Feature ID	Project Component	Investigation Date	Description of Site	Feature Description	Feature Sensitivity
C62	<ul style="list-style-type: none"> Collection Line Crossing Turbine 38 	July 7, 2011	<ul style="list-style-type: none"> The watercourse flows through a wheat field with a 2 m riparian buffer of cultural meadow (CUM1-1). No tile drain inputs were noted. Surrounding topography is flat. 	<ul style="list-style-type: none"> The watercourse is a defined channelized feature. It is a straight channel that is all flat run. There was no flow during the time of investigation, only stagnant water. It is classified as an intermittent system by ABCA. The banks are slightly unstable. Substrate consists of muck and is algae choked. Canopy cover is low and consists of grasses and herbaceous vegetation. Instream habitat cover is high and is dominated by aquatic algae followed by aquatic vegetation. No groundwater indicators were observed. Potential low flow fish barrier observed due to build-up of algae. Downstream fish species consist of a baitfish community, Brown Bullhead, Rainbow Trout and Northern Pike (ABCA, 2001; MNR, 2003). 	Low

Photograph 1. Site overview ↑

Photograph 2. Channel overview ↑
