Goshen Wind Energy Centre
Water Assessment and Water Body Report

Project Location
December 2012
Project 60155032

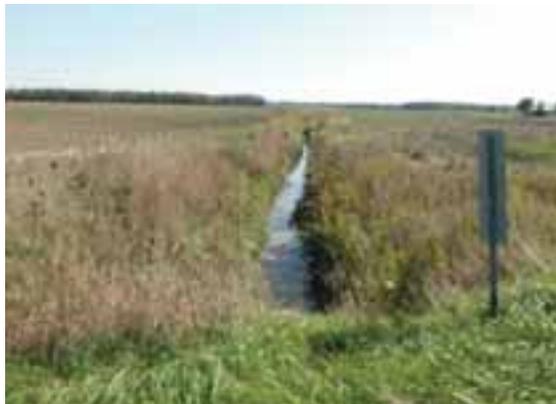
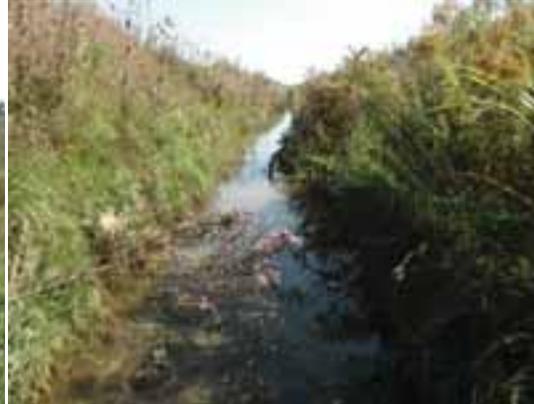
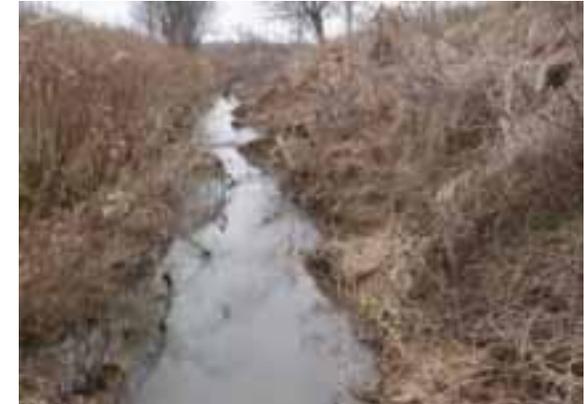
C63
MWD(m):	0.2
MBD(m):	0.6

Feature ID	Project Component	Investigation Date	Description of Site	Feature Description	Feature Sensitivity
C63	• Road Buffer	October 6, 2011 December 16, 2011	• The watercourse flows through a crop agricultural field with a 2 m riparian buffer of cultural meadow (CUM1-1) both east and west of Shipka Line. Flowing tile drain inputs were observed. Surrounding topography is flat.	• The watercourse is a defined channelized feature. The water was clear to slightly turbid and flowing during the time of investigations. It is classified as intermittent by ABCA, and is a straight channel that is all run. The banks are stable and well vegetated. Substrate is dominated by silt and clay followed by a mix of muck, gravel, detritus, cobble and boulder. Canopy cover is low and is a mix of grasses and shrubs followed by trees. Instream habitat cover is high and dominated by aquatic vegetation followed by cobble and boulder. No groundwater indicators were noted. Downstream fish species consist of a baitfish community, Brown Bullhead, Rainbow Trout and Northern Pike (ABCA, 2001; MNR, 2003).	Low

Photograph 1. Site overview ↑

Photograph 2. Channel overview east ↑

Photograph 3. Channel overview west ↑

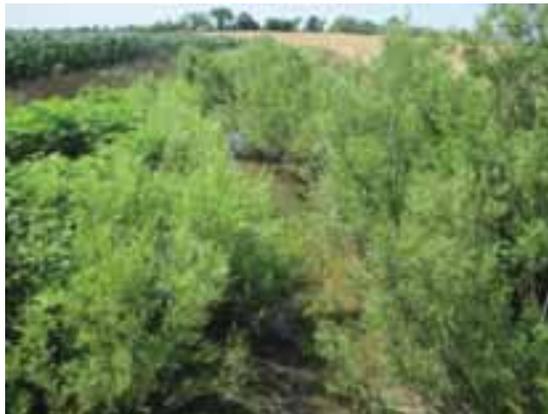
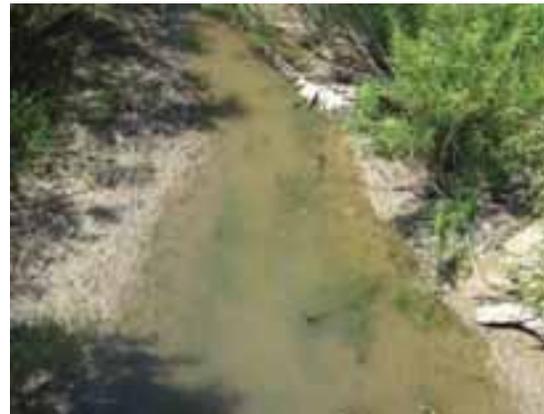
D46
MWD(m):	0.16
MBD(m):	0.25

Photograph 1. Site overview ↑

Photograph 2. Channel view ↑

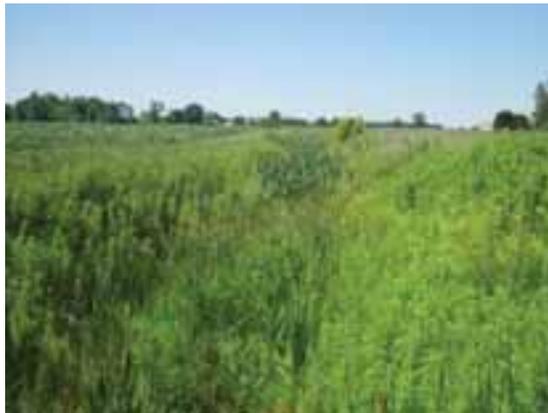
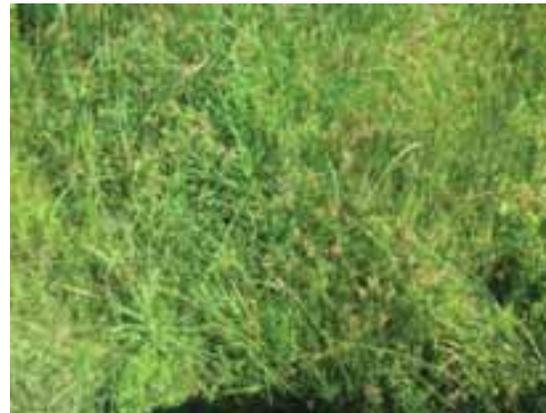
D47
MWD(m):	0.08
MBD(m):	0.4

Photograph 1. Site overview ↑

Photograph 2. Channel view ↑

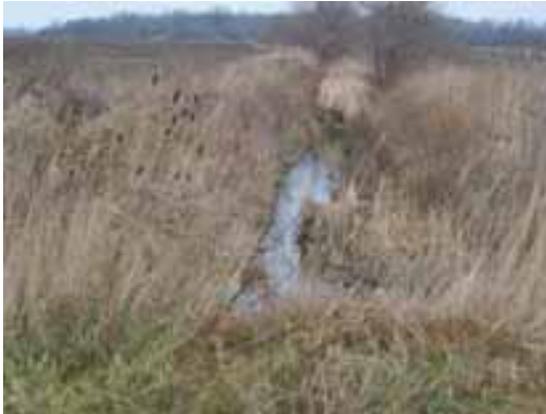
D09
MWD(m):	0.2
MBD(m):	n/a

Photograph 1. Site overview ↑

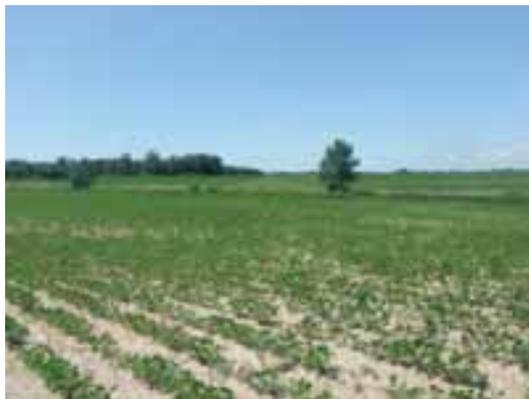
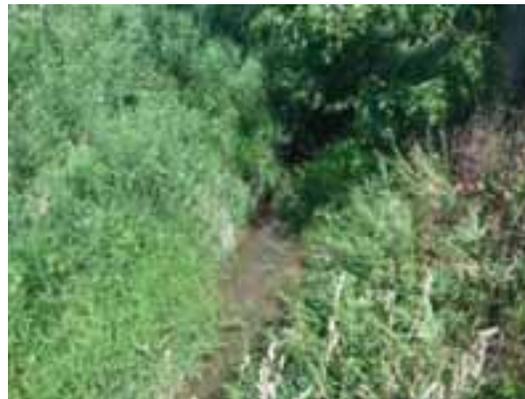
C86
MWD(m):	0.1
MBD(m):	0.3

Feature ID	Project Component	Investigation Date	Description of Site	Feature Description	Feature Sensitivity
C86	• Turbine 41	July 13, 2011	<ul style="list-style-type: none"> The watercourse is located in a crop agricultural field with a 2 m riparian buffer of cultural meadow (CUM1-1). No tile drain inputs were observed. Surrounding topography is flat. 	<ul style="list-style-type: none"> The watercourse is a defined channelized feature. The watercourse is all flat channel. The water was clear and slow moving during the time of investigation. The system is classified as intermittent by ABCA. Banks are stable and vegetated. Substrate consists of muck and cobble. Canopy cover is moderate and is dominated by grasses, followed by shrubs and trees. Instream habitat cover is low and consists of cobble and undercut banks. Channel is choked with grasses and shrubs in some areas. No groundwater indicators were noted. Upstream fish species consist of baitfish community (MNR, 1994). 	Low

Photograph 1. Site overview ↑

Photograph 2. Channel overview ↑

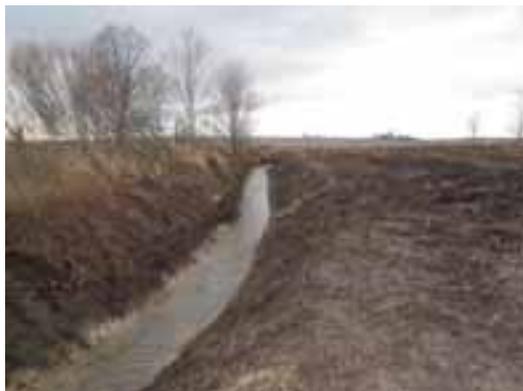
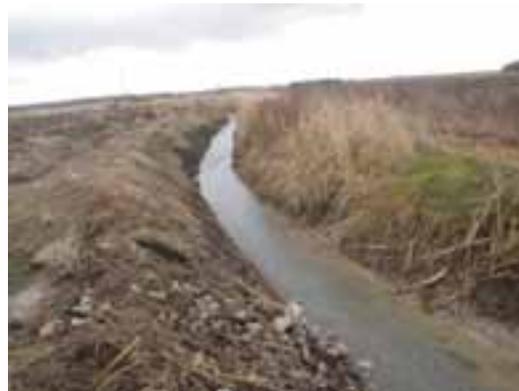
C110		C110
MWW(m):	1.5	MWD(m):	0.15
MBW(m):	2.3	MBD(m):	0.45

Feature ID	Project Component	Investigation Date	Description of Site	Feature Description	Feature Sensitivity
C110	• Turbine 65	December 15, 2011	• The watercourse is located in crop agricultural fields. Tile drain inputs were observed. Surrounding topography is flat. Riparian buffer is 1 m of cultural meadow (CUM1-1) exists on the left bank, while the buffer on the left was recently removed.	• The watercourse is a defined channelized feature that was newly dug out. The morphology is all run. The water was turbid and had moderate flow during the time of investigation; however it is classified as intermittent by ABCA. The banks are stable. Substrate consists of clay followed by silt, gravel and cobble. There is no canopy cover. Instream habitat cover is high and consists of only cobble. No groundwater indicators were noted. A perched culvert is present at the edge of the property, obstructing fish passage.	Low

Photograph 1. Site overview ↑

Photograph 2. Site overview ↑

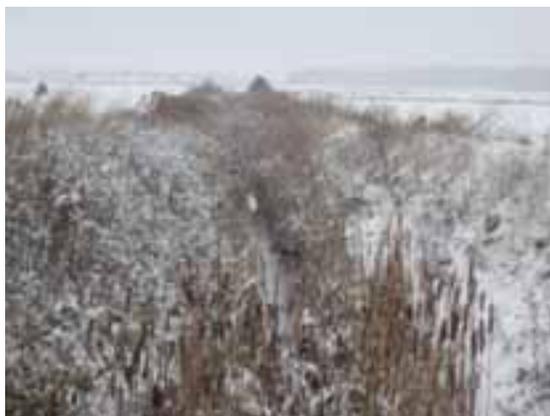
C37
MWD(m):	n/a
MBD(m):	n/a

Photograph 1. Site overview ↑

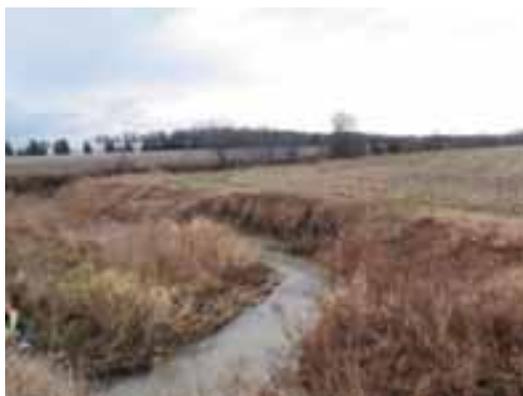
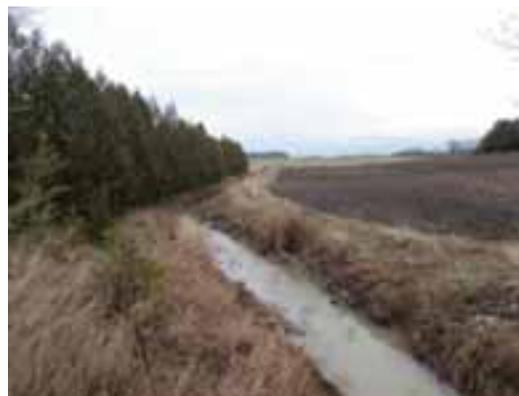
C209		C209
MWW(m):	1.5	MWD(m):	n/a
MBW(m):	2.5	MBD(m):	n/a

Feature ID	Project Component	Investigation Date	Description of Site	Feature Description	Feature Sensitivity
C209	• Collection Line Crossing	December 15, 2011	• The watercourse is located in crop agricultural fields, crossing Bronson Line. No tile drain inputs were observed at time of investigation. Surrounding topography is flat. Riparian buffer is 2 m of cultural meadow (CUM1-1) consisting of grasses and trees.	• The watercourse is a defined channelized feature. The morphology is all run. The water was turbid and had high flow during the time of investigation. It is classified as a permanent warm water system by ABCA. Banks are slightly unstable due to 90 degree bends. Substrate consists of gravel and sand followed by clay. Canopy cover is low and is dominated by grasses. No groundwater indicators were observed. Fish species at Bronson Line crossing consist of baitfish community (MNR, 1994).	Low

Photograph 1. Site overview ↑

Photograph 2. Site overview ↑

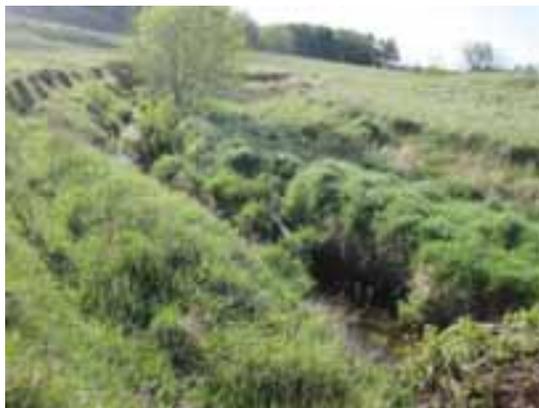
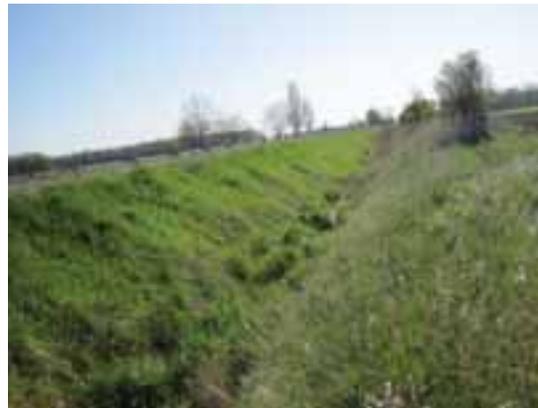
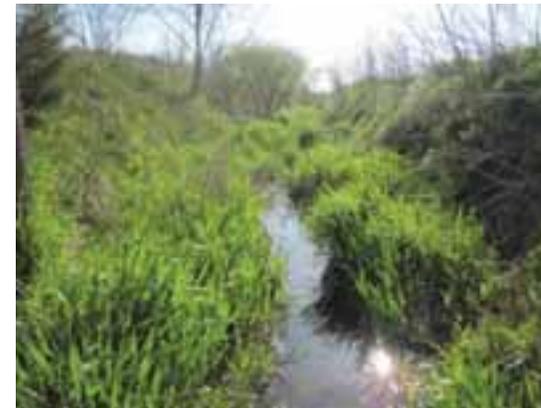
C48		C48
MWW(m):	1.2	MWD(m):	0.2
MBW(m):	2.5	MBD(m):	0.65

Feature ID	Project Component	Investigation Date	Description of Site	Feature Description	Feature Sensitivity
C48	<ul style="list-style-type: none"> Collection Line Crossing Road Crossing Turbine 17 	May 11, 2012	<ul style="list-style-type: none"> The watercourse originates at a tile drain into a deciduous forest (classified as FOD7-2, FOD4c, ELC Feature ID 232) and then in an agricultural field and travels along the roadside of Crediton Road beside another agricultural field. Flowing tile drain inputs were noted during time of investigation and providing flow to the watercourse. Surrounding topography is flat. Riparian buffer is 1.5 m on the north bank and 0.5 m on the south bank and great in the forest area. 	<ul style="list-style-type: none"> The watercourse is a defined channelized feature. The watercourse meanders slightly in the north bank and is mainly flat with some riffles and pools present. The water was clear and had low flow during the time of second site investigation. It is classified as an intermittent water system by ABCA. Banks are slightly unstable with signs of erosion and slumping. Substrate consists of detritus, muck and clay followed by gravel, cobble, sand and silt. Canopy cover is high in the forest and low in the agricultural fields. Instream habitat cover is moderate and consists of aquatic vegetation and detritus followed by cobble, boulders and undercut banks. Groundwater indicator water speedwell was observed. Downstream fish species consist of baitfish community, Brown Bullhead and Rainbow Trout (ABCA, 2001; MNR, 2003). 	Low

Photograph 1. Site overview ↑

Photograph 2. Site overview ↑

Photograph 3. Channel overview ↑

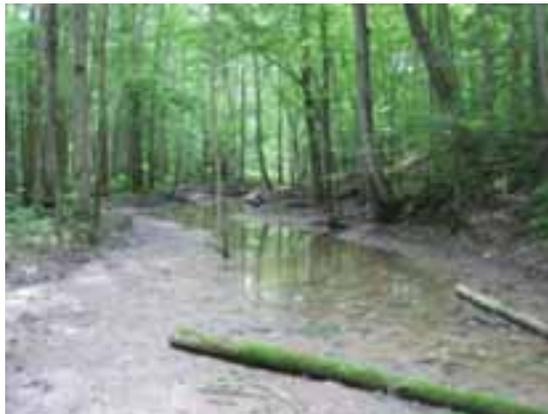
D51
MWD(m):	0.05
MBD(m):	0.1

Photograph 1. Site overview ↑

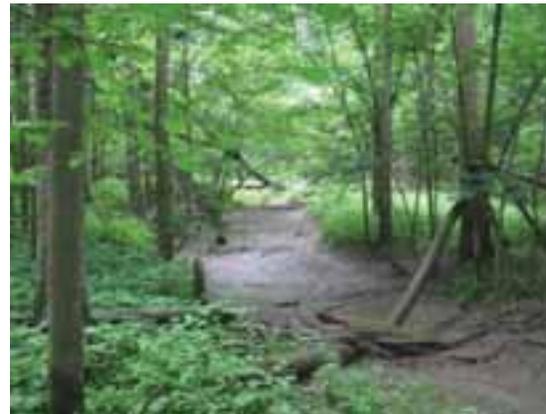
Photograph 2. Low flow barrier ↑

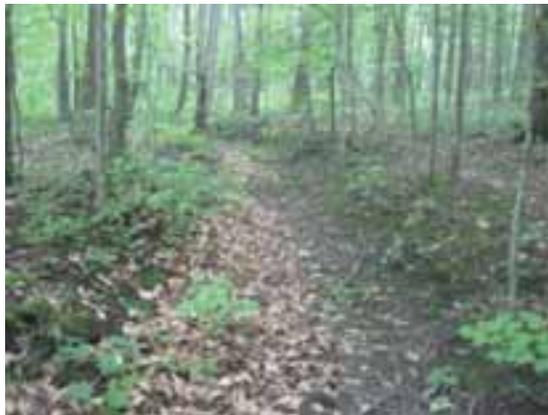
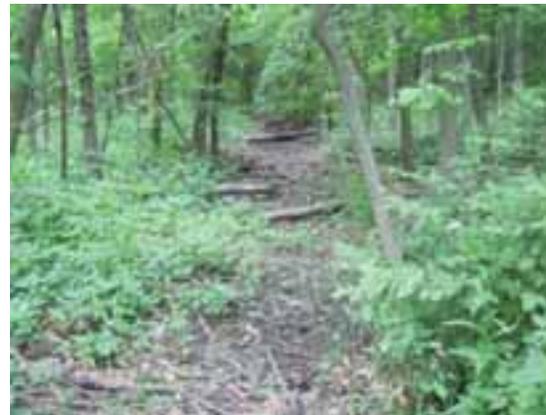
D52		D52
MWW(m):	n/a	MWD(m):	n/a
MBW(m):	1.2	MBD(m):	0.15

Feature ID	Project Component	Investigation Date	Description of Site	Feature Description	Feature Sensitivity
D52	• Turbine 35	June 11, 2012	<ul style="list-style-type: none"> The watercourse is located within a deciduous forest (classified as FOD5-6, ELC Feature ID 290) surrounded by crop agricultural fields. No tile drain inputs were observed at time of investigation. Surrounding topography is flat and slightly sloped to the south in the forest. Riparian buffer is greater than 15 m of forest. 	<ul style="list-style-type: none"> The watercourse is an ephemeral natural feature. There was no water at time of investigation. It is not mapped by ABCA. Banks are stable with no signs of erosion. Substrate consists of sand, silt and clay. Canopy cover is high and is dominated by trees. No groundwater indicators were observed. 	Low

Photograph 1. Site overview ↑

Photograph 2. Site overview ↑

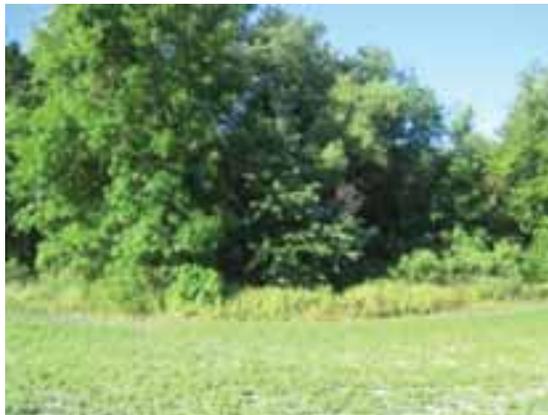
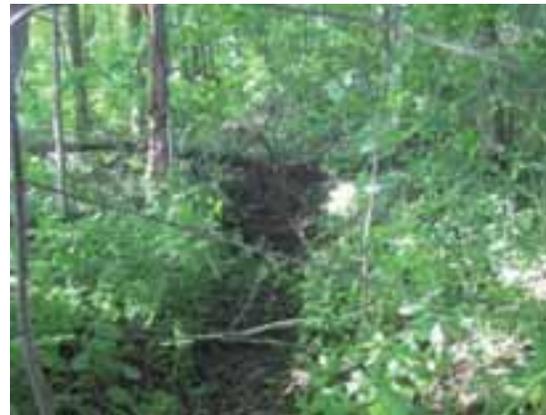
D53		D53
MWW(m):	n/a	MWD(m):	n/a
MBW(m):	n/a	MBD(m):	n/a

Photograph 1. Site overview ↑

Photograph 2. Channel overview ↑

D53	New water body feature observed – previously unmapped	A channel was observed in Feature 273, which flows through a deciduous forest
D56	Not as mapped	Tile drain feature – no surface channel
D58	Not as mapped	Tile drain feature – no surface channel
P1	Not as mapped	Temporarily ponded area that is farmed
P19	New water body feature observed – previously unmapped	A pond was observed.
P12	New feature observed – previously unmapped	A dugout pond was observed.
P11	New water body feature observed – previously unmapped	A pond was observed.
P13	New feature observed – previously unmapped	A dugout pond was observed.
P15	New feature observed – previously unmapped	A dugout pond was observed.
P18	New feature observed – previously unmapped	A dugout pond was observed.
P17	New feature observed – previously unmapped	A dugout pond was observed.
P14	New feature observed – previously unmapped	A dugout pond was observed.

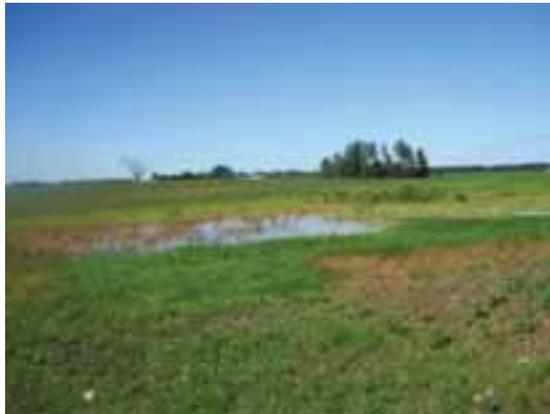
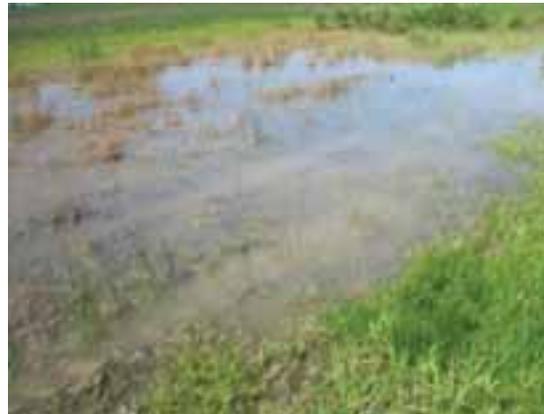
Feature ID	Project Component	Investigation Date	Description of Site	Feature Description	Feature Sensitivity
P11	<ul style="list-style-type: none"> Transmission Line Buffer 	June 22, 2012	<ul style="list-style-type: none"> The pond is located in a soybean field. The pond is 15 by 10 m and 0.25 m deep. The riparian buffer is 0.5 to 2 m of cultural meadow (CUM1-1). 	<ul style="list-style-type: none"> The pond is a natural feature that appears to be seasonal. The pond is a natural depression area that is offline. The substrate consists of silt and clay. <i>In situ</i> cover is low and consists of aquatic vegetation. No groundwater indicators were observed. 	Low

Photograph 1. Pond overview ↑

Photograph 2. Pond view ↑

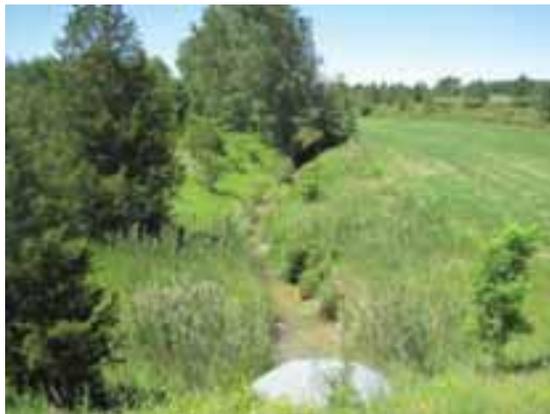
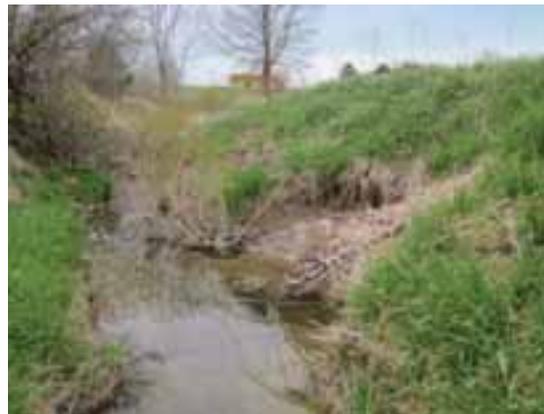
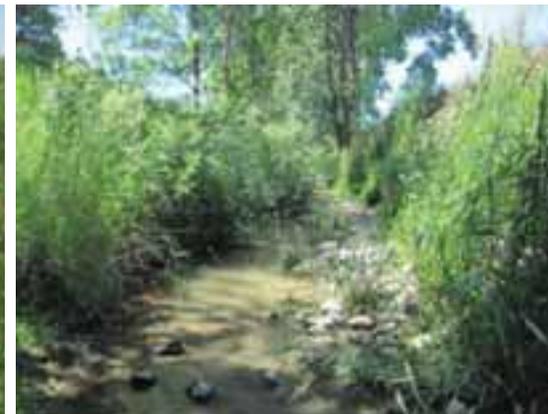
D16
MWD(m):	0.2
MBD(m):	1.75

Feature ID	Project Component	Investigation Date	Description of Site	Feature Description	Feature Sensitivity
D16	• Collection Line Crossing	April 26, 2012 June 25, 2012	<ul style="list-style-type: none"> The watercourse surrounded by cultural meadow (classified as CUM1-1, ELC Feature ID 220), soybean and row crop fields and crosses Grand Bend Line. Tile drain inputs were noted east of Grand Bend Line. Surrounding land topography is flat with sloping towards the watercourse. Riparian buffer is 1.5 m west of Grand Bend Line and greater than 5 m east consisting of meadow and trees. 	<ul style="list-style-type: none"> The watercourse is a defined channelized feature that is starting to naturalize. The watercourse is straight flat channel that has a few riffle pool run sequence. The water was slightly turbid and had slow flow at time of investigations. It is classified as a permanent warm water system by ABCA. Banks are slightly unstable with signs of erosion and old slumping present. Substrate is silt and clay followed by cobble, gravel and boulders. Canopy cover is high and dominated by trees and shrubs. Instream habitat cover is moderate and consists of cobble followed by boulders, aquatic vegetation, woody debris and undercut banks. No groundwater indicators were observed. Cyprinids were observed during April and young of the year fish were observed during June. Upstream fish species consist of a baitfish community, Brown Bullhead, Rainbow Trout and Northern Pike (ABCA, 2001; MNR 2003). 	Low

Photograph 1. Site overview west ↑

Photograph 2. Site overview east ↑

Photograph 3. Channel view ↑

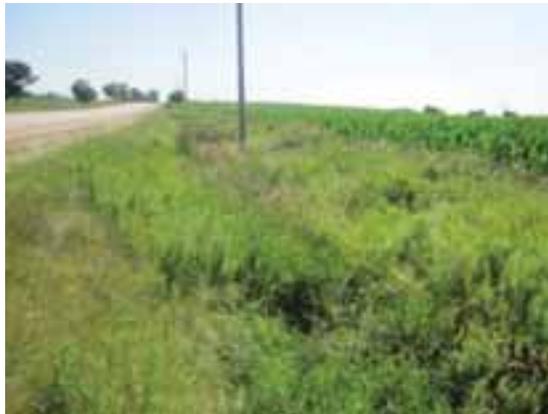
D45		D45
MWW(m):	1.25	MWD(m):	0.08
MBW(m):	3.0	MBD(m):	0.8

Photograph 1. Site overview ↑

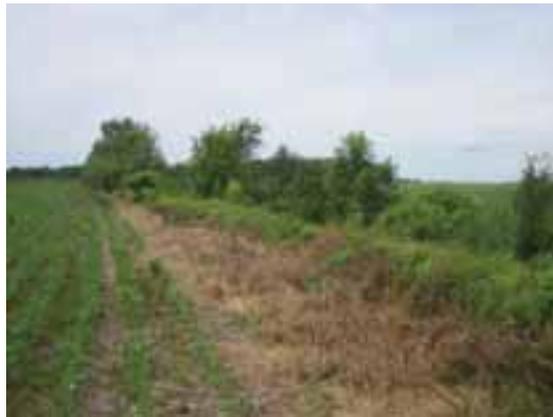
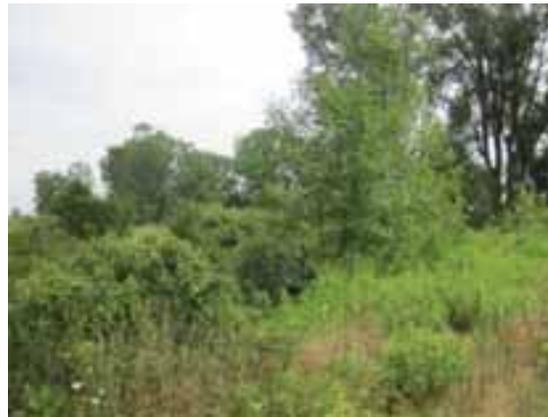
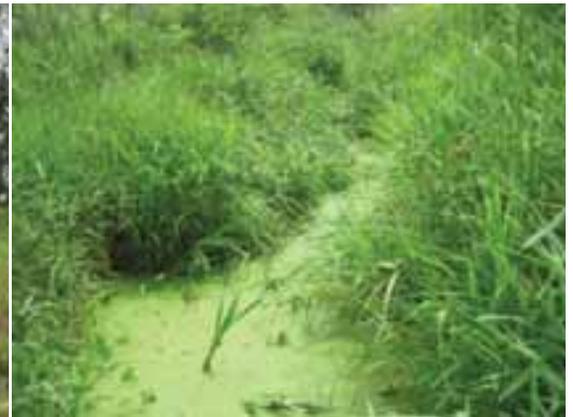
Watercourse Name	Pfaff Drain	D55	D55
DFO Drain Classification	F	MWW(m): 0.5	MWD(m): 0.1
		MBW(m): 1.5	MBD(m): 0.3

Feature ID	Project Component	Investigation Date	Description of Site	Feature Description	Feature Sensitivity
D55	<ul style="list-style-type: none"> Collection Line Buffer Turbine 38 	July 27, 2011	<ul style="list-style-type: none"> The watercourse is located in a crop agricultural field and the riparian buffer is 1 m of cultural meadow (CUM1-1). No tile inputs were noted and the surrounding topography is flat. 	<ul style="list-style-type: none"> The watercourse is a defined channelized feature that appears to be naturalizing. During the time of investigation there was no flow, only standing water. It is classified as intermittent by ABCA. The banks are stable and vegetated. Substrate consists of muck followed by clay and silt. Canopy cover is low and consists of shrubs and trees. Instream cover is moderate dominated by aquatic vegetation followed by undercut bank and woody debris. Groundwater indicator watercress was observed. 	Low

Photograph 1. Site overview ↑

Photograph 2. Site overview ↑

Photograph 3. Channel close-up ↑

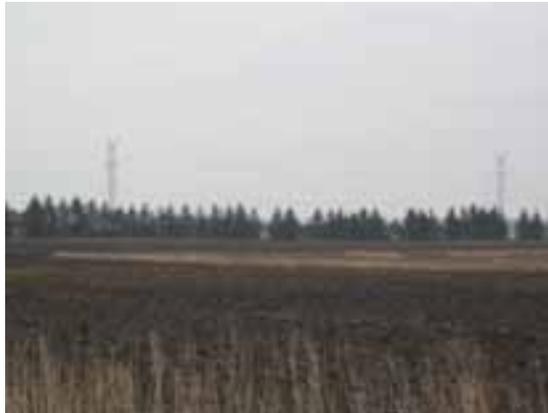
Feature ID	Project Component	Investigation Date	Description of Site	Feature Description	Feature Sensitivity
P19	<ul style="list-style-type: none"> Collection Line Crossing Road Crossing 	November 17, 2011 December 22, 2011	<ul style="list-style-type: none"> The pond is located in an agricultural field. Riparian buffer of grasses exists. 	<ul style="list-style-type: none"> The pond is a dugout offline feature. Water was present at time of investigation. 	Low

Photograph 1. Pond overview ↑

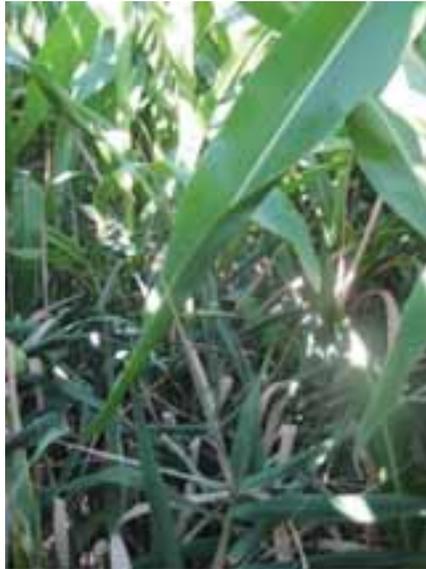
Feature ID	Project Component	Investigation Date	Description of Site	Feature Description	Feature Sensitivity
P1	<ul style="list-style-type: none"> Collection Line Buffer 	July 25, 2012	<ul style="list-style-type: none"> The feature is located in a corn field. There was no water body present. 	<ul style="list-style-type: none"> No water body was present. Some Common Reed was present in the corn field. 	Not Sensitive

Photograph 1. Site view ↑

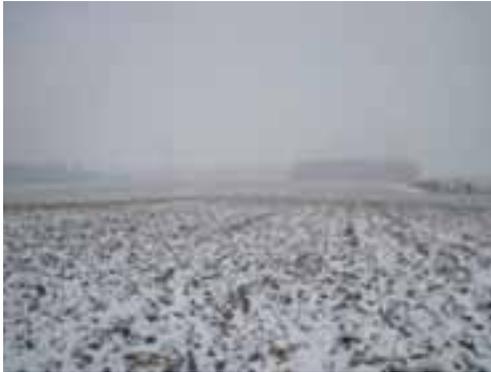
Feature ID	Project Component	Investigation Date	Description of Site	Feature Description	Feature Sensitivity
C212	• Turbine 72	January 13, 2012	• The feature is located in an agricultural field. No water body was present.	• No water body feature present.	Not Sensitive

**Photograph 1. Site overview** ↑

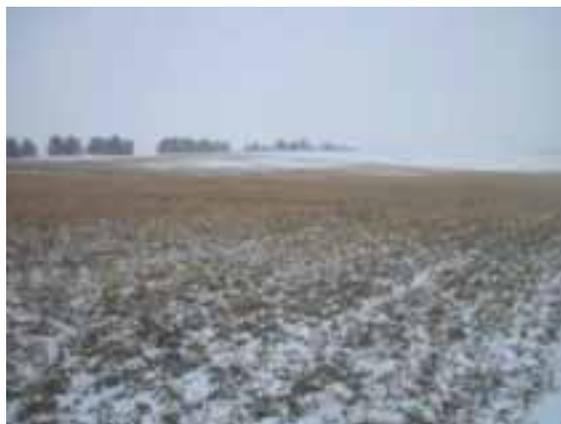
Feature ID	Project Component	Investigation Date	Description of Site	Feature Description	Feature Sensitivity
C213	<ul style="list-style-type: none"> • Collection Line Crossing • Road Crossing • Turbine 73 	January 13, 2012	<ul style="list-style-type: none"> • The feature is located in an agricultural field. No water body was present. 	<ul style="list-style-type: none"> • No water body feature present. 	Not Sensitive

Photograph 1. Site overview ↑

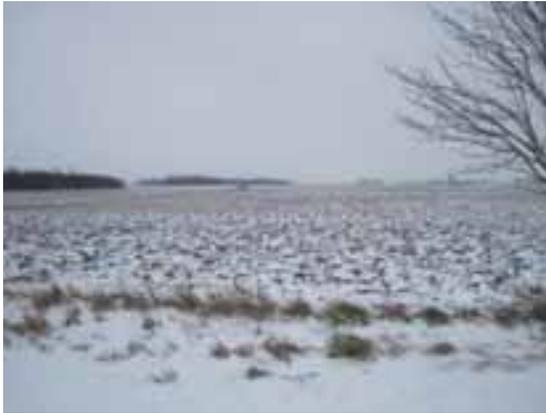
Feature ID	Project Component	Investigation Date	Description of Site	Feature Description	Feature Sensitivity
C217	• Turbine 76	January 13, 2012	• The feature is located in an agricultural field. No water body was present.	• No water body feature present.	Not Sensitive

**Photograph 1. Site overview ↑**

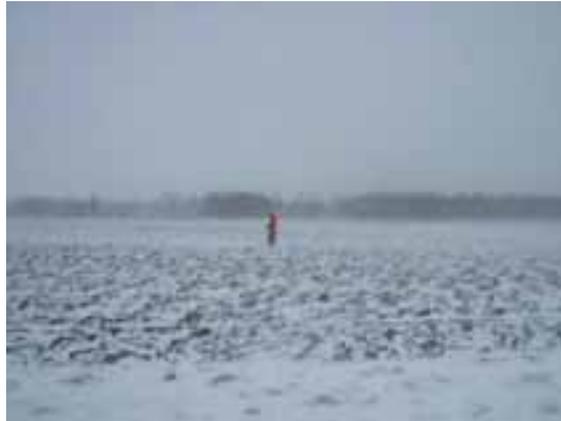
Feature ID	Project Component	Investigation Date	Description of Site	Feature Description	Feature Sensitivity
C214	• Turbine 77	January 13, 2012	• The feature is located in an agricultural field. No water body was present.	• No water body feature present.	Not Sensitive

**Photograph 1. Site overview ↑**

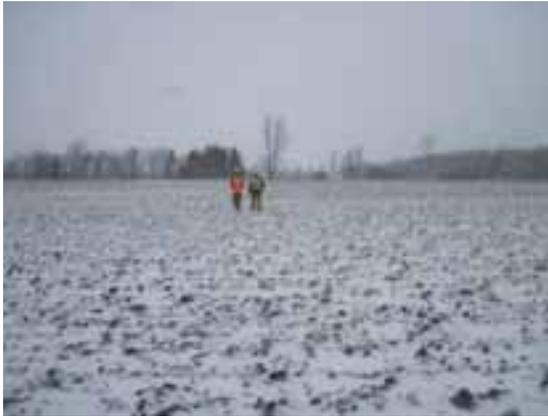
Feature ID	Project Component	Investigation Date	Description of Site	Feature Description	Feature Sensitivity
C215	• Turbine 78	January 13, 2012	• The feature is located in an agricultural field. No water body was present.	• No water body feature present.	Not Sensitive

**Photograph 1. Site overview** ↑

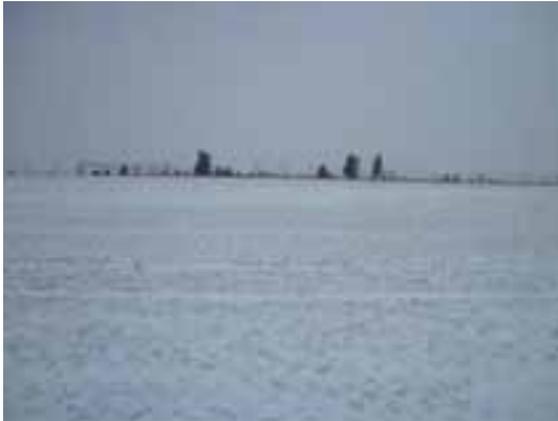
Feature ID	Project Component	Investigation Date	Description of Site	Feature Description	Feature Sensitivity
C216	• Turbine 79	January 13, 2012	• The feature is located in an agricultural field. No water body was present.	• No water body feature present.	Not Sensitive

**Photograph 1. Site overview ↑**

C216	Swale feature, no water body found	No channel was found field ploughed through, however some low lying areas that may provide seasonal surface water conveyance.
C9	Not as mapped	Tile drain feature – no surface channel
C31	Not as mapped	Tile drain feature – no surface channel
P3	Not as mapped	Temporarily ponded area that is farmed
C127	Not as mapped	Tile drain feature – no surface channel
C211	Not as mapped	Tile drain feature – no surface channel
C109	Not as mapped	Tile drain feature – no surface channel
C106	Not as mapped	Tile drain feature – no surface channel
C210	Not as mapped	Tile drain feature – no surface channel
D30	Not as mapped	Tile drain feature – no surface channel
D41	Not as mapped	Tile drain feature – no surface channel
D52	New water body feature observed – previously unmapped	A channel was observed in Feature 290, which flows through a deciduous forest
D51	New water body feature observed – previously unmapped	A channel was observed in Feature 258, which flows through a deciduous forest

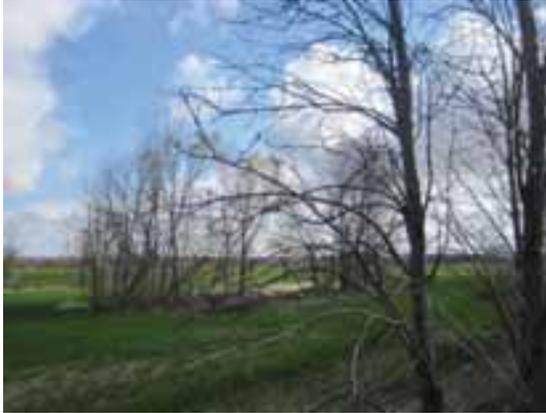
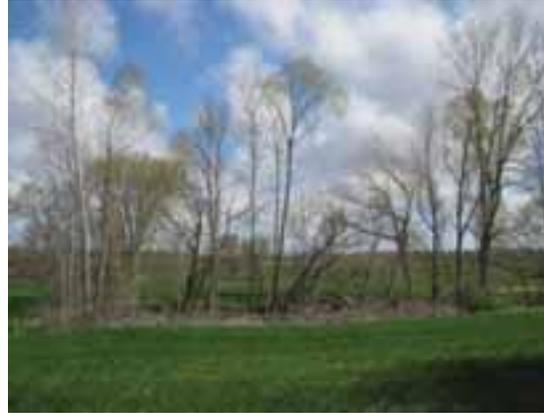
Feature ID	Project Component	Investigation Date	Description of Site	Feature Description	Feature Sensitivity
P18	<ul style="list-style-type: none"> • Collection Line Buffer • Road Buffer • Turbine 86 	April 26, 2012	<ul style="list-style-type: none"> • The pond is located in a field of winter wheat, surrounded by deciduous trees. 	<ul style="list-style-type: none"> • The pond is a dugout offline feature. 	Not Sensitive

Photograph 1. Pond overview ↑

Photograph 2. Pond overview ↑

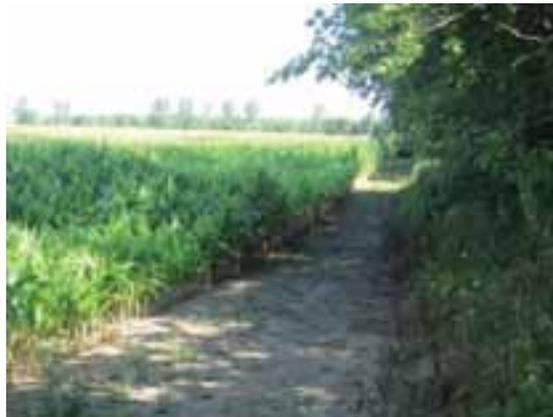
Watercourse Name	Brock Drain
DFO Drain Classification	T

Feature ID	Project Component	Investigation Date	Description of Site	Feature Description	Feature Sensitivity
C31	• Turbine 67	July 27, 2011	<ul style="list-style-type: none"> No channel was observed as it has been ploughed through. The site is a crop agricultural field adjacent to a deciduous forest (classified as FOD, ELC Feature ID 325). 	<ul style="list-style-type: none"> No water body feature present. It is classified as tiled by ABCA. 	Not Sensitive

Photograph 1. Site overview ↑

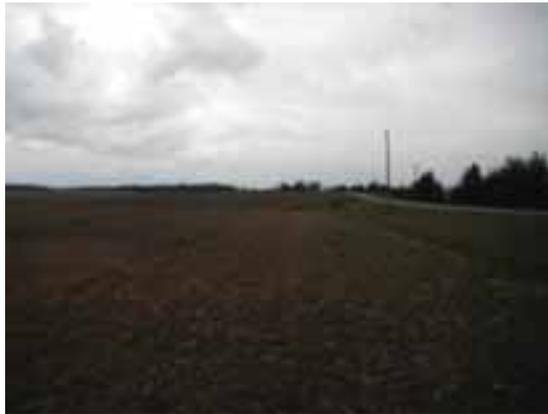
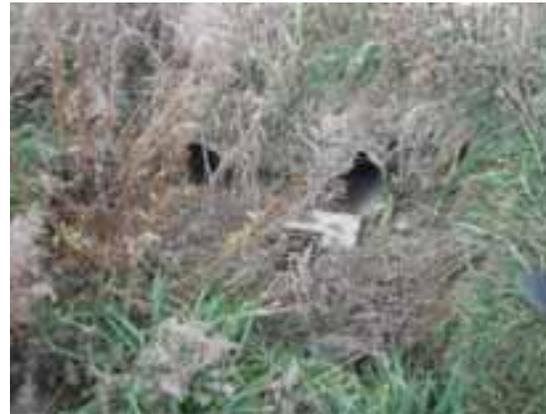
Watercourse Name	Haugh Drain
DFO Drain Classification	T

Photograph 1. Site overview ↑

Photograph 2. Tile drain Goshen Line ↑

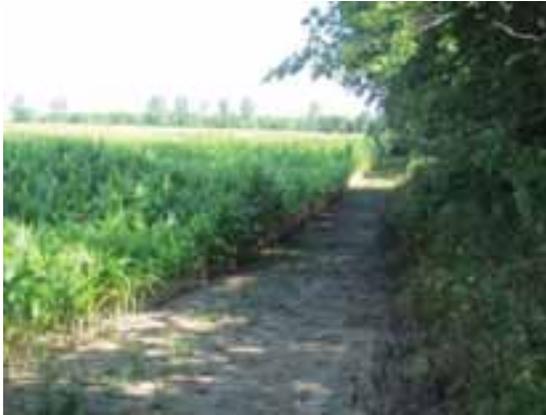
Feature ID	Project Component	Investigation Date	Description of Site	Feature Description	Feature Sensitivity
P3	• Turbine 67	July 27, 2011	• The feature is located in a corn field. No water body is present, it has been ploughed through.	• No water body present.	Not Sensitive

**Photograph 1. Site overview ↑**

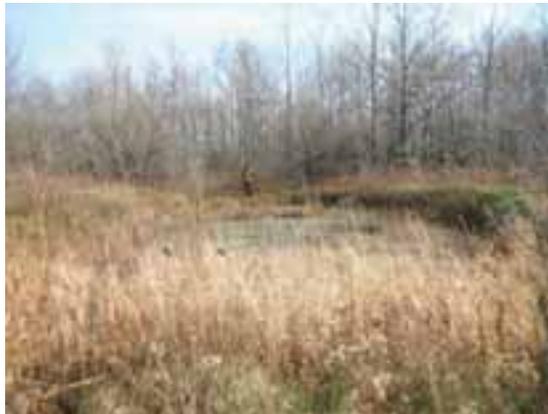
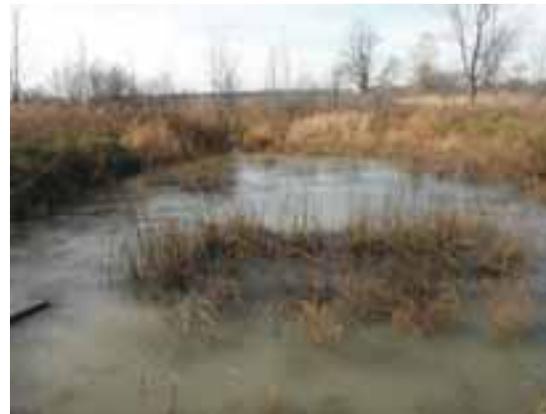
Feature ID	Project Component	Investigation Date	Description of Site	Feature Description	Feature Sensitivity
P17	<ul style="list-style-type: none"> Collection Line Buffer Turbine 37 	November 18, 2011	<ul style="list-style-type: none"> The pond is surrounded by a mix of deciduous forest, cultural meadow and cultural thicket (classified as FOC9b, CUM1-1, CUT1h, ELC Feature ID 236). The pond is 40 m long. Riparian vegetation 	<ul style="list-style-type: none"> The pond is dugout offline feature. Emergent aquatic vegetation is present. No groundwater indicators were noted at time of investigation. 	Not Sensitive

Photograph 1. Pond overview ↑

Photograph 1. Pond view ↑

P17	New feature observed – previously unmapped	A dugout pond was observed.
P20	New feature observed – previously unmapped	A dugout pond was observed.

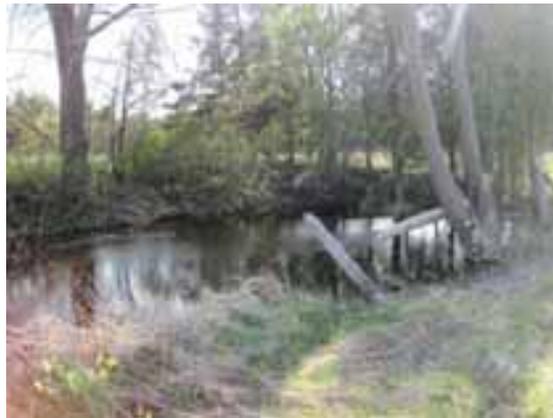
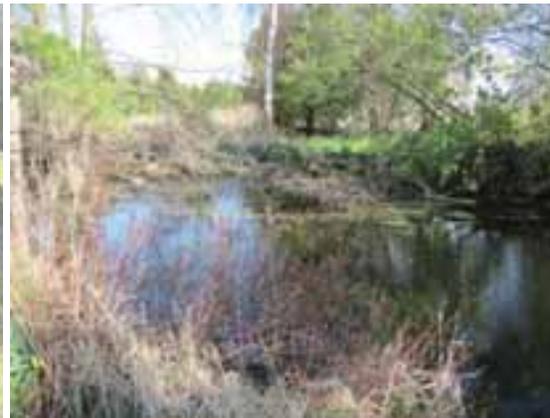
Feature ID	Project Component	Investigation Date	Description of Site	Feature Description	Feature Sensitivity
P15	<ul style="list-style-type: none"> Collection Line Buffer 	April 17, 2012	<ul style="list-style-type: none"> Pond is located on Credition Road, east of D18. It is surrounded by crop agricultural fields. Surrounding land topography is flat. Riparian buffer is 2 m of cultural meadow (CUM1-1) containing trees and shrubs. Pond is approximately 20 m by 10 m. 	<ul style="list-style-type: none"> The pond may be a dugout pond since the surrounding vegetation is not associated with a wetland. The pond appears to be offline, as no connection was evident. The pond was turbid with brown colour during the investigation. <i>In situ</i> cover is moderate and consists of aquatic vegetation followed by woody debris. No groundwater indicators were noted. 	Not Sensitive

Photograph 1. Pond overview ↑

Photograph 2. Pond overview ↑

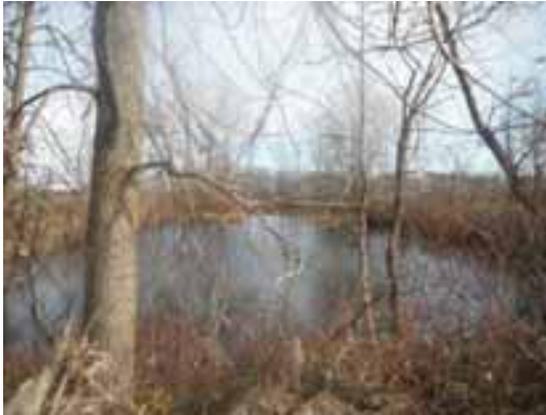
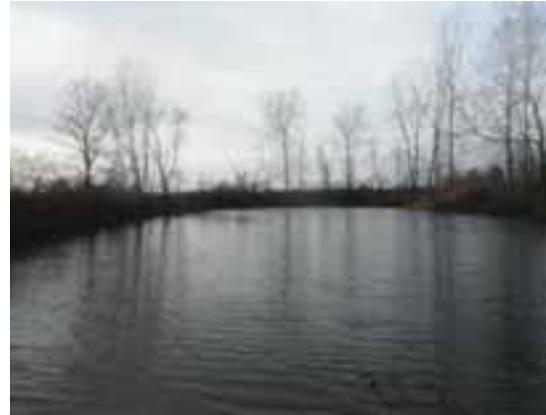
Feature ID	Project Component	Investigation Date	Description of Site	Feature Description	Feature Sensitivity
P5	• Turbine 39	November 18, 2011	• The pond is located in an agricultural field. The pond is 100 by 40 m. Riparian buffer is 10 m of trees, shrubs and grasses.	• The pond is a dugout offline feature. Substrate consists of silt, sand and gravel. There is no <i>in situ</i> habitat cover. No groundwater indicators were observed.	Not Sensitive

Photograph 1. Pond overview ↑

Photograph 2. Pond overview ↑

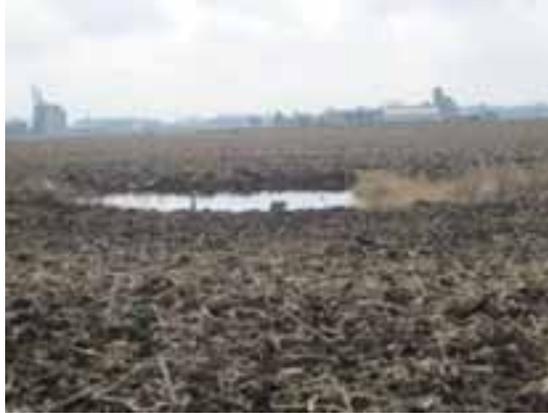
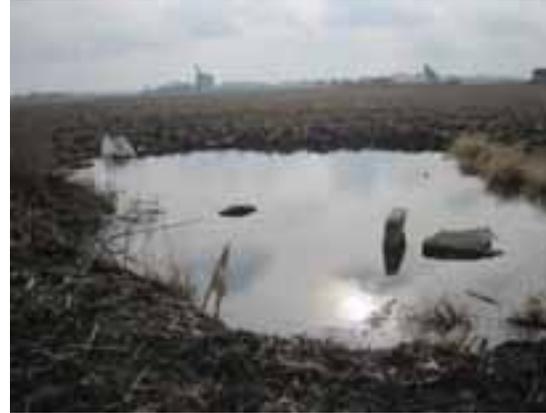
Feature ID	Project Component	Investigation Date	Description of Site	Feature Description	Feature Sensitivity
P10	<ul style="list-style-type: none"> Collection Line Buffer Road Buffer 	December 22, 2011	<ul style="list-style-type: none"> The pond is located in an agricultural field. There is no riparian buffer for the pond. 	<ul style="list-style-type: none"> The pond is a dugout offline feature that is used for farming. Substrate consists of silt. The pond was filled with garbage. No groundwater indicators were observed. 	Not Sensitive

Photograph 1. Pond overview ↑

Photograph 2. Pond view ↑

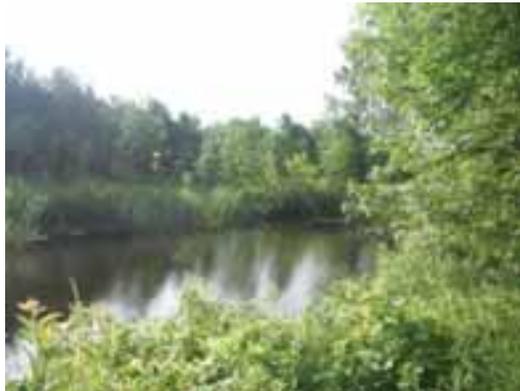
Feature ID	Project Component	Investigation Date	Description of Site	Feature Description	Feature Sensitivity
P2	• Turbine 34	July 13, 2011	<ul style="list-style-type: none"> The pond is bordered by cultural plantation (classified as CUP3-1, ELC Feature ID 759) on the east and corn field on the west. Surrounding topography is flat. Riparian buffer in the agricultural field is 3 m and is greater than 3 m in the cultural plantation. 	<ul style="list-style-type: none"> The pond is defined as a permanent feature. The water was clear and had moderate flow during the time of investigation. The banks are stable. Canopy cover is low and consists of grasses, shrubs and herbaceous vegetation. Instream habitat cover is low and consists algae, submergent and emergent vegetation. No groundwater indicators were observed. 	Not Sensitive

Photograph 1. Pond overview ↑

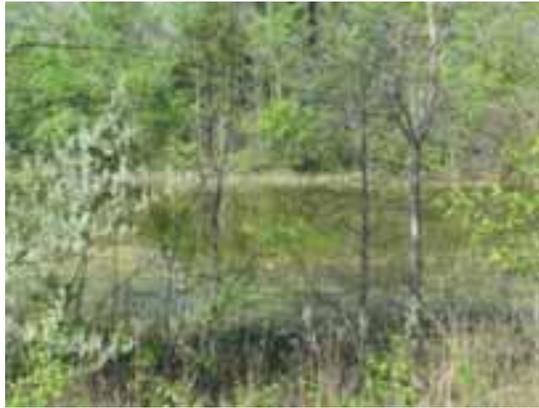
Feature ID	Project Component	Investigation Date	Description of Site	Feature Description	Feature Sensitivity
P9	<ul style="list-style-type: none"> Collection Line Buffer 	May 11, 2012	<ul style="list-style-type: none"> Pond is located in mixed forest (classified as FOM5-2, ELC Feature ID 255) with a riparian buffer of greater than 5 m along the roadsides and greater than 30 m to the north and west. 	<ul style="list-style-type: none"> The pond feature appears to be natural but could not be confirmed. The water was clear during the time of investigation. Pond was approximately 40 m by 20 m and appeared to be shallow. Cattails surrounded the pond and algae were seen in the pond. No groundwater indicators were observed. 	Not Sensitive

Photograph 1. Pond overview ↑

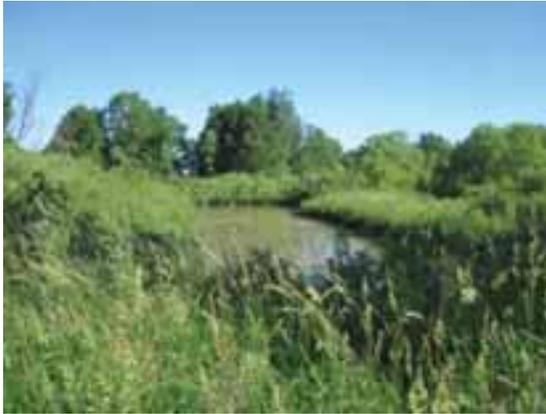
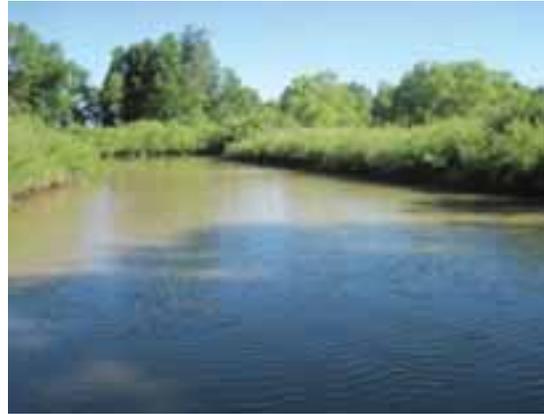
Feature ID	Project Component	Investigation Date	Description of Site	Feature Description	Feature Sensitivity
P13	<ul style="list-style-type: none"> Transmission Line Buffer 	June 13, 2012	<ul style="list-style-type: none"> The pond is located in a swamp thicket (classified as SWT2-2, ELC Feature ID 609) adjacent to corn fields. The pond is 50 by 15 m. The riparian buffer is 5-15 m of swamp thicket. 	<ul style="list-style-type: none"> The pond is dugout offline feature, which is possibly used for farming. The water was turbid at time of investigation. The substrate is silt and clay. No groundwater indicators were observed. 	Not Sensitive

Photograph 1. Pond overview ↑

Photograph 2. Pond view ↑

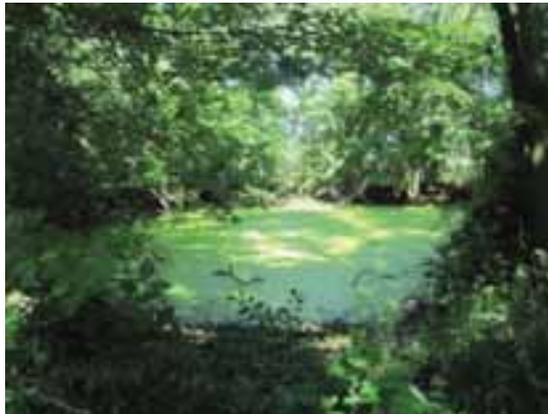
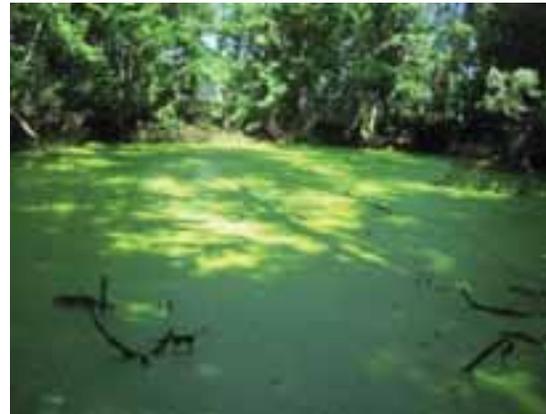
Feature ID	Project Component	Investigation Date	Description of Site	Feature Description	Feature Sensitivity
P12	<ul style="list-style-type: none"> Transmission Line Buffer 	June 22, 2012	<ul style="list-style-type: none"> Pond is located in a deciduous forest and cultural meadow (classified as FOD7f, CUM1-1, FOD6-5, ELC Feature ID 720) that is surrounded by agricultural fields. The pond is 15 by 20 m and greater than 0.3 m deep. The riparian buffer is greater than 10 m of forest. 	<ul style="list-style-type: none"> The pond is a dugout offline feature. The water was clear at time of investigation. The substrate is muck and detritus. <i>In situ</i> cover is high and consists of aquatic vegetation followed by woody debris. The majority of aquatic vegetation is duckweed. No groundwater indicators were observed. 	Not Sensitive

Photograph 1. Pond overview ↑

Photograph 2. Pond view ↑

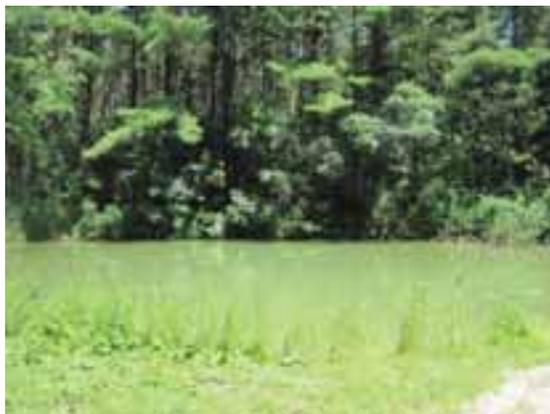
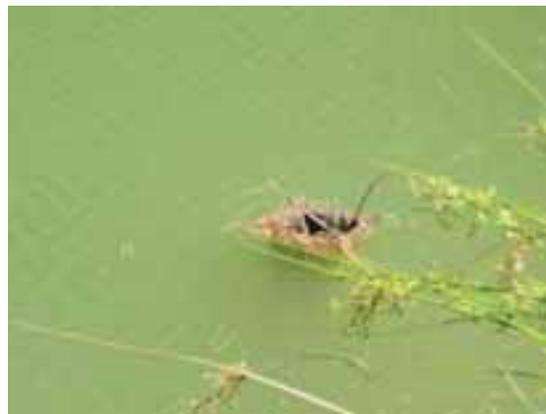
Feature ID	Project Component	Investigation Date	Description of Site	Feature Description	Feature Sensitivity
P14	<ul style="list-style-type: none"> Collection Line Buffer 	June 25, 2012	<ul style="list-style-type: none"> The pond is located in a cultural plantation (classified as CUP3-2, ELC Feature ID 209). The pond is 20 by 20 m. The riparian buffer is 5 to 15 m of cultural plantation. 	<ul style="list-style-type: none"> The pond is a dugout offline pond that has an outflow pipe directly into another pond (P8). The water was turbid at time of investigation. Substrate consists of sand and silt followed by muck. <i>In situ</i> cover is low and consists of aquatic vegetation and woody debris. No groundwater indicators were observed. 	Not Sensitive

Photograph 1. Pond overview ↑

Photograph 2. Outflow pipe ↑

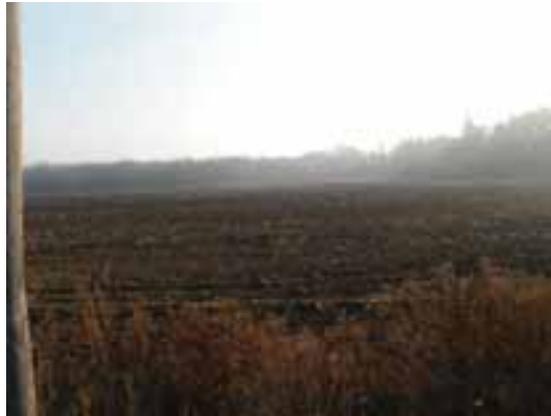
Feature ID	Project Component	Investigation Date	Description of Site	Feature Description	Feature Sensitivity
D58	<ul style="list-style-type: none"> Collection Line Buffer Road Buffer 	November 22, 2012	<ul style="list-style-type: none"> The feature is located in an agricultural field. No water body is present, it has been ploughed through. 	<ul style="list-style-type: none"> The water body may be tiled drained. It is classified as tiled by ABCA. 	Not Sensitive

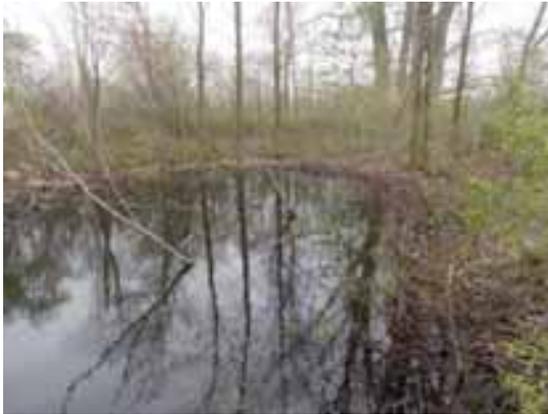
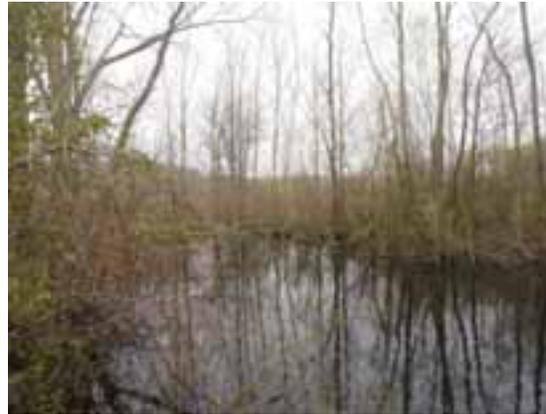
Feature ID	Project Component	Investigation Date	Description of Site	Feature Description	Feature Sensitivity
P20	<ul style="list-style-type: none"> Collection Line Buffer 	May 2, 2012	<ul style="list-style-type: none"> The pond is surrounded by swamp thicket (classified as SWT2b, ELC Feature ID 754) in an agricultural field. The pond is approximately 20 by 9 m and 2 m deep. 	<ul style="list-style-type: none"> The pond is an offline dugout feature. The water was clear at time of investigation. <i>In situ</i> vegetation was low and consisted of emergent vegetation. 	Not Sensitive

Photograph 1. Pond overview ↑

Photograph 2. Pond view ↑

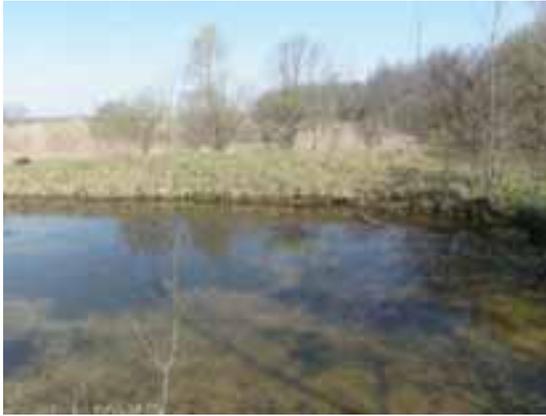
Feature ID	Project Component	Investigation Date	Description of Site	Feature Description	Feature Sensitivity
P17	• Collection Line Buffer	April 19, 2012	• The pond is located in a mix of cultural meadow, cultural thicket and meadow marsh (classified as CUM1-1, CUT1h, MAM2-2, ELC Feature ID 236). The pond is 19 by 13 m and 0.55 m deep.	• The pond is an offline dugout features. The water was clear at time of investigation. <i>In situ</i> cover is moderate and consists of submergent, emergent and floating vegetation	Not Sensitive

**Photograph 1. Site overview ↑**
