Goshen Wind Energy Centre
Water Assessment and Water Body Report

Project Location
December 2012
Project 60155032

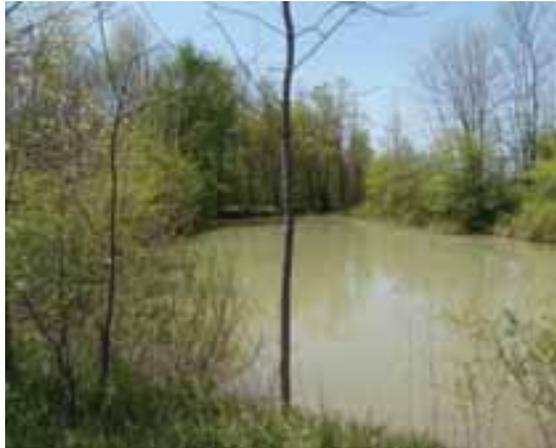
D36		D36
MWW(m):	7.0	MWD(m):	n/a
MBW(m):	8.25	MBD(m):	n/a

Photograph 1. Site overview ↑
