AECOM

Study Area: Jericho Goshen Bluewater Land Parcel# GSH 2016 Turbine # C144
 Date: Dec 16, 2011 Start time: 11:15 End Time: 11:45
 Weather Conditions: Cloudy, 1°C Field Notes By: CB

Study Area: Jericho Goshen Bluewater Land Parcel# GSH2016 Turbine # C144

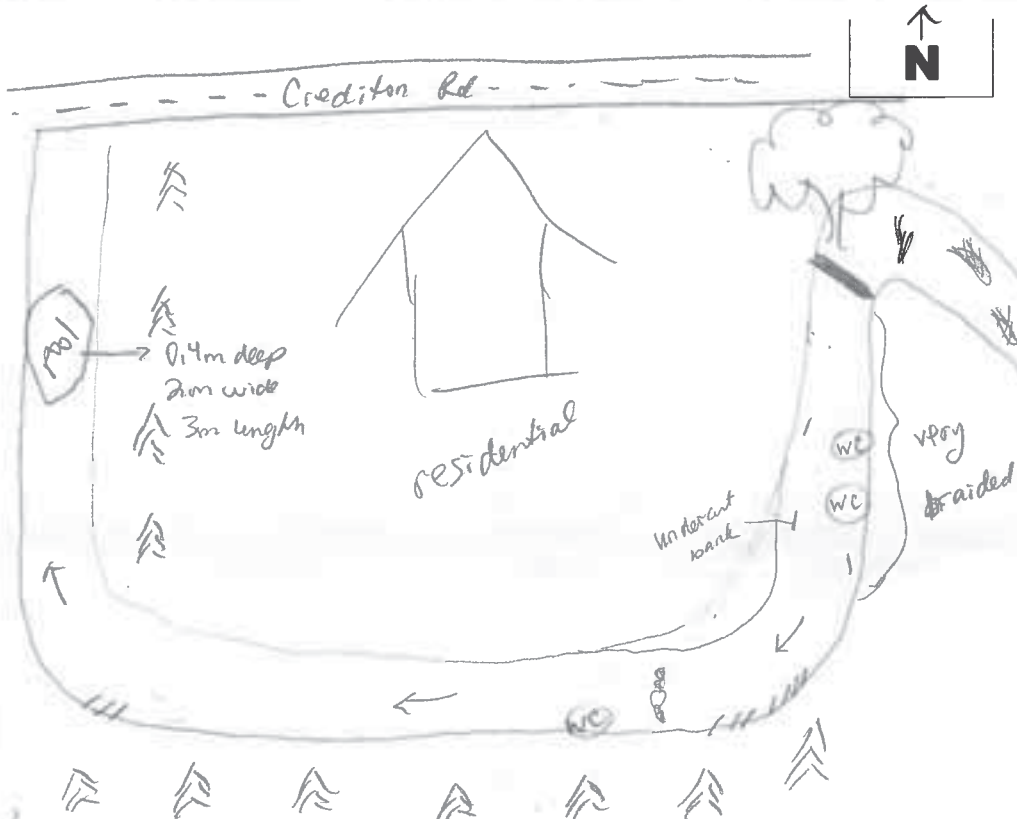
018

- white tailed deer footprints, small mammal den
- tadpoles + minnows observed
- cobbles covered in algae
- cliff swallow nest observed in West culvert (box)

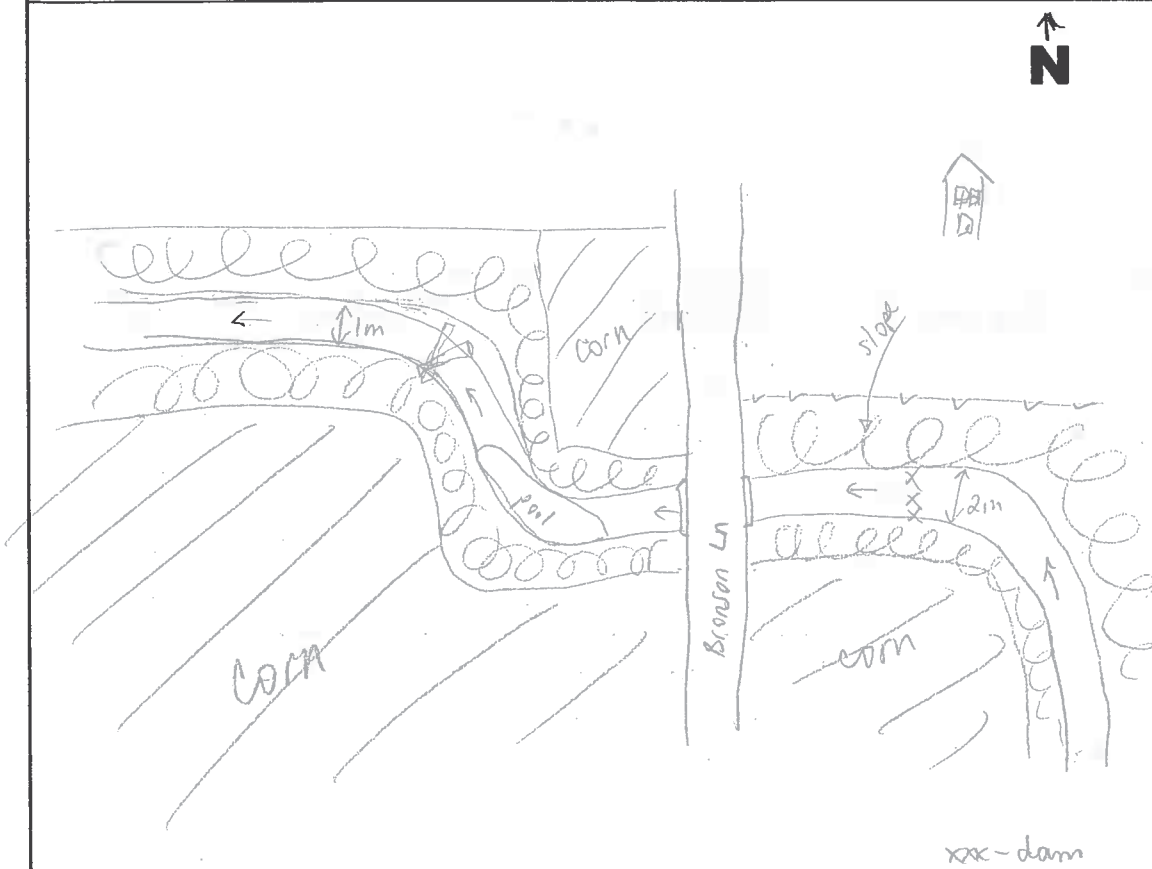
- ~40m east of culvert a grass den/dam observed. Potentially a muskrat home.
- fish observed (minnow) on both sides of culvert
- east side sl. different than the west (east less veg, more confined, faster flow)

xxx - dam
v - electric fence
o - riparian meadow

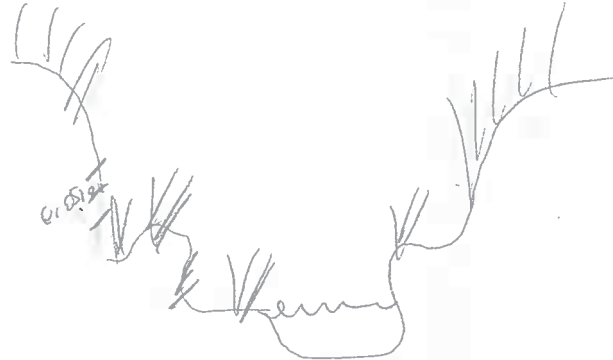
Horizontal View of Channel

• erosion + shaping found throughout
 • algal coating substrate throughout
