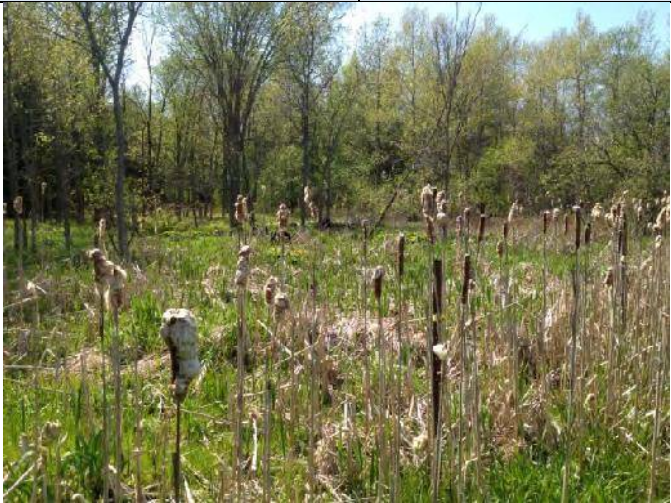
<p>W8 – feature dominated by wetland vegetation(photo: May 15, 2012)</p>

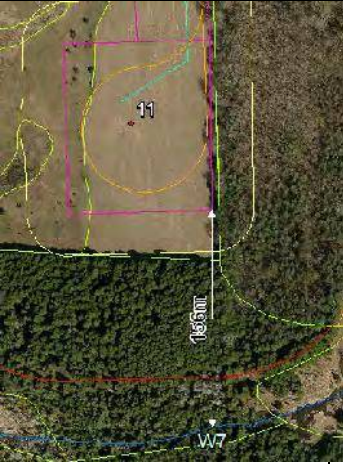
<p>This feature was identified in Records Review and investigated; however, a change to the project layout in June 2012 meant the feature was no longer within 120m of the project location.</p>	<p>May 16, 2012</p>	<p>n/a</p>	<p>W7 removed from list of water bodies because >120m from Project Location.</p>

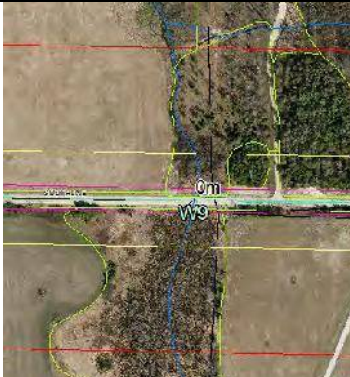
<p>W9 - 0m from underground collection line in existing road right of way.</p>	<p>Property access was not provided for the property where this feature was located and for that reason a roadside survey was conducted. Water in channel was pooling close to the road such that the bankfull width was approximately 1m, and bankfull depth approximately 0.5m. Upstream of the road crossing the channel was much narrower (20-30cm) with a grassy riparian edge. Abundant algal mats were present in May. Feature conveys water between two red maple deciduous swamps (ELC units 256 and 400). The riparian edge is predominantly Lake-bank sedge (<i>Carex lacustris</i>) with occasional red-osier dogwood, narrow-leaved cattail, and white cedar. Little in the way of instream or riparian cover available. No fish observed in channel. Substrate predominantly gravel. Water temperature = 20C on May 15, 2012</p>	<p>May 15, 2012 August 1, 2012</p>

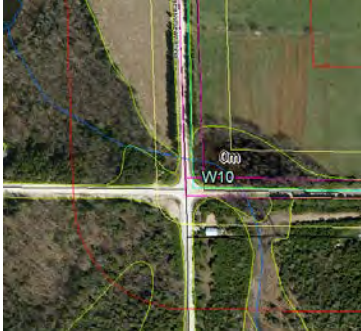
<p>W10 - 0m from underground collection line in existing road right of way.</p>	<p>Property access was not provided for the property where this feature was located and for that reason a roadside survey was conducted. Feature is characterized as part of red maple deciduous swamp (ELC units 258/411/413) comprised of slender willow, chokeberry, and narrow-leaved cattail as understory and common milkweed, spotted joe-pye weed, timothy grass, water parsnip and reed-canary grass as the dominant species within the groundcover; and coniferous forest (ELC unit 259) dominated by eastern white cedar. Hydrophytic vegetation was dominant within the feature; therefore it was treated as a wetland and addressed within the NHA. Parts of W10 are within the boundary of Beaver Meadow PSW and the remainder of the feature was treated as a significant wetland.</p> <p>W10 was determined not to meet the definition of a 'water body' as outlined in O. Reg. 359/09.</p>	<p>May 15, 2012 August 1, 2012</p>

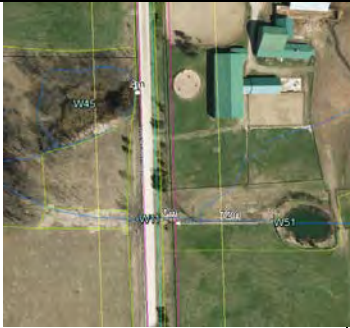
<p>W11 - 0m from underground collection line in existing road right of way. W45 - 4m from underground collection line in existing road right of way. W51 - 72m from underground collection line in existing road right of way.</p>	<p>Property access was not provided for the property where these features were located and for that reason a roadside survey was conducted.</p> <p>W11 provides seasonal conveyance of water through an intermittent channel from upstream agricultural fields and dugout pond (W51) to a meadow marsh (ELC unit 260) on the downstream side of Boot Jack Ranch Road. At the time of survey less than 5 cm of standing water was documented on the upstream side of the road and no water was observed in the channel downstream of the culvert. No fish were observed.</p> <p>Bankfull width= 0.5m (approx.) Water temperature=24C (May 15, 2012).</p> <p>No open water feature was found at W45. This feature was determined during ELC surveys to be part of ELC unit 413 (red maple deciduous swamp). Parts of W45 are within the boundary of Beaver Meadow PSW and was addressed as a significant wetland in the NHA for the project. W45 was dominated by hydrophytic vegetation and determined not to conform to the definition of a 'water body' as outlined in O. Reg. 359/09.</p> <p>W51 was investigated through the</p>	May 15, 2012

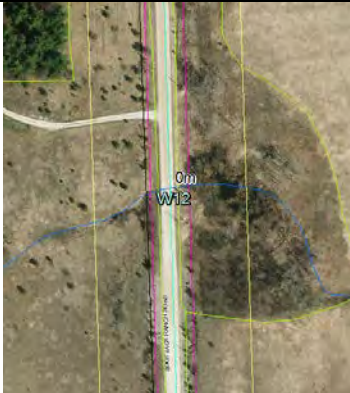
<p>W12 - 0m from underground collection line in existing road right of way.</p>	<p>Property access was not provided for the property where this feature was located and for that reason a roadside survey was conducted.</p> <p>W12 provides seasonal pooling of water in a culvert crossing of Boot Jack Ranch Road between a deciduous swamp (ELC unit 266) on the east side of the road and a small area dominated by hydrophytic vegetation on the west side of the road. Standing water was documented in the channel during survey; no flow was detected through the culvert. This area was treated as a significant wetland feature in the NHA for the Project. W12 was determined to be a grassed channel on the upstream side of the road and dominated by emergent and hydrophytic vegetation on the downstream side. This feature did not conform to the definition of a 'water body' as outlined in O. Reg. 359/09.</p>	May 15, 2012

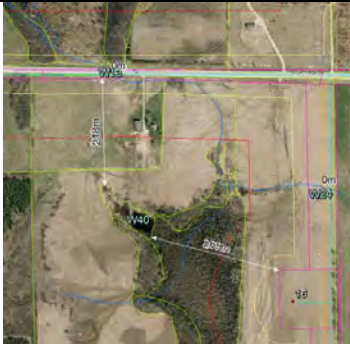
<p>W13 – 0m from underground collection line in existing road right of way. W24 - 0m from underground collection line in existing road right of way. W40 – 218m from underground collection line in existing road right of way.</p>	<p>Two features along the same watercourse were identified through Records Review and investigated further: W13 (crossing of County Rd. 4) and W24 (within an agricultural field on the south side of County Rd. 4). W40, a pond feature in the vicinity of these water features was identified during Site Investigation, but later determined to be > 120m from the Project Location.</p> <p>Property access was not provided for the property on the north side of County Rd. 4 and for that reason a roadside survey was conducted of the downstream portion of W13.</p> <p>W13 – saturated soils suggest culvert holds water seasonally during spring melt from agricultural field on the south side of County Rd. 4 and the cattail marsh (ELC unit 88) on north side of the road. At the time of survey standing water was documented within the culvert; however, grassy roadside ditch on either side of culvert was free of water. No open water component was documented. W13 was determined not to meet the definition of a ‘water body’ as outlined in O. Reg. 359/09.</p>	May 16, 2012

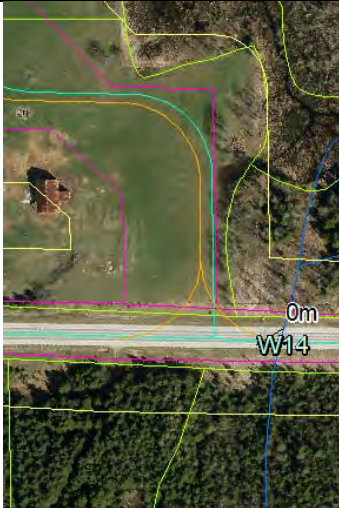
<p>W14 – 0m from underground collection line in existing road right of way.</p>	<p>Property access was not provided for the property on the south side of the road and for that reason a roadside survey was conducted of the upstream portion.</p> <p>W14 functions to provide seasonal conveyance of water from one wetland feature to another. ELC unit 85 (a tamarack coniferous swamp) is located on the south side of County Road 4, and ELC unit 62 (a white cedar coniferous swamp) is located on the north side of the road. Both of these features are dominated by wetland species and are within the boundary of Beaver Meadow PSW. These features were addressed as significant wetlands through the NHA and determined not to meet the definition of a 'water body' under O.Reg. 359/09.</p>

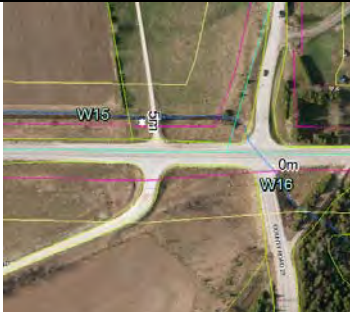
<p>W15 – 5m from underground electrical collection line in road right of way; W16 - underground electrical collection line in road right of way crosses the feature (0m);</p>	<p>Property access was not provided for the property where these features were located and for that reason a roadside survey was conducted.</p> <p>NRVIS data indicated a connection between W16 (furthest upstream) and flow continuing from there to W15, to W28, to W26, and to W18. Mapping obtained from SSWPC (2011) classifies these sites as a cold water stream.</p> <p>Description of feature at W16 : Pool at culvert = 0.37m deep Bankfull width = 1.5m; channel wider upstream (approximately 3m) with fast riffle (0.15m deep) Substrate was a mix of cobble/gravel/boulder. Instream cover was available in the form of willow. Banks were stable. No fish were observed at the time of survey. Water temperature = 16C (May 15, 2012), 18C (Aug. 1, 2012) Immediate riparian vegetation is mostly manicured lawn, with birch and cedar, adjacent land use is transportation and agricultural. Feature is highly altered as it passes under 2 structures within 20m; a metal culvert under County Rd. 4 and an old concrete bridge for rail line (no longer in use). Upstream</p>	<p>May 15, 2012 Aug. 1, 2012</p>

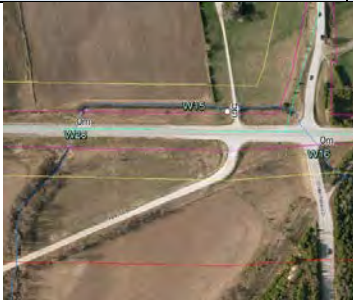
<p>W28 – 0m from underground electrical collection line in road right of way</p>	<p>Description of feature at W28: This feature passes under County Rd. 4 and under The Glen Road. No property access was provided, therefore survey was conducted from crossing at the Glen Road.</p> <p>Upstream of The Glen Road: Wetted depth at roadside = 0.43m Bankfull width = 1.5 – 2m Greater than 95% of substrate is fines/silt with random dispersal of cobble (<5%). Young of year fish and green frog observed.</p> <p>In stream cover provided by emergent vegetation. Overhanging vegetation upstream provides additional cover. Little cover available at roadside. Banks are stable. Narrow riparian (<5m) comprised of meadow plants, ash and maple; adjacent land use is agricultural.</p> <p>Downstream of The Glen Road: Bankfull width = 5m at roadside, 3m in channel Wetted width = 3m at roadside Wetted depth = 0.15m Substrate 80% cobble, 20% gravel. Large number of minnows observed. Perched culvert under low flow conditions obstructs fish movement. Narrow riparian (<10m) of meadow plants, ash and maple; adjacent land use is agricultural. Banks are stable. Water temperature = 20C (Aug 1, 2012)</p>	August 1, 2012

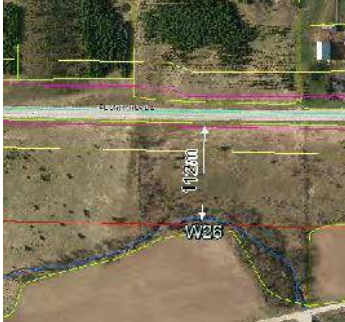
W26 – 112m from underground electrical collection line in road right of way;	Description of feature at W26: Upstream (south side of The Glen Road): Culvert buried Pool at roadside = 0.35m deep Wetted width = 2m Bankfull width = 6m Riparian comprised of cedar, ash, poplar and willow, (5-10m wide); adjacent landuse is agricultural. Young of year fish observed in channel. Banks are stable. Downstream (north side of The Glen Road): Bankfull width = 2.5m Substrate predominantly fines (80%), 10% boulder and 10%	August 1, 2012

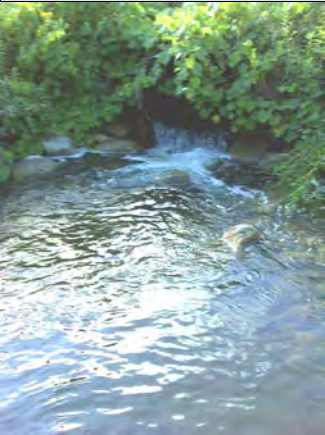
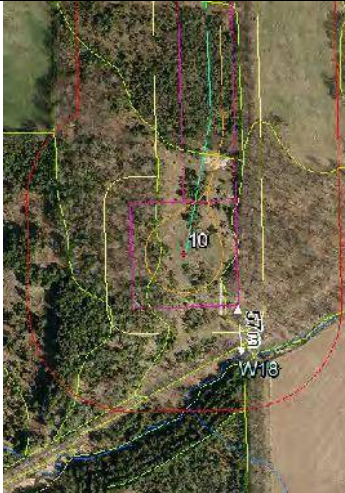
Description of feature at W18: Located adjacent to an old railway line in a valley. Steep slope from north to access the stream below. Stream is crossed by an unmaintained road with double culverts. Upstream: No property access was provided to portion of W18 upstream of the road crossing such that data was collected from roadside. Large pool (10m wide) on upstream side of farm lane. Fine substrates. Immediately adjacent to agricultural field. Riparian edge is	May 16, 2012

<p>Existing crossing of stream at W18 – unmaintained dirt road extends from Glen Road to Southline.</p>

<p>W18 - Double culverts convey water under road crossing downstream to sugar maple forest and forb meadow marsh.</p>	W18 – part of permanent stream

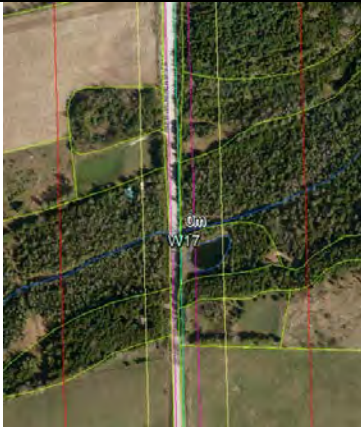
<p>W17 - 0m from underground electrical collection line in road right of way</p>	<p>Property access was not provided for the property where this feature was located and for that reason a roadside survey was conducted.</p> <p>Description of feature at W17: This feature is part of Durham Creek and is a permanent cold water stream that conveys water through a Coniferous swamp (dominated by tamarack and balsam fir with occasional black ash and red maple). Watercress was observed in the channel as evidence of groundwater seepage.</p> <p>Substrate mix of cobble and boulder. Large (>1m wide), deep plunge pool on downstream side resulting from perched culvert. Visible portion of channel beyond pool is riffle. Upstream is predominantly riffle. Wide riparian buffer that functions as a wildlife corridor. Abundant in-stream cover in the form of emergent vegetation and woody debris. Banks stable. Water temperature= 11C (May15, 2012), 11C (July 5, 2012). MNR fisheries records document Central Mudminnow, Brook Trout and Slimy Sculpin. Wetted width = 8m (May 15) Bankfull width = 10m Wetted depth = 0.3m (approx.)</p>	<p>May 15, 2012 July 5, 2012</p>

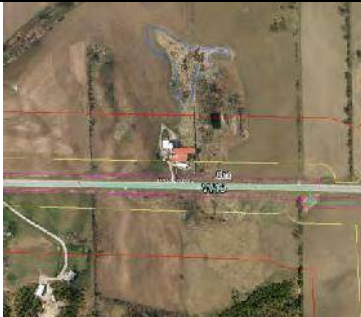
<p>W19 – 0m from underground electrical collection line in road right of way</p>	<p>Low spot in agricultural field with some cattail and other hydrophytic vegetation investigated during field surveys was determined not to meet the definition of a water body under O. Reg. 359/09.</p> <p>Water temperatures (9C) and vegetation suggest seepage on north side of road.</p>	<p>May 16, 2012</p>

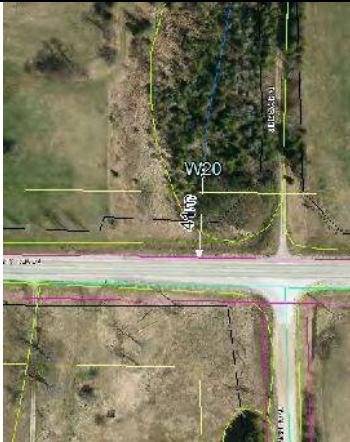
<p>W20 – 41m from underground electrical collection line in road right of way</p>	<p>Property access was not provided for the property where this feature was located and for that reason a roadside survey was conducted.</p> <p>Features investigated at the corner of Boot Jack Ranch Rd. and County 4 Rd. indicated that no open water was contained in roadside ditches and seasonal conveyance of water through culverts between small groupings of cattail vegetation suggests soils are saturated. This feature was determined to be dominated by hydrophytic vegetation; and, as such not a 'water body as defined under O.Reg. 359/09.</p>	<p>May 16, 2012 August 1, 2012</p>

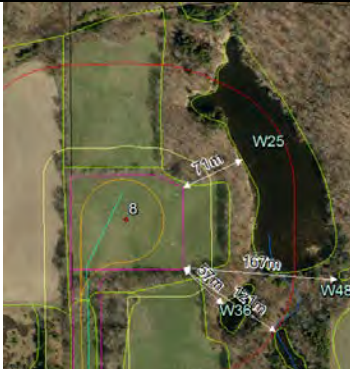
<p>W25 - 71m from Turbine 8 and associated access road and underground electrical collection.</p>	<p>This large feature is dominated by un-vegetated open water. A few trees of red maple (and yellow birch and shrubs consisting of red-osier dogwood and pussy willow occur along the edge or on elevated mounds within the pond. Horsetail, broad-leaved cattail, and lesser duckweed were common ground species that colonized the fringe. Beaver activity was noted around the pond. Midland painted turtle, snapping turtle, green heron, Abystomid egg masses, Canada goose, gray treefrog, Eastern gartersnake, Northern leopard frog, mink frog, green frog and small minnows observed at time of surveys. Abundant in-stream cover in the form of woody debris and vegetation. This feature was identified as providing several types of significant wildlife habitat through the NHA process. This feature is also included within the boundary of Beaver Meadow PSW and was addressed as such within the NHA (see mapping in Appendix B).</p>	<p>May 16, 2012 July 24, 2012</p>

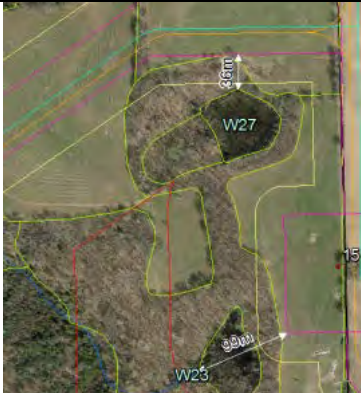
<p>W27 – 36m from Turbine 15 and associated access road and underground collection line.</p>	<p>This feature was identified as ELC unit 121 (a forb shallow marsh). This unit was dominated by marsh vegetation and was treated as a significant wetland feature and was addressed as such within the NHA (see mapping in Appendix B). W27 was determined not to conform to the definition of a ‘water body’ as outlined in O. Reg. 359/09.</p>	<p>May 15, 2012 June 15, 2012 July 5, 2012</p>

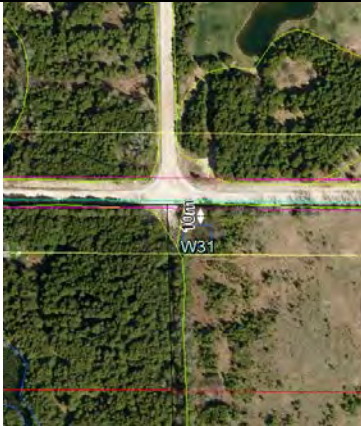
<p>W31 - 0m from underground electrical collection line in existing road right of way.</p>	<p>This feature (W31) was identified through Records Review and investigated further. Property access was not provided for the property where this feature was located and for that reason a roadside survey was conducted. No surface water feature was found at W31. The area consisted of open meadow vegetation with dogwood at the edges. No channel was found to lead into or out of the area along the two edges (Sideroad 40 and Concession 4 Rd.) that were surveyed. This feature was determined not to be a water body as defined under the REA process.</p>	<p>June 14, 2012</p>

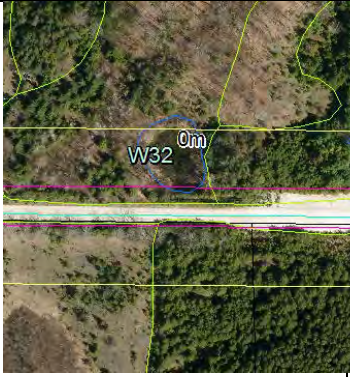
<p>Property access was not provided for the property where this feature was located and for that reason a roadside survey was conducted. This feature was determined during site investigation to be part of a balsam poplar and black ash deciduous swamp (ELC unit 293). Hydrophytic vegetation was dominant within the feature; therefore it was treated as a wetland and addressed within the NHA as a significant wetland (see mapping in Appendix B).</p> <p>W32 was determined not to meet the definition of a 'water body' as outlined in O. Reg. 359/09.</p>	June 14, 2012

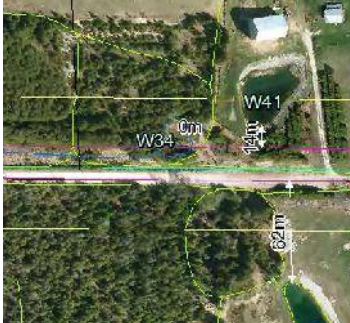
<p>W34 – 0m from underground electrical collection in road right of way.</p>	<p>Property access was not provided for the property where this feature was located and for that reason a roadside survey was conducted.</p> <p>This feature was determined during site investigation to be part of a white cedar coniferous swamp (ELC unit 410). Hydrophytic vegetation was dominant within the feature; therefore it was treated as a wetland and addressed within the NHA as a significant wetland (see mapping in Appendix B).</p> <p>W34 was determined not to meet the definition of a 'water body' as outlined in O. Reg. 359/09.</p>	June 14, 2012

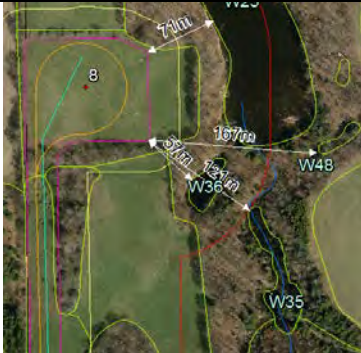
<p>W35 - 121m from Turbine 8 and associated access road and underground electrical collection.</p>	<p>Feature was determined to be greater than 120m from the final project location and not investigated further.</p>	<p>May 16, 2012 July 24, 2012</p>

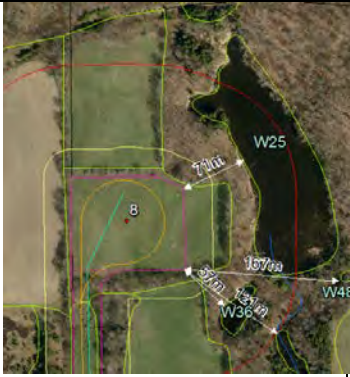
<p>W36 - 57m from Turbine 8, access road and underground electrical collection.</p>	<p>This feature was classified through site investigation as ELC unit 56 - Small pond with surface area dominated by duckweed (Lemna minor) in summer with small clusters of water parsnip, jewel weed, and sensitive fern along the edges. Surrounded by sugar maple ash deciduous forest. No fish observed within the pond. Size much reduced in summer condition. Gray tree frog, spring peeper, Canada goose, wood duck, Northern leopard frog, green frog, wood frog, Midland painted turtle observed during surveys. No fish documented in pond.</p> <p>This feature is included within the boundary of Beaver Meadow PSW and was addressed as significant wetland within the NHA (see mapping in Appendix B).</p>	May 16, 2012

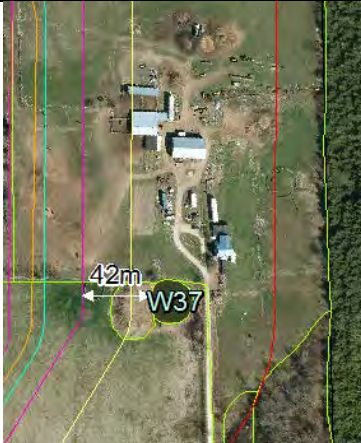
<p>W37 - 42m from access road and underground electrical collection line to Turbine 13</p>	<p>This feature was determined during site investigation to be a dugout pond. It was considered further within the NHA for the Project. W37 was determined not to meet the definition of a 'water body' as outlined in O. Reg. 359/09.</p>	<p>May 15, 2012</p>

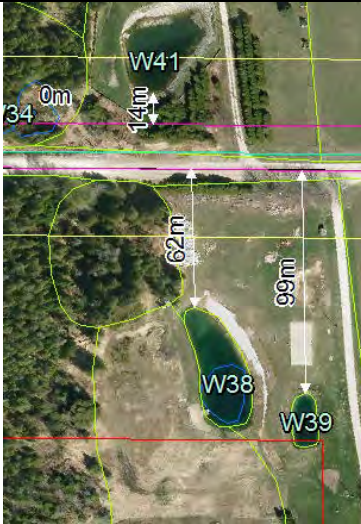
<p>W38 – 62m from underground electrical collection in road right of way.</p>	<p>This feature was determined during site investigation to be a dugout pond. It was considered further within the NHA for the Project and identified therein as significant wildlife habitat. W38 was determined not to meet the definition of a 'water body' as outlined in O. Reg. 359/09.</p>	<p>May 15, 2012</p>

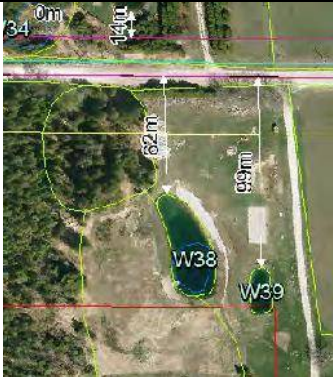
<p>W39 – 99m from underground electrical collection in road right of way.</p>	<p>This feature was determined during site investigation to be a dugout pond. It was considered further within the NHA for the Project and identified therein as significant wildlife habitat. W39 was determined not to meet the definition of a 'water body' as outlined in O. Reg. 359/09.</p>	<p>May 15, 2012</p>
