NextEra Energy Canada, ULC
Goshen Wind Energy Centre

DRAFT Water Assessment and Water Body Report

60155032

September, 2012

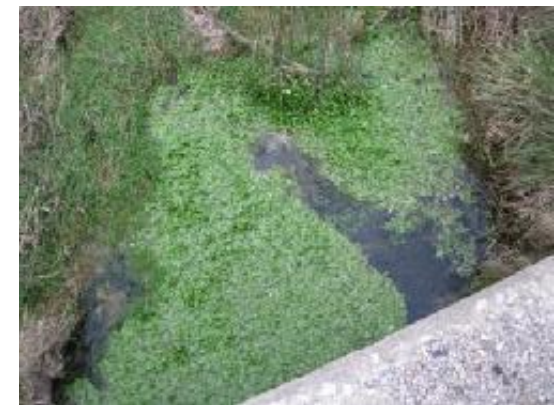
Photograph 3. Watercress ↑

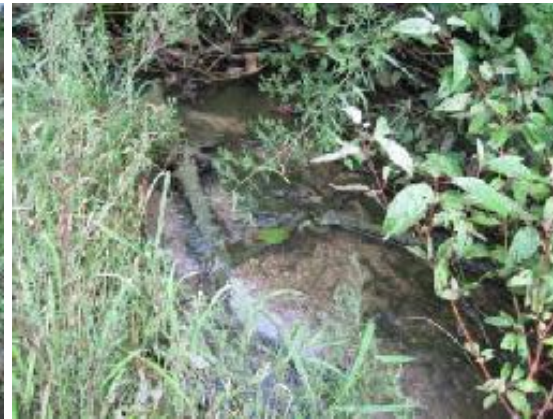
Photograph 2. Substrate ↑

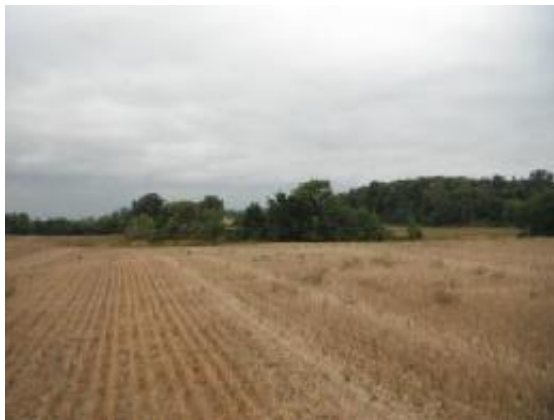
Feature ID	Project Component	Investigation Date	Description of Site	Feature Description	Feature Sensitivity
C7	• Turbine 11	September 13, 2011	<ul style="list-style-type: none"> The watercourse runs through cultural woodland (classified as CUW1e, ELC Feature ID 369) surrounded by crop agricultural fields with a riparian buffer of 3 m. Tile drain inputs were noted throughout the site. The surrounding topography is slightly rolling hills sloping towards the watercourse. 	<ul style="list-style-type: none"> The watercourse is a defined natural channel. The watercourse is mostly flat with some riffles and pools present. No visible flow was observed during the site visit and the watercourse is classified as intermittent by ABCA. The banks are unstable and evidence of slumping and erosion was noted throughout. Substrate was a mix of cobble, gravel and sand followed by clay and detritus. Canopy cover is high and dominated by trees. Instream habitat cover is moderate with cobble dominating followed by woody debris and boulders. Groundwater indicator iron staining was observed. 	Moderate

Photograph 1. Site overview ↑

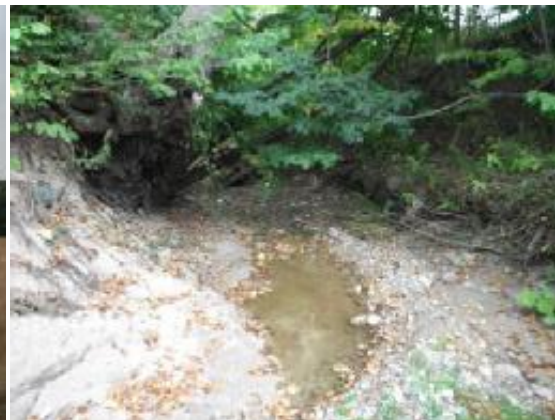
Photograph 2. Channel view ↑

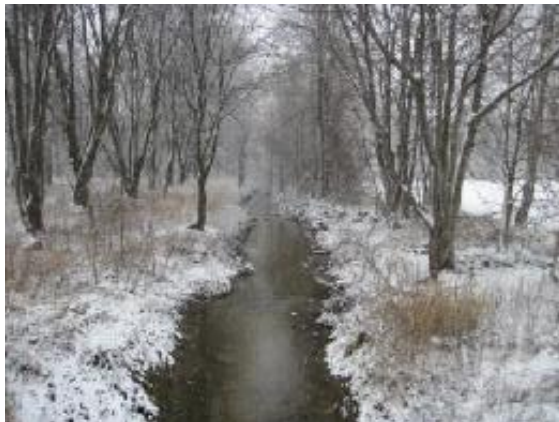
Feature ID	Project Component	Investigation Date	Description of Site	Feature Description	Feature Sensitivity
C33	<ul style="list-style-type: none"> Collection Line Crossing 	December 9, 2011	<ul style="list-style-type: none"> The watercourse flows a mix of deciduous forest and swamp (classified as FOD7-4, SWD3-3, ELC Feature ID 309) and adjacent crop agricultural field, under Huron Street, emerging in a crop agricultural field. The surrounding topography was flat. There were multiple tile drain inputs and one flowing watercourse observed to be feeding into the main channel approximately 80 m from Huron Street. Riparian buffer is 5 m on the right bank and 30 m on the forested left bank. 	<ul style="list-style-type: none"> The watercourse is a defined channelized feature, and is classified as a permanent warm water system by ABCA. It is a straight channel that is uniform run. The water was clear and had a moderate flow at the time of investigation. The banks are stable and vegetated. Substrate is dominated by sand followed by gravel and clay and then detritus. Canopy cover is high and dominated by trees then shrubs and grasses. Instream habitat cover is low and dominated by leaf detritus followed by woody debris and aquatic vegetation. Groundwater indicator watercress was noted. Upstream fish species consist of baitfish community (MNR, 1995). 	Moderate

Photograph 1. Site overview ↑

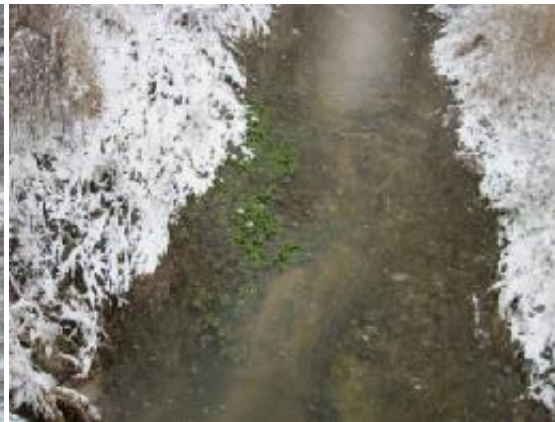
Photograph 2. Channel view ↑

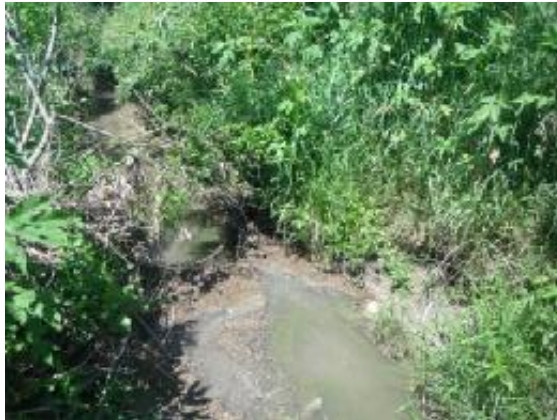
Feature ID	Project Component	Investigation Date	Description of Site	Feature Description	Feature Sensitivity
C89	<ul style="list-style-type: none"> • Turbine 42 • Collection Line Buffer • Road Buffer 	July 13, 2011 September 8, 2011	<ul style="list-style-type: none"> • The watercourse flows along cultural woodland to the edge of a deciduous forest (classified as CUW1c, FOD9-4, ELC Feature ID 206) surrounded by agricultural fields. No tile drain inputs were noted. The surrounding topography is flat. Riparian buffer is 3.5 m along the agricultural field and greater than 3.5 m in the forest area. 	<ul style="list-style-type: none"> • The watercourse is a defined natural feature. There is little morphological diversity- only run or flats. The water was clear and water was slow flowing at time of investigations. It is classified as a permanent warm water system by ABCA. The banks are slightly unstable with evidence of slumping noted. Substrate consists of silty sand with gravel, muck and cobble. Canopy cover is moderate and is a mix of grasses, shrubs and trees. Instream habitat cover is moderate and is a mix of aquatic vegetation, cobble, and woody debris. No groundwater indicators were noted. 	Moderate

Photograph 1. Channel overview ↑

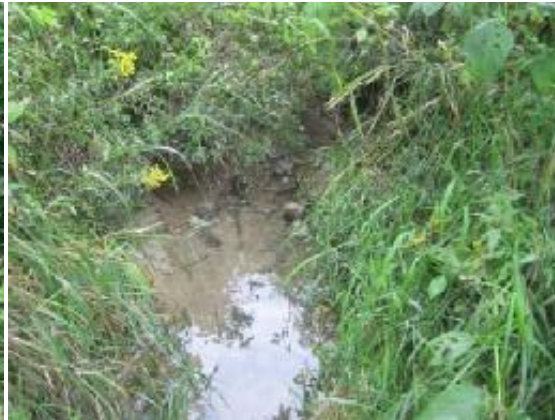
Photograph 2. Channel overview ↑

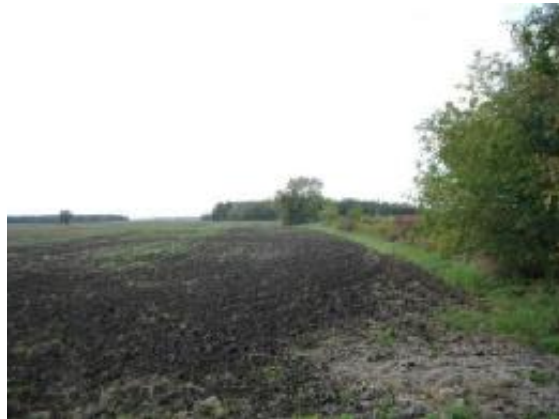
Feature ID	Project Component	Investigation Date	Description of Site	Feature Description	Feature Sensitivity
C42	<ul style="list-style-type: none"> Collection Line Crossing 	September 27, 2011	<ul style="list-style-type: none"> The watercourse flows through a deciduous forest (classified as FOD6-1, FOD7-2, ELC Feature ID 266), crosses Blackbush Line and continues into a crop agricultural field. No tile drain inputs observed and surrounding topography is flat. Riparian buffer is 1 m in agricultural field and greater than 5 m in the forest area. 	<ul style="list-style-type: none"> The watercourse flows through two distinct land use areas and as a result has differing characteristics throughout (forest and agricultural field). Overall the watercourse is classified as a permanent warm water system by ABCA. The section of watercourse running through the forest area is a defined natural channel. The banks are stable and substrate consists of silt muck and detritus. Canopy cover is high and is dominated by trees. Instream cover is low and dominated by woody debris. No groundwater indicators observed. The section of watercourse running through the agricultural field is a defined channelized feature. The banks are stable and substrate consists of silt and clay. Canopy cover is high and dominated by shrubs followed by grasses. Instream cover moderate and dominated by aquatic vegetation. Groundwater indicator watercress observed. Downstream fish species consists of a baitfish community (MNR, 1995). 	Moderate

Photograph 1. Site overview ↑

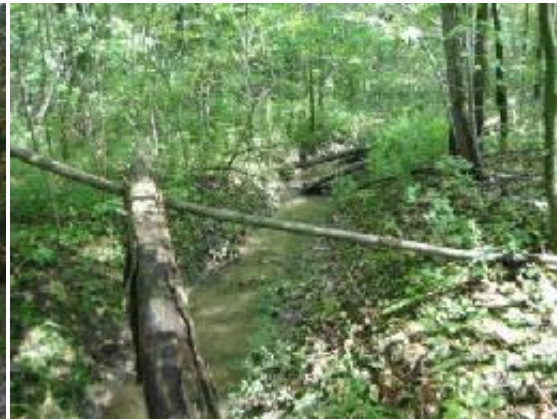
Photograph 2. Channel overview forest ↑

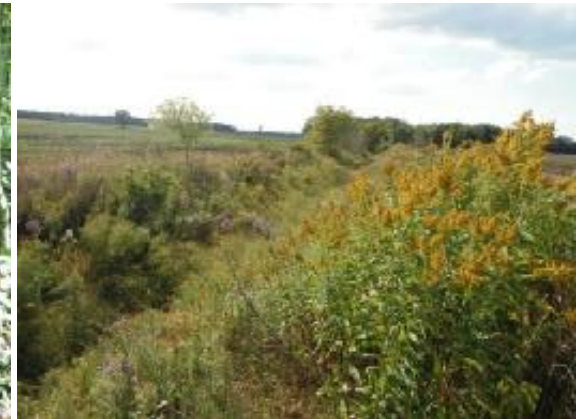
Photograph 3. Channel overview agricultural field ↑

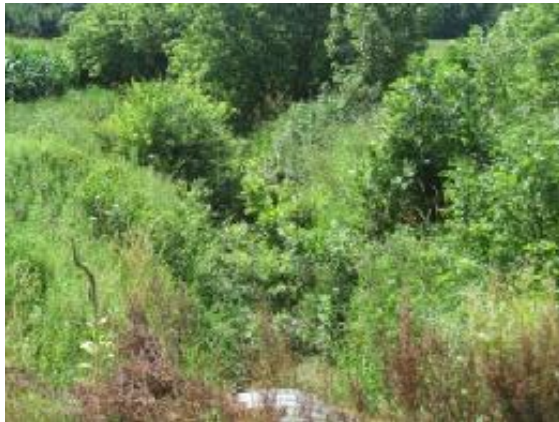
Feature ID	Project Component	Investigation Date	Description of Site	Feature Description	Feature Sensitivity
C43	<ul style="list-style-type: none"> Turbines 20 and 66 Collection Line Crossing 	July 27, 2011	<ul style="list-style-type: none"> The watercourse runs through a crop agricultural field into a deciduous forest (classified as FOD7-2, ELC Feature ID 267) north of Kirkton Road. No tile drain inputs were noted and the surrounding area is flat. The riparian buffer in the agricultural fields is 3 m. 	<ul style="list-style-type: none"> The watercourse is a defined channelized feature. There is a slight meander with a riffle run pool sequence. The water was slightly turbid and had a slow flow during the time of investigation. It is classified as a permanent warm water system by ABCA. The banks are stable to slightly unstable. Substrate consists of silt and clay followed by gravel, sand, cobble and boulder. Canopy cover is high and a mix of grasses and trees. Instream habitat cover is moderate and a mix of undercut bank, woody debris, aquatic vegetation, cobble and boulder. Groundwater indicator watercress was noted. Fish were observed during time of investigation. Downstream and upstream fish species consists of a baitfish community and Rock Bass (MNR, 1980, 1981, 1994). 	Moderate

Photograph 1. Site overview agricultural field ↑

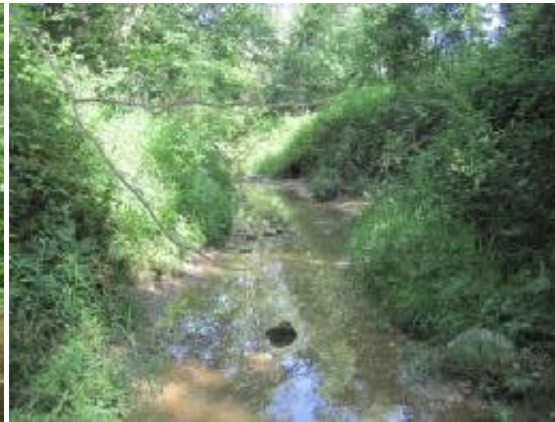
Photograph 2. Channel overview forest ↑

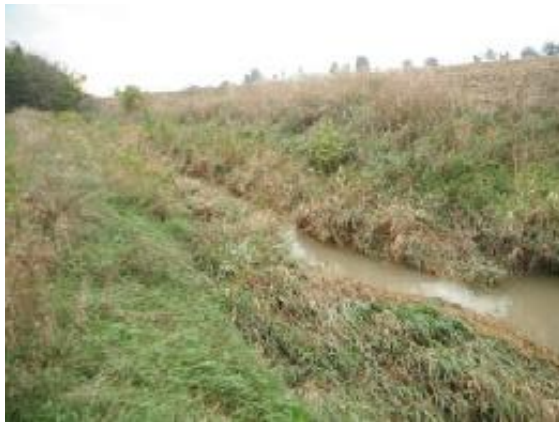
Feature ID	Project Component	Investigation Date	Description of Site	Feature Description	Feature Sensitivity
C46	• Turbine 16	July 27, 2011	<ul style="list-style-type: none"> • The watercourse flows through a crop agricultural field that has a 1 m riparian buffer, into deciduous forest (classified as FOD7-1, ELC Feature ID 258). Tile drain inputs were observed throughout the agricultural field area. The surrounding landscape has slightly rolling hills. • The morphology of the watercourse changes as it moves from agricultural field into forest and will be described separately in the feature description. 	<ul style="list-style-type: none"> • The watercourse is a defined feature that begins as channelized then moves into a natural feature. In both portions of the stream it is uniform run with no obvious riffles or pools. The water was turbid and had some flow during site investigations. It is classified as a permanent warm water feature by ABCA. The banks are stable in the agricultural field, but slightly unstable in the forest. Substrate is a mix of gravel, sand, silt and clay with some cobble, boulder and detritus. Canopy cover is low in the agricultural field, but high in the forest and dominated by trees. Instream habitat cover is low in the agricultural field consisting of cobble and aquatic vegetation, but moderate in the forest which consists of woody debris followed by undercut bank, boulder and cobble. No groundwater indicators were noted. Fish observed in the forest area during site investigation in July. Upstream fish species consist of a baitfish community (MNR, 1981, 2007). 	Moderate

Photograph 1. Site overview agricultural field ↑

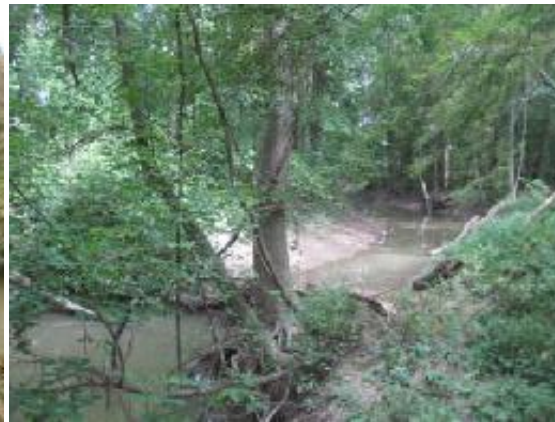
Photograph 2. Site overview forest ↑

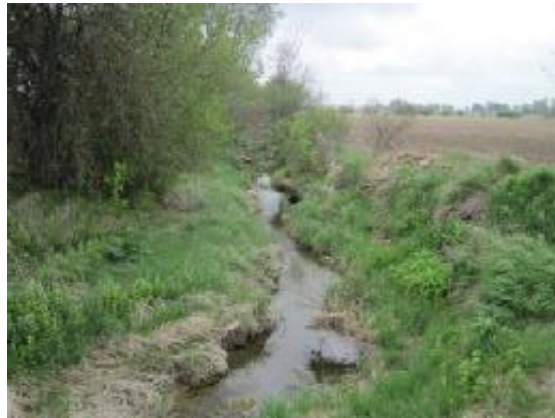
Photograph 1. Site overview ↑

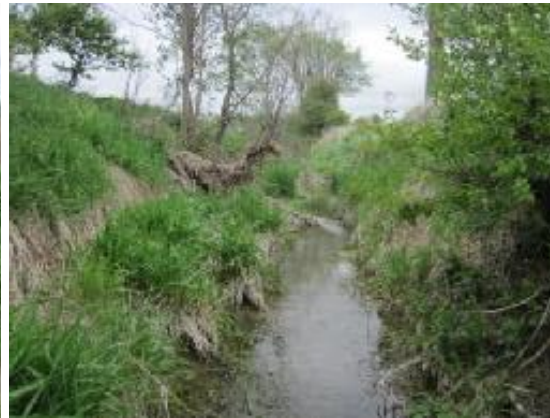
Photograph 2. Channel overview ↑

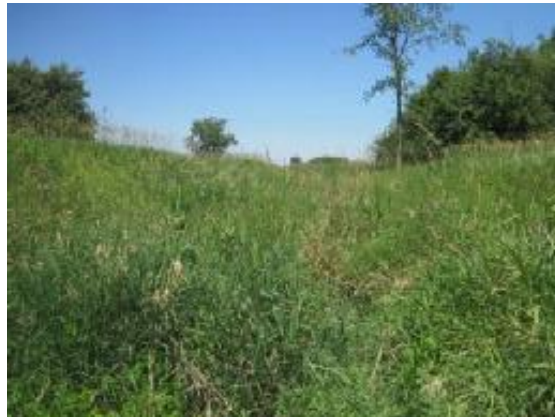
Feature ID	Project Component	Investigation Date	Description of Site	Feature Description	Feature Sensitivity
D38	<ul style="list-style-type: none"> Transmission Line Crossing 	July 12, 2012	<ul style="list-style-type: none"> The watercourse flows through cultural meadow (classified as CUM1-1, ELC Feature ID 648) surrounded by soybean fields. No tile drain inputs were observed. D39 flows into watercourse. The surrounding topography is sloped towards the watercourse. Riparian buffer is 20 m of cultural meadow (CUM1-1). 	<ul style="list-style-type: none"> The watercourse is a defined channelized feature that appears to be naturalizing. The watercourse is mainly flat with some riffles present. The water was clear and had low flow at the time of investigation, however it is classified as an intermittent system by ABCA. The banks are slight unstable with signs of erosion and undercut banks. Substrate consists of silt followed by gravel and cobble. Canopy cover is moderate and is dominated by grasses. Instream habitat cover is low and consists of cobble and aquatic vegetation followed by undercut banks. Small pockets of groundwater indicator watercress were observed. Downstream and upstream fish species consist of a baitfish community (ABCA, 2009; MNR, 1980). 	Moderate

Photograph 1. Site overview ↑

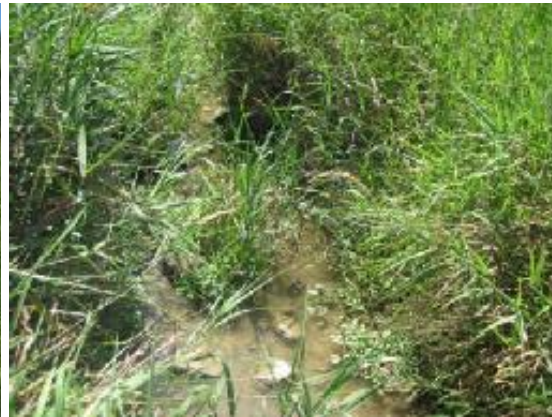
Photograph 2. Channel view ↑

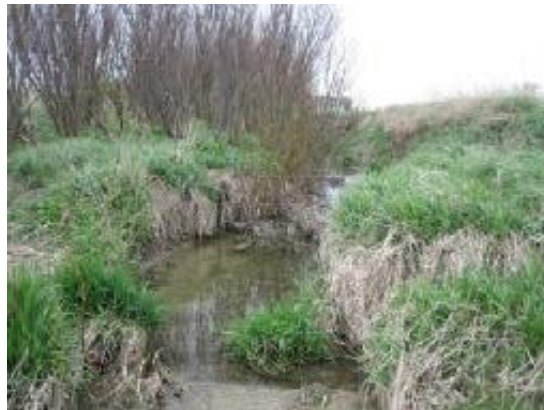
Feature ID	Project Component	Investigation Date	Description of Site	Feature Description	Feature Sensitivity
C52	<ul style="list-style-type: none"> Collection Line Crossing Road Crossing Turbine 86 	September 28, 2011 December 16, 2011 April 26, 2012	<ul style="list-style-type: none"> The watercourse is surrounded by crop agricultural fields and crosses Blackbush Line. The northwestern reach is at the edge of deciduous swamp (classified as SWD2-2, ELC Feature ID 249). No tile drain inputs were observed. The surrounding topography is flat. Riparian buffer is 1.5 to 5 m. 	<ul style="list-style-type: none"> The watercourse is a defined channelized feature that appears to be naturalizing. The water was turbid and had a moderate flow during the time of first two site investigations. The water was clear and had low flow in April. The system is classified as a permanent warm water system by ABCA. Banks are slightly unstable. Substrate consists of silt, sand with gravel followed by clay, cobble and boulder. Canopy cover is moderate and is a mix of shrubs, trees and grasses. Instream habitat cover is moderate consisting of aquatic vegetation and woody debris. Groundwater indicator watercress was noted. An obstruction to fish passage exists at a man-made crossing of concrete dumped into the watercourse. A low flow barrier exists in the form of vehicles driving straight through the watercourse. Upstream fish species consists of baitfish community (MNR, 1981, 2007). 	Moderate

Photograph 1. Site overview ↑

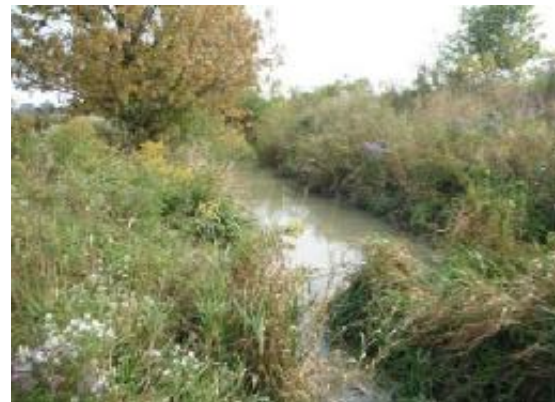
Photograph 2. Channel overview ↑

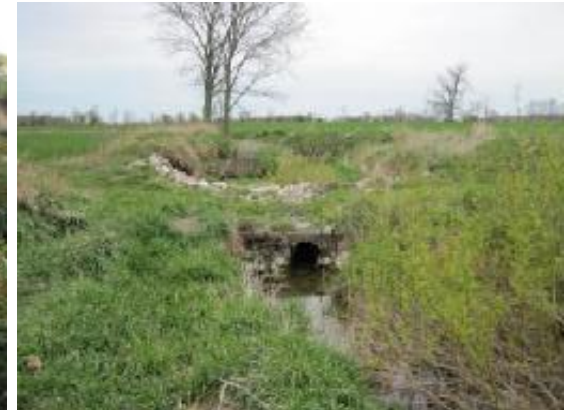
Photograph 3. Potential barrier ↑

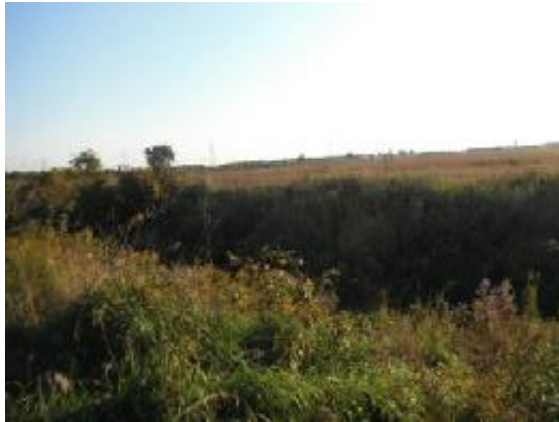
Feature ID	Project Component	Investigation Date	Description of Site	Feature Description	Feature Sensitivity
C139	• Collection Line Crossing	October 6, 2011 November 18, 2011	• The watercourse flows through a crop agricultural field with a 1.5 m riparian buffer of cultural meadow (CUM1-1). Tile drains input were noted throughout the site. Surrounding topography is flat with a little sloping from the southwest.	• The watercourse is a defined channelized feature. There was low morphological diversity as the channel was only classified as run. The water was turbid and there was moderate flow during the time of investigations. It is classified as a permanent warm water system by ABCA. The banks are slightly unstable but vegetated. Substrate consists of silt clay followed by muck and detritus. Canopy cover is low consisting of trees, shrubs and grasses. Instream habitat cover is low and dominated by aquatic vegetation followed by woody debris and undercut banks. No groundwater indicators were noted. Upstream fish species consist of baitfish community (MNR, 1995).	Moderate

Photograph 1. Site overview ↑

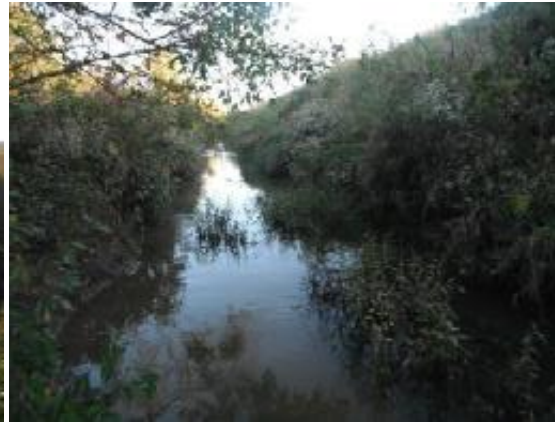
Photograph 2. Channel overview ↑

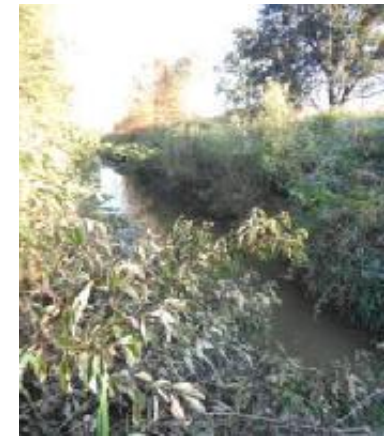
Photograph 3. Channel overview ↑

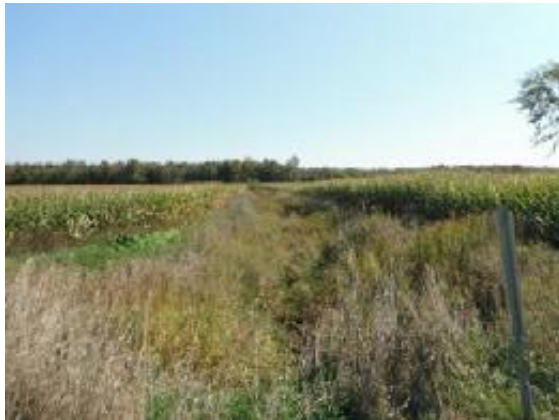
Photograph 1. Site overview ↑

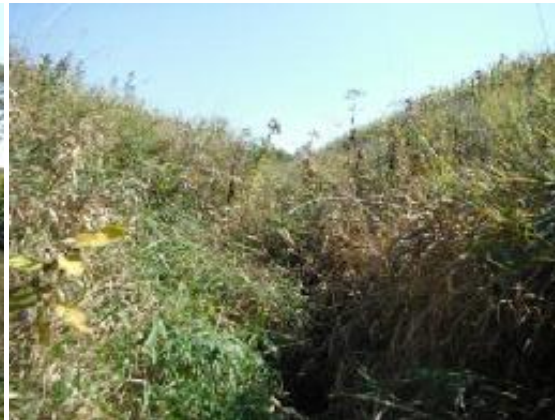
Photograph 2. Channel overview ↑

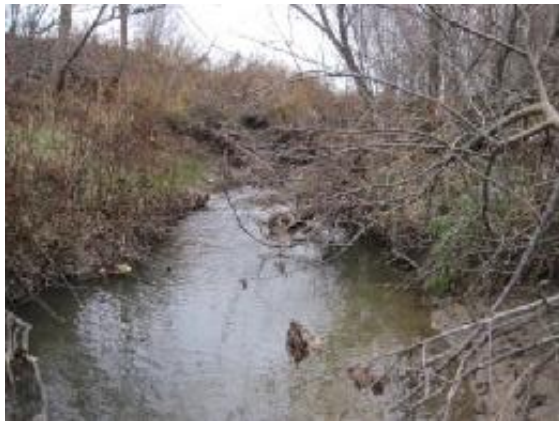
Feature ID	Project Component	Investigation Date	Description of Site	Feature Description	Feature Sensitivity
C66	<ul style="list-style-type: none"> Collection Line Buffer Road Buffer 	November 17, 2011	<ul style="list-style-type: none"> The watercourse flows through cultural thicket (classified as CUT1i, ELC Feature ID 210) surrounded by crop agricultural field with a 2 m riparian buffer. No tile drain inputs were observed. Surrounding topography is flat. 	<ul style="list-style-type: none"> The watercourse is defined channelized feature. The channel may be naturalizing as there are riffle, run, pool sequences is present. The water was clear and had moderate flow during time of investigation. It is classified as a permanent warm water system by ABCA. Banks are moderately unstable with exposed soils and evidence of slumping. Substrate consists of sandy silty clay with gravel. Canopy cover is moderate and is a mix of trees, grasses and shrubs. Instream habitat cover is moderate and dominated by woody debris followed by undercut banks. No groundwater indicators were noted. Upstream fish species consists of a baitfish community (ABCA, 1999). 	Moderate

Photograph 1. Channel overview ↑

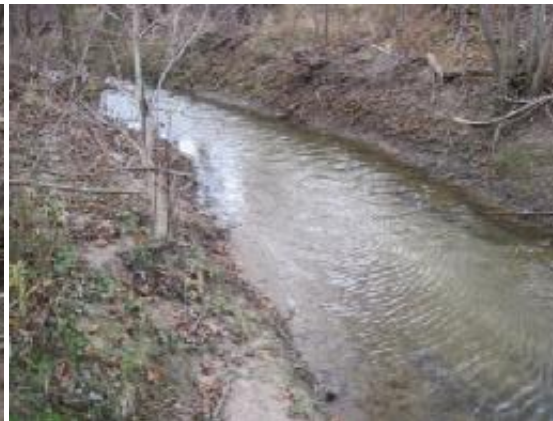
Photograph 2. Channel overview ↑

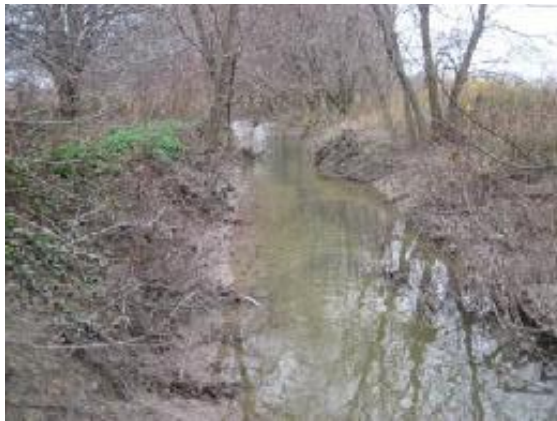
Feature ID	Project Component	Investigation Date	Description of Site	Feature Description	Feature Sensitivity
C67	<ul style="list-style-type: none"> Collection Line Crossing Turbine 57 	November 17, 2011	<ul style="list-style-type: none"> The watercourse flows through a deciduous forest (classified as FOD7-2, ELC Feature ID 198) surrounded by crop agricultural field with a 2 m riparian buffer. Tile drain inputs were observed. Surrounding topography is flat. 	<ul style="list-style-type: none"> The watercourse is a defined channelized feature. A riffle, run, pool sequences occur in the reach. The water was slightly turbid and had visible flow. It is a permanent warm water system by ABCA. Banks are slightly to moderately unstable with scouring and exposed tree roots present. Substrate is dominated by sand followed by gravel and clay. Canopy cover is high and dominated by trees followed by shrubs, grasses and herbaceous vegetation. Instream habitat cover is low and dominated by woody debris followed by undercut banks. No groundwater indicators were observed. Upstream fish species consist of a baitfish community (ABCA, 1999). 	Moderate

Photograph 1. Channel overview ↑

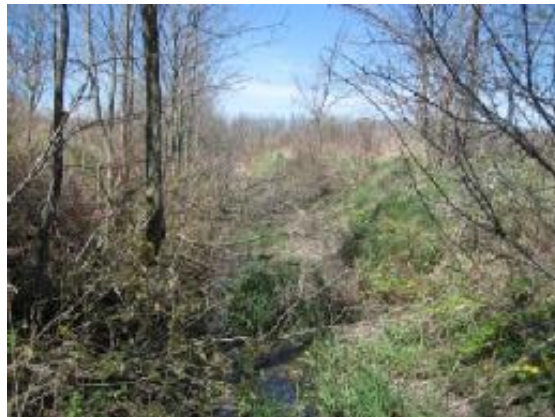
Feature ID	Project Component	Investigation Date	Description of Site	Feature Description	Feature Sensitivity
D44	<ul style="list-style-type: none"> Collection Line Buffer Turbine 63 	April 18, 2012	<ul style="list-style-type: none"> The watercourse is located in a crop agricultural field with a 1 m riparian buffer of cultural meadow (CUM1-1). No tile drain inputs were observed. Surrounding topography is flat. 	<ul style="list-style-type: none"> The watercourse is a defined channelized feature. The watercourse is straight flat channel. The water was clear and stagnant during the time of investigation. The system is classified as intermittent by ABCA. Banks are stable and vegetated. Substrate consists of sand and silt. Canopy cover is high and is dominated by shrubs, followed by trees and grasses. Instream habitat cover is moderate and consists of aquatic vegetation and detritus followed by woody debris. Groundwater indicator watercress was observed. Small fish were observed at time of investigation. 	Moderate

Photograph 1. Site overview ↑

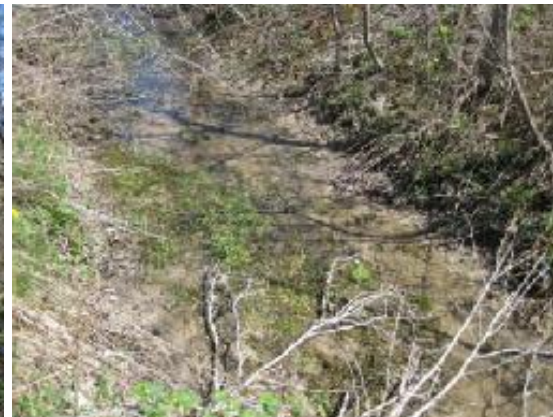
Photograph 1. Channel overview ↑

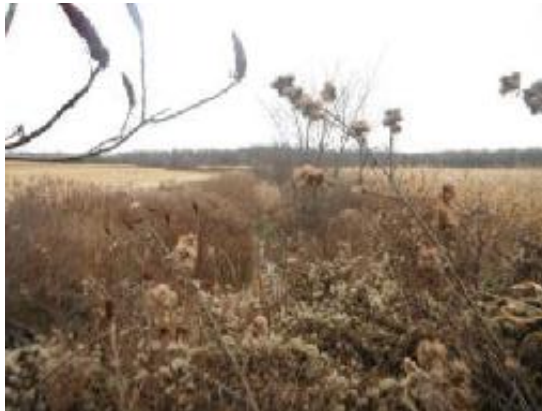
Feature ID	Project Component	Investigation Date	Description of Site	Feature Description	Feature Sensitivity
C124	<ul style="list-style-type: none"> Collection Line Crossing Road Buffer Turbine 22 	September 27, 2011 November 18, 2011	<ul style="list-style-type: none"> The watercourse begins with a crop agricultural field to the north and a mix of deciduous swamp and forest (classified as FOD4e, SWD2-2, ELC Feature ID 266) to the south. The watercourse continues to flow in crop agricultural fields after the forest area. Tile drain inputs were observed in the agricultural fields. Surrounding topography is flat. Riparian buffer in the agricultural fields is 2 m and is greater than 15 m in the forest area. 	<ul style="list-style-type: none"> The watercourse is a defined channelized feature. The watercourse is mainly flat with some riffles, runs and pools present. The water was clear and had moderate flow during the time of investigations, however it is classified as intermittent by ABCA. Banks are slightly unstable with evidence of erosion. Substrate consists of silt, clay, sand followed by gravel, cobble and boulders. Canopy cover is high in the forest and dominated by trees and shrubs. Canopy cover is moderate in the agricultural field and is dominated by grasses and shrubs. Instream habitat cover is moderate consisting of mainly aquatic vegetation followed by detritus and woody debris. Groundwater indicator watercress was observed. 	Moderate

Photograph 1. Site overview ↑

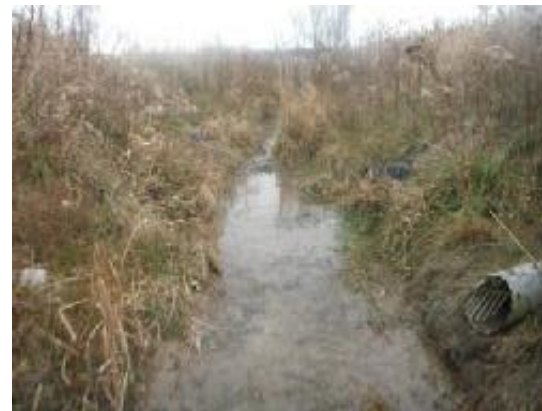
Photograph 2. Channel overview agricultural fields ↑

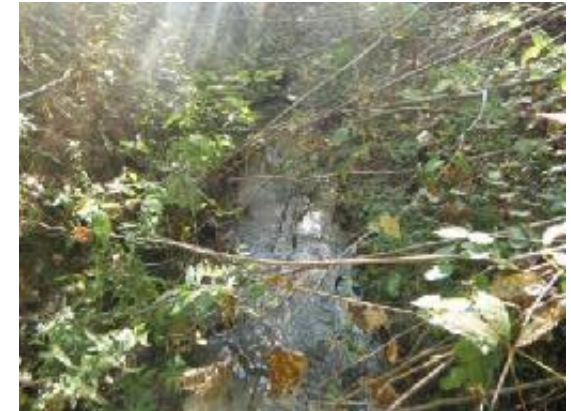
Photograph 3. Channel view forest ↑

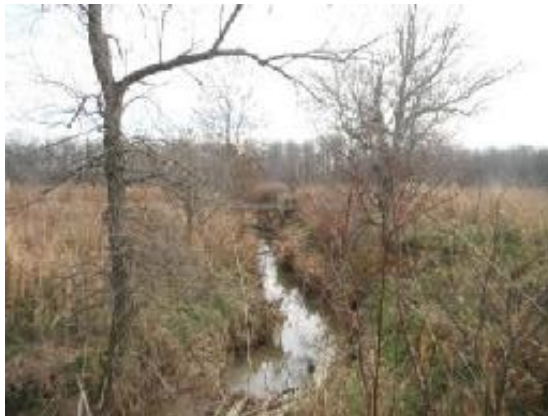
Feature ID	Project Component	Investigation Date	Description of Site	Feature Description	Feature Sensitivity
C137	Collection Line Crossing	November 18, 2011	<ul style="list-style-type: none"> The watercourse begins in mix of deciduous forest, meadow marsh, cultural meadow, deciduous swamp and cultural thicket (classified as FOD9b, FOD7-2, MAM2-2, CUM1-1, CUT1h, SWD2-2, ELC Feature ID 236) emerging into agricultural fields. No tile drain inputs were noted during time of investigation. Surrounding topography is flat with a slight slope from the east. 	<ul style="list-style-type: none"> The watercourse is a defined channelized feature. A riffle, run sequences occurs in the reach. The water was turbid and had slow flow during the time of investigation. It is classified as a permanent warm water system by ABCA. Banks are slightly to moderately unstable with exposed soils and evidence of erosion. Substrate consists of silt followed by clay, silt and sand followed by gravel. Canopy cover is high in the forest area dominated by trees and is moderate in the agricultural field dominated by grasses and shrubs. Instream habitat cover is low in the forest area consisting of woody debris and moderate in the agricultural field consisting of undercut banks followed by woody debris. No groundwater indicators were observed. Downstream fish species consist of a baitfish community, Brown Bullhead (<i>Ameiurus nebulosus</i>), Rainbow Trout and Northern Pike (ABCA, 2001; MNR 2003). 	Moderate

Photograph 1. Site overview agricultural field ↑

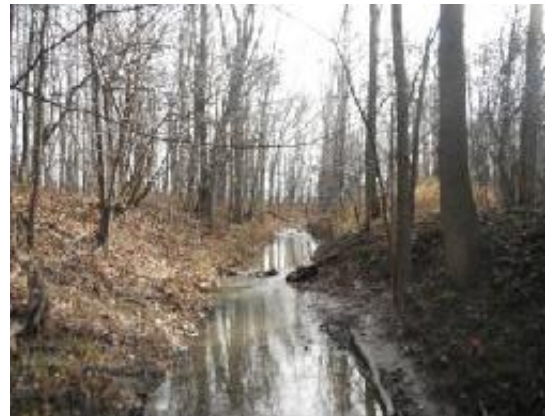
Photograph 2. Site overview forest ↑

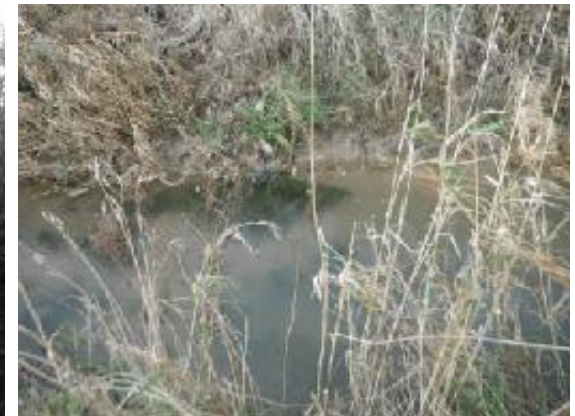
Photograph 3. Channel view ↑

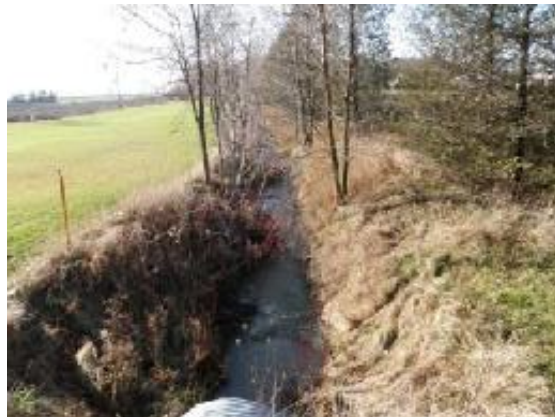
Photograph 1. Site overview ↑

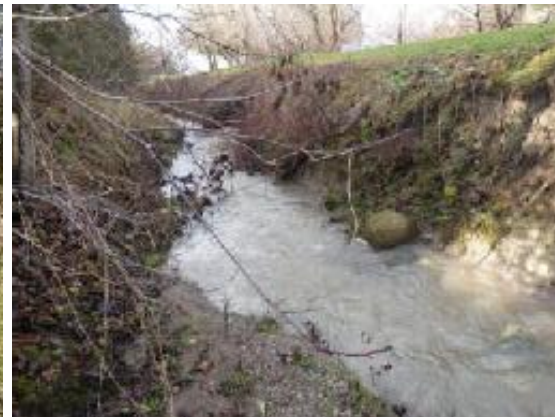
Photograph 2. Channel overview ↑

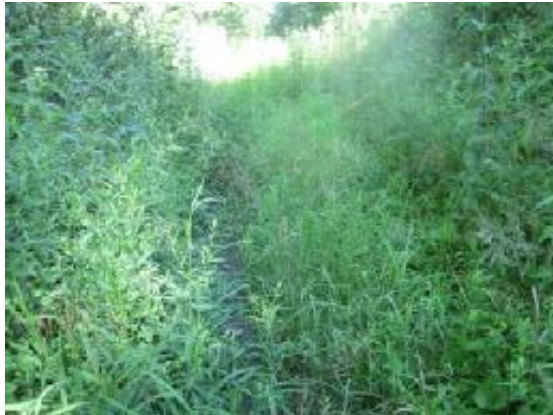
Feature ID	Project Component	Investigation Date	Description of Site	Feature Description	Feature Sensitivity
D57	• Turbine 85	July 25, 2012	<ul style="list-style-type: none"> The watercourse is located in a mix of deciduous forest and cultural meadow (classified as FOD6-4, CUM1-1, ELC Feature ID 271) surrounded by corn fields. No tile drain inputs were observed at time of investigation. Surrounding topography is flat. Riparian buffer is greater than 5 m of deciduous forest and cultural meadow. 	<ul style="list-style-type: none"> The watercourse is a defined channelized feature that is starting to naturalize. The watercourse has a straight flat channel. The watercourse was dry with some isolated pools present at the time of investigation. It is classified as an intermittent water system by ABCA. Banks are slightly unstable with exposed soils. Substrate consists of clay, silt and sand followed by gravel, cobble and boulders. Canopy cover is moderate and dominated by trees. Instream habitat cover is moderate and consists of cobble followed by aquatic vegetation and boulders. Groundwater indicator watercress was present in small isolated clumps. 	Moderate

Photograph 1. Site overview ↑

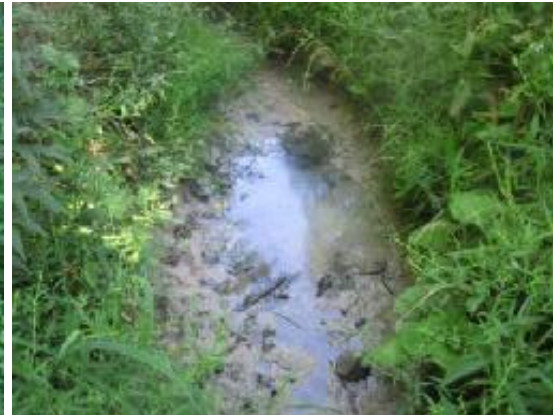
Photograph 2. Channel view ↑

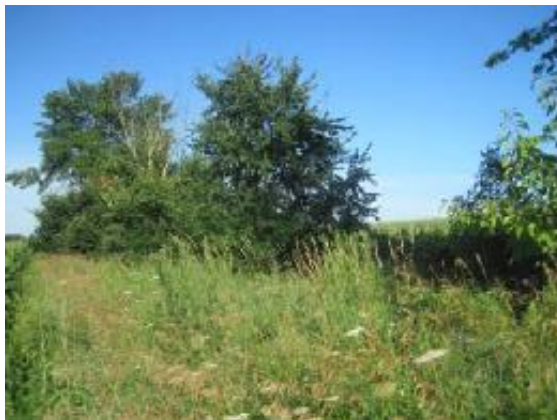
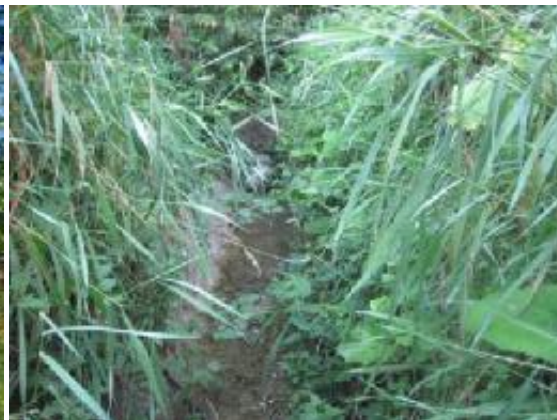
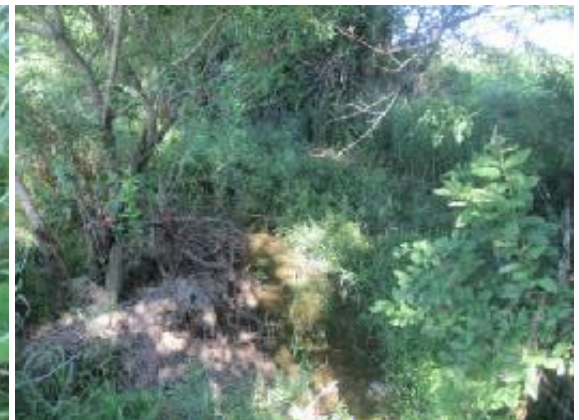
Feature ID	Project Component	Investigation Date	Description of Site	Feature Description	Feature Sensitivity
C15	<ul style="list-style-type: none"> Road Buffer Collection Line Crossing Turbine 13 	July 27, 2011	<ul style="list-style-type: none"> The watercourse flows from a deciduous forest (classified as FOD5-2, ELC Feature ID 352) into a crop agricultural field. No tile drain inputs were observed at time of investigation. Surrounding land topography is flat. Riparian buffer is 1 m consisting of trees and grasses. 	<ul style="list-style-type: none"> The watercourse is a defined channelized feature. Overall the channel straight uniform with some pools present. Water was clear and slow flowing at time of investigation. It is classified as a permanent warm water system by ABCA. Banks are stable and well vegetated. Substrate consists of silt and clay followed by sand, gravel, cobble and boulder. Canopy cover is high consisting of grasses and trees. Instream habitat cover is high and dominated by aquatic vegetation followed by cobble and boulders. Groundwater indicator watercress was observed. A few fish were observed during time of investigation. 	Moderate

C15
MWD(m)	0.15
MBD(m):	0.3

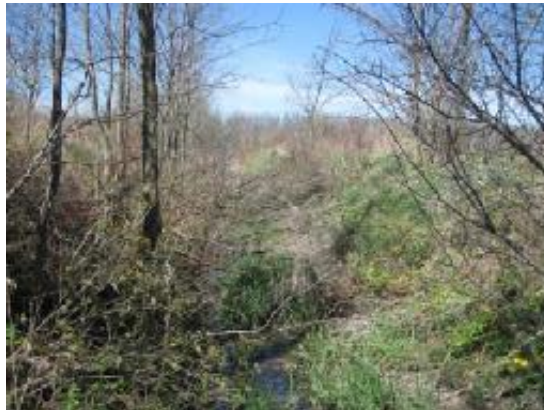
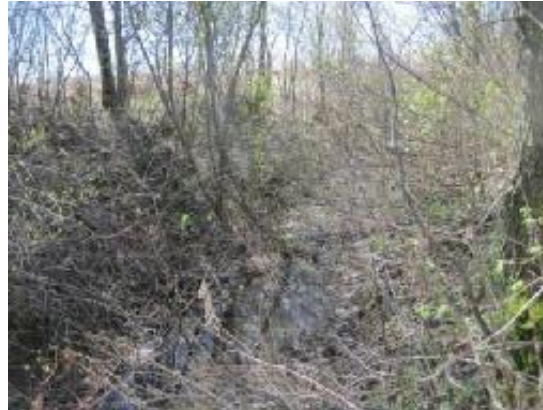
Feature ID	Project Component	Investigation Date	Description of Site	Feature Description	Feature Sensitivity
C74	<ul style="list-style-type: none"> Collection Line Crossing Road Crossing Turbine 60 MET Tower Buffer 	July 13, 2011 April 18, 2012	<ul style="list-style-type: none"> The watercourse flows through a soybean field to the south and wheat field to the north. No tile drain inputs were noted during time of investigation. Surrounding topography is flat. Riparian buffer is 3 m of cultural meadow (CUM1-1) consisting of trees, shrubs and grasses. 	<ul style="list-style-type: none"> The watercourse is a defined channelized feature. There was no flow during the time of investigation. It is classified as intermittent system by ABCA. Banks are stable and vegetated. Substrate consists of silt and sand. Canopy cover is high consisting of shrubs, trees and grasses. Instream habitat cover is moderate and consists of aquatic vegetation, detritus and woody debris. Groundwater indicator watercress was observed. Minnows were observed during time of investigation in April. 	Moderate

C74
MWD(m):	0.05
MBD(m):	0.6

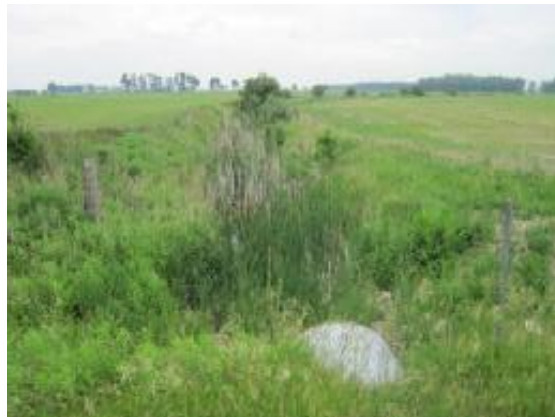
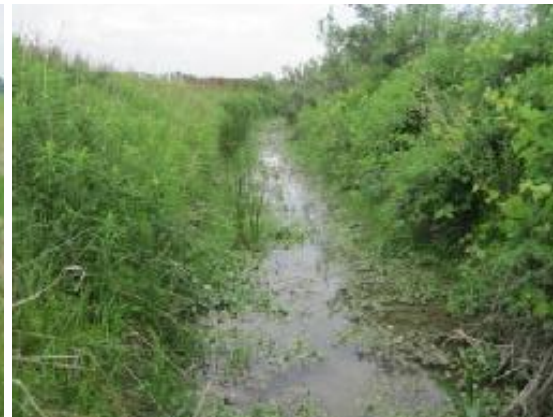
Feature ID	Project Component	Investigation Date	Description of Site	Feature Description	Feature Sensitivity
D43	<ul style="list-style-type: none"> Collection Line Crossing 	June 11, 2012	<ul style="list-style-type: none"> The watercourse begins at Crediton Road and flows south through soybean fields. Tile drain inputs were noted at time of investigation with one flowing. Surrounding topography is flat. Riparian buffer is less than 0.5 m of cultural meadow (CUM1-1). 	<ul style="list-style-type: none"> The watercourse is a defined channelized feature. The watercourse is a straight flat channel with some pools present. The water was slightly turbid and had slow flow at time of investigation. It is classified as an intermittent system by ABCA. Banks are stable and well vegetated. Substrate consists of muck, silt and clay followed by sand. Canopy cover is moderate and consists of grasses, shrubs and some trees. Instream habitat cover is high and consists of aquatic vegetation followed by vegetation debris. Groundwater indicator water speedwell was observed. 	Moderate

D43
MWD(m):	0.15
MBD(m):	0.5

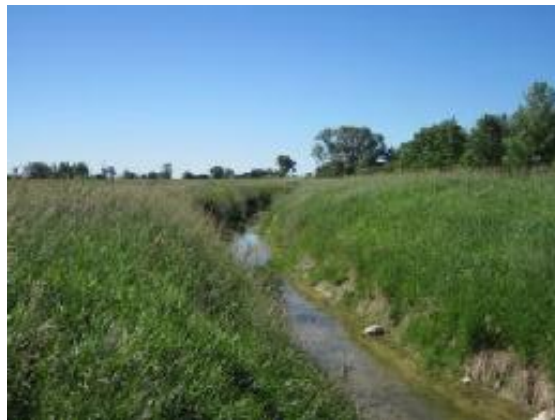
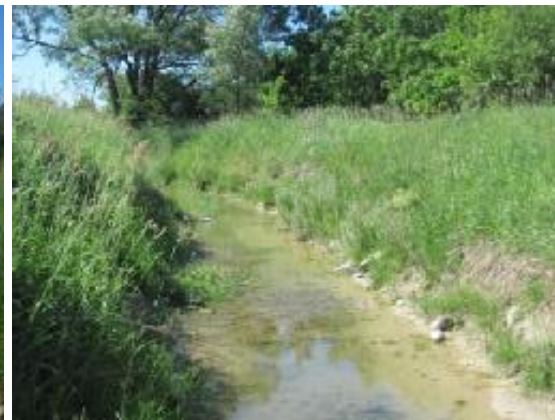
Feature ID	Project Component	Investigation Date	Description of Site	Feature Description	Feature Sensitivity
D37	• Transmission Line Crossing	June 13, 2012	<ul style="list-style-type: none"> The watercourse flows through a 15 m cultural meadow and cultural thicket (classified as CUT1j, CUM1-1, ELC Feature ID 635) riparian buffer surrounded by agricultural fields. Tile drain inputs were observed at time of investigation with some flowing. Surrounding topography is flat. 	<ul style="list-style-type: none"> The watercourse is a defined channelized feature. The watercourse is mostly straight flat channel with some riffle pool run sequences. The water was clear and had moderate flow at time of investigation. It is classified as a permanent warm water system by ABCA. Banks were slightly unstable with some areas of erosion and bare soil. The substrate consists of clay followed by sand, silt and cobble. Canopy cover is low and dominated by grasses. Instream habitat cover is low and dominated by aquatic vegetation followed by cobble. Groundwater indicators water speedwell and watercress were observed. Cyprinids and darters were observed at time of investigation. Downstream and upstream fish species consist of a baitfish community (ABCA, 2009; MNR, 1980). 	Moderate

D37
MWD(m):	0.25
MBD(m):	1.0

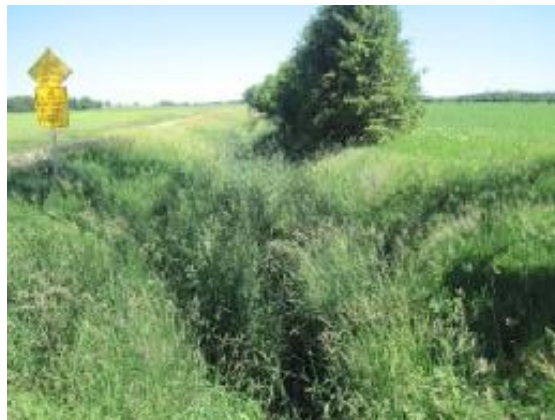
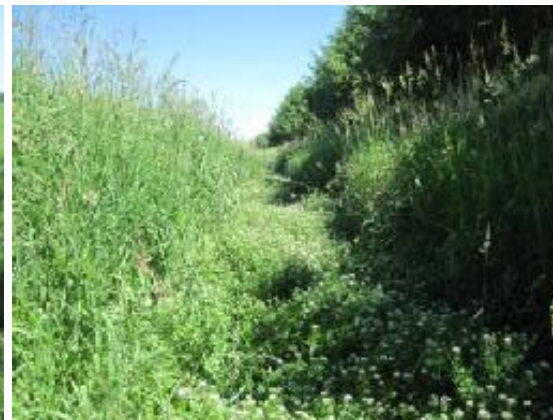
Feature ID	Project Component	Investigation Date	Description of Site	Feature Description	Feature Sensitivity
D35	<ul style="list-style-type: none"> Transmission Line Crossing 	May 1, 2012 June 13, 2012	<ul style="list-style-type: none"> The watercourse runs adjacent to McTaggart Line and adjacent to a corn field. Tile drain inputs were observed at time of investigation, they were not flowing. Surrounding topography is flat. Riparian buffer is 1 m of cultural meadow (CUM1-1) on the right bank and 1.5 m of cultural meadow consisting of grasses and tree row on the left bank. 	<ul style="list-style-type: none"> The watercourse is a defined channelized feature. The watercourse is straight uniform flat channel. The water was clear and had very low flow at time of first investigation. The water was clear and was stagnant at time of second site investigation. It is classified as unknown by ABCA. The banks are stable and well vegetated. The substrate consists of muck followed by silt, sand and clay. The canopy cover is low and dominated by grasses. Instream habitat cover is high and consists of only aquatic vegetation. The majority of the channel was vegetation choked. Groundwater indicators watercress, water speedwell and bittercress were present throughout the site. Downstream fish species consist of baitfish community, Stonecat and Rock Bass (ABCA, 2000). 	Moderate

D35
MWD(m):	0.16
MBD(m):	0.75

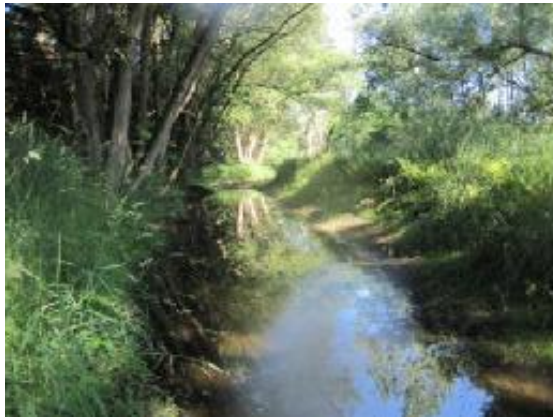
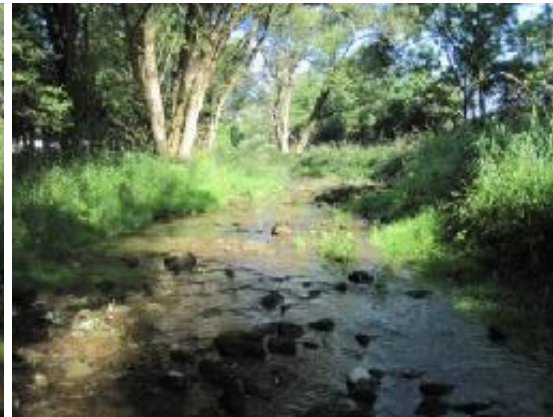
Feature ID	Project Component	Investigation Date	Description of Site	Feature Description	Feature Sensitivity
D32	<ul style="list-style-type: none"> Transmission Line Crossing Breaker Switch Station Buffer 	May 9, 2012 June 22, 2012	<ul style="list-style-type: none"> The watercourse is surrounded by a mix of deciduous forest, swamp, cultural thicket and cultural meadow (classified as FOD5-6, SWD4-1, CUM1-1, CUT1k, ELC Feature ID 738) and agricultural fields. The watercourse also crosses Dump Road. One tile drain input that was not flowing was observed at time of investigation. Surrounding land topography is flat with slight rolling towards the watercourse. Riparian buffer is greater than 10 m in the forest area and 3 m in the agricultural area. 	<ul style="list-style-type: none"> The watercourse is a defined natural feature in the forest and channelized in the agricultural field. The watercourse meanders and follows a riffle pool run sequence in a few locations. The water was clear and had moderate flow at time of investigations. It is classified as a permanent warm water system by UTRCA. The banks are stable to slightly unstable with evidence of erosion. The substrate consists of silt, cobble, gravel and sand followed by boulders. The canopy cover is moderate and is dominated by trees in the forest and low in the agricultural field. Instream habitat cover is high and consists of aquatic vegetation and cobble followed by boulders, undercut banks and woody debris. No groundwater indicators were observed. Cyprinids and darters were observed at time of investigations. One live Giant Floater mussel was observed in June. Fish species upstream and downstream include common baitfish community, Rock Bass and Northern Pike (UTRCA, 1974, 2000, 2001, 2003, 2005, 2007, 2008). 	Moderate

D32
MWD(m):	0.26
MBD(m):	0.9

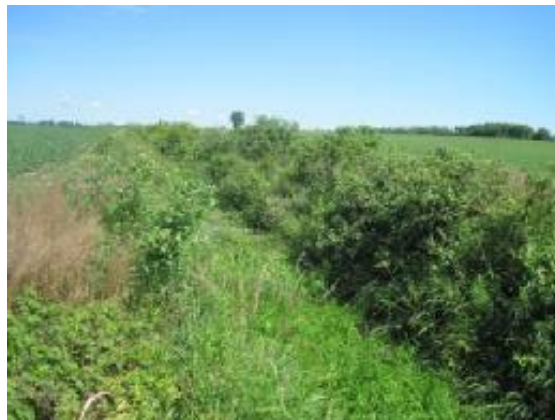
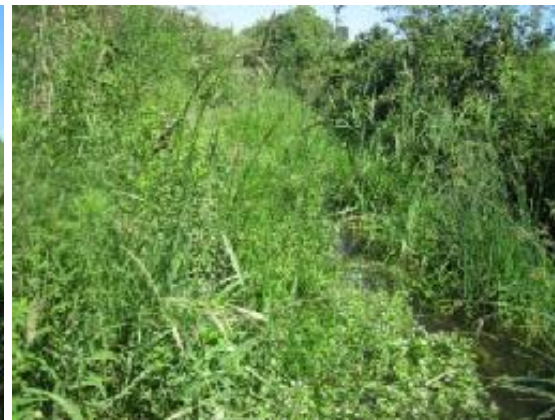
Feature ID	Project Component	Investigation Date	Description of Site	Feature Description	Feature Sensitivity
D40	<ul style="list-style-type: none"> Transmission Line Crossing 	June 22, 2012	<ul style="list-style-type: none"> The watercourse is located in soybean fields. Flowing tile drain inputs were observed at time of investigation. Surrounding topography is flat. Riparian buffer is 1 m of cultural meadow (CUM1-1). 	<ul style="list-style-type: none"> The watercourse is a defined channelized feature. The watercourse is straight flat channel. The water was clear and had slow flow at time of investigation. It is classified as a permanent warm water system by UTRCA. The banks are stable and well vegetated. Substrate consists of silt, sand and muck. Canopy cover is high and is dominated by grasses. Instream habitat cover is high and consists of aquatic vegetation followed by undercut banks. The majority of the channel is vegetation choked. Groundwater indicators watercress, water speedwell and bittercress cover the majority of the reach. A school of fish was observed in a pool near one of the culverts. Fish species found in Washburn Drain and downstream include common baitfish community, sunfish and Rock Bass (UTRCA, 2000, 2005). 	Moderate

D40
MWD(m):	0.45
MBD(m):	0.7
