NextEra Energy Canada, ULC
Goshen Wind Energy Centre

DRAFT Water Assessment and Water Body Report

60155032

September, 2012

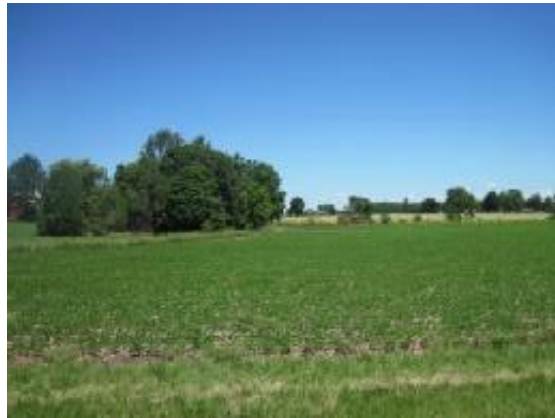
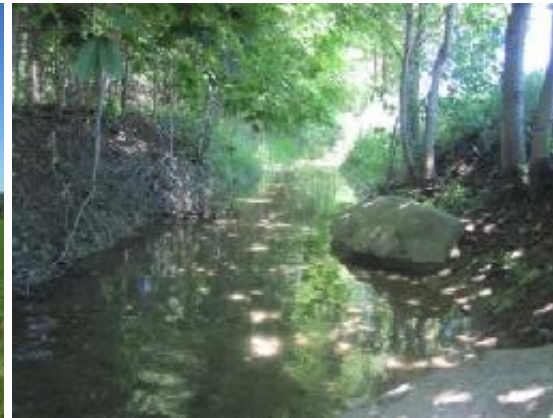
Feature ID	Project Component	Investigation Date	Description of Site	Feature Description	Feature Sensitivity
D23	<ul style="list-style-type: none"> Transmission Line Crossing 	June 22, 2012	<ul style="list-style-type: none"> The watercourse is surrounded by soybean and corn fields and a residential property. No tile drain inputs were observed at time of investigation. Surrounding topography is flat. Riparian buffer is 2.5 m of cultural meadow (CUM1-1) and trees on the left bank and greater than 10 m of cultural meadow and trees on the right bank. 	<ul style="list-style-type: none"> The watercourse is a defined channelized feature. The watercourse is straight flat channel with some riffle pool fun sequences. The water was clear and had slow flow at time of investigation. It is classified as an intermittent system by ABCA. The banks are slightly unstable with some evidence of erosion. Substrate is silt, gravel and sand followed by cobble. Canopy cover is high and is dominated by trees. Instream habitat cover is moderate and consists of cobble followed by aquatic vegetation, woody debris and boulders. Small clumps of groundwater indicators watercress and water speedwell were present throughout the site. Brook Stickleback (<i>Culaea inconstans</i>) were observed at time of investigation. 	Moderate

D23
MWD(m):	0.12
MBD(m):	0.25

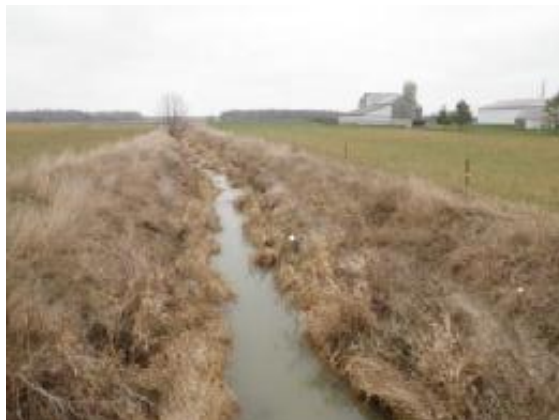
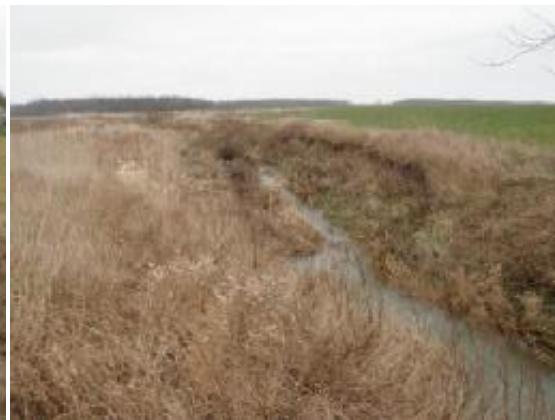
Feature ID	Project Component	Investigation Date	Description of Site	Feature Description	Feature Sensitivity
C45	<ul style="list-style-type: none"> Collection Line Buffer Road Buffer 	December 16, 2011	<ul style="list-style-type: none"> The watercourse is located in a crop agricultural field with livestock pasture to the south. Flowing tile drain inputs were observed at time of investigation. The surrounding topography is flat. Riparian buffer is 2.5 m of cultural meadow (CUM1-1) consisting mainly of grasses. 	<ul style="list-style-type: none"> The watercourse is a defined channelized feature. There is a slight meander in the channel however no riffles or pools were observed. The water was turbid and moderately flowing at the time of investigation. It is classified as a permanent warm water system by ABCA. The banks are stable and well vegetated. Substrate consists of silt and clay. Canopy cover is low and consists of grasses followed by few trees. Instream habitat cover could not be determined due to turbid water. No groundwater indicators were noted. Upstream fish species consist of a baitfish community (MNR, 1981, 2007). 	Moderate

C45
MWD(m):	0.4
MBD(m):	0.8

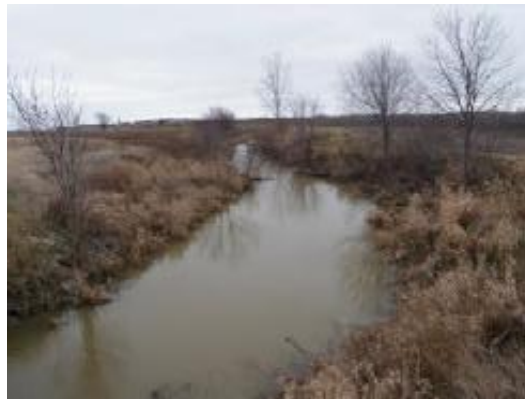
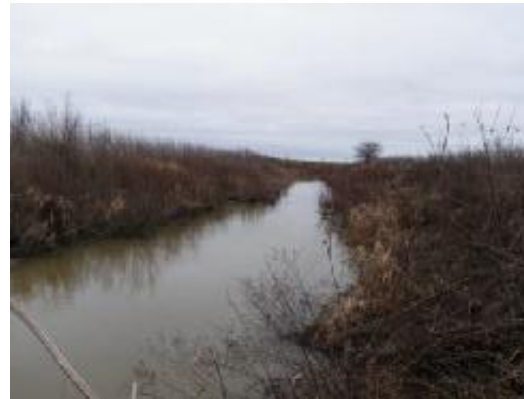
Feature ID	Project Component	Investigation Date	Description of Site	Feature Description	Feature Sensitivity
C144	<ul style="list-style-type: none"> Collection Line Crossing 	December 16, 2011	<ul style="list-style-type: none"> The watercourse is located in crop agricultural fields. Flowing tile drain inputs were noted. Surrounding topography is flat with some depression areas. Riparian buffer 2.5 m consisting of cultural meadow (CUM1-1). 	<ul style="list-style-type: none"> The watercourse is a defined channelized feature. The watercourse has uniform channel that is all run. The water was turbid and had slow flow during the time of investigation. It is classified as a permanent warm water system by ABCA. The banks are stable. Substrate consists of silt and clay. Canopy cover is low and consists of only grasses. No groundwater indicators were observed. Downstream fish species consist of baitfish community (MNR, 1995). 	Moderate

C144
MWD(m):	n/a
MBD(m):	n/a

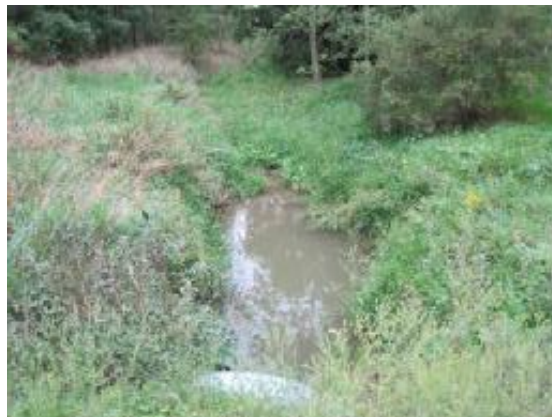
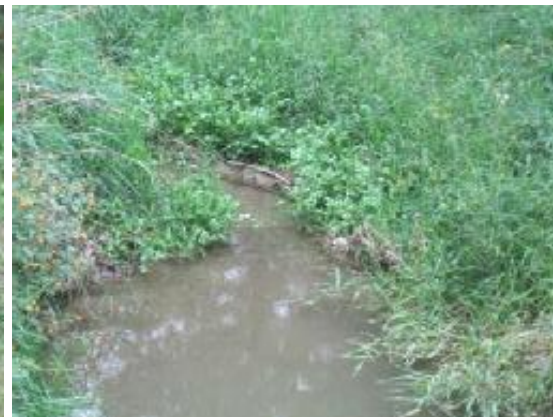
Feature ID	Project Component	Investigation Date	Description of Site	Feature Description	Feature Sensitivity
C44	<ul style="list-style-type: none"> Collection Line Crossing 	September 7, 2011	<ul style="list-style-type: none"> The watercourse flows is surrounded by cultural plantation (classified as CUP1-7, CUP1a, ELC Feature ID 266) and crosses Blackbush Line. No tile drain inputs were observed at time of investigation. Surrounding topography is flat. 	<ul style="list-style-type: none"> The watercourse is a defined natural feature. The watercourse is flat channel. The water was turbid and had no visible flow during time of investigation. It is classified as a permanent warm water system by ABCA. The banks are stable and well vegetated. Substrate consists of muck, clay and silt. Canopy cover is moderate and dominated by trees. Instream habitat cover is low and consists of aquatic vegetation followed by woody debris. Groundwater indicator watercress was observed. Downstream fish species consists of a baitfish community and Rock Bass (MNR, 1981, 1994). 	Low

C44
MWD(m):	0.25
MBD(m):	n/a

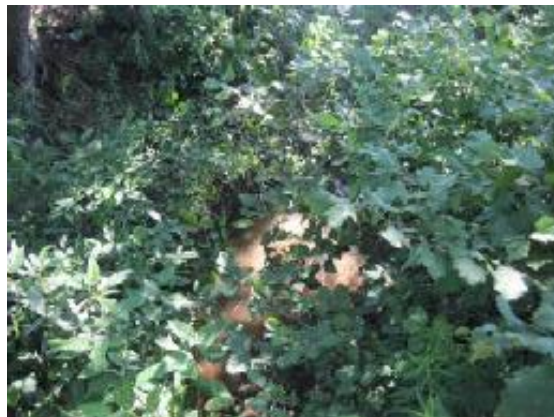
Feature ID	Project Component	Investigation Date	Description of Site	Feature Description	Feature Sensitivity
C76	<ul style="list-style-type: none"> Collection Line Crossing Road Crossing Turbine 62 	July 13, 2011	<ul style="list-style-type: none"> The watercourse flows through a soybean field with a 5 m riparian buffer into a deciduous forest (classified as FOD7-2, ELC Feature ID 177). No tile drain inputs were observed. Surrounding topography is flat. 	<ul style="list-style-type: none"> The watercourse is a defined channelized feature. It is a straight run uniform channel. The water was clear and not flowing at time of investigation, and is classified as intermittent by ABCA. The banks are stable and vegetated. Substrate consists of sand and silt. Canopy cover is moderate and a mix of grasses, trees and shrubs. Instream habitat cover is moderate and a mix of woody debris and aquatic vegetation. No groundwater indicators were observed. Potential low flow fish barrier present due to low water levels. 	Low

C76
MWW(m):	0.3
MBW(m):	1.5

C76
MWD(m):	0.05
MBD(m):	0.3

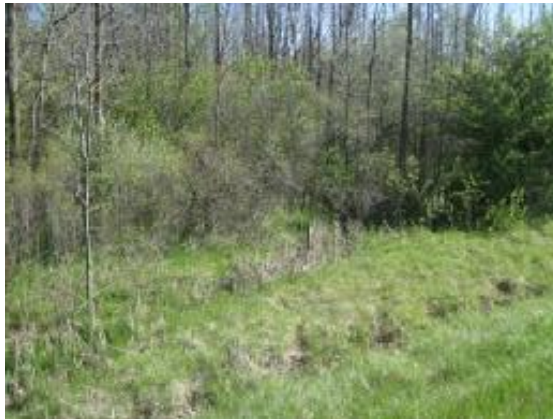
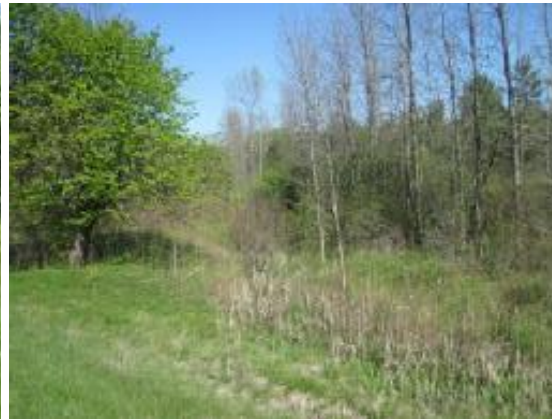
Feature ID	Project Component	Investigation Date	Description of Site	Feature Description	Feature Sensitivity
D05	<ul style="list-style-type: none"> Collection Line Buffer 	May 11, 2012	<ul style="list-style-type: none"> The watercourse is located in mixed forest (classified as FOM5-2, ELC Feature ID 255) and runs along Credition Road for 10 m. No tile drain inputs were observed at time of investigation. Riparian buffer is greater than 5 m of mixed forest. 	<ul style="list-style-type: none"> The watercourse is classified as an intermittent system by ABCA. The channel is cattail and grass choked throughout. No groundwater indicators were observed. 	Low

Watercourse Name	Shipka Drain
DFO Drain Classification	F

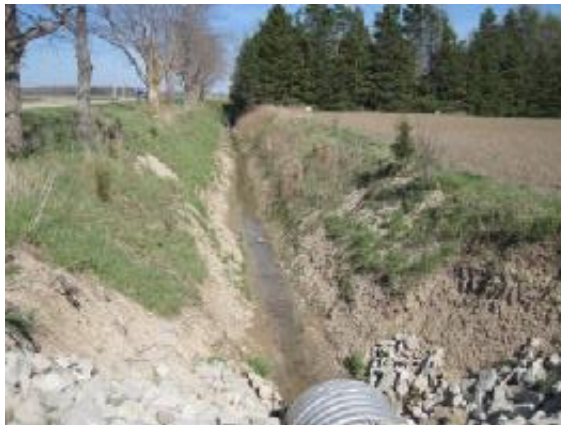
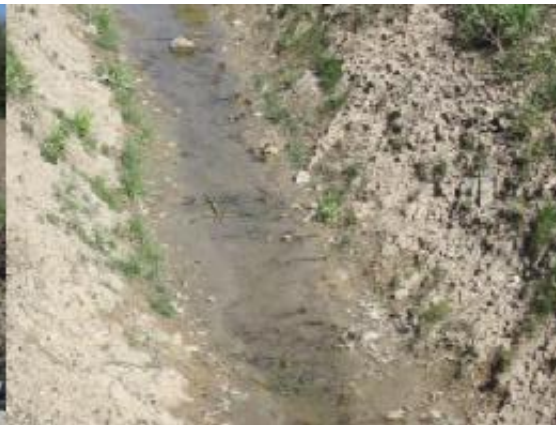
Feature ID	Project Component	Investigation Date	Description of Site	Feature Description	Feature Sensitivity
D01	• Collection Line Buffer	April 18, 2012	<ul style="list-style-type: none"> The watercourse runs along roadside that is adjacent to crop agricultural fields and a residential property. Tile drain inputs were observed. Surrounding topography is flat. Riparian buffer is 3 m of cultural meadow (CUM1-1). 	<ul style="list-style-type: none"> The watercourse is a defined channelized feature. It is a straight and uniform channel – appears to have been recently dug out. The water was clear and had very low flow at time of investigation. It is classified as tiled by ABCA. The banks are stable but sparsely vegetated. Substrate consists of sand and gravel followed by cobble, silt and clay. Canopy cover low. Instream habitat cover is low and consists of aquatic vegetation and cobble. No groundwater indicators were noted. 	Low

D01		D01
MWW(m):	0.75	MWD(m):	0.05
MBW(m):	1.5	MBD(m):	0.6

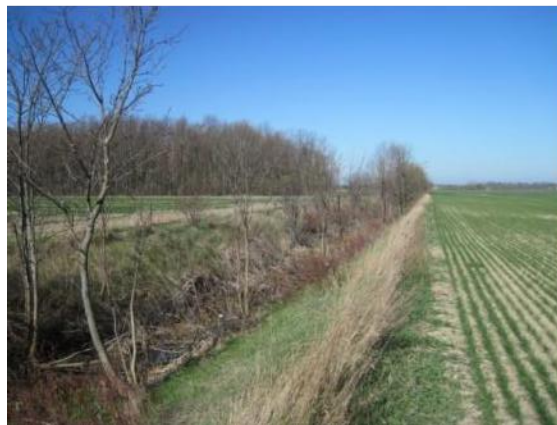
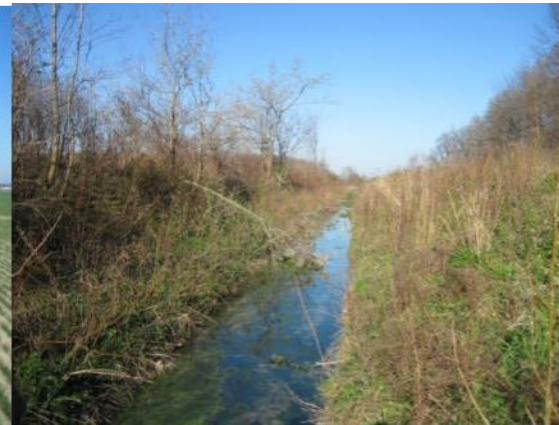
Feature ID	Project Component	Investigation Date	Description of Site	Feature Description	Feature Sensitivity
C75	<ul style="list-style-type: none"> Collection Line Crossing Road Crossing Turbines 61 and 59 	April 18, 2012	<ul style="list-style-type: none"> The watercourse runs between crop agricultural fields. Flowing tile drain inputs were observed. Surrounding topography is flat. There is no riparian buffer on the right bank and 1.5 m on the left bank of cultural meadow (CUM1-1). 	<ul style="list-style-type: none"> The watercourse is a defined channelized feature. The watercourse is straight and there was low flow only at tile drain inputs. It is classified as intermittent by ABCA. The banks are stable and well vegetated. Substrate consists of silt and clay. Canopy cover moderate with shrubs dominating. Instream habitat cover moderate and consists of aquatic vegetation and woody debris. Groundwater indicator watercress was the dominate instream vegetation. 	Low

C75		C75
MWW(m):	1.5	MWD(m):	0.2
MBW(m):	2.2	MBD(m):	0.6

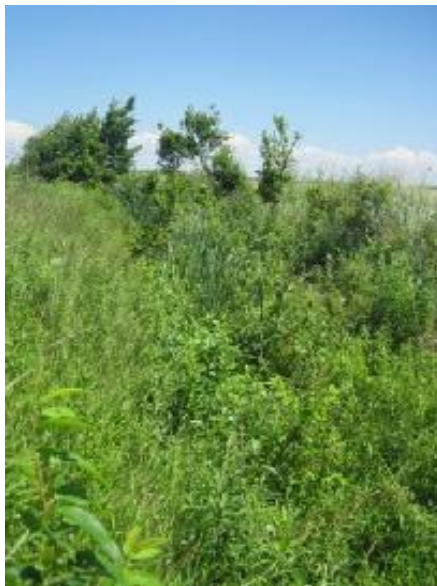
C73		C73
MWW(m):	n/a	MWD(m):	n/a
MBW(m):	1.5	MBD(m):	0.5

Feature ID	Project Component	Investigation Date	Description of Site	Feature Description	Feature Sensitivity
C73	<ul style="list-style-type: none"> Collection Line Crossing Road Crossing Turbine 58 	July 13, 2011	<ul style="list-style-type: none"> Watercourse runs through agricultural fields. No tile drain inputs were noted at time of investigation. Surrounding topography is flat. Riparian buffer is 1 m on left bank and 3 m on right bank of cultural meadow (CUM1-1) consisting of trees and grasses. 	<ul style="list-style-type: none"> The watercourse is a defined channelized feature. There was no flow at time of investigation. It is classified as a permanent warm water system by ABCA. The banks are stable and well vegetated. Substrate consists of silt and sand. Canopy cover is high and dominated by grasses. Instream habitat cover is high and consists of aquatic vegetation. The channel is cattail choked. No groundwater indicators were observed. 	Low

Photograph 1. Site overview ↑

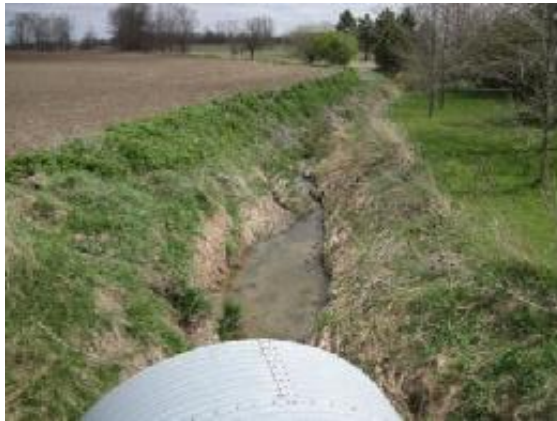
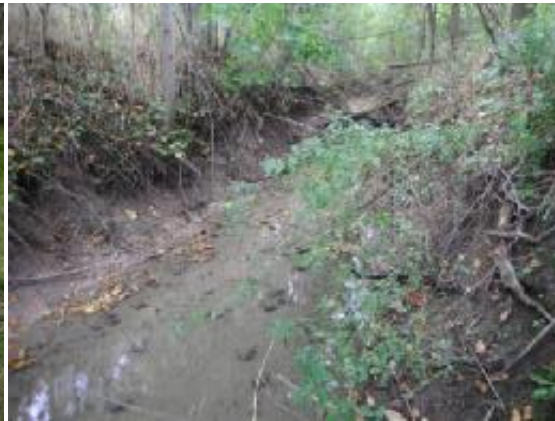
D14		D14
MWW(m):	1.0	MWD(m):	0.1
MBW(m):	3.0	MBD(m):	0.7

Feature ID	Project Component	Investigation Date	Description of Site	Feature Description	Feature Sensitivity
D14	<ul style="list-style-type: none"> Collection Line Crossing Road Buffer Turbine 76 	September 28, 2011 April 17, 2012 June 25, 2012	<ul style="list-style-type: none"> Watercourse originates as a tile drain and flows through a deciduous forest (classified as FOD6-5, FOC6-4, ELC Feature ID 245) into crop agricultural fields. Flowing tile drains were observed throughout the site. Surrounding topography is flat. Riparian buffer was 1 m on right bank and 3 m on left bank primarily consisting of grasses in the agricultural field. In the forest the riparian buffer is greater than 15 m. 	<ul style="list-style-type: none"> The watercourse is a defined channelized feature. The watercourse has a straight flat channel in the agricultural fields and has a few riffle run pool sequences in the forest. The water was clear and had very low flow at time of investigations. It is classified as intermittent by ABCA. The banks are stable and well vegetated in the agricultural field and slightly unstable in the forest. Substrate consists of silt, clay, gravel and muck followed by cobble and boulders. Canopy cover is low in the agricultural field and high in the forest. Instream habitat cover in the agricultural field is high and consists of aquatic vegetation. Areas of the watercourse were cattail choked. Instream habitat cover in the forest is moderate and consists of cobble followed by woody debris and boulders. No groundwater indicators were noted. One low flow barrier of sediment and vegetation build up was present. Young of the year fish were observed in the forest during the second site investigation. 	Low

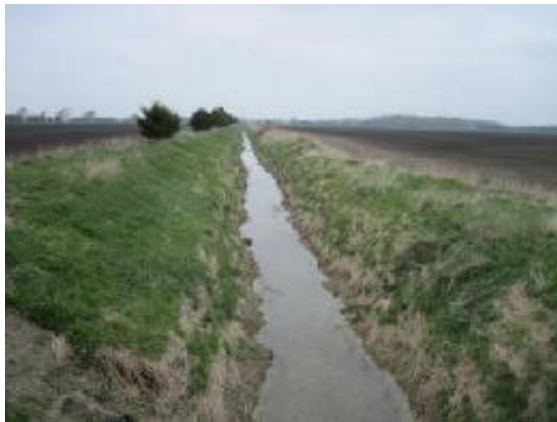
D26		D26
MWW(m):	2.2	MWD(m):	0.18
MBW(m):	3.5	MBD(m):	0.9

Feature ID	Project Component	Investigation Date	Description of Site	Feature Description	Feature Sensitivity
D26	<ul style="list-style-type: none"> Transmission Line Crossing 	May 1, 2012	<ul style="list-style-type: none"> Watercourse is surrounded by crop agricultural fields. Tile drain inputs were observed and flowing very slowly at time of investigation. Surrounding topography is flat. Riparian vegetation is 1 m of cultural meadow (CUM1-1) primarily consisting of grasses. 	<ul style="list-style-type: none"> The watercourse is a defined channelized feature. It is a straight and potentially a regularly maintained channel. The water was clear and had very low flow at time of investigation. It is classified as a permanent warm water system by ABCA. The banks are slightly unstable with exposed soils but no evidence of meandering. Substrate consists of silt and clay followed by gravel. Canopy cover is low. Instream habitat cover is low and consists of aquatic vegetation. No groundwater indicators were noted. Downstream fish species consist of baitfish community, Stonecat and Rock Bass (ABCA, 2000). 	Low

Photograph 1. Site overview ↑

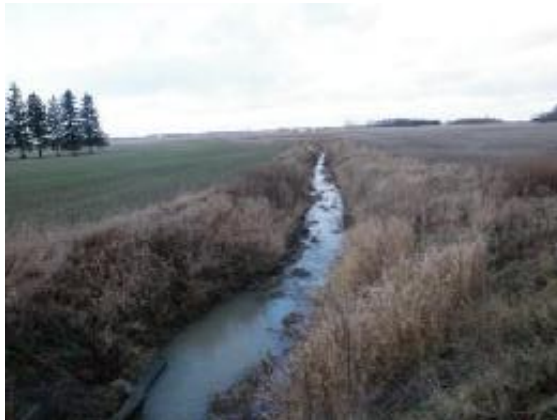
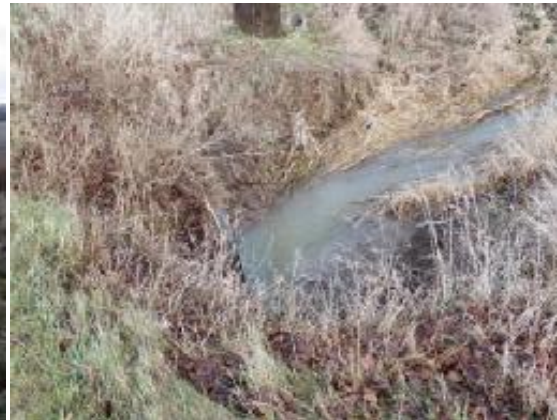
C11
MWD(m):	n/a
MBD(m):	n/a

Feature ID	Project Component	Investigation Date	Description of Site	Feature Description	Feature Sensitivity
C11	<ul style="list-style-type: none"> Collection Line Crossing 	December 15, 2011	<ul style="list-style-type: none"> The watercourse runs through crop agricultural field and passes Bronson Line into another crop agricultural field and residence. Flowing tile drains were observed. The surrounding topography is flat. The riparian buffer is 3 m of cultural meadow (CUM1-1). 	<ul style="list-style-type: none"> The watercourse is a defined channelized feature. It is a straight uniform channel. The water was turbid and had high flow at the time of investigation, however it is classified as an intermittent system by ABCA. The banks are stable and well vegetated. Substrate consists of sand and gravel followed by muck and clay. Canopy cover is low and is dominated by grasses and some shrubs. Instream habitat cover is moderate consisting primarily of aquatic vegetation. No groundwater indicators were observed. 	Low

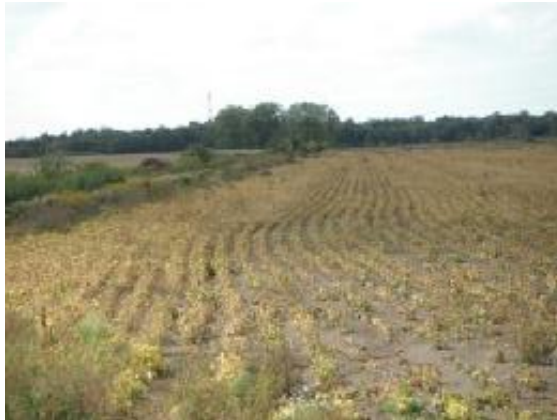
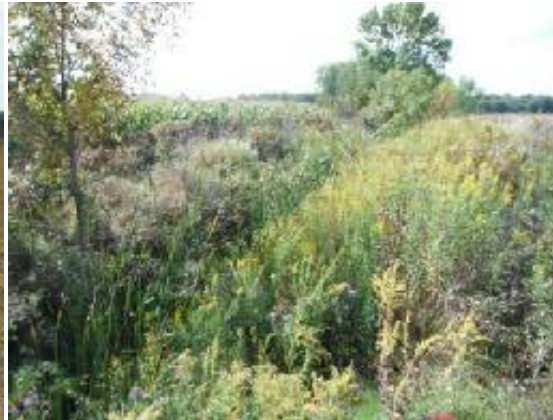
C36
MWD(m):	0.15
MBD(m):	0.4

Feature ID	Project Component	Investigation Date	Description of Site	Feature Description	Feature Sensitivity
C36	• Collection Line Crossing	September 27, 2011	<ul style="list-style-type: none"> The watercourse is located in a crop agricultural field with a riparian buffer of 1.5 m. No tile drain inputs were observed and the surrounding topography is flat. A bridge with a culvert placed in the watercourse is present approximately 90 m from Babylon Line. Riparian buffer is 1.5 m of cultural meadow (CUM1-1). 	<ul style="list-style-type: none"> The watercourse is a defined channelized feature. It is a straight uniform channel. The water was clear and flowing at the time of investigation, however it is classified as intermittent by ABCA. The banks are stable and well vegetated. Substrate consists of silt, clay with some sand, cobble and boulder. Canopy cover is moderate and dominated by grasses followed by trees. Instream habitat cover is moderate and dominated by aquatic vegetation followed by cobble and boulder. Channel was choked with cattails. No groundwater indicators were noted. 	Low

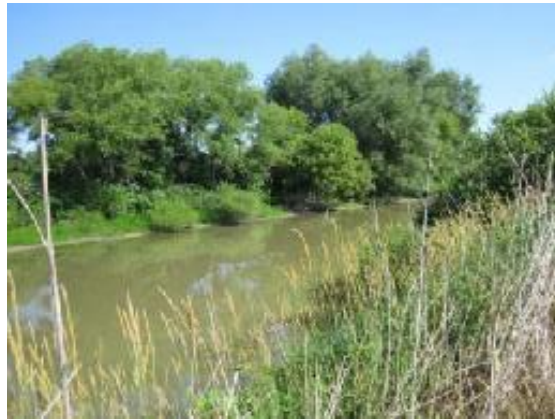
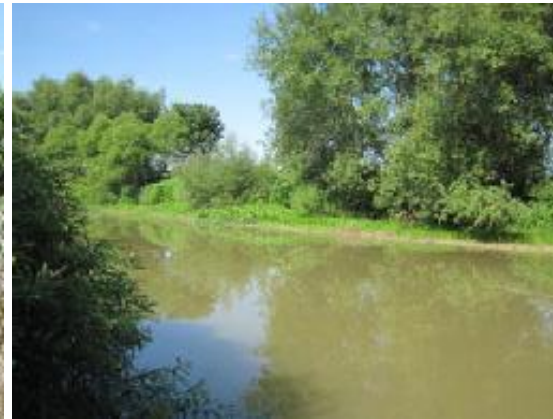
D48
MWD(m):	0.4
MBD(m):	1.3

Feature ID	Project Component	Investigation Date	Description of Site	Feature Description	Feature Sensitivity
D48	• MET Tower Buffer	July 12, 2012	<ul style="list-style-type: none"> The watercourse flows through corn fields. No tile drain inputs were observed, however several channel flow into watercourse on the left bank. The surrounding topography is flat with slight sloping towards the watercourse. Riparian buffer is 6 m of cultural meadow (CUM1-1). 	<ul style="list-style-type: none"> The watercourse is a defined natural feature. The watercourse is all flat. The water was turbid and had low at the time of investigation. It is classified as a permanent warm water feature by ABCA. The banks are stable and well vegetated. Substrate consists of silt. Canopy cover is low and consists of trees and shrubs. Instream habitat cover is low and consists of woody debris and aquatic vegetation. No groundwater indicators were observed. 	Low

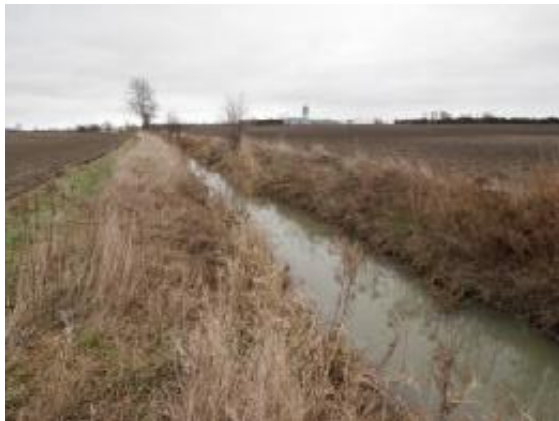
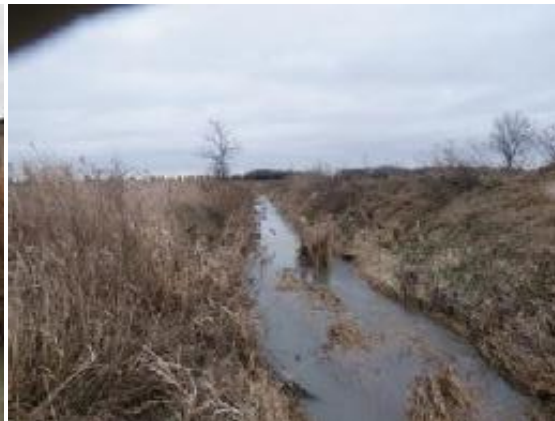
C56
MWD(m)	0.5
MBD(m):	0.8

Feature ID	Project Component	Investigation Date	Description of Site	Feature Description	Feature Sensitivity
C56	• Turbine 48	December 16, 2011	<ul style="list-style-type: none"> The watercourse flows through a crop agricultural field with a 1.5 m riparian buffer of cultural meadow (CUM1-1). Tile drain input was observed. Surrounding topography is flat. 	<ul style="list-style-type: none"> The watercourse is a defined channelized feature. It is a straight run channel. The water was turbid and had a moderate flow during the time of investigation, however it is classified as intermittent by ABCA. The banks are stable and well vegetated. Substrate consists of silt clay with gravel. Canopy cover is low and dominated by grasses. Instream habitat cover is low and dominated by grasses. No groundwater indicators were observed. 	Low

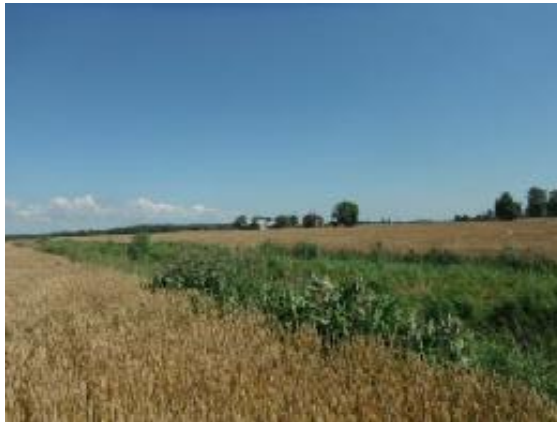
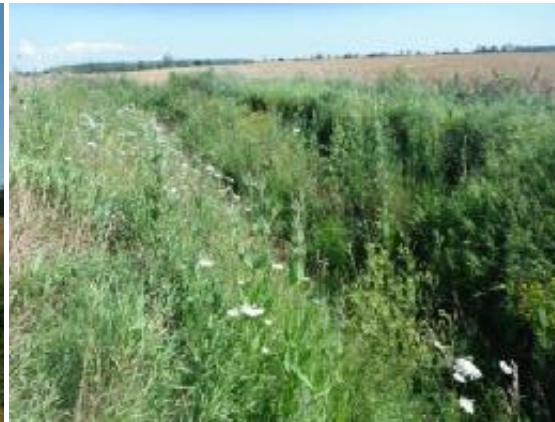
C62
MWD(m):	0.1
MBD(m):	2.0

Feature ID	Project Component	Investigation Date	Description of Site	Feature Description	Feature Sensitivity
C62	<ul style="list-style-type: none"> Collection Line Crossing Turbine 38 	July 7, 2011	<ul style="list-style-type: none"> The watercourse flows through a wheat field with a 2 m riparian buffer of cultural meadow (CUM1-1). No tile drain inputs were noted. Surrounding topography is flat. 	<ul style="list-style-type: none"> The watercourse is a defined channelized feature. It is a straight channel that is all flat run. There was no flow during the time of investigation, only stagnant water. It is classified as an intermittent system by ABCA. The banks are slightly unstable. Substrate consists of muck and is algae choked. Canopy cover is low and consists of grasses and herbaceous vegetation. Instream habitat cover is high and is dominated by aquatic algae followed by aquatic vegetation. No groundwater indicators were observed. Potential low flow fish barrier observed due to build-up of algae. Downstream fish species consist of a baitfish community, Brown Bullhead, Rainbow Trout and Northern Pike (ABCA, 2001; MNR, 2003). 	Low

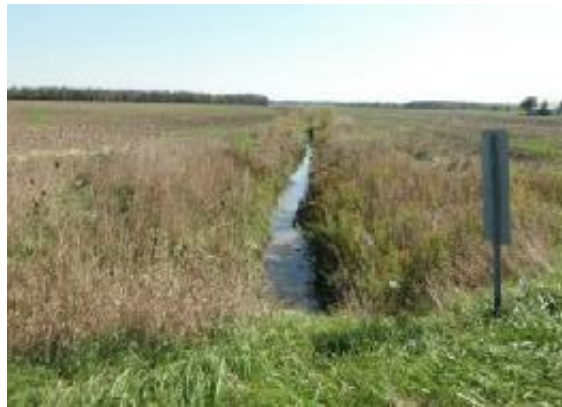
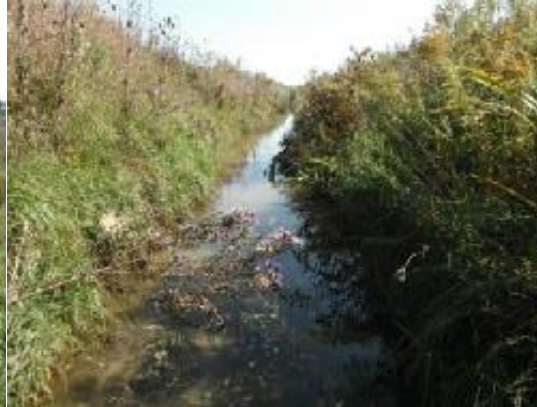
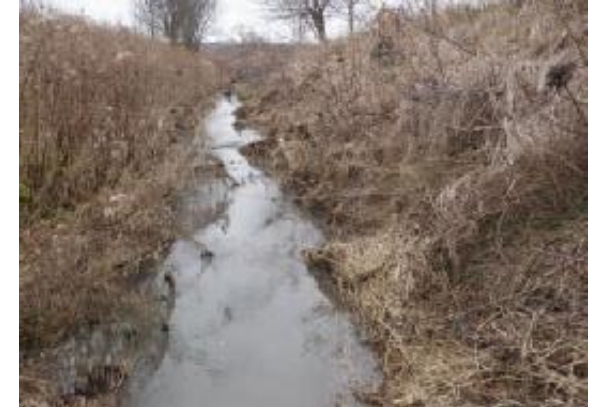
C63
MWD(m):	0.2
MBD(m):	0.6

Feature ID	Project Component	Investigation Date	Description of Site	Feature Description	Feature Sensitivity
C63	• Road Buffer	October 6, 2011 December 16, 2011	• The watercourse flows through a crop agricultural field with a 2 m riparian buffer of cultural meadow (CUM1-1) both east and west of Shipka Line. Flowing tile drain inputs were observed. Surrounding topography is flat.	• The watercourse is a defined channelized feature. The water was clear to slightly turbid and flowing during the time of investigations. It is classified as intermittent by ABCA, and is a straight channel that is all run. The banks are stable and well vegetated. Substrate is dominated by silt and clay followed by a mix of muck, gravel, detritus, cobble and boulder. Canopy cover is low and is a mix of grasses and shrubs followed by trees. Instream habitat cover is high and dominated by aquatic vegetation followed by cobble and boulder. No groundwater indicators were noted. Downstream fish species consist of a baitfish community, Brown Bullhead, Rainbow Trout and Northern Pike (ABCA, 2001; MNR, 2003).	Low

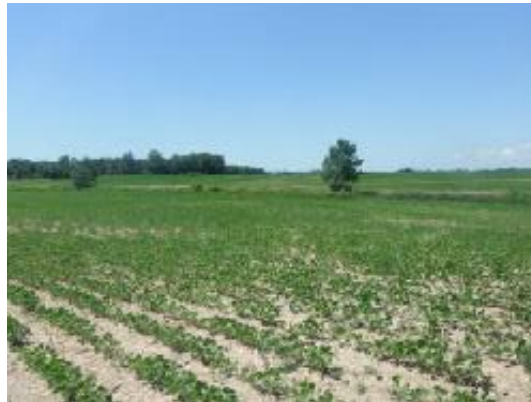
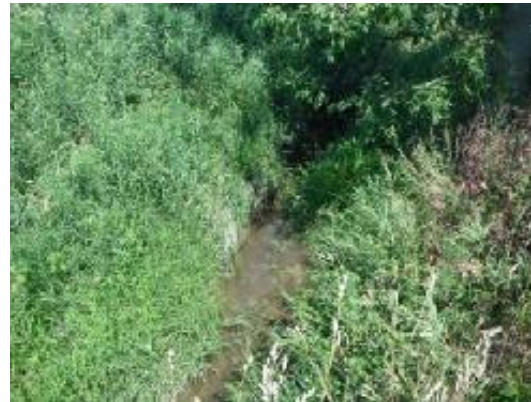
C86
MWD(m):	0.1
MBD(m):	0.3

Feature ID	Project Component	Investigation Date	Description of Site	Feature Description	Feature Sensitivity
C86	• Turbine 41	July 13, 2011	<ul style="list-style-type: none"> The watercourse is located in a crop agricultural field with a 2 m riparian buffer of cultural meadow (CUM1-1). No tile drain inputs were observed. Surrounding topography is flat. 	<ul style="list-style-type: none"> The watercourse is a defined channelized feature. The watercourse is all flat channel. The water was clear and slow moving during the time of investigation. The system is classified as intermittent by ABCA. Banks are stable and vegetated. Substrate consists of muck and cobble. Canopy cover is moderate and is dominated by grasses, followed by shrubs and trees. Instream habitat cover is low and consists of cobble and undercut banks. Channel is choked with grasses and shrubs in some areas. No groundwater indicators were noted. Upstream fish species consist of baitfish community (MNR, 1994). 	Low

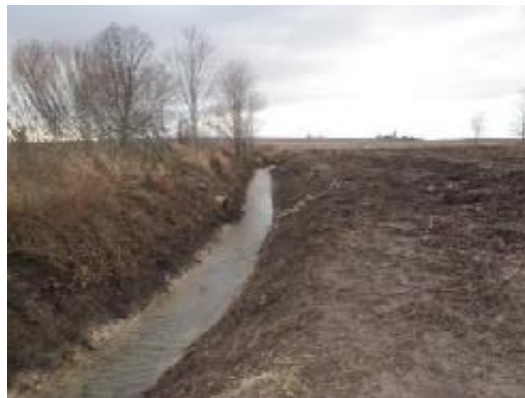
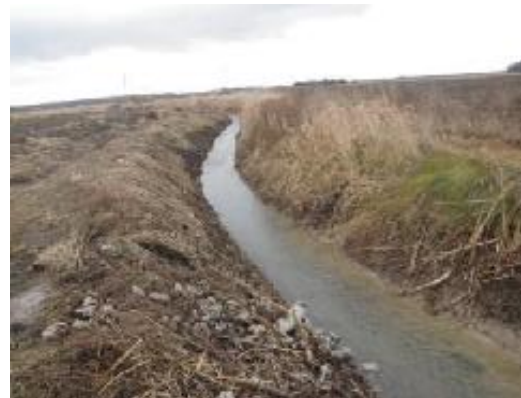
C110
MWD(m):	0.15
MBD(m):	0.45

Feature ID	Project Component	Investigation Date	Description of Site	Feature Description	Feature Sensitivity
C110	• Turbine 65	December 15, 2011	<ul style="list-style-type: none"> The watercourse is located in crop agricultural fields. Tile drain inputs were observed. Surrounding topography is flat. Riparian buffer is 1 m of cultural meadow (CUM1-1) exists on the left bank, while the buffer on the left was recently removed. 	<ul style="list-style-type: none"> The watercourse is a defined channelized feature that was newly dug out. The morphology is all run. The water was turbid and had moderate flow during the time of investigation; however it is classified as intermittent by ABCA. The banks are stable. Substrate consists of clay followed by silt, gravel and cobble. There is no canopy cover. Instream habitat cover is high and consists of only cobble. No groundwater indicators were noted. A perched culvert is present at the edge of the property, obstructing fish passage. 	Low

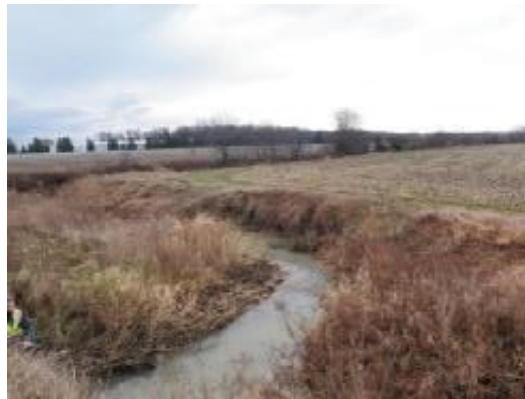
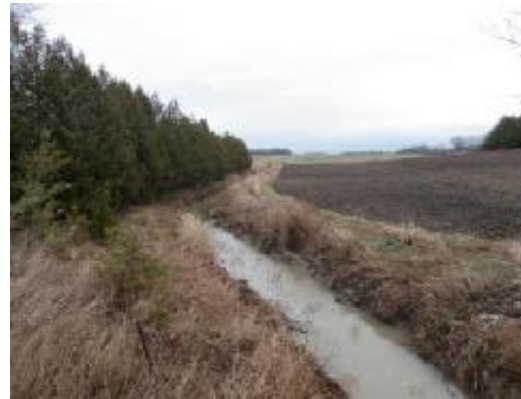
C209
MWD(m):	n/a
MBD(m):	n/a

Feature ID	Project Component	Investigation Date	Description of Site	Feature Description	Feature Sensitivity
C209	<ul style="list-style-type: none"> Collection Line Crossing 	December 15, 2011	<ul style="list-style-type: none"> The watercourse is located in crop agricultural fields, crossing Bronson Line. No tile drain inputs were observed at time of investigation. Surrounding topography is flat. Riparian buffer is 2 m of cultural meadow (CUM1-1) consisting of grasses and trees. 	<ul style="list-style-type: none"> The watercourse is a defined channelized feature. The morphology is all run. The water was turbid and had high flow during the time of investigation. It is classified as a permanent warm water system by ABCA. Banks are slightly unstable due to 90 degree bends. Substrate consists of gravel and sand followed by clay. Canopy cover is low and is dominated by grasses. No groundwater indicators were observed. Fish species at Bronson Line crossing consist of baitfish community (MNR, 1994). 	Low

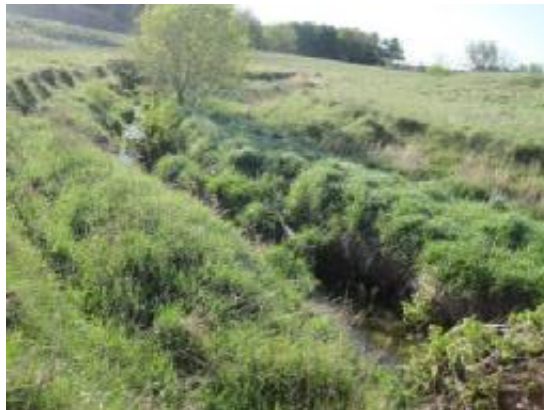
C48
MWD(m):	0.2
MBD(m):	0.65

Feature ID	Project Component	Investigation Date	Description of Site	Feature Description	Feature Sensitivity
C48	<ul style="list-style-type: none"> Collection Line Crossing Road Crossing Turbine 17 	May 11, 2012	<ul style="list-style-type: none"> The watercourse originates at a tile drain into a deciduous forest (classified as FOD7-2, FOD4c, ELC Feature ID 232) and then in an agricultural field and travels along the roadside of Crediton Road beside another agricultural field. Flowing tile drain inputs were noted during time of investigation and providing flow to the watercourse. Surrounding topography is flat. Riparian buffer is 1.5 m on the north bank and 0.5 m on the south bank and great in the forest area. 	<ul style="list-style-type: none"> The watercourse is a defined channelized feature. The watercourse meanders slightly in the north bank and is mainly flat with some riffles and pools present. The water was clear and had low flow during the time of second site investigation. It is classified as an intermittent water system by ABCA. Banks are slightly unstable with signs of erosion and slumping. Substrate consists of detritus, muck and clay followed by gravel, cobble, sand and silt. Canopy cover is high in the forest and low in the agricultural fields. Instream habitat cover is moderate and consists of aquatic vegetation and detritus followed by cobble, boulders and undercut banks. Groundwater indicator water speedwell was observed. Downstream fish species consist of baitfish community, Brown Bullhead and Rainbow Trout (ABCA, 2001; MNR, 2003). 	Low

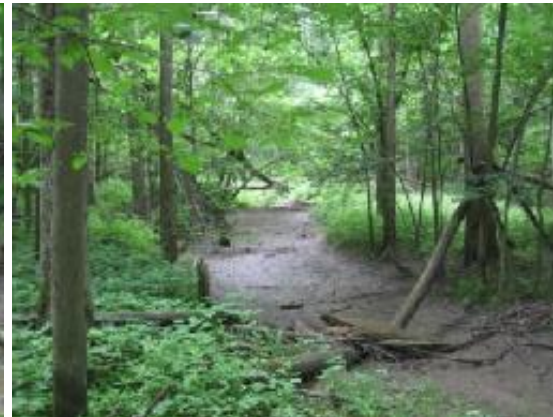
Photograph 2. Low flow barrier ↑

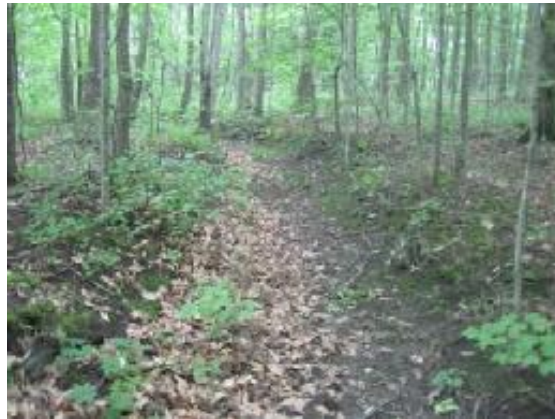
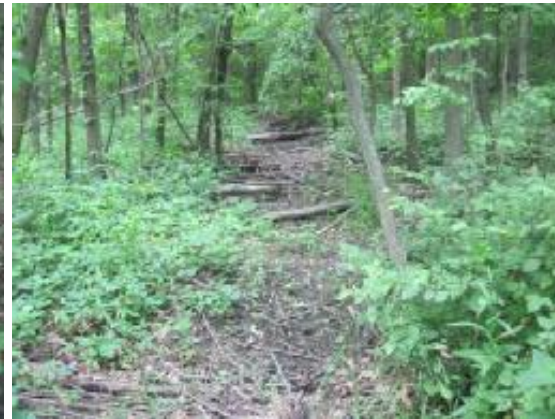
Feature ID	Project Component	Investigation Date	Description of Site	Feature Description	Feature Sensitivity
D52	• Turbine 35	June 11, 2012	<ul style="list-style-type: none"> The watercourse is located within a deciduous forest (classified as FOD5-6, ELC Feature ID 290) surrounded by crop agricultural fields. No tile drain inputs were observed at time of investigation. Surrounding topography is flat and slightly sloped to the south in the forest. Riparian buffer is greater than 15 m of forest. 	<ul style="list-style-type: none"> The watercourse is an ephemeral natural feature. There was no water at time of investigation. It is not mapped by ABCA. Banks are stable with no signs of erosion. Substrate consists of sand, silt and clay. Canopy cover is high and is dominated by trees. No groundwater indicators were observed. 	Low

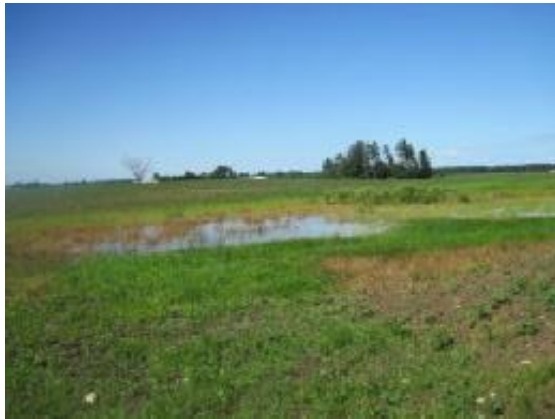
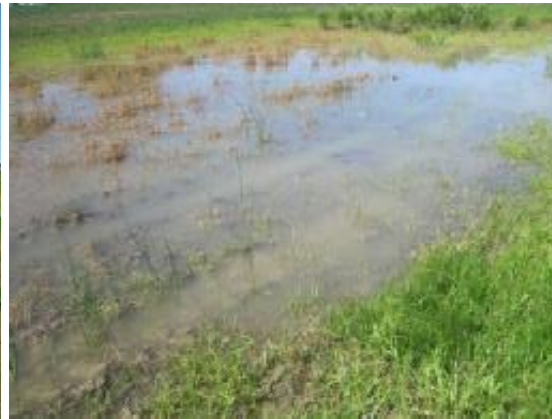
Feature ID	Project Component	Investigation Date	Description of Site	Feature Description	Feature Sensitivity
P11	<ul style="list-style-type: none"> Transmission Line Buffer 	June 22, 2012	<ul style="list-style-type: none"> The pond is located in a soybean field. The pond is 15 by 10 m and 0.25 m deep. The riparian buffer is 0.5 to 2 m of cultural meadow (CUM1-1). 	<ul style="list-style-type: none"> The pond is a natural feature that appears to be seasonal. The pond is a natural depression area that is offline. The substrate consists of silt and clay. <i>In-situ</i> cover is low and consists of aquatic vegetation. No groundwater indicators were observed. 	Low

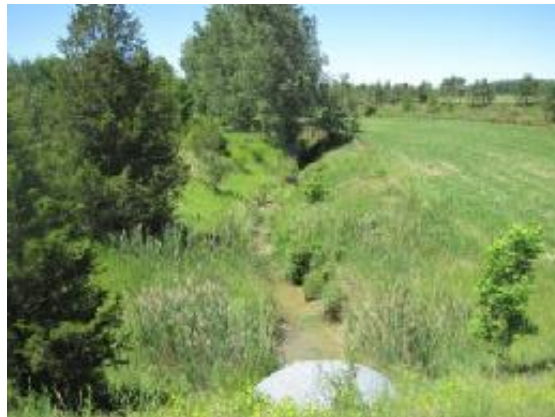
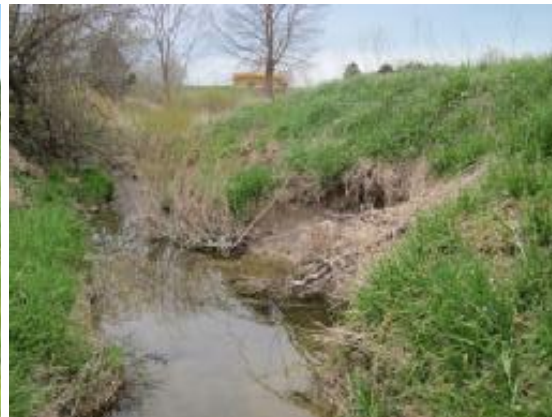
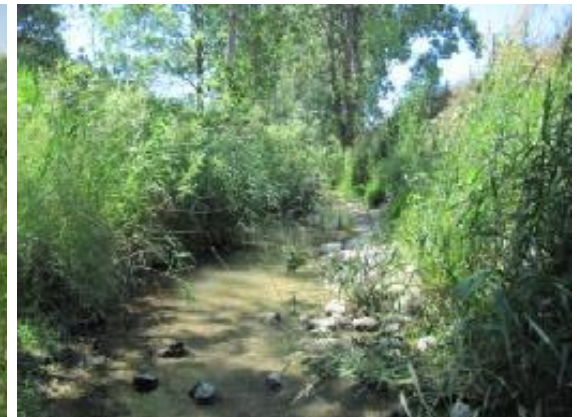
Feature ID	Project Component	Investigation Date	Description of Site	Feature Description	Feature Sensitivity
D16	• Collection Line Crossing	April 26, 2012 June 25, 2012	<ul style="list-style-type: none"> The watercourse surrounded by cultural meadow (classified as CUM1-1, ELC Feature ID 220), soybean and row crop fields and crosses Grand Bend Line. Tile drain inputs were noted east of Grand Bend Line. Surrounding land topography is flat with sloping towards the watercourse. Riparian buffer is 1.5 m west of Grand Bend Line and greater than 5 m east consisting of meadow and trees. 	<ul style="list-style-type: none"> The watercourse is a defined channelized feature that is starting to naturalize. The watercourse is straight flat channel that has a few riffle pool run sequence. The water was slightly turbid and had slow flow at time of investigations. It is classified as a permanent warm water system by ABCA. Banks are slightly unstable with signs of erosion and old slumping present. Substrate is silt and clay followed by cobble, gravel and boulders. Canopy cover is high and dominated by trees and shrubs. Instream habitat cover is moderate and consists of cobble followed by boulders, aquatic vegetation, woody debris and undercut banks. No groundwater indicators were observed. Cyprinids were observed during April and young of the year fish were observed during June. Upstream fish species consist of a baitfish community, Brown Bullhead, Rainbow Trout and Northern Pike (ABCA, 2001; MNR 2003). 	Low

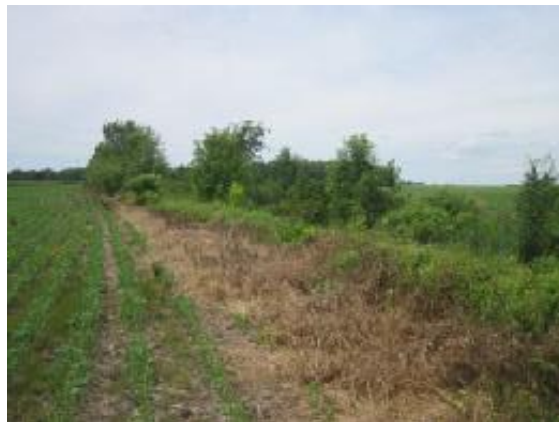
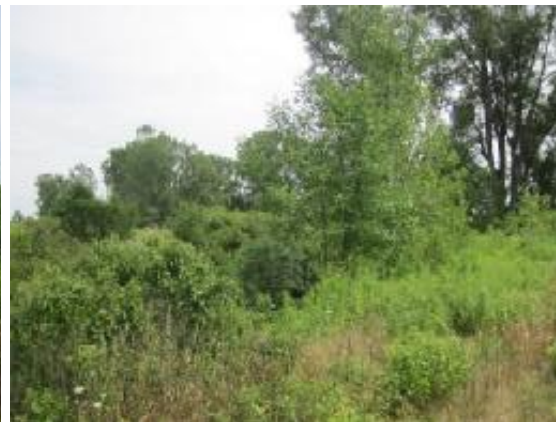
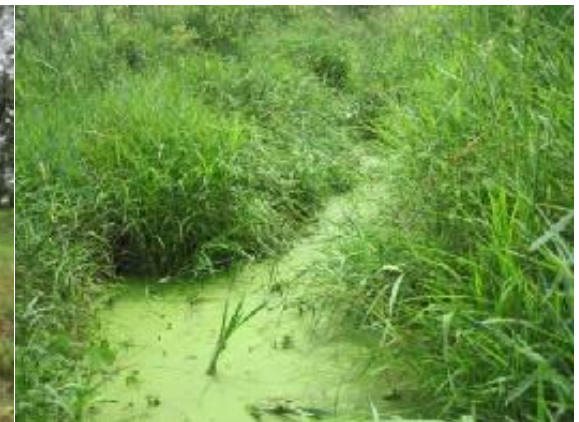
Feature ID	Project Component	Investigation Date	Description of Site	Feature Description	Feature Sensitivity
D55	<ul style="list-style-type: none"> Collection Line Buffer Turbine 38 	July 27, 2011	<ul style="list-style-type: none"> The watercourse is located in a crop agricultural field and the riparian buffer is 1 m of cultural meadow (CUM1-1). No tile inputs were noted and the surrounding topography is flat. 	<ul style="list-style-type: none"> The watercourse is a defined channelized feature that appears to be naturalizing. During the time of investigation there was no flow, only standing water. It is classified as intermittent by ABCA. The banks are stable and vegetated. Substrate consists of muck followed by clay and silt. Canopy cover is low and consists of shrubs and trees. Instream cover is moderate dominated by aquatic vegetation followed by undercut bank and woody debris. Groundwater indicator watercress was observed. 	Low

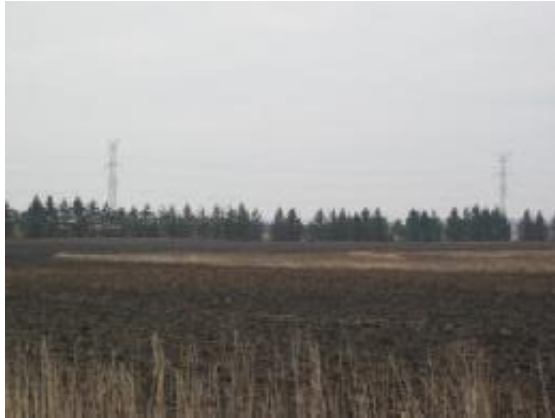
Feature ID	Project Component	Investigation Date	Description of Site	Feature Description	Feature Sensitivity
P19	<ul style="list-style-type: none"> Collection Line Crossing Road Crossing 	November 17, 2011 December 22, 2011	<ul style="list-style-type: none"> The pond is located in an agricultural field. Riparian buffer of grasses exists. 	<ul style="list-style-type: none"> The pond is a dugout offline feature. Water was present at time of investigation. 	Low

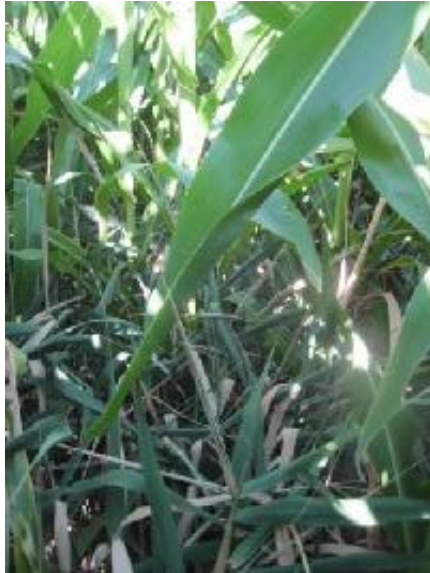
Feature ID	Project Component	Investigation Date	Description of Site	Feature Description	Feature Sensitivity
P1	<ul style="list-style-type: none"> Collection Line Buffer 	July 25, 2012	<ul style="list-style-type: none"> The feature is located in a corn field. There was no water body present. 	<ul style="list-style-type: none"> No water body was present. Some Common Reed was present in the corn field. 	Not Sensitive

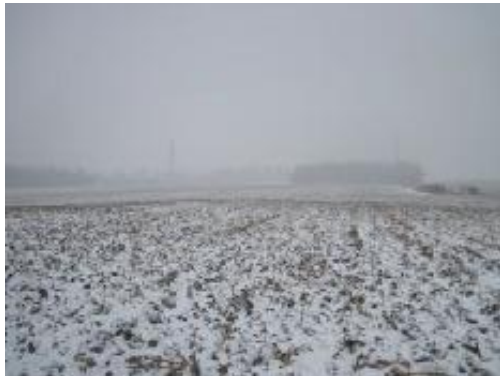
Feature ID	Project Component	Investigation Date	Description of Site	Feature Description	Feature Sensitivity
C212	• Turbine 72	January 13, 2012	• The feature is located in an agricultural field. No water body was present.	• No water body feature present.	Not Sensitive

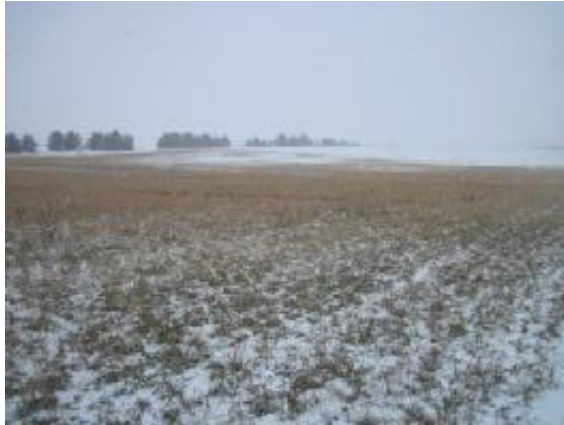
Feature ID	Project Component	Investigation Date	Description of Site	Feature Description	Feature Sensitivity
C213	<ul style="list-style-type: none"> • Collection Line Crossing • Road Crossing • Turbine 73 	January 13, 2012	<ul style="list-style-type: none"> • The feature is located in an agricultural field. No water body was present. 	<ul style="list-style-type: none"> • No water body feature present. 	Not Sensitive

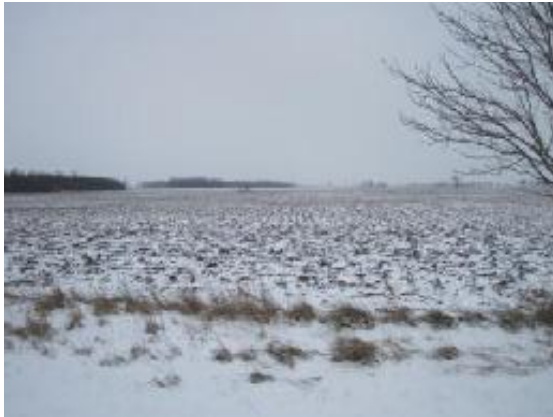
Feature ID	Project Component	Investigation Date	Description of Site	Feature Description	Feature Sensitivity
C217	• Turbine 76	January 13, 2012	• The feature is located in an agricultural field. No water body was present.	• No water body feature present.	Not Sensitive

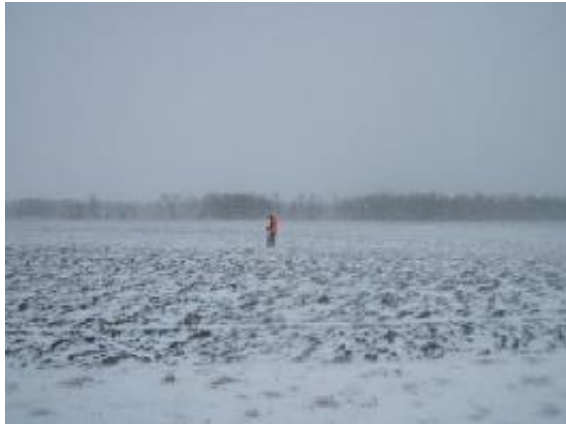
Feature ID	Project Component	Investigation Date	Description of Site	Feature Description	Feature Sensitivity
C214	• Turbine 77	January 13, 2012	• The feature is located in an agricultural field. No water body was present.	• No water body feature present.	Not Sensitive

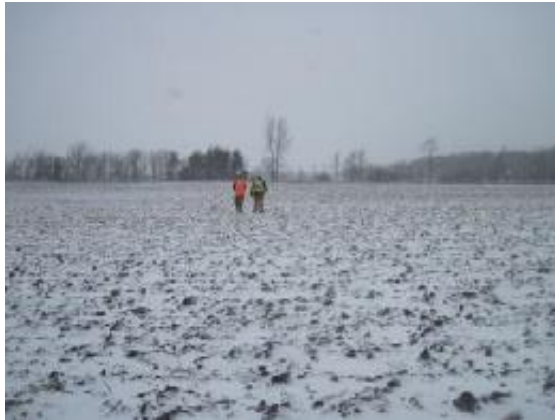
Feature ID	Project Component	Investigation Date	Description of Site	Feature Description	Feature Sensitivity
C215	• Turbine 78	January 13, 2012	• The feature is located in an agricultural field. No water body was present.	• No water body feature present.	Not Sensitive

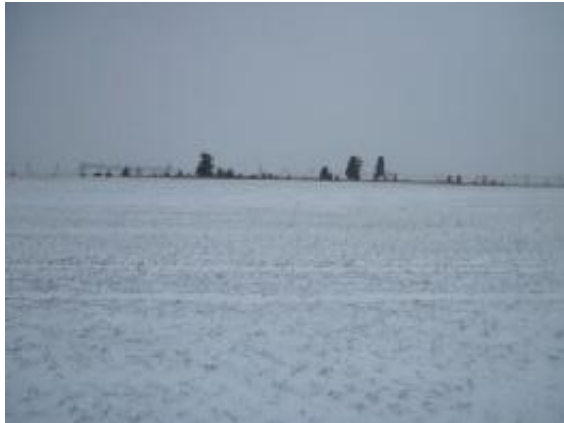
Feature ID	Project Component	Investigation Date	Description of Site	Feature Description	Feature Sensitivity
C216	• Turbine 79	January 13, 2012	• The feature is located in an agricultural field. No water body was present.	• No water body feature present.	Not Sensitive
