**SUNCOR ENERGY CEDAR POINT
WIND POWER PROJECT
PROPERTY LINE SETBACK ASSESSMENT
REPORT**

File No. 160960709
April 2013

**Figures: Individual Turbine Locations and
Property Line Setbacks**

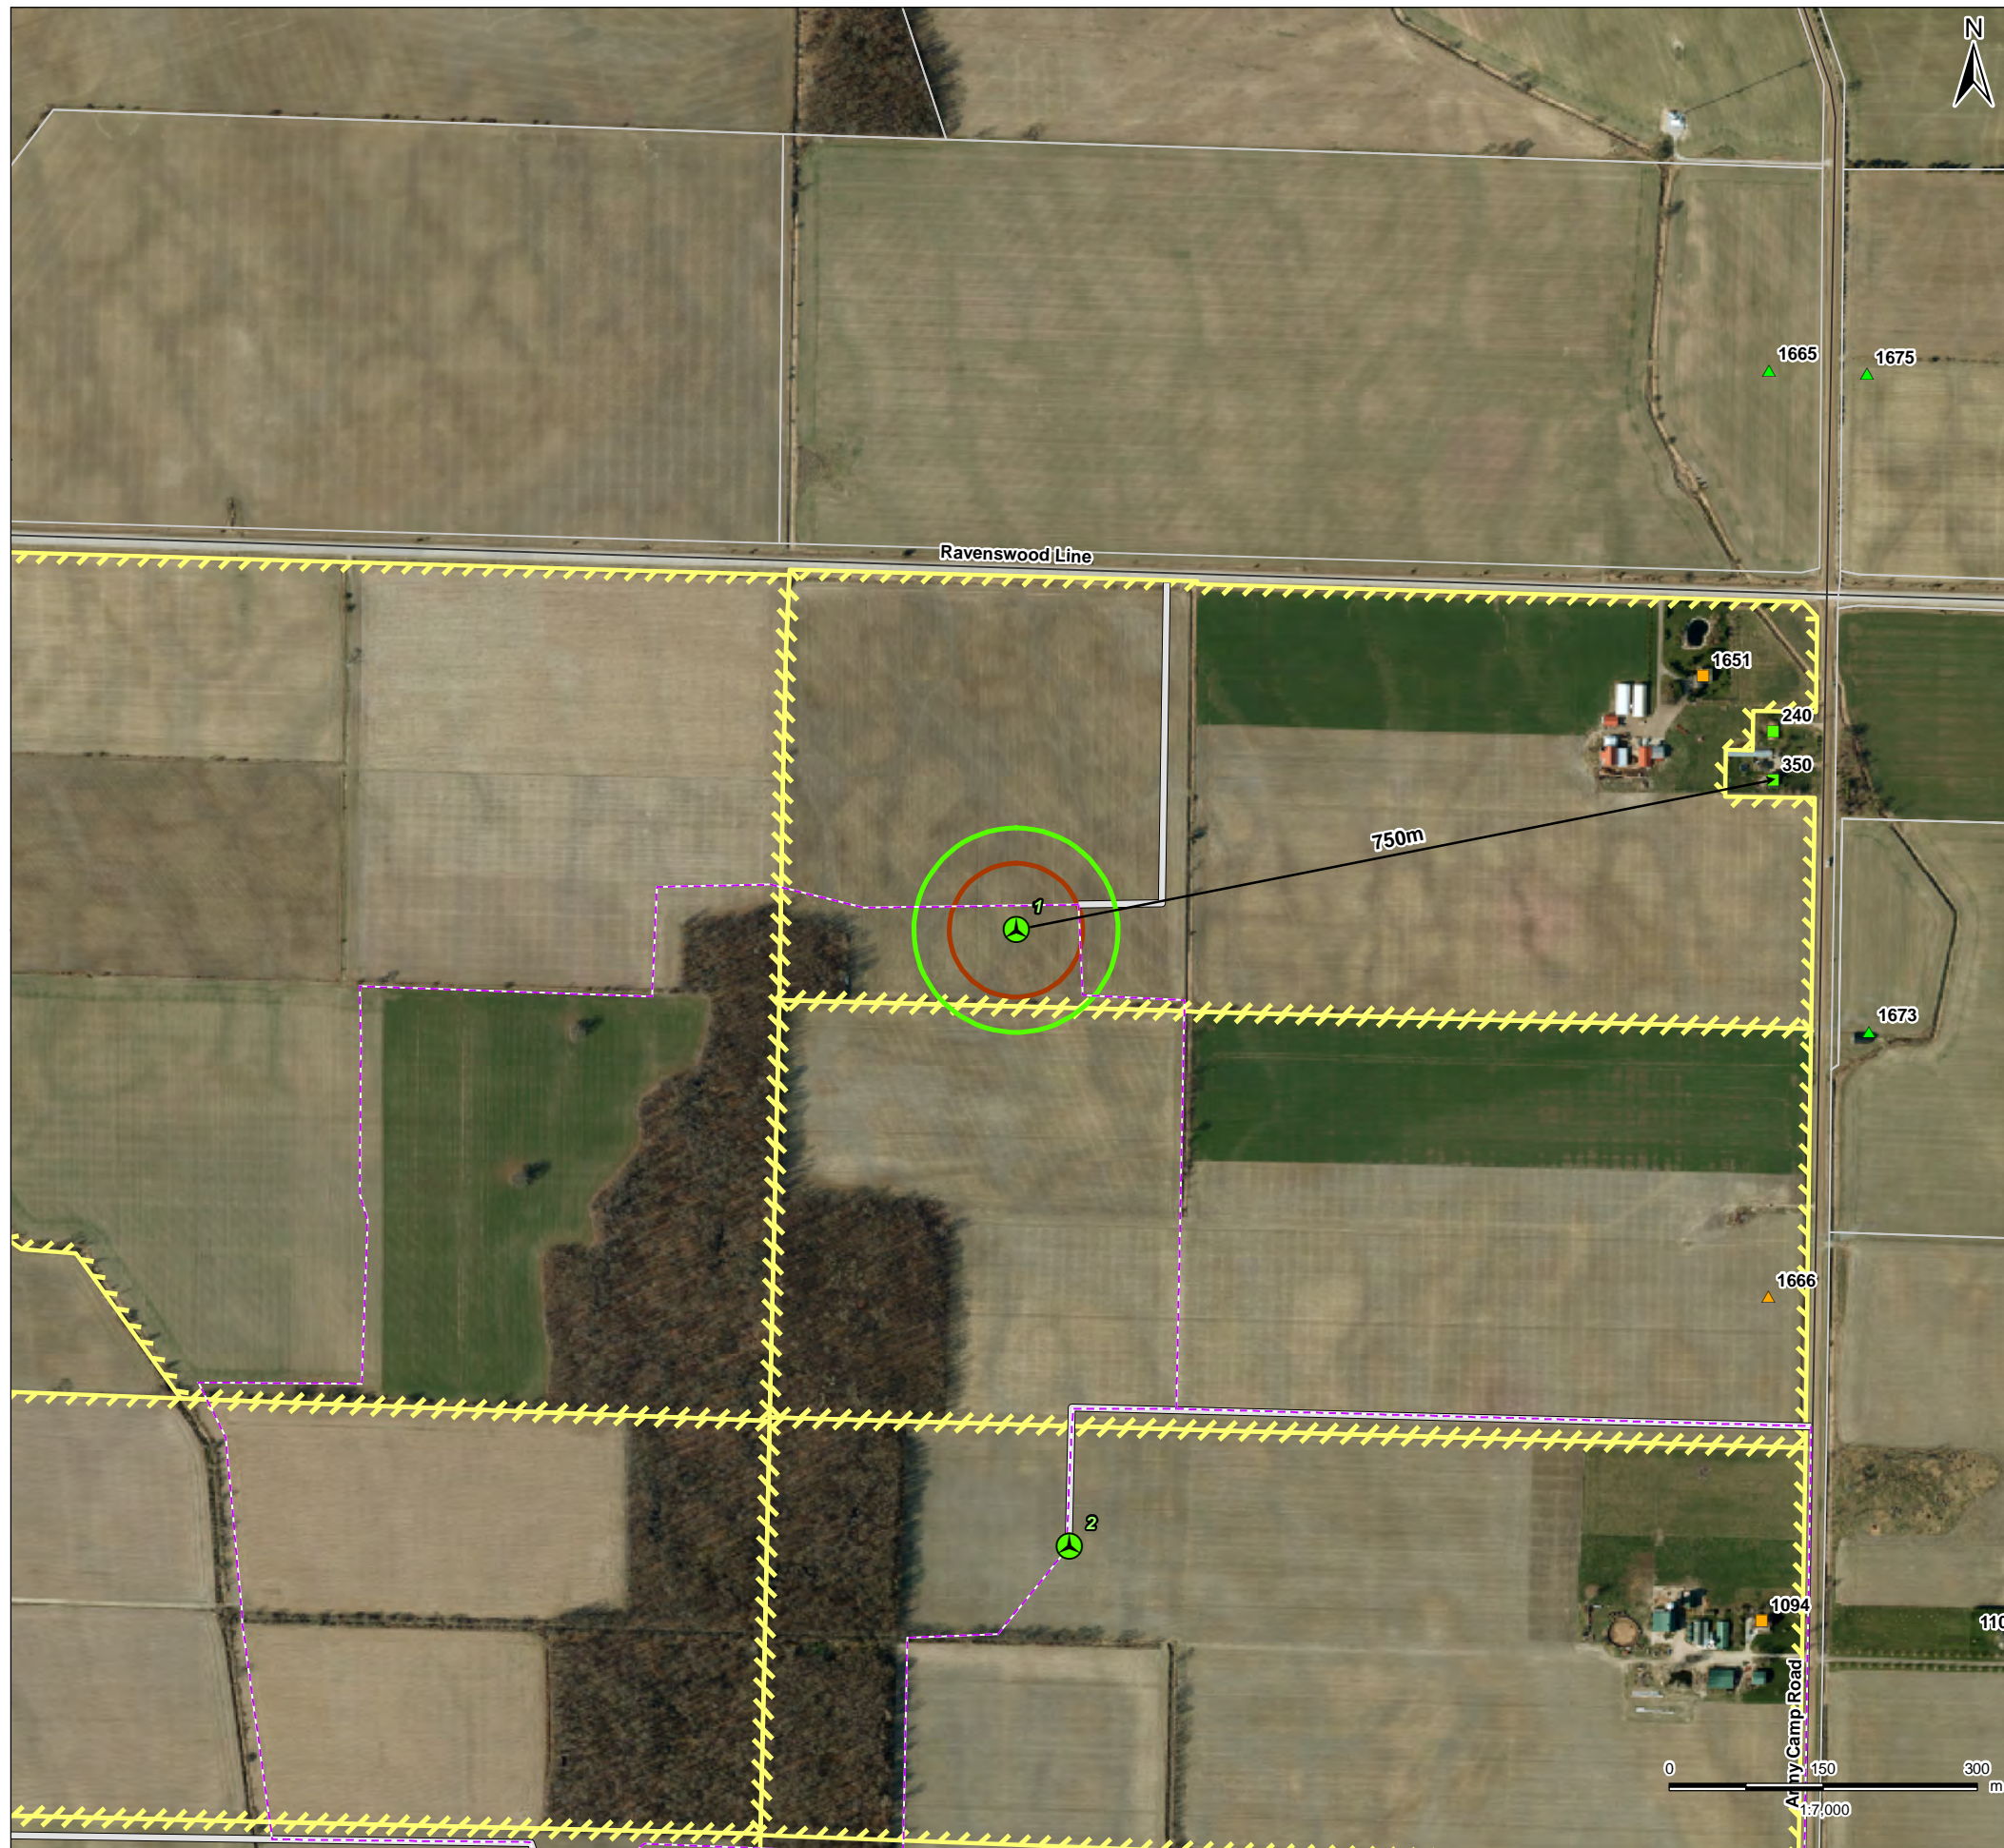
Figure No.
Turbine 1

Detailed Turbine Location

Turbine ID	Distance to Property Line (m)	Distance of Overlap (m)	Features Within Overlap	Potential Adverse Impacts	Preventative Measures
1	74.3	25.2	Infrastructure: <input type="checkbox"/> Land Use and Businesses: <input checked="" type="checkbox"/> Hedgerows: <input type="checkbox"/> Woodlots: <input type="checkbox"/> Watercourses: <input type="checkbox"/>	Potential adverse impacts to agricultural land, including crop damage, soil compaction and tile drainage damage may occur in the unlikely event of turbine collapse.	The turbines would be constructed and designed by professional engineers, undergo regular maintenance and monitoring by operational staff, and contain shutdown mechanisms in instances such as extreme weather or malfunction. In the unlikely event of damage to agricultural land due to turbine collapse, landowners would be compensated by Suncor for any crop damage, soil compaction would be remediated and damaged tile drains (if any) would be repaired. <i>* Neighbouring property is a participating vacant lot.</i>

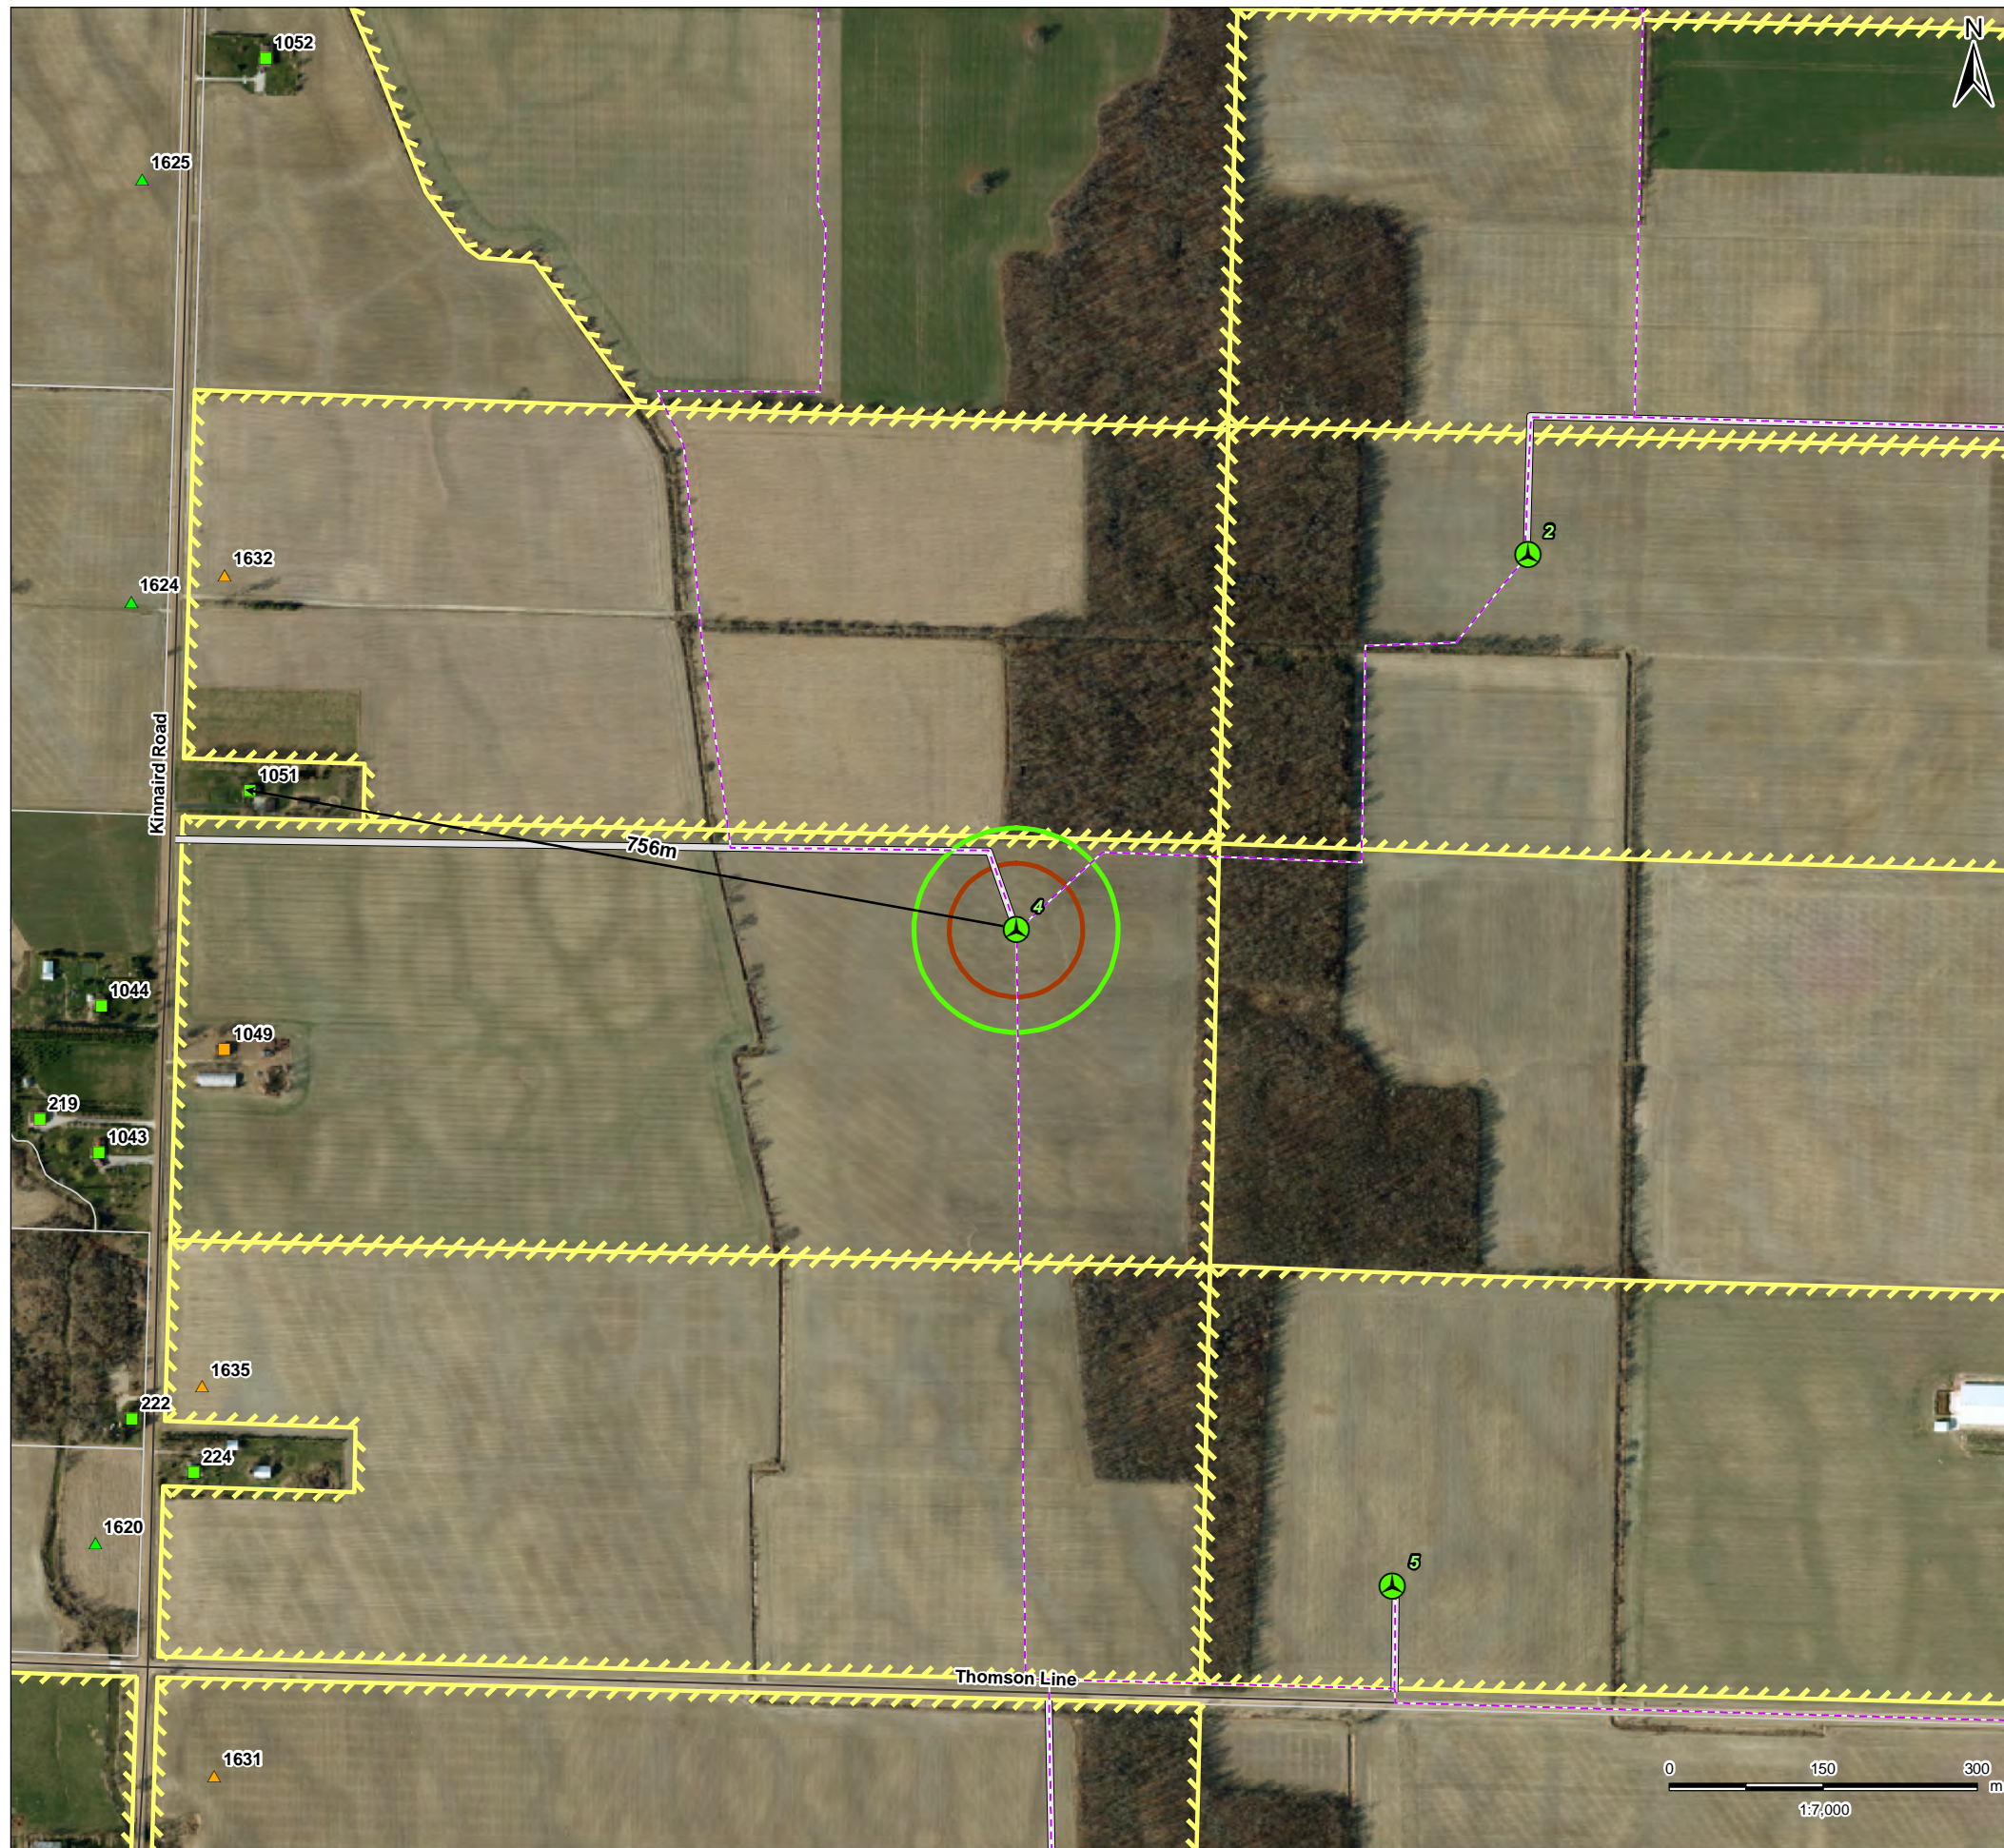
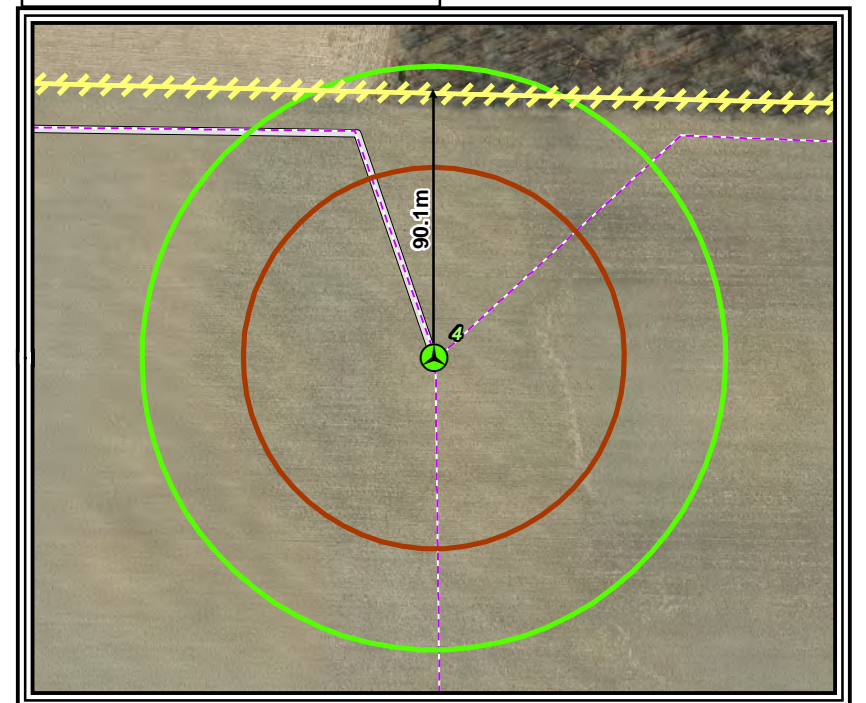
Figure No.
Turbine 4

Detailed Turbine Location

4	90.1	9.4	Infrastructure: <input type="checkbox"/> Land Use and Businesses: <input type="checkbox"/> Hedgerows: <input type="checkbox"/> Woodlots: <input checked="" type="checkbox"/> Watercourses: <input type="checkbox"/>	Potential damage to natural features within the adjacent woodlot. Damage to the woodlot would be limited to less than 1% of the total area of the woodlot and the impact would not be considered significant to the overall function of the woodlot.	The turbines would be constructed and designed by professional engineers, undergo regular maintenance and monitoring by operational staff, and contain shutdown mechanisms in instances such as extreme weather or malfunction. Damaged trees and vegetation would be removed and the impacted land remediated to a similar condition to the extent practical. <i>* Neighbouring property is a participating vacant lot.</i>
9	90.5	9	Infrastructure: <input type="checkbox"/> Land Use and Businesses: <input type="checkbox"/> Hedgerows: <input type="checkbox"/> Woodlots: <input checked="" type="checkbox"/> Watercourses: <input type="checkbox"/>	Potential damage to natural features within the adjacent woodlot. Damage to the woodlot would be limited to less than 1% of the total area of the woodlot and the impact would not be considered significant to the overall function of the woodlot.	The turbines would be constructed and designed by professional engineers, undergo regular maintenance and monitoring by operational staff, and contain shutdown mechanisms in instances such as extreme weather or malfunction. Damaged trees and vegetation would be removed and the impacted land remediated to a similar condition to the extent practical.

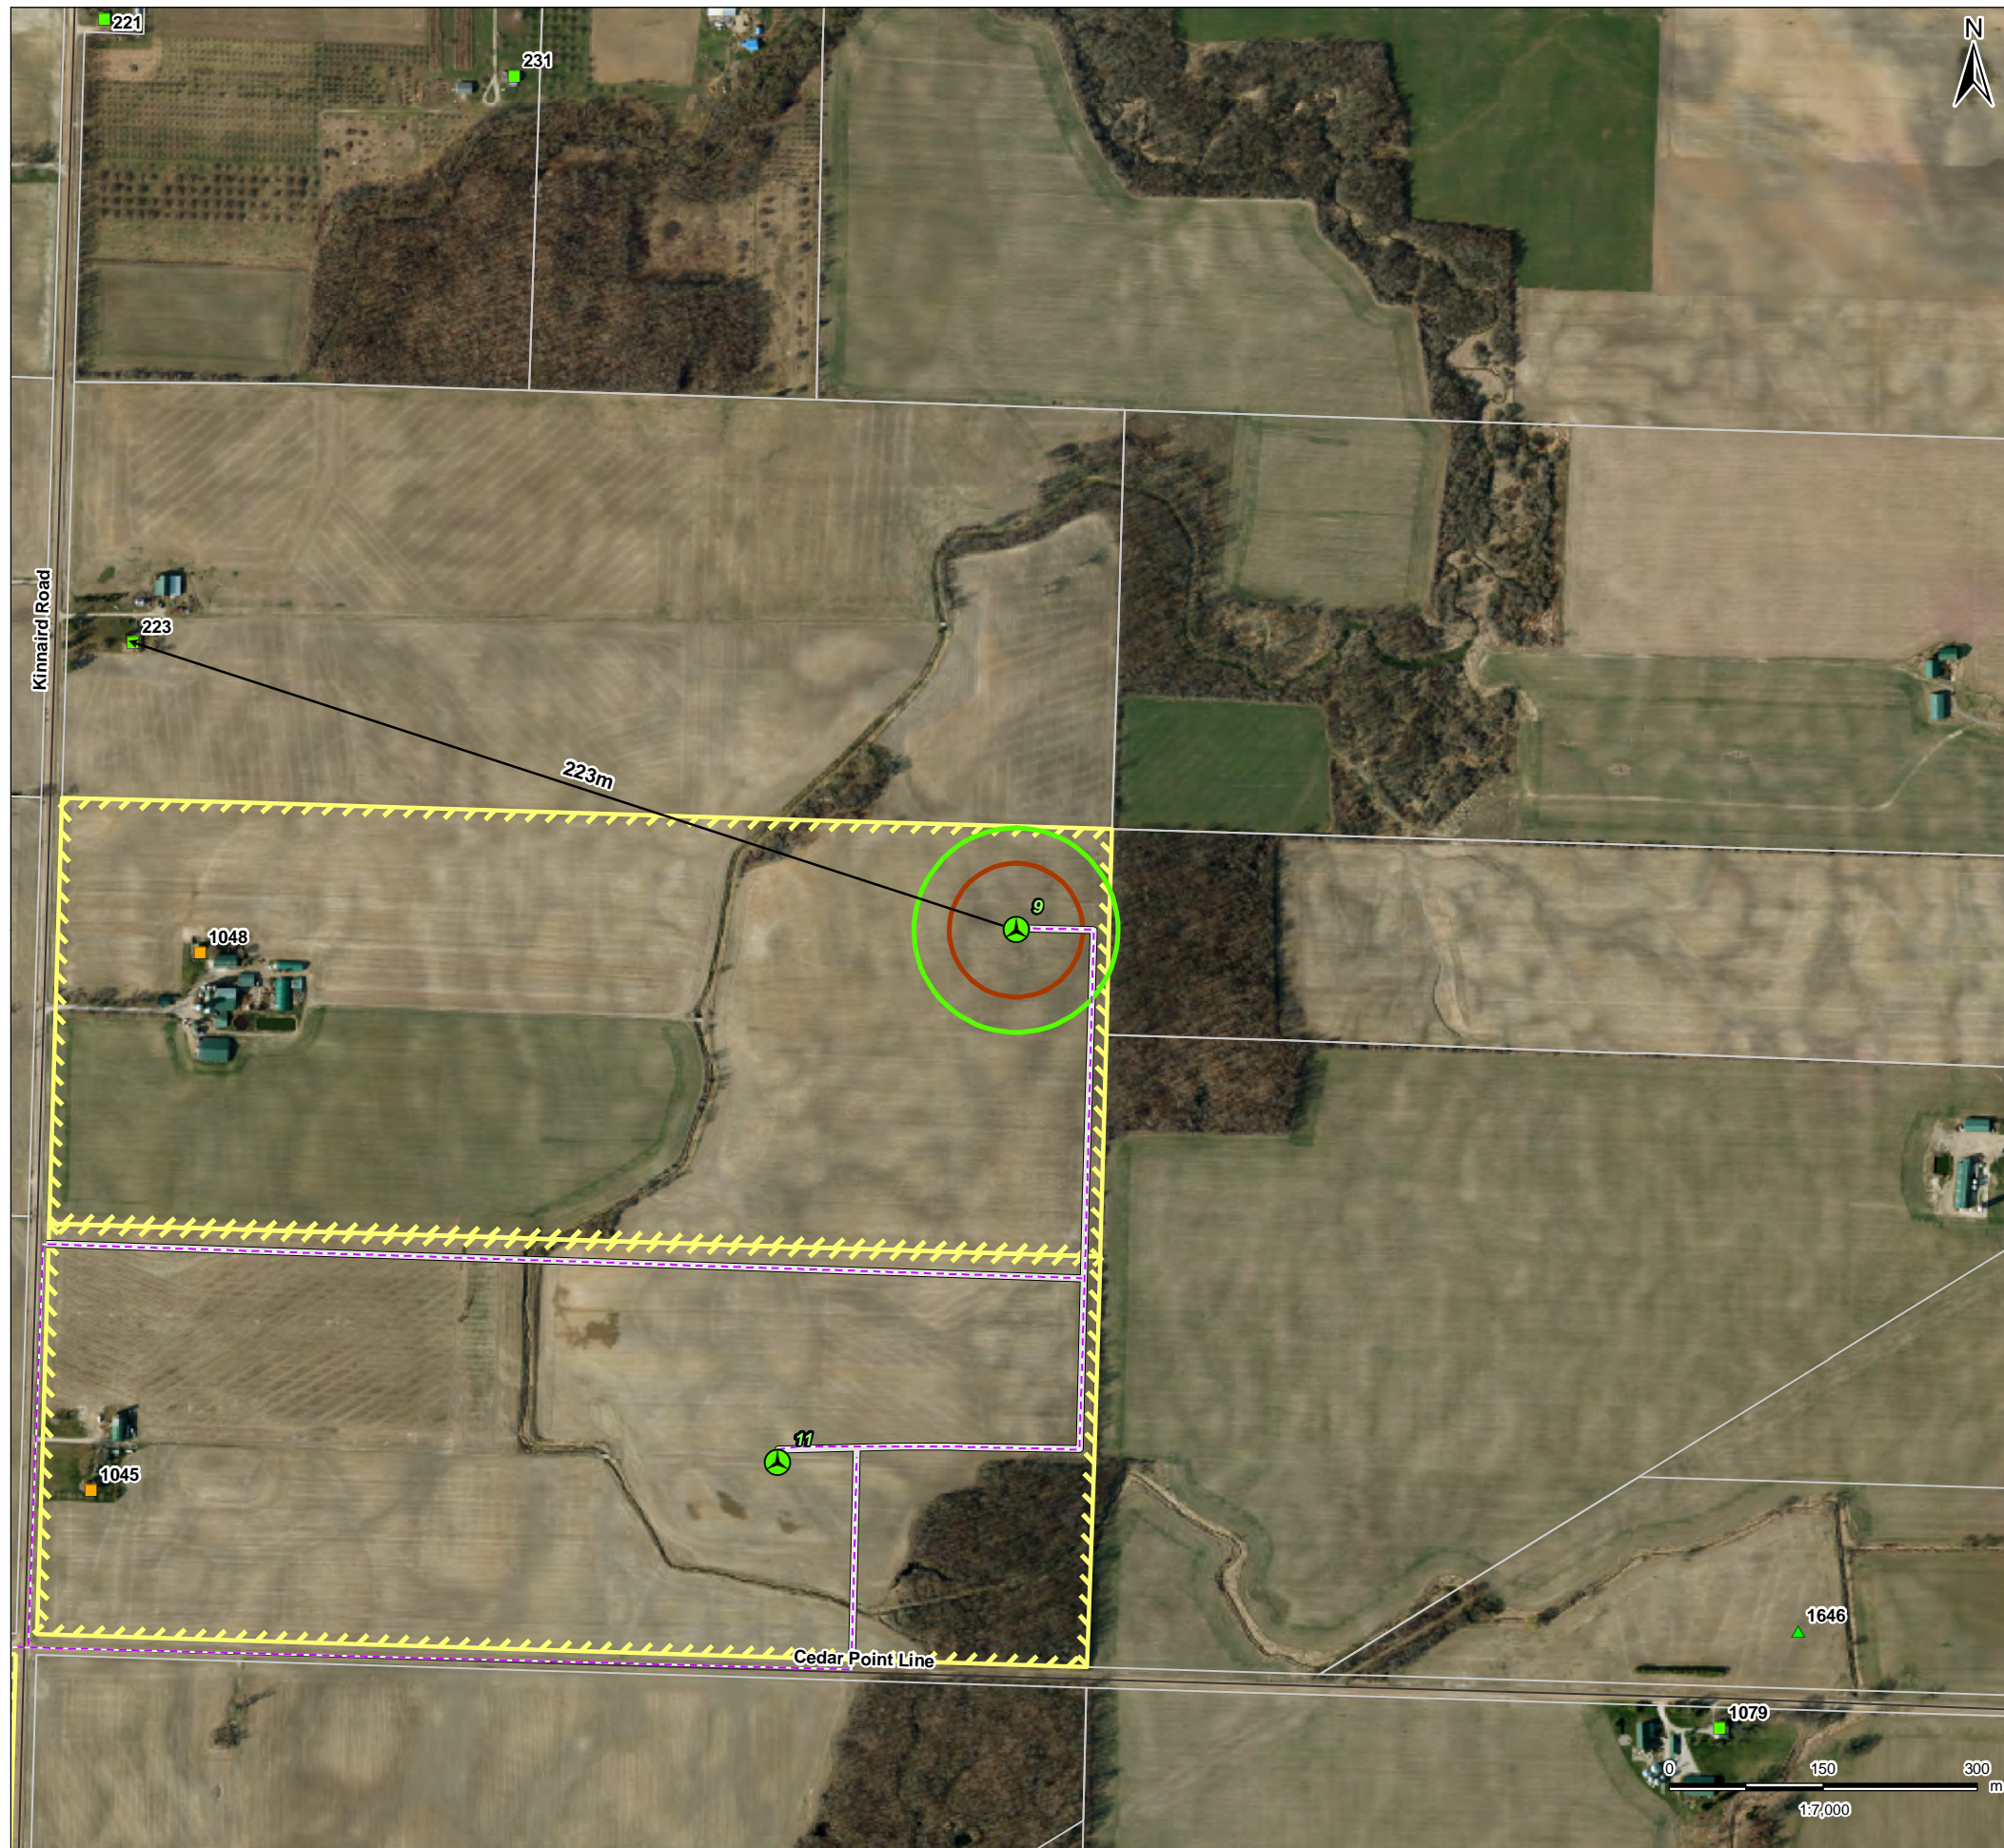
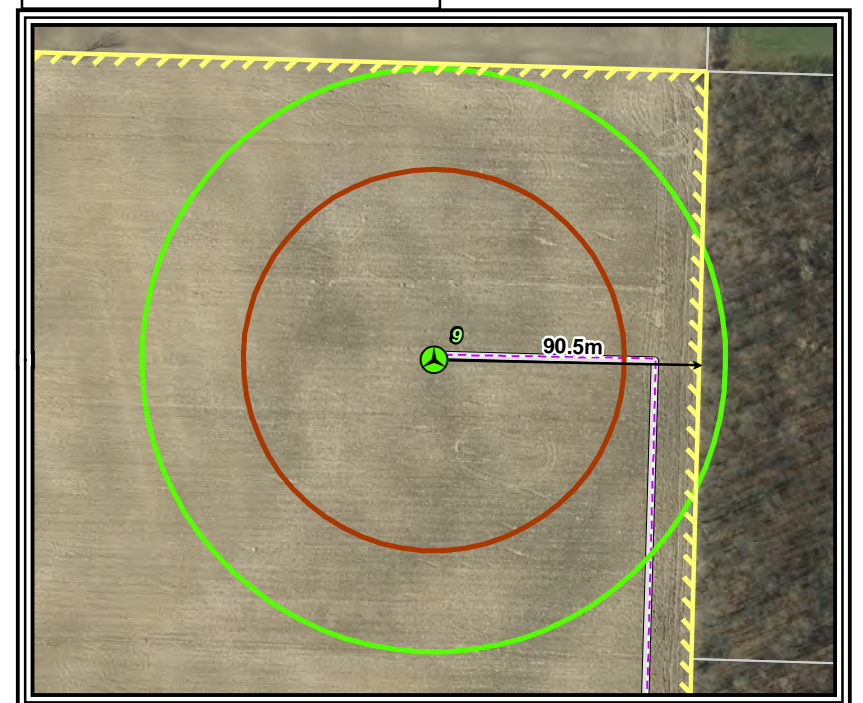
Figure No.
Turbine 9

Detailed Turbine Location

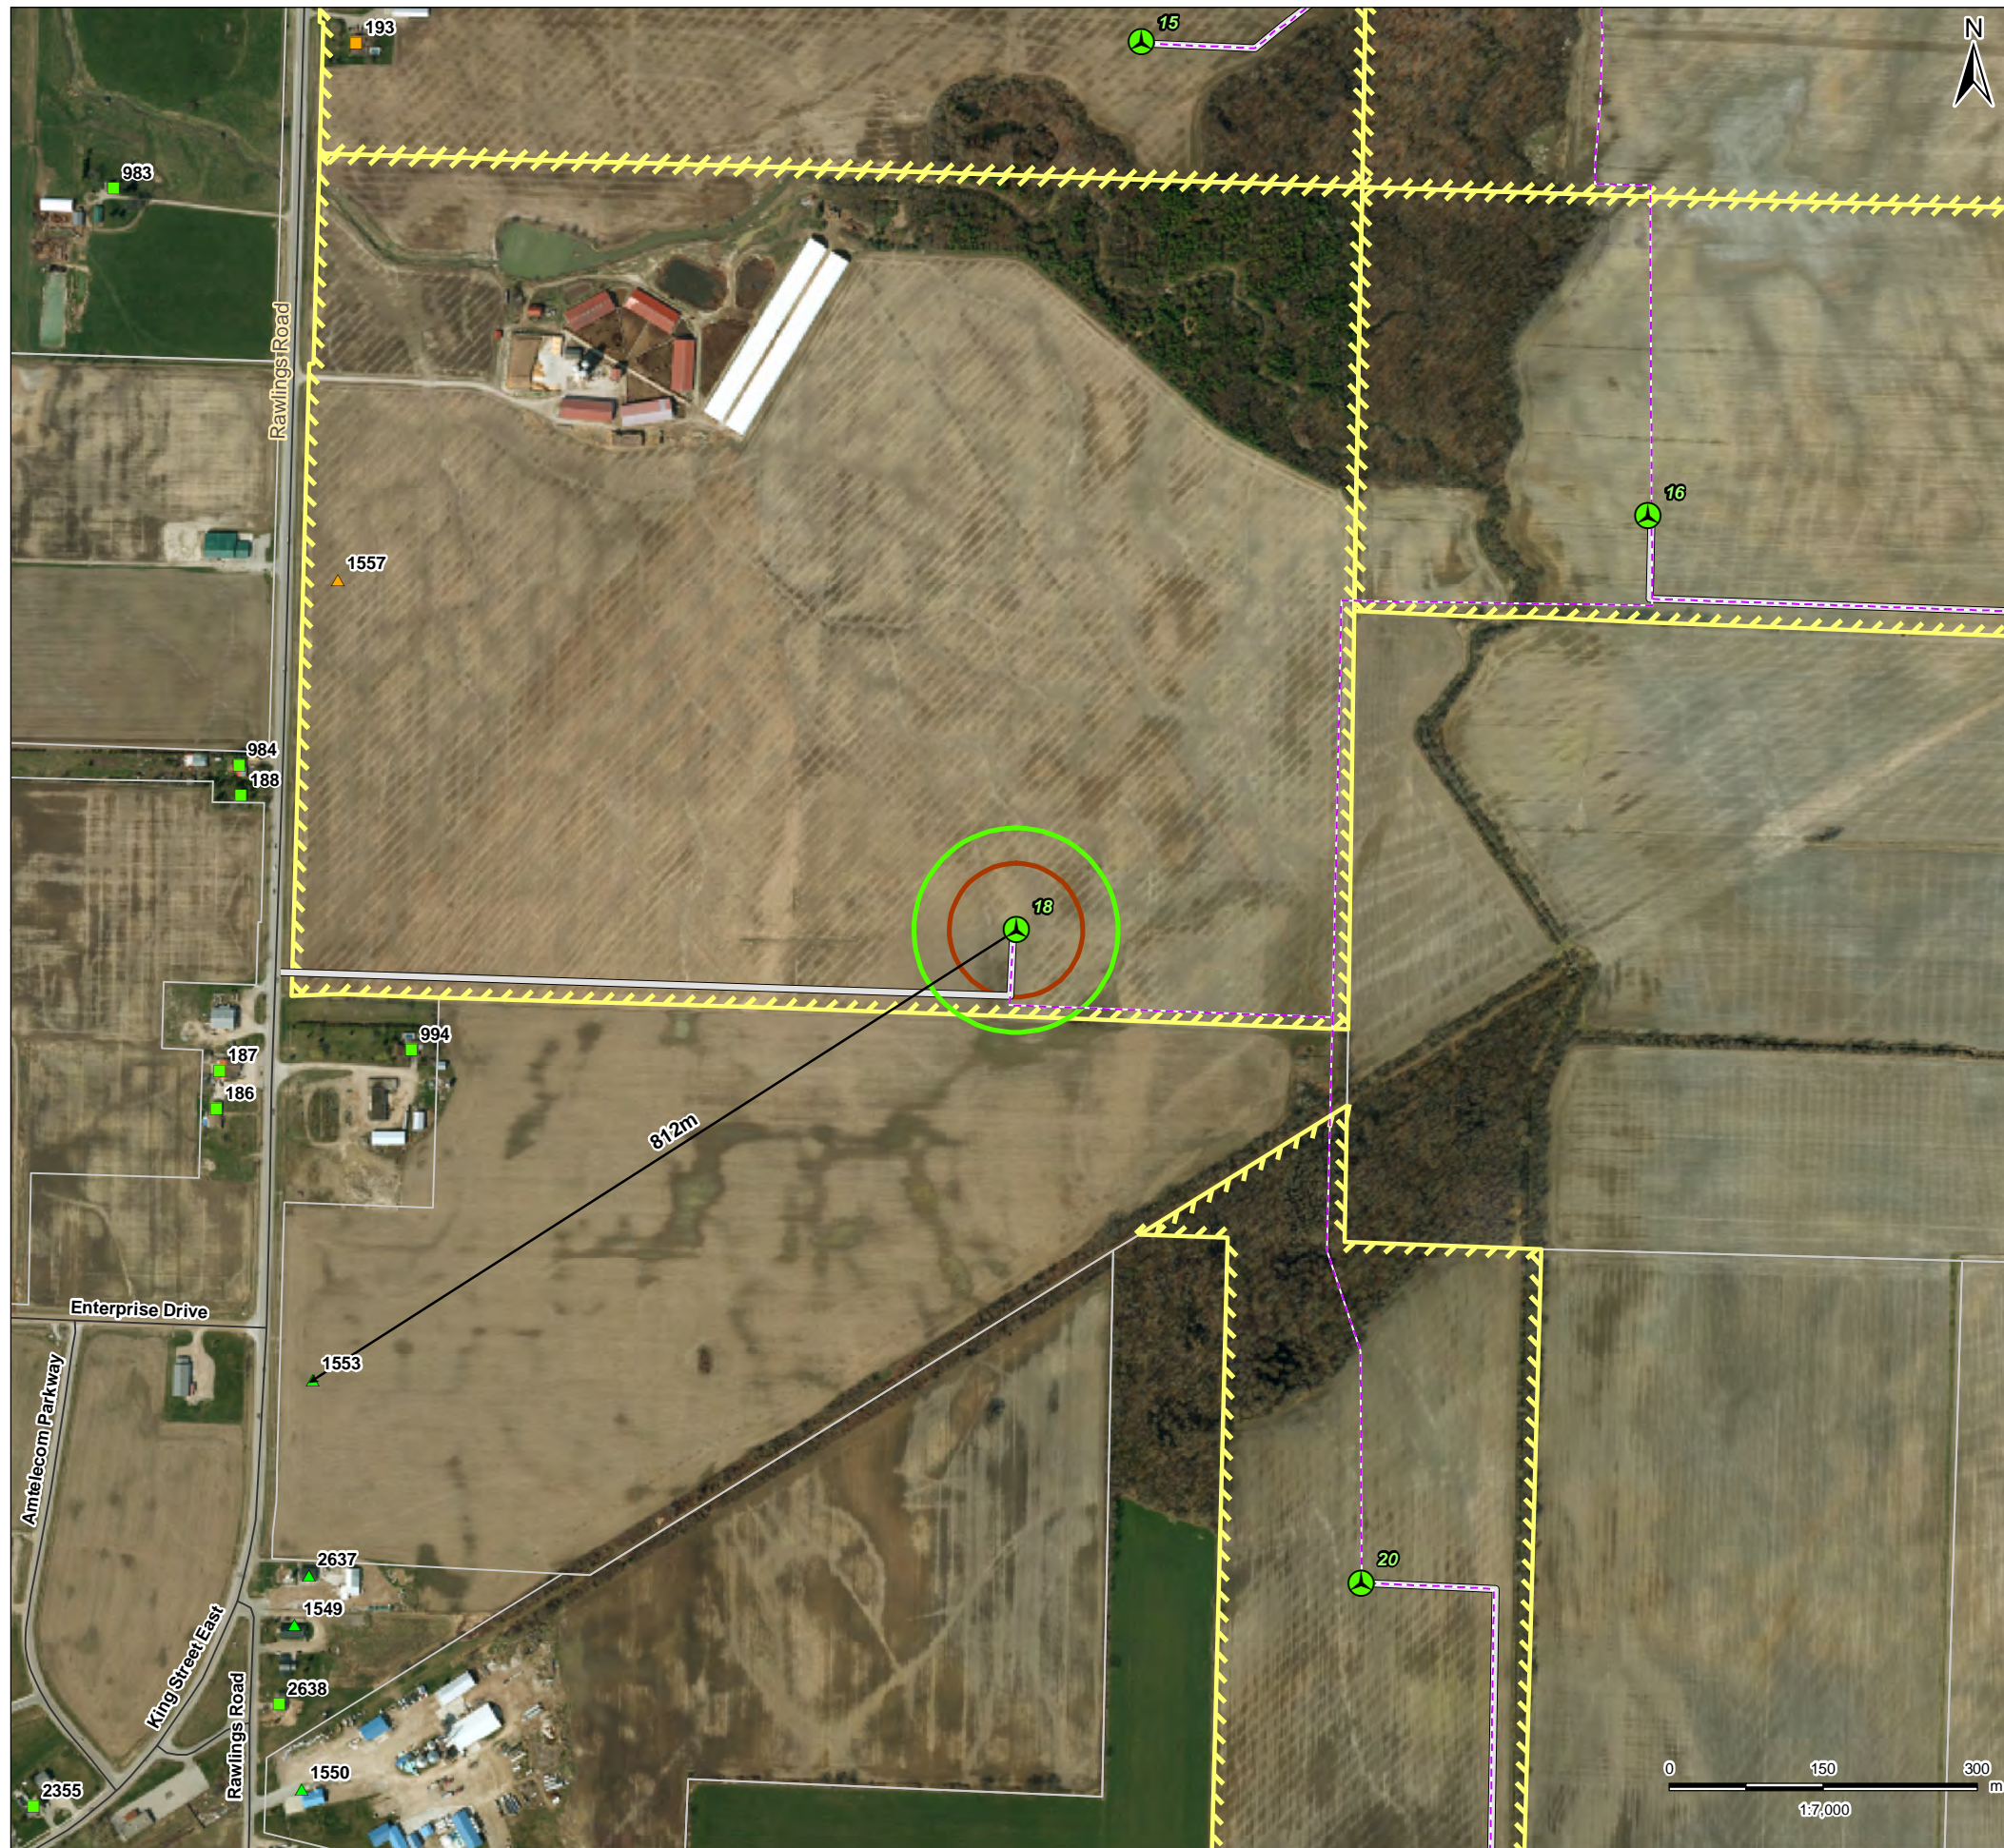
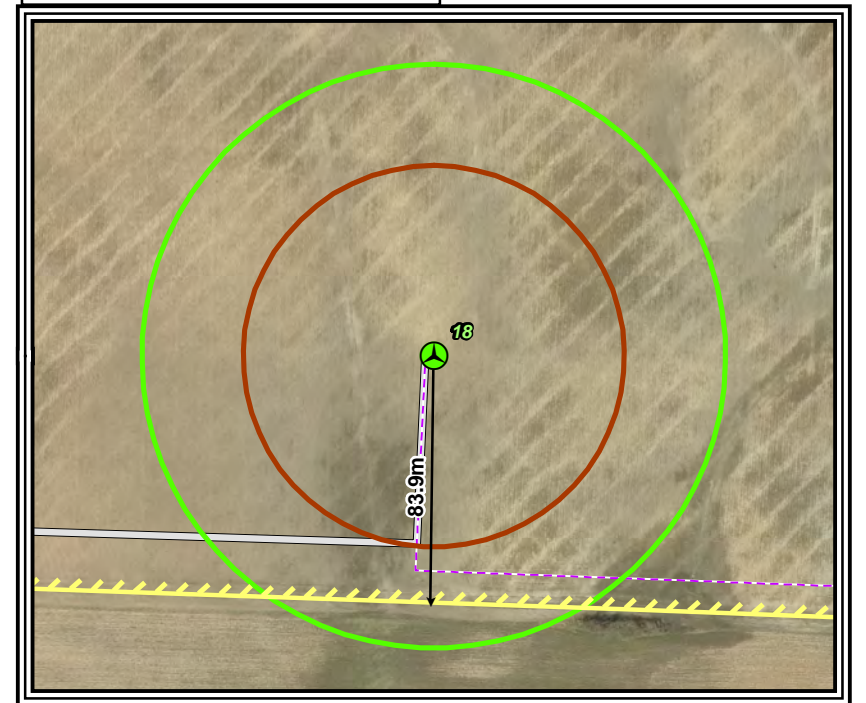
Figure No.
Turbine 18

Detailed Turbine Location

18	83.9	15.6	Infrastructure: <input type="checkbox"/> Land Use and Businesses: <input checked="" type="checkbox"/> Hedgerows: <input type="checkbox"/> Woodlots: <input type="checkbox"/> Watercourses: <input type="checkbox"/>	Potential adverse impacts to agricultural land, including crop damage, soil compaction and tile drainage damage may occur in the unlikely event of turbine collapse.	The turbines would be constructed and designed by professional engineers, undergo regular maintenance and monitoring by operational staff, and contain shutdown mechanisms in instances such as extreme weather or malfunction. In the unlikely event of damage to agricultural land due to turbine collapse, landowners would be compensated by Suncor for any crop damage, soil compaction would be remediated and damaged tile drains (if any) would be repaired.
21	75.5	24	Infrastructure: <input type="checkbox"/> Land Use and Businesses: <input checked="" type="checkbox"/> Hedgerows: <input type="checkbox"/> Woodlots: <input type="checkbox"/> Watercourses: <input type="checkbox"/>	Potential adverse impacts to agricultural land, including crop damage, soil compaction and tile drainage damage may occur in the unlikely event of turbine collapse.	The turbines would be constructed and designed by professional engineers, undergo regular maintenance and monitoring by operational staff, and contain shutdown mechanisms in instances such as extreme weather or malfunction. In the unlikely event of damage to agricultural land due to turbine collapse, landowners would be compensated by Suncor for any crop damage, soil compaction would be remediated and damaged tile drains (if any) would be repaired.

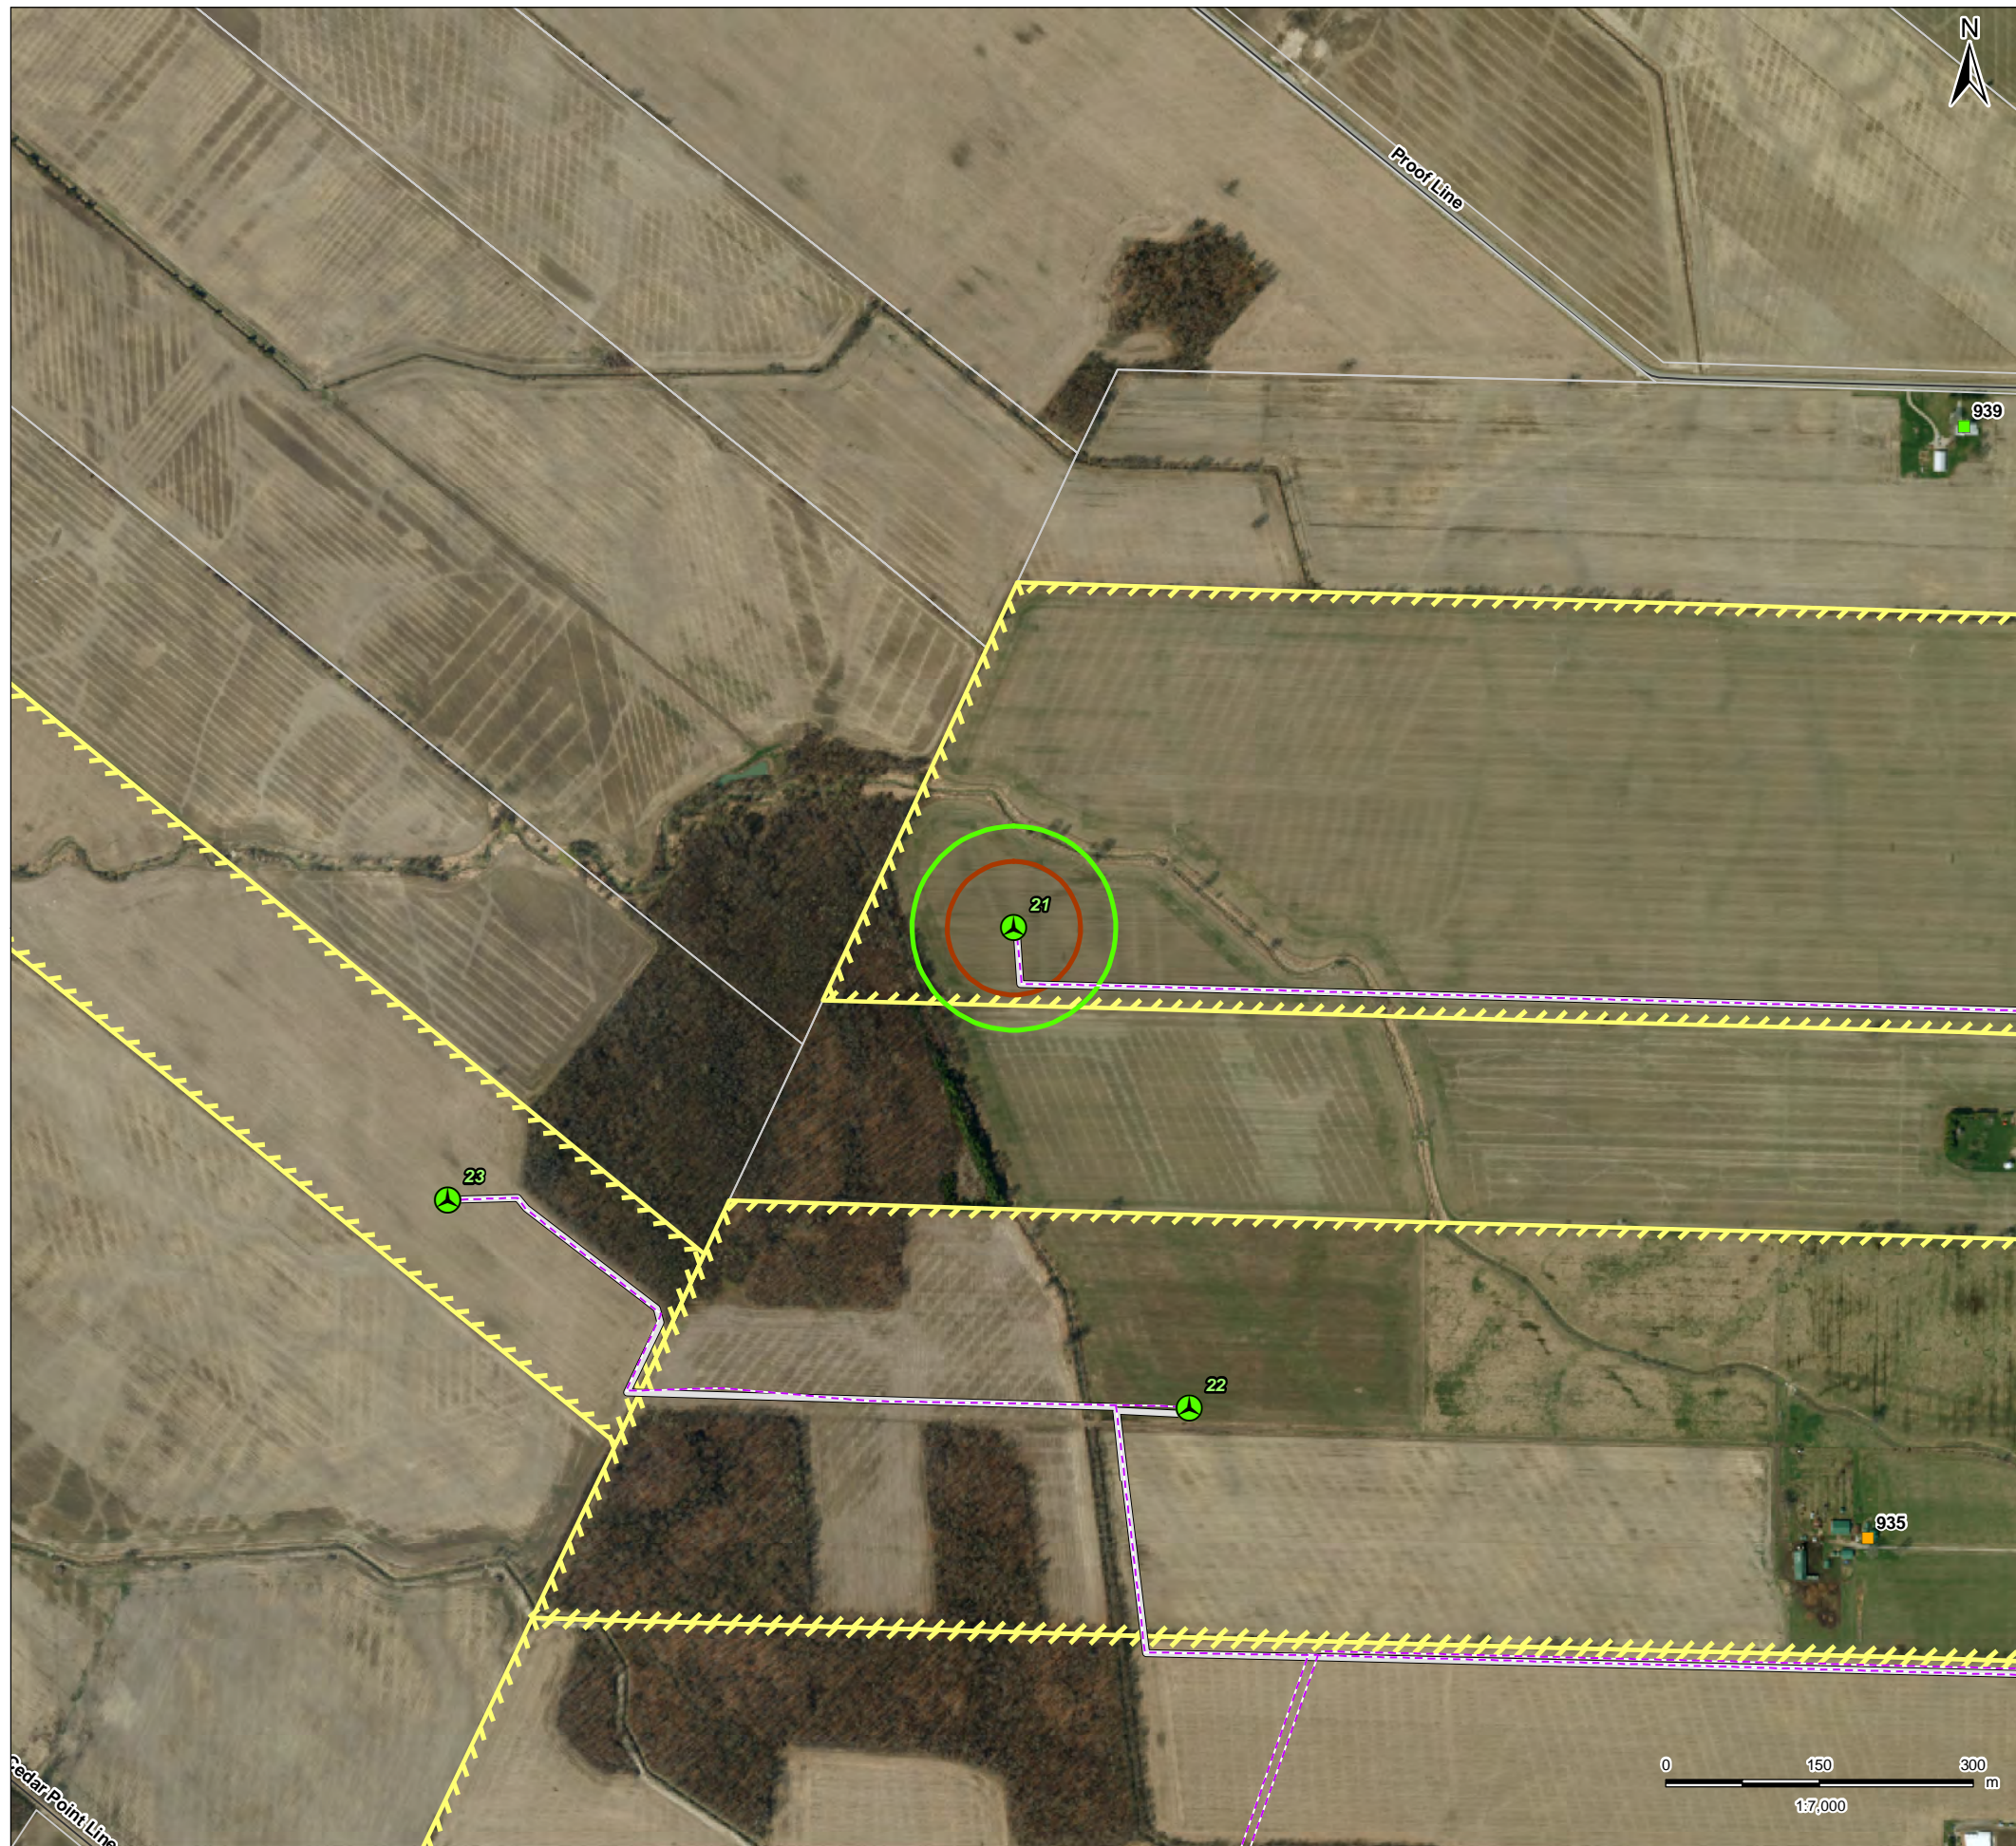
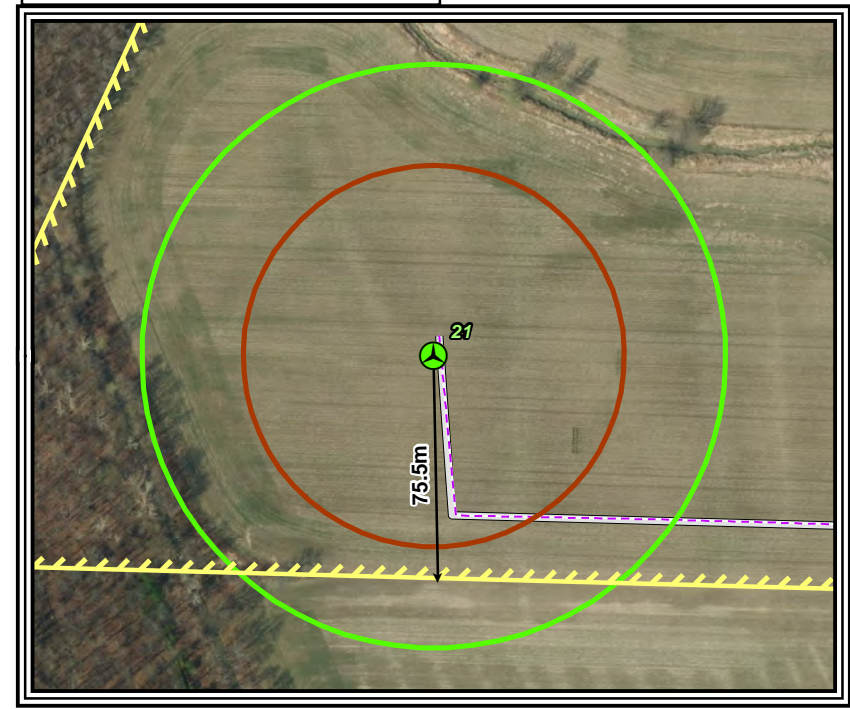
Figure No.
Turbine 21

Detailed Turbine Location
