**SUNCOR ENERGY CEDAR POINT
WIND POWER PROJECT
PROPERTY LINE SETBACK ASSESSMENT
REPORT**

File No. 160960709
April 2013

**Figures: Individual Turbine Locations and
Property Line Setbacks**

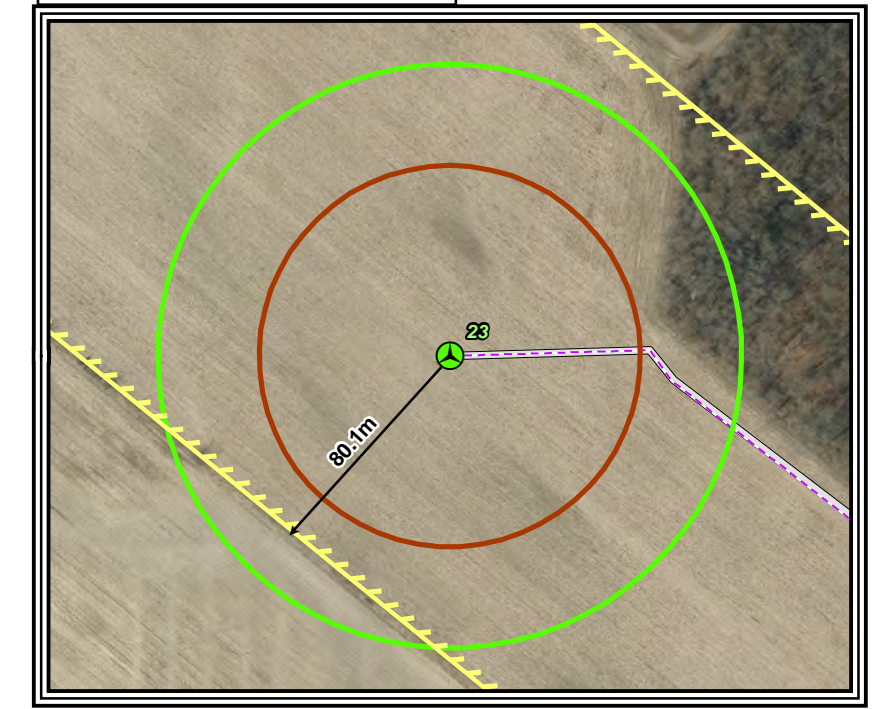
Figure No.
Turbine 23

Detailed Turbine Location

23	80.1	19.4	Infrastructure: <input type="checkbox"/> Land Use and Businesses: <input checked="" type="checkbox"/>	Potential adverse impacts to agricultural land, including crop damage, soil compaction and tile drainage damage may occur in the unlikely event of turbine collapse.	The turbines would be constructed and designed by professional engineers, undergo regular maintenance and monitoring by operational staff, and contain shutdown mechanisms in instances such as extreme weather or malfunction. In the unlikely event of damage to agricultural land due to turbine collapse, landowners would be

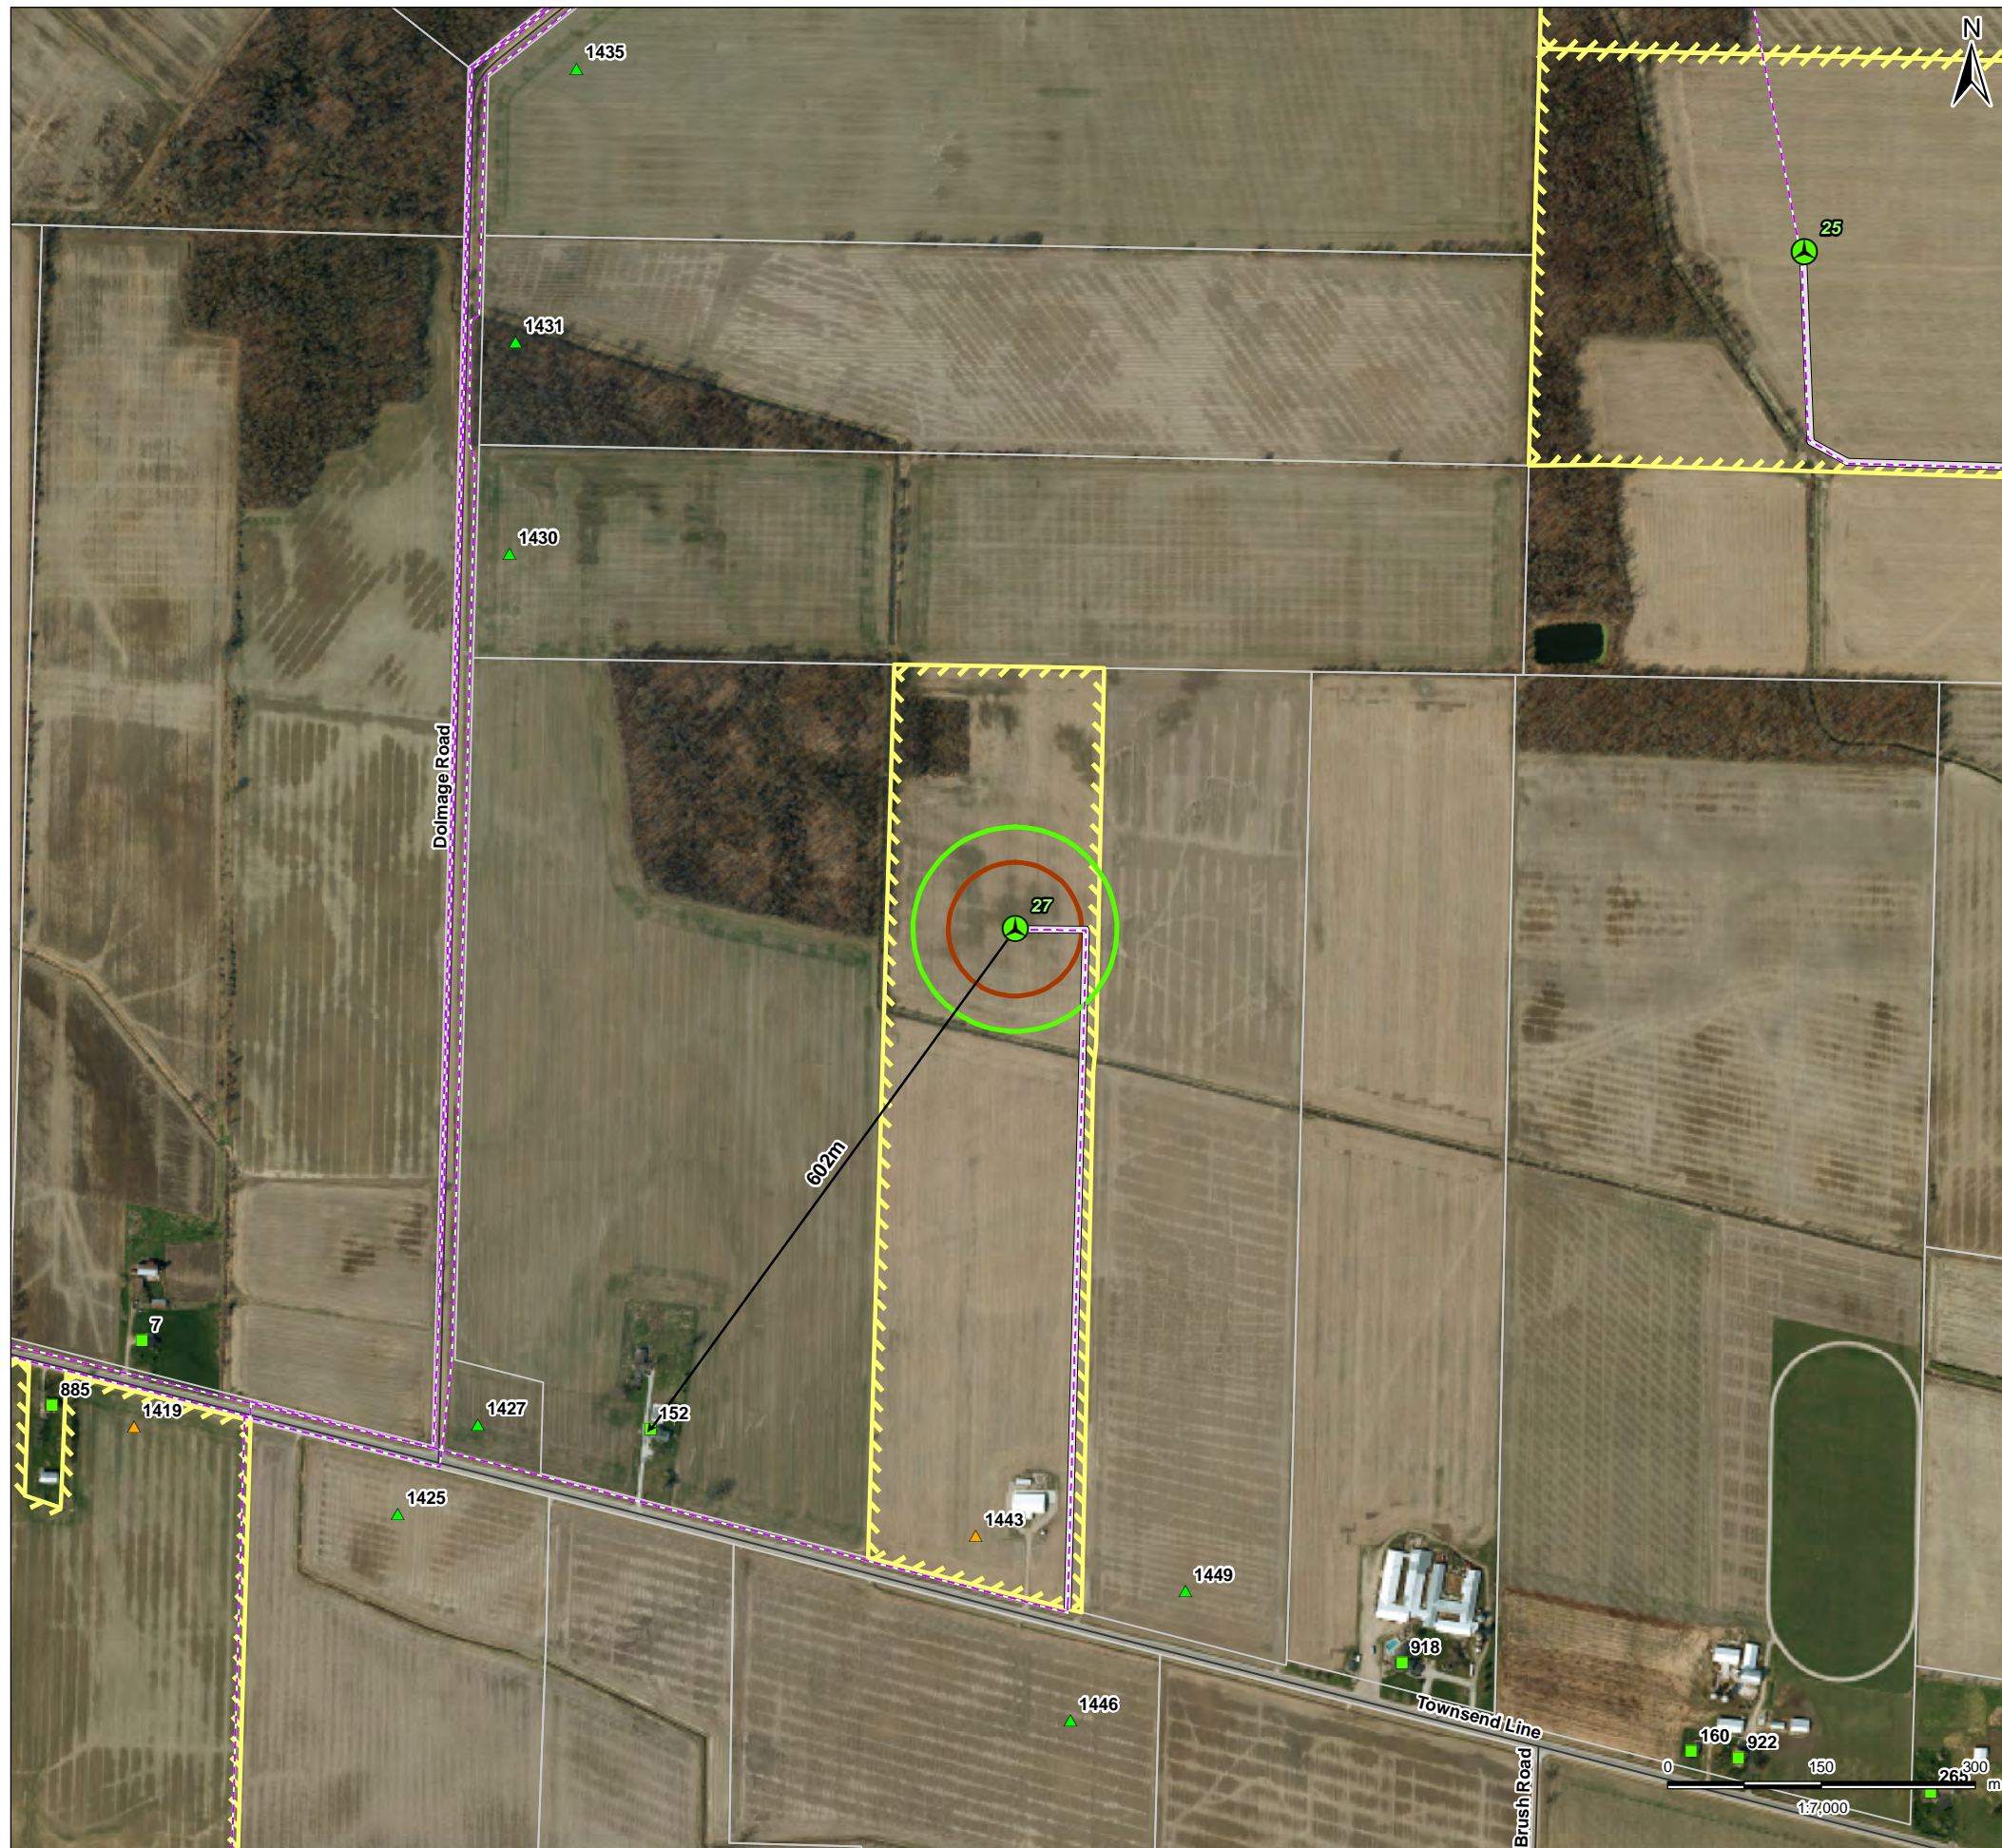
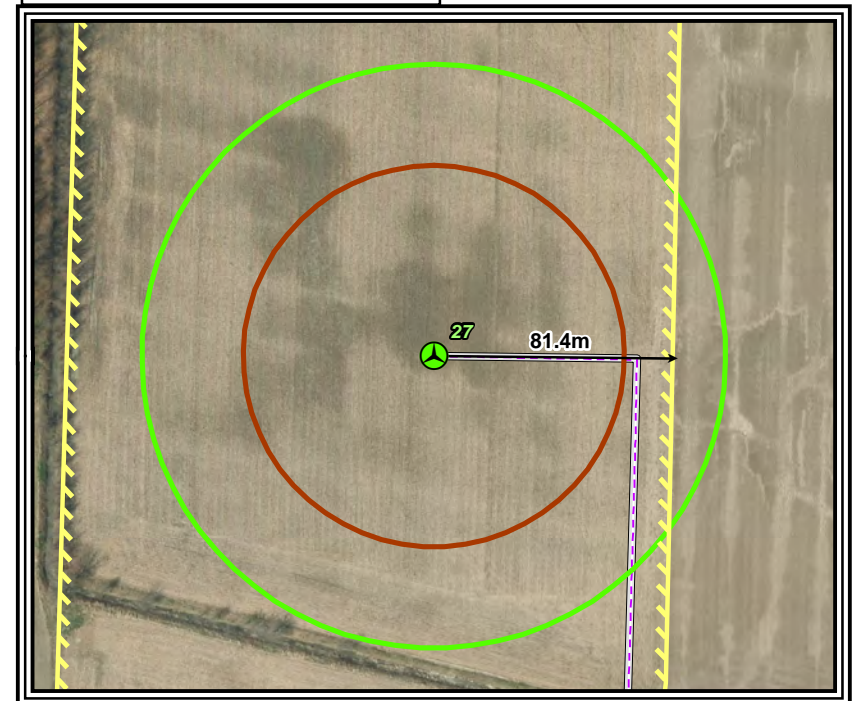
Turbine 27

Detailed Turbine Location

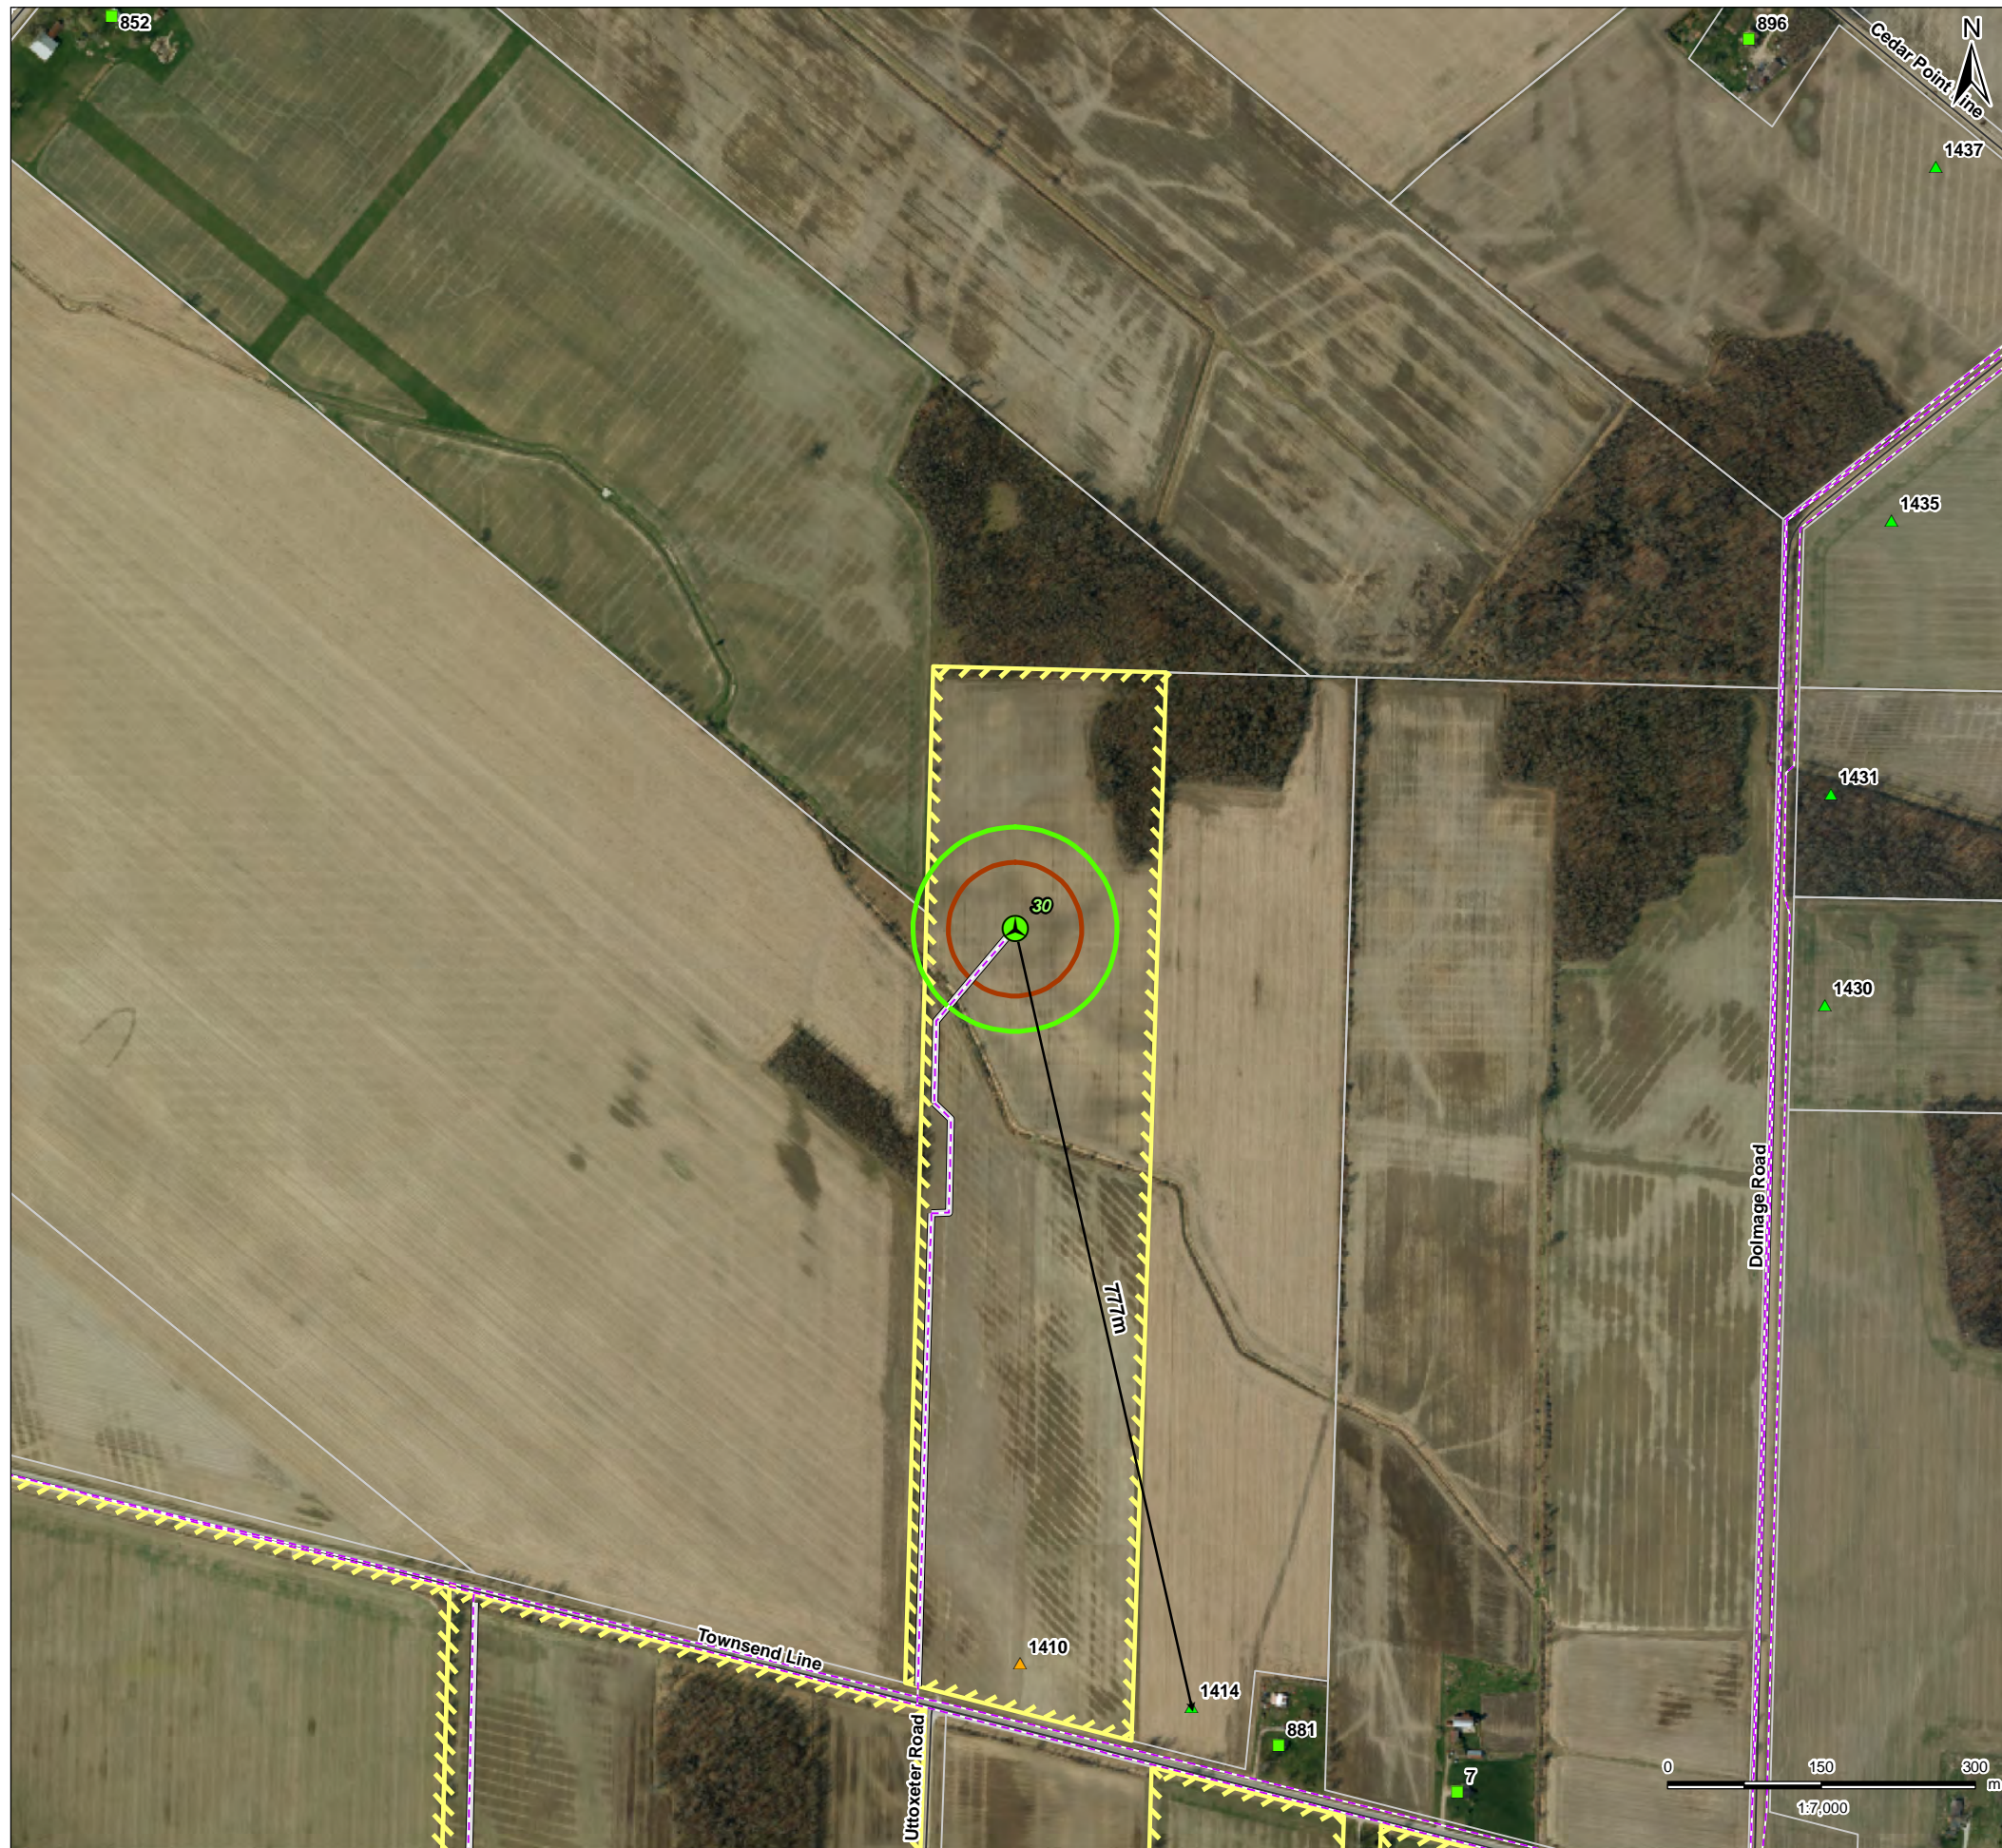
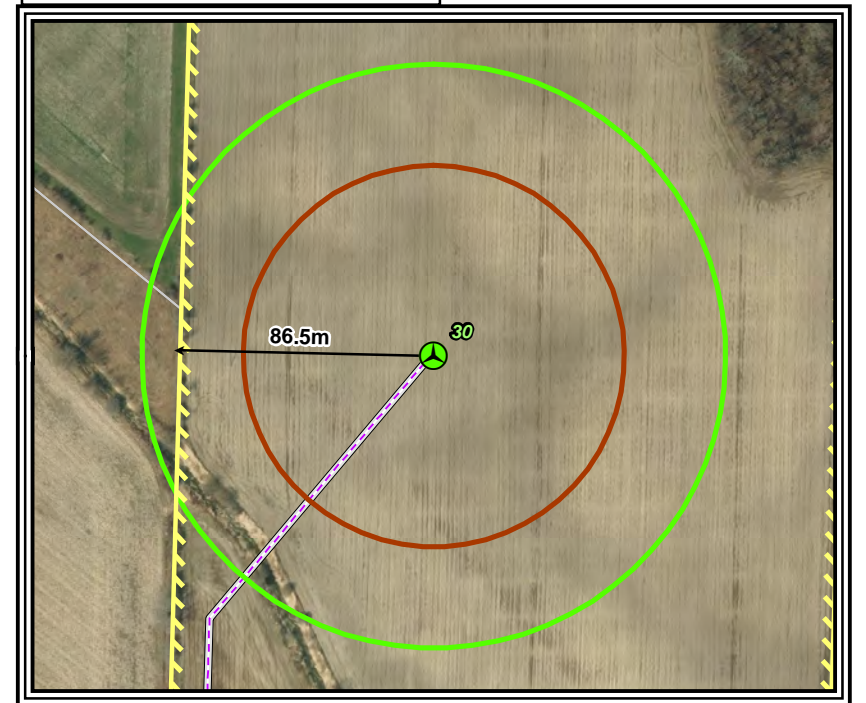
Figure No.
Turbine 30

Detailed Turbine Location

30	86.5	13	Infrastructure: <input type="checkbox"/> Land Use and Businesses: <input checked="" type="checkbox"/> Hedgerows: <input type="checkbox"/> Woodlots: <input type="checkbox"/> Watercourses: <input type="checkbox"/>	Potential adverse impacts to agricultural land, including crop damage, soil compaction and tile drainage damage may occur in the unlikely event of turbine collapse.	The turbines would be constructed and designed by professional engineers, undergo regular maintenance and monitoring by operational staff, and contain shutdown mechanisms in instances such as extreme weather or malfunction. In the unlikely event of damage to agricultural land due to turbine collapse, landowners would be compensated by Suncor for any crop damage, soil compaction would be remediated and damaged tile drains (if any) would be repaired.
31	92	7.5	Infrastructure: <input type="checkbox"/> Land Use and Businesses: <input checked="" type="checkbox"/> Hedgerows: <input type="checkbox"/> Woodlots: <input type="checkbox"/> Watercourses: <input type="checkbox"/>	Potential adverse impacts to agricultural land, including crop damage, soil compaction and tile drainage damage may occur in the unlikely event of turbine collapse.	The turbines would be constructed and designed by professional engineers, undergo regular maintenance and monitoring by operational staff, and contain shutdown mechanisms in instances such as extreme weather or malfunction. In the unlikely event of damage to agricultural land due to turbine collapse, landowners would be compensated by Suncor for any crop damage, soil compaction would be remediated and damaged tile drains (if any) would be repaired. * Neighbouring property is a participating lot.

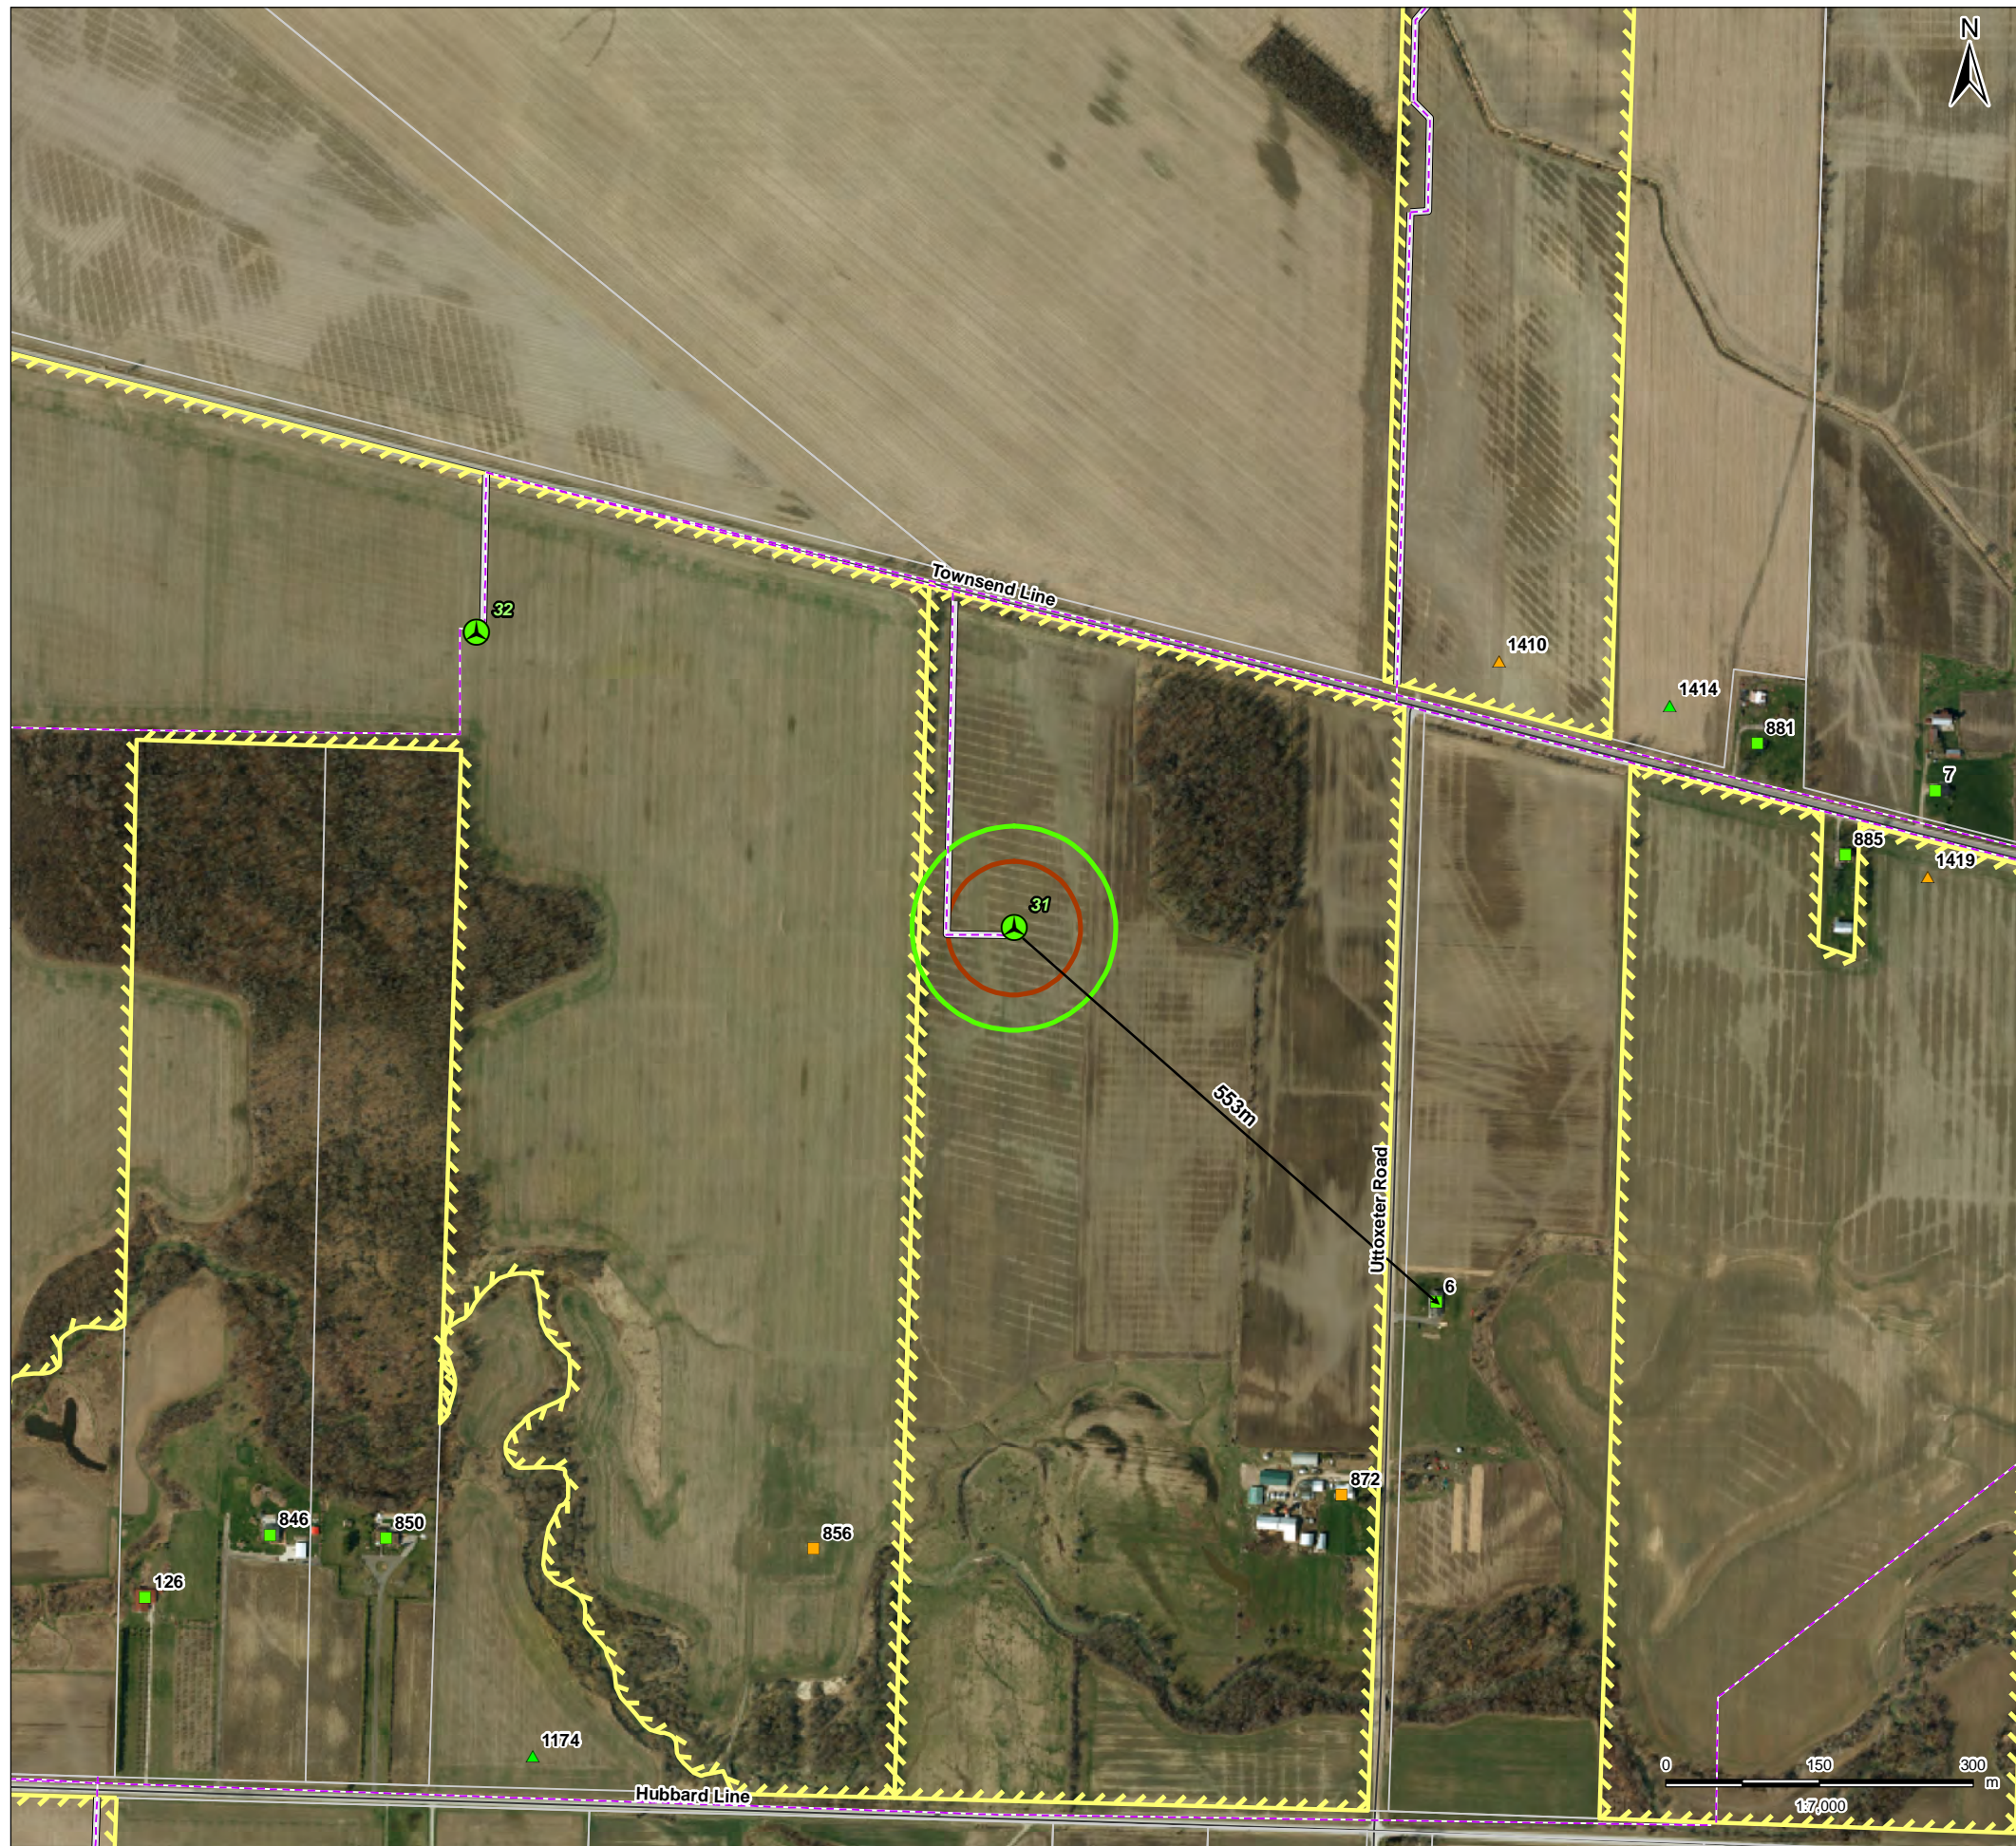
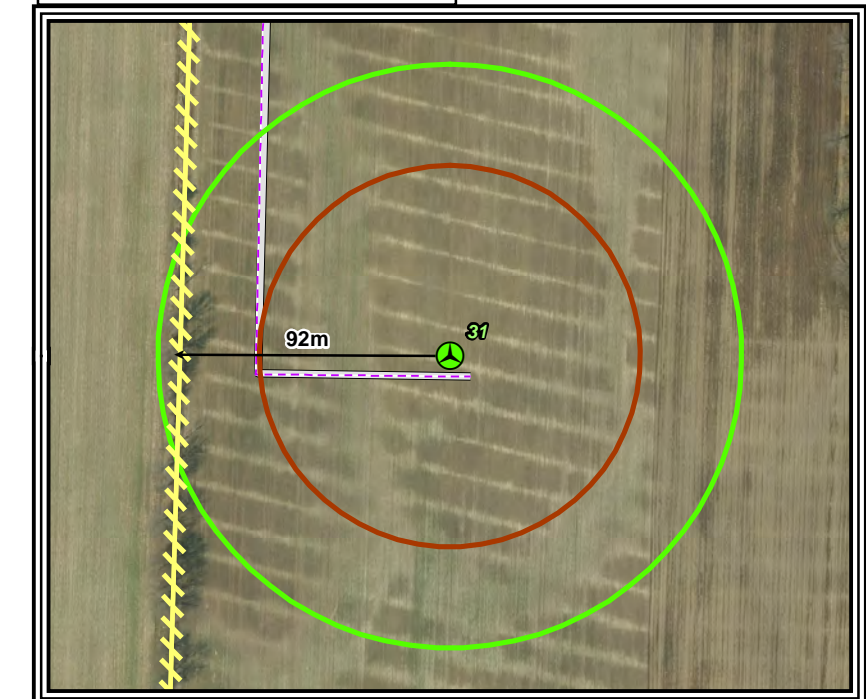
Figure No.
Turbine 31

Detailed Turbine Location

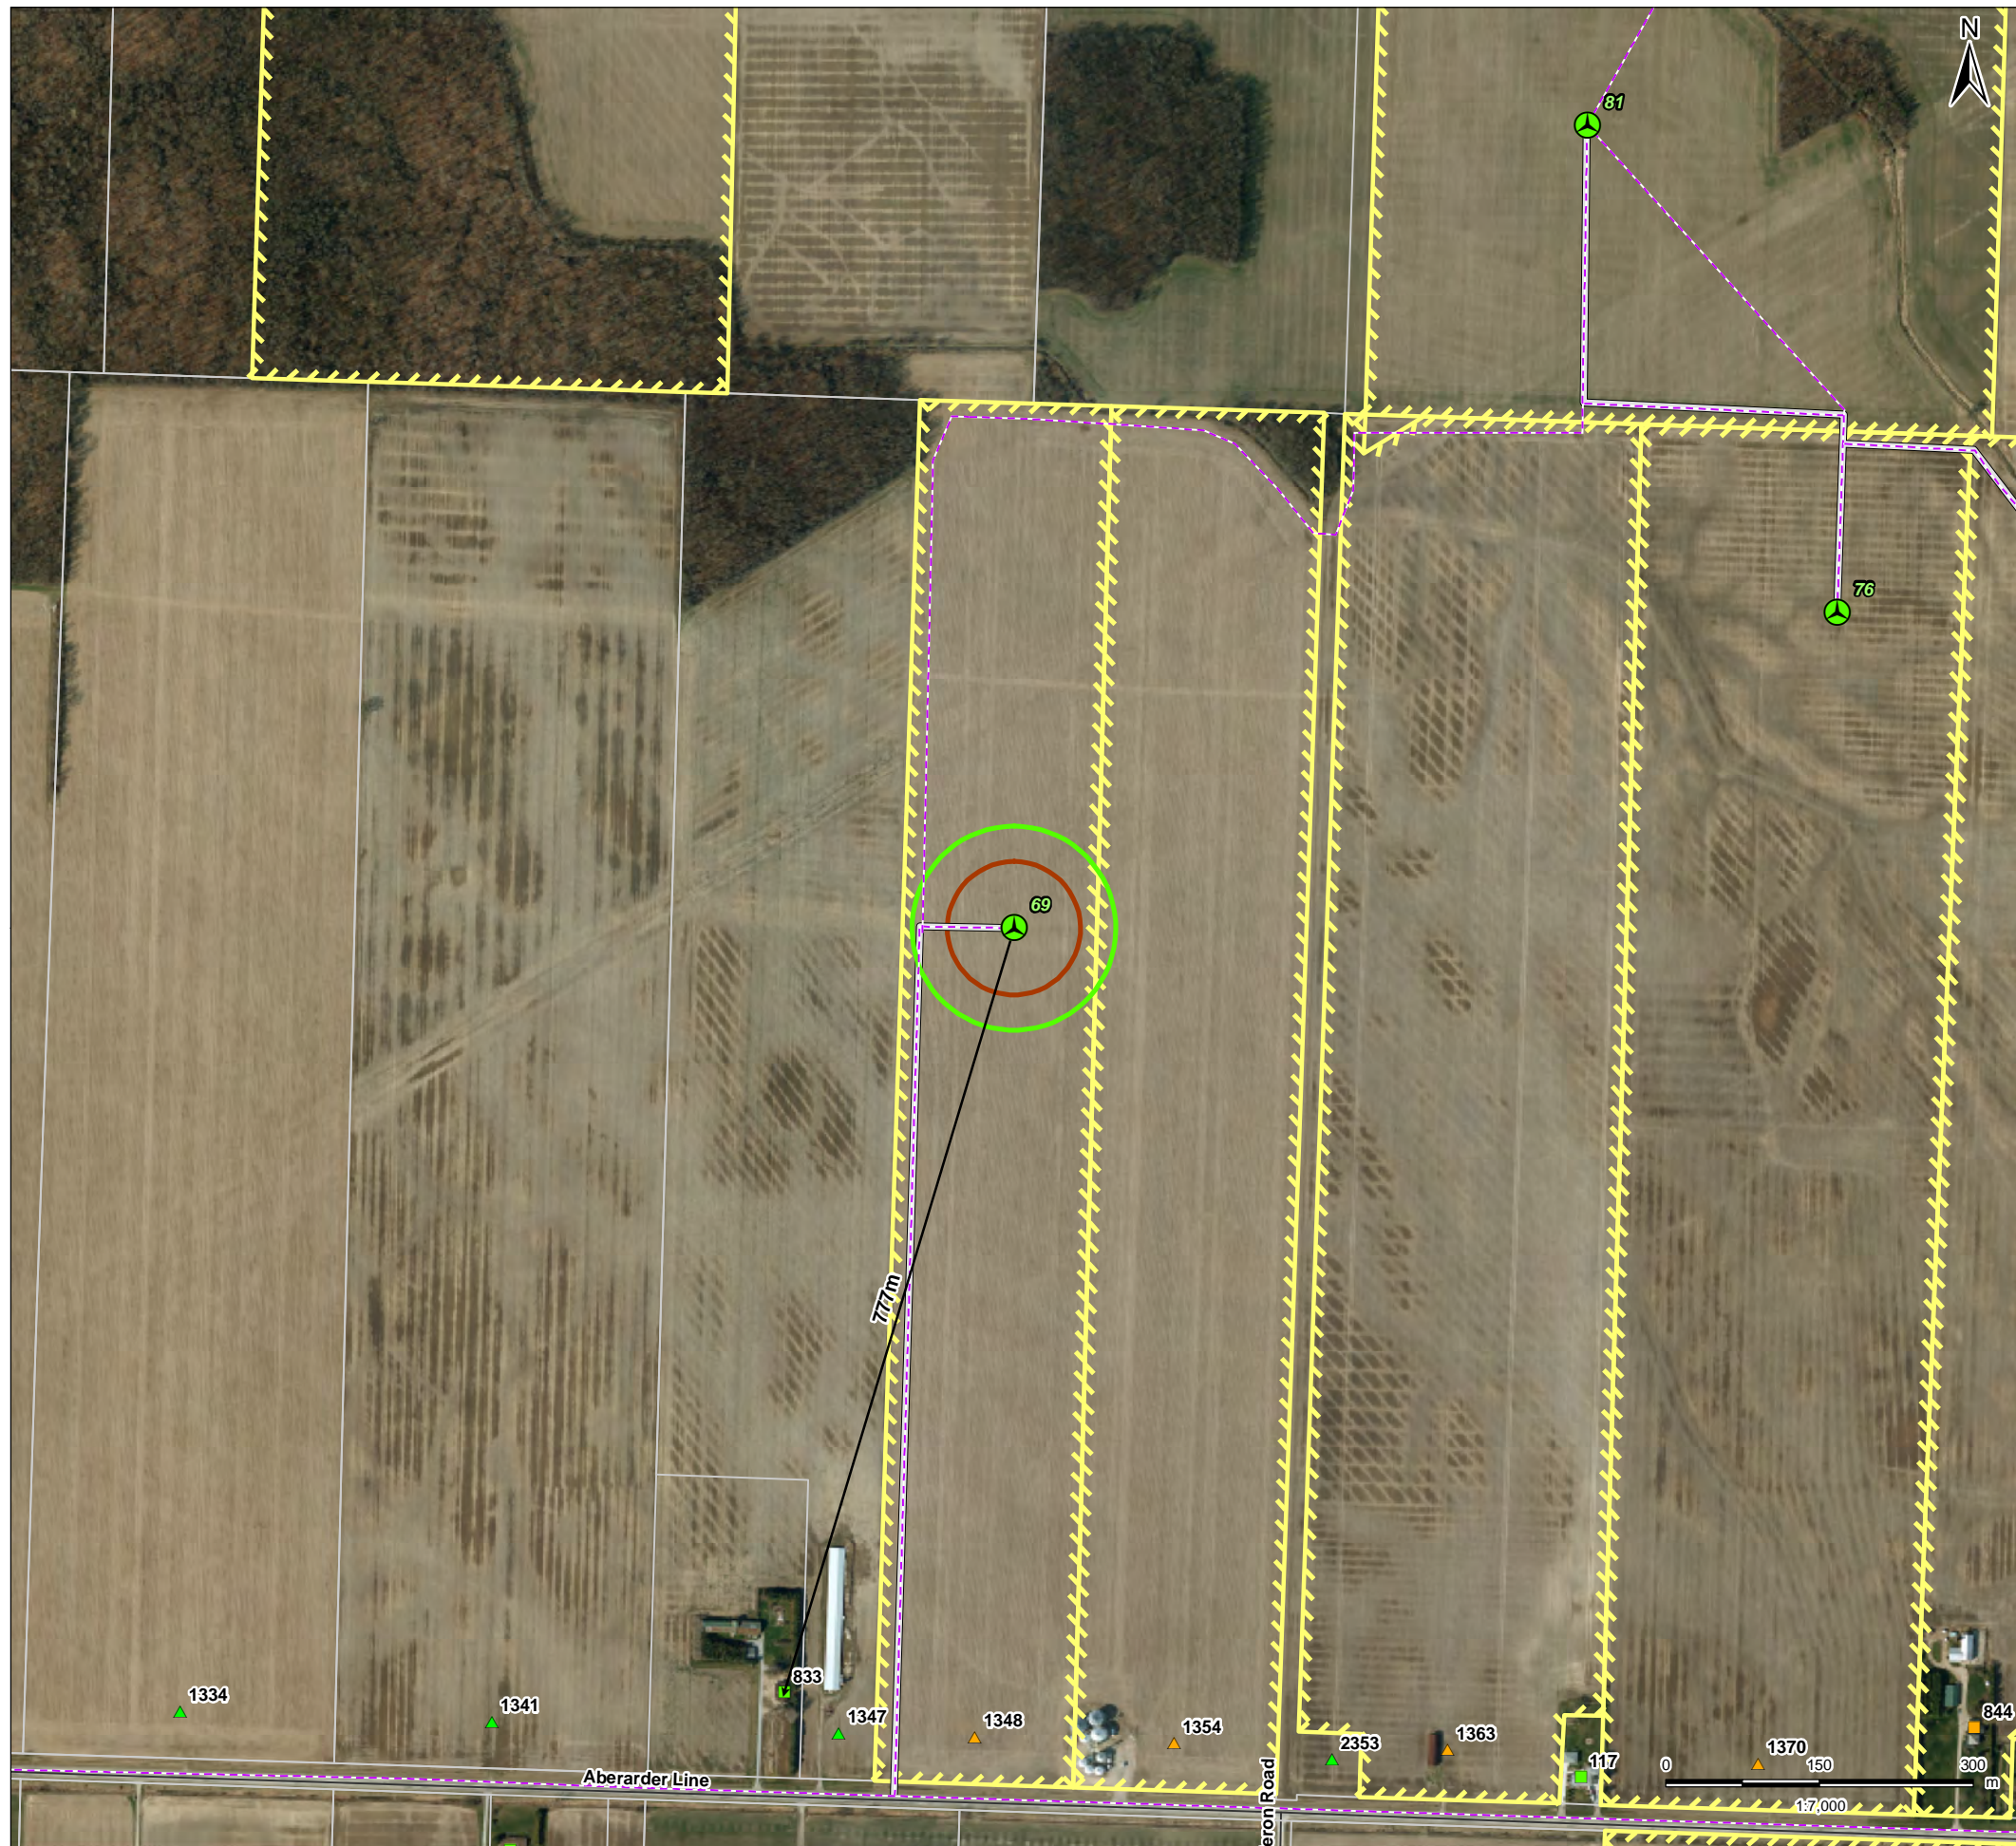
Figure No.
Turbine 69

Detailed Turbine Location

69	80.9	18.6	Infrastructure: <input type="checkbox"/> Land Use and Businesses: <input checked="" type="checkbox"/> Hedgerows: <input type="checkbox"/> Woodlots: <input type="checkbox"/> Watercourses: <input type="checkbox"/>	Potential adverse impacts to agricultural land, including crop damage, soil compaction and tile drainage damage may occur in the unlikely event of turbine collapse.	The turbines would be constructed and designed by professional engineers, undergo regular maintenance and monitoring by operational staff, and contain shutdown mechanisms in instances such as extreme weather or malfunction. In the unlikely event of damage to agricultural land due to turbine collapse, landowners would be compensated by Suncor for any crop damage, soil compaction would be remediated and damaged tile drains (if any) would be repaired.
70	86.9	12.6	Infrastructure: <input type="checkbox"/> Land Use and Businesses: <input checked="" type="checkbox"/> Hedgerows: <input type="checkbox"/> Woodlots: <input type="checkbox"/> Watercourses: <input type="checkbox"/>	Potential adverse impacts to agricultural land, including crop damage, soil compaction and tile drainage damage may occur in the unlikely event of turbine collapse.	The turbines would be constructed and designed by professional engineers, undergo regular maintenance and monitoring by operational staff, and contain shutdown mechanisms in instances such as extreme weather or malfunction. In the unlikely event of damage to agricultural land due to turbine collapse, landowners would be compensated by Suncor for any crop damage, soil compaction would be remediated and damaged tile drains (if any) would be repaired.

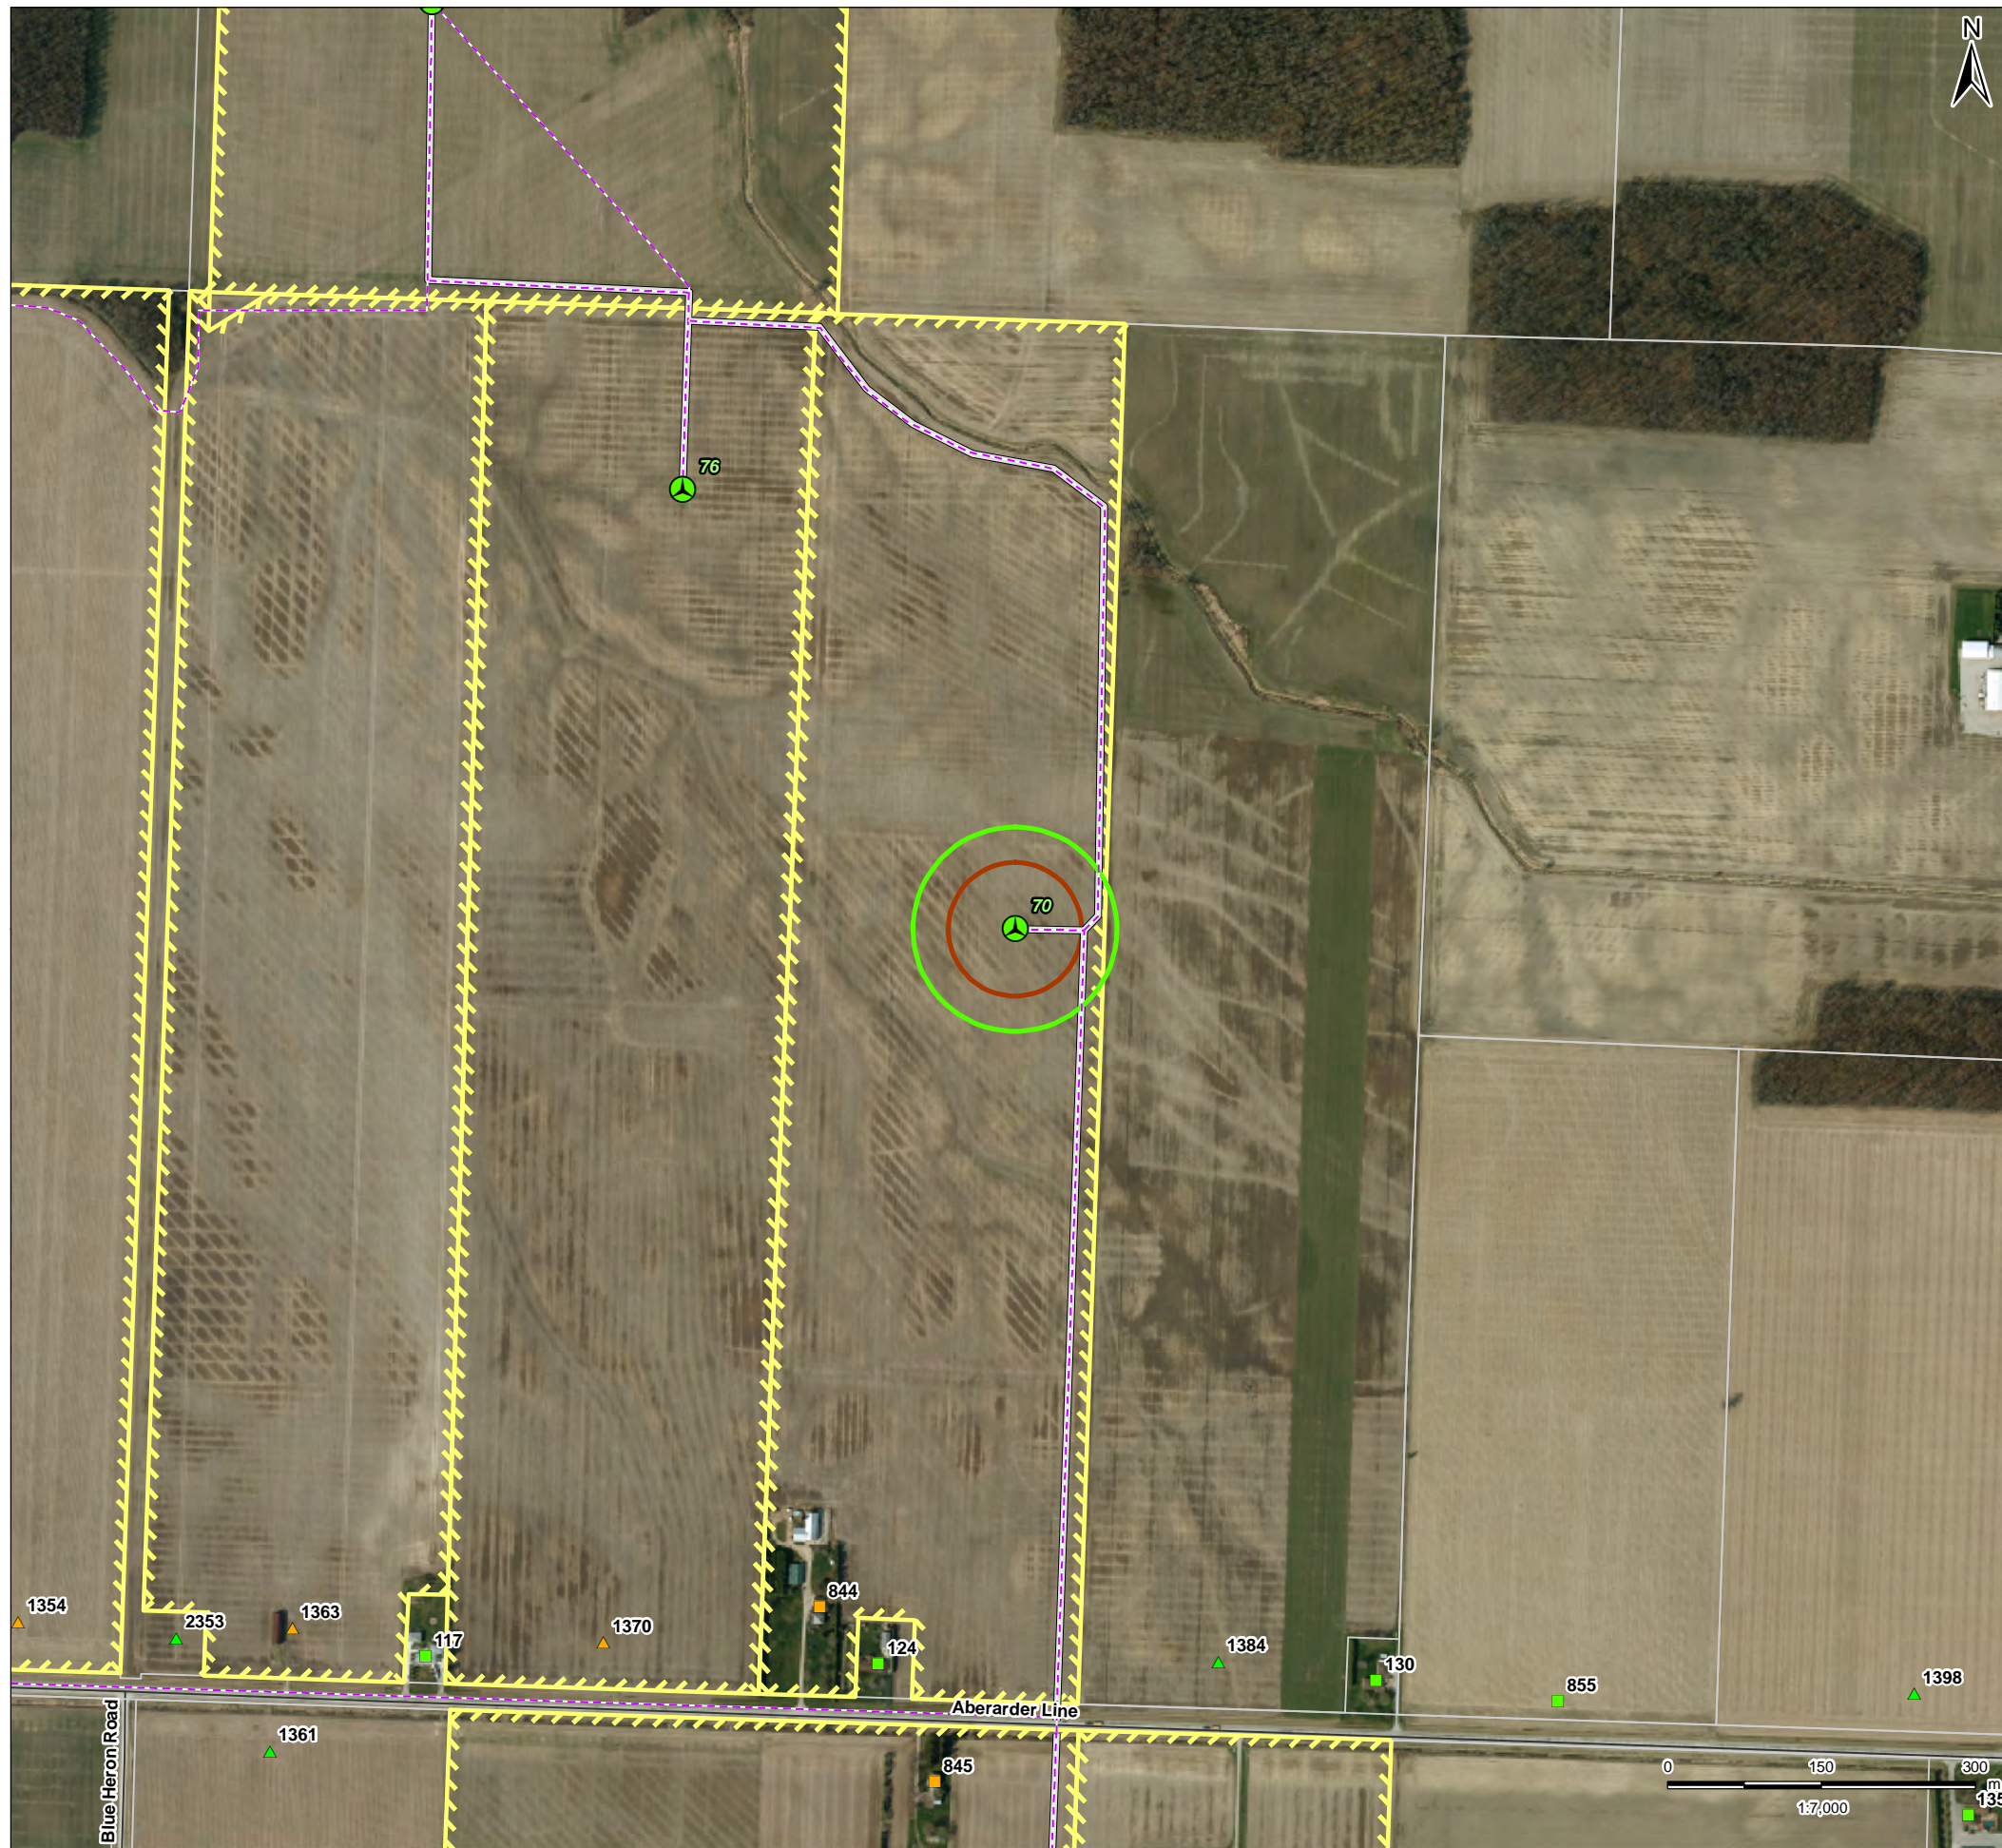
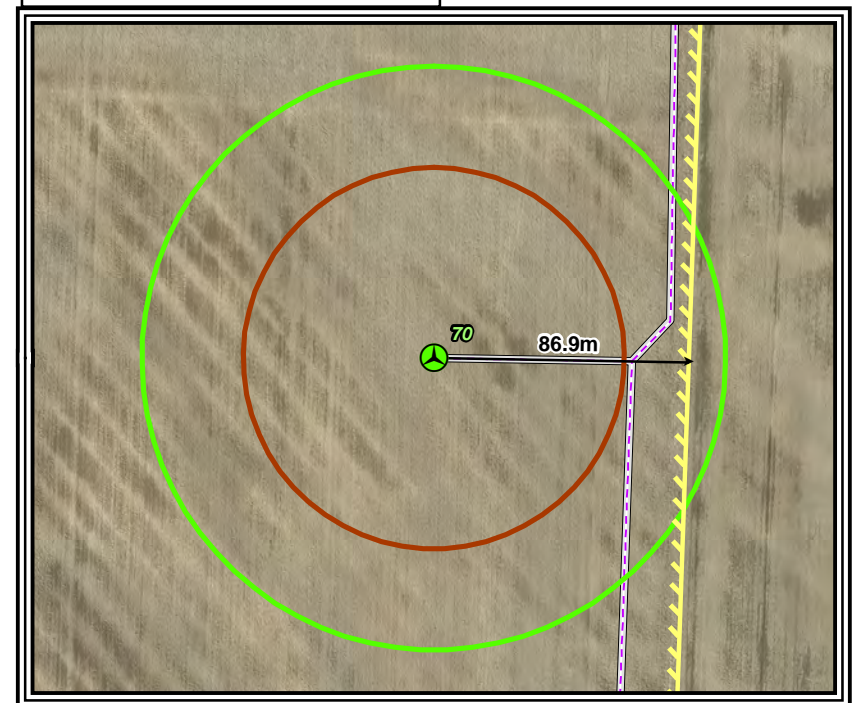
Figure No.
Turbine 70

Detailed Turbine Location
