**SUNCOR ENERGY CEDAR POINT
WIND POWER PROJECT
PROPERTY LINE SETBACK ASSESSMENT
REPORT**

File No. 160960709
April 2013

**Figures: Individual Turbine Locations and
Property Line Setbacks**

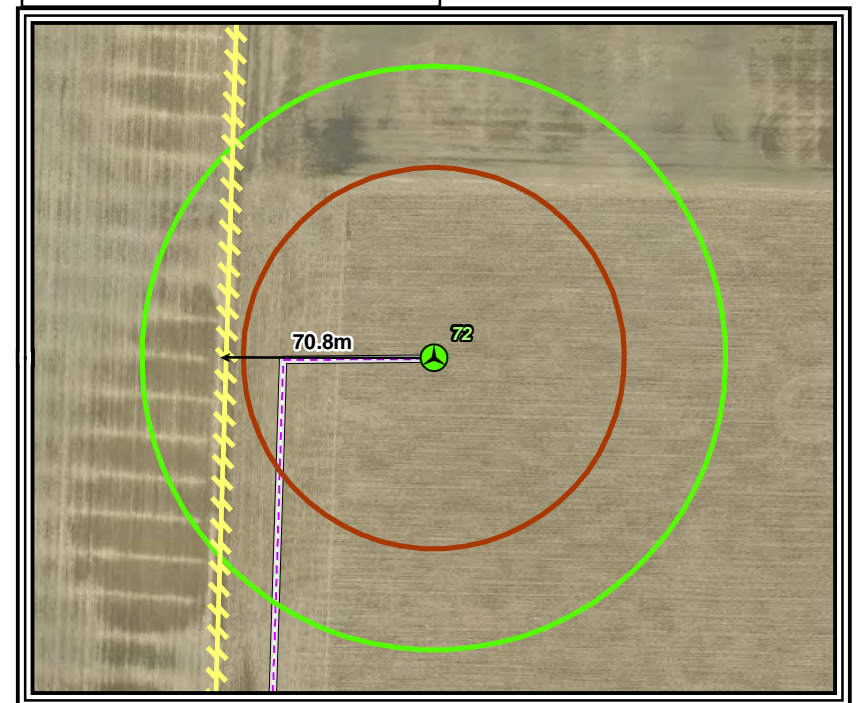
Figure No.
Turbine 72

Detailed Turbine Location

Turbine ID	Distance to Property Line (m)	Distance of Overlap (m)	Features Within Overlap	Potential Adverse Impacts	Preventative Measures
72	70.8	28.7	Infrastructure: <input type="checkbox"/> Land Use and Businesses: <input checked="" type="checkbox"/> Hedgerows: <input type="checkbox"/> Woodlots: <input type="checkbox"/> Watercourses: <input type="checkbox"/>	Potential adverse impacts to agricultural land, including crop damage, soil compaction and tile drainage damage may occur in the unlikely event of turbine collapse.	The turbines would be constructed and designed by professional engineers, undergo regular maintenance and monitoring by operational staff, and contain shutdown mechanisms in instances such as extreme weather or malfunction. In the unlikely event of damage to agricultural land due to turbine collapse, landowners would be compensated by Suncor for any crop damage, soil compaction would be remediated and damaged tile drains (if any) would be repaired. * Neighbouring property is a participating occupied lot.

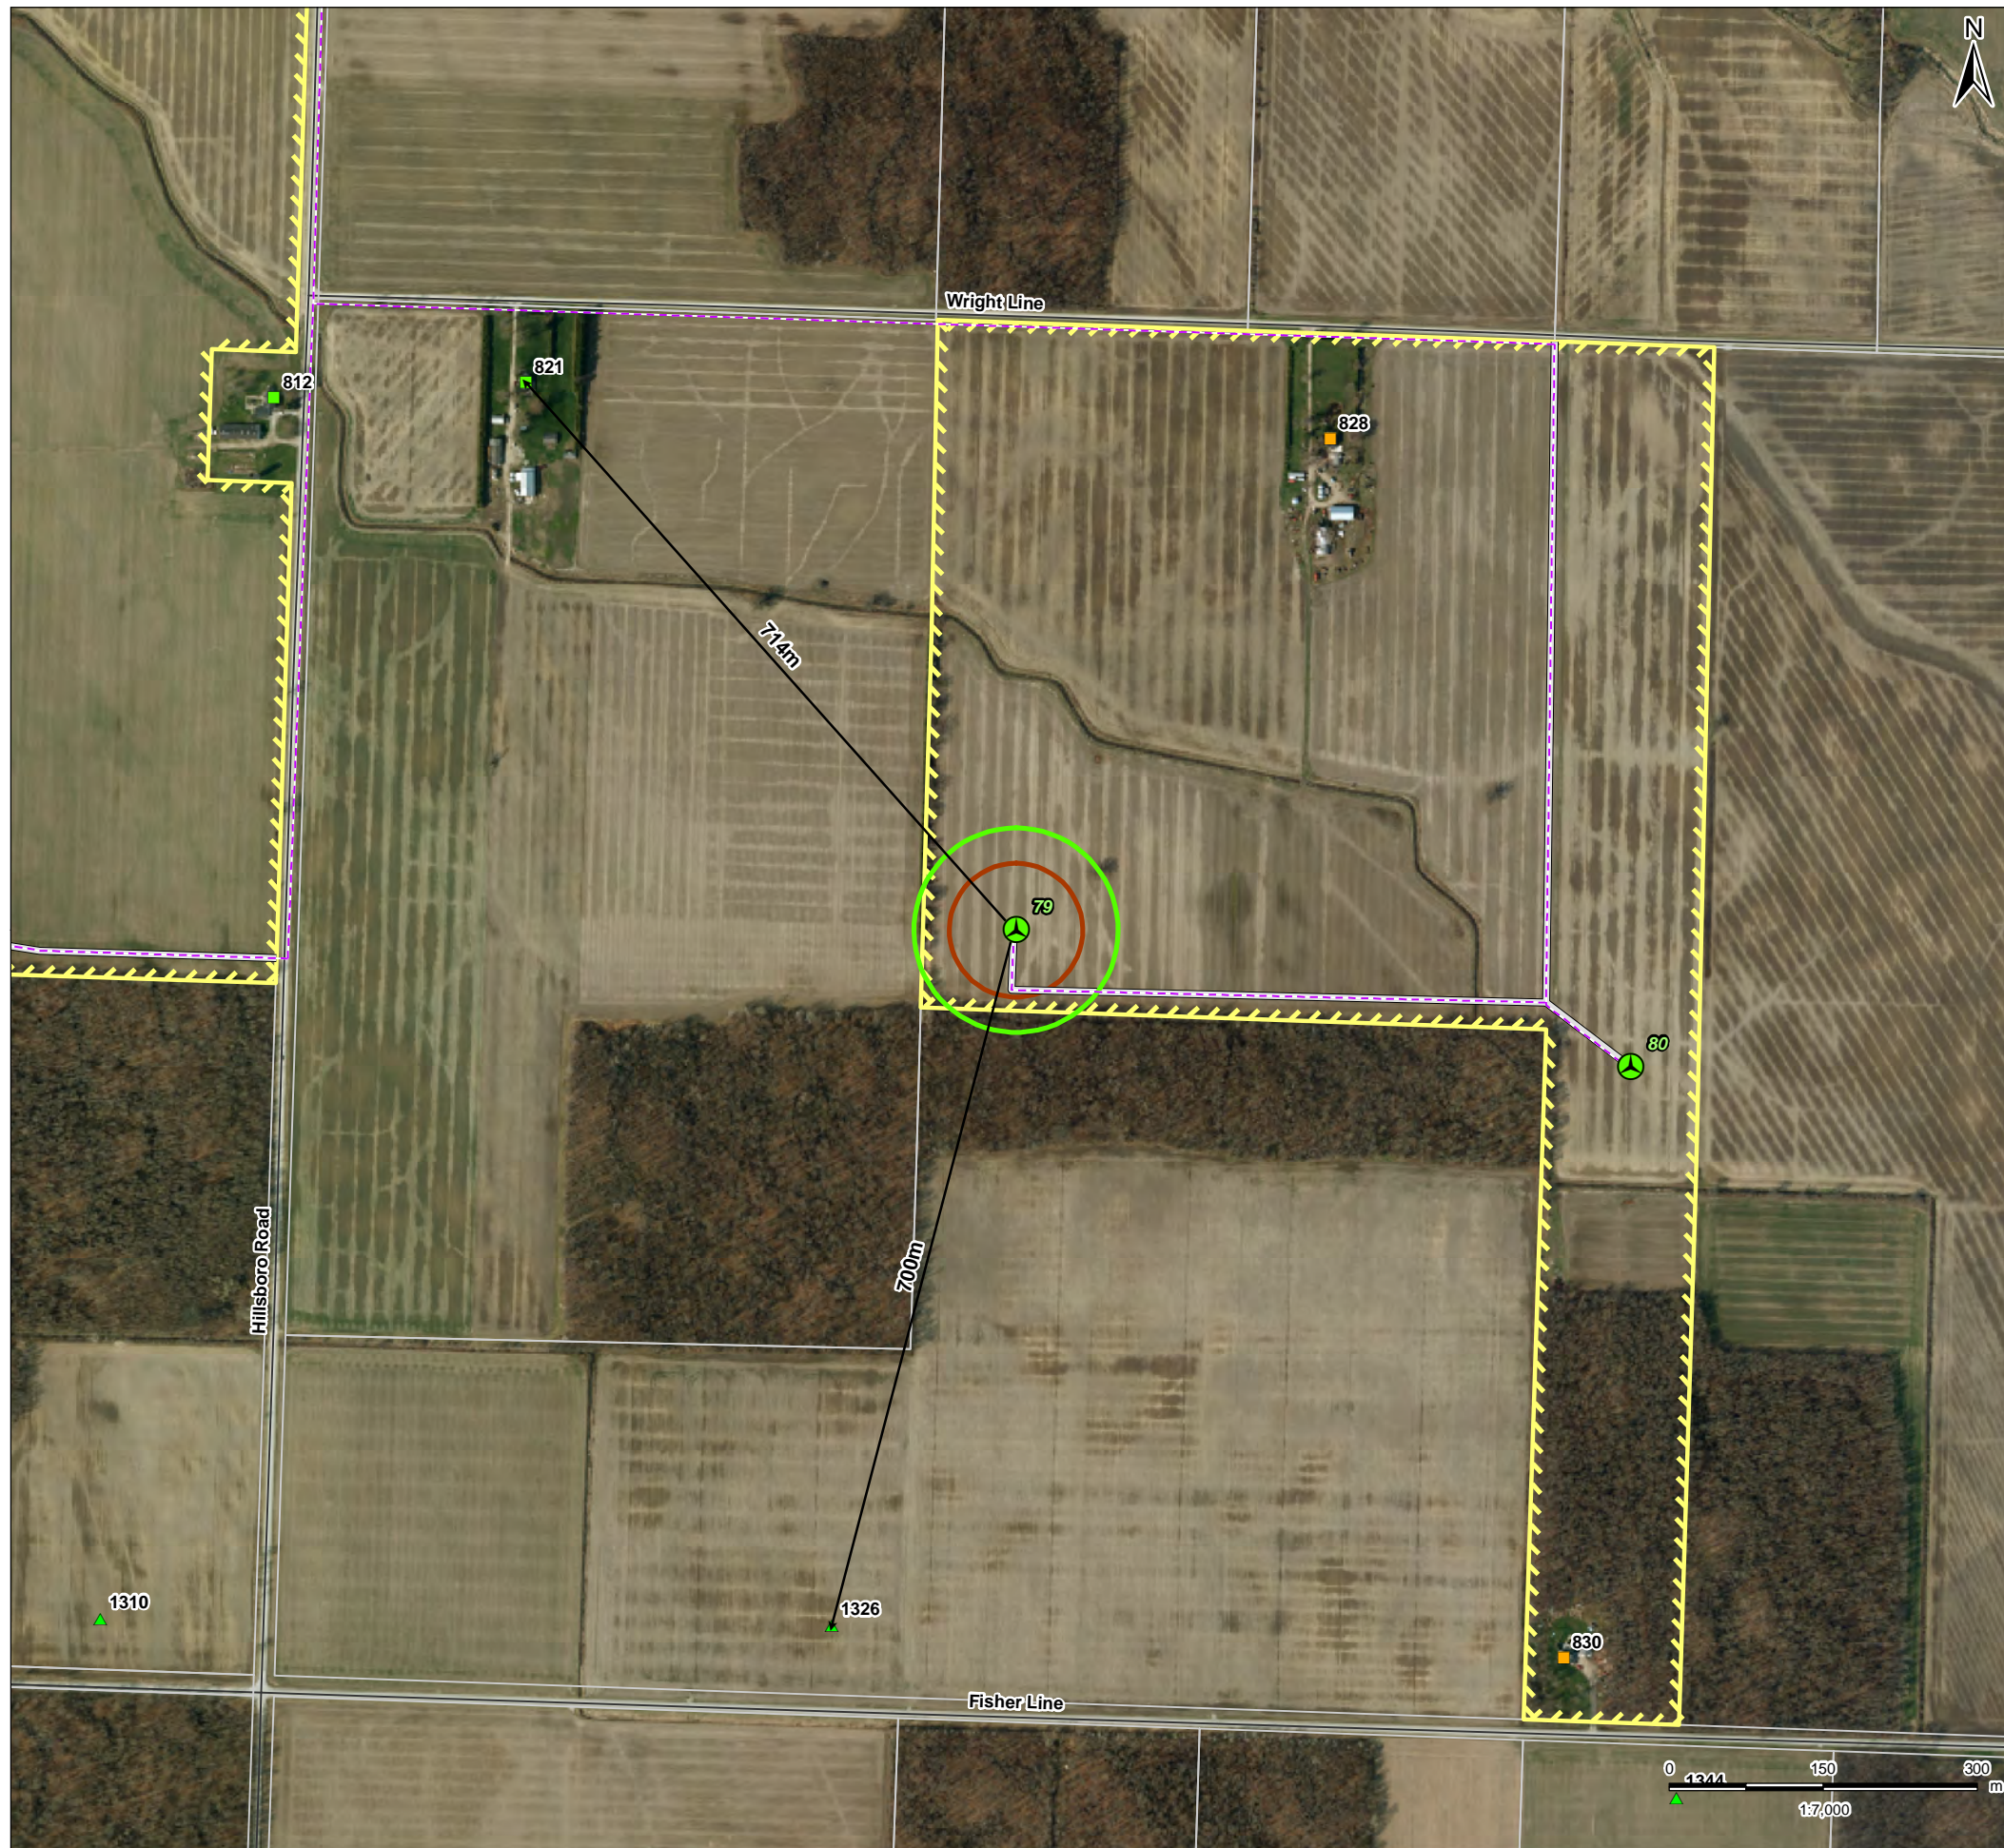
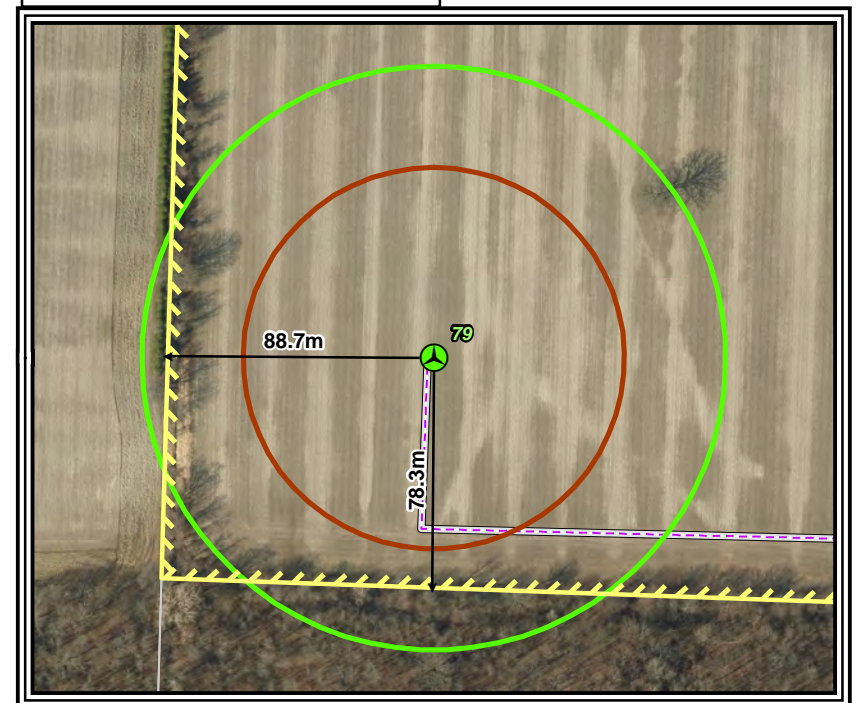
Figure No.
Turbine 79

Detailed Turbine Location

79	78.3	21.2	Infrastructure: <input type="checkbox"/> Land Use and Businesses: <input type="checkbox"/> Hedgerows: <input type="checkbox"/> Woodlots: <input checked="" type="checkbox"/> Watercourses: <input type="checkbox"/>	Potential damage to natural features within the adjacent woodlot. Damage to the woodlot would be limited to less than 1% of the total area of the woodlot and the impact would not be considered significant to the overall function of the woodlot.	The turbines would be constructed and designed by professional engineers, undergo regular maintenance and monitoring by operational staff, and contain shutdown mechanisms in instances such as extreme weather or malfunction. Damaged trees and vegetation would be removed and the impacted land remediated to a similar condition to the extent practical.
79	88.7	10.8	Infrastructure: <input type="checkbox"/> Land Use and Businesses: <input checked="" type="checkbox"/> Hedgerows: <input type="checkbox"/> Woodlots: <input type="checkbox"/> Watercourses: <input type="checkbox"/>	Potential adverse impacts to agricultural land, including crop damage, soil compaction and tile drainage damage may occur in the unlikely event of turbine collapse.	The turbines would be constructed and designed by professional engineers, undergo regular maintenance and monitoring by operational staff, and contain shutdown mechanisms in instances such as extreme weather or malfunction. In the unlikely event of damage to agricultural land due to turbine collapse, landowners would be compensated by Suncor for any crop damage, soil compaction would be remediated and damaged tile drains (if any) would be repaired.
